Phase III Environmental Assessment

Venus Abandoned Mine Site

Final Report

Environmental Services
Public Works and Government Services Canada
Pacific & Western Regions

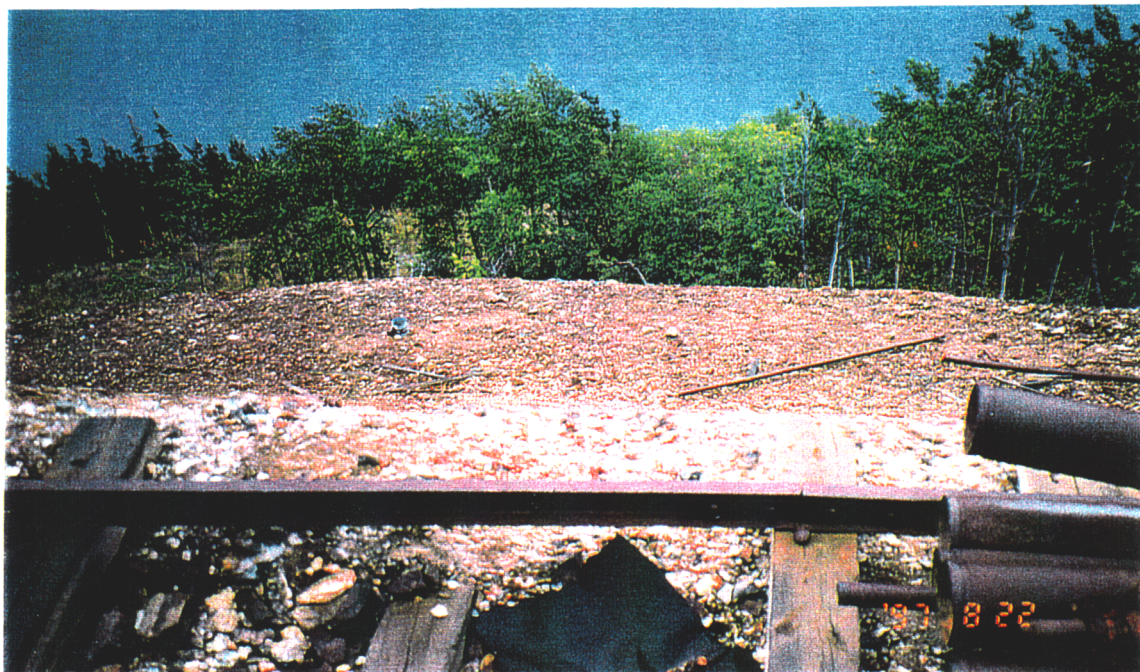
Photo #V1: Looking east down slope from adjacent to shack at north portion of area near adit 1. Note lower benches of waste rock and of access road. Note fallen pipes.

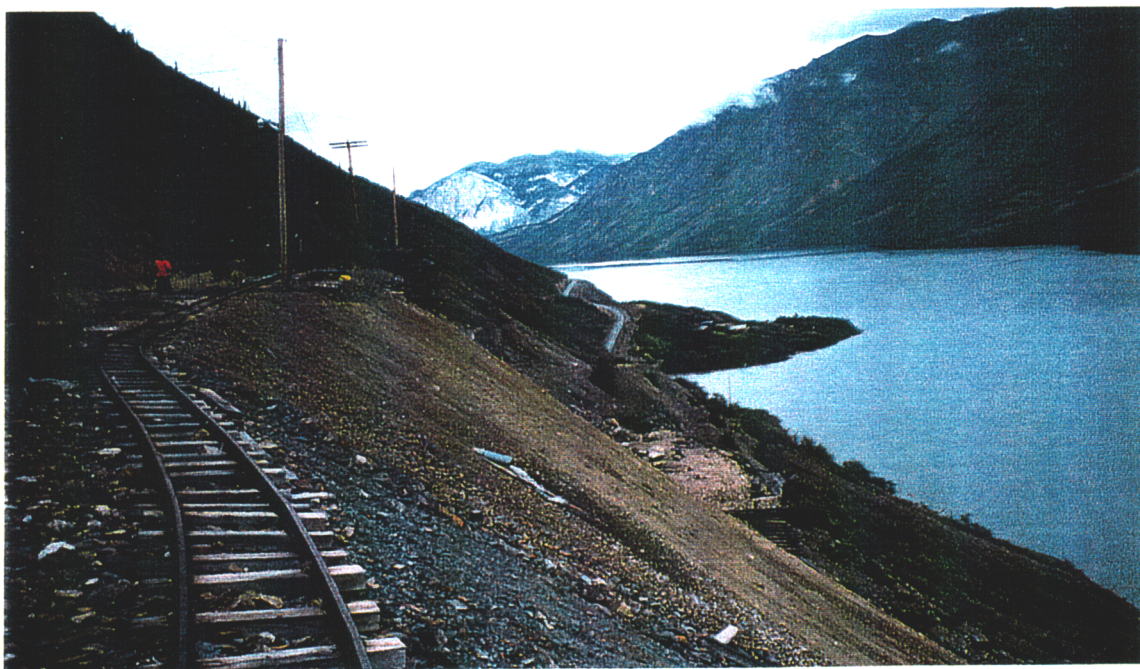
Photo #V2: Looking north along tracks at area of adit 2. Note culvert along waste rock pile slope; note lower retaining wall built of log cribbing.

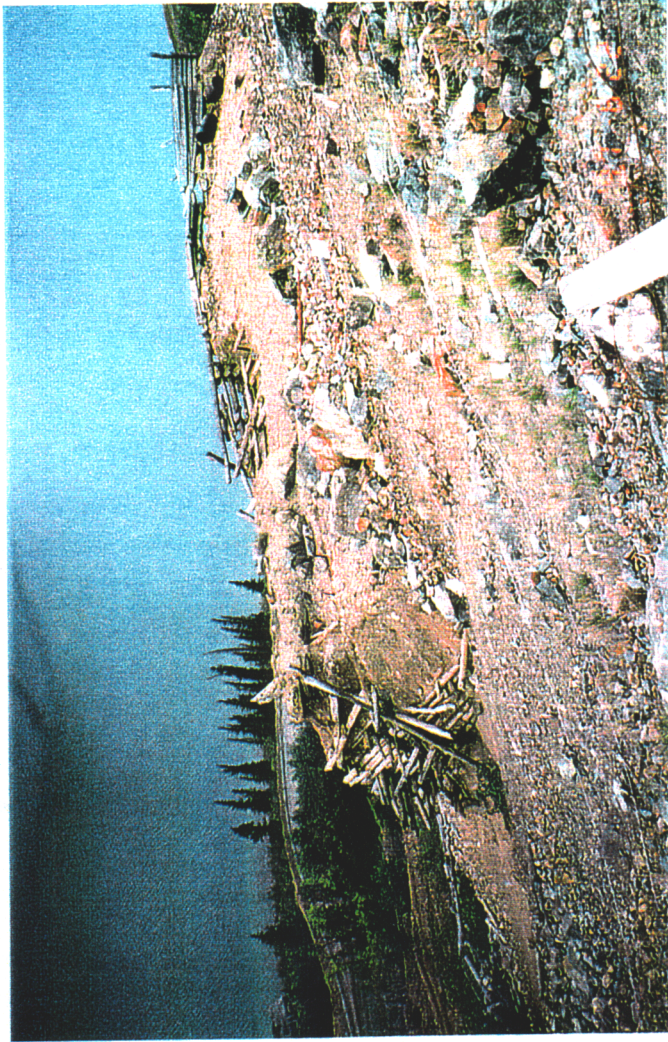
The more significant feature is the presence of unstable retaining walls along the waste rock slope. The walls are constructed with log cribbing and have shown natural degradation over the approximately 25 years of existence. The lower wall showed decay of the log cribbing and some failure at the joints along the edges. There was also extensive sloughing of the waste rock behind the wall, as well as tension cracks parallel to the wall. If the joints along the cribbing continue to fail to a point where the waste rock begins to deform and the strength within the remaining cribbing support is insufficient to restrain the waste rock from mobilizing downslope, it is uncertain that the benches below would prevent this materials from impacting the highway. The rate of failure is uncertain. This material is estimated to be approximately 500 m³.

Photo #V4: Looking south east at lower retaining wall. Note sloughing of waste rock material; note poor condition of log cribbing supports.

The most significant feature in the area of Adit 2 was the presence of relatively unstable retaining walls along the waste rock slope. These are illustrated in plan drawing 12953-12 and profile 12953-13 as well as in photos #V3 and #V4. Of particular note were the two retaining walls built in series along the waste rock pile slope shown as section B-B on drawings 12953-12 and 12953-13. These have been constructed with log cribbing and have shown natural degradation over their 25 or more year existence. With respect to the lower wall, the log cribbing itself showed some natural decay and there were some failures noted at the joints along the edges. There was also extensive sloughing of the waste rock behind the wall and tension cracks parallel to the wall. As the integrity of the wall and waste rock mass is undermined by natural decay and slight movements, a sudden failure may eventually occur leading to a large mass of waste rock mobilizing downslope. This could occur if the joints along the cribbing continue to fail to the point where the waste rock begins to deform and the strength within the remaining cribbing support is insufficient to restrain the waste rock mass from

Recommendation 1. The two retaining walls below Adits 1 and 2 should be intentionally failed to reduce the risk to the South Klondike Highway below the site. It is recommended that the material behind the retaining walls be relocated to the bench area near Adit 2.

1. In regards to the two retaining walls located in the area of Adit 2, it is recommended to intentionally fail these structures to reduce the risk of a future impact on the South Klondike Highway. This could be accomplished by implementing option 1 which involves constructing a catchment area to restrain the fallen waste rock from extending to the highway during the demolition. The fallen waste rock would be moved from the catchment area in a stepwise fashion and hauled to a suitable disposal site within a close proximity to the Venus Mine Site. A second option to demolish these retaining walls would involve relocating the material behind the retaining wall to the bench area near adit 2. As requested, Class 'D' cost estimates to an accuracy of +/- 25% has been prepared and is enclosed under separate cover.
