KIJO
SITE #23
MINFILE# 105M001aa

5.1 Mine Openings and Excavations

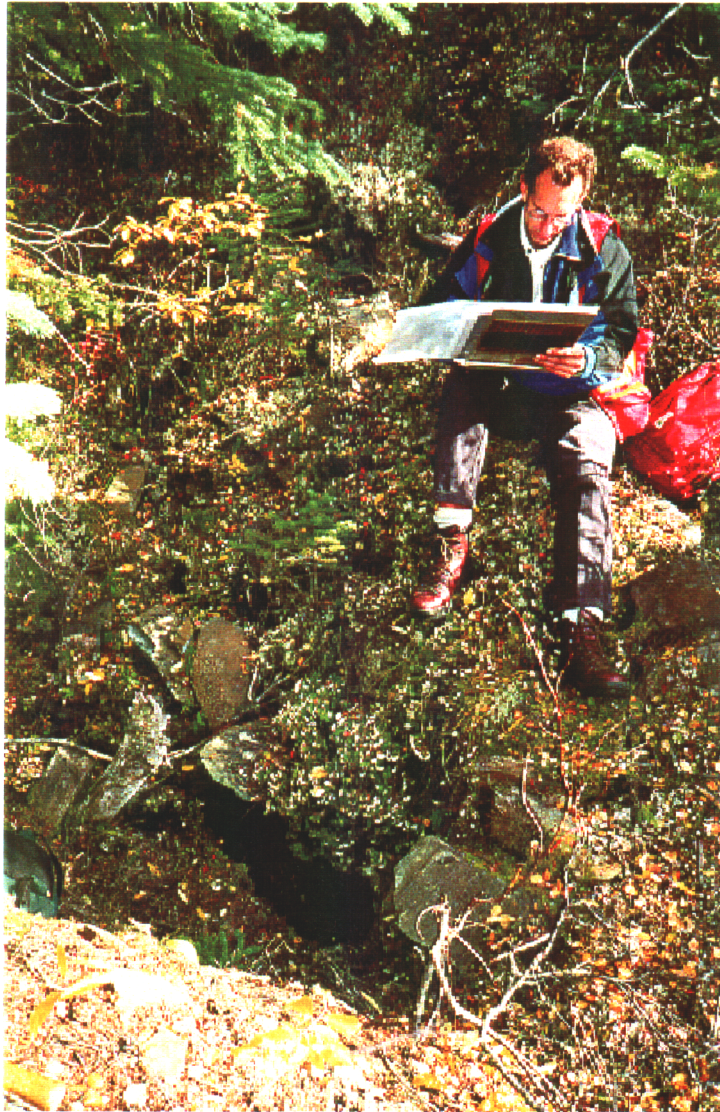
Lower Adit/Trench (photo 23-1)

The trench is oriented at 030°. The trench and portal is overgrown with trees and shrubs. The lower portal area is caved; there is a small opening into the adit.

Supports: Likely wood or rock; however, it is not clear as adit has collapsed and is re-vegetated. It is not clear from the small opening found onsite.

Condition: The adit is collapsed, and the trench appears to be safe. The trench has been reclaimed by shrubs and other bush.

Accessibility: The trench is overgrown but can still be accessed by foot. The adit has partially collapsed and the opening is too small to access the adit.

Photo 23-1: Caved lower portal area; note small opening below mapper's feet and natural revegetation of the site. Photo Direction (Azimuth 040°)

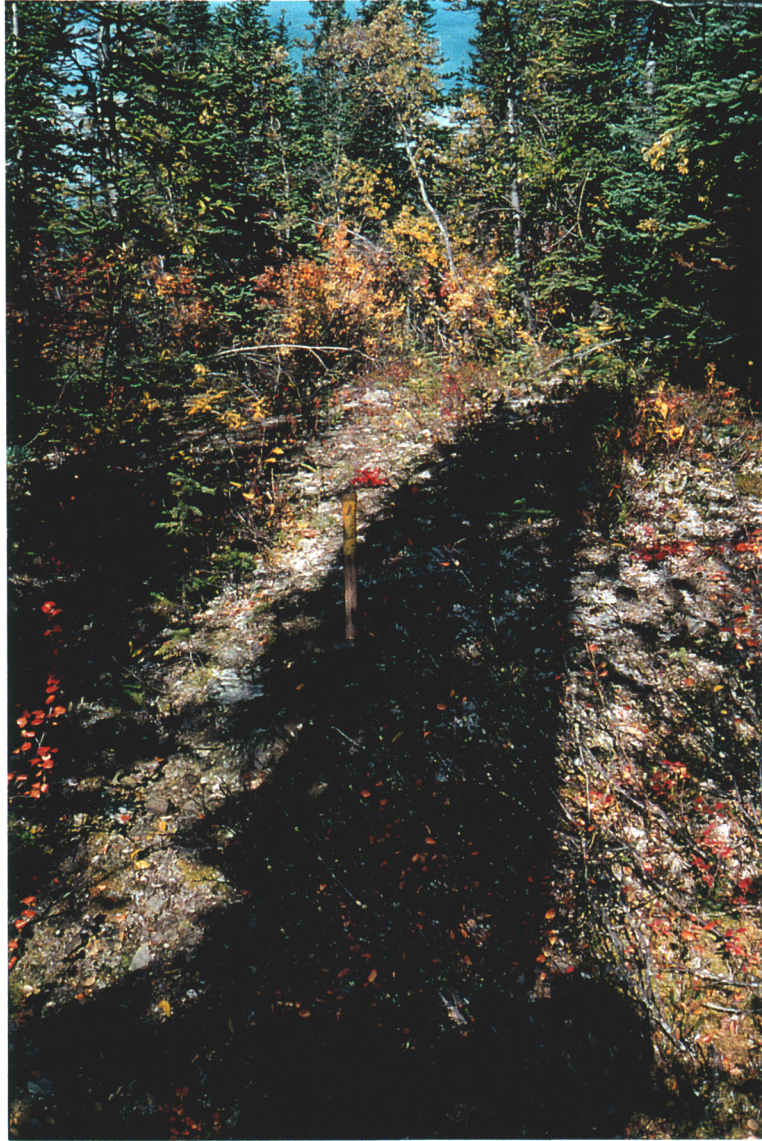
Waste rock pile #2 (photo 23-2)

Waste rock in this pile is from the lower adit/trench. The waste material is composed of overburden, soil, and trenched bedrock. Revegetation of trees and bushes are growing on the waste rock pile. No surface water runoff was noted. No sign of oxidation was noted on the rock pile.

Location: Waste rock was deposited just outside the southern end of the lower trench.

Dimensions (L x W x H): 20m x 3m x 1m

Photo 23-2: Rock dump from lower trench and adit. Note heavy natural revegetation. Photo Direction(Azimuth 340°)

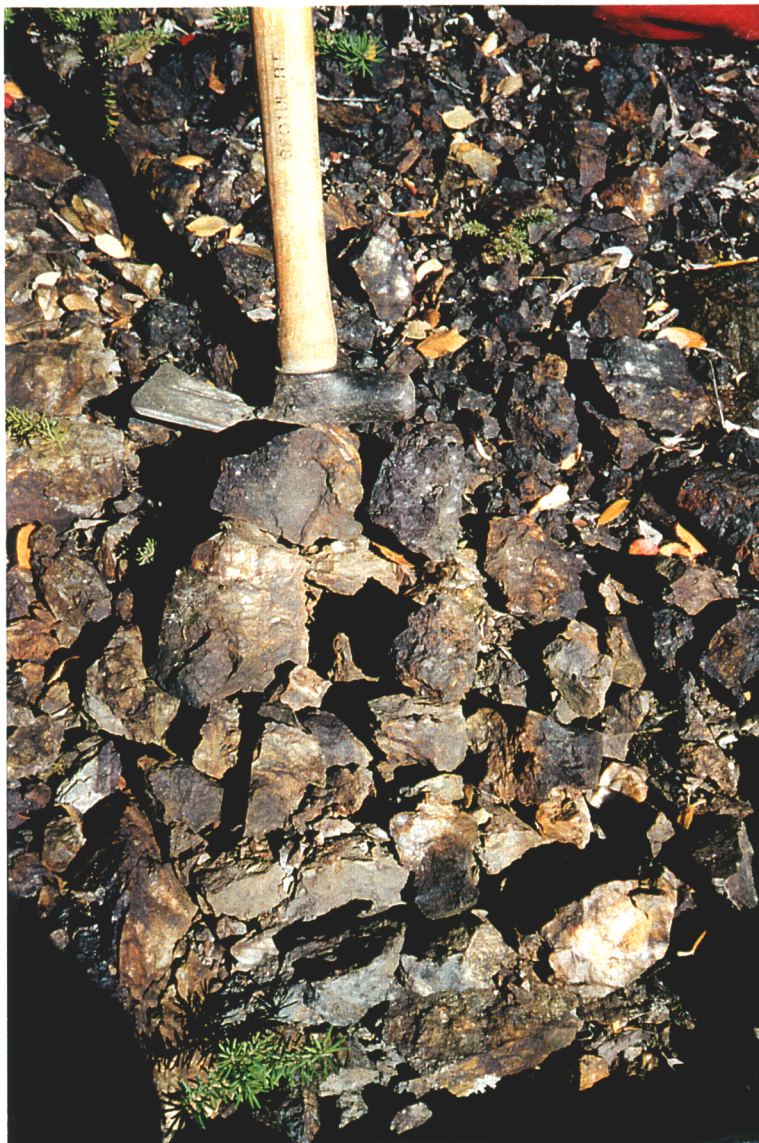
Ore Stockpile #1 (photo 23-3)

The small ore stockpile is composed of strongly weathered semi-massive galena, tetrahedrite, siderite quartz vein. The ore was extracted from the middle adit/trench. No surface water runoff was noted. Oxidation on the ore rock was observed.

Location: The stockpile is located 8m to the southwest from the southwestern end of the trench.

Photo 23-3: Close-up of strongly weathered, semi-massive galena-tetrahedrite siderite-quartz vein ore stockpile material (5m x 3m x 0.5m).

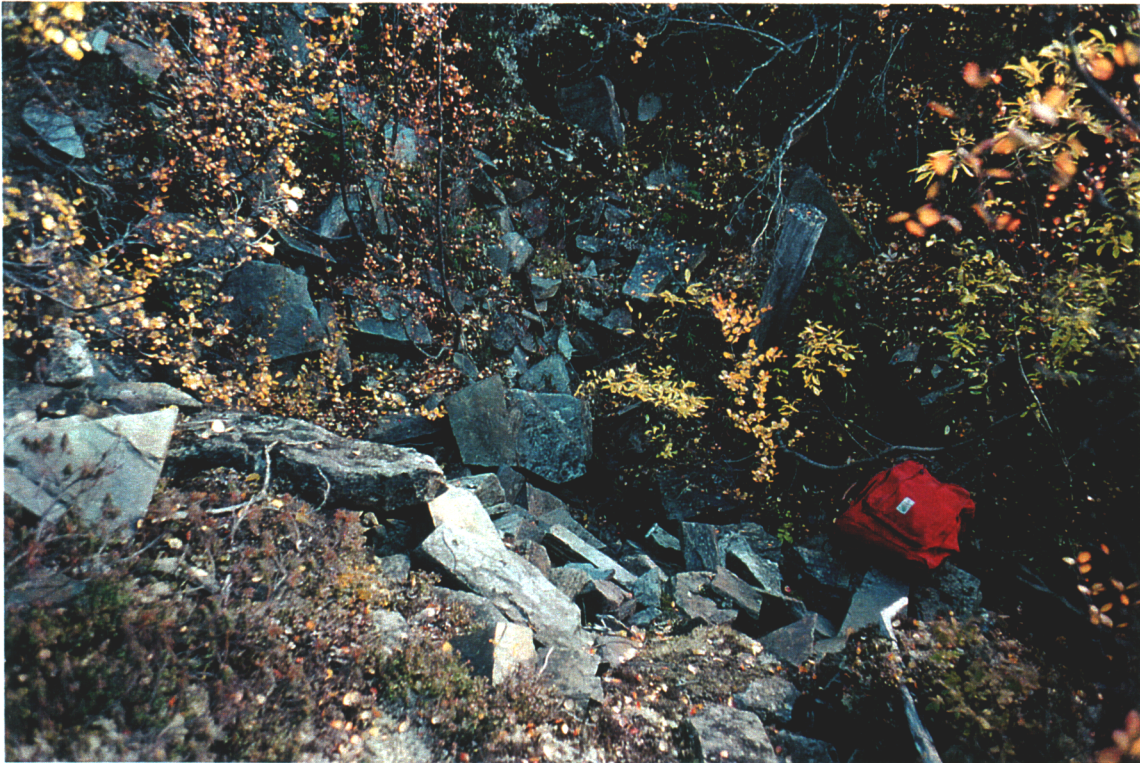
Middle Adit/Trench (photo 23-4)

The trench is oriented at 070°. The trench is overgrown with trees and shrubs. Timber used to construct the portal protrudes from angular colluvial greenstone boulders in the trench.

Supports: Likely wood or rock; however, the adit has collapsed and is re-vegetated. A portal timber was noted (see photo).

Condition: The adit is collapsed and not visible, and the trench appears to be safe. The trench has been reclaimed by shrubs and other bush.

Photo 23-4: Collapsed middle trench and adit area. Note portal timber above pack protruding from angular colluvial greenstone boulders.
Photo Direction (Azimuth 150°)

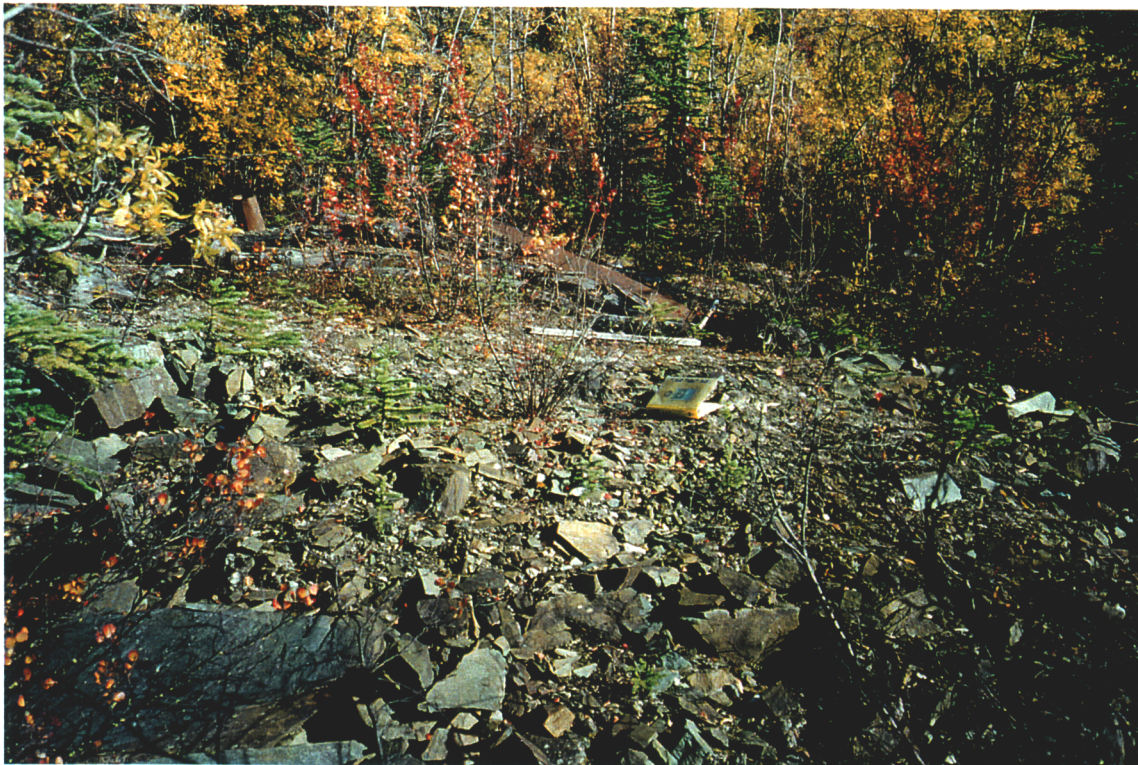
Waste rock pile #1 (photo 23-6)

Waste rock in this pile is from the upper adit/trench. The waste material is composed of roughly 80% overburden, soil, and coarse angular boulders. Revegetation of trees and bushes are growing on the waste rock pile. No surface water runoff was noted. No sign of oxidation was noted on the rock pile.

Location: The waste rock was deposited just outside the southwestern end of the upper trench.

Dimensions (L x W x H): 18m x 4m x 2m

Photo 23-6: Rock dump from upper trench and adit (18m x 4m x 2m). Material comprised of approximately 80% colluvial soil and angular greenstone boulders.
Photo Direction (Azimuth 120°)

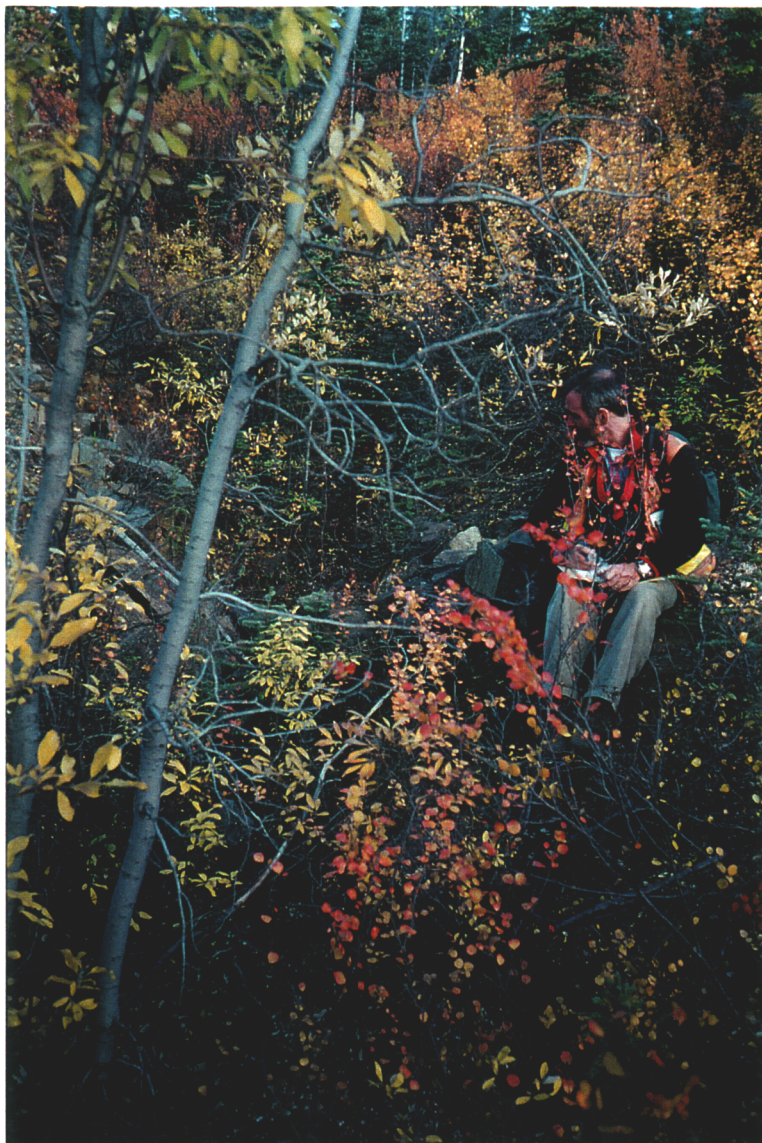
Upper Adit/Trench (photo 23-5)

The trench is oriented at 070°. The trench is overgrown with trees and shrubs. A colluvial rock pile composed of small boulders is deposited at the south end of the trench. The adit is collapsed and is not a safety risk. Vegetation has re-claimed the area.

Stability: The walls appear to be relatively stable (some loose rock).

Condition: The adit is collapsed and not visible, and the trench appears to be safe. The trench has been reclaimed by shrubs and other bush.

Accessibility: The trench is overgrown but can still be accessed by foot. The adit has collapsed and cannot be accessed.

Photo 23-5: Collapsed upper trench and adit area.
Photo Direction (Azimuth 120°)
