GOLD HILL NUMBER 2

SITE #37

MINFILE# 105M 001au

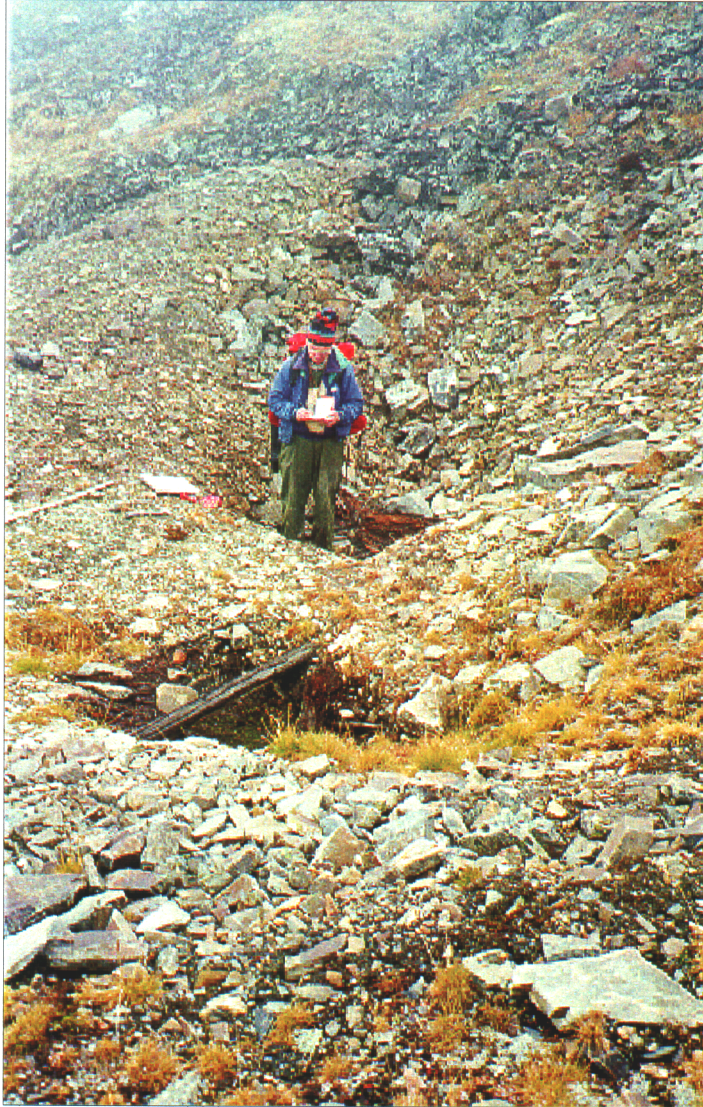
Gold Hill Number 2/Discovery Shaft (photo 37-1)

At the northeast end, beside the Discovery Showing, of the site is a 1.5m by 1.5m collapsed shaft. Waste and mineralized dump material beside the timbered collapsed discovery shaft suggest it is about 3m deep.

Supports: Log cribbing was used to support the collar of the shaft.

Condition: The log cribbing has rotted and the shaft is collapsed.

Accessibility: The shaft cannot be accessed.

Photo 37-1 : Gold Hill No. 2. View of the Discovery shaft and showing. (Azimuth 320°)

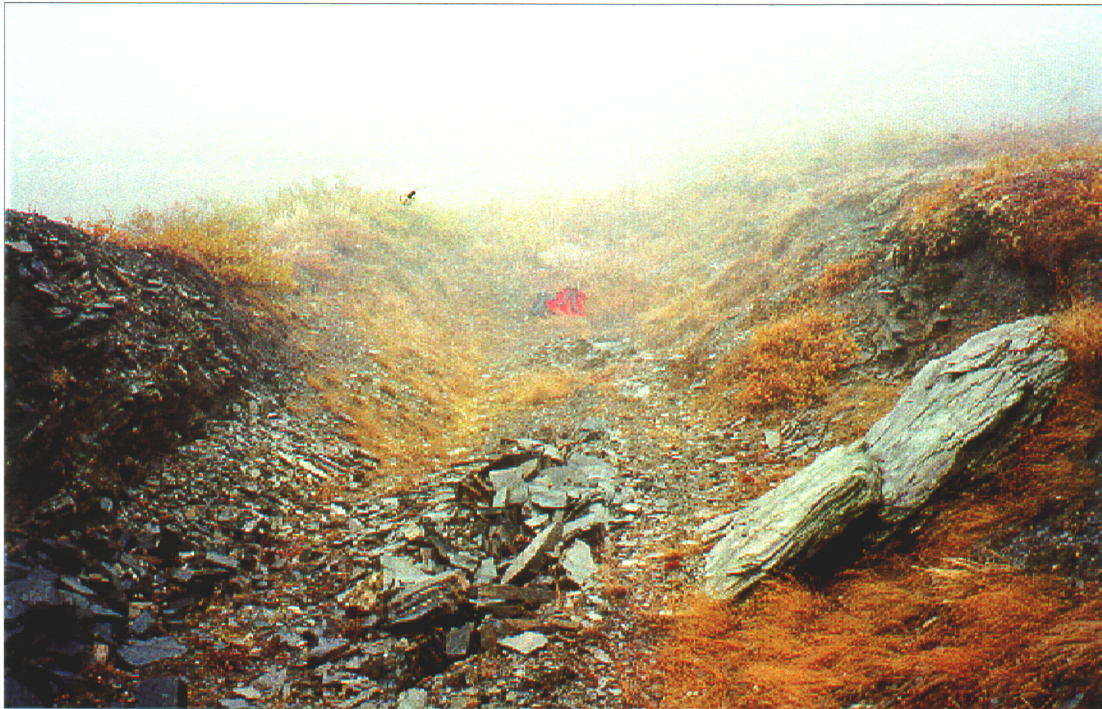
Trenches (photo 37-2)

There are twelve trenches at this site. The trenches are excavated from the Discovery Shaft and to the southwest for roughly a kilometer. The trenches range in size from 15m to 63m in length, 1m to 12m in width and 1m to 8m in depth. The gentle to moderately sloped walls of the trenches do not pose any stability concerns. All of the trenches could be easily accessed.

Photo 37-2 : Gold Hill No.2. View of Trench #5. (Azimuth 340°)

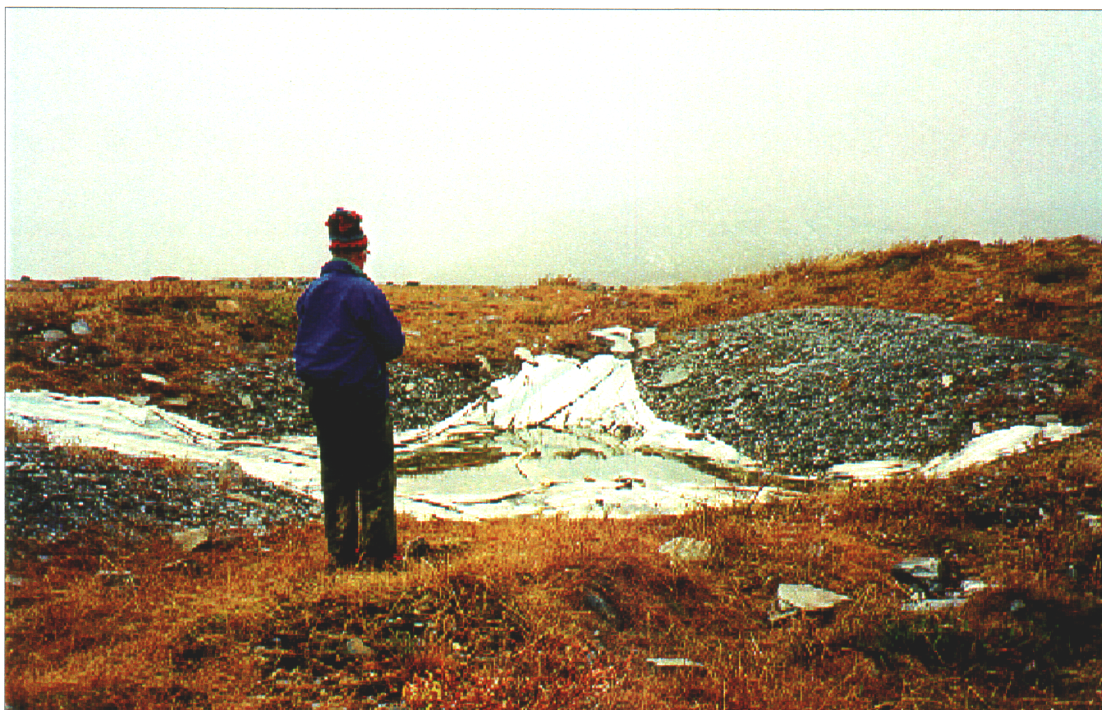
There are no buildings at the Gold Hill Number 2 site. On the western side of the Monument Hill Trail, there is a 10m x 10m x 2.5m sump (photo 37-3) lined with old style geotextile that was used for holding drill water. A hose leads from the sump to a metal tank at trench #4 (photo 37-4). No other mine site infrastructure was encountered at the site.

There was no water in any of the trenches at the time of the site visit. A lined pond (photo 37-3) is located to the west of the Monument Hill Trail.

Photo 37-3 : Gold Hill No.2. Lined sump used for holding water for diamond drilling.
(Azimuth 280°)

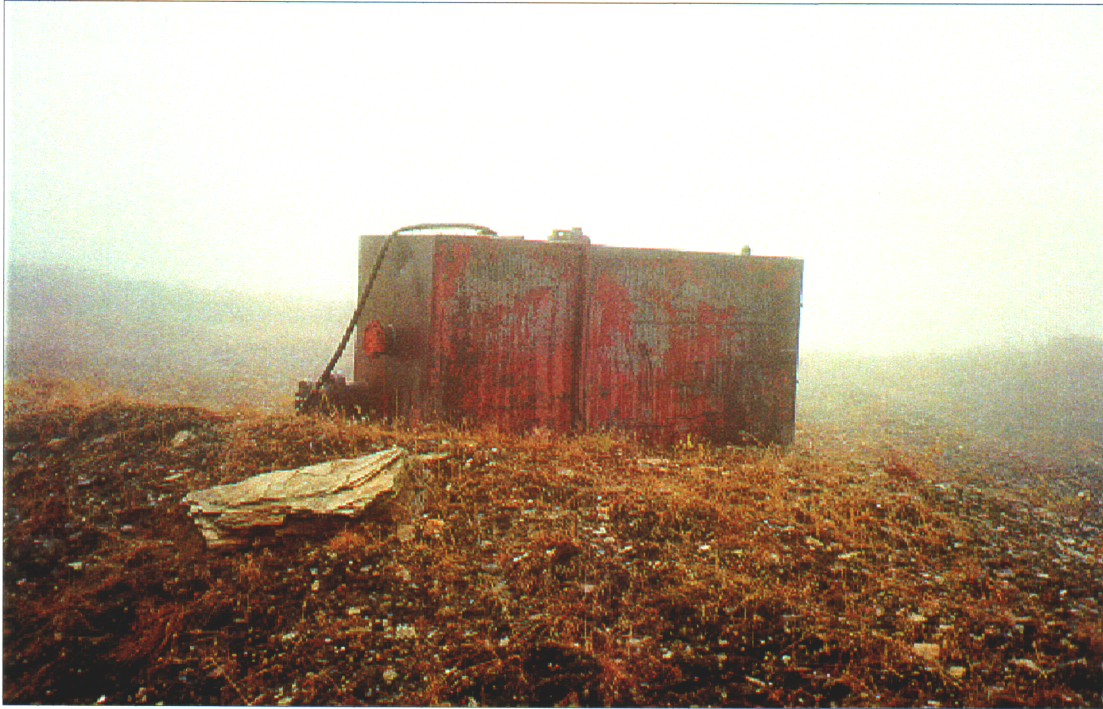
Photo 37-4 : Gold Hill No.2. Metal water tank near Trench #4. (Azimuth 212°)
