FOX
SITE #38
MINFILE#105M 001av

1. LOCATION AND ACCESS

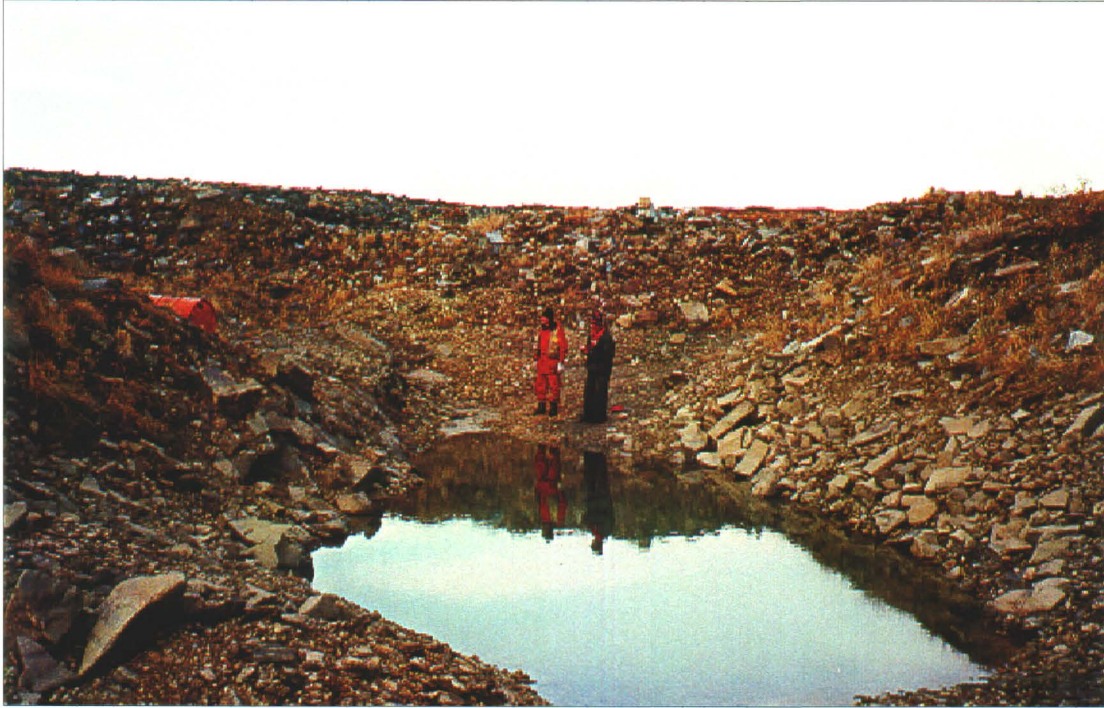
Trench #1 (photo 38-1)

Trench 1 is oriented to the north-northwest. There is a 2m quartz vein near the north end. The bottom of the trench is filled with 0.5m of water.

Condition: The trench walls are not steep and appear stable.

There is a small pond of water measuring 13m in length, 4m wide and averaging 0.5m in depth at the bottom of trench #1. A sample (Fox C1-Fox-15/09/99) was collected for analysis. The field pH was 5.2 and the conductivity was 30 μ S/cm.

Photo 38-1 : Fox. Water ponded at the base of Trench #1. (Azimuth 020^o)
