AVENUE (#69)
MINFILE# 105M 053

1. LOCATION AND ACCESS

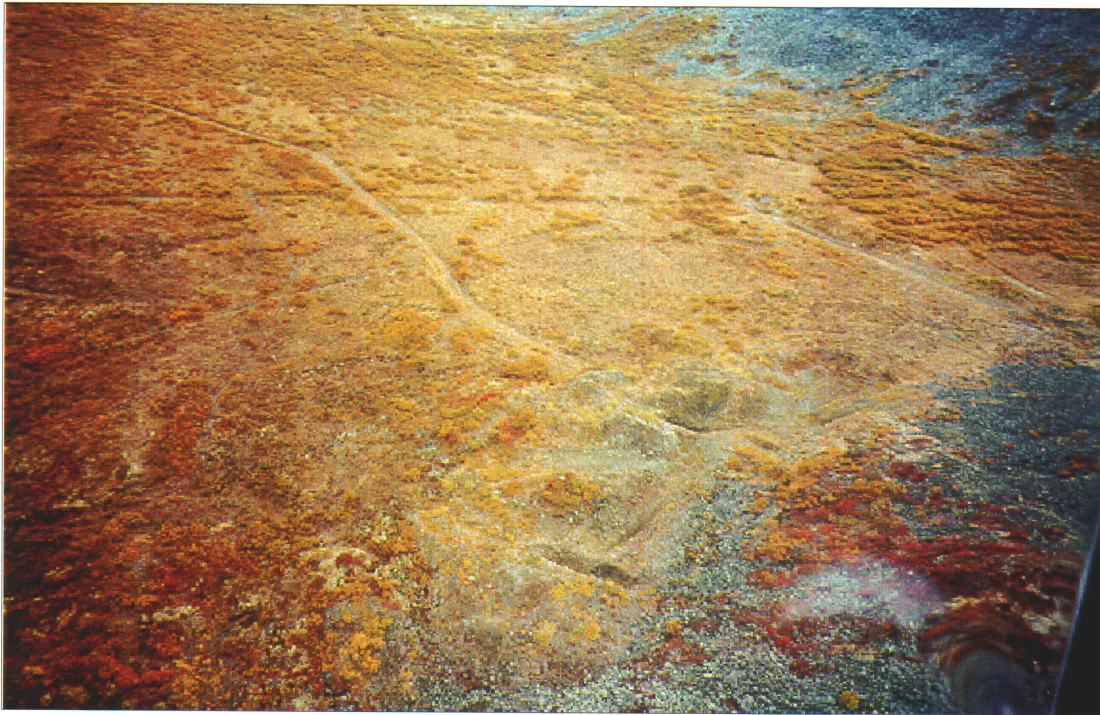
Photo 69-1: Aerial photograph of Avenue site showing western trenches. Pit 1 and Trench 4 are clearly visible just below centre of photograph. Trench 2 can be seen in upper righthand corner. Trail leading up southeastern slope of Keno Hill enters photograph from upper lefthand corner.

There were 8 trenches observed at the Avenue site. Five are located on western side of the site at the end of a trail leading up the southeast slope of Keno Hill (photo 69-1). They lie at the base of a small hill. Three more trenches lie about 200 m to the east. Two are at the edge of a cliff sloping to the north. The other lies on the plateau about 75 m further east. A pit is located among the western series of trenches. Trenches 1 to 8 and Pit 1 are described below in order from the west to east.

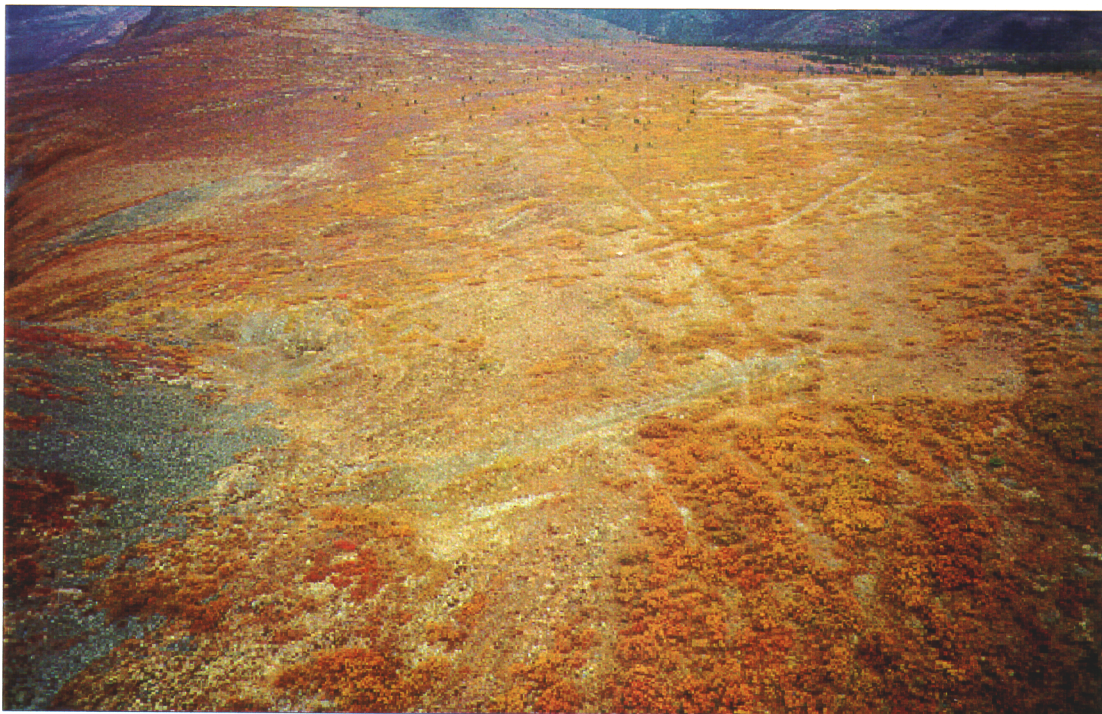
Photo 69-2: Aerial photograph of Avenue site with a good view of plateau. Trench 2 is visible just below centre of photograph.

The Avenue site lies on a plateau between Caribou Hill and Beauvette Hill above the tree line (photo 69-2). Permafrost lies under the entire site. Most of the site slopes gently to the southeast and drains down the slope towards Faith Creek. A series of trenches at the eastern side of the site slope to the north at the edge of a cliff. These trenches drain off the cliff towards Keno Ladue Creek.

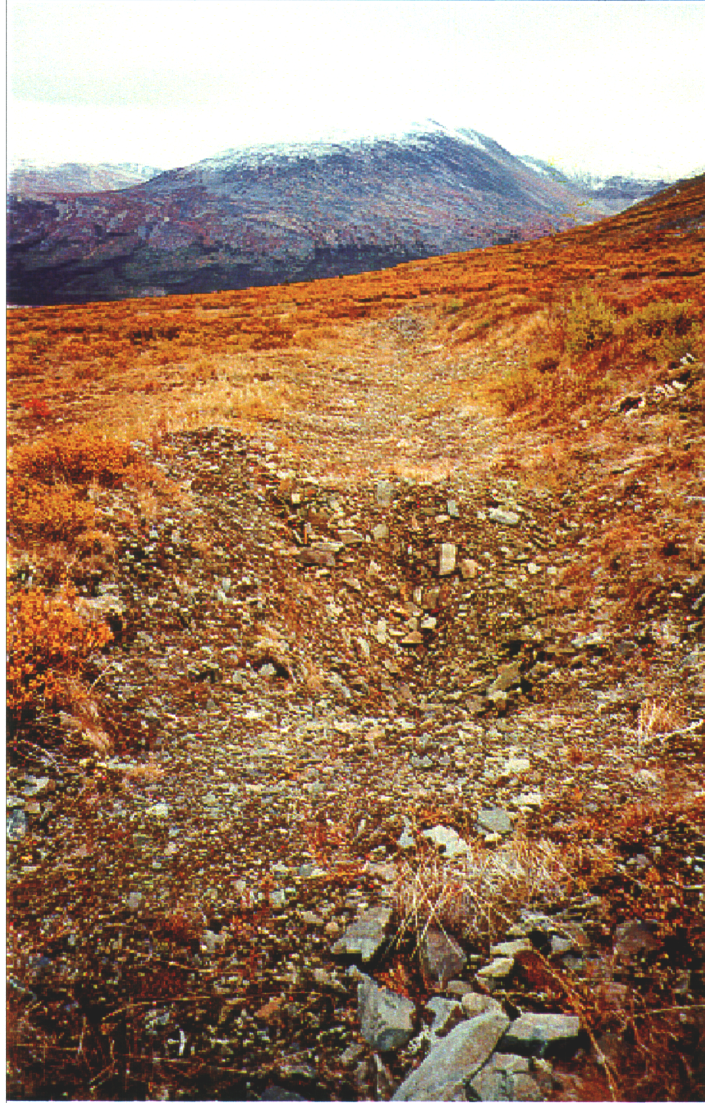
Shallow trench with a small pit at the NW end (photo 69-3)

Dimensions (L x W x H): 78 m x 4 m x 1 m - longitudinal bearing AZ 330

Condition: stable - 30% revegetated

Photo 69-3: View along length of Trench 2 with small pit in foreground. (AZ 149)

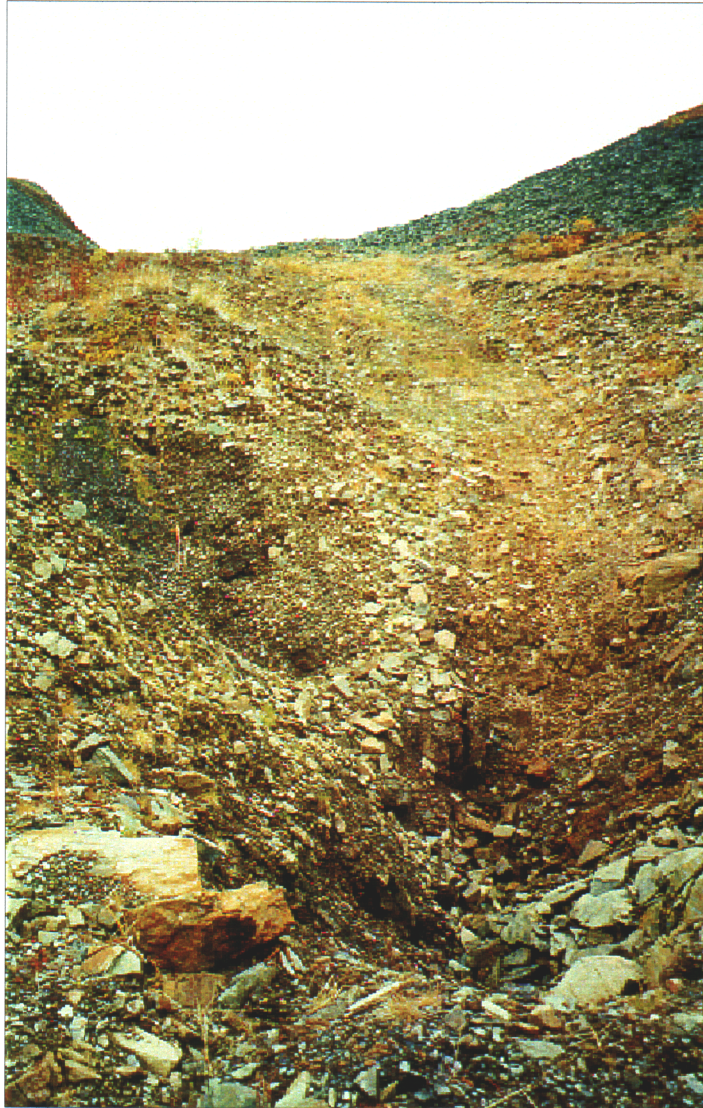
Pit 1 (photo 69-4)

Narrow pit

Dimensions (L x W x H): 6 m x 3 m x 3 m - longitudinal bearing AZ 260

Condition: stable - gentle slopes are 30% revegetated

Photo 69-4: View of Pit 1 at Avenue site. (AZ 266)

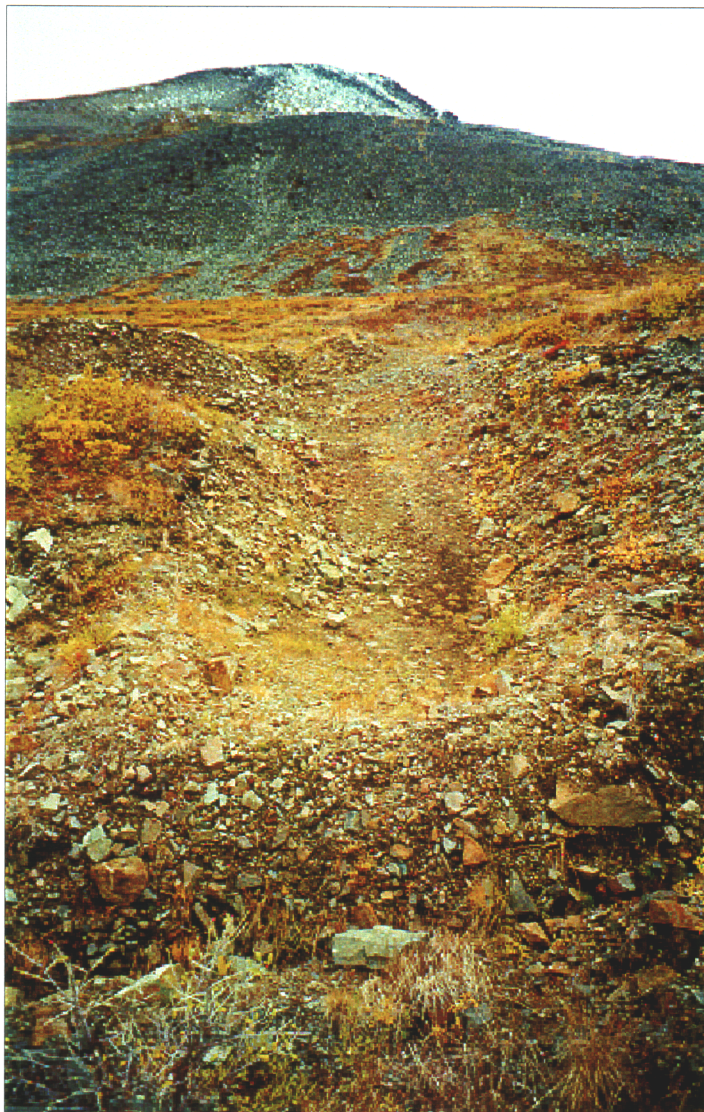
Trench 3 (photo 69-5)

Shallow trench

Dimensions (L x W x H): 30 m x 6 m x 1 m - longitudinal bearing AZ 219

Condition: stable - 20% revegetated

Photo 69-5: View along length of Trench 3 with Trench 4 crossing it in foreground. (AZ 219)

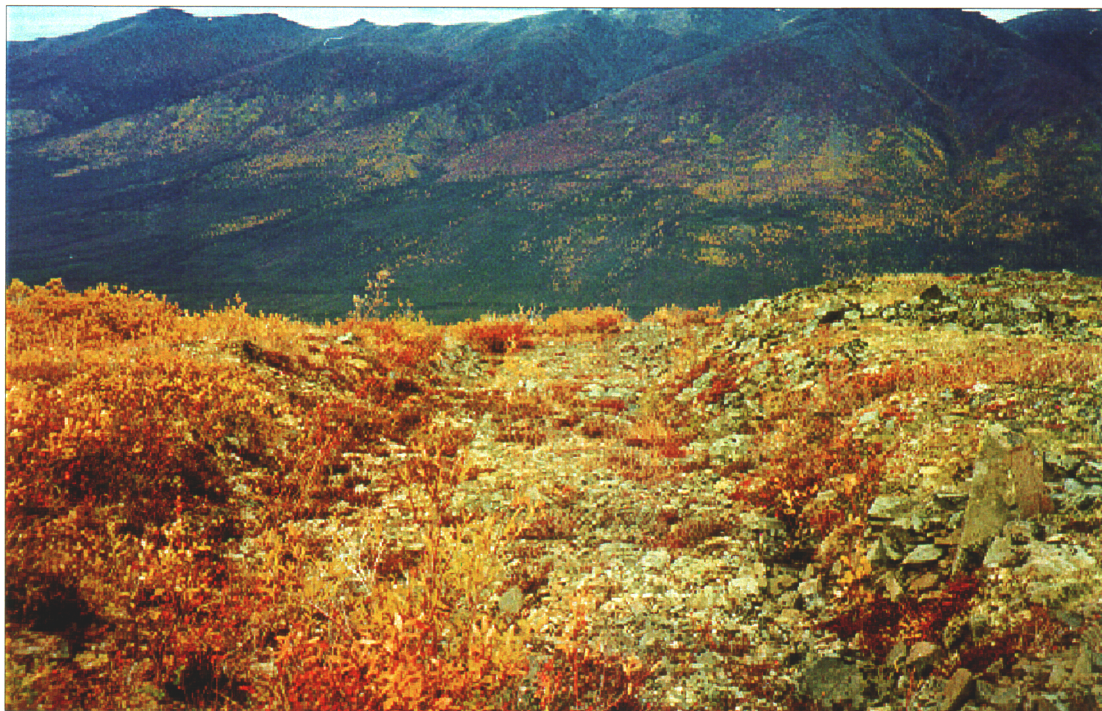
Trench 6 (photo 69-6)

Dimensions (L x W x H): 30 m x 3 m x 1.5 m

Condition: stable - 70% revegetated

Photo 69-6: View about NNW along length of Trench 6.

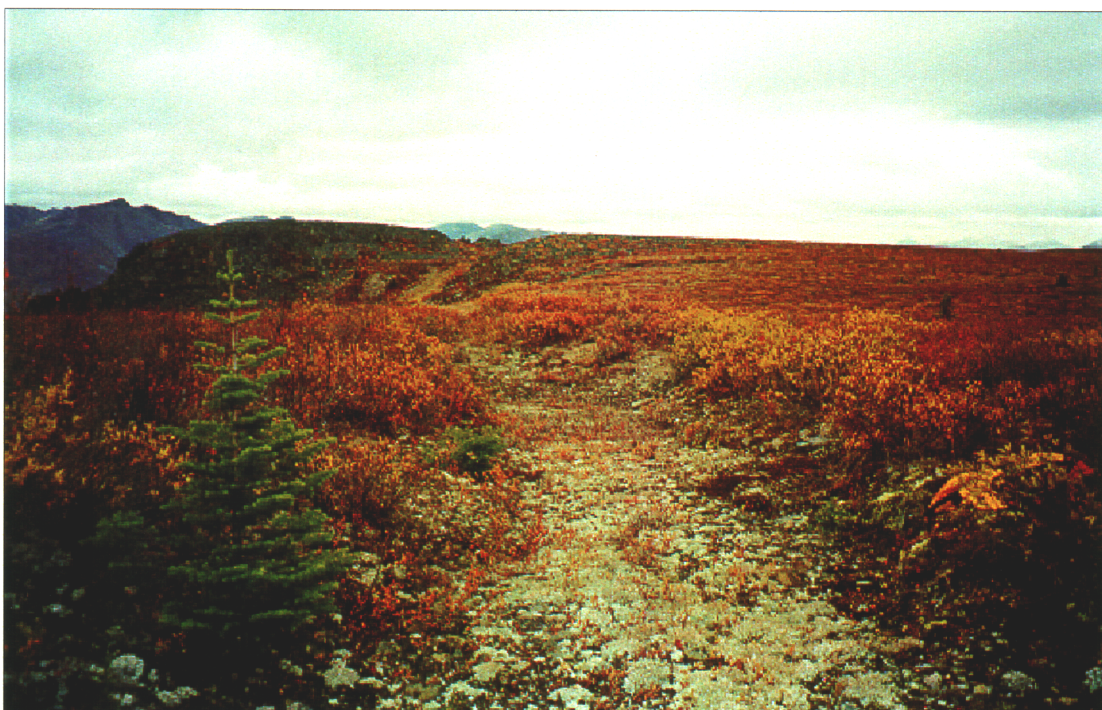
Trench 8 (photo 69-7)

Dimensions (L x W x H): 30 m x 2.5 m x 1 m – longitudinal bearing AZ 33

Condition: stable - 70% revegetated

Photo 69-7: View along length of Trench 8. (AZ 033)
