GOLD QUEEN

SITE #44

MINFILE# 105M 004

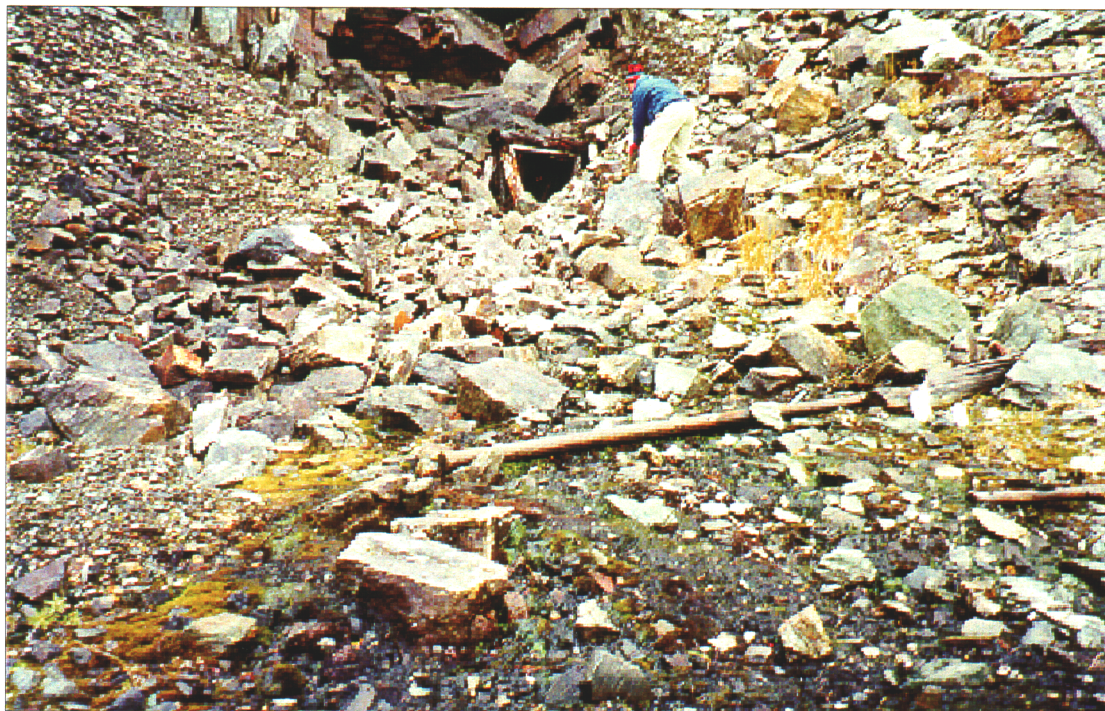
Gold Queen Adit (photo 44-1)

The adit was collared at the base of a 15m high cliff, immediately east of a strong flowing tributary of Silver Basin Gulch. Below the adit the tributary disappears into the talus. The adit itself was dry at the time of the site visit.

Supports: The adit is supported by log cribbing at the portal.

Condition: The adit is in fair condition.

Photo 44-1 : Gold Queen. Entrance to the Gold Queen Adit. (Azimuth 190 °)
