SHANGHAI

SITE #65

MINFILE# 105M 028

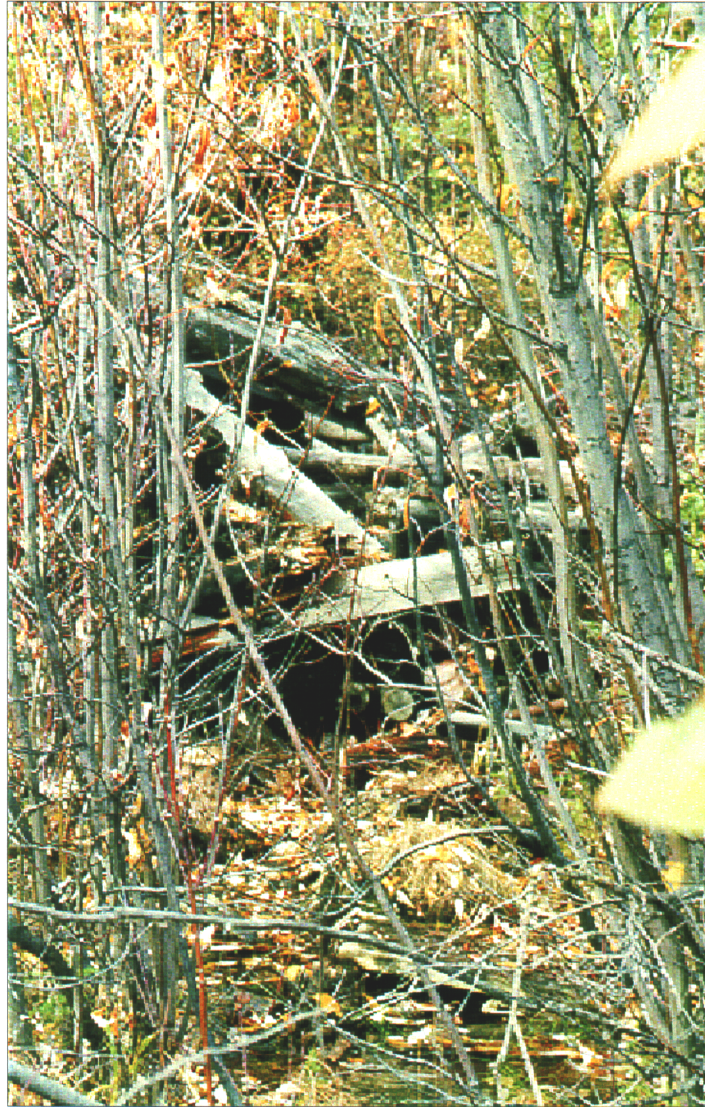
Main Adit (photo 65-1)

The main adit is located roughly 30m north of the clearing where the old camp was and where the waste rock was deposited. A 10m long log portal structure built outside of the adit has collapsed. A stream of water flows from the adit.

Dimensions (L x W x H): 835m (total length of all underground development) x 3m x 2m

Accessibility: The adit can no longer be accessed.

Photo 65-1 : Shanghai. Collapsed Main Adit with water flowing. (Azimuth 340°)

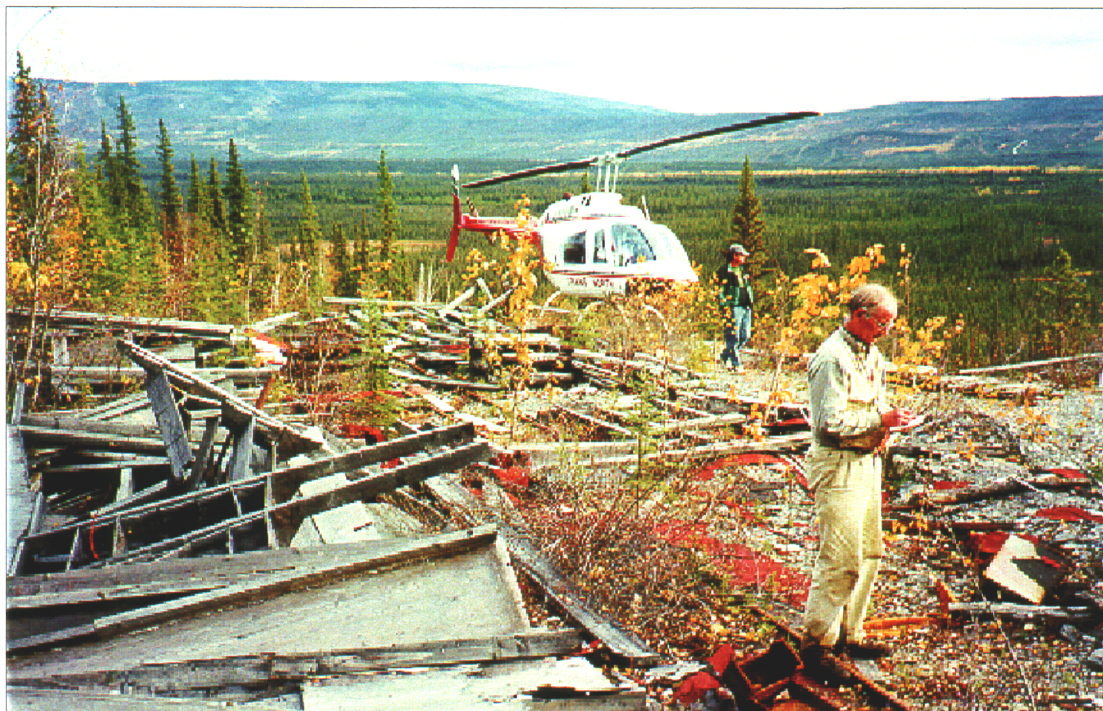
5.2 Waste Rock Disposal Areas (photo 65-2)

Waste rock from the adit is spread over a 48m by 34m area in front of the adit. The water flowing from the adit flows around the waste rock pile on the eastern side. No water was observed on the pile.

The face of the waste rock pile is composed of highly broken dark gray carbonaceous Keno Hill quartzite with approximately 30% of the area having patches of brown to rusty highly oxidized vein material. A sample (Shanghai-Waste Rock-Sept.18/99) of the later material gave a paste pH of 4.7 and conductivity of >1000 μ S/cm.

Most exploration adits generally have a section of the pile where low grade to high grade oreshoot vein material is stored. None was seen at any location along the dump face. It is assumed that no sorting took place.

Photo 65-2 : Shanghai. Aerial view of waste rock pile and mine site debris. (Azimuth 120°)
