POTATO HILLS (PAN) SITE #92 (MINFILE #106D 026)

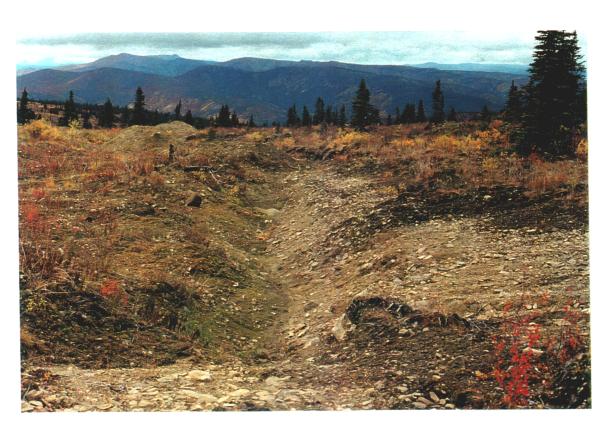
Small number of bulldozed trenches along the southwest side of Dublin Gulch Road (Photo 92-1).

Dimensions: (L x W x H): $\sim 100 \text{ m x } 3 \text{ m x } 0.75 \text{ m}$

<u>Condition</u>: loose packed overburden; appears to be stable; small piles of overburden in the vicinity; no watercourses in area of site.

Photo 92-1 : Potato Hill (proper) showing extensive trench work along access road (over-burden) looking S.

Natural revegetation is beginning to occur in the trench areas and other disturbed locations of the site along Dublin Gulch Road (see Photo 92-1). No evidence of any reclamation measures at this site.
