**ELLIS**  
**SITE #94**  
**(MINFILE #106D 028)**

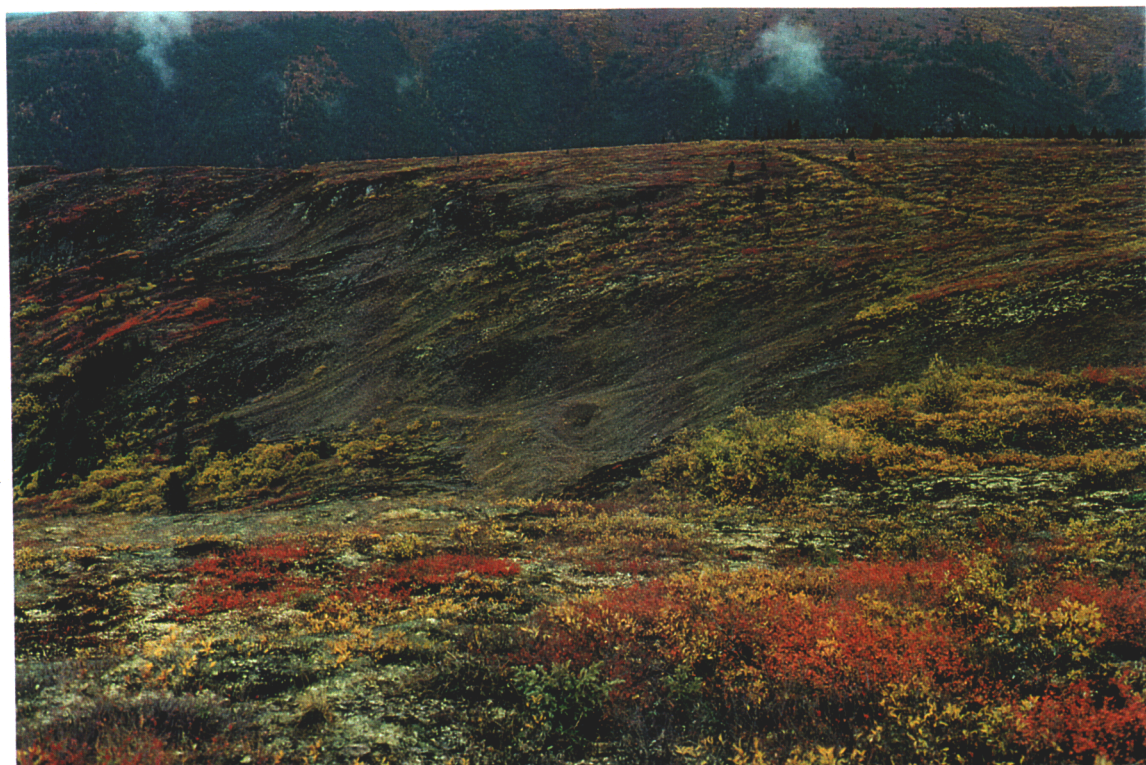
Two old bulldozed trenches from early 60's along the northeast slope of gulch approximately 1500 m down the side of the slope (Photos 94-1 and 94-2).

Condition: loose packed overburden; appears to be stable

Waste rock was associated with trenching along the northeast slope of gulch (see Photo 94-2). This was limited to soil overburden and a limited volume of host rock as well as quartz vein material for the trenches along the northeastern slope. There was no evidence of sulphide mineralization in the associated waste rock.

Photo 94-2 : Potato Hill. One of 1964 bulldoze trenches (centre) #1 looking N. - N.W.  
from access trail.

Natural revegetation is beginning to occur at the site in the suspected trench areas along the top of the gulch (see Photos 94-3 and 94-4). The trench area along the east slope of the gulch, however, remains bare (see Photos 94-1 and 94-2). No evidence of any reclamation measures at this site.

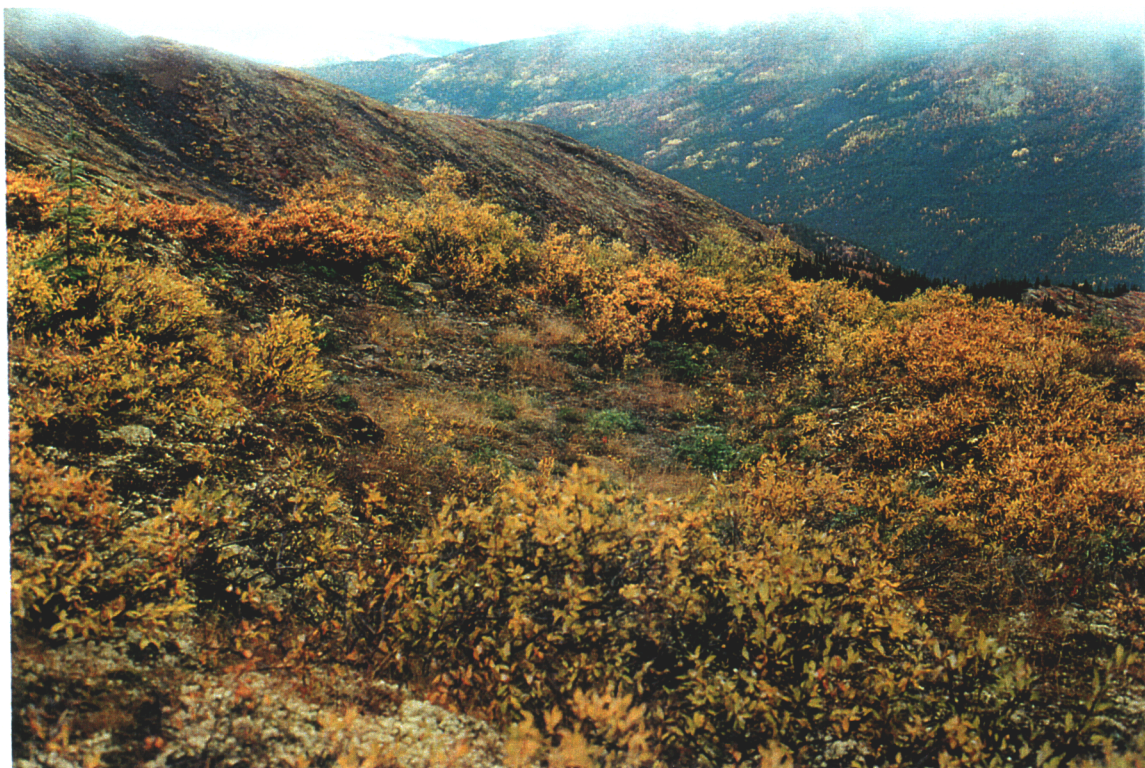
Two old bulldozed trenches from early 60's at top of gulch along access trail at 45 degree angles from each other leading north and north-northeast (Photo 94-3 and 94-4).

Dimensions: (L x W x H): ~ 35 m x 6 m x 0.5 m

Condition: hard-packed overburden; natural revegetation occurring; appears to be stable

Photo 94-3 : Potato Hill. One of 1964 bulldoze trenches (3) (centre) #2 looking W.

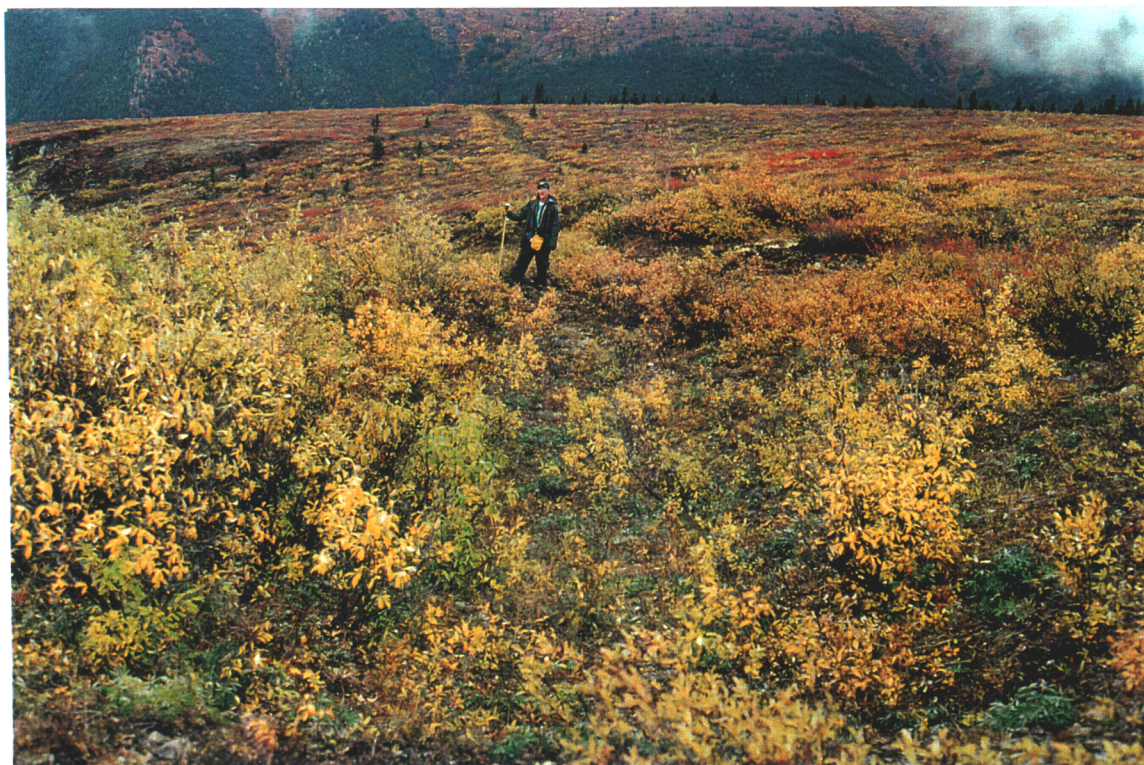
Photo 94-4 : Potato Hill. One of 1964 bulldoze trenches (3) (centre) #3 looking E. (upslope).
