Flooding in Old Crow: Exposure analysis and risk reduction recommendations

March | 2022

Executive Summary

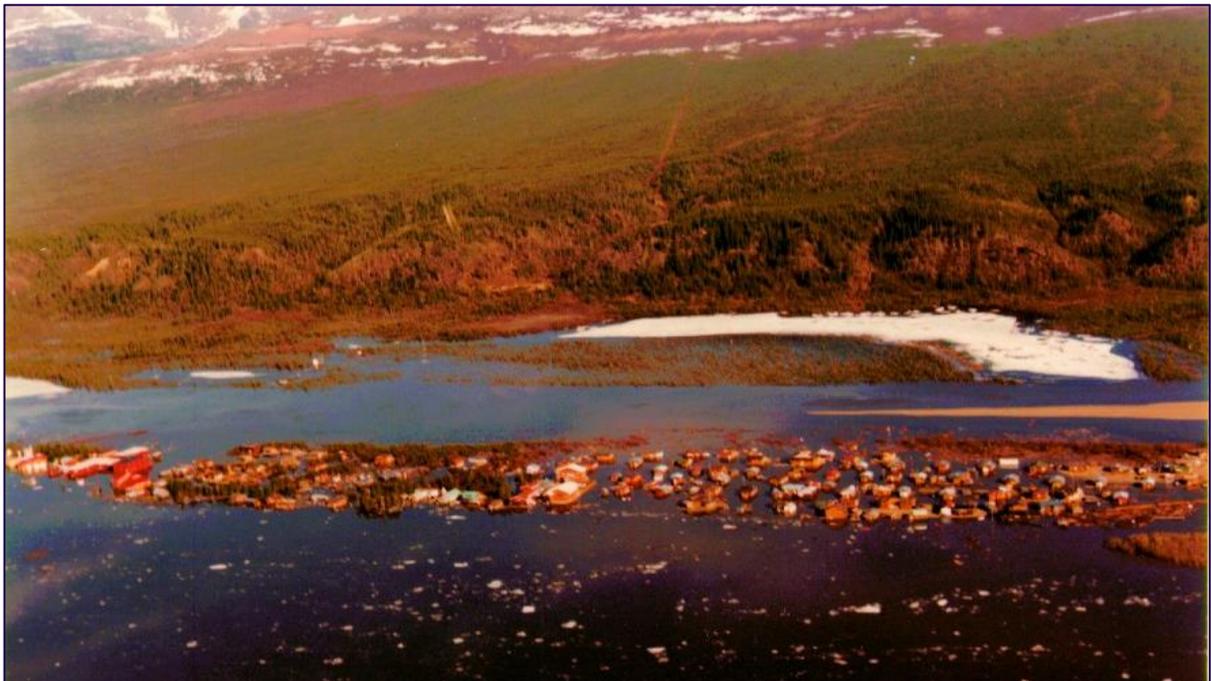
This ice jam created extensive flooding in Old Crow, as presented in the photograph in Figure 3.2.1 and as simulated in Figure 3.2.2, despite the fact that the head of the jam was not even visible from Old Crow. Jasek (1997) did not miss pointing out that the flood could have been even worse if the ice jam had extended all the way upstream to Old Crow, but luckily, the stationary ice in the Porcupine River stayed in place upstream of the Chiiveenjik (Bell River) and Ch'izhin Njik (Eagle River) for a few days, which gave time to the Old Crow ice jam to melt in place and eventually release. Subsequent ice runs did not encounter any obstacle and the water level rise associated with their passage did not generate any flooding.

FIGURE 3.2.1. OLD CROW FLOODED ON MAY 8, 1991, JUST BEFORE THE ICE JAM RELEASED. PART OF THE EMERGED AIR STRIP IS VISIBLE ON THE RIGHT. PHOTO FROM DEPARTMENT OF INDIAN AFFAIRS AND NORTHERN DEVELOPMENT, GOVERNMENT OF CANADA (DIAND).

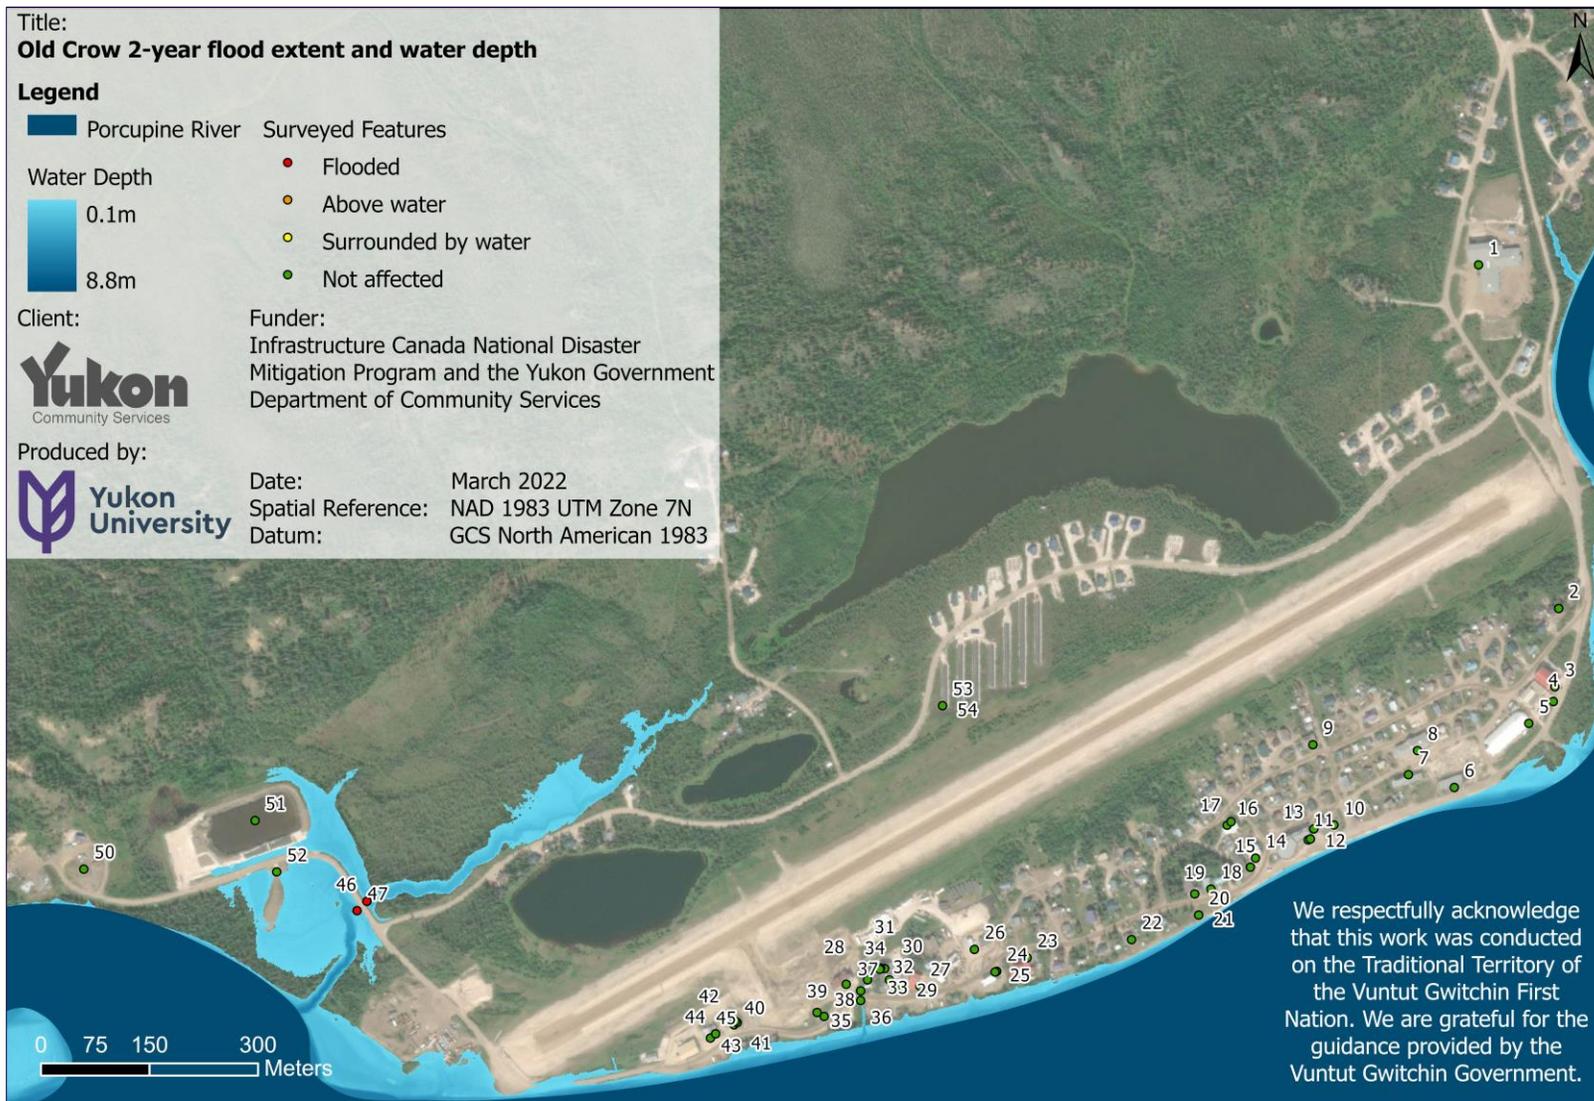
FIGURE 4.2.2. 2-YEAR FLOOD EXTENT, WATER DEPTH, AND SURVEYED ASSETS CATEGORIZED BY FLOOD EXPOSURE. NO FLOOD DAMAGE TO REPORT, JUST MINOR FLOODING ON THE ROAD DOWNSTREAM OF THE COMMUNITY.

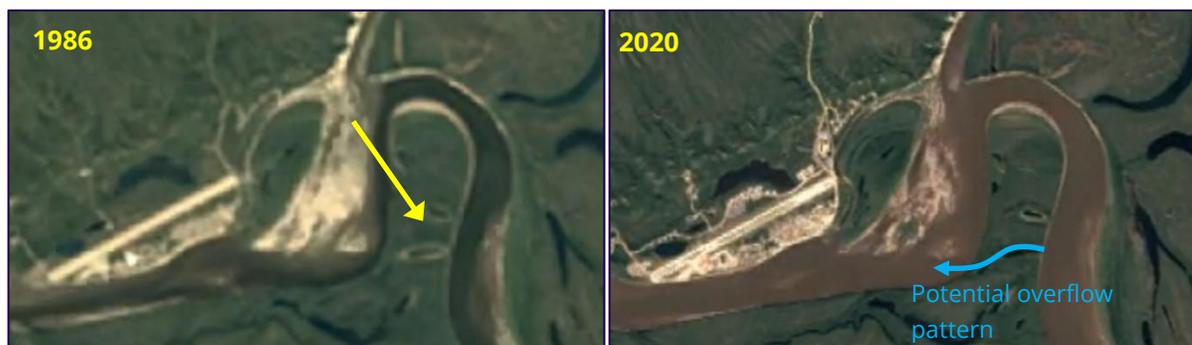
Beyond ice and runoff driven flooding processes, the evolving alignment and shape of the Porcupine River channel is an important consideration. The tight meander bend in the Porcupine River just upstream of Old Crow is apparently becoming thinner (based on a comparison of satellite imagery, Figure 5.2.4). Regardless of a changing climate and melting permafrost, natural forces (ice jam overflow) could eventually cut this meander, a process that would result in a significant destabilization of the Porcupine River channel at Old Crow and a change in flooding probabilities for the community.

FIGURE 5.2.4. SLOWLY EVOLVING PENINSULA ON THE INNER SIDE OF THE MEANDER BEND UPSTREAM OF OLD CROW BETWEEN 1986 AND 2020. (GOOGLE EARTH ENGINE)

On one side, hydrological, ice, and morphological processes in the changing North are very complex. On the other side, historical hydrometric records are short and partial. A consultation with VGFN about the impact of climate change on high water levels in the Porcupine River has not happened yet. It is therefore recommended to consider that flood elevations based on the 1989-2021 stage record, as defined in this study, should be used until a more comprehensive climate change research assessment is completed, while keeping an eye on morphological processes, such as the stability of the meander bend located just upstream of the community.

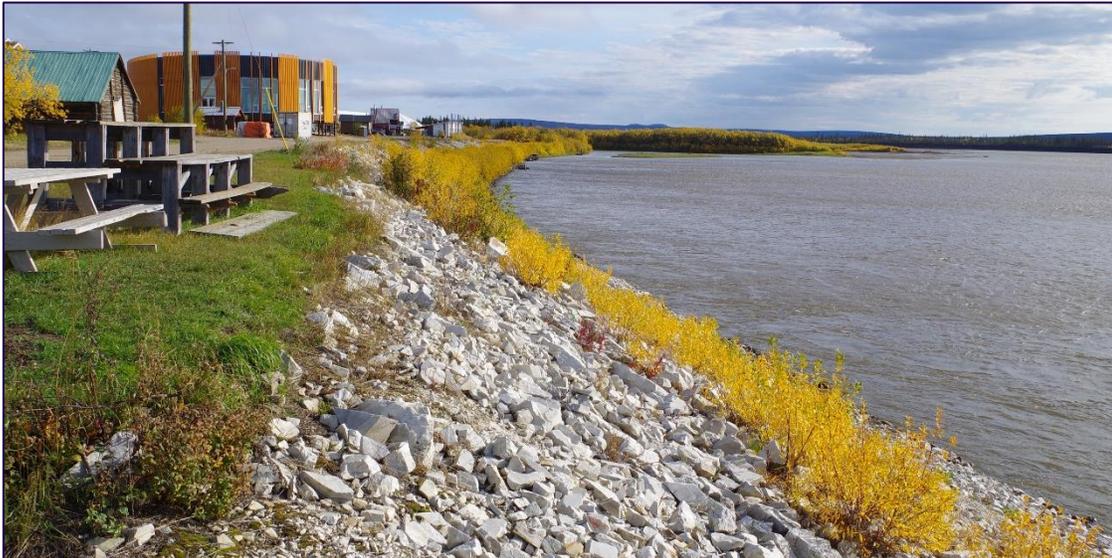
It has been observed, during the dynamic breakup of May 2020, that ice pieces from the Porcupine River easily push and move rocks (generally smaller than 200 mm) composing the erosion protection (riprap) layout on the upstream bank in Old Crow. Not only is the sizing of the rocks questionable (even without ice abrasion, see Figure 6.1.1), but the alignment and downstream extent of the erosion protection may not be optimal, especially as the channel orientation continues to evolve. It is recommended to obtain professional advice about potential improvements to erosion protection, especially in the context where new assets have been built along the riverbank.

FIGURE 6.1.1. EROSION PROTECTION ALONG THE PORCUPINE RIVER IN OLD CROW LOOKING EAST

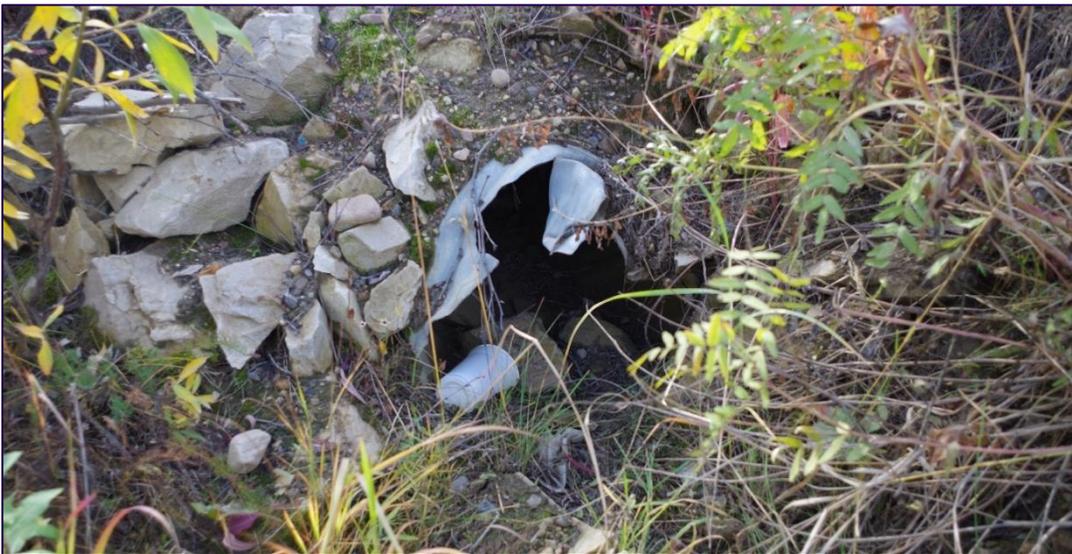
In the community, various culverts are installed to drain low areas whereas other culverts are meant to connect road-side ditches in order to drain streets and properties. A large majority of these culverts are structurally damaged by vehicles, or half buried under gravel, soil and vegetation (Figure 6.2.1, Appendix B). Some ditches are also blocked by debris and vegetation. Beyond the irritation associated with water accumulations in the community, this poses an increased risk for permafrost thawing. In order to avoid snowmelt and rain runoff water accumulations in the community, it is recommended to maintain, fix, and replace these culverts and ditches, and to design a functional surface water management network.

FIGURE 6.2.1. EXAMPLE OF A CULVERT THAT IS DAMAGED AND UNLIKELY TO SERVE AS DESIGNED.

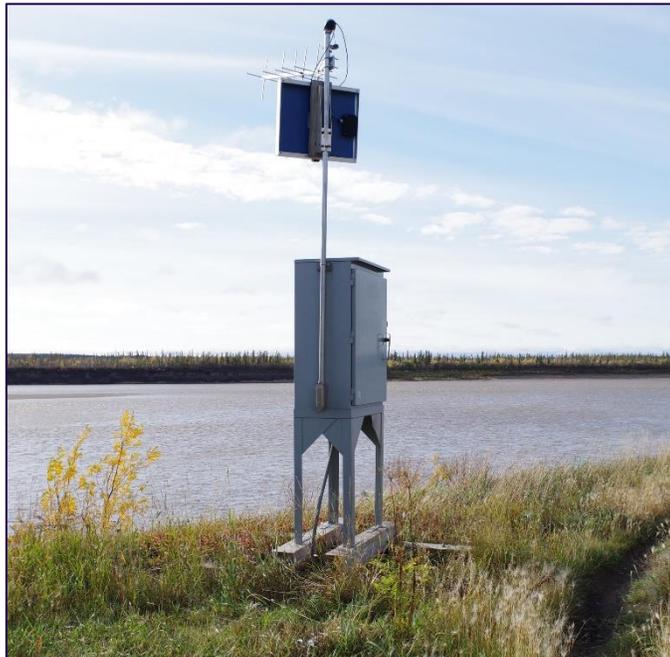
- The Water Survey of Canada real-time hydrometric station would be surrounded by water for a river surface elevation corresponding to a 20-year event. Since large ice blocks would also be push against the bank for that same event, the station could be severally damaged once every 20 years (this is discussed in Section 6).

FIGURE 6.5.1. THE WATER SURVEY OF CANADA STATION 09FD003 SEEMS EXTREMELY VULNERABLE TO ICE JAM IMPACTS AND FLOODS, AND THIS IS WHEN THE DATA IS NEEDED.

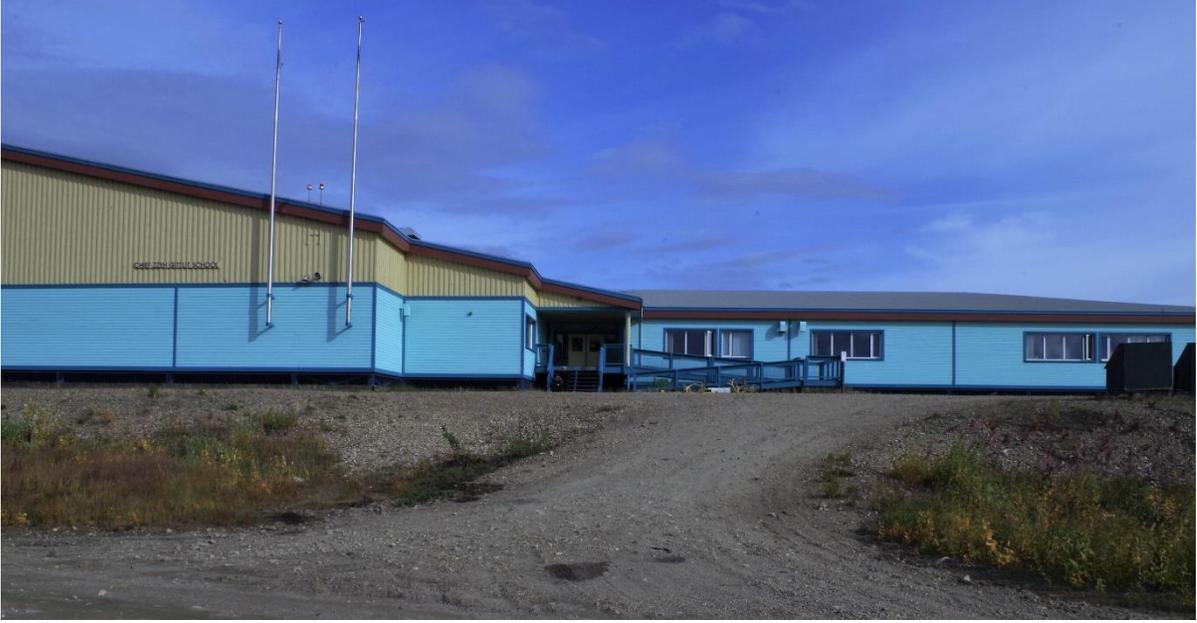
Community	Old Crow		
ID #	1		
Asset	Chief Zzheh Gittlit School		
Location	Northeastern tip of community / North of airstrip

Surveyed feature	Doorstep / First floor / Top of stairs		
Elevation	251.2 m	Flood return period	7000 years*
		Annual overflow probability	0.01%*

* Isolated by a flood (surrounded by water) every 200 years, approximately.

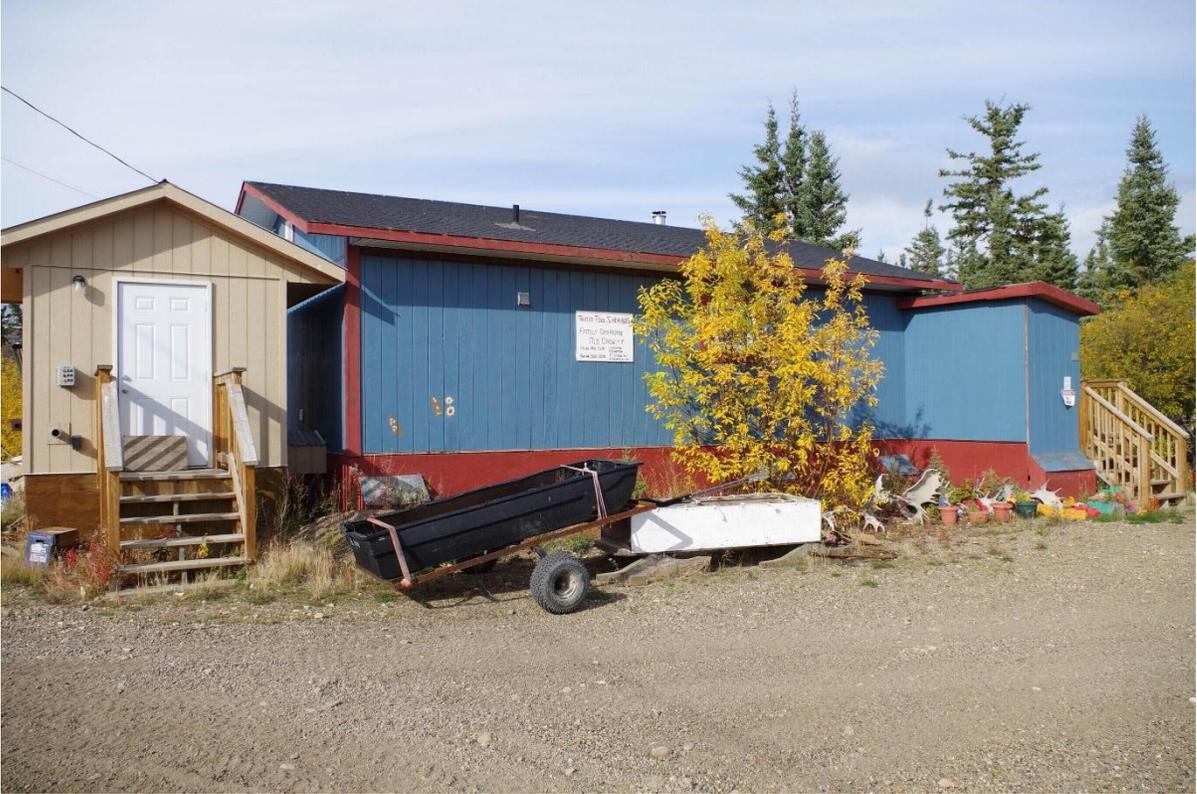
Community	Old Crow		
ID #	2		
Asset	Trinin Tsul Zheh, Family Day Home Old Crow		
Location	Eastern end of community / Street corner

Surveyed feature	Doorstep / First floor / Top of stairs		
Elevation	248.2 m	Flood return period	185 years*
		Annual overflow probability	0.5%*

* Isolated by a flood (surrounded by water) every 80 years, approximately.

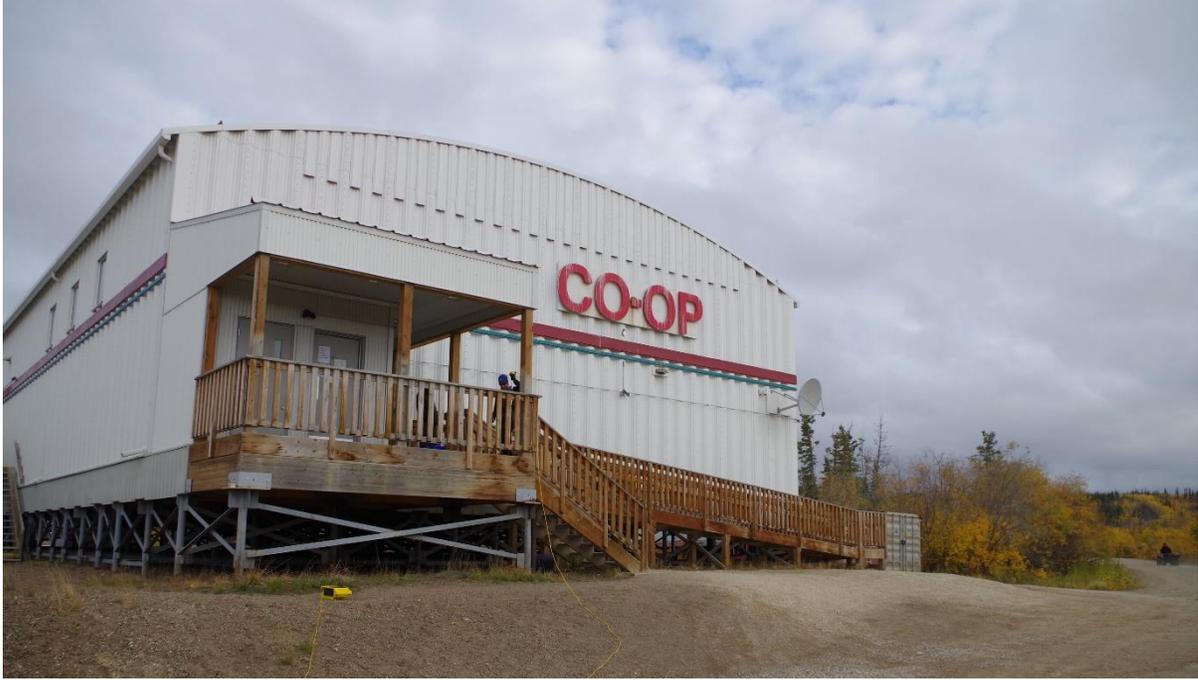
Community	Old Crow		
ID #	3		
Asset	Coop (Super Market and accommodation)		
Location	Eastern end of the community, in front of the Porcupine River

Surveyed feature	First floor / Main floor		
Elevation	249.3 m	Flood return period	750 years
		Annual flood probability	0.1%

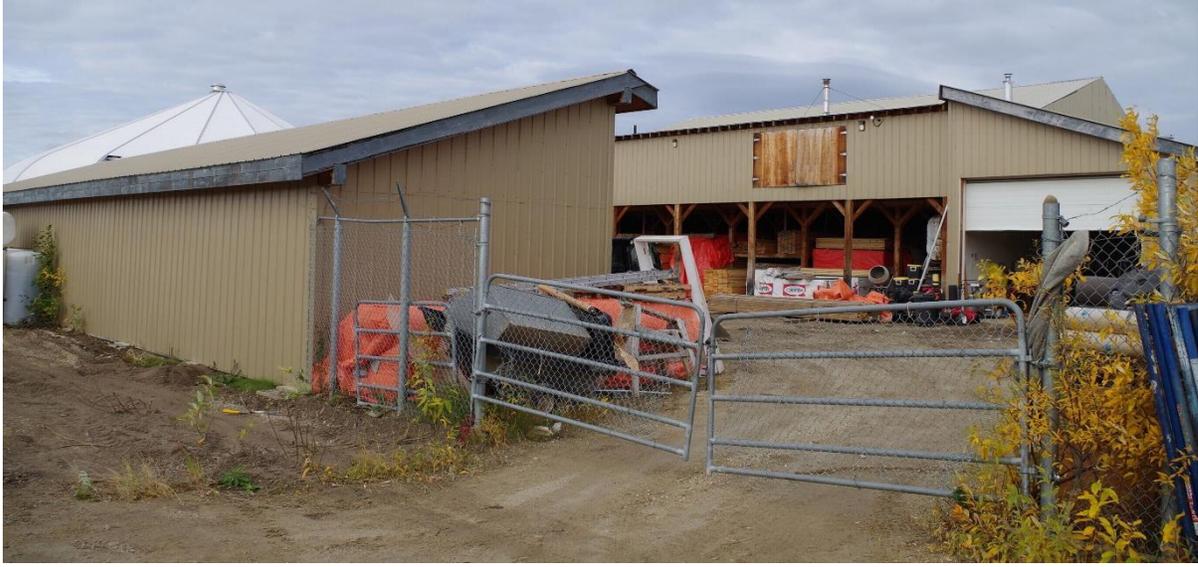
Community	Old Crow		
ID #	4		
Asset	Wood yard / Construction material storage		
Location	Eastern end of the community, besides Coop

Surveyed feature	Ground level / Yard entrance		
Elevation	246.2 m	Flood return period	20 years
		Annual flood probability	5 %

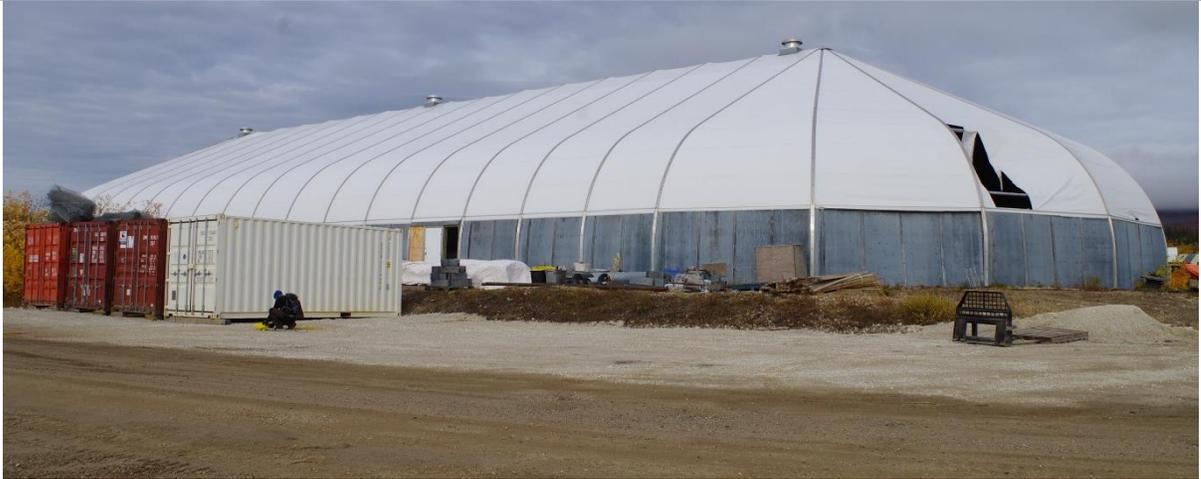
Community	Old Crow		
ID #	5		
Asset	Old Crow Arena		
Location	Eastern end of the community

Surveyed feature	Ground level / Floor level		
Elevation	246.8 m	Flood return period	40 years
		Annual flood probability	2.5 %

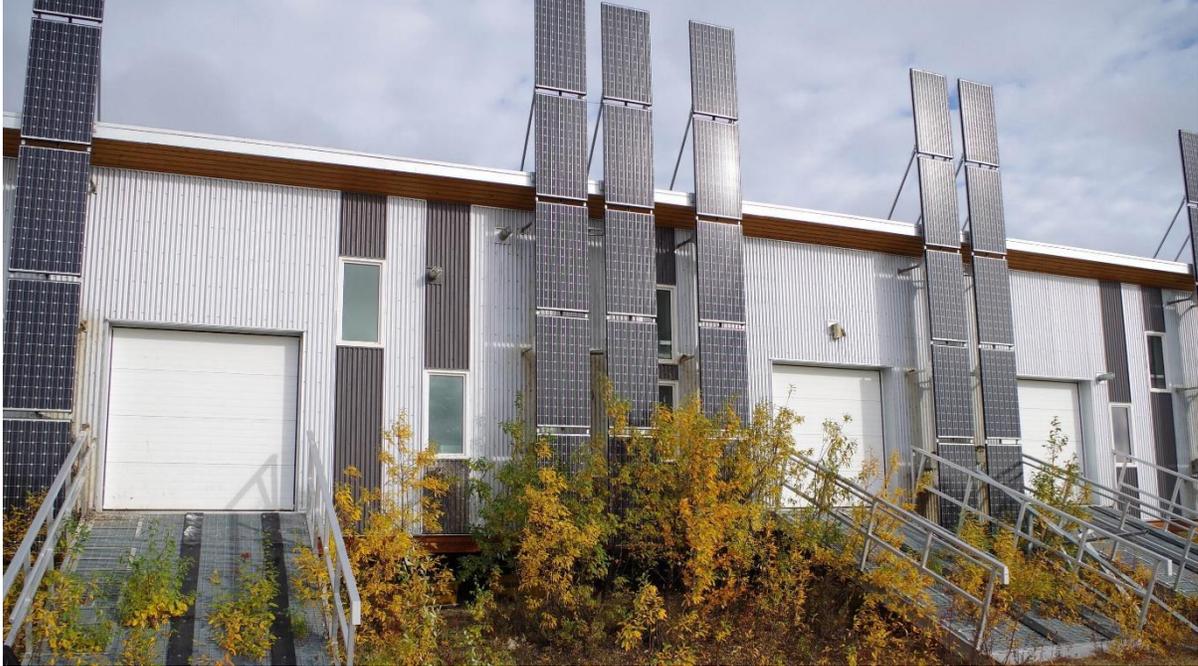
Community	Old Crow		
ID #	6		
Asset	Old Crow Arctic Research Facility		
Location	Waterfront / East of John Tizya Community Centre

Surveyed feature	Floor level, doorstep / Top of ramp		
Elevation	247.2 m	Flood return period	65 years
		Annual flood probability	1.5 %

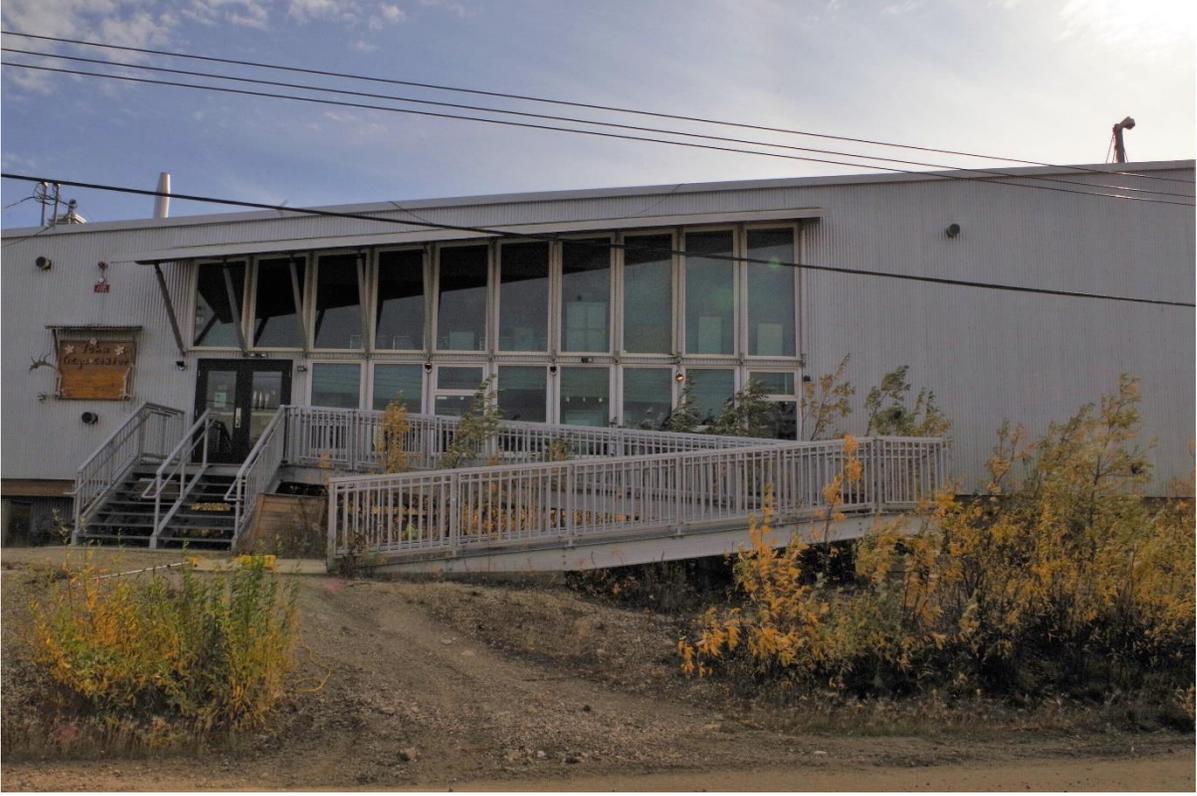
Community	Old Crow		
ID #	7		
Asset	John Tizya (community) Centre		
Location	One street away from waterfront / West of Old Crow Research Facility

Surveyed feature	Doorstep / First floor / Top of stairs		
Elevation	249.1 m	Flood return period	800 years*
		Annual overflow probability	0.1%*

* Isolated by a flood (surrounded by water) every 180 years, approximately.

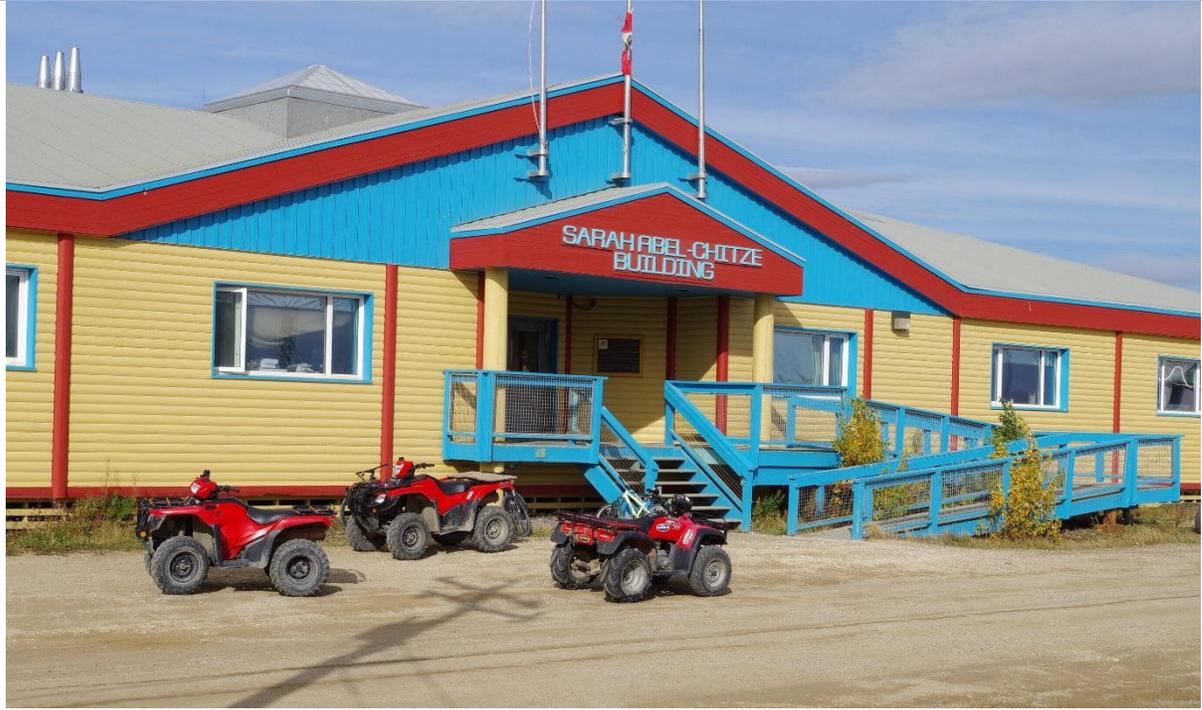
Community	Old Crow		
ID #	8		
Asset	Sarah Abel Chitze (VG Government) Building		
Location	One street away from waterfront / North of John Tizya Centre

- The first floor of the Sarah Abel Chitze Building would be flooded once every 250 years, but the building itself could suffer flood damage more frequently.

Surveyed feature	Doorstep / First floor / Top of stairs		
Elevation	248.3 m	Flood return period	260 years*
		Annual overflow probability	0.4%*

* Isolated by a flood (surrounded by water) every 80 years, approximately.

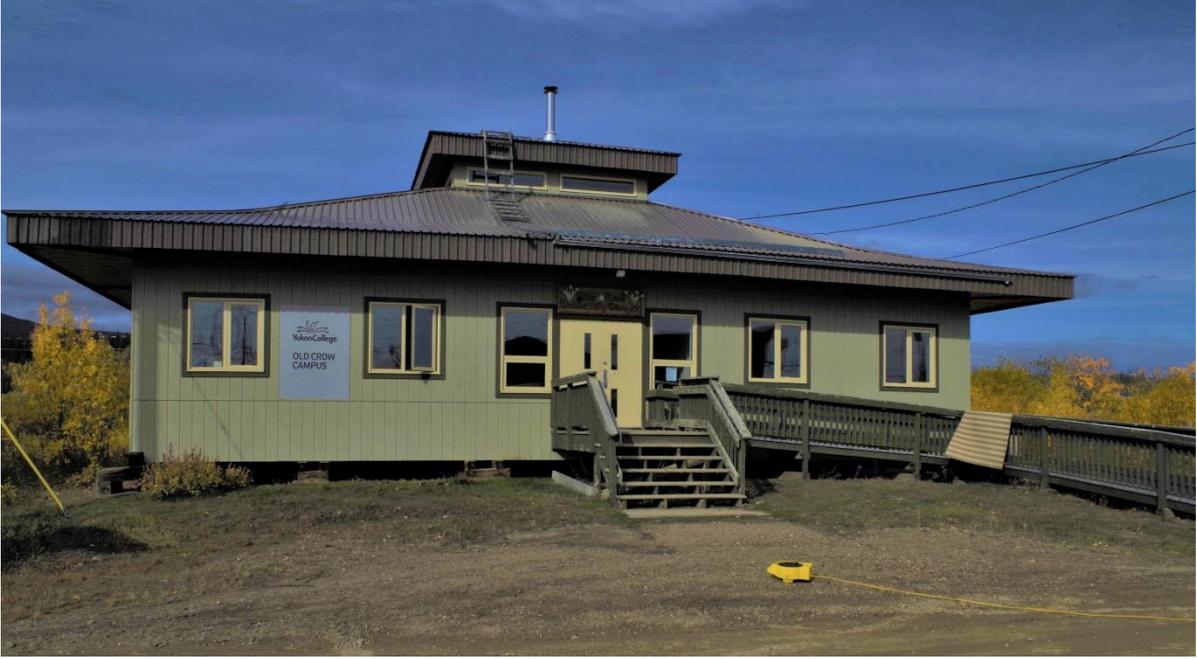
Community	Old Crow		
ID #	9		
Asset	Yukon University / Old Crow Campus		
Location	Middle of community, airstrip side street

Surveyed feature	Doorstep / First floor / Top of stairs		
Elevation	248.1 m	Flood return period	200 years*
		Annual overflow probability	0.5%*

* Isolated by a flood (surrounded by water) every 50 years, approximately.

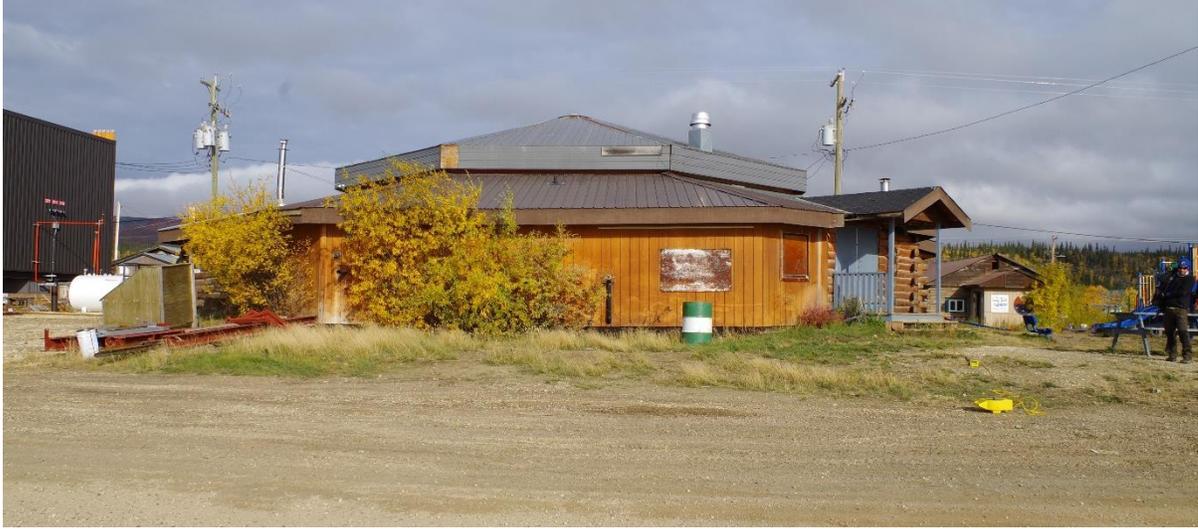
Community	Old Crow		
ID #	10		
Asset	Old Community Centre		
Location	Waterfront / next to New Community Centre

Surveyed feature	Doorstep / First floor		
Elevation	247.8 m	Flood return period	170 years
		Annual flood probability	0.6 %

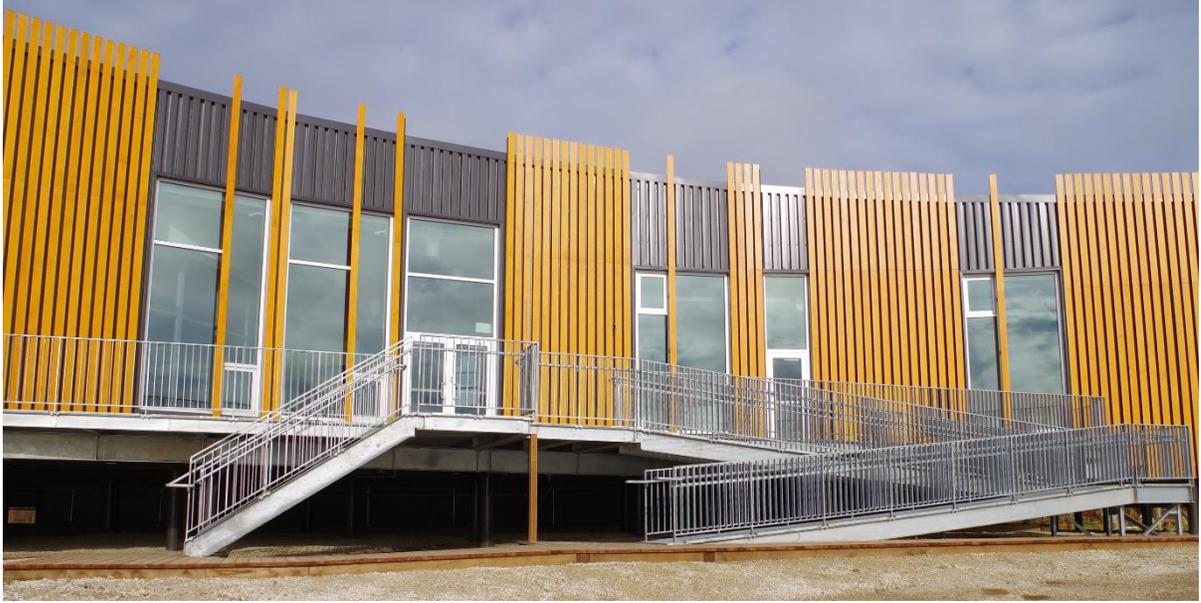
Community	Old Crow		
ID #	11		
Asset	New Community Centre		
Location	Waterfront / next to Old Community Centre

Surveyed feature	Doorstep / First floor (top of outside stairs and ramps)		
Elevation	249.6 m	Flood return period	1600 years*
		Annual flood probability	0.06 %

* Outdoor stairs and ramps could be damaged by ice once every 100 to 200 years.

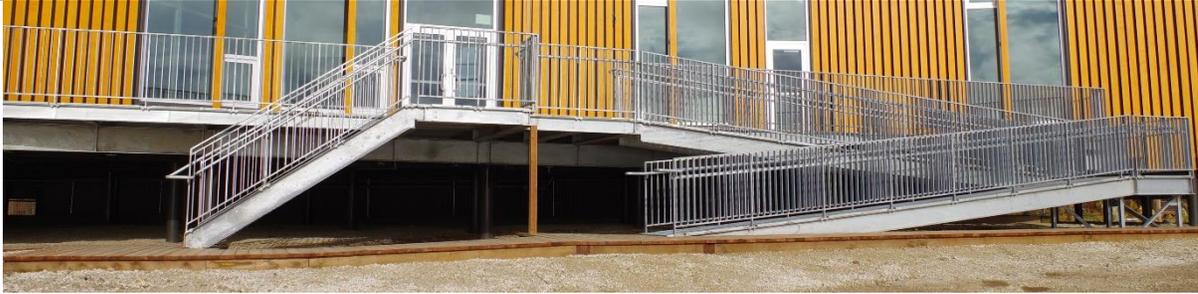
Community	Old Crow		
ID #	12		
Asset	Boardwalk – New Community Centre		
Location	Waterfront / next to Old Community Centre

Surveyed feature	Flood level / Surface of boardwalk / Lowest point		
Elevation	247.6 m	Flood return period	125 years
		Annual flood probability	0.8 %

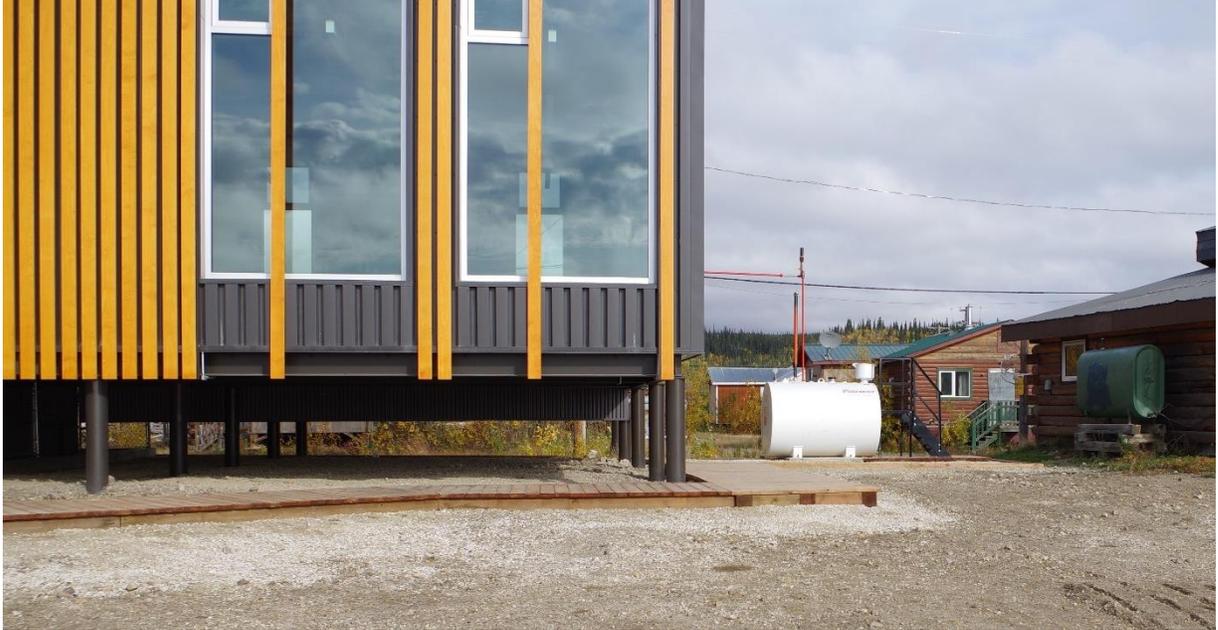
Community	Old Crow		
ID #	13		
Asset	Fuel Tank (White) – New Community Centre		
Location	Between New and Old Community Centre

Surveyed feature	Concrete pad / Ground level		
Elevation	247.8 m	Flood return period	160 years
		Annual flood probability	0.6 %

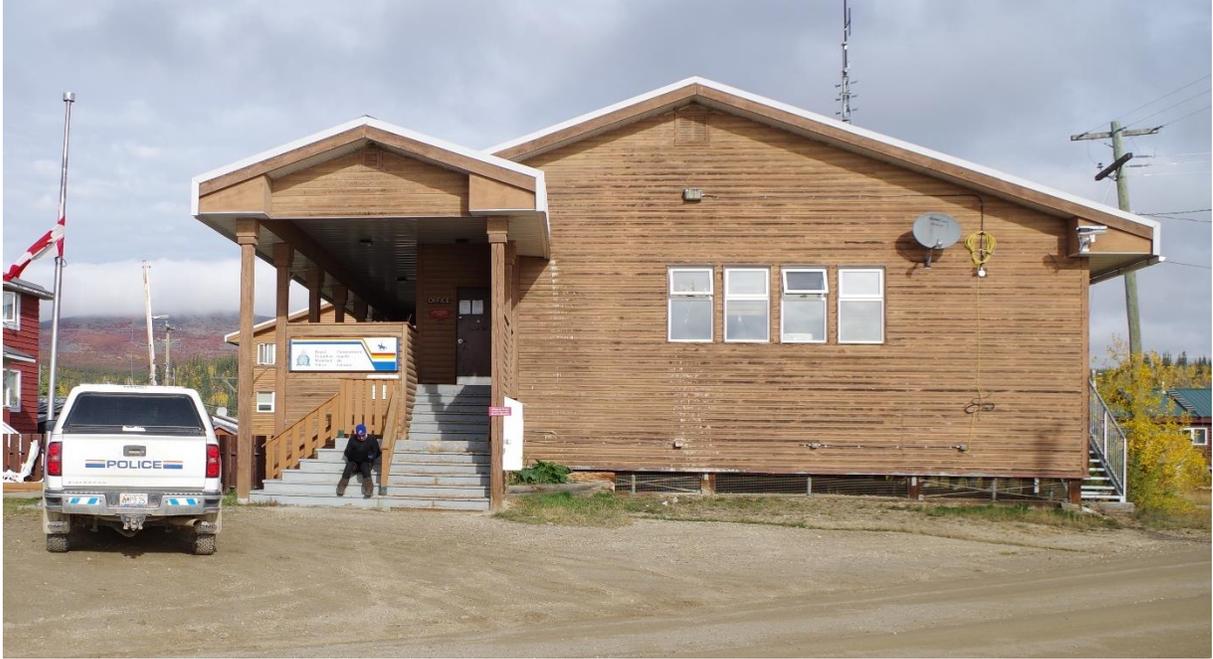
Community	Old Crow		
ID #	14		
Asset	RCMP main building		
Location	West side of New Community Centre / Waterfront / Brown building

Surveyed feature	Doorstep / First floor / Top of outdoor stairs		
Elevation	249.4 m	Flood return period	1250 years*
		Annual flood probability	0.08 %*

* Some electric and ventilation assets as well as storage below first floor may be exposed to floods on a more frequent basis.

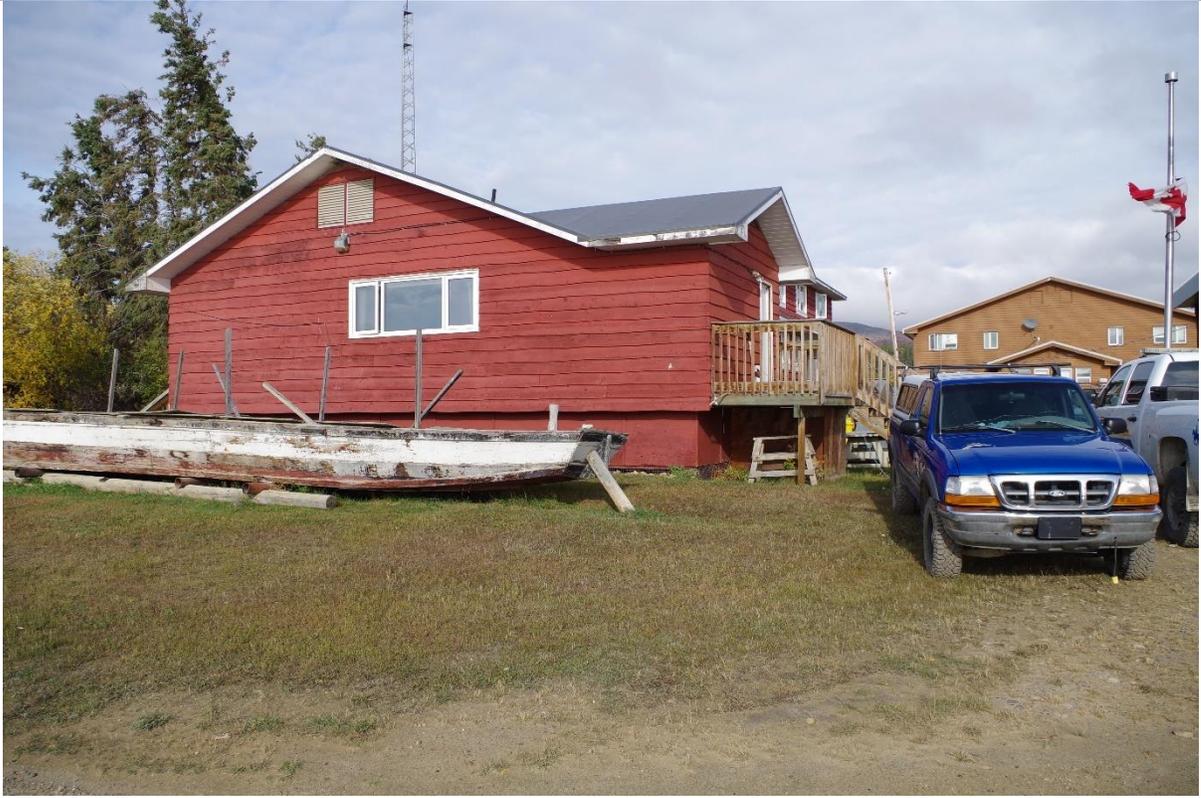
Community	Old Crow		
ID #	15		
Asset	RCMP Temporary Quarters		
Location	West of RCMP main building / Waterfront / Red building

Surveyed feature	Doorstep / First floor / Top of outdoor stairs		
Elevation	248.6 m	Flood return period	420 years*
		Annual flood probability	0.25 %*

* Some electric and ventilation assets as well as storage below first floor may be exposed to floods on a more frequent basis.

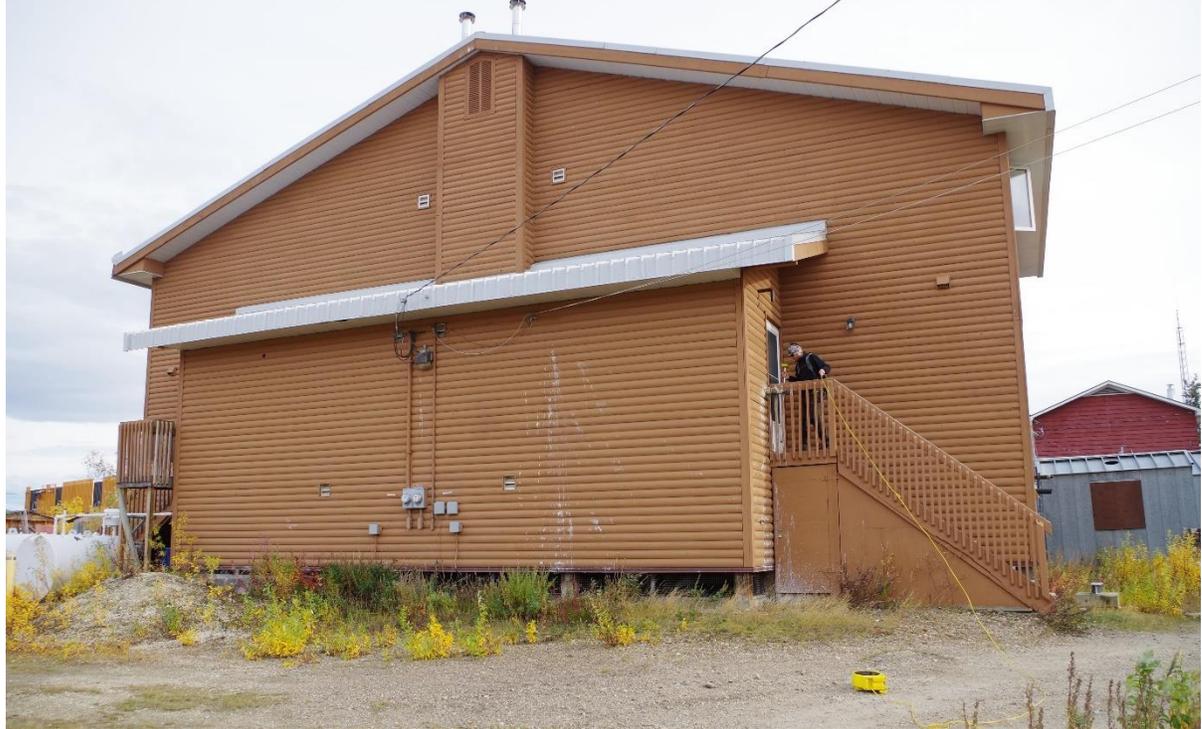
Community	Old Crow		
ID #	16-17		
Asset	RCMP large building (two story building)		
Location	At the back of the yard between two RCMP buildings (back view below)

Surveyed feature	Doorstep / First floor / Top of stairs (electric boxes)		
Elevation	249.4 m (247.5)	Flood return period	1200 years (125 years)*
		Annual overflow probability	0.1 (0.8%)*

* Some vulnerable components of the building may be located at lower elevations and therefore could be affected more frequently by water.

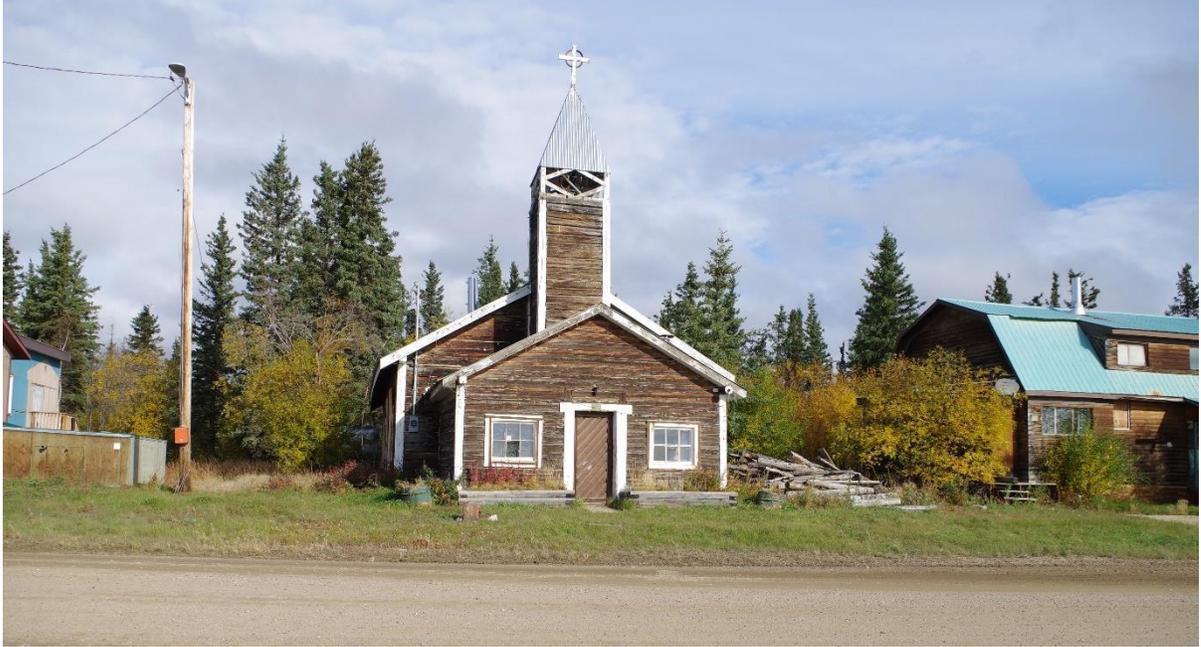
Community	Old Crow		
ID #	18		
Asset	Old Church		
Location	Waterfront / Next to New Church (St. Luke's Anglican Church)

Surveyed feature	Doorstep / First floor		
Elevation	246.8 m	Flood return period	45 years
		Annual flood probability	2.3 %

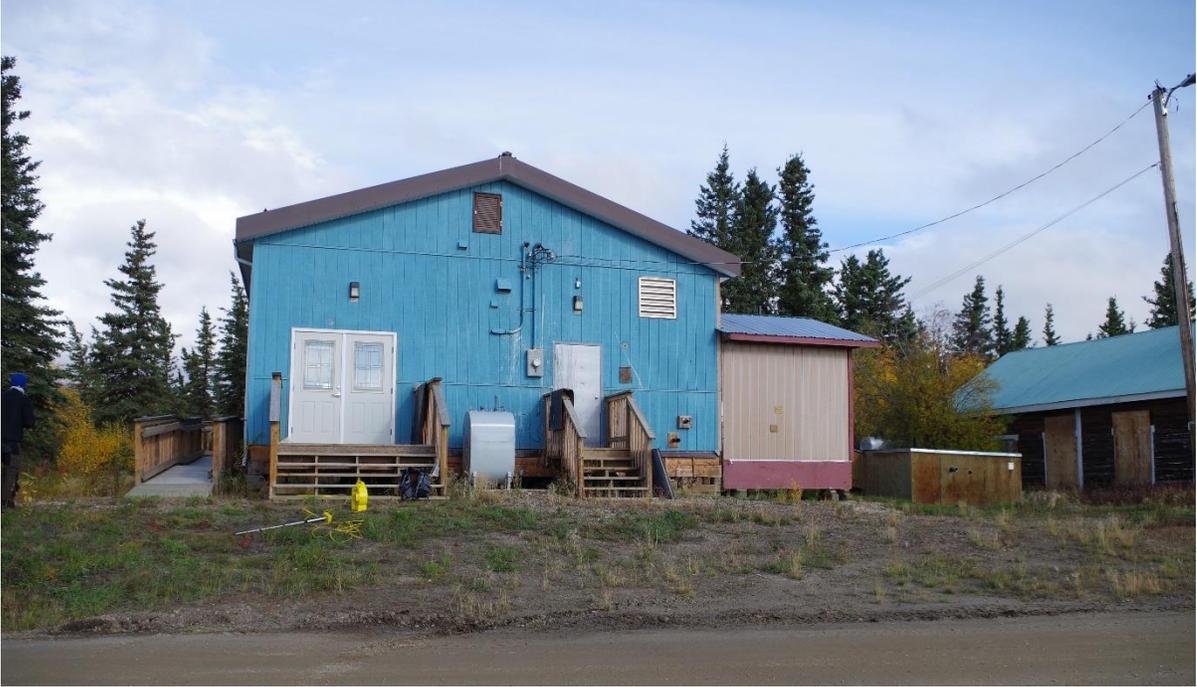
Community	Old Crow		
ID #	19		
Asset	St. Luke's Anglican Church		
Location	Waterfront / next to old Church

Surveyed feature	Doorstep / First floor		
Elevation	248.2 m	Flood return period	265 years
		Annual flood probability	0.4%

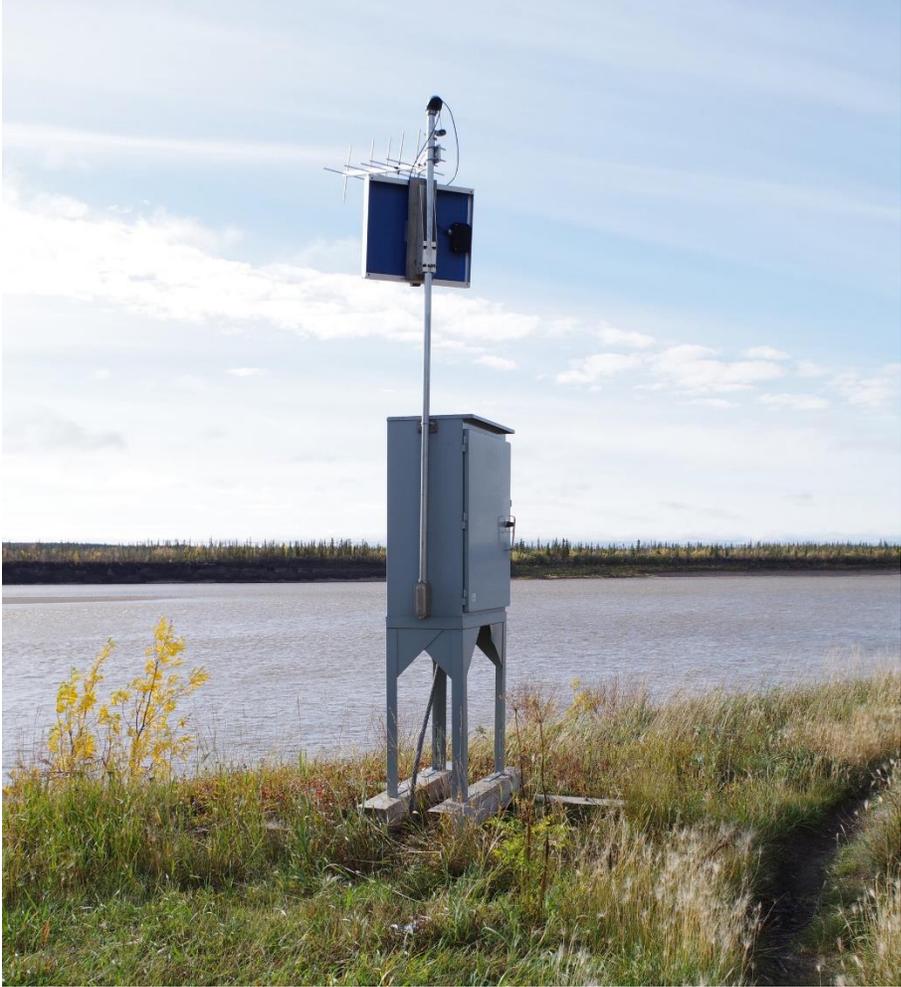
Community	Old Crow		
ID #	20-21		
Asset	Water Survey of Canada Hydrometric station 09FD003		
Location	Water edge / Front of St. Luke's Anglican Church

Surveyed feature	Wood structure and support (& Electronic box)		
Elevation	246.2 m (247.2 m)	Flood return period	20 years (80 years*)
		Annual flood probability	5% (1.2%*)

* The station could be severely damaged more frequently (ice could be pushed on the station every 20 to 50 years) and debris and ice could affect stage measurements even more often (cables are exposed).
