Flooding in Old Crow: Exposure analysis and risk reduction recommendations

March | 2022

Executive Summary

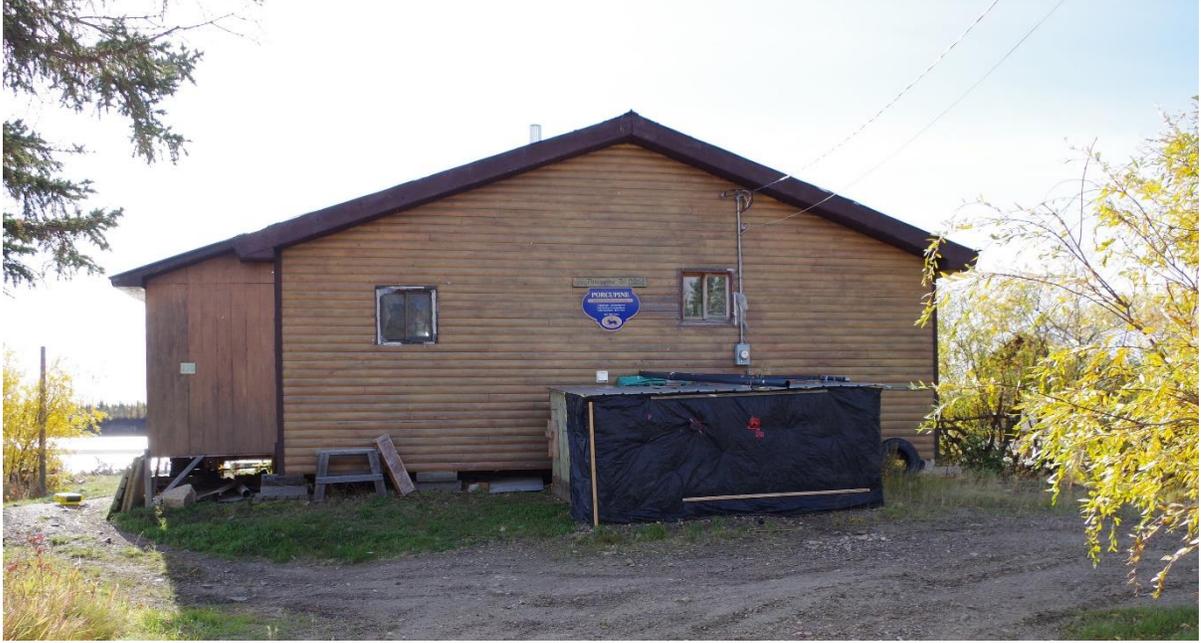
Community	Old Crow		
ID #	22		
Asset	Porcupine B&B		
Location	Waterfront / Access from main street

Surveyed feature	Doorstep / First floor / Top of outdoor stairs		
Elevation	247.9 m	Flood return period	200 years*
		Annual flood probability	0.5 %*

* Given its location on the waterfront, this building could be damaged by ice more often.

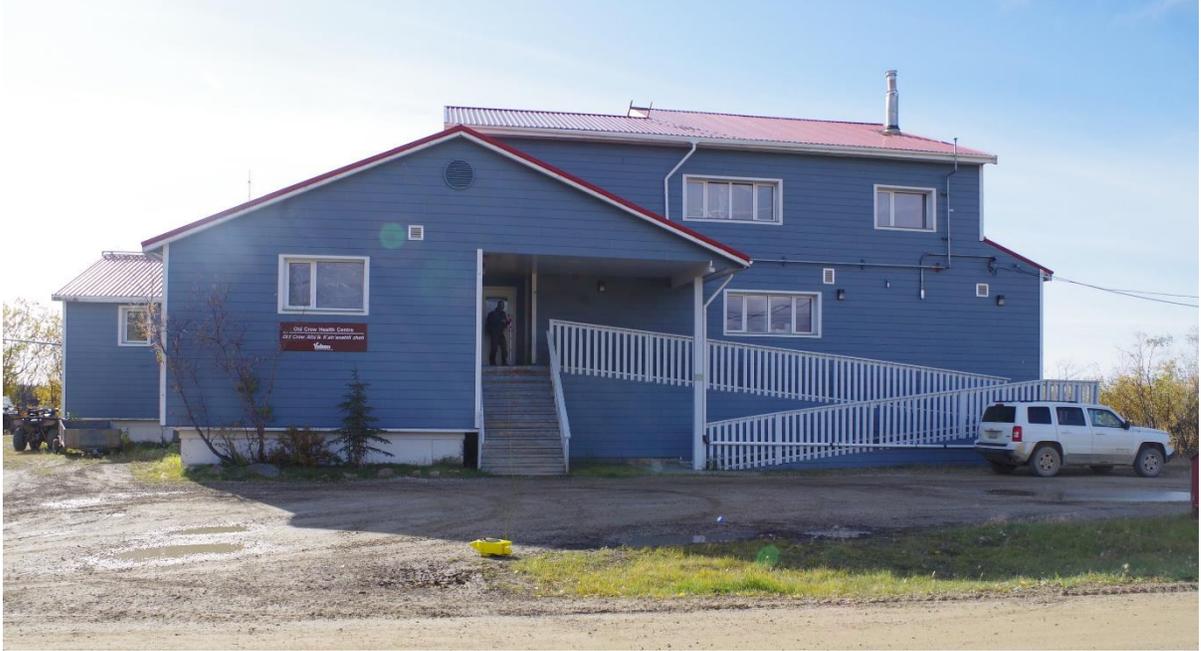
Community	Old Crow		
ID #	23		
Asset	Old Crow Health Centre / Nursing station (Alts'ik K'atr'anahtii Zheh)		
Location	Waterfront / Main street (Blue two story building / red roof)

- The first floor of the current Old Crow Health Centre (Old Crow Alts'ik K'atr'anahtii Zheh) is out of reach of most floods, with an elevation that corresponds to a 500-year event. However, the Centre would be isolated by more than 0.3 m of water once every 30 years on average and could be damaged by ice once every 80 years or so. A new Health Centre is currently being built on the other side of the community, close to the school, where the 200-year water level is estimated to 248.2 m.

Surveyed feature	Doorstep / First floor / Top of outdoor stairs		
Elevation	248.5 m	Flood return period	500 years*
		Annual flood probability	0.2 %*

* Isolated by a flood (surrounded by water) and crawl space flooded every 30 years.

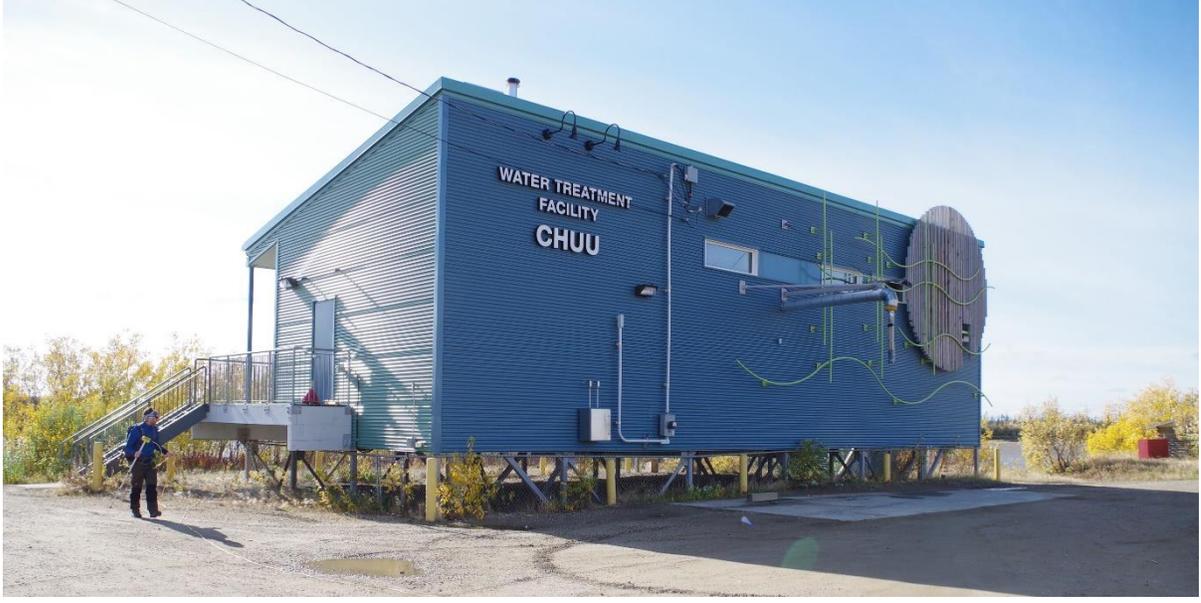
Community	Old Crow		
ID #	24-25		
Asset	Water treatment facility		
Location	Waterfront / East of Airport terminal

Surveyed feature	Doorstep / First floor / Top of outdoor stairs (electric box / meter)		
Elevation	247.9 m (247.4 m)	Flood return period	230 years (110 years)*
		Annual flood probability	0.4 % (0.9%)*

* Water would reach the concrete pad (groundwater surface and ground water wells) every 20 years.

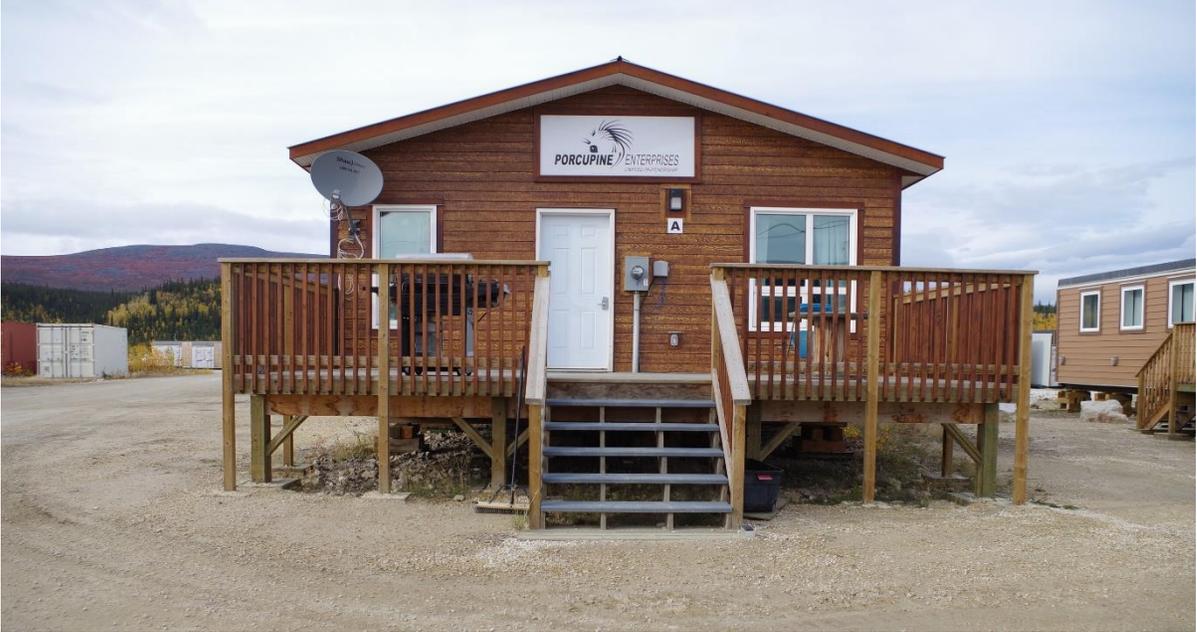
Community	Old Crow		
ID #	26		
Asset	Porcupine Enterprises / Offices		
Location	Across Water Treatment Facility

Surveyed feature	Doorstep / First floor / Top of stairs		
Elevation	247.6 m	Flood return period	160 years
		Annual overflow probability	0.6%

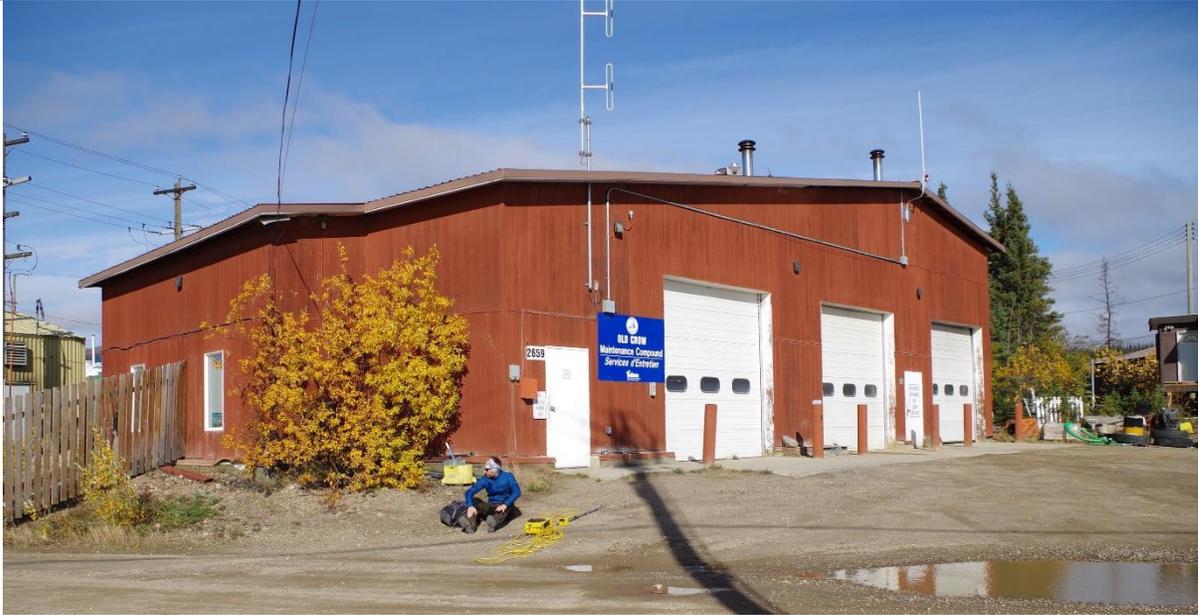
Community	Old Crow		
ID #	27		
Asset	Maintenance Compound / Highways and Public Works garage		
Location	Main street / Airstrip side / East of Airport terminal

Surveyed feature	Concrete pad / Doorstep		
Elevation	246.6 m	Flood return period	35 years
		Annual flood probability	3%

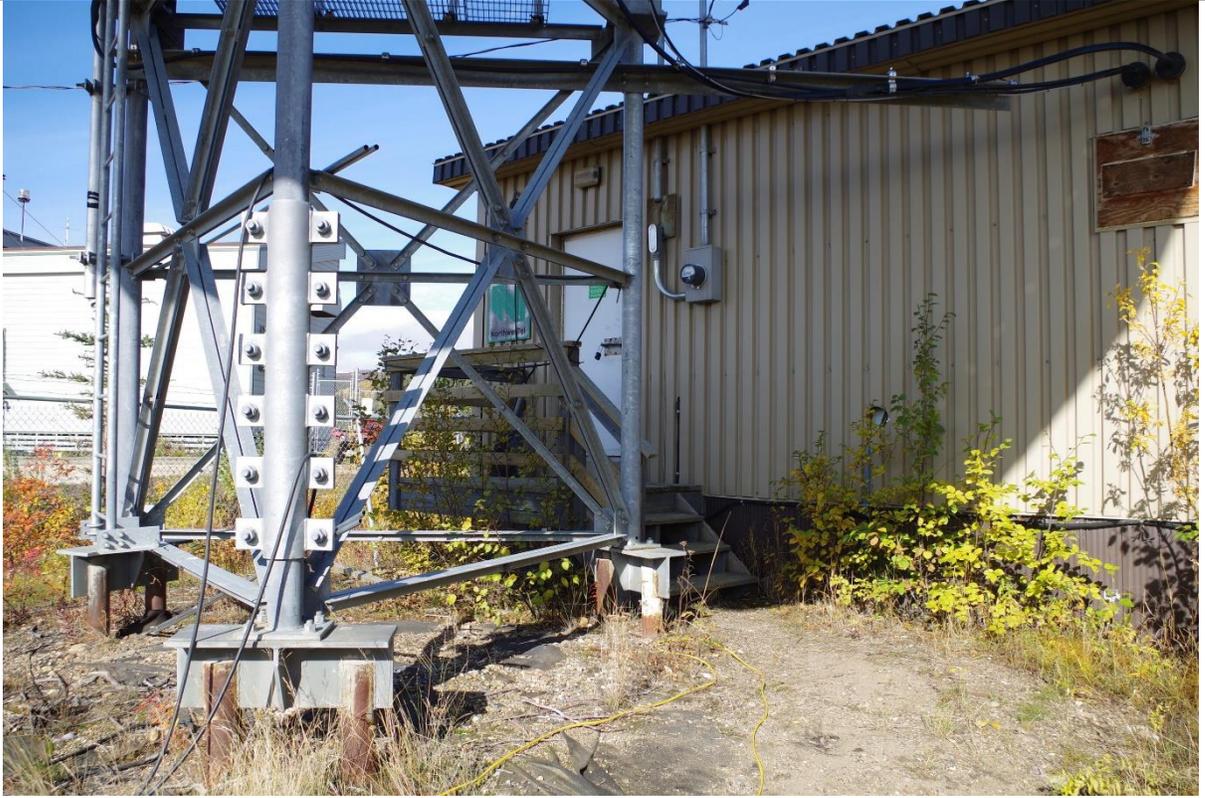
Community	Old Crow		
ID #	28		
Asset	Northwestel Building / below antenna		
Location	Between HPW Garage and Airport terminal

Surveyed feature	Doorstep / First floor		
Elevation	247.0 m	Flood return period	60 years
		Annual flood probability	1.6%

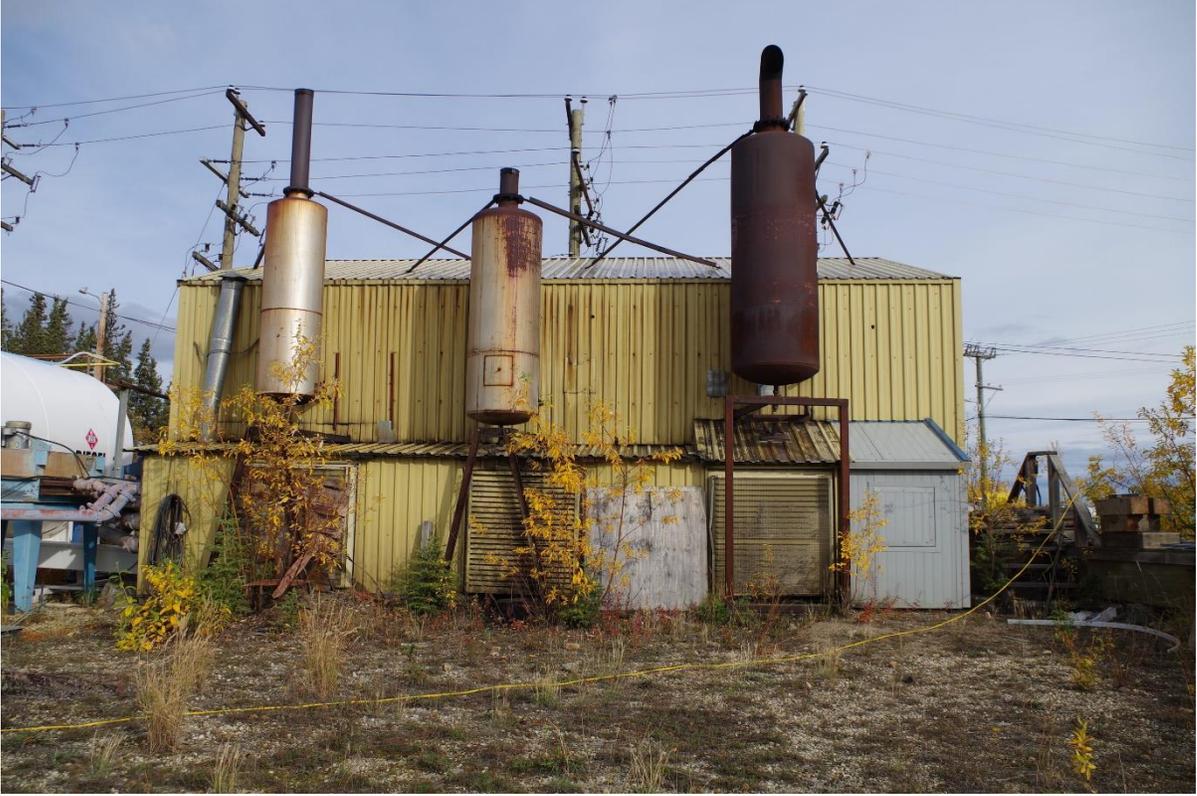
Community	Old Crow		
ID #	29		
Asset	ATCO old diesel generator		
Location	Northeastern tip of community / North of airstrip

Surveyed feature	Bottom of building / ground level		
Elevation	246.8 m	Flood return period	45 years*
		Annual overflow probability	2%*

* The elevation of critical components of the generating system and the impact of contact with water are unknown.

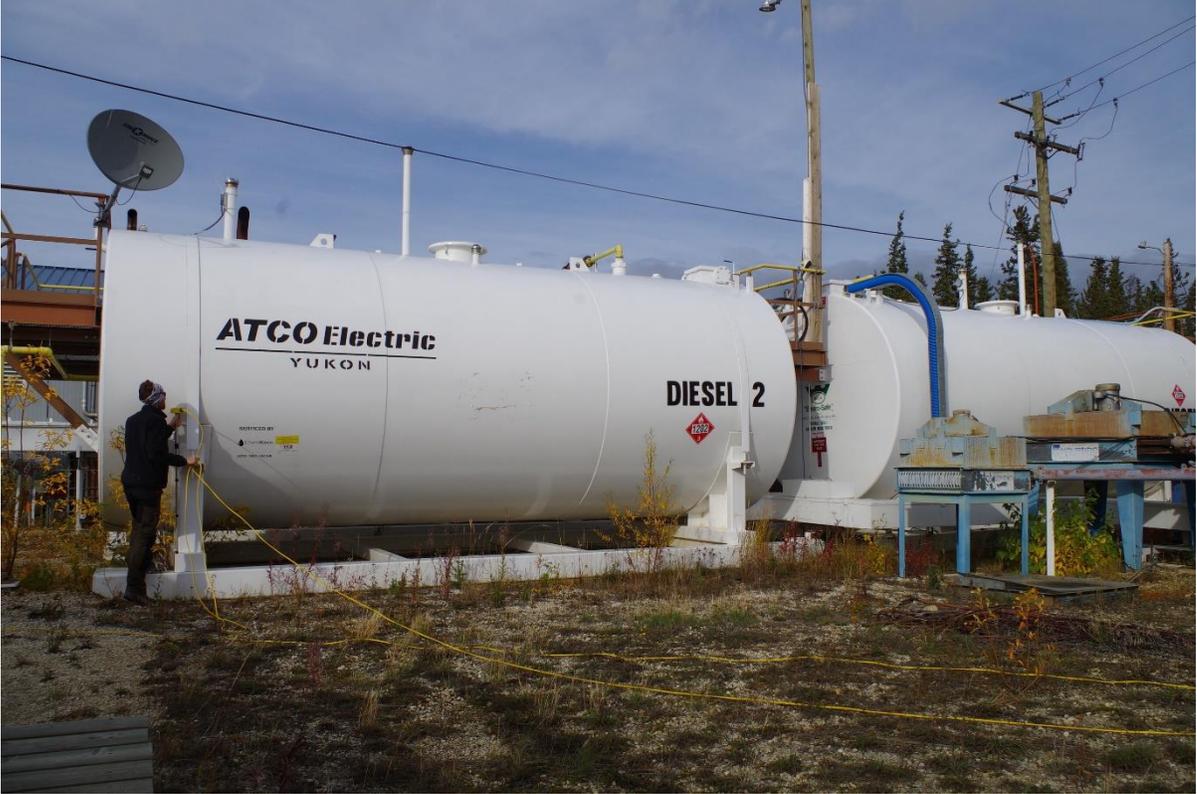
Community	Old Crow		
ID #	30		
Asset	ATCO Fuel tanks		
Location	Northeastern tip of community / North of airstrip

Surveyed feature	Foot of tank		
Elevation	247.1 m	Flood return period	65 years*
		Annual overflow probability	2%*

* Access would be affected by water from the Porcupine River at that frequency

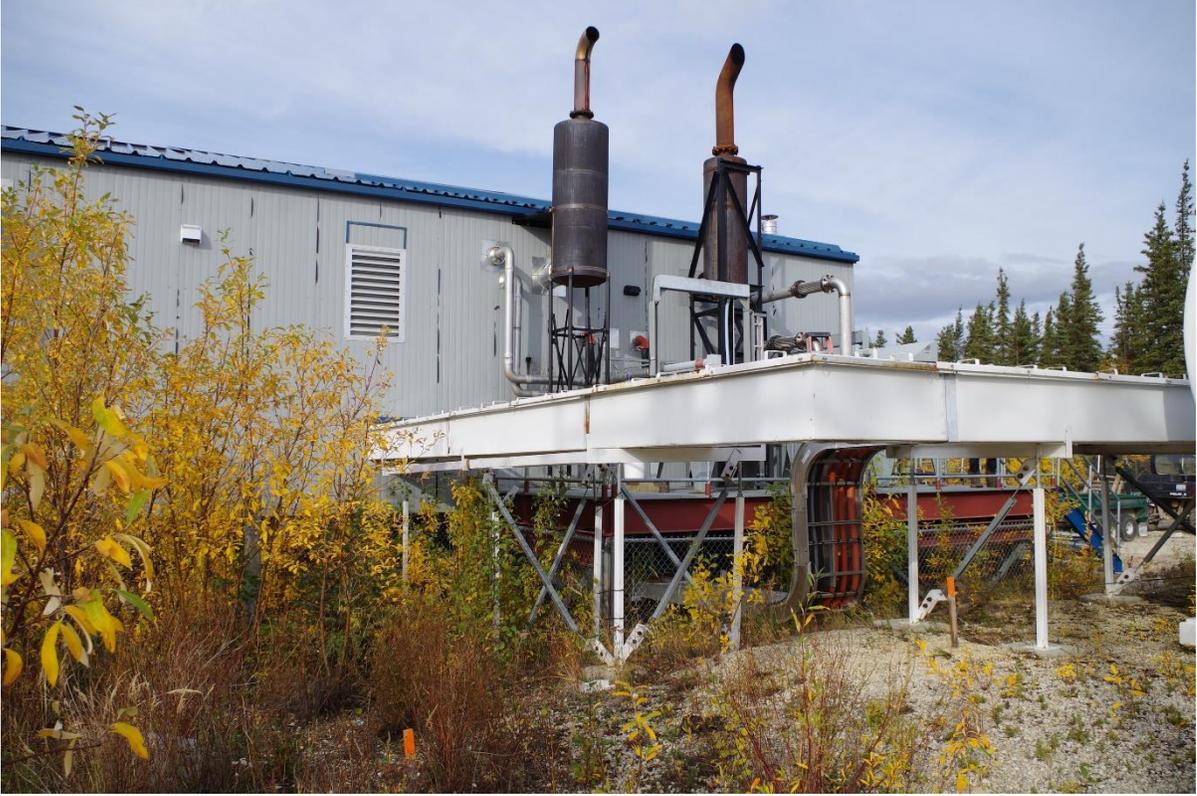
Community	Old Crow		
ID #	31		
Asset	ATCO (new) diesel generators		
Location	Northeastern tip of community / North of airstrip

Surveyed feature	Foot of tank		
Elevation	247.7 m	Flood return period	160 years*
		Annual overflow probability	0.6%*

* The elevation of critical components of the generating system and the impact of contact with water are unknown.

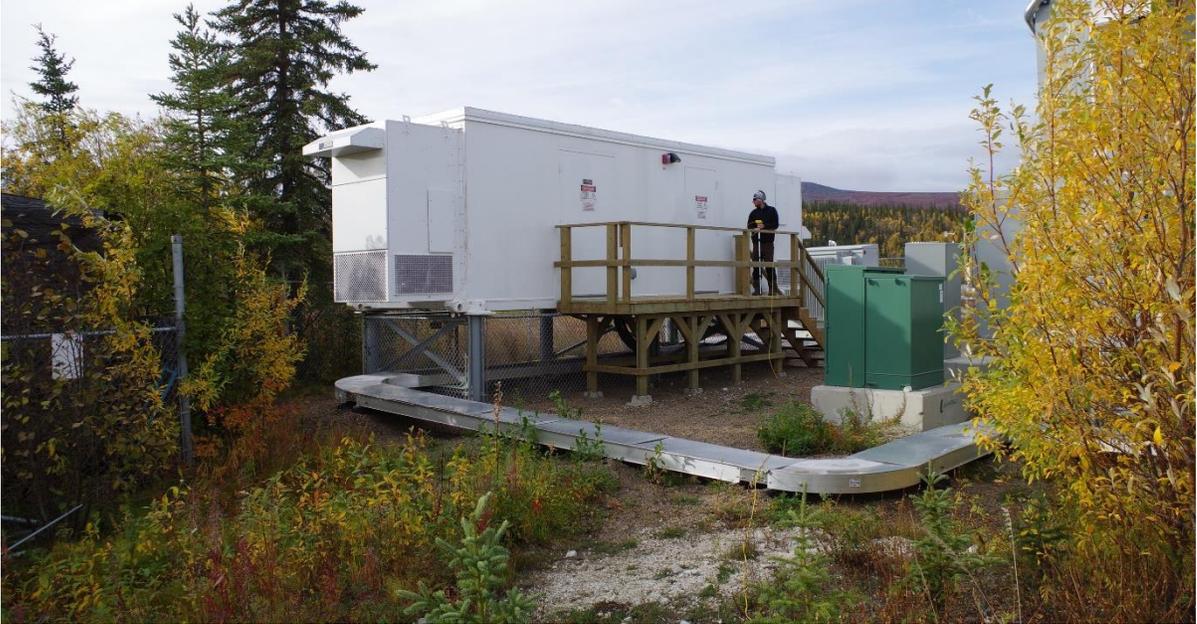
Community	Old Crow		
ID #	32		
Asset	ATCO (assumed) battery		
Location	Northeastern tip of community / North of airstrip

Surveyed feature	Bottom of building / Top of stairs / First floor		
Elevation	247.8 m	Flood return period	200 years*
		Annual overflow probability	0.5%*

* The elevation of critical components of the generating system and the impact of contact with water are unknown.

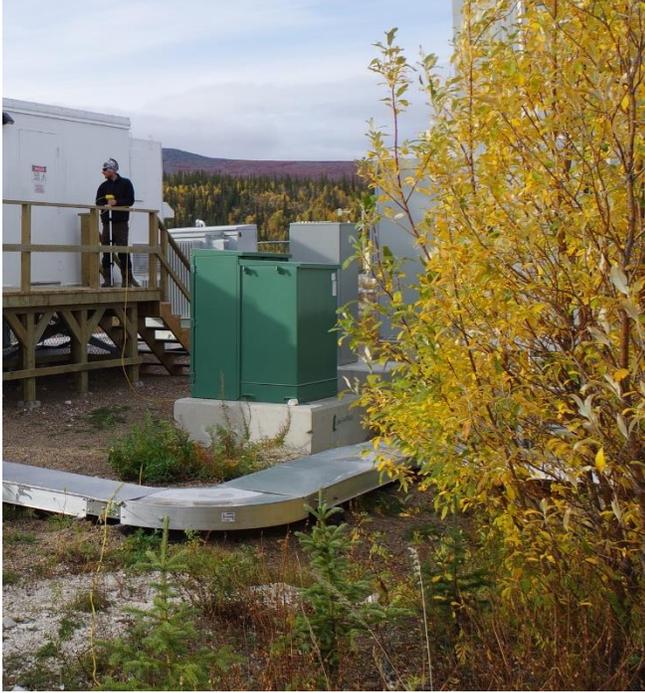
Community	Old Crow		
ID #	33		
Asset	ATCO (assumed) transformer (green metal box on concrete footing)		
Location	Northeastern tip of community / North of airstrip

Surveyed feature	Concrete surface / Foot box		
Elevation	246.7 m	Flood return period	40 years*
		Annual overflow probability	2.5%*

* The elevation of critical components of the generating system and the impact of contact with water are unknown.

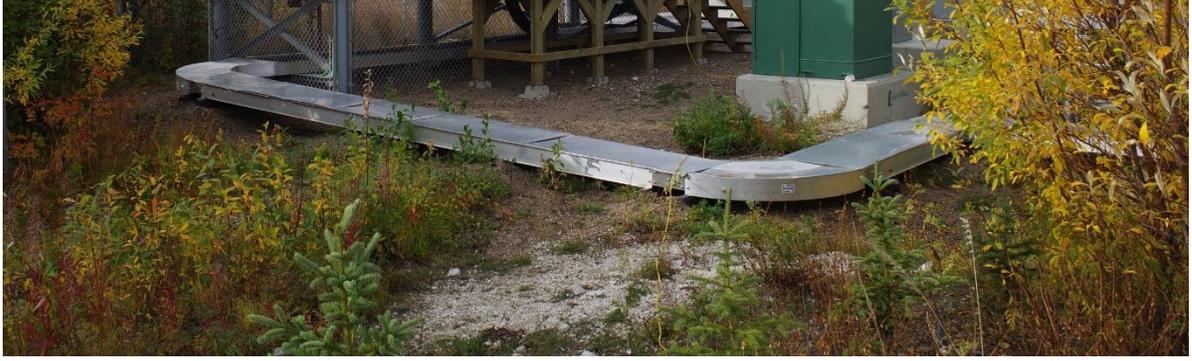
Community	Old Crow		
ID #	34		
Asset	ATCO electric cables in metal track		
Location	Northeastern tip of community / North of airstrip

Surveyed feature	Top of metal track on floor		
Elevation	246.4 m	Flood return period	25 years*
		Annual overflow probability	4%*

* The elevation of critical components of the generating system and the impact of contact with water are unknown.

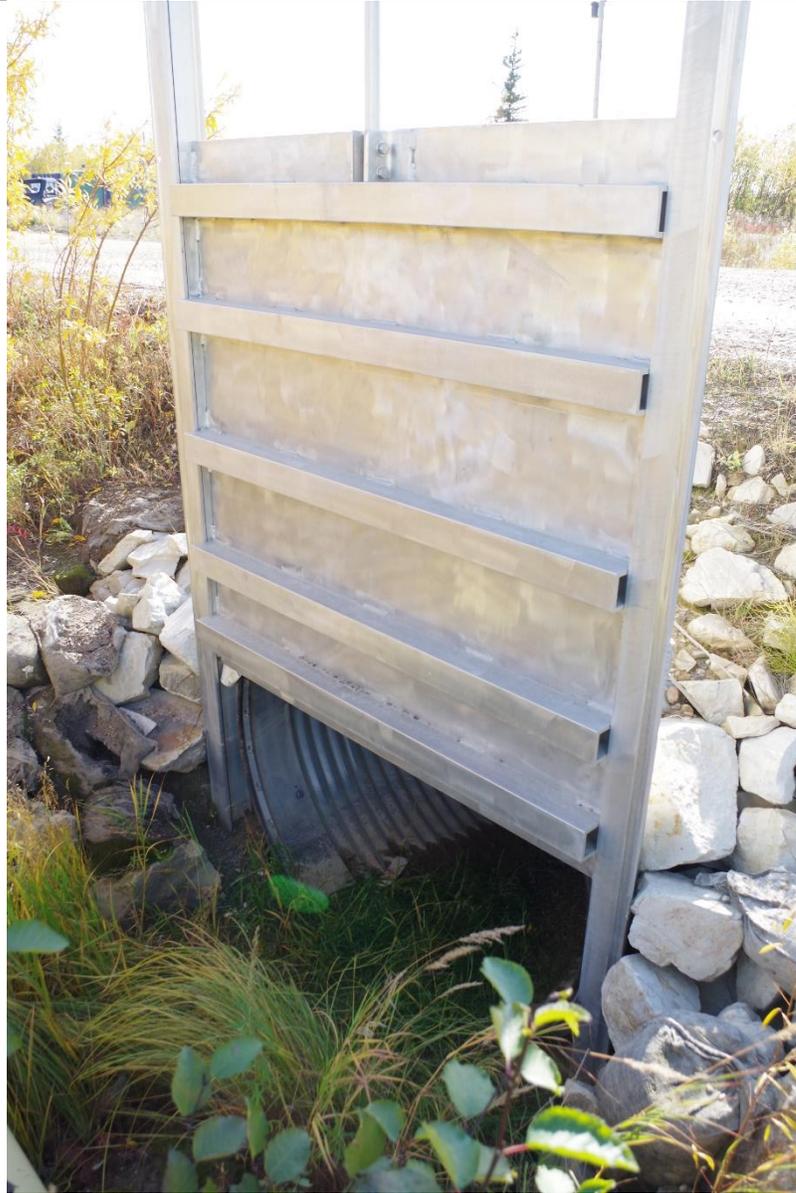
Surveyed feature	Upstream side (with gate) / Bottom of culvert		
Elevation	244.2 m	Flood return period*	2 years
		Annual overflow probability*	50 %

benign hydrological events with a return period of 5 years. In turn, these valves are bypassed (the road is overtopped by water) for more significant events that do cause damage. It is therefore recommended to remove these valves rather than to maintain or fix them, unless there would be a plan to build vulnerable assets at low elevation on that side of the airstrip.

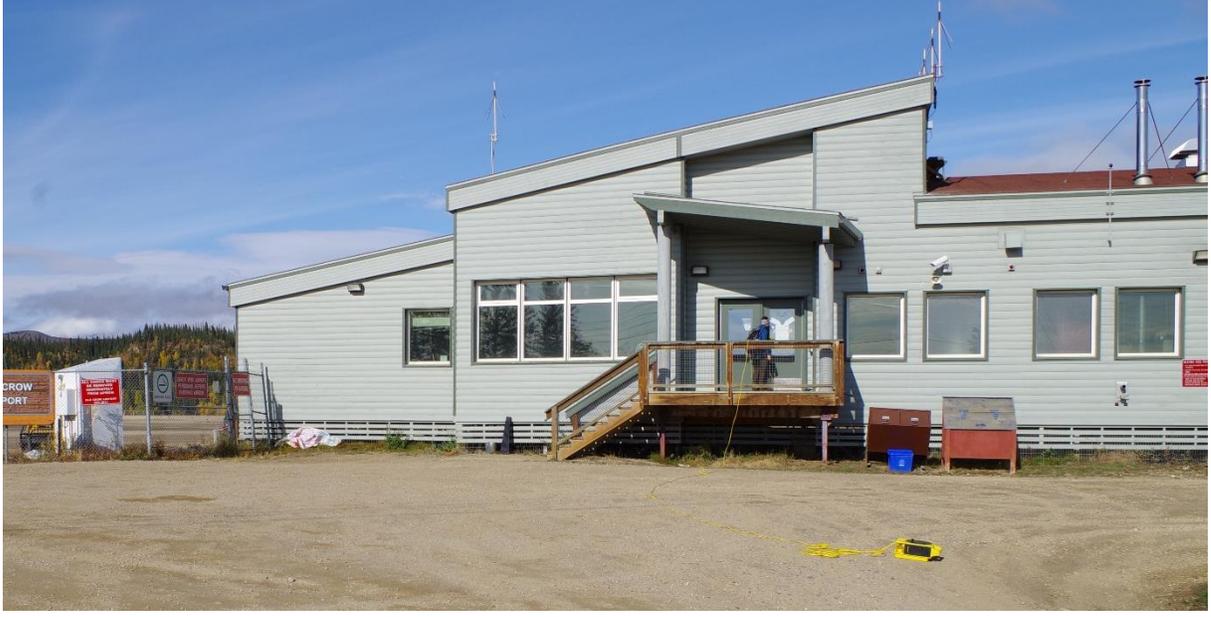
Community	Old Crow		
ID #	37		
Asset	Airport Terminal		
Location	West of airport runway

Surveyed feature	Doorstep / First floor / Top of outdoor stairs		
Elevation	248.0 m	Flood return period	260 years*
		Annual flood probability	0.4%*

* Water from the Porcupine River would start affecting airport operations every 20 years, on average.

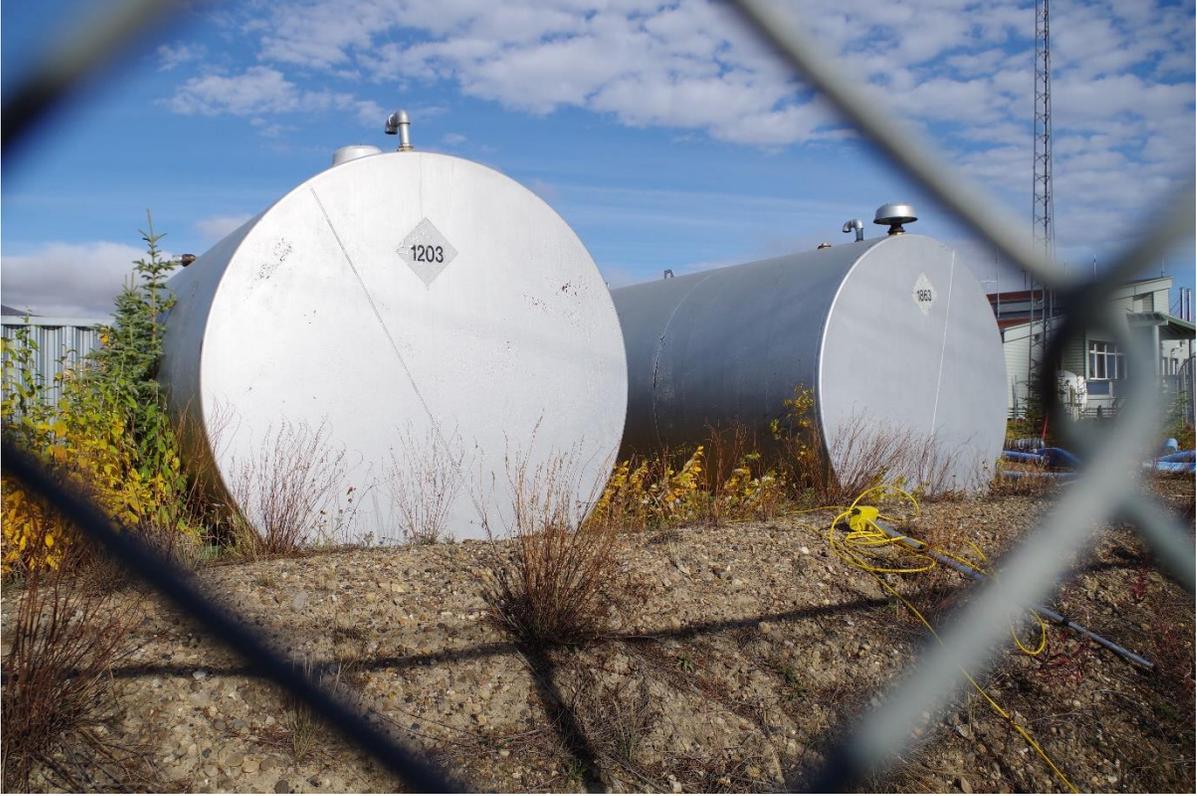
Surveyed feature	Foot of tanks (and low point in the dike around the tanks*)		
Elevation	246.1 m (246.3 m)	Flood return period	18 years (25 years)
		Annual overflow probability	6 % (4%)

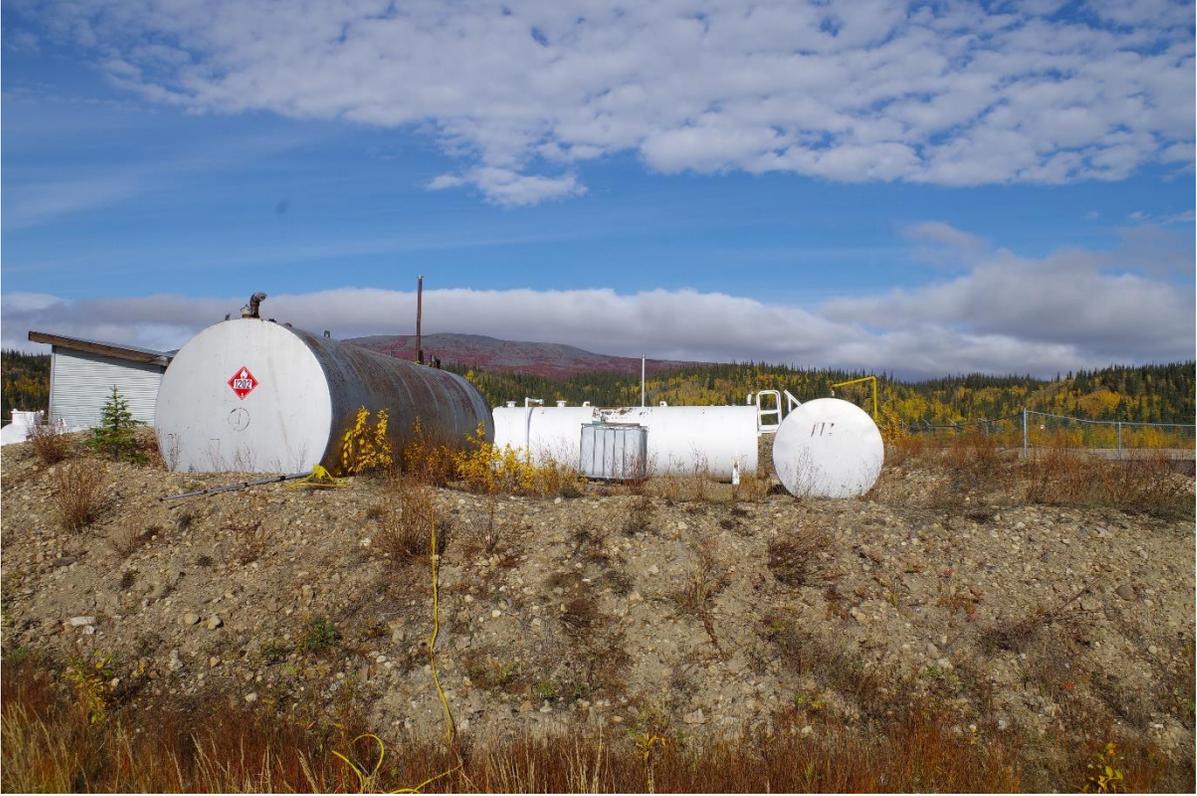
Surveyed feature	Foot of lowest tank (and low point in the dike around the tanks*)		
Elevation	246.1 m (246.4 m)	Flood return period	18 years (28 years)
		Annual overflow probability	6 % (4%)

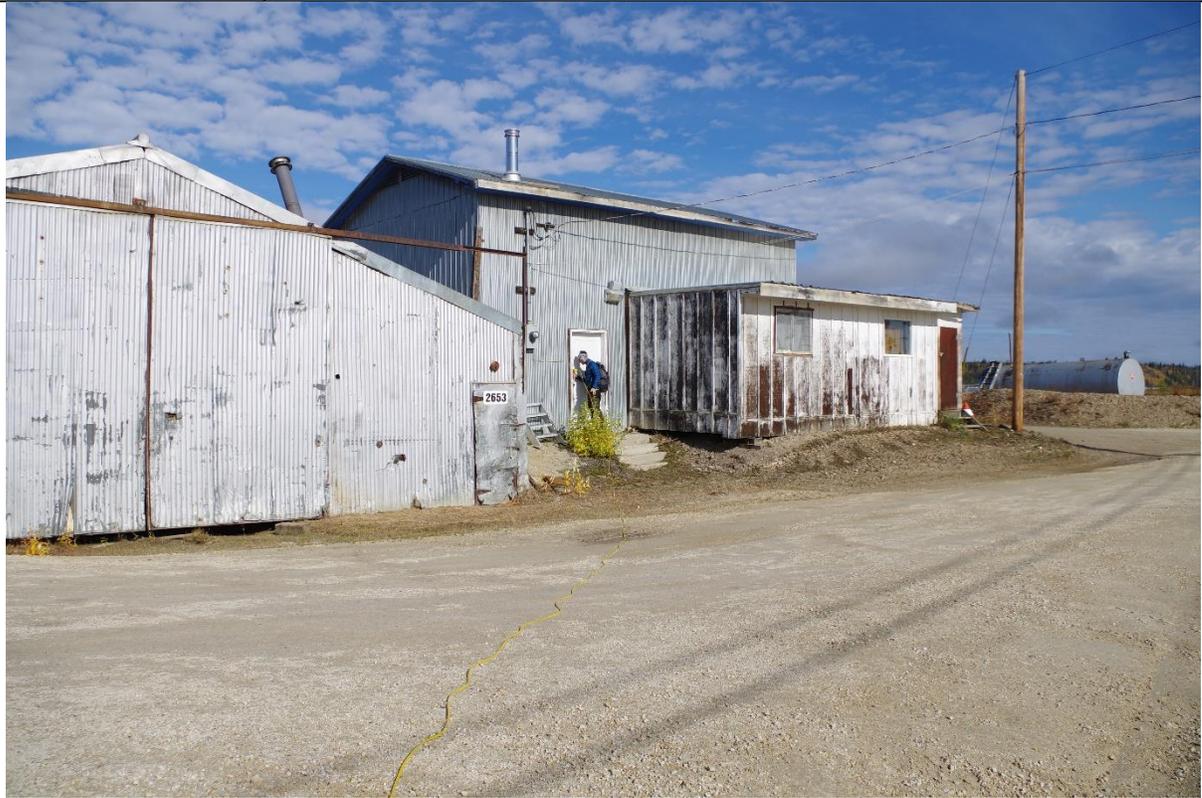
Community	Old Crow		
ID #	44		
Asset	Old compound for machinery (silver metal sheet buildings)		
Location	West of airport / Western tip of Old Crow / East of large compound

Surveyed feature	Concrete pad / Doorstep / First floor		
Elevation	246.4 m	Flood return period	25 years
		Annual overflow probability	4%

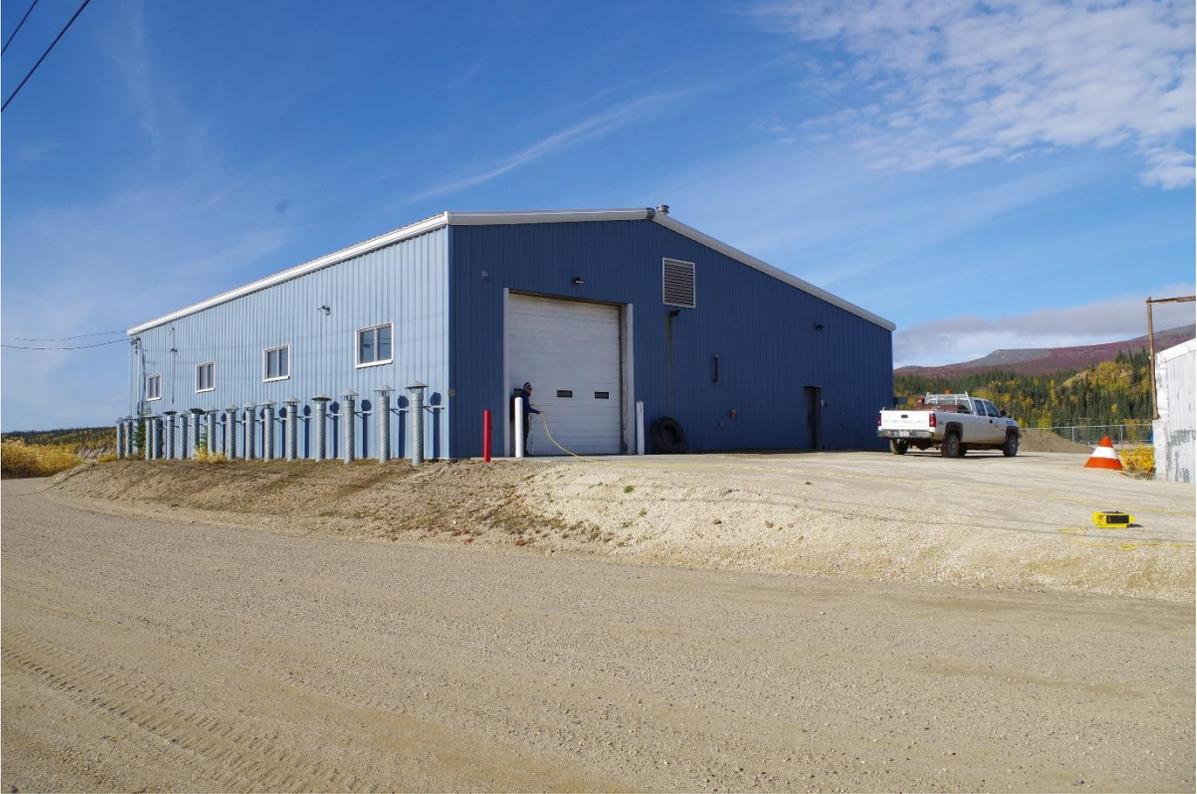
Community	Old Crow		
ID #	45		
Asset	New (larger) compound for machinery (blue metal sheet buildings)		
Location	West of airport / Western tip of Old Crow / West of small compound

Surveyed feature	Concrete pad / Doorstep / First floor		
Elevation	246.7 m	Flood return period	40 years
		Annual overflow probability	2.5%

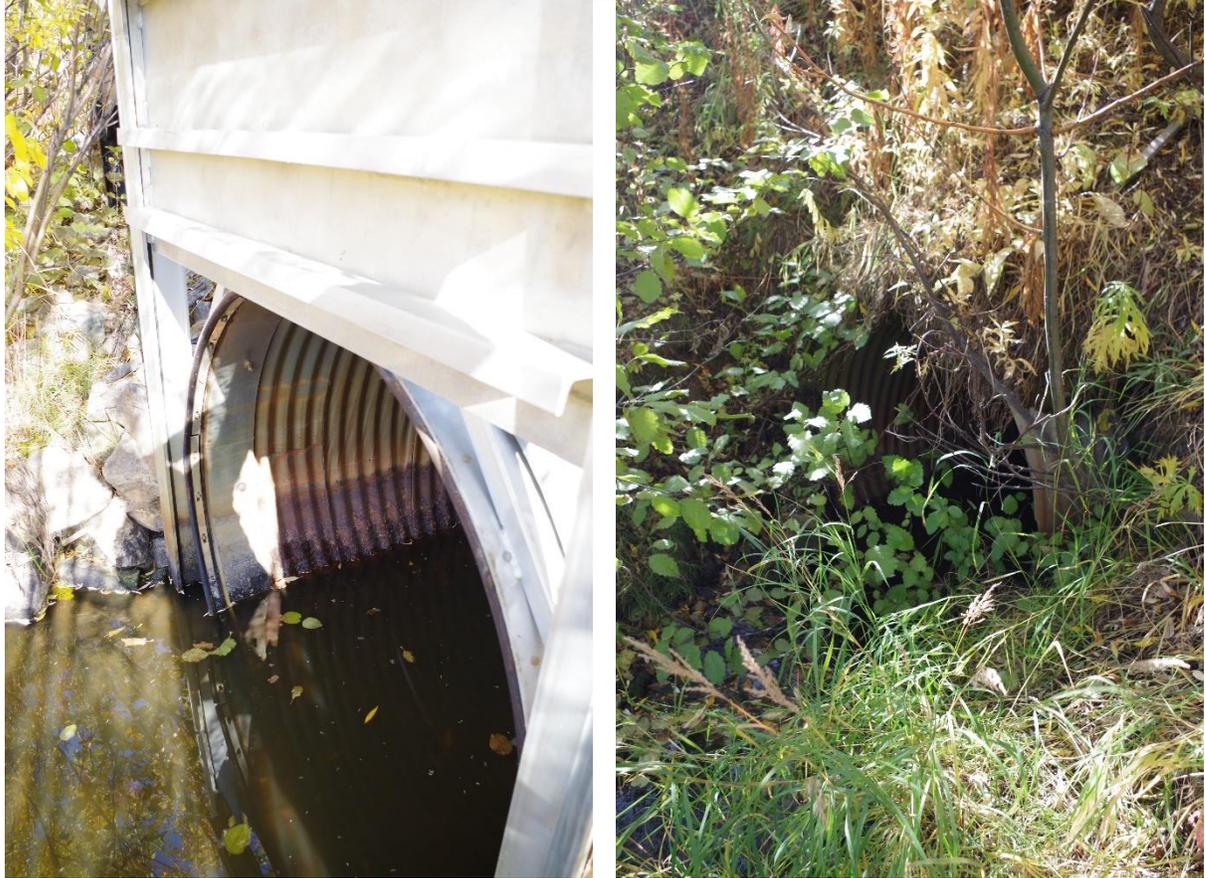
Community	Old Crow		
ID #	46-47		
Asset	Large culvert (Creek / drainage of the north side of airstrip)		
Location	Western tip of Old Crow / Road towards the sewage lagoon and dump

Surveyed feature	Upstream side (picture on the right) / Bottom of culvert		
Elevation	242.6 m	Flood return period*	0.4 years**
		Annual overflow probability*	260 %**

* Porcupine River backwater upstream of road into the creek

** It is difficult / dangerous to attempt closing the gate for a water elevation of 244.6 m, which corresponds to a return period of 3 years, or an annual probability of 33%.

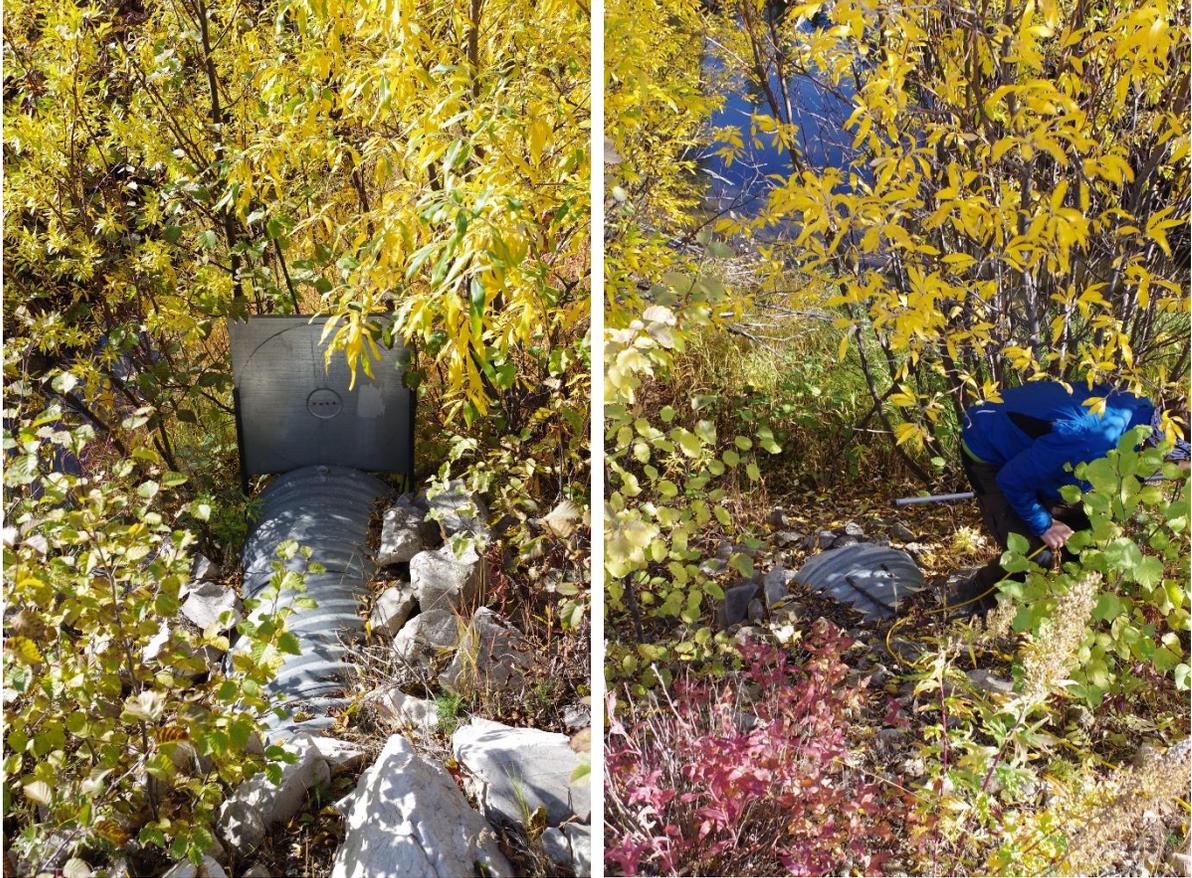
Community	Old Crow		
ID #	48-49		
Asset	Secondary culvert (Creek / drainage of the north side of airstrip)		
Location	Western tip of Old Crow / Road towards the sewage lagoon and dump

Surveyed feature	Upstream side (picture on the right) / Bottom of culvert		
Elevation	243.0 m	Flood return period*	0.6 years**
		Annual overflow probability*	170 %**

* Porcupine River backwater upstream of road into the creek

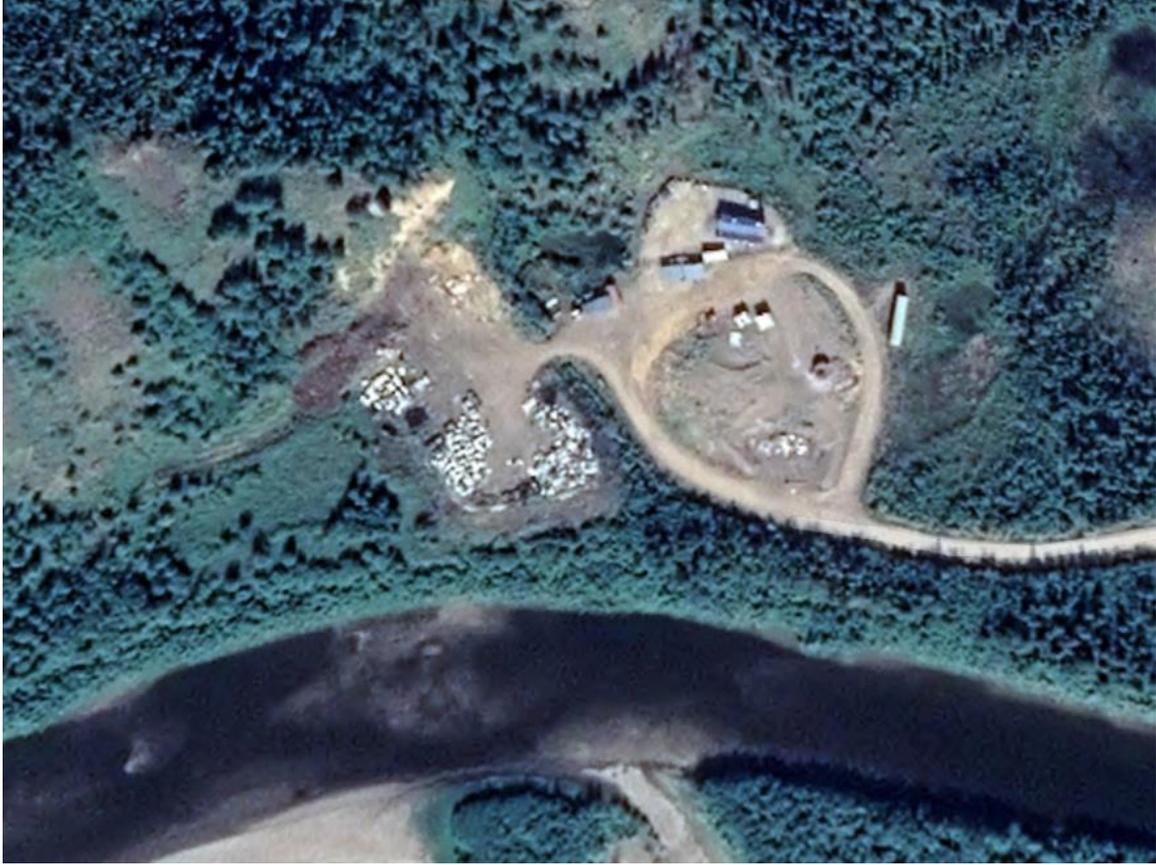
Community	Old Crow		
ID #	50		
Asset	Household Waste Dump		
Location	West of the community / End of main road

Surveyed feature	Ground level / Low point (from DEM information, photo from Google Earth)		
Elevation	249.1 m	Flood return period	1600 years*
		Annual overflow probability	0.06%*

* The dump would not be accessible for a flood return period of approximately 2 years because of water on the road.

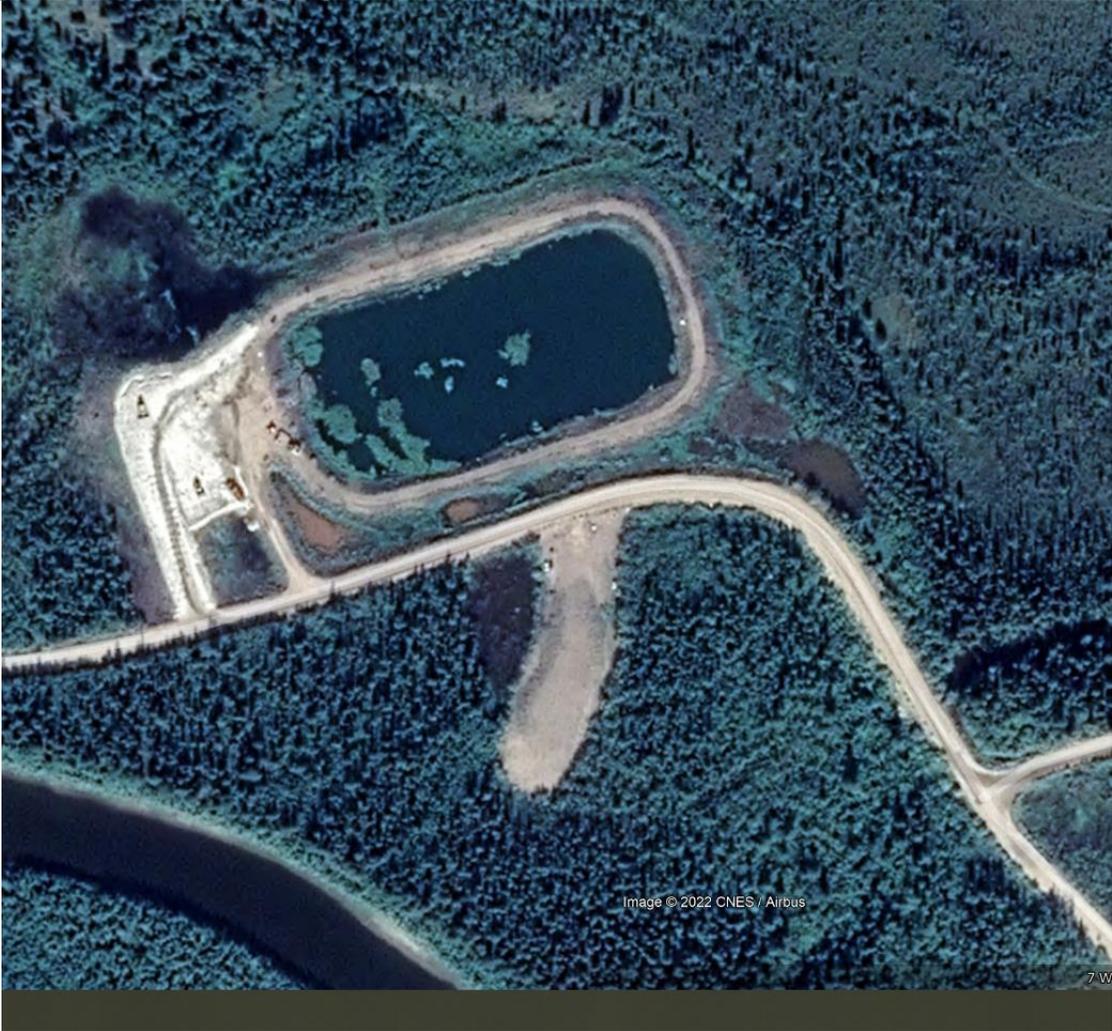
Surveyed feature	Top of dike around lagoon (from DEM, photo from Google Earth)		
Elevation	244.5 m	Flood return period	2.5 years
		Annual overflow probability	40%

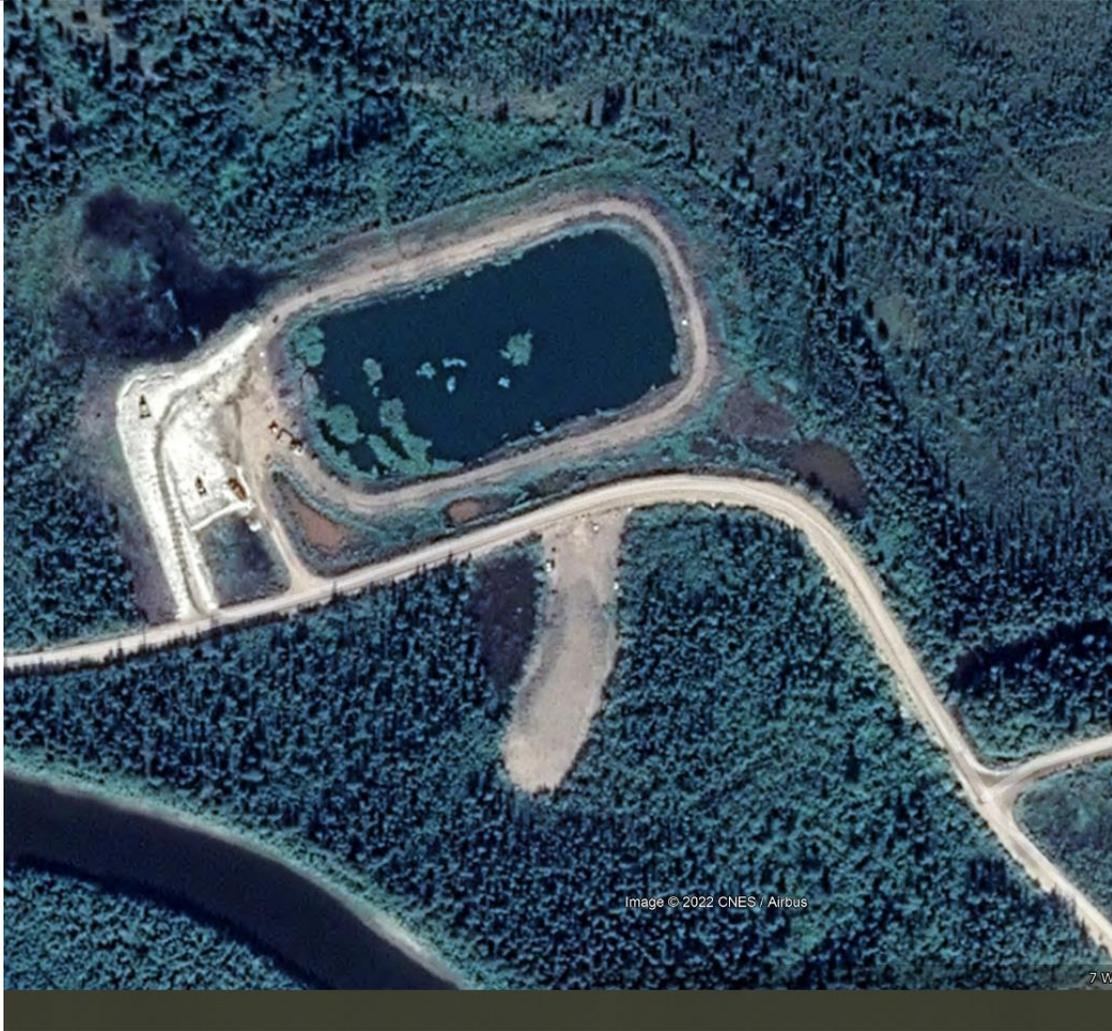
Community	Old Crow
ID #	52
Asset	Metal dump
Location	Left side of main road when going to the community dump / across Lagoon

Surveyed feature	Ground level / Low point (from DEM information, photo from Google Earth)		
Elevation	244.4 m	Flood return period	2.5 years
		Annual overflow probability	40%
