Flooding in Old Crow: Exposure analysis and risk reduction recommendations

March | 2022

Executive Summary

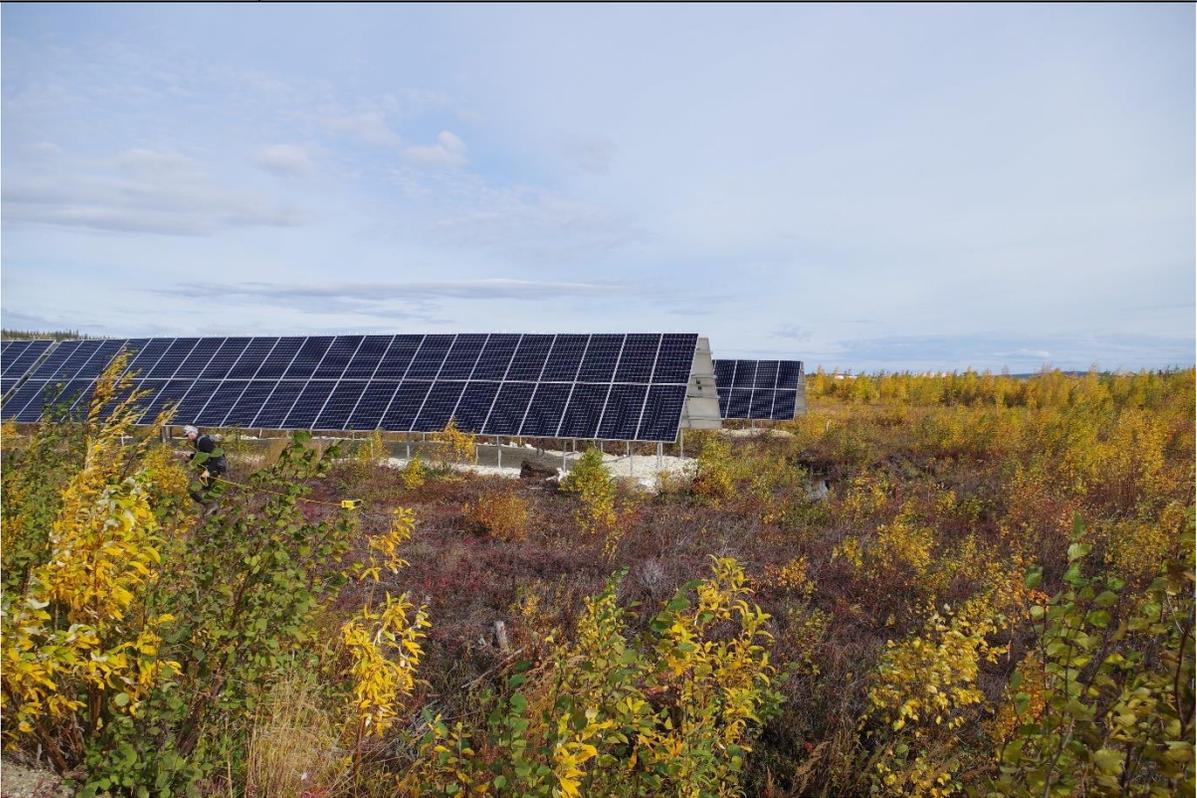
Community	Old Crow		
ID #	53-54		
Asset	Solar farm / Solar panel array A (lowest elevation)		
Location	North or airstrip

Surveyed feature	Lowest panel (lowest gravel pad corner)		
Elevation	246.4 m (245.5 m)	Flood return period*	25 years (8 years)
		Annual overflow probability*	4% (12%)

* The impact of flooding the lowest component of a solar panel is unknown

For example, the lowest solar panel and electric cables connecting diesel turbines to other small buildings on the ATCO property in Old Crow could be affected by water every 25 years on average. However, it cannot be confirmed if this water level would result in damage to an entire system, an entire solar panel array, or just a few solar panels.

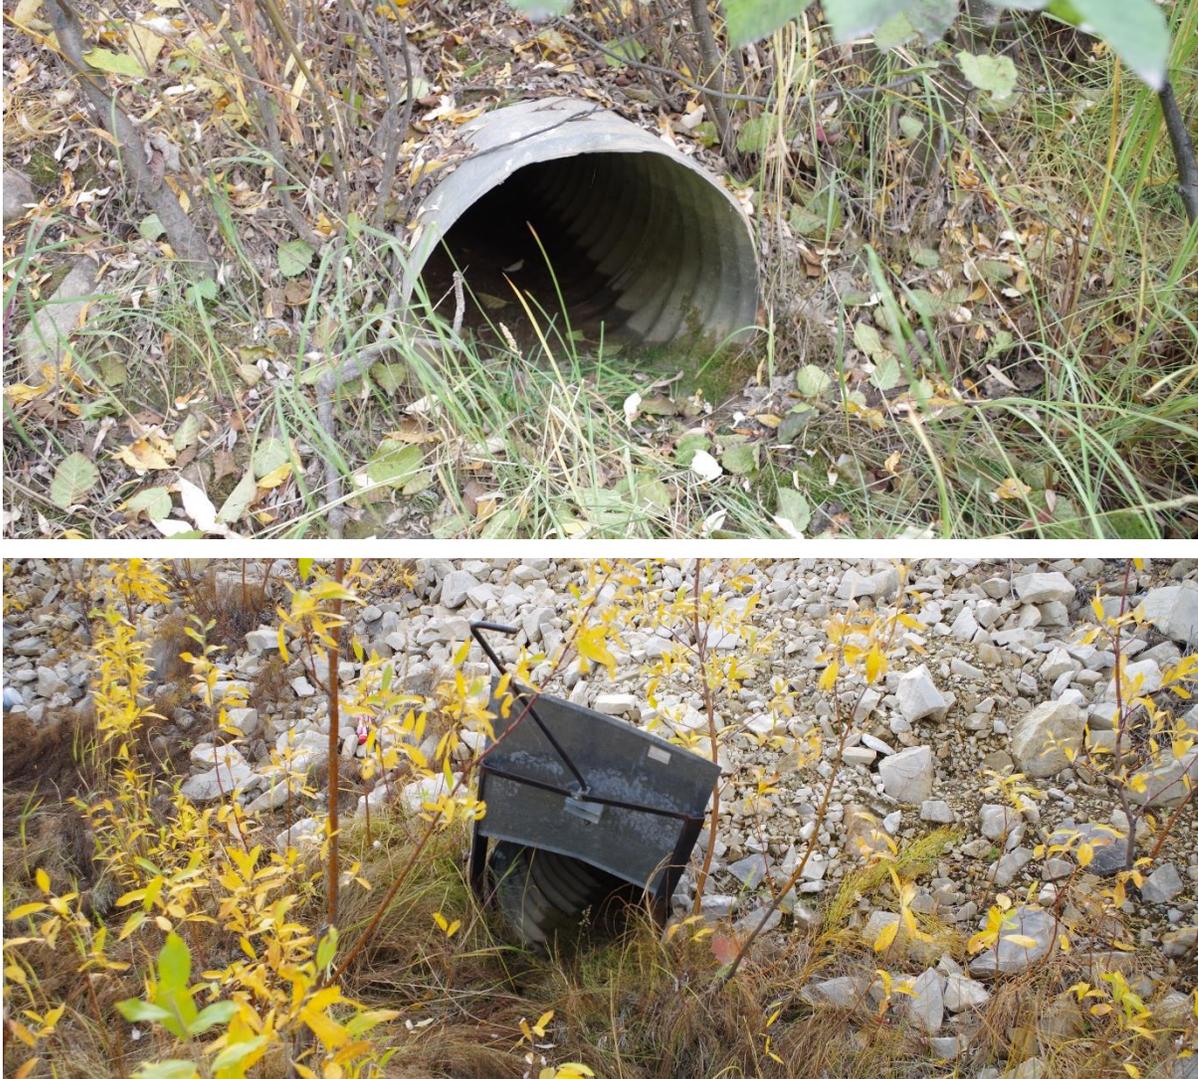
Community	Old Crow		
ID #	55-56		
Asset	Culvert (community drainage / storm drain)		
Location	Eastern end of the community / across Old Crow Arena

Surveyed feature	Upstream side (picture at the top) / Bottom of culvert		
Elevation	244.0 m	Flood return period*	1.5 years
		Annual overflow probability*	70 %

* Porcupine River backwater upstream of street

In the community, various culverts are installed to drain low areas whereas other culverts are meant to connect road-side ditches in order to drain streets and properties. A large majority of these culverts are structurally damaged by vehicles, or half buried under gravel, soil and vegetation (Figure 6.2.1, Appendix B). Some ditches are also blocked by debris and vegetation. Beyond the irritation associated with water accumulations in the community, this poses an increased risk for permafrost thawing. In order to avoid snowmelt and rain runoff water accumulations in the community, it is recommended to maintain, fix, and replace these culverts and ditches, and to design a functional surface water management network.

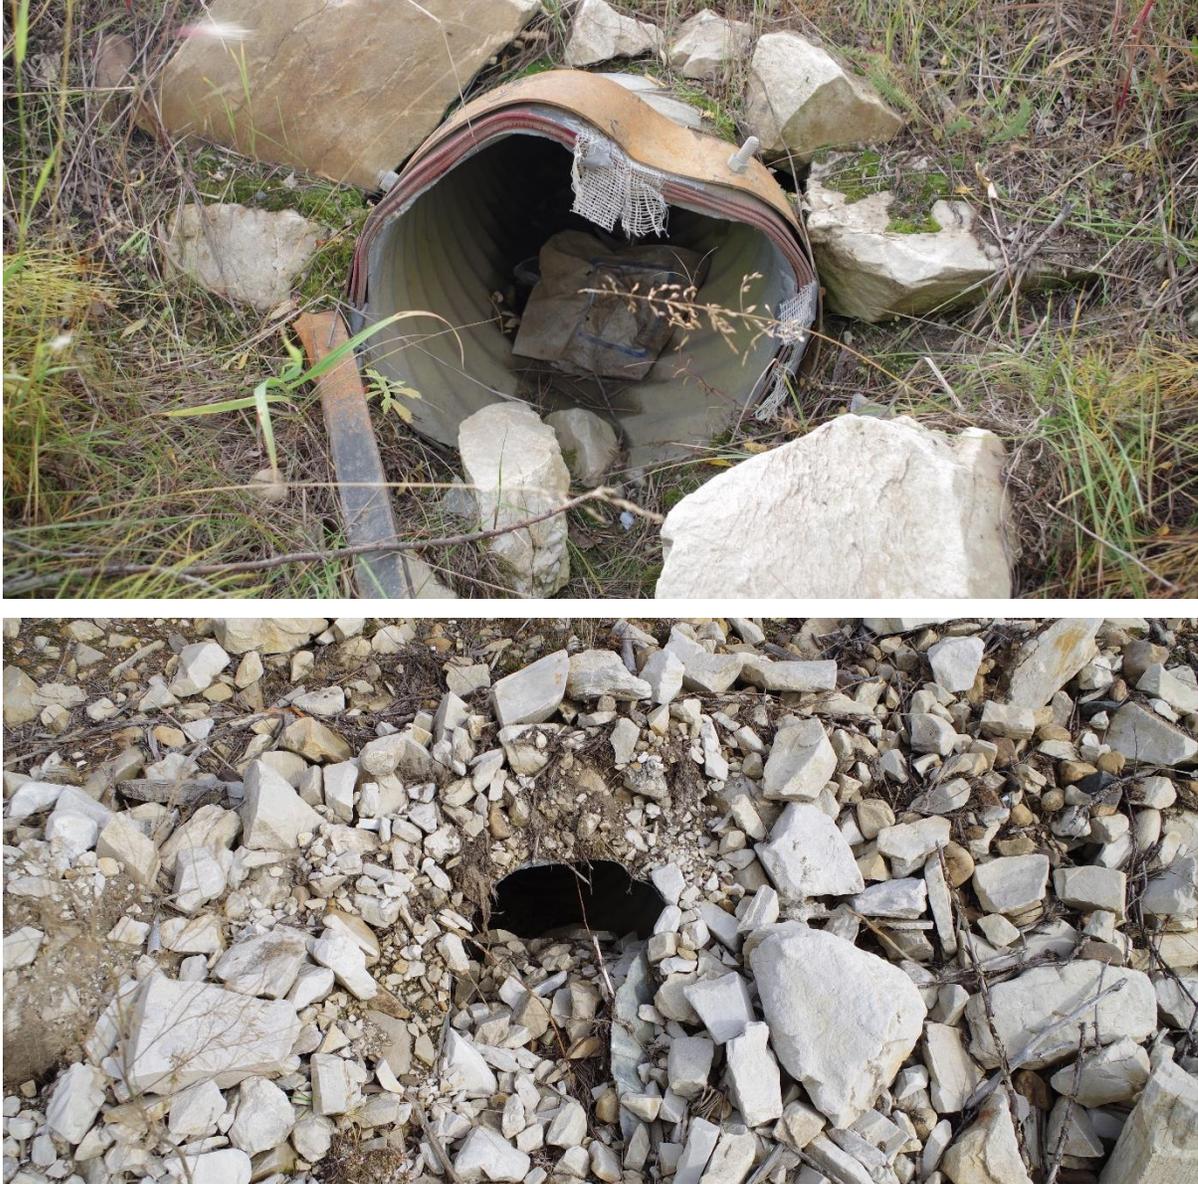
Community	Old Crow		
ID #	57-58		
Asset	Culvert (community drainage / storm drain)		
Location	In front of Old Community Centre / kids park area / Waterfront

Surveyed feature	Upstream side (picture at the top) / Bottom of culvert		
Elevation	245.4 m	Flood return period*	7 years
		Annual overflow probability*	14 %

* Porcupine River backwater upstream of street

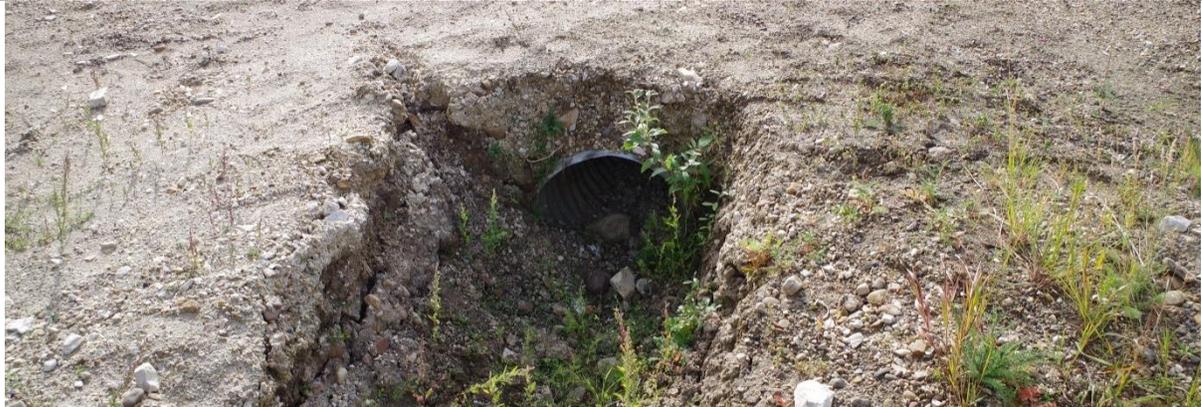
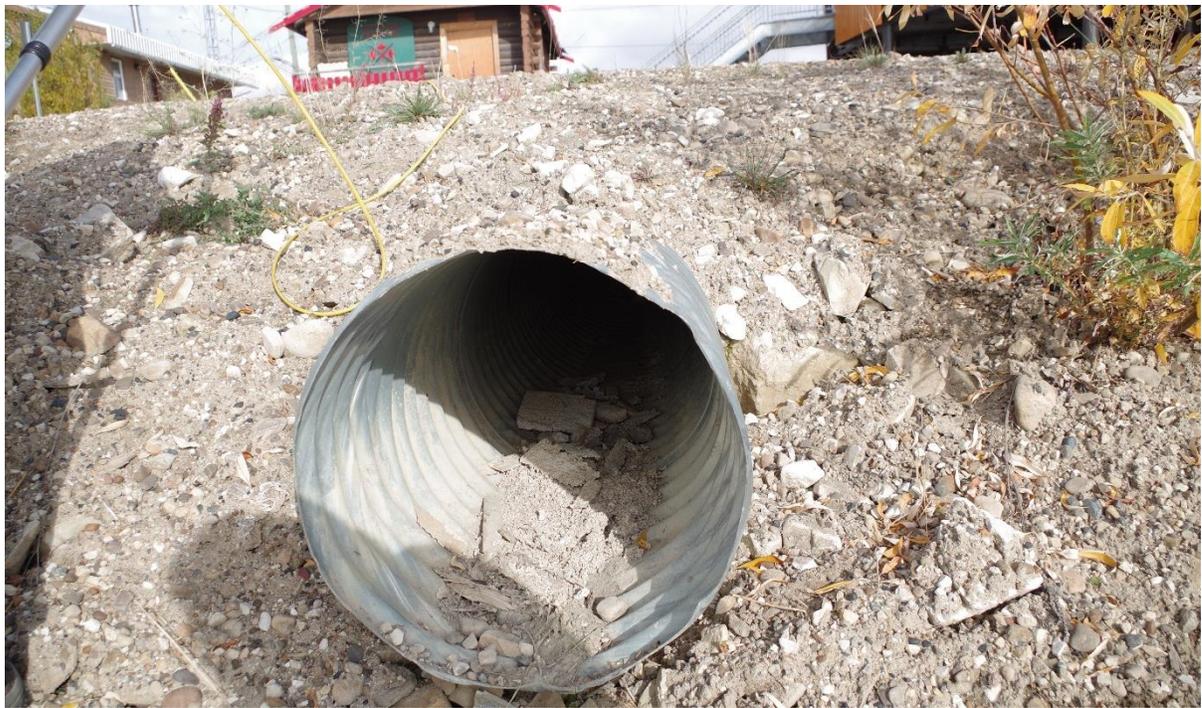
Community	Old Crow
ID #	59-60
Asset	Culvert (community drainage / storm drain)
Location	West end of New Community Centre / Waterfront

Surveyed feature	Upstream side (picture at the top) / Bottom of culvert		
Elevation	245.9 m	Flood return period*	12 years
		Annual overflow probability*	8 %

* Porcupine River backwater upstream of street

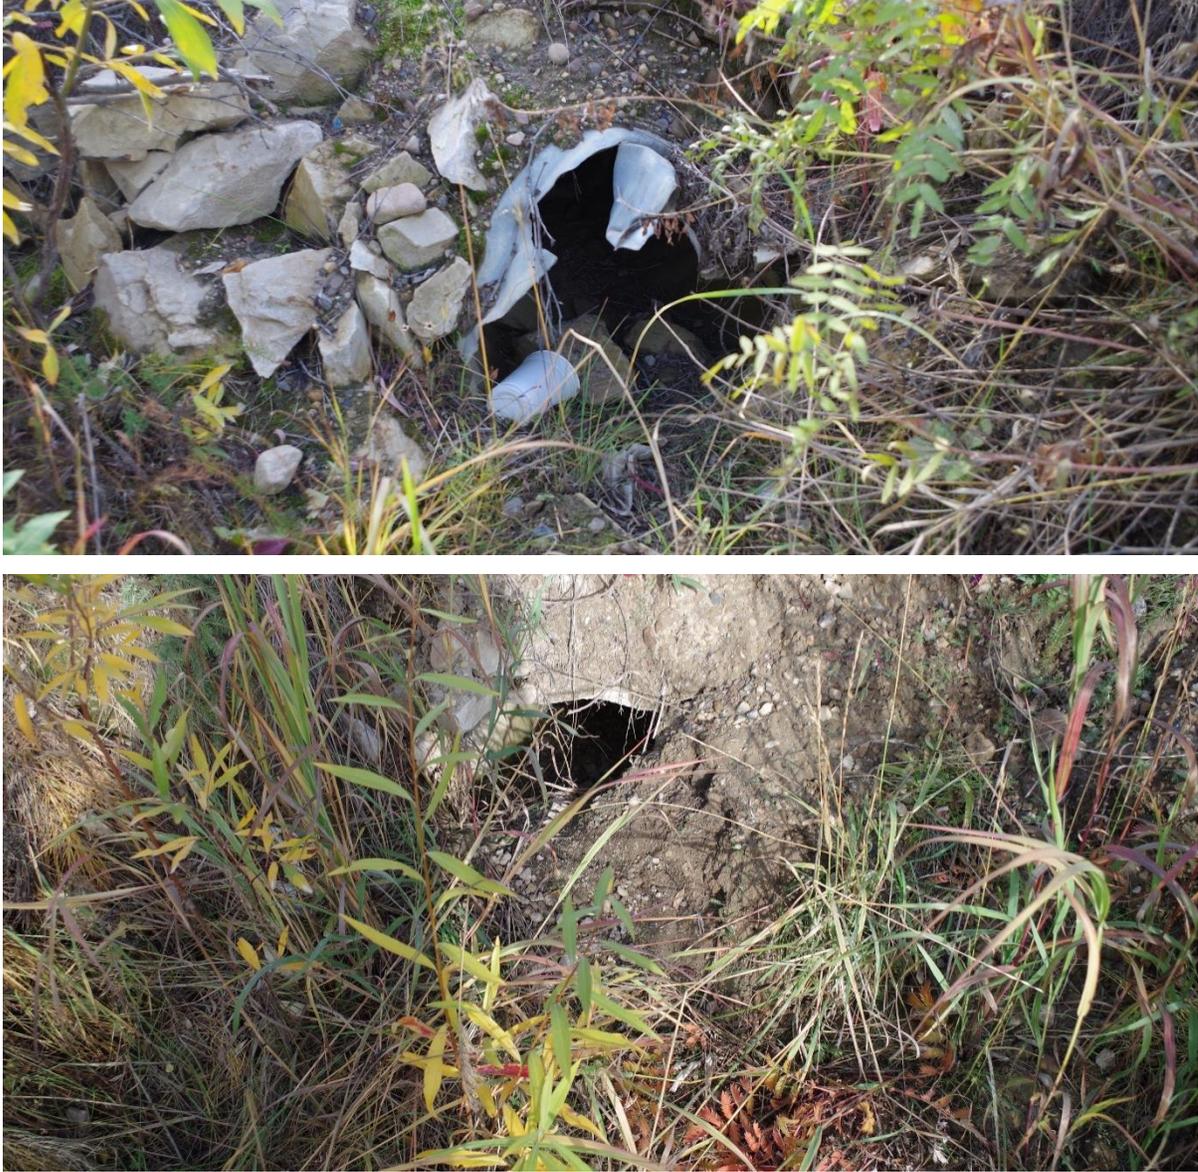
Community	Old Crow		
ID #	61-62		
Asset	Culvert (community drainage / storm drain)		
Location	Road crossing (T) / West of St. Luke's Anglican Church

Surveyed feature	Upstream side (picture at the top) / Bottom of culvert		
Elevation	245.9 m	Flood return period*	13 years
		Annual overflow probability*	7 %

* Porcupine River backwater upstream of street

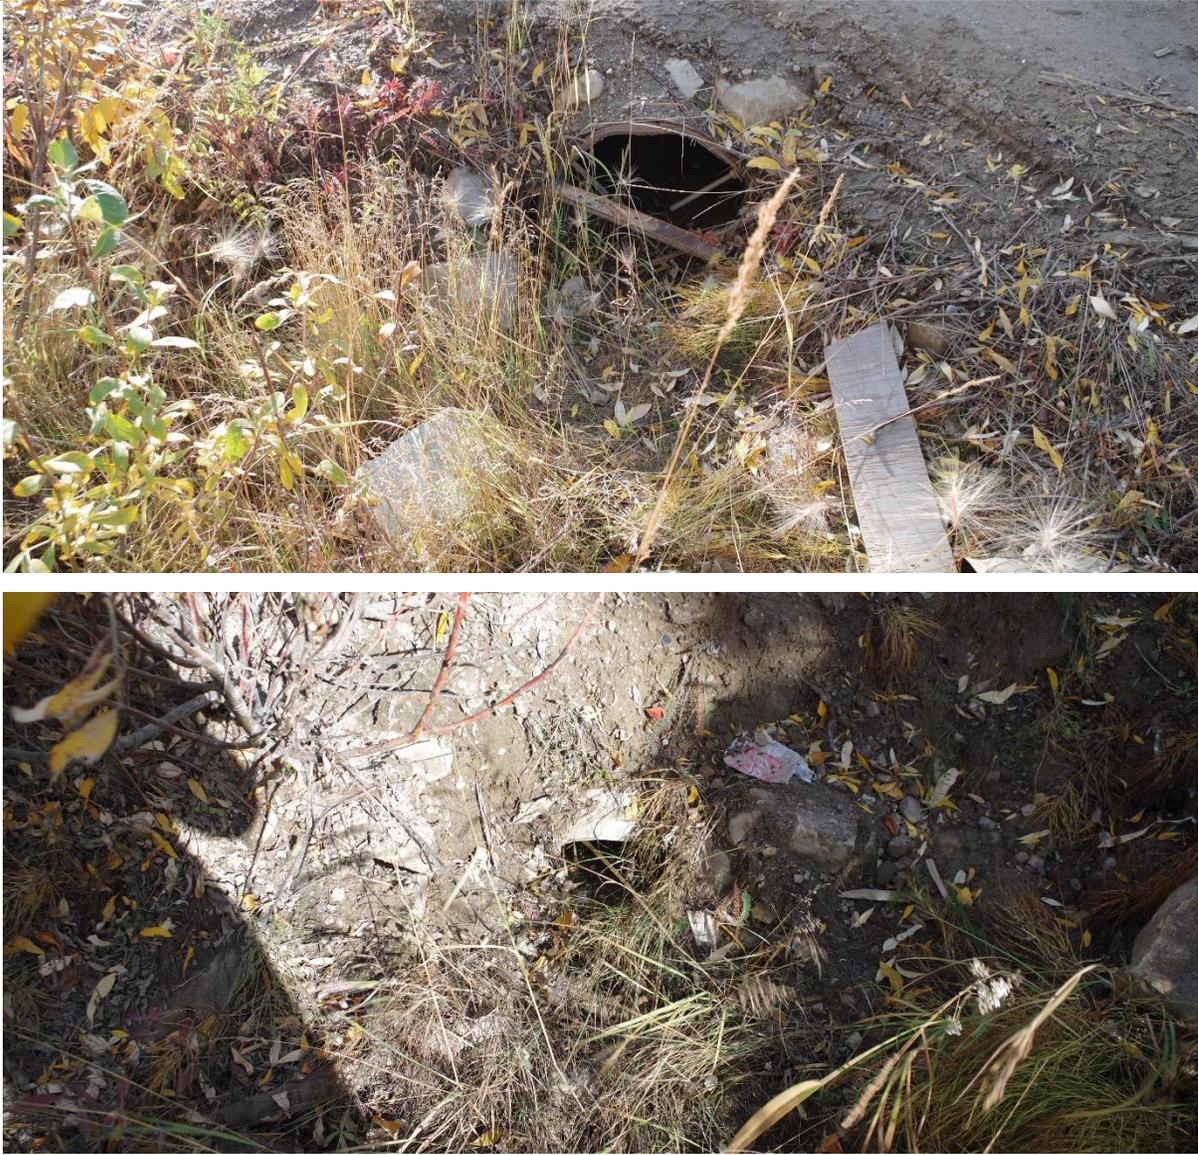
Community	Old Crow		
ID #	63-64		
Asset	Culvert (community drainage / storm drain)		
Location	Main street / East of Nursing Station / Old Crow Health Centre

Surveyed feature	Upstream side (picture at the top) / Bottom of culvert		
Elevation	245.6 m	Flood return period*	10 years
		Annual overflow probability*	10 %

* Porcupine River backwater upstream of street

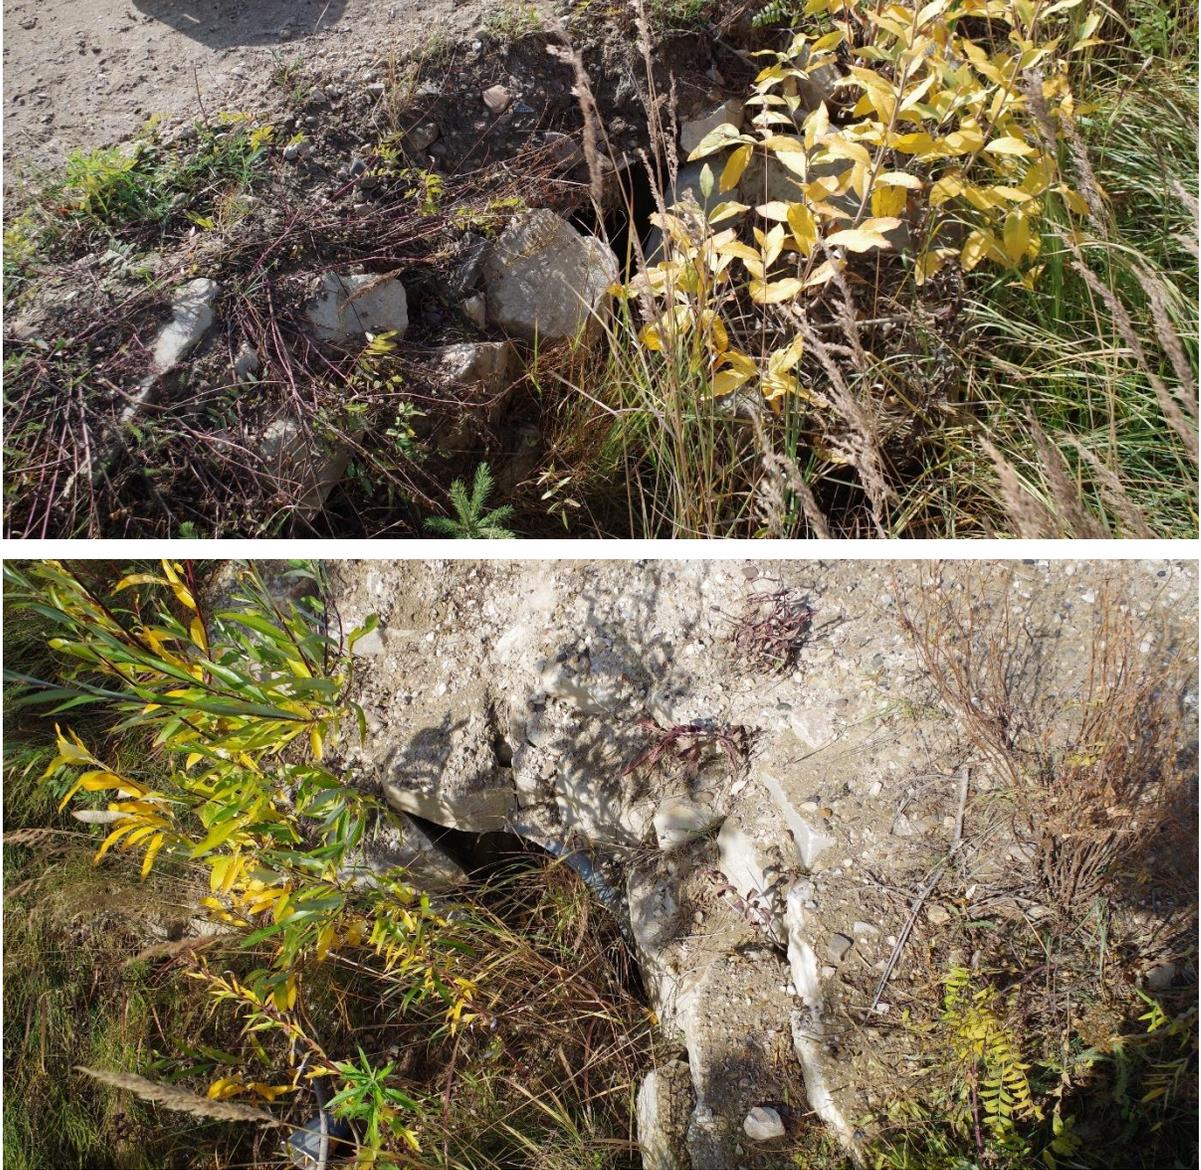
Community	Old Crow		
ID #	65-66		
Asset	Culvert (community drainage / storm drain)		
Location	Western of Airport terminal / East of machinery compounds

Surveyed feature	Upstream side (picture at the top) / Bottom of culvert		
Elevation	244.8 m	Flood return period*	4 years
		Annual overflow probability*	25 %

* Porcupine River backwater upstream of street

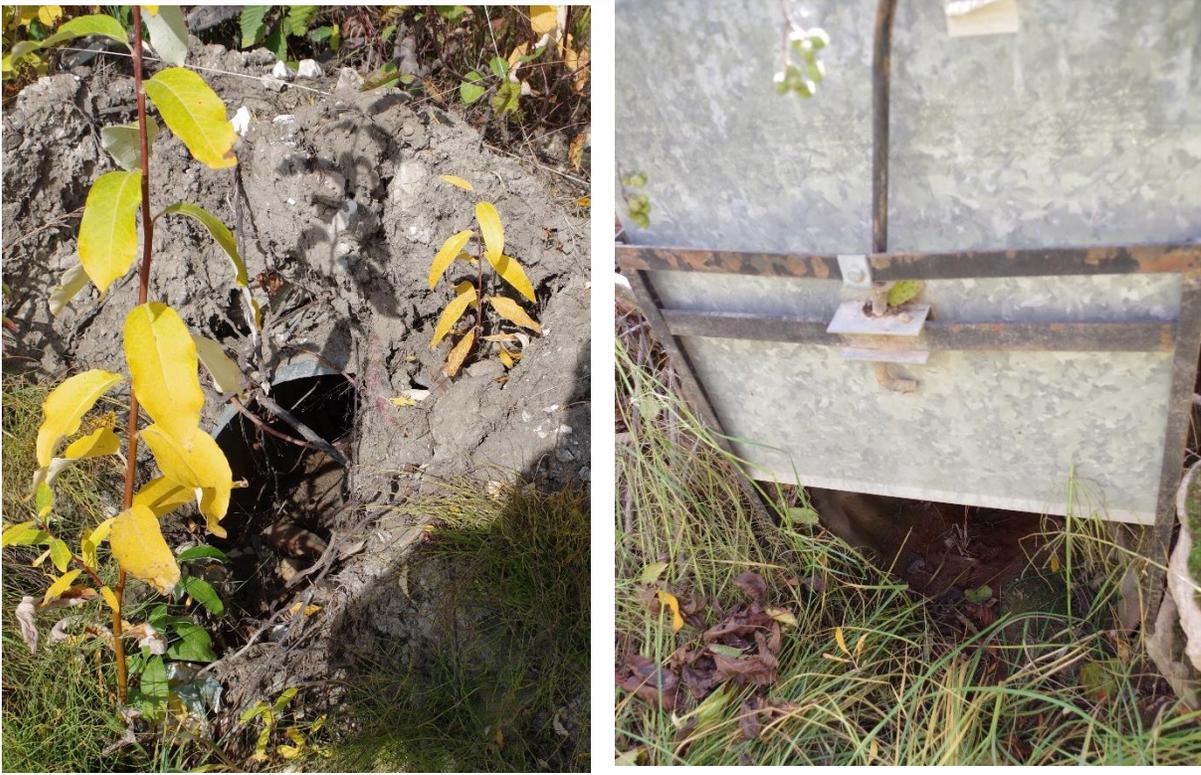
Community	Old Crow		
ID #	67-68		
Asset	Culvert (community drainage / storm drain)		
Location	Western end of airstrip / West of machinery compound

Surveyed feature	Upstream side (picture on the right) / Bottom of culvert		
Elevation	243.4 m	Flood return period*	0.8 years
		Annual overflow probability*	120 %

* Porcupine River backwater upstream of street
