# Giant Mine Remediation Project

**Giant Mine Remediation Joint Project Office**

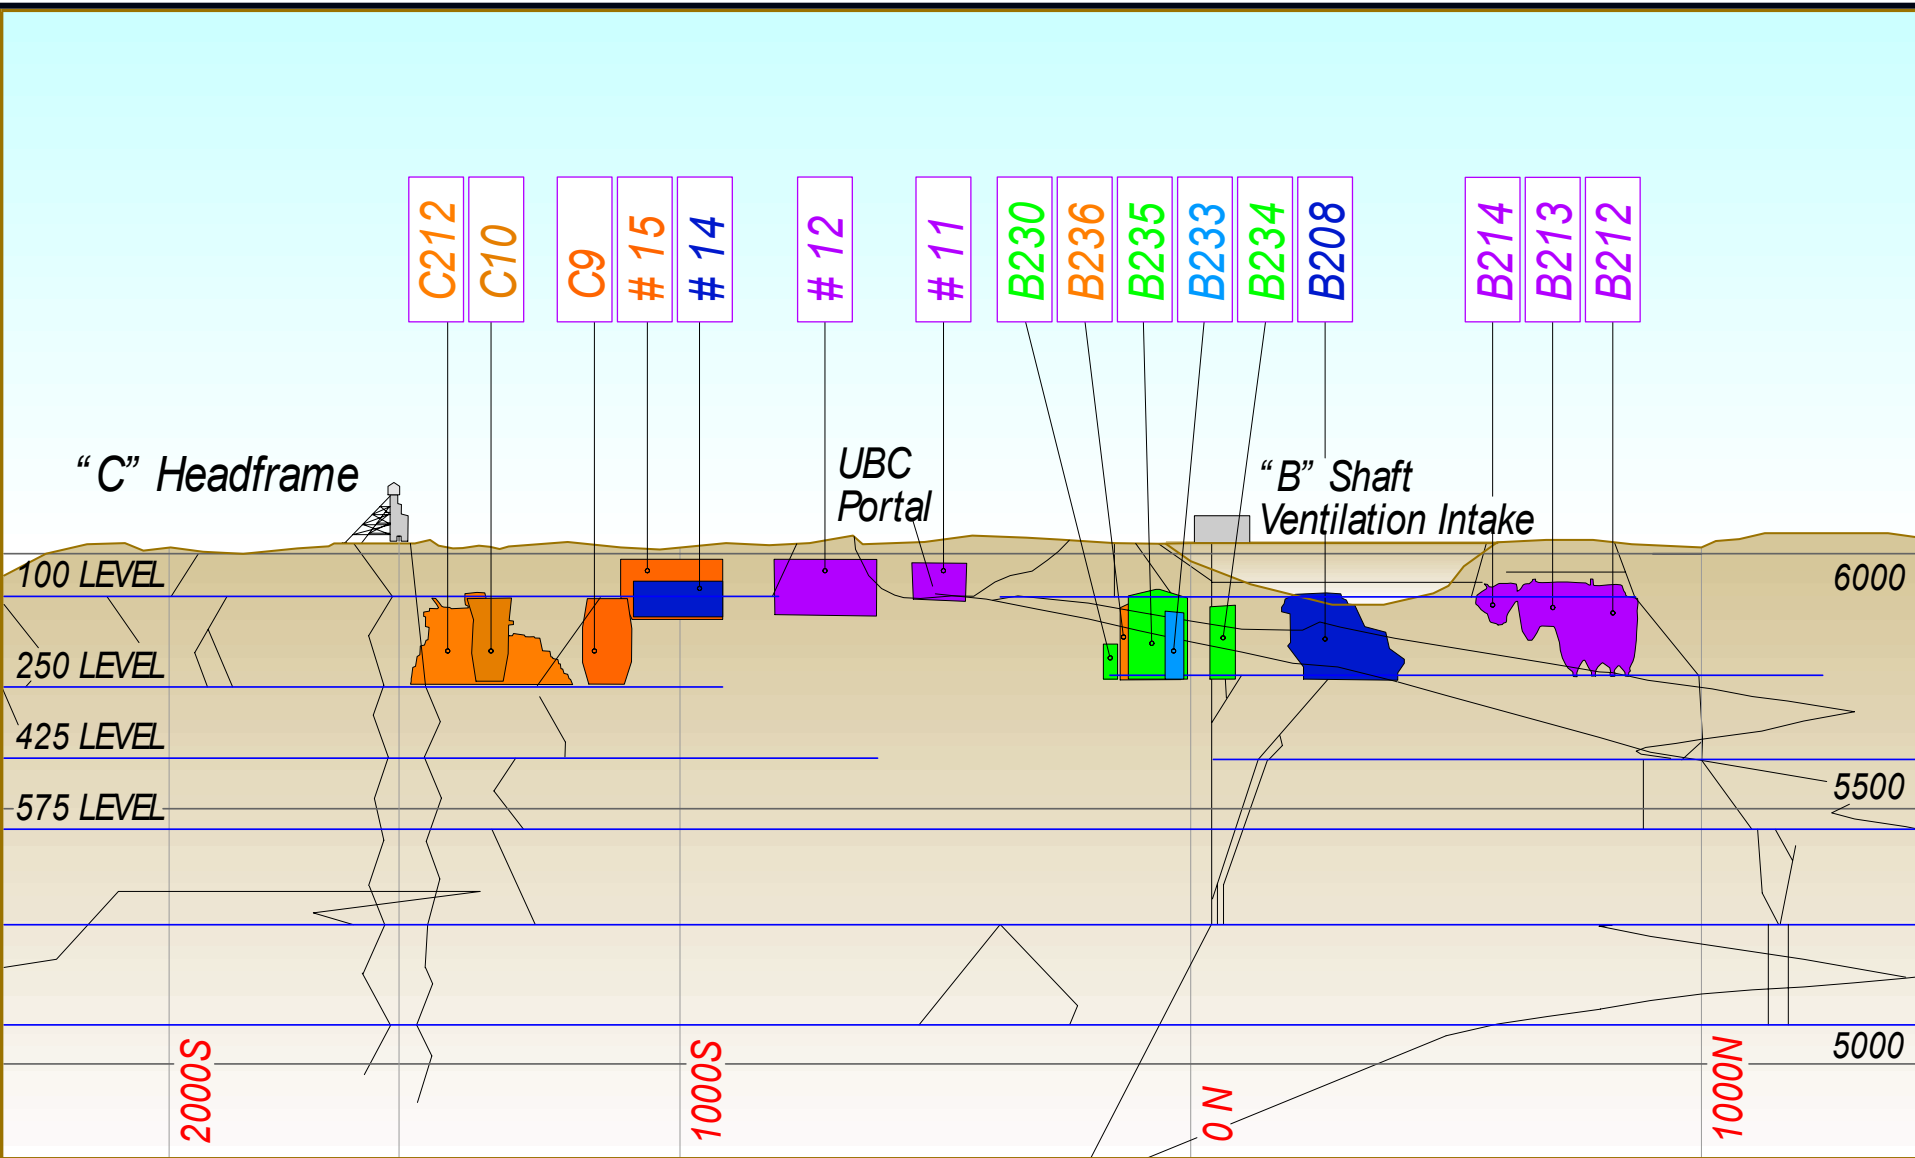
• Arsenic trioxide dust, currently stored underground in 10 chambers and 5 stopes, are enclosed in rock with access drifts sealed by cement bulkheads.

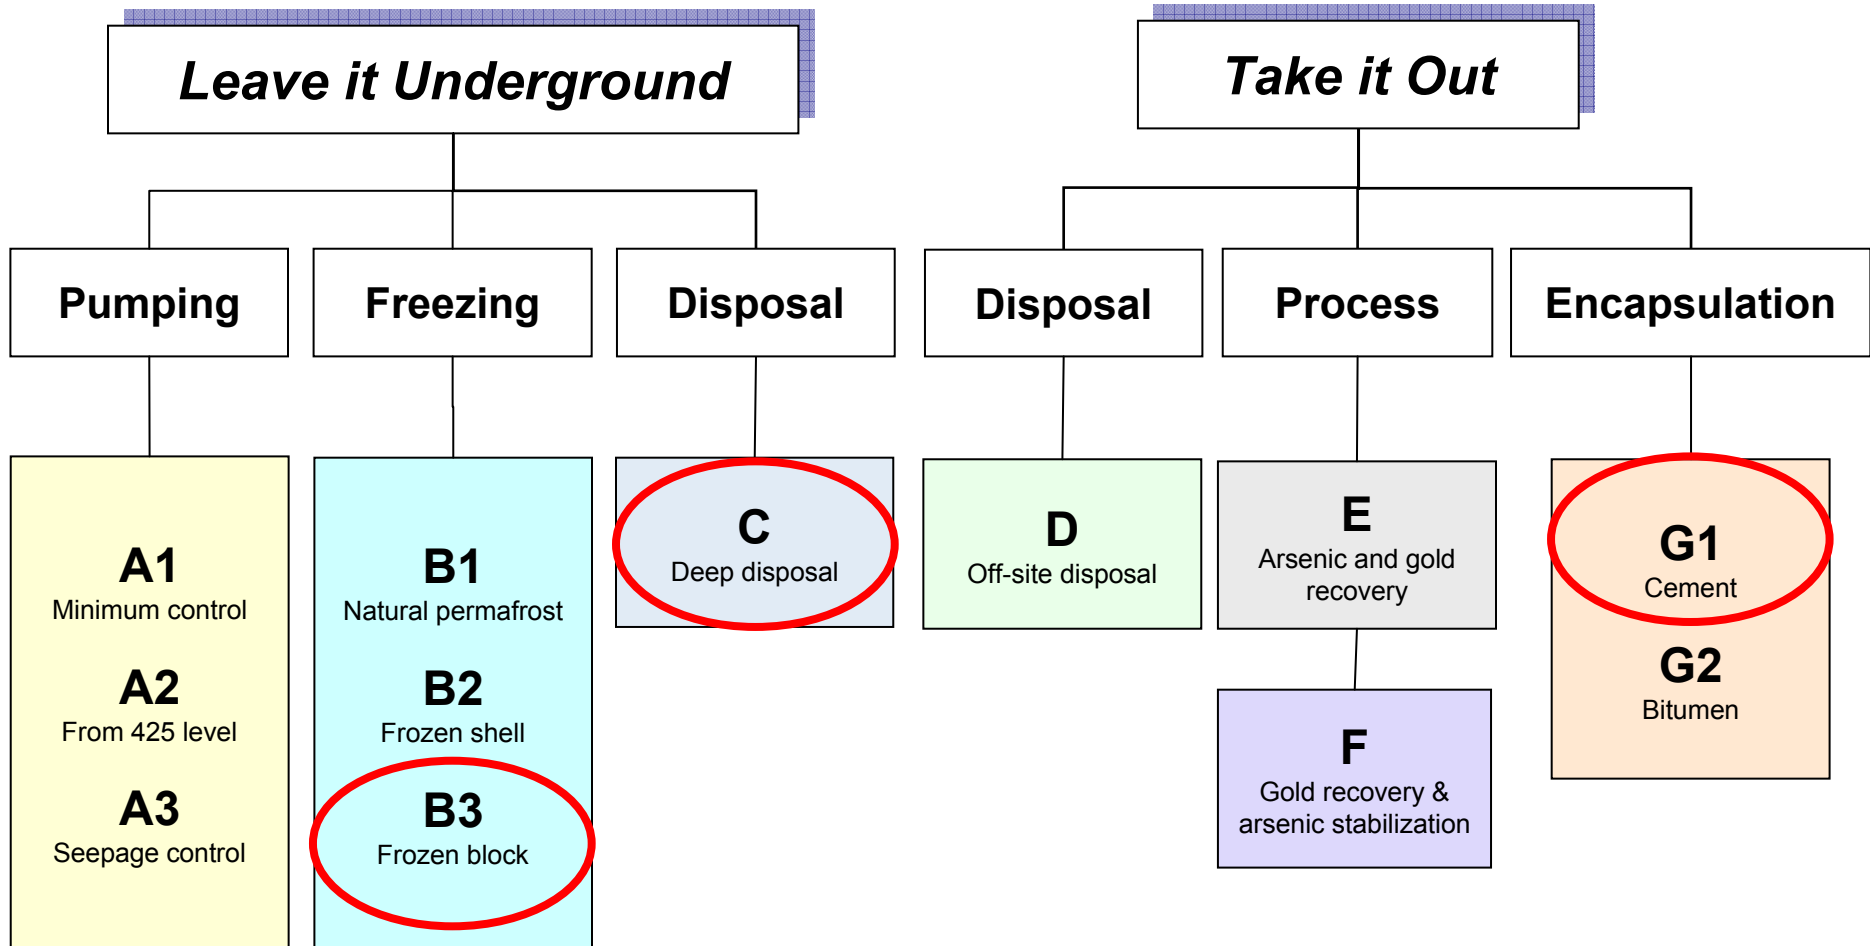
- Arsenic Management Options

Note: Alternatives B1, E and G2 deemed not feasible early in evaluation.

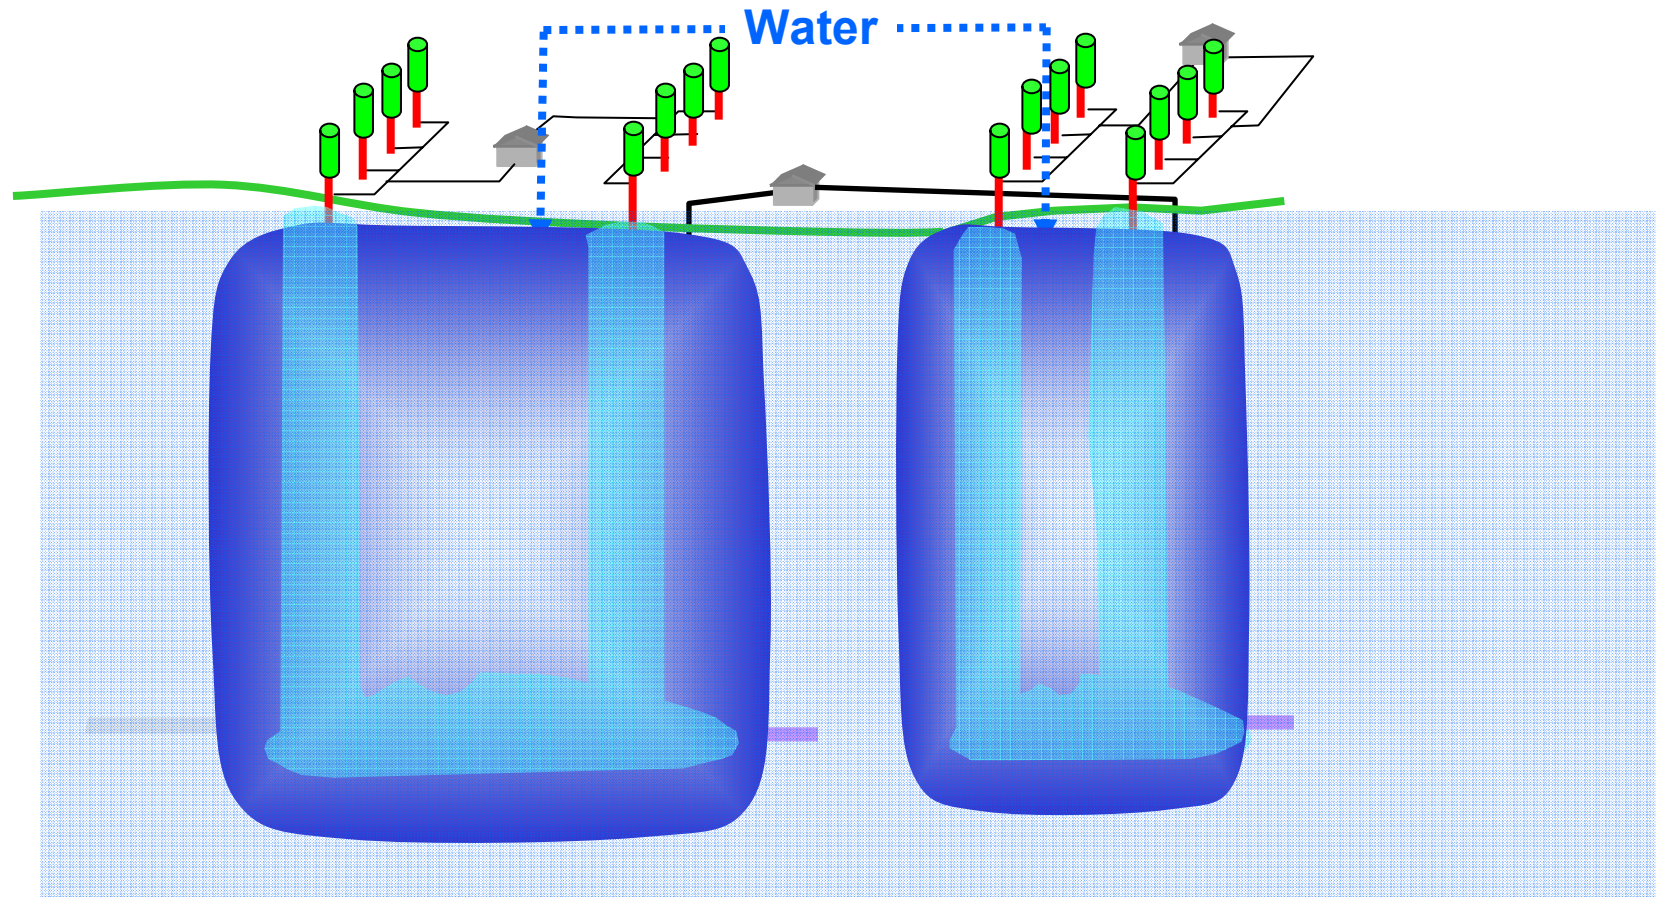
- Freezing and water management process

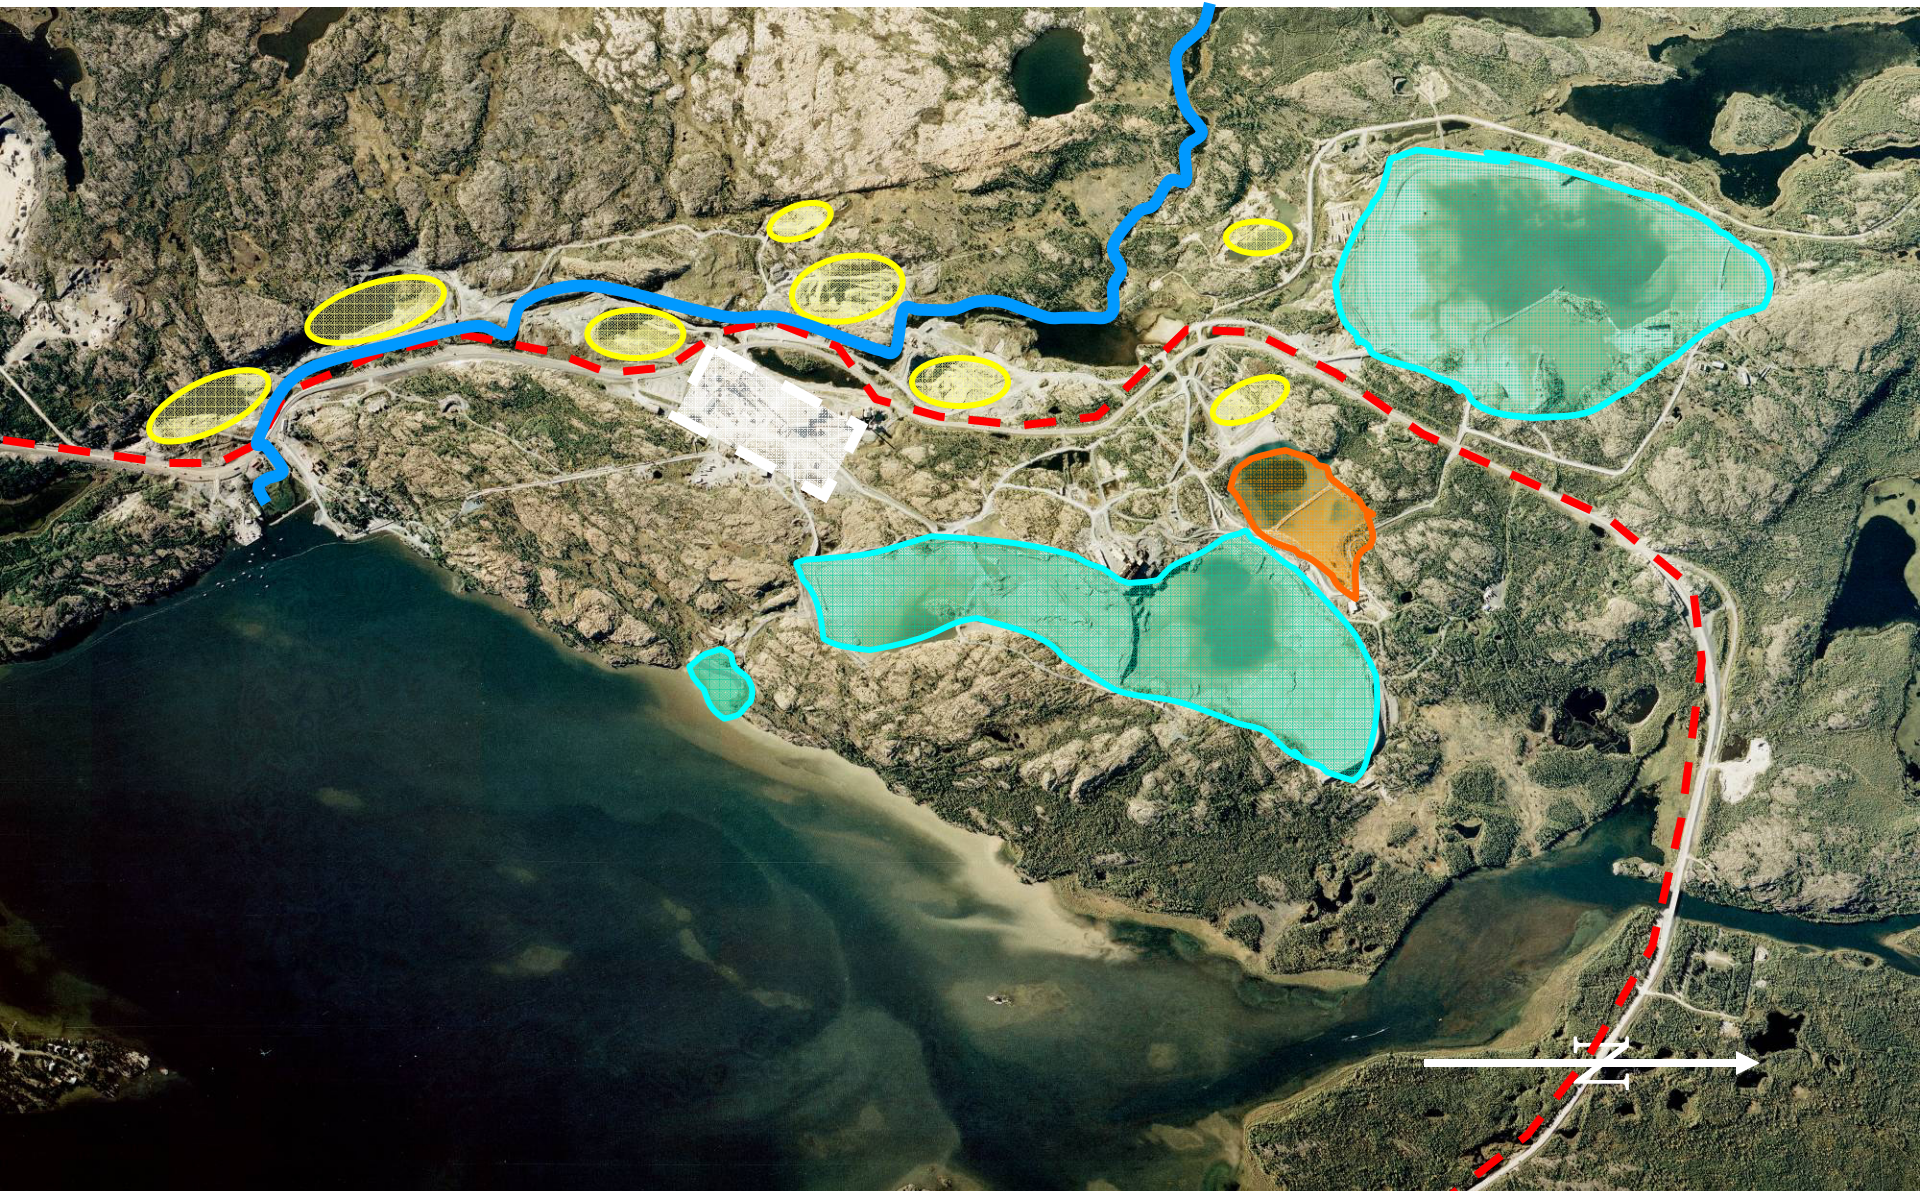
- 2002 air photo

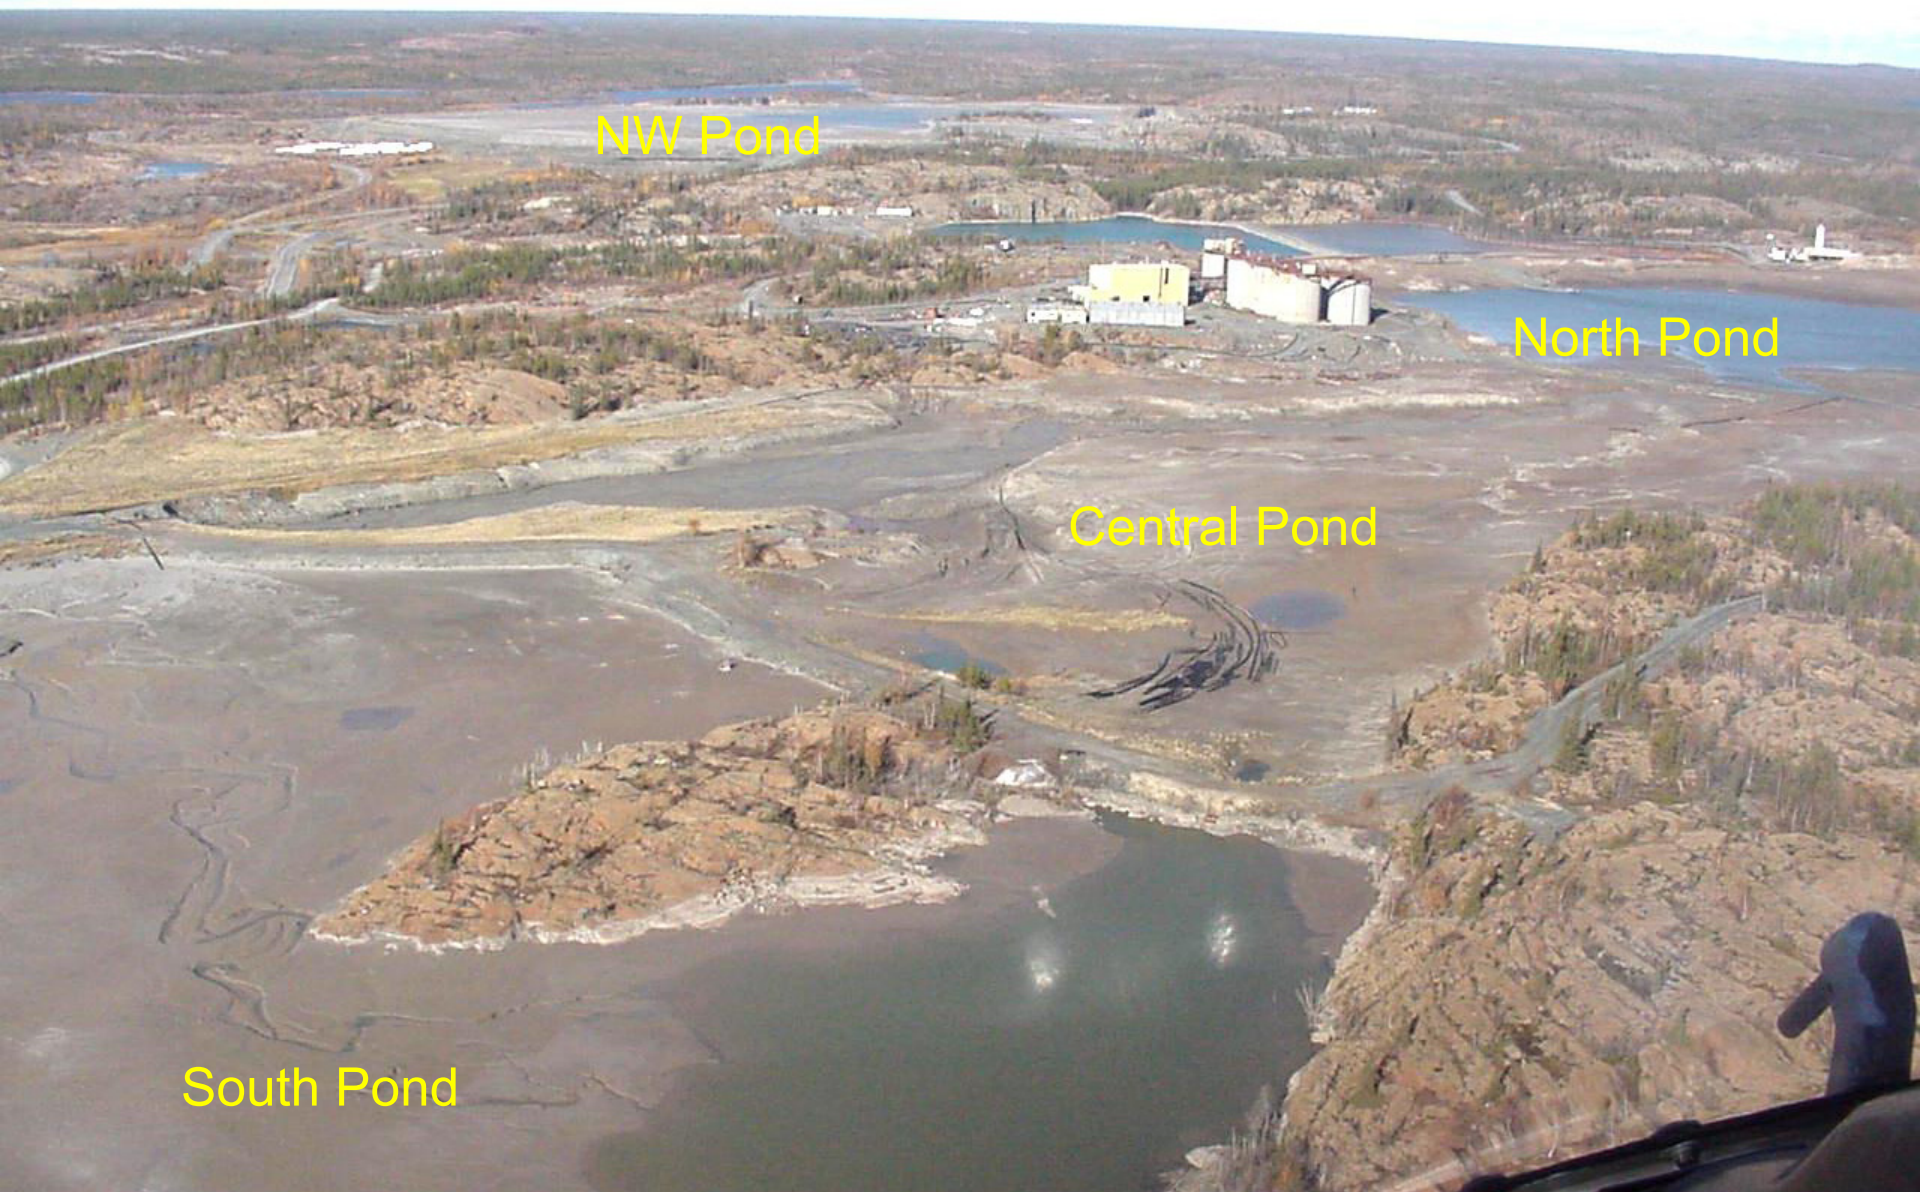
- Tailings Containment Areas (95 hectares)

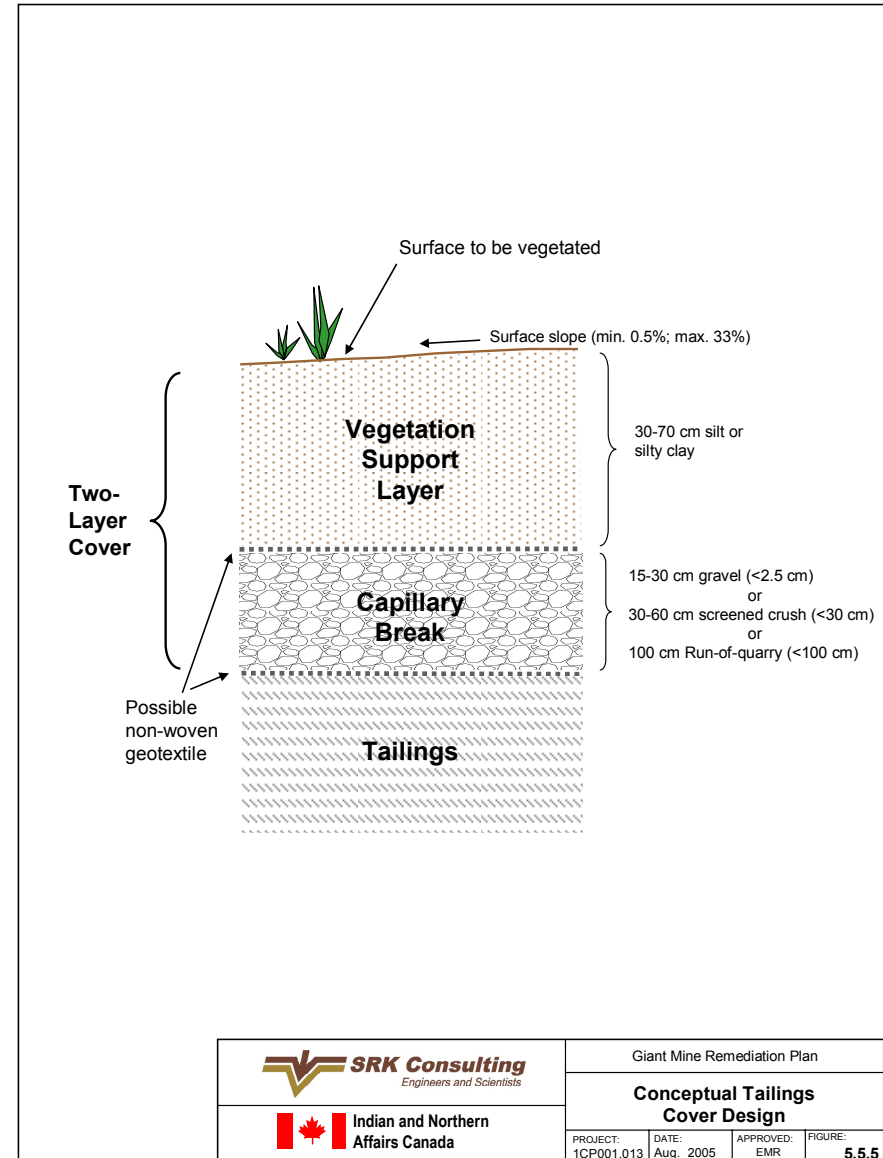
Fig 5.5.5\_5.5.6-Conceptual Tailings Cover Design.ppt

- Bottom layer of broken rock has 4 functions:
  - Physical Barrier to prevent contact with the tailings by humans or animals;
  - Prevents erosion (ATV's, Dirt Bikes);
  - Prevent upward wicking of arsenic salts through to cover; and
  - Helps prevent roots from penetrating tailings.
- Upper layer of locally available silt and silty clay will:
  - Act as clean surface to shed runoff;
  - Allow vegetation to establish;
  - Reduce water infiltration;
  - Allow for future recreational and/or traditional use;
  - Eliminate airborne tailings fines on windy days

Note: Typical tailings cap cross-section

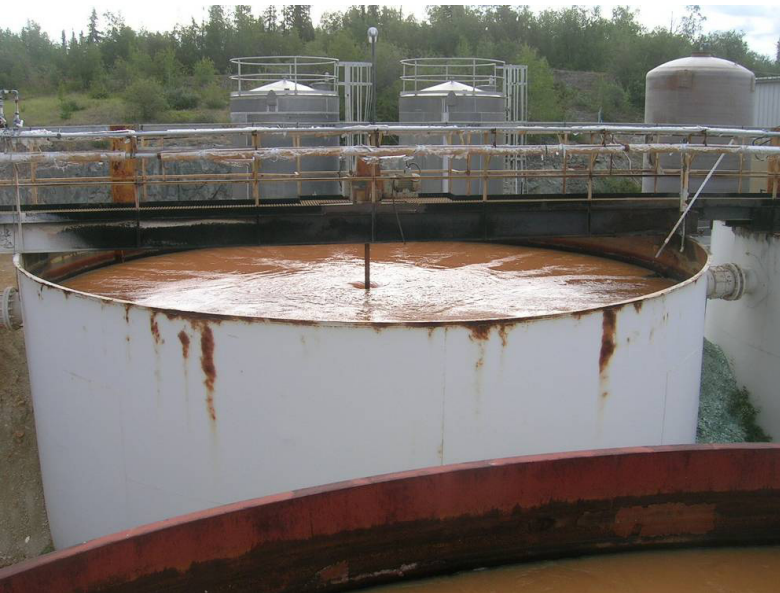
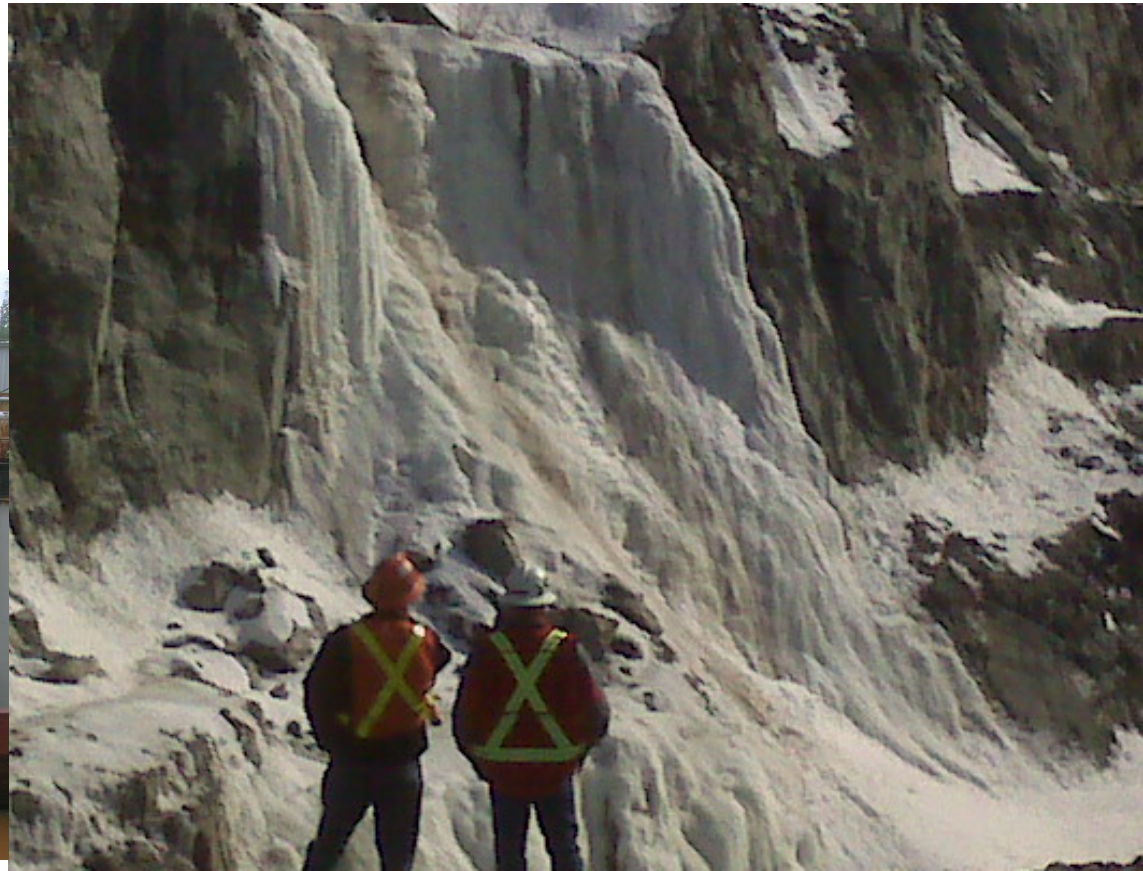
- Expected to require treatment for an extended period of time after remediation measures have been implemented.
- Current water treatment system:
  - The age of the current plant and seasonal treatment is a concern; and
  - One bank of reactor tanks has been decommissioned because of leakage.
