Wetland Enhancement Project at the Terra Mine Site

Sabrina Sturman
Sahtu Region Project Officer
Contaminants and Remediation Directorate, INAC
Yellowknife, NWT

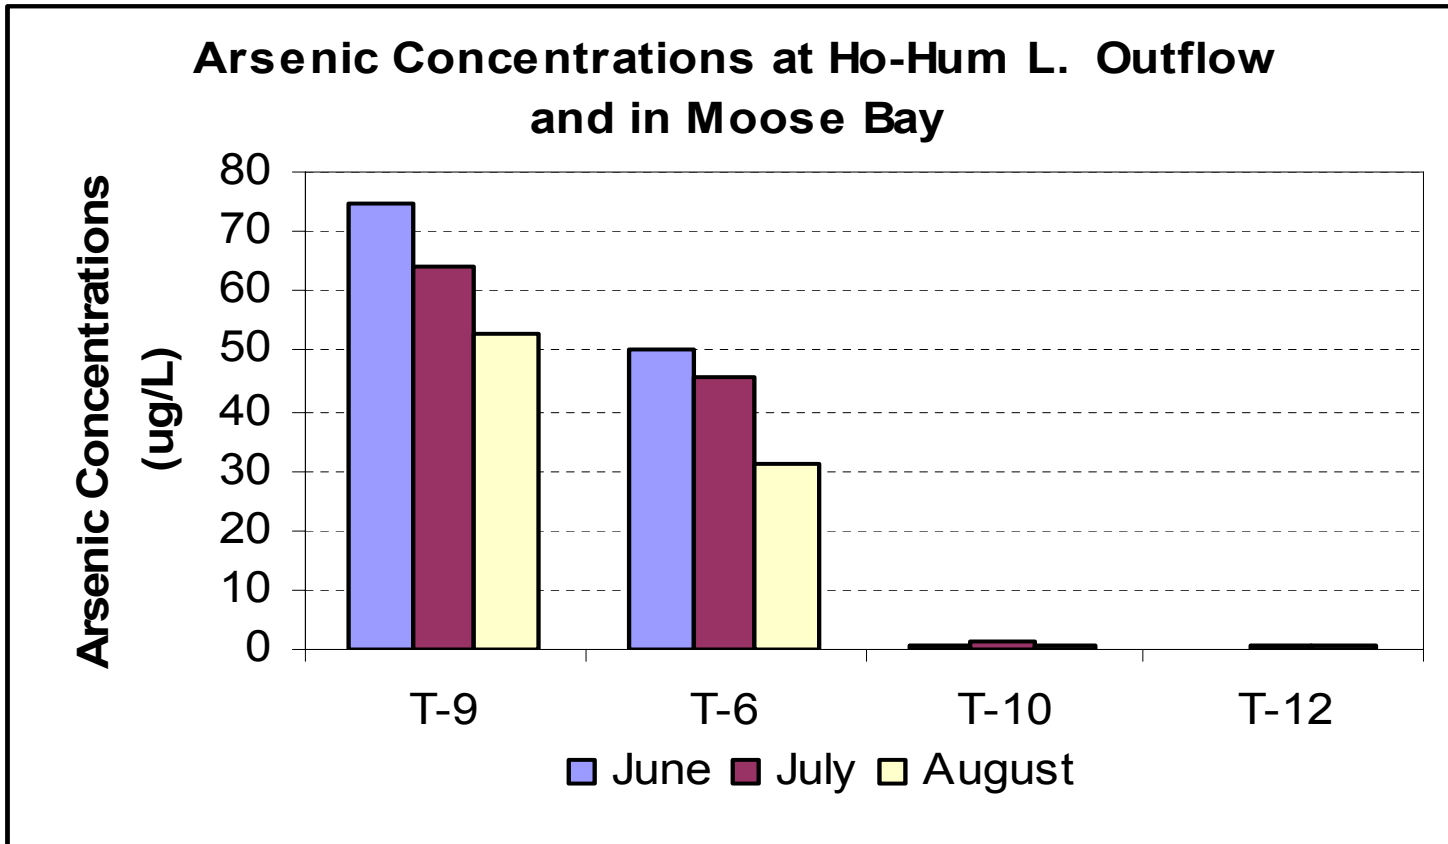
Ho-Hum Lake discharge Water Quality

**Ho-Hum
Lake**

T-9

T-6

T-10

Moose Bay

T-12

- Ho-Hum lake water quality is higher in As, Be, Co, Cu, Ni, Pb and Hg compared to many other sites
- As and Cu are the two main elements of concern
 - Arsenic consistently ranges from 52.7 to 83.2 $\mu\text{g/L}$
 - Copper ranges from 4.3 to 8.4 $\mu\text{g/L}$

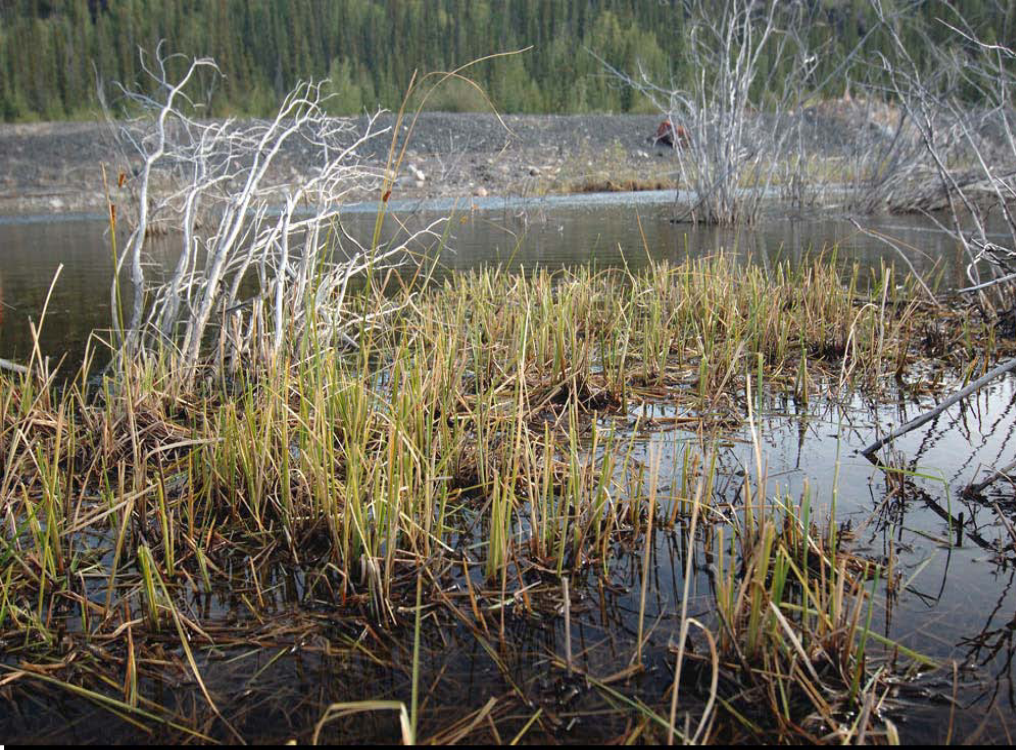
Outflow of Ho Hum Lake showing browsed *Carex*. The larger trees are willows that were killed as the area was flooded.

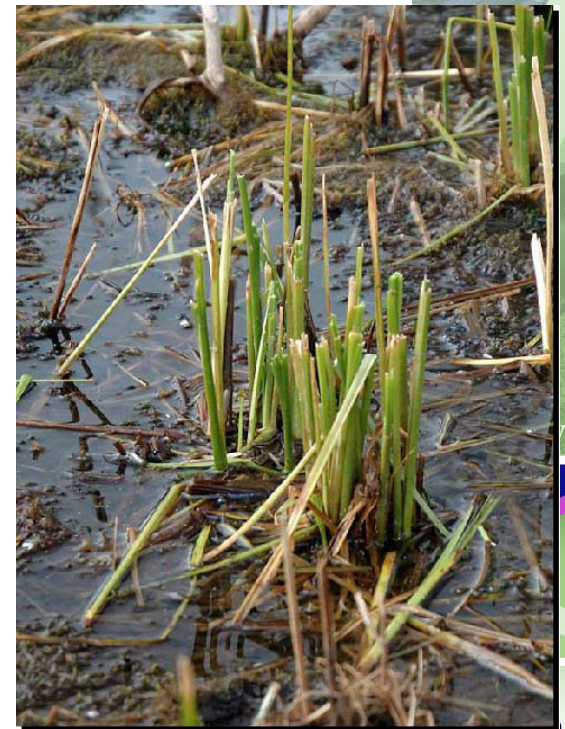
Close-up of a *Carex* plant showing loss of the top of the plant, probably due to browsing by moose.

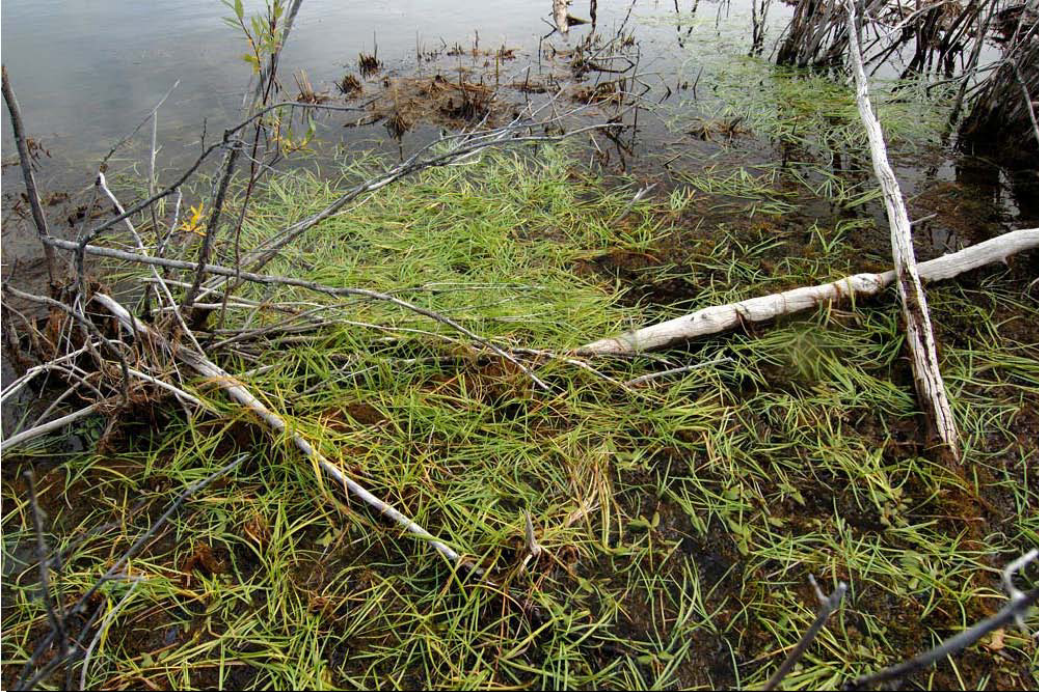
Macrophyte mat situated along
Ho Hum Lake shoreline

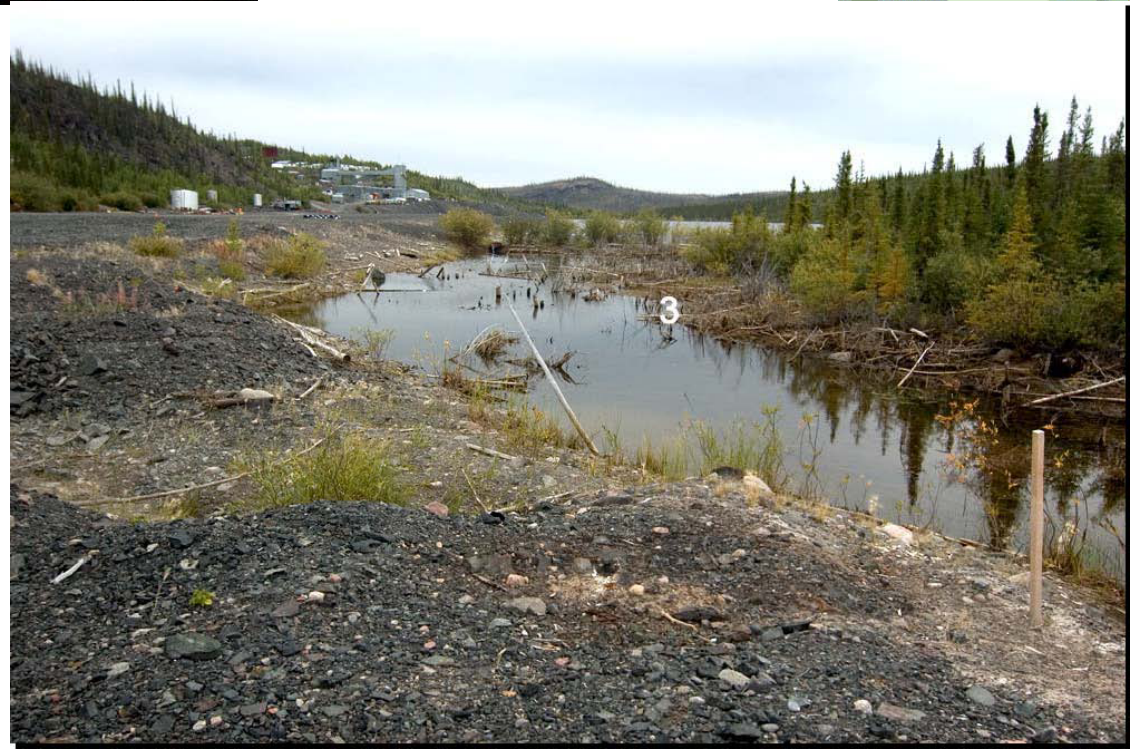
Willows along shoreline of the
wetland, leading into spruce on
drier upland area. Several
submerged macrophytes were
present in the flooded area.

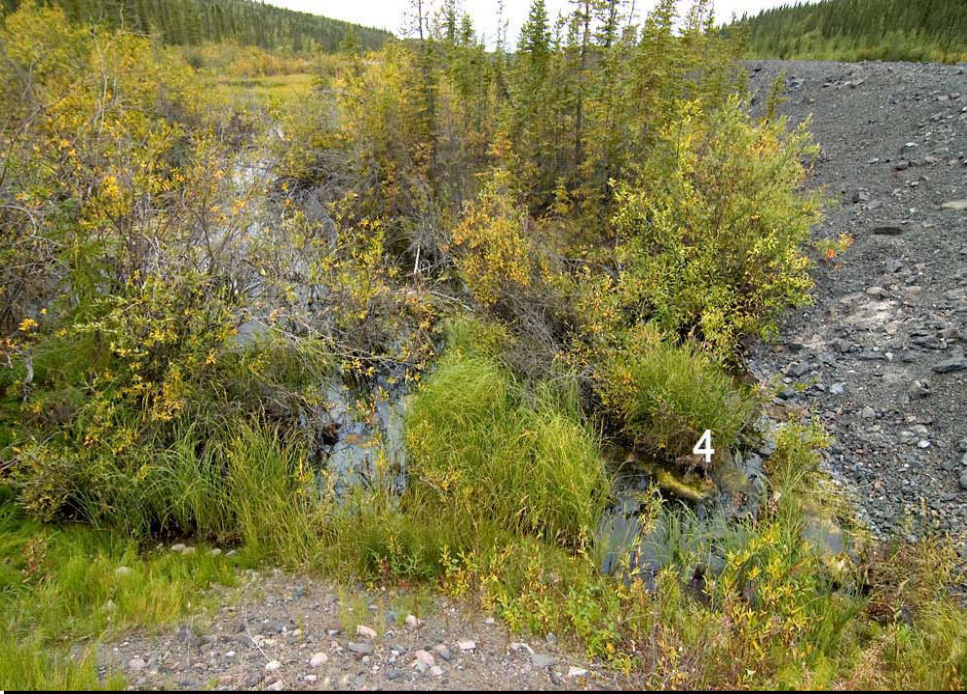
At the outflow from Ho Hum Lake into Moose Bay. Moose Bay in background. Plant species include *Carex*, willow, *Equisitum*, spruce and Labrador tea at base of the spruce.

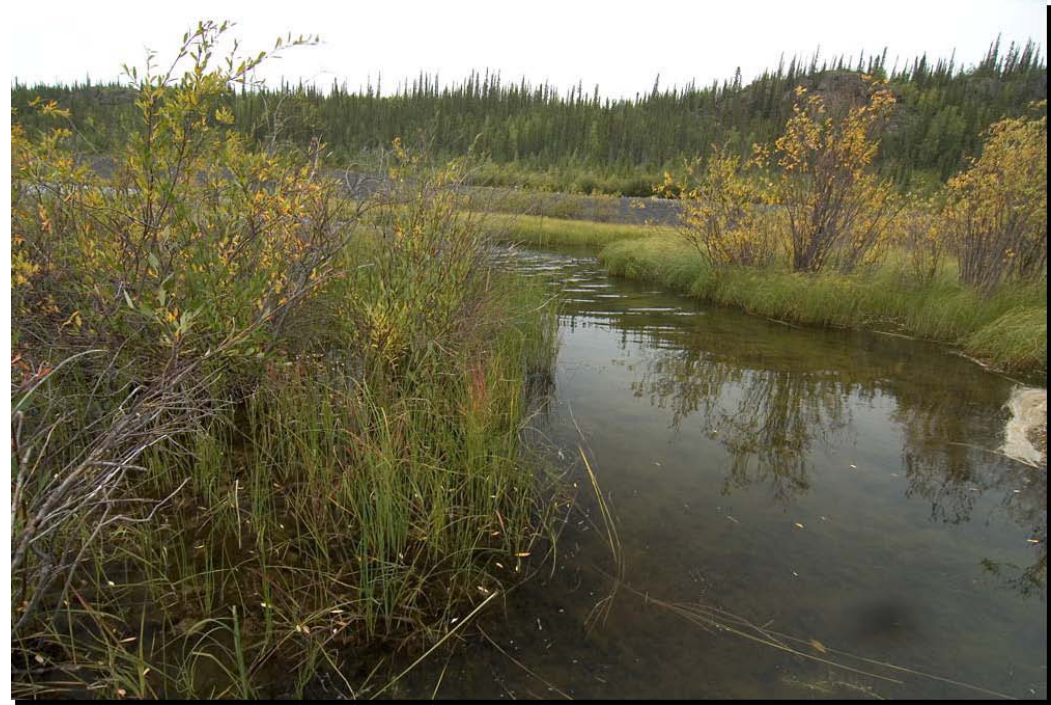
Edge of wetland as it enters Moose Bay (to left).
Vegetation includes *Carex*, *Equisitum*, and willow.
