Geospatial applications in the Alaska AML Program

Examples & Practical Results from an
Alaskan User's Perspective

Alaska AML Program

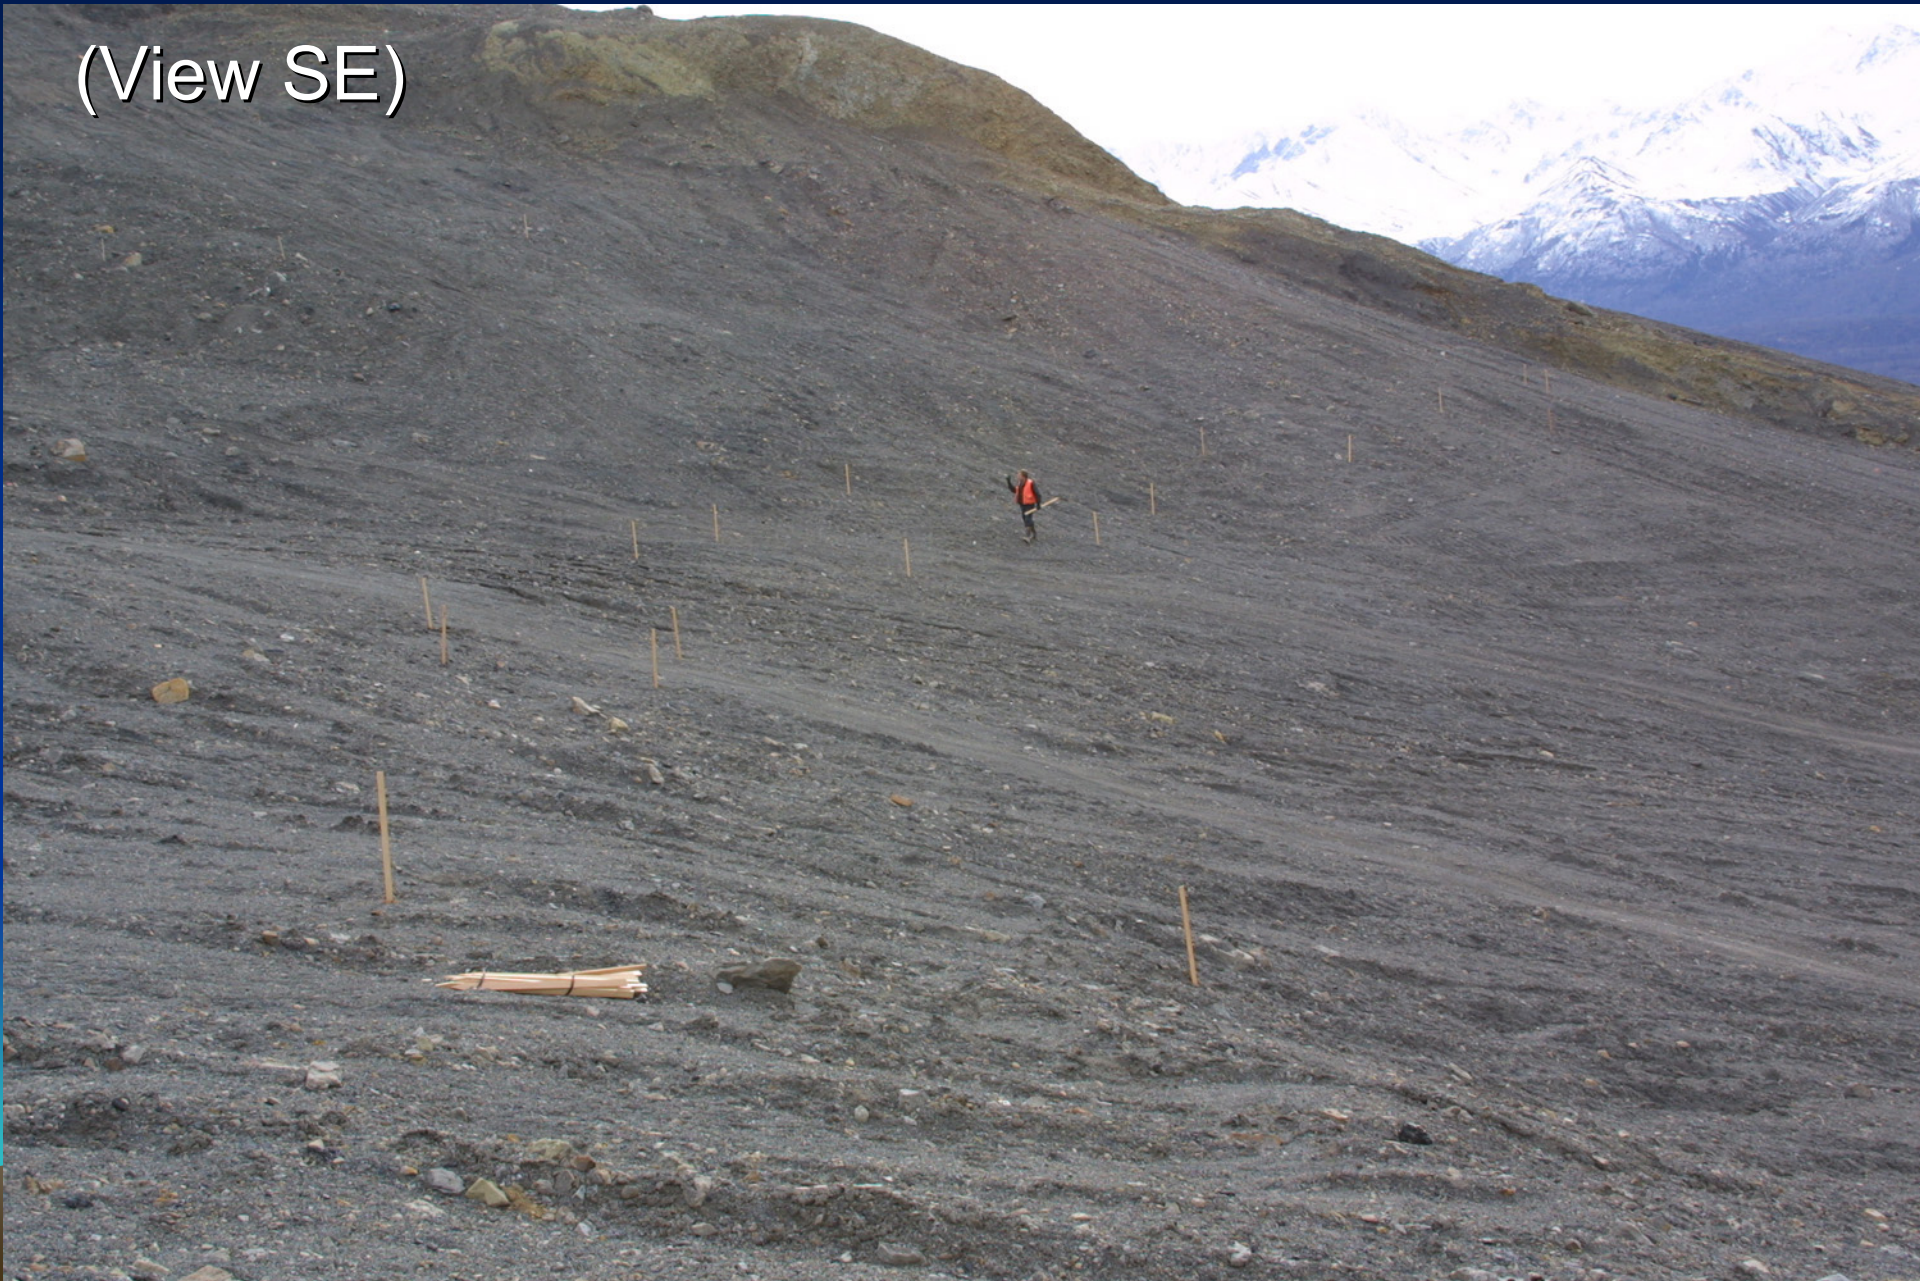
NJ3 GPS berm layout – 4-03

(View SE)

Berm crests generated in the office.

Survcad used to generate lines with 1% upslope away from downdrains.

Principal line vertices saved to *.txt xyz file

Coordinates loaded into Geo II and CE XT as waypoints

Waypoints Field-located and staked 4-22-03.

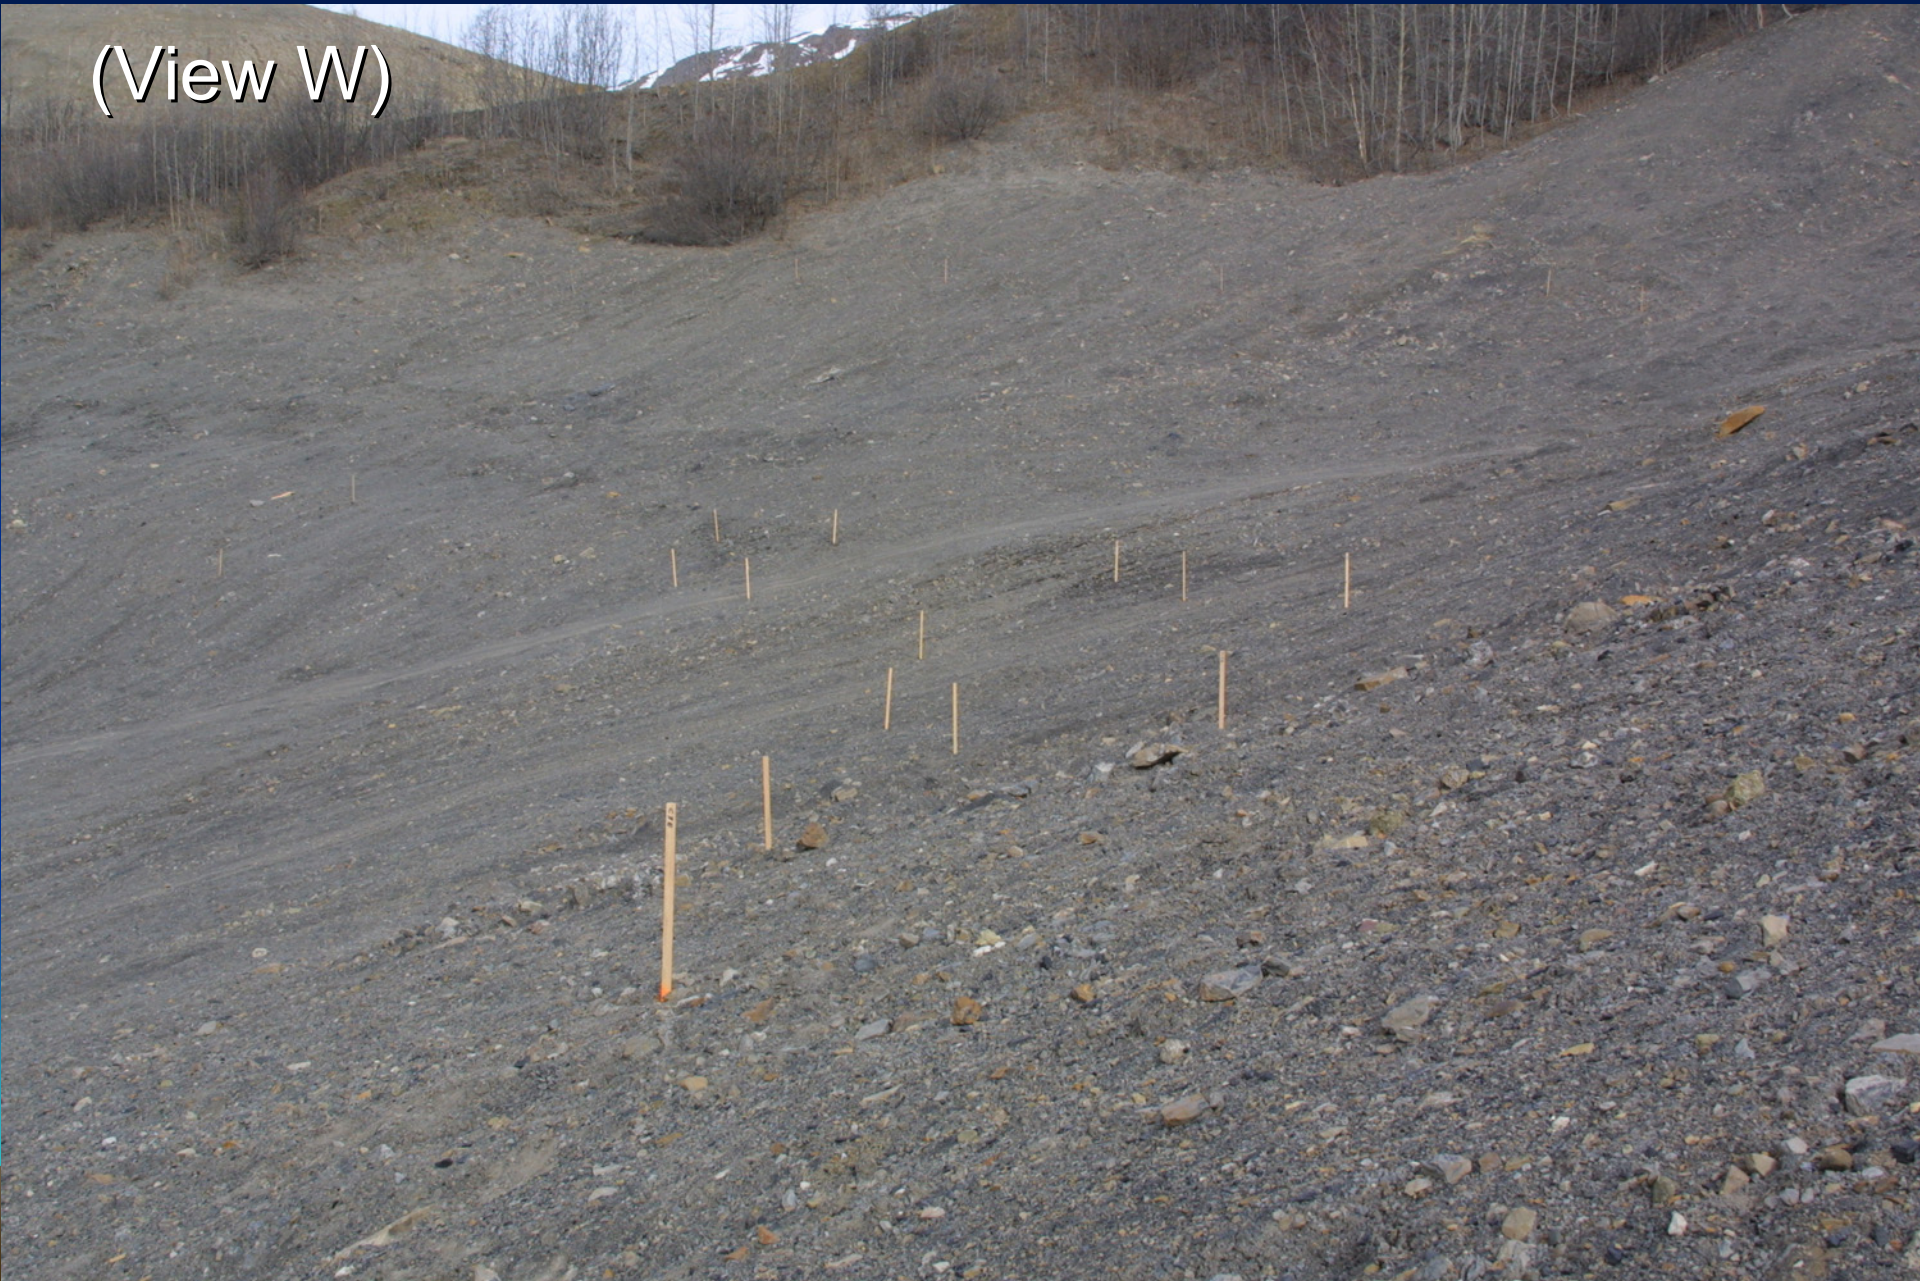
NJ3 GPS berm layout – 4-03

(View W)

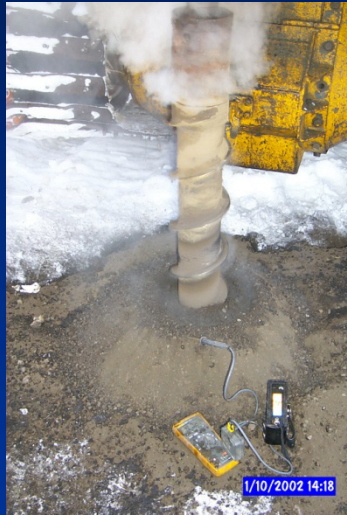
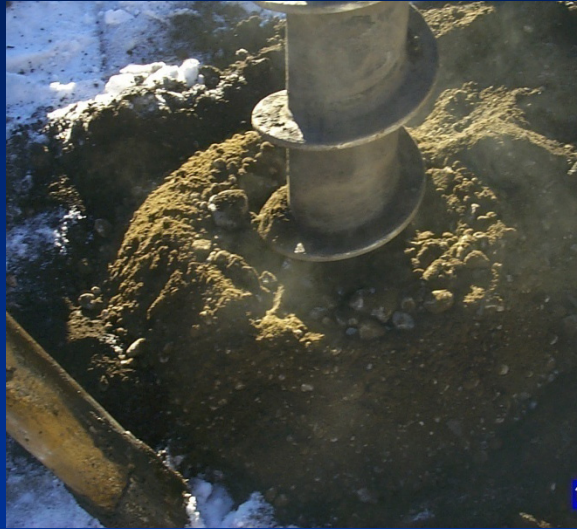
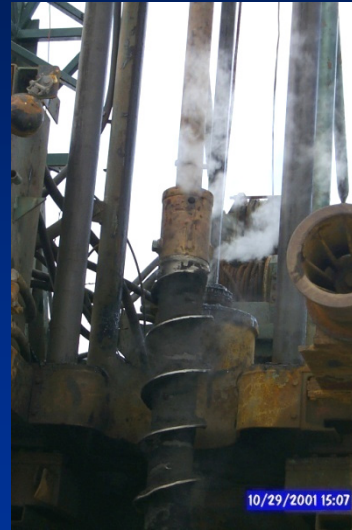
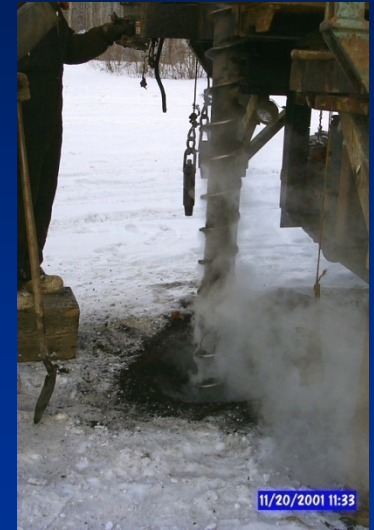
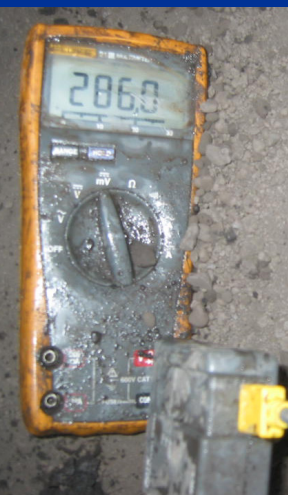
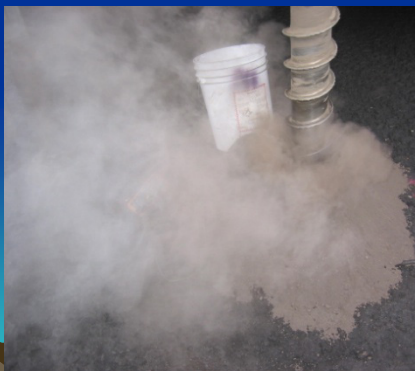
Site Drilling Oct. – Nov. 2001

Found some heat, fumes, BOCM

Coaly fines, some airborne ash

Hot zones occasionally exhibit fumes from cuttings & bell housing while drilling

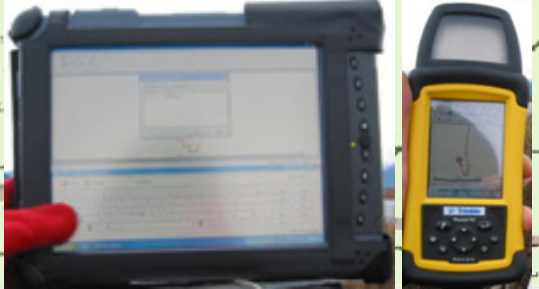
Used iPlore 104TD tablet and Trimble Recon for survey
