Brewery Creek Mine

From Assessment and Permitting through
Production, Closure, and Reclamation

A Post Closure Analysis of a Northern Heap Leach
Mine

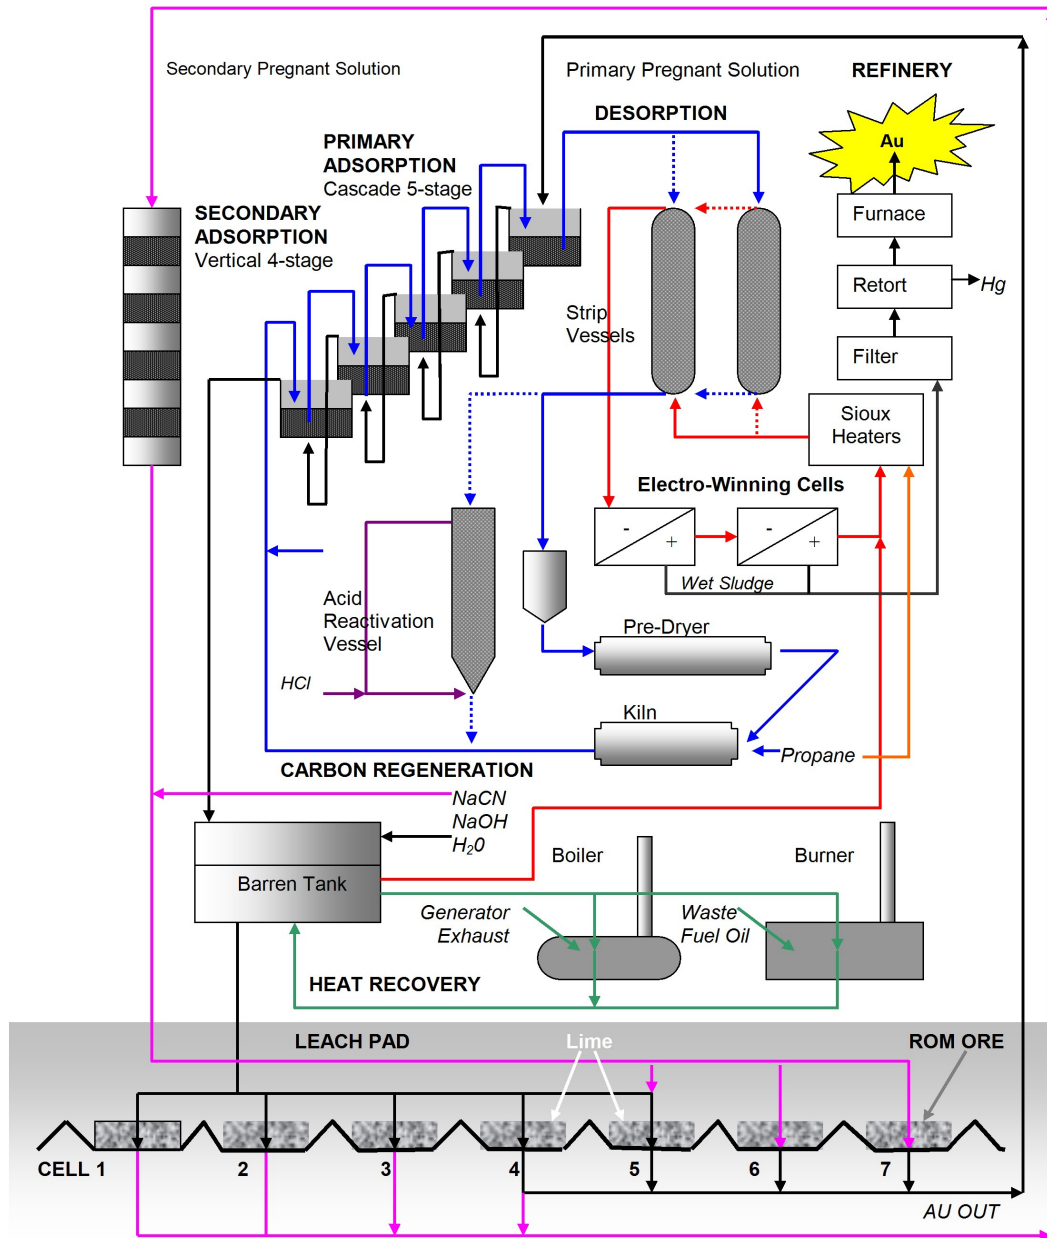
Figure 2 Heap Solution Process Flow Sheet

- Lower than expected recovery rates
- A second application circuit of the process water to the heap was added to increase solution concentrations

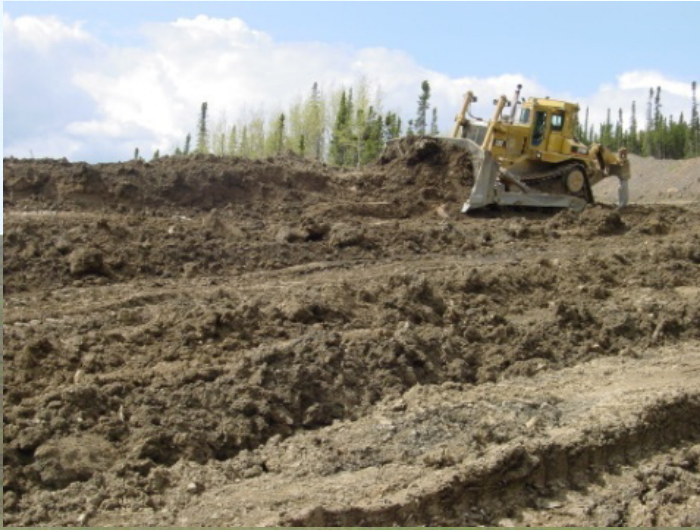
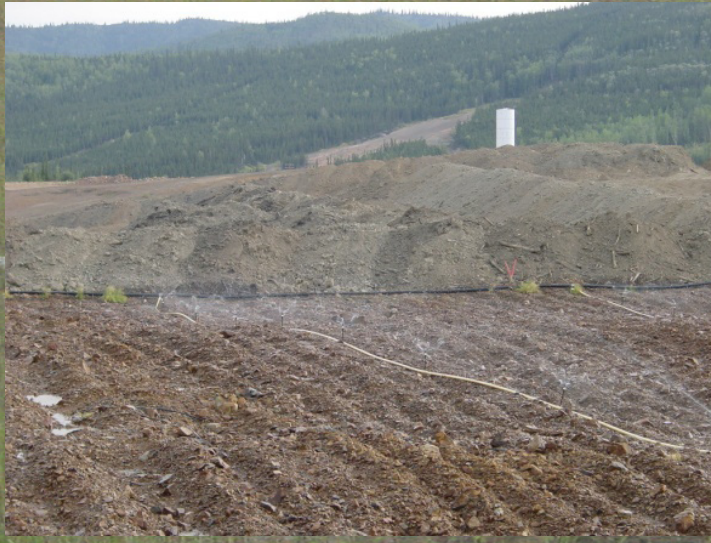
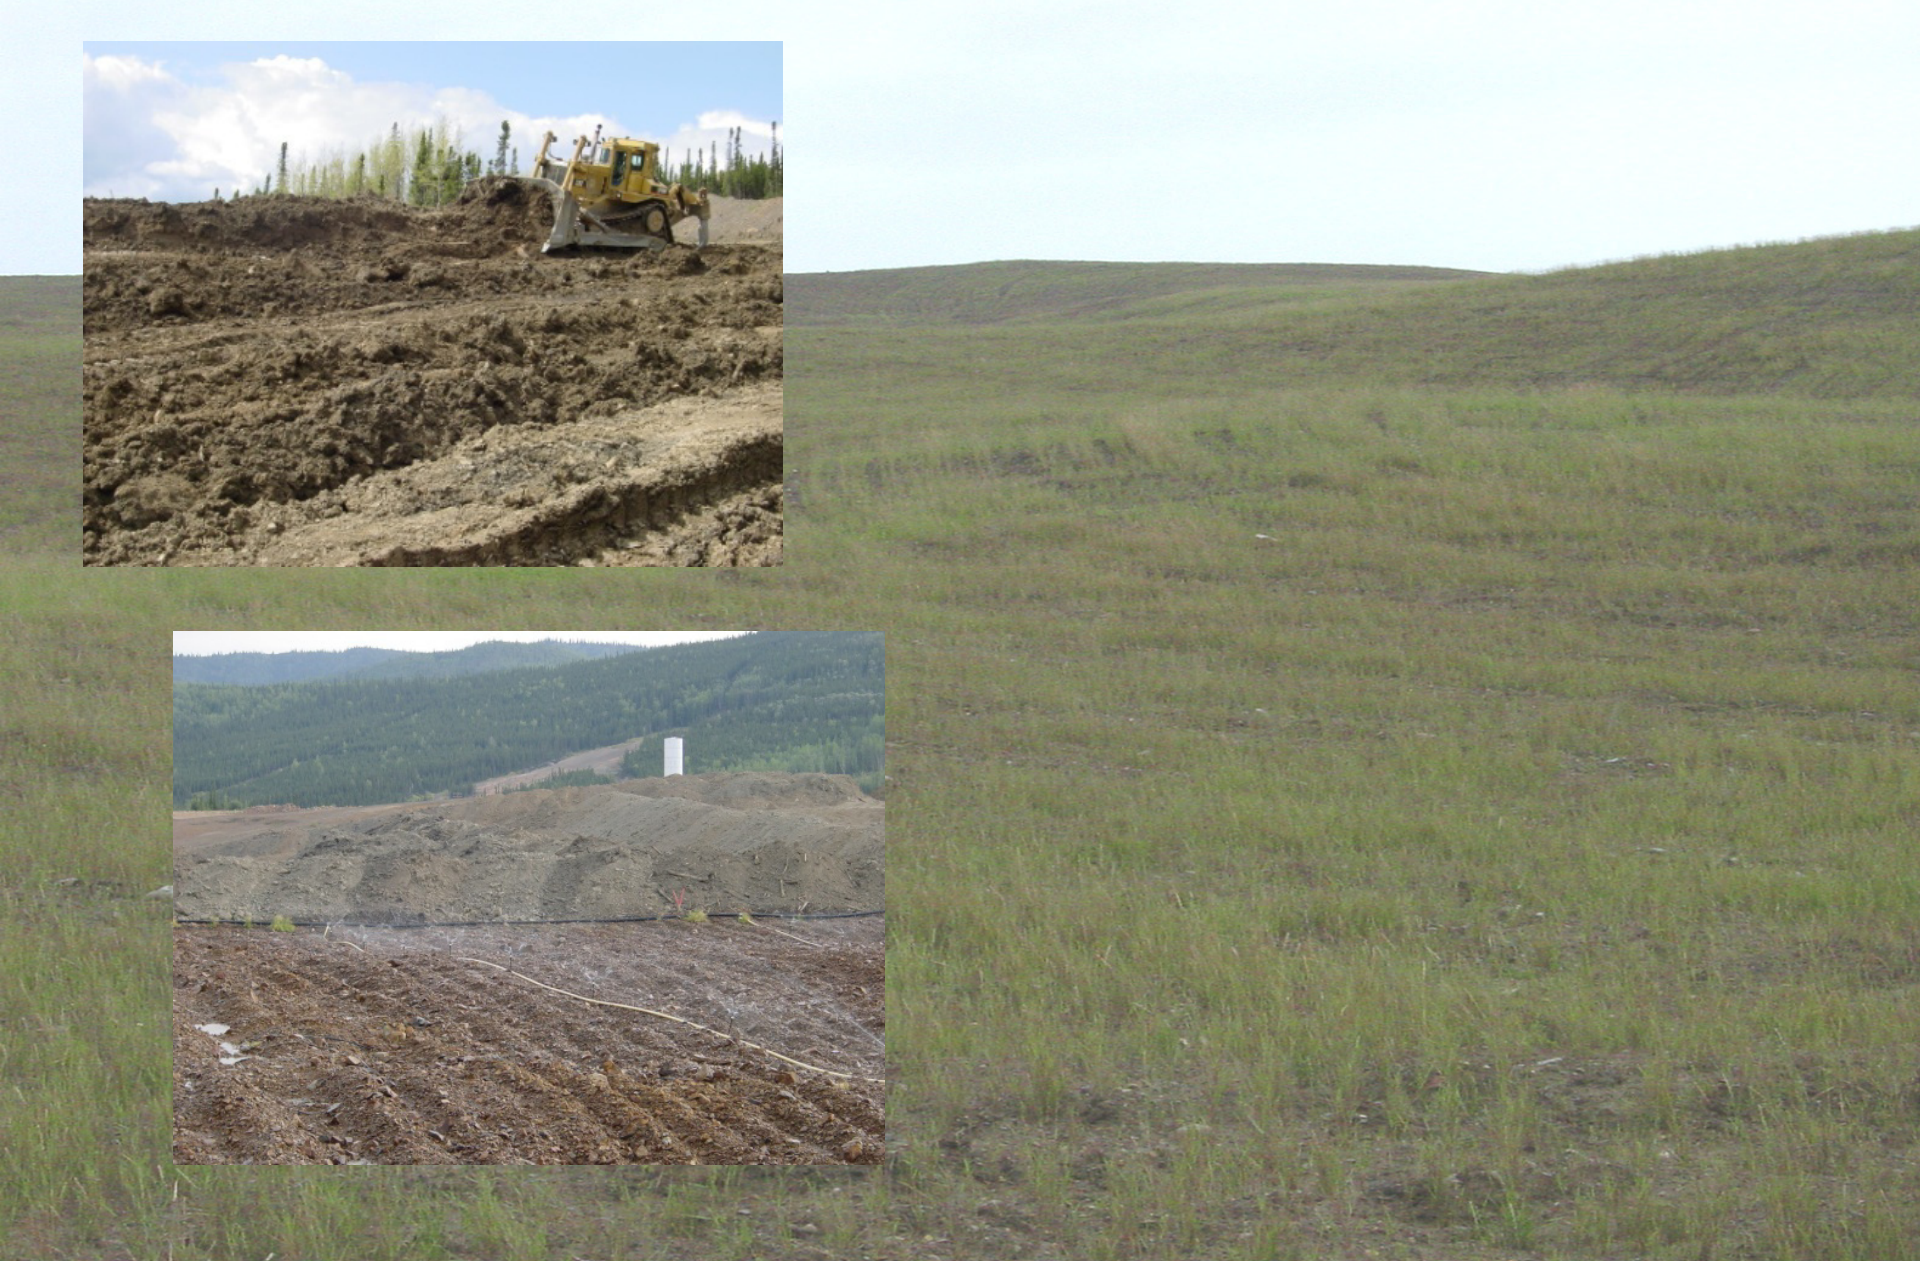
Detoxified, Soil Cover & Revegetated Heap

In 2003, the heap leach pad was recontoured, 80,000 m³ of growth media applied and the area revegetated.

- to reduce the infiltration of precipitation runoff into the heap so that the volume of effluent requiring further passive secondary treatment and/or release to the environment is likewise reduced.
- provides an environment for successful natural revegetation

- The design for soil cover over the heap estimated an annual infiltration rate of 24%.
- All of the secondary contingency measures and long-term release volumes had been estimated using a 30% infiltration factor
