Tséi Zhéte Sinwaa Éex'i Yé Conrad Historic Site

MANAGEMENT PLAN

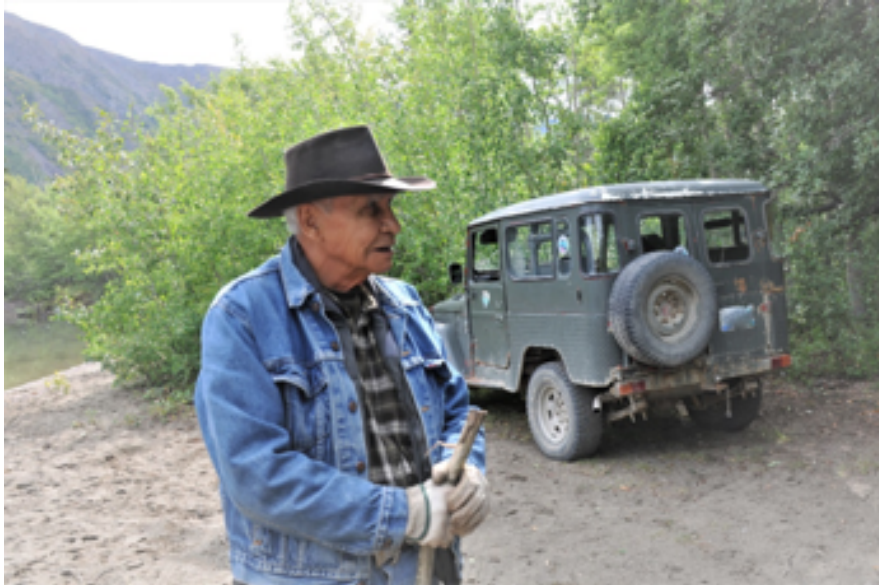
Art Johns at Conrad Historic Site, August 2021

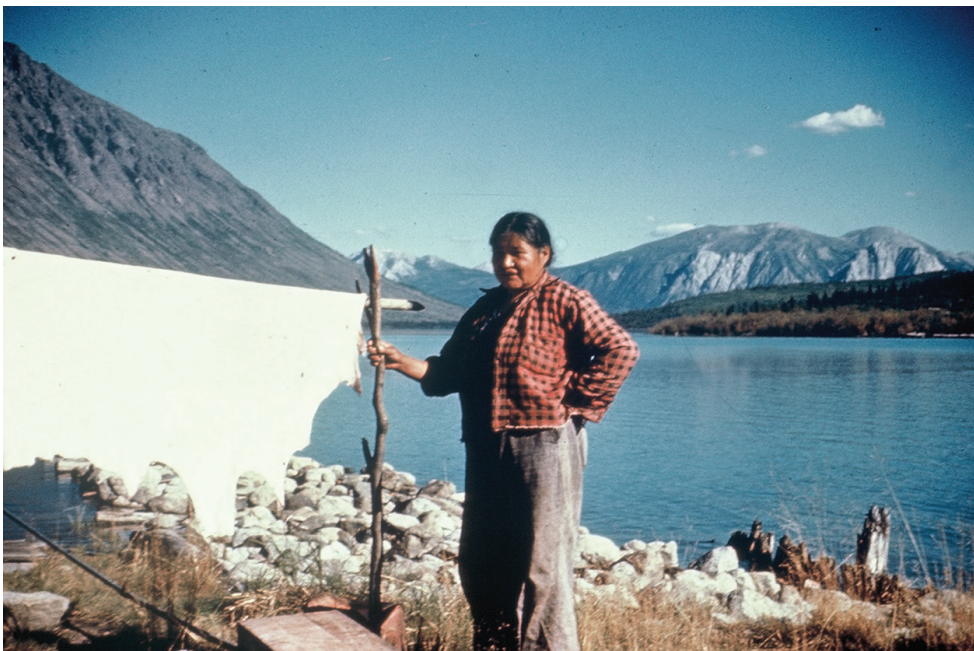
Angela Sidney/Ch'ünèhtè' Mā/Stúw with washed moosehide, August 1949, Carcross; Howling Rock is in the background at right. Canadian Museum of Civilization S71-645

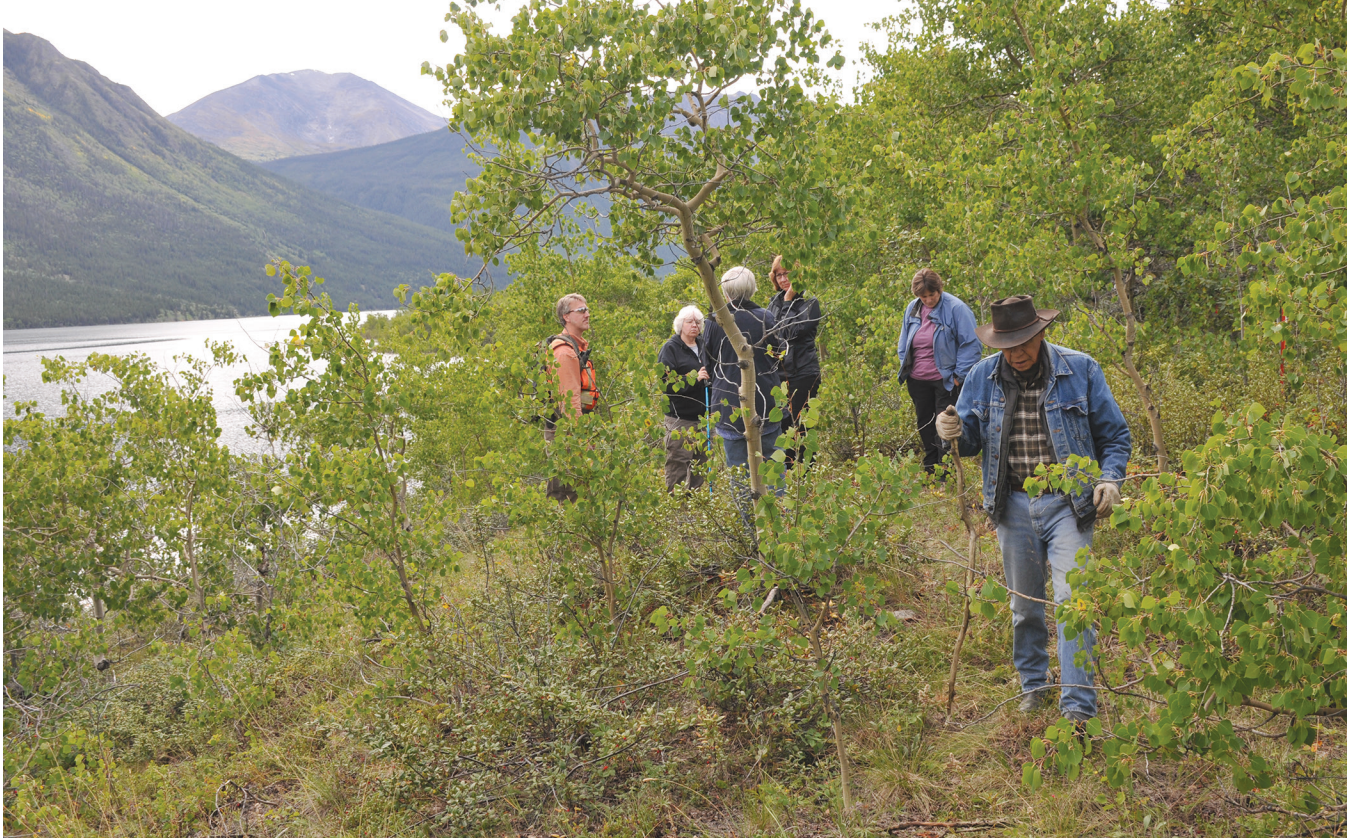
2.0 Planning Process

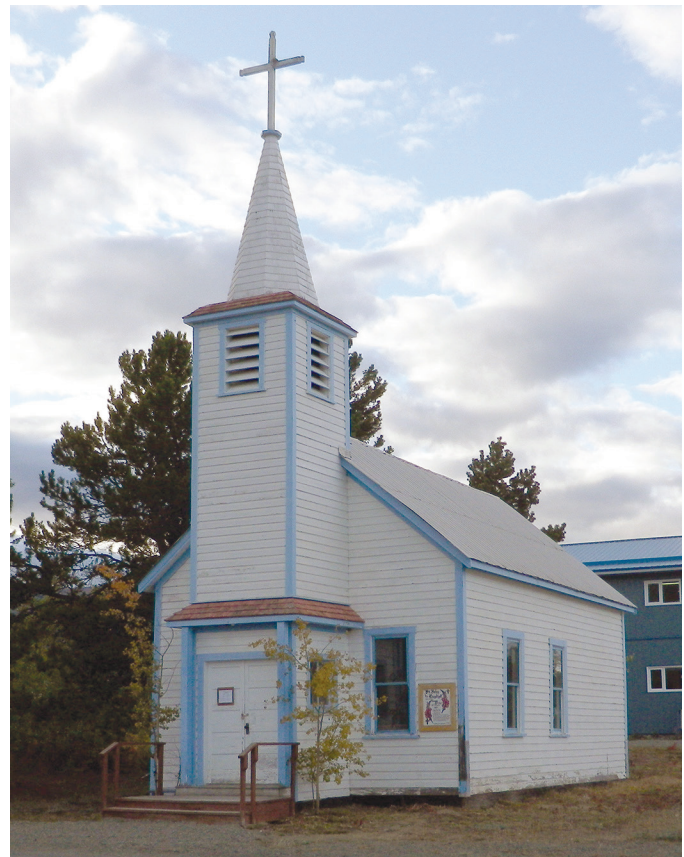
St. John the Baptist Catholic Church was brought from Conrad to Carcross in 1939.

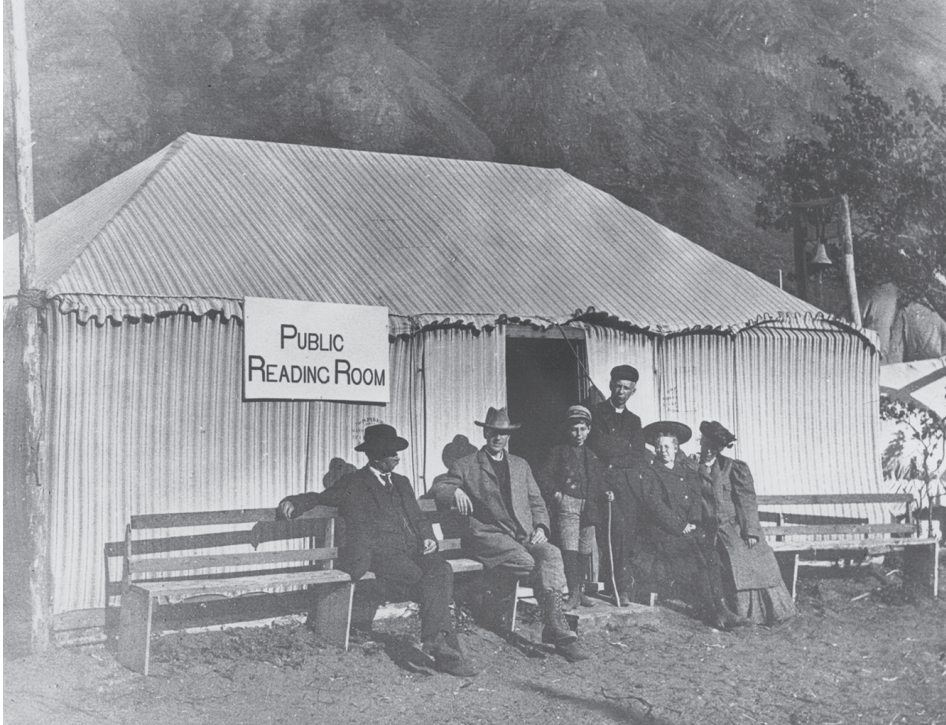
Public reading room run by the Anglican Church at Conrad, circa 1905.
 YA, Anglican Church of Canada General Synod Archives fonds (Stringer Collection), 78/67 #P7517-279

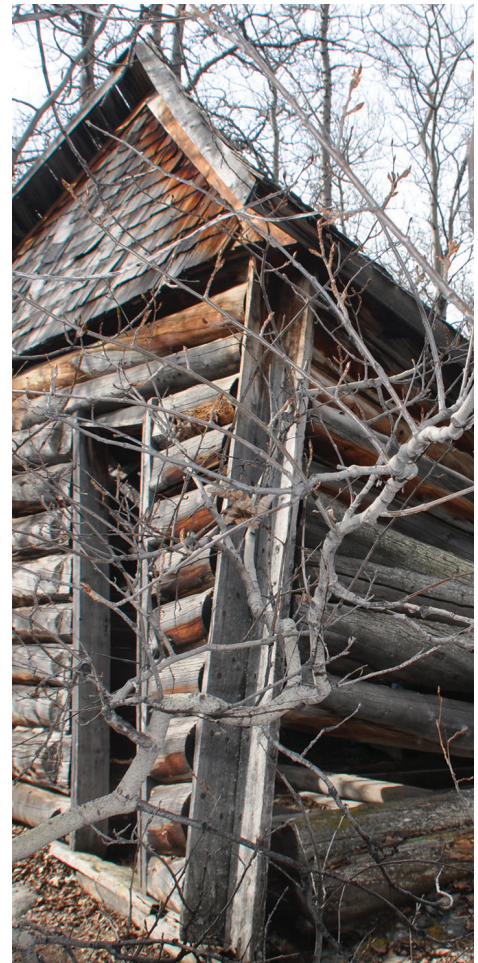
Example of a Yukon corner, Cabin 2.

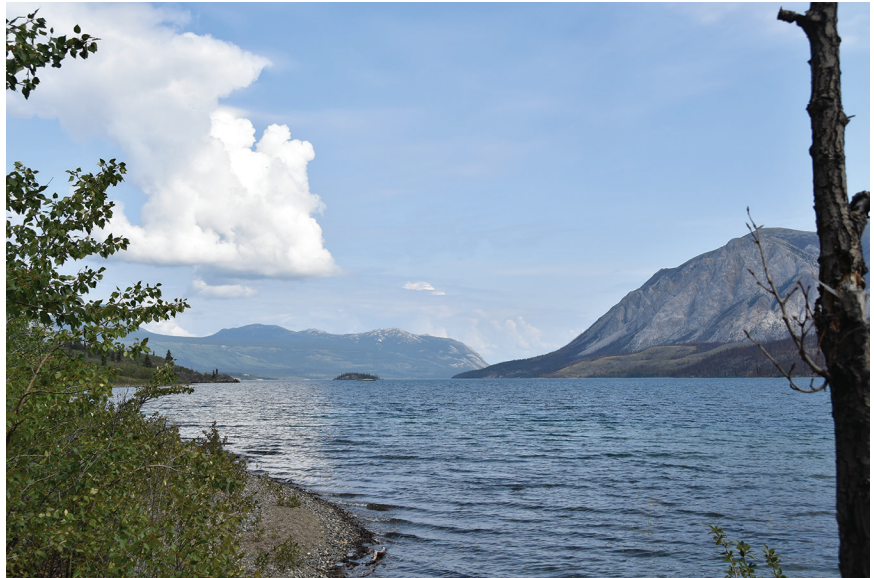
View of Windy Arm from Conrad Historic Site.

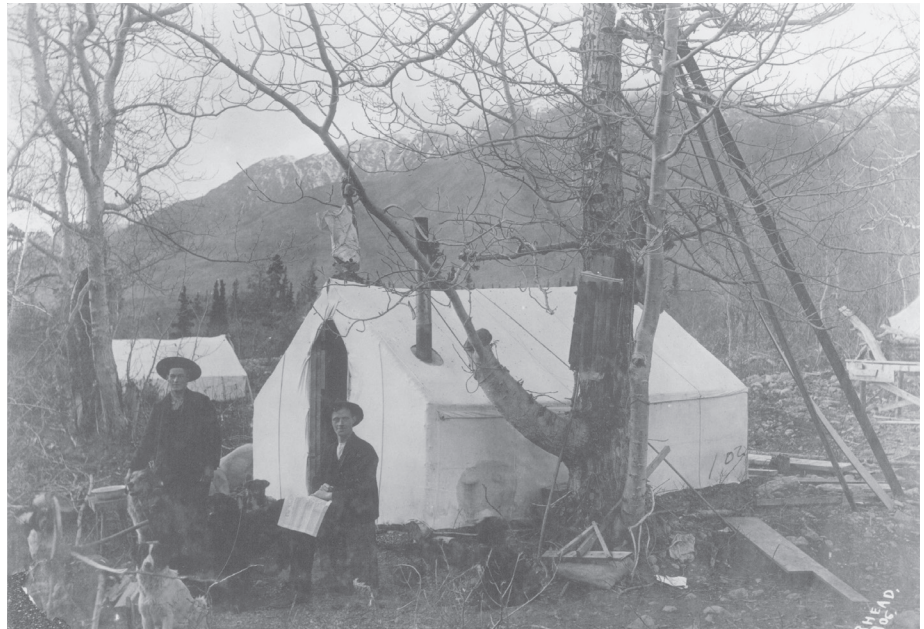
Conrad, 1906. A bag, probably containing food, is suspended above the tent doorway. YA, John Scott fonds, 89/31 #200

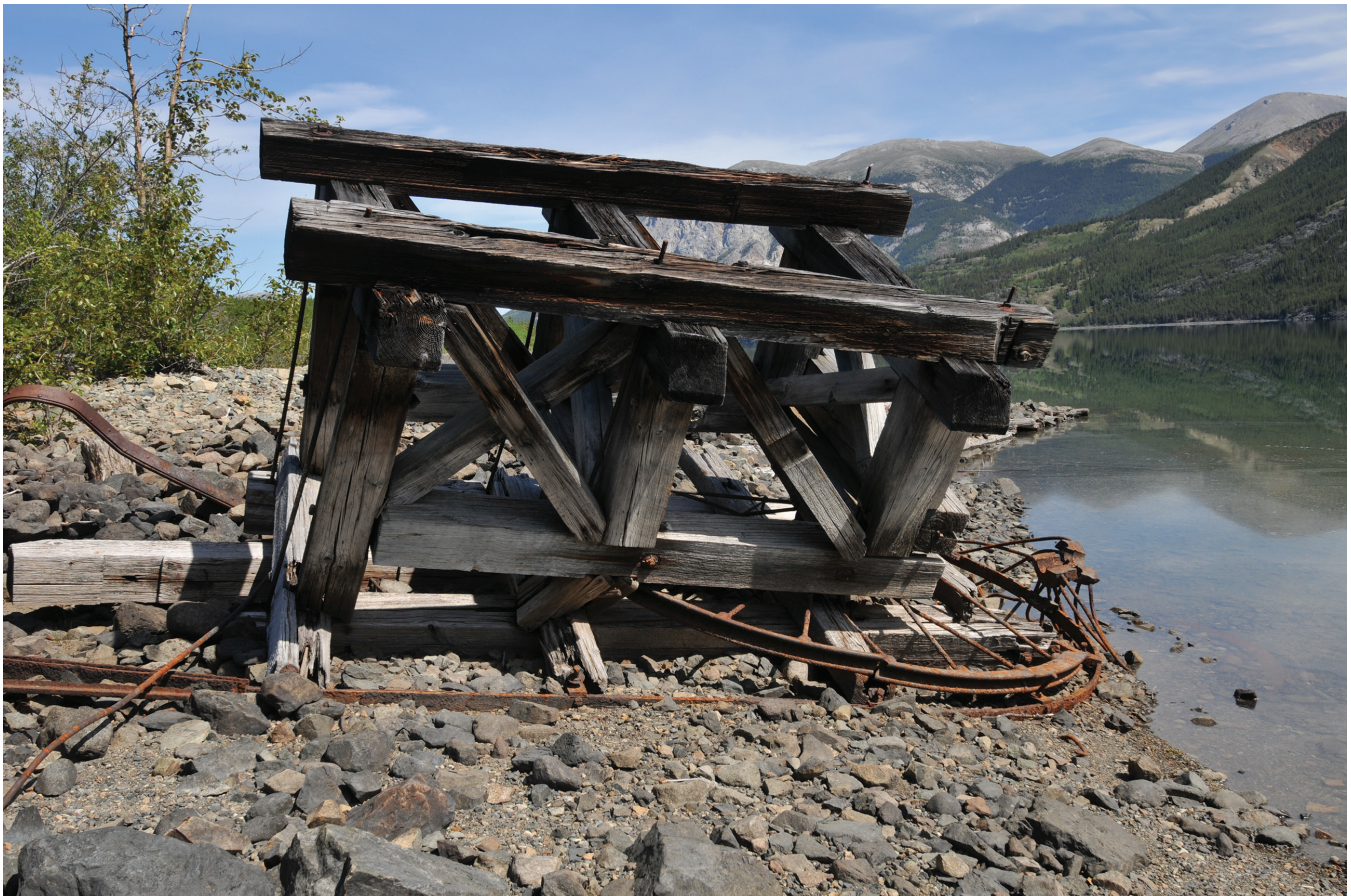
The Mountain Hero Tramway Terminal is a complex structure that is very incomplete at this time. Two large sections still exist. Both appear to be portions of the upper structure of the terminal. One appears to be in or close to its original location on or near the end of the wharf. The other has toppled to the southeast and sits in water when the lake levels are high. Both structures are composed of horizontal, vertical and angled Douglas fir timbers of varying sizes. The timbers are connected by bolts/ threaded rod, timber washers and nuts. In addition to the wood components and metal fasteners there are a variety of metal components used for the operational requirements of the tramway.

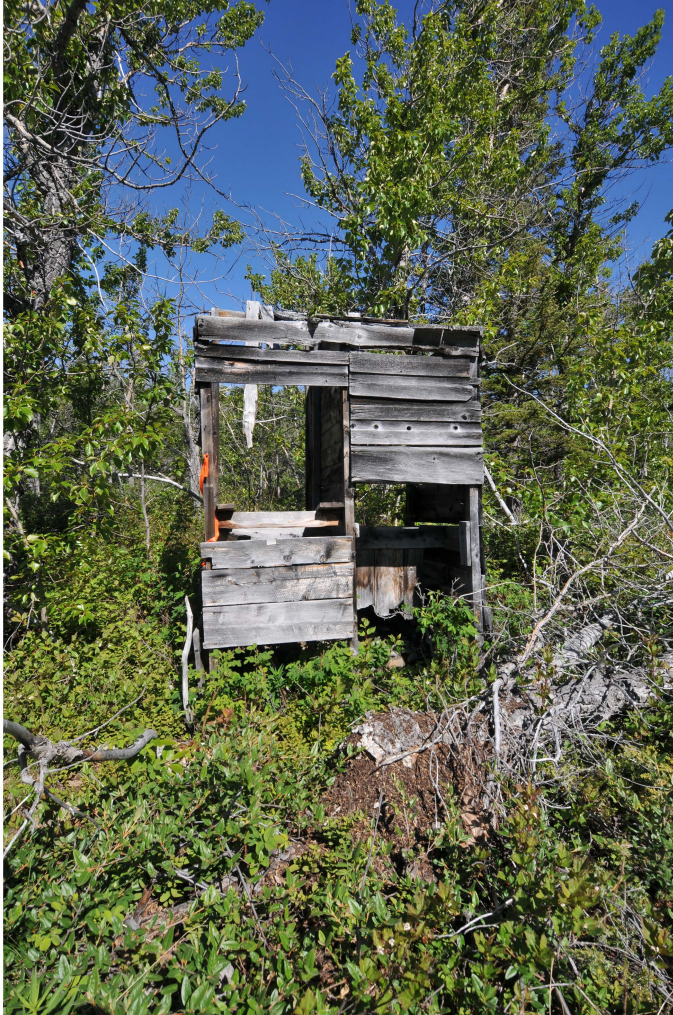
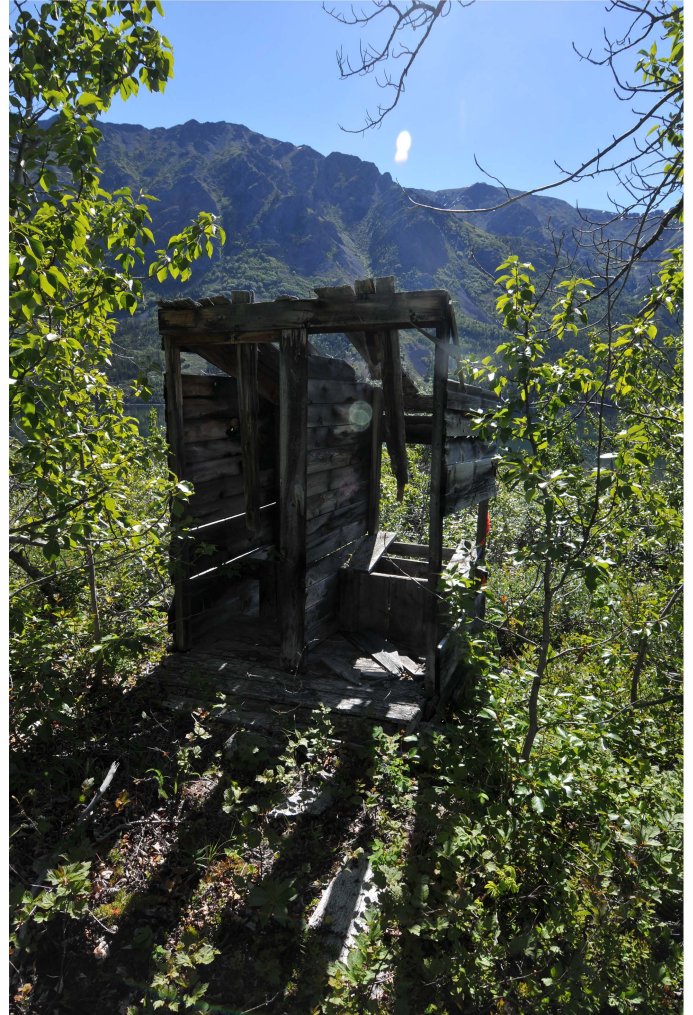
Outhouse (Two-Seat Outhouse)

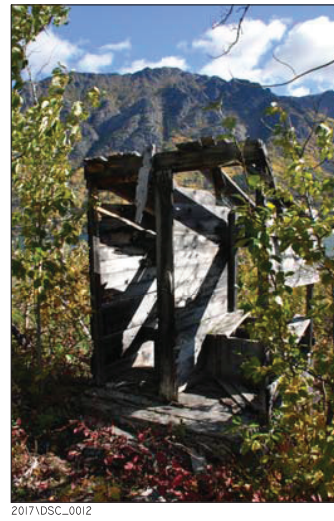
2017\DSC_0012
VIEW FROM THE SOUTHWEST
NTS
