Clinton Creek Asbestos Mine  
Abandonment Plan

ABANDONMENT PLAN

PROJECT: CLINTON CREEK ASBESTOS MINE

LOCATION: CLINTON CREEK, YUKON TERRITORY

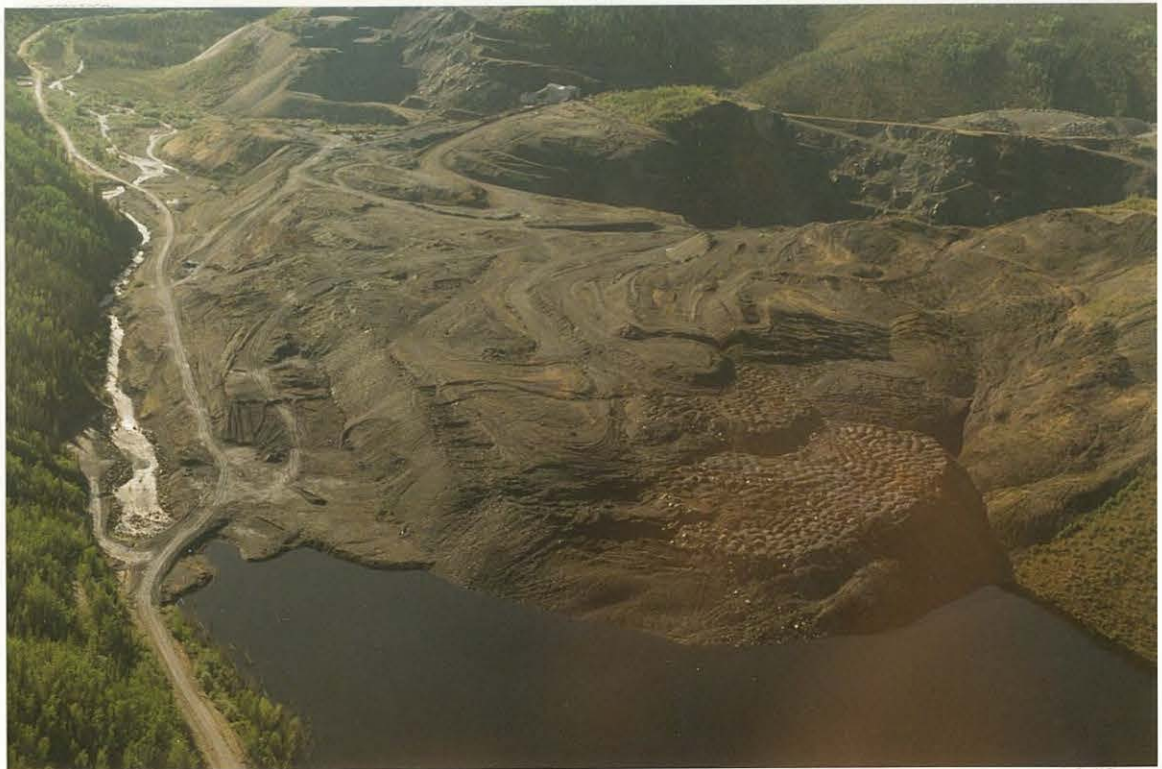
Photo 2: Clinton Creek waste dump, showing Hudgeon Lake at bottom of photo and channel of Clinton Creek over waste dump on left. June 1985.

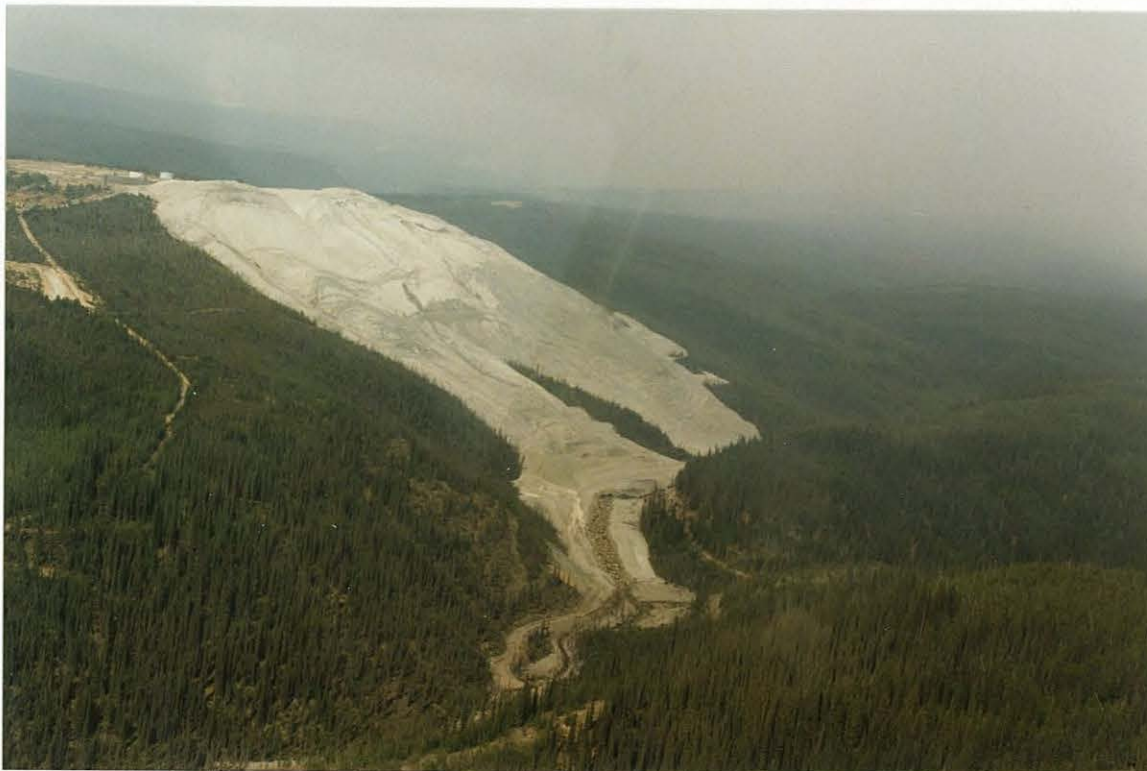
Photo 7: Wolverine Creek tailings piles looking upstream (north).  
July 1986.

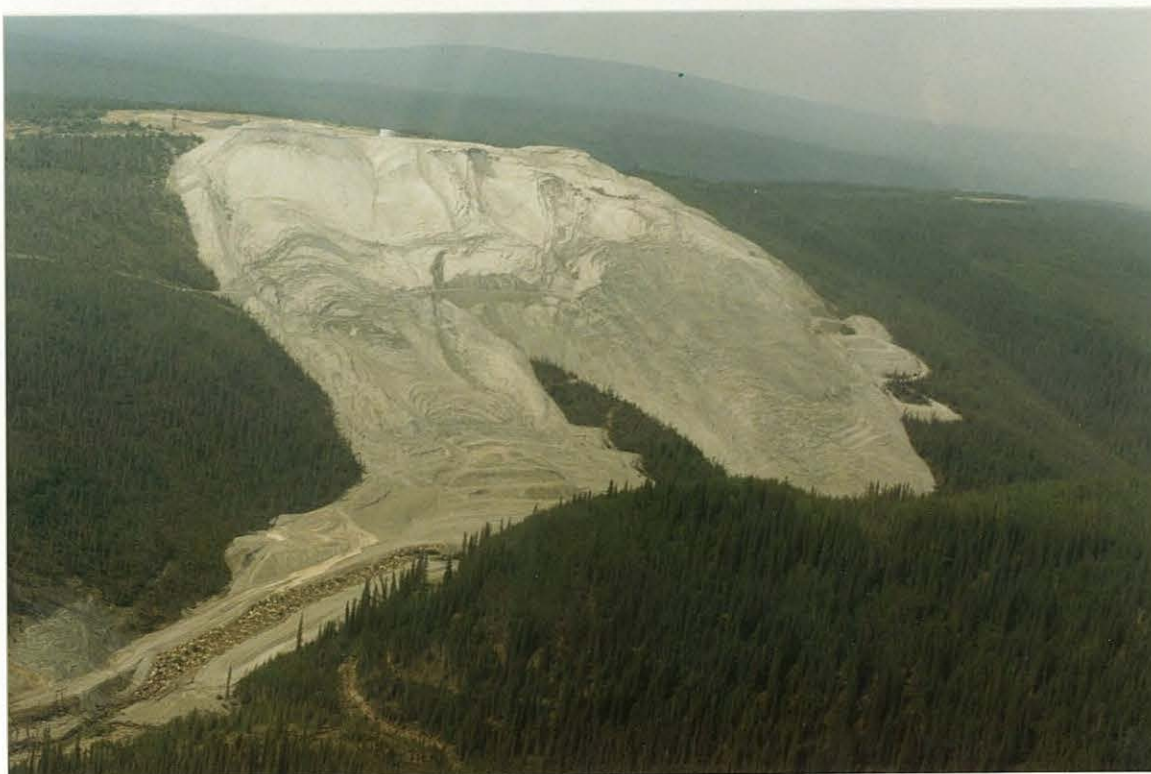
Photo 8: Wolverine Creek tailings piles looking northwest. July 1986.

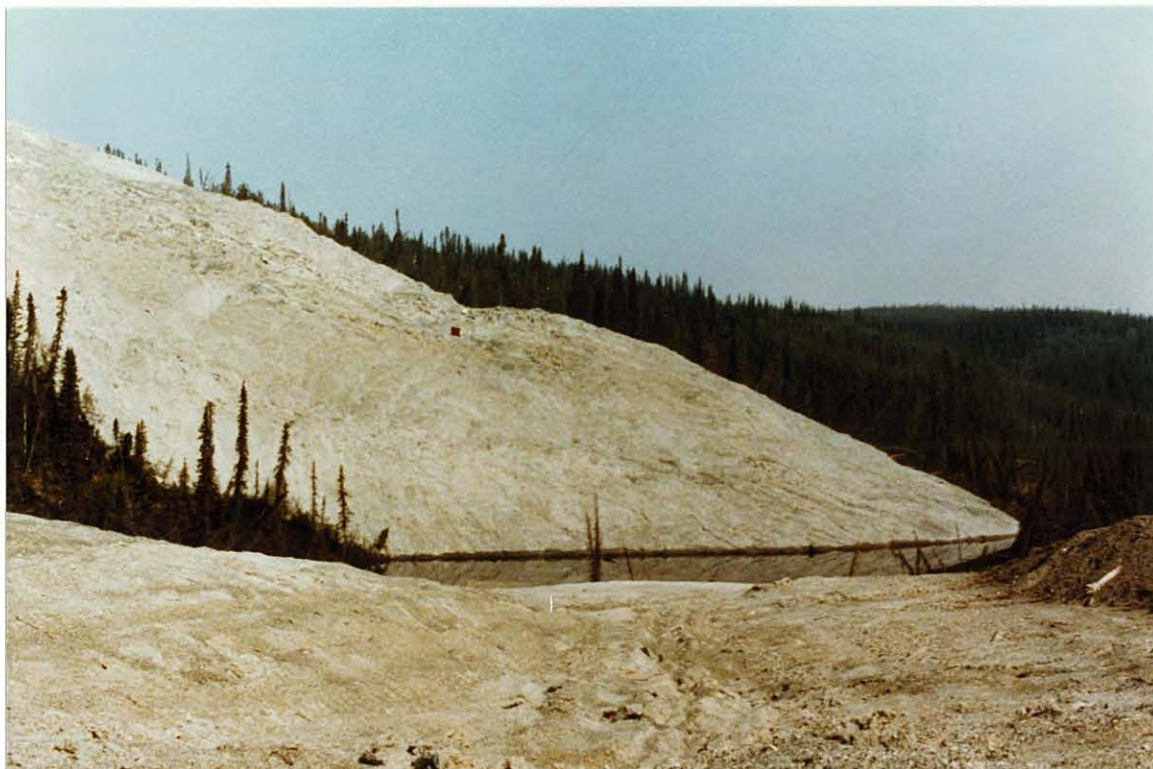
The north tailings lobe has been sliding down the valley slope at a considerable rate. The surface is highly distorted, with a continuous series of scarps from top to bottom. The toe has moved over 400 ft from its position as plotted in 1978, and the tailings have now reached the valley bottom. Movements of monitoring points on the north lobe have reached maximum horizontal rates of over 100 ft/yr on the lower part of the lobe. Movements appear to have reached a peak in 1983 and have slowed to a maximum observed rate of 62 ft/yr in July, 1986. Monitoring points near the top indicated much lower movements of less than 2 ft/yr. The monitor locations and rates of horizontal movement observed in July, 1986 are shown on Drawing D-1004C. Prior to the 1985 site visit, a high steep face existed at the toe of the north lobe. In June, 1985 this face slumped and flattened considerably, so that the potential for rapid movement of the north lobe is reduced.

Photo 9: Toe of north tailings lobe. July 1986.

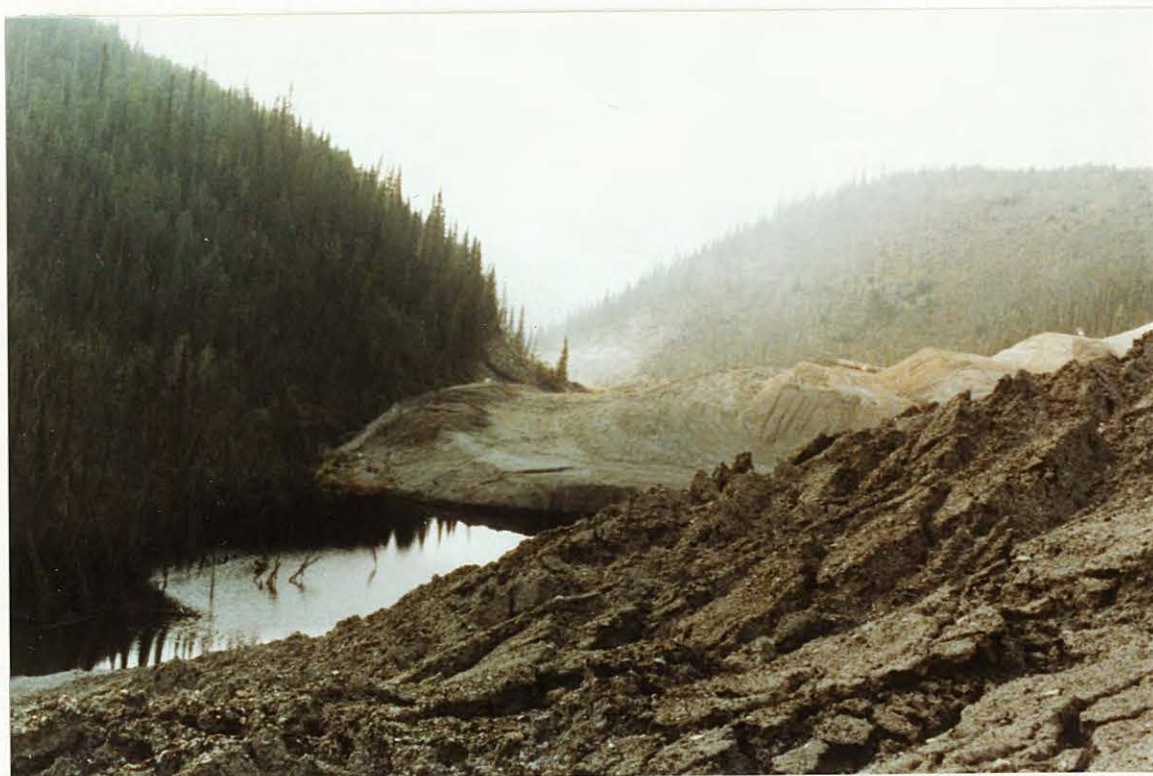
Movements of the south tailings lobe are considerably lower than the north lobe, but are still significant as the maximum movement rate observed in July, 1986 was 21.5 ft/yr on monitor point 24A. The highest rates are in the lower part of the south lobe. Movements have been increasing slightly over recent years, with the highest rates recorded in 1986. The channel conveying the stream past the toe of the south

Photo 10: Toe of south tailings lobe. July 1986.

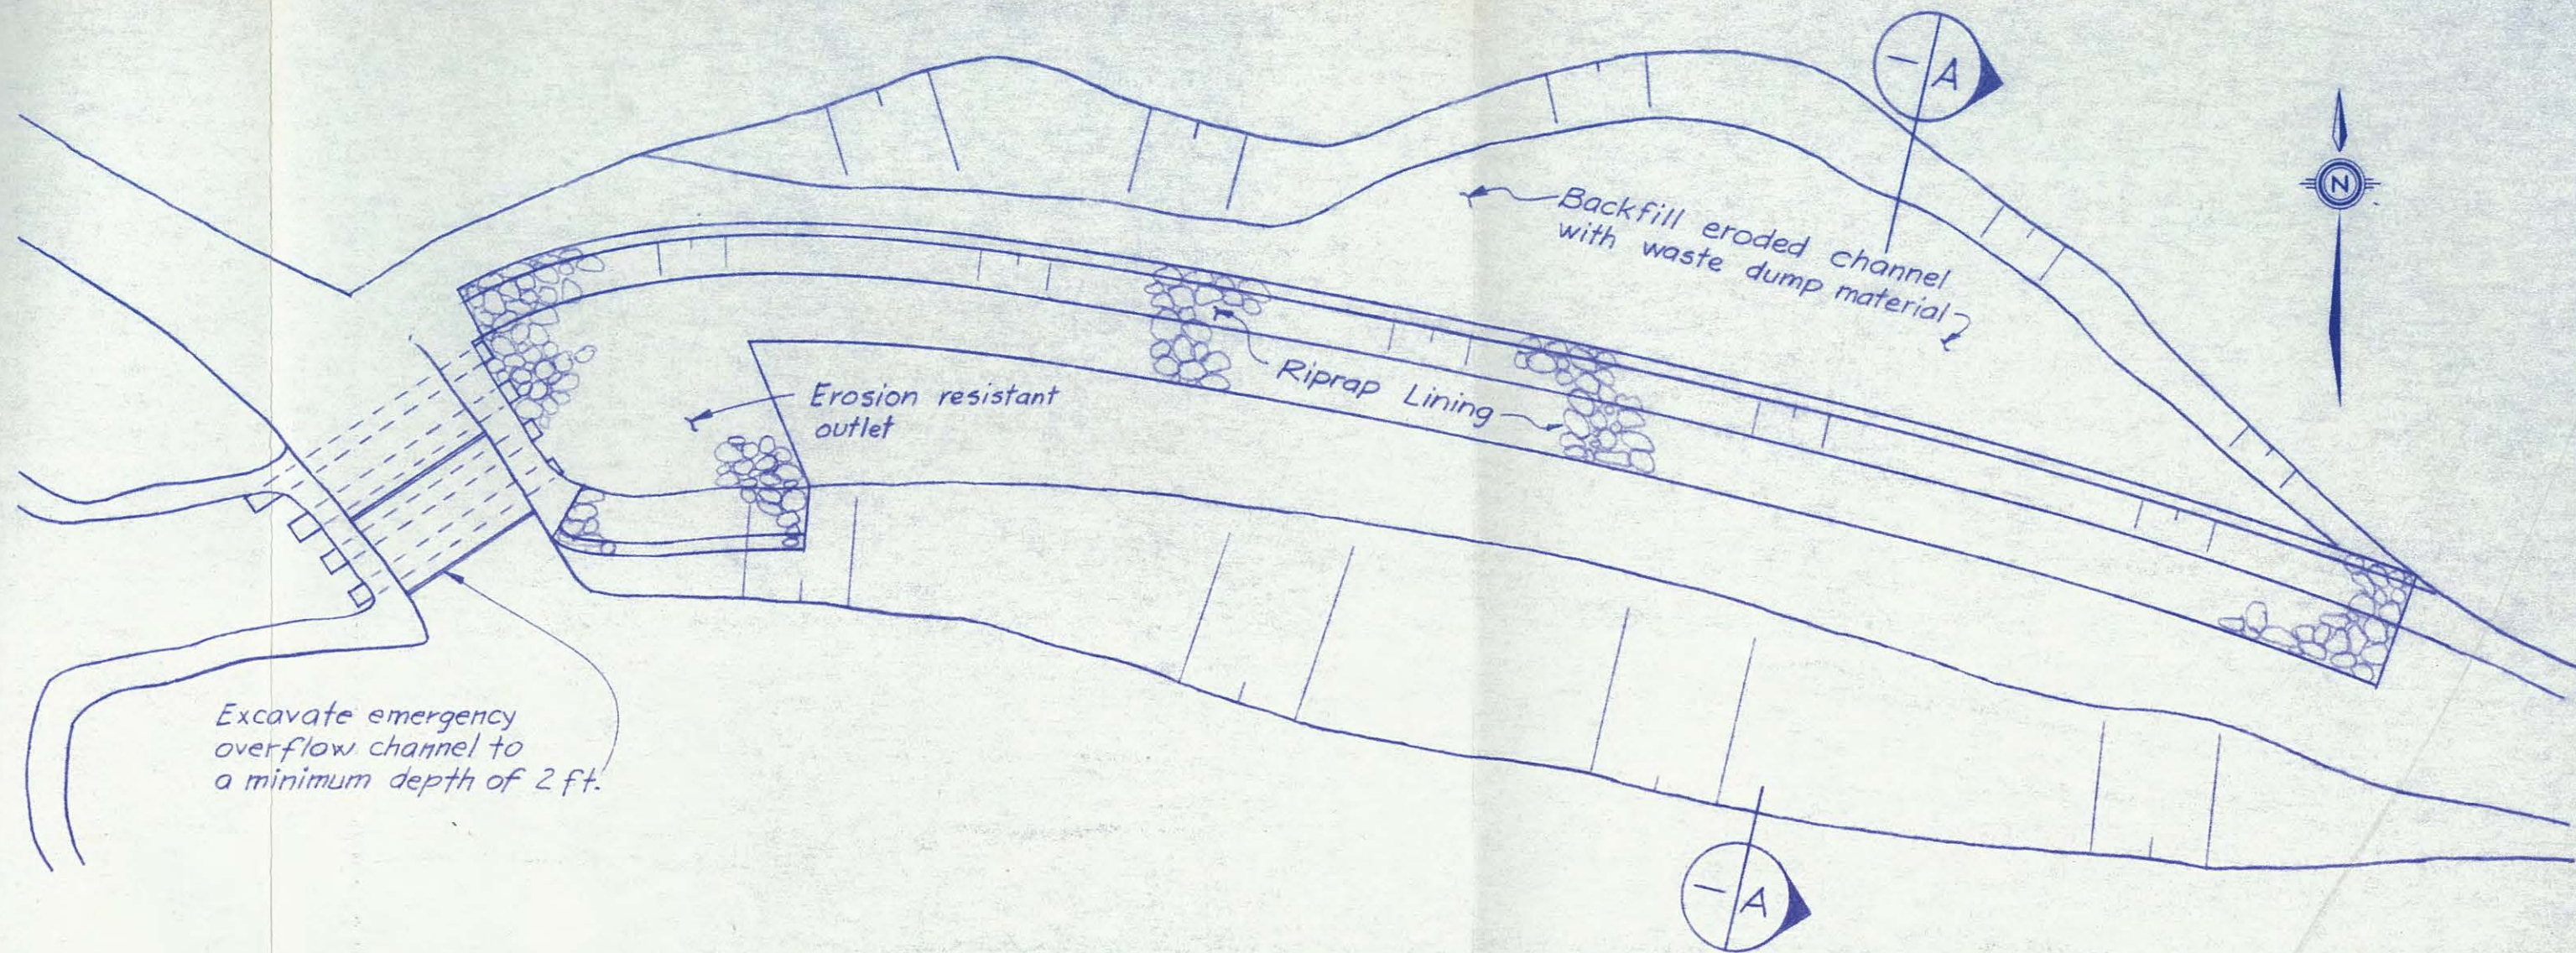
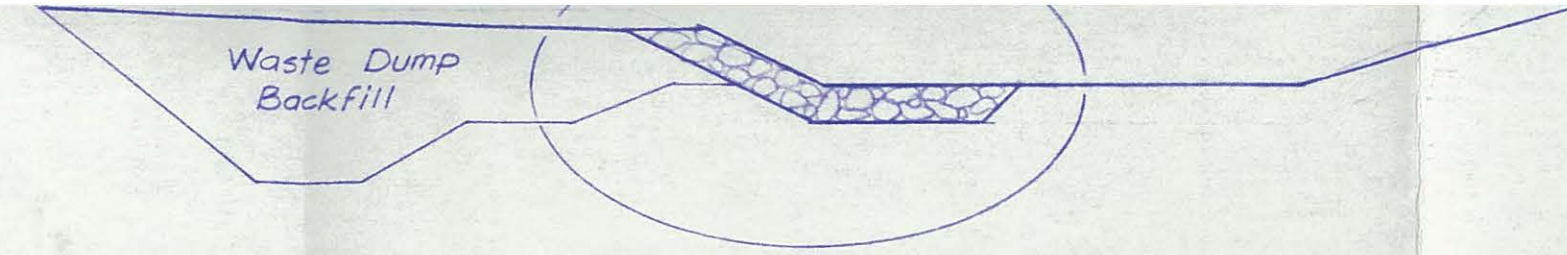
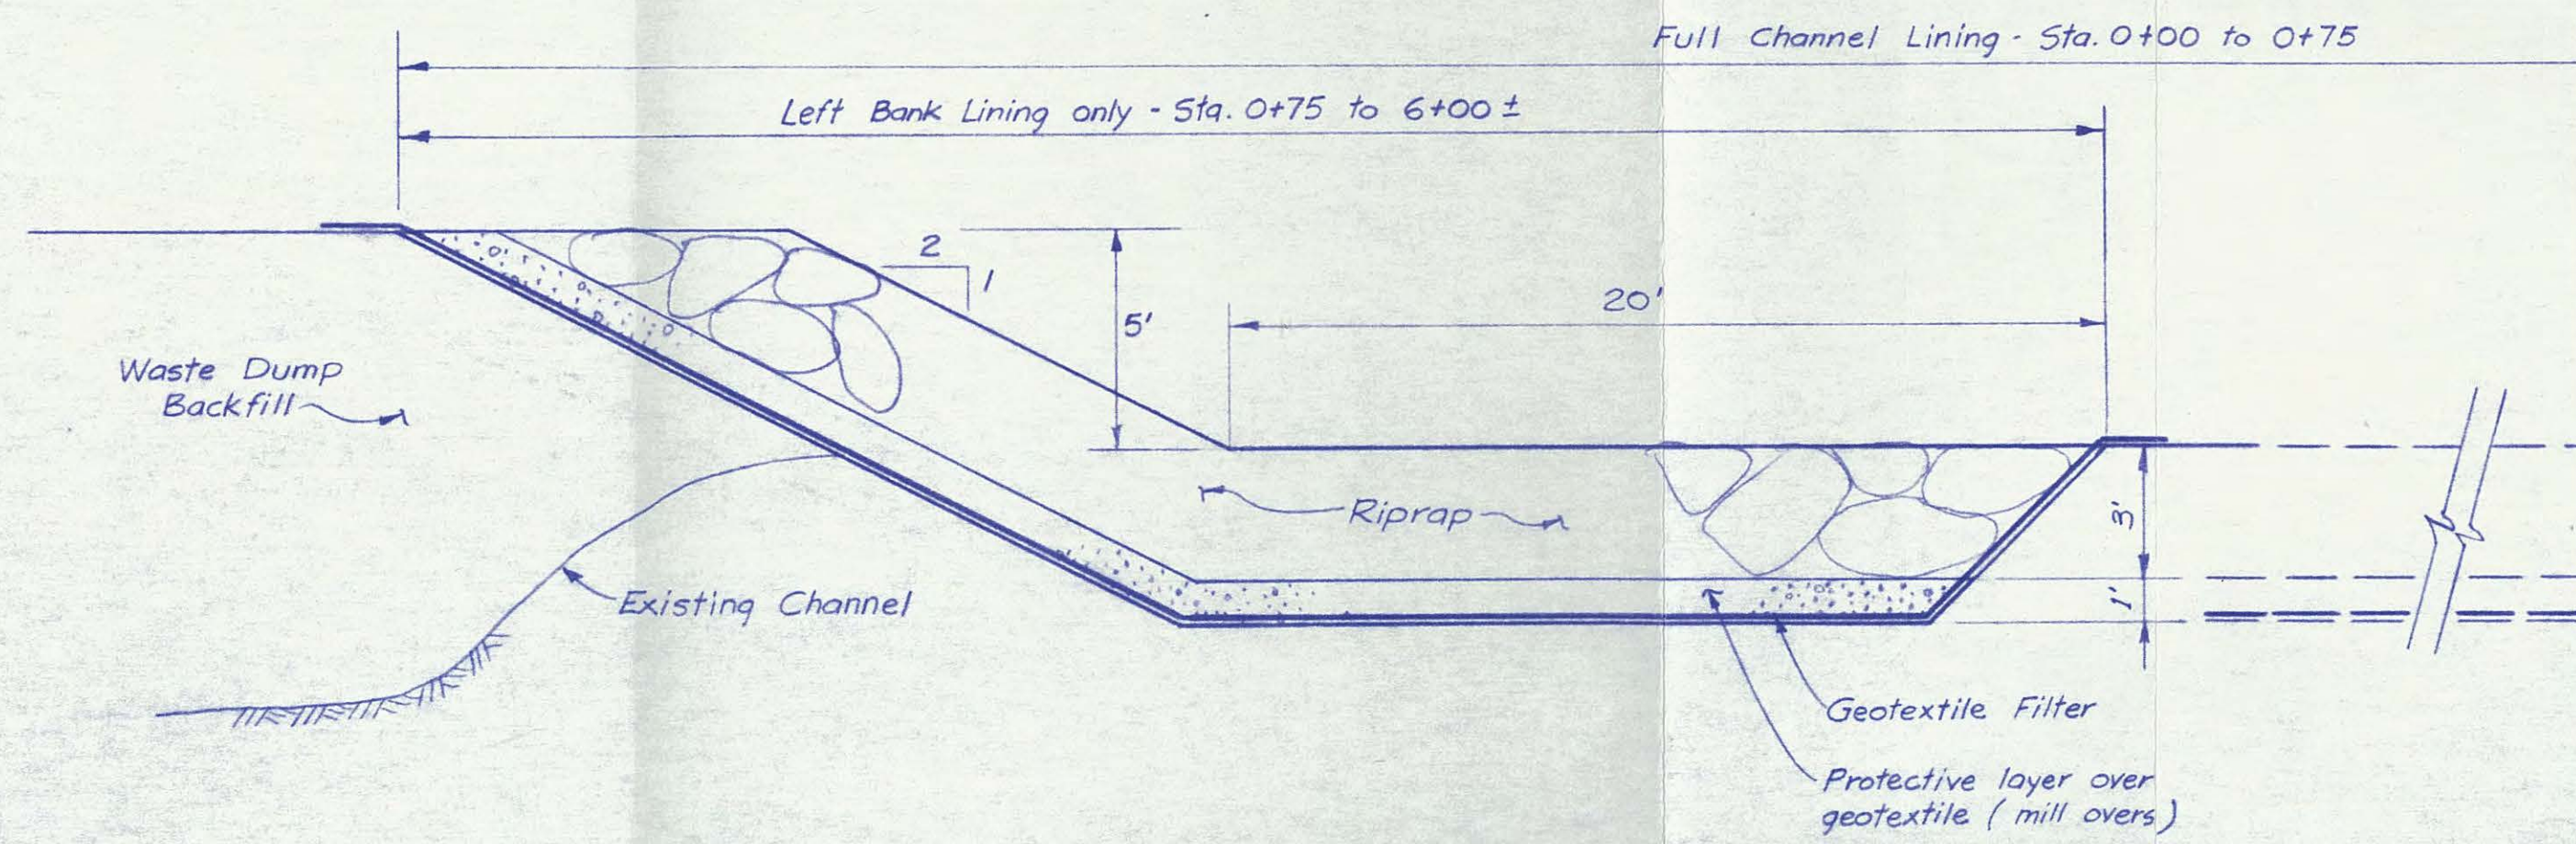
### SITE PLAN SHOWING CHANNEL LINING

SECTION A  
TYPICAL SECTION OF CHANNEL - STA. 0+75 TO 6+00  
Scale : 1" = 20'

DETAILS OF CHANNEL LINING  
Scale 1" = 4'

- Final alignment of riprap lining and extent of riprap placement to be approved by the Engineer on site.
