AMP Event #4 Response: Status Report

SRK Project Number 1CD003.063

May 2005

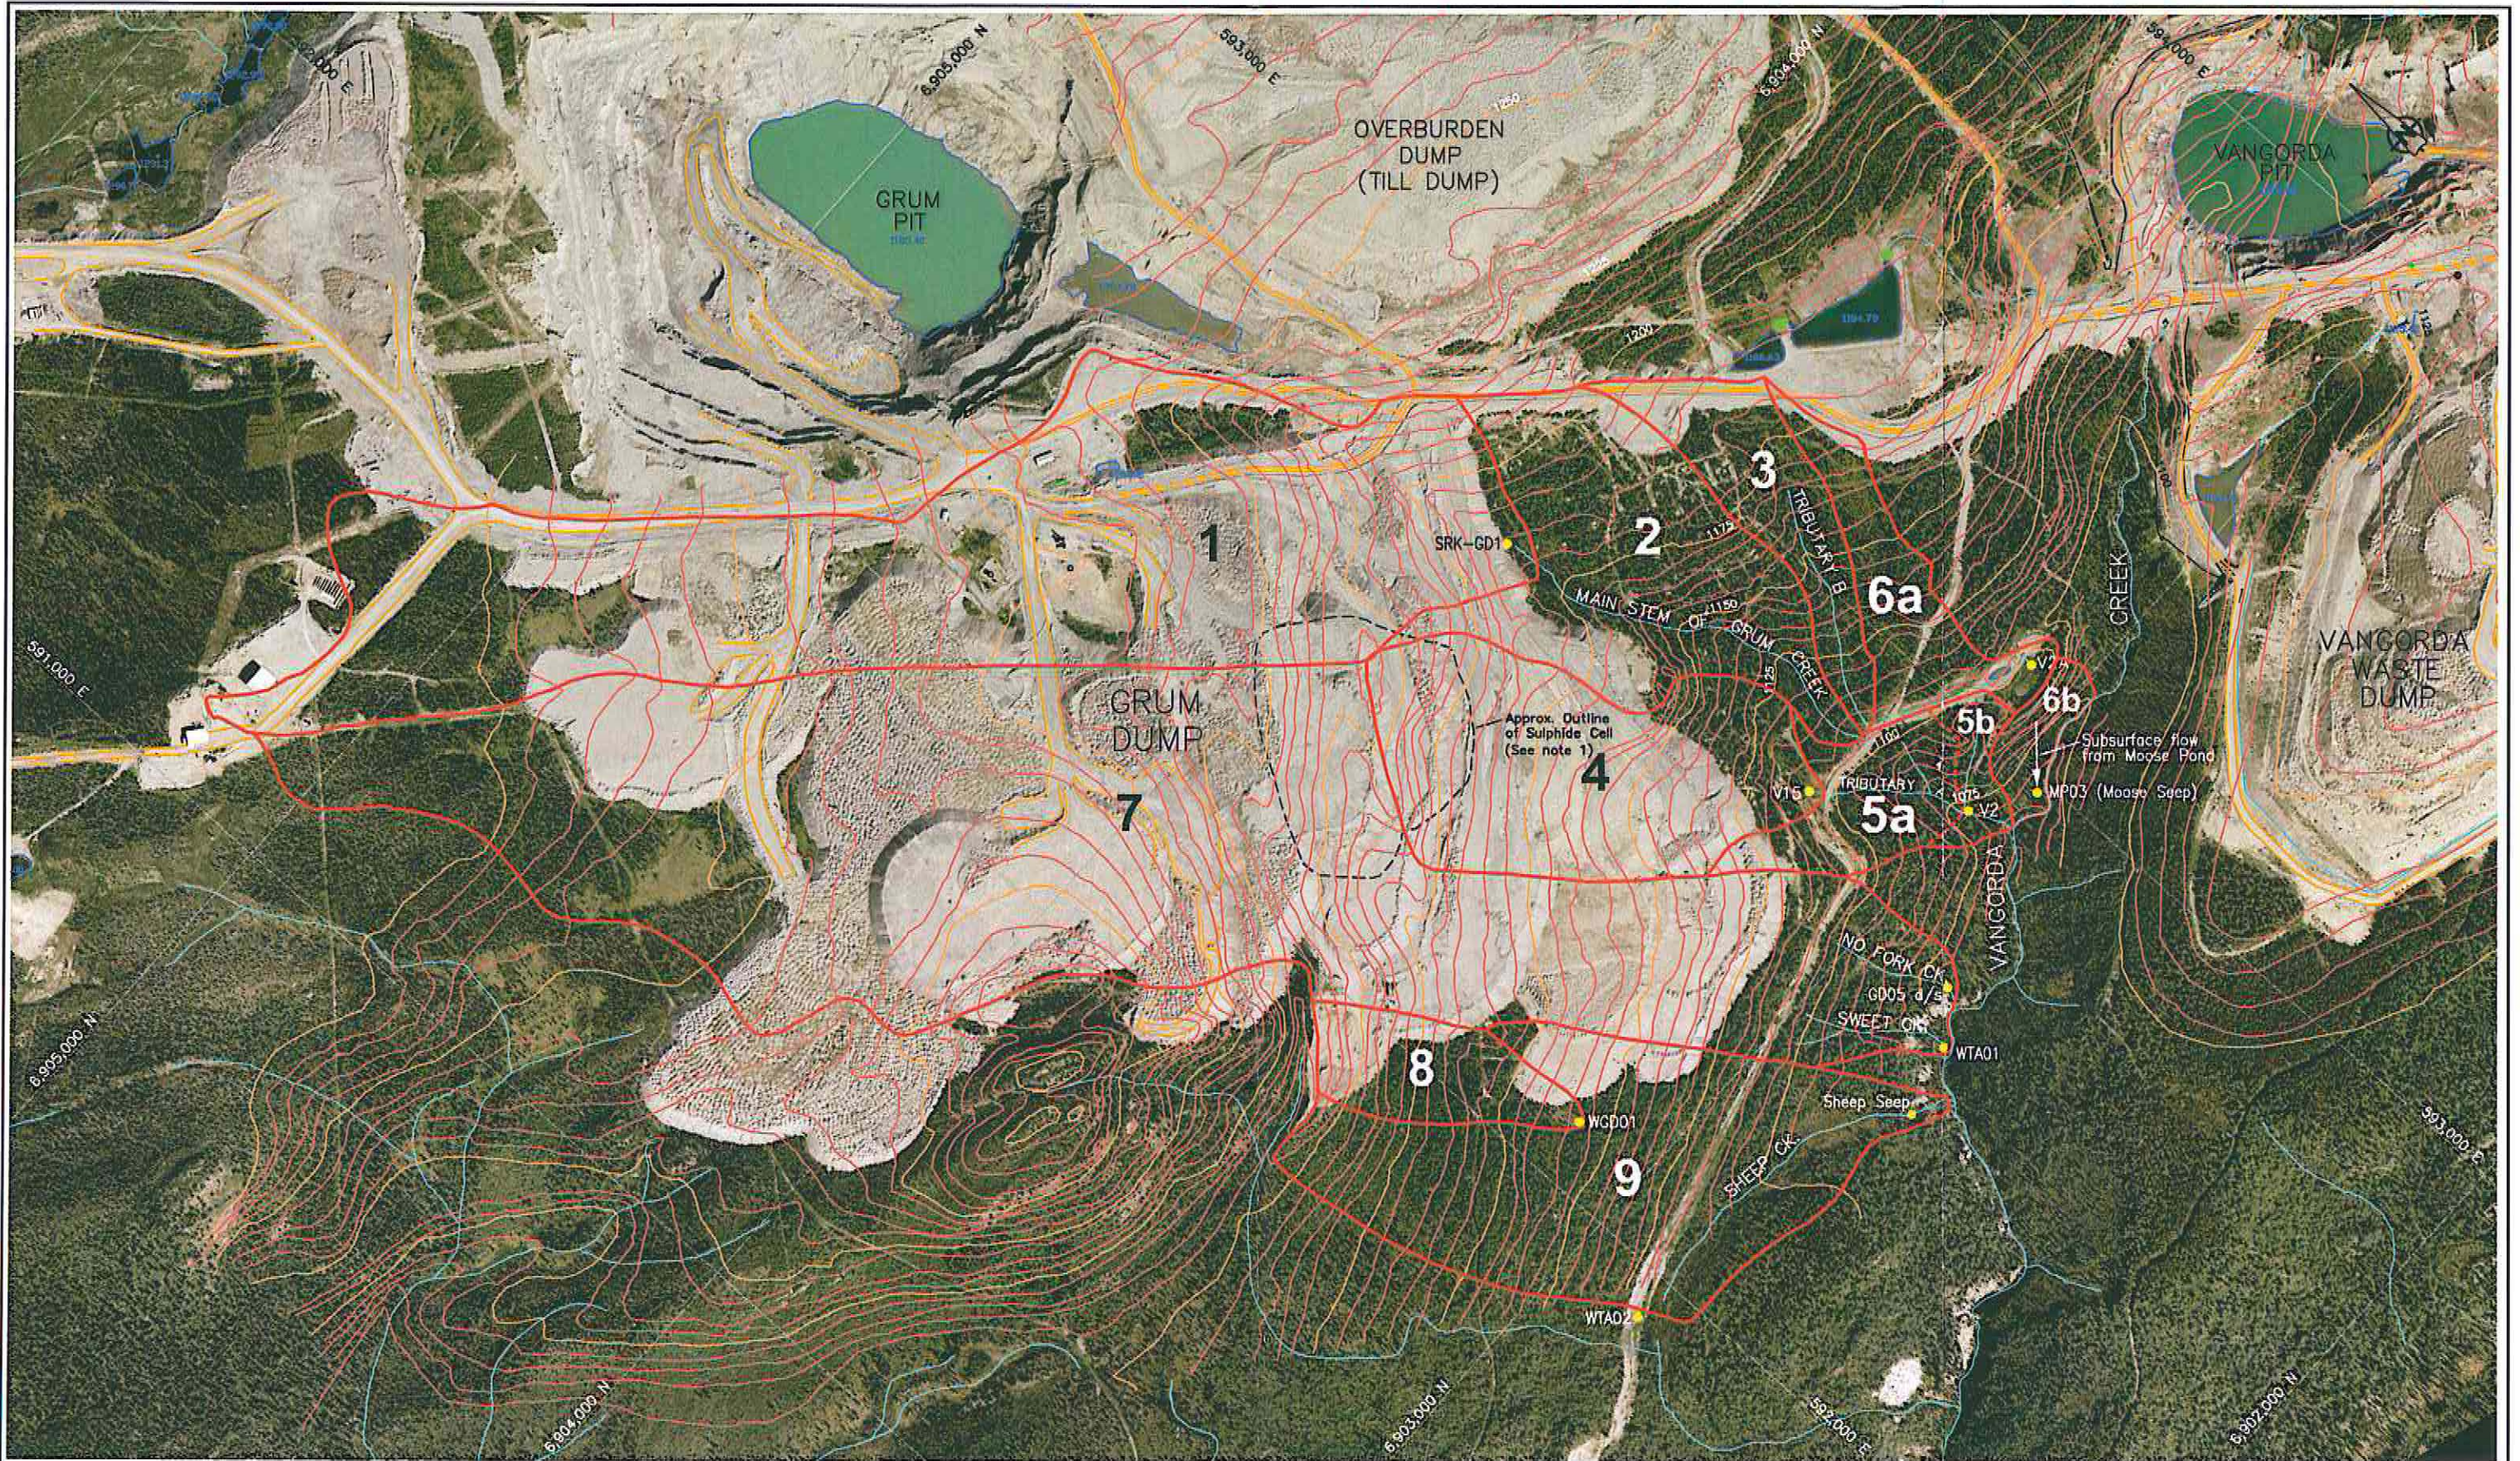
PROJECT NO.	DATE	APPROVED	FIG.
1CD003.063.0100	Feb. 2005		4.1

GRUM DUMP CATCHMENTS

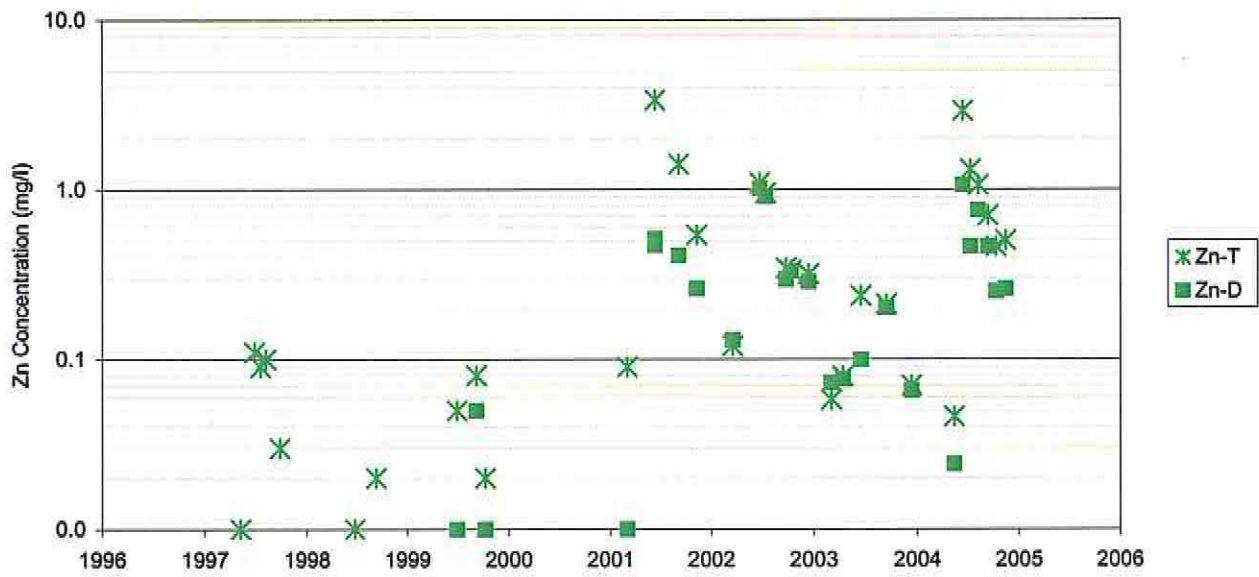
Project 1D003.063.0100	Date Mar-05	Approved	Figure 3.5
---------------------------	----------------	----------	----------------------

V2A - SO4

V2A - Zn

Zinc and Sulphate Concentrations at V2A

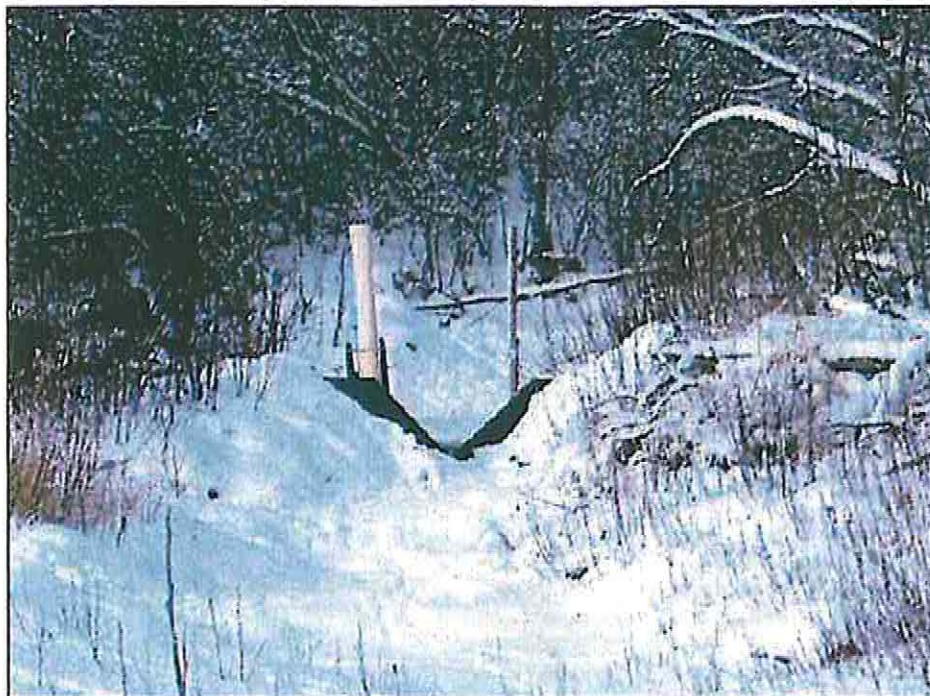
- Installed stilling well and two (2) metre staff gauge in Grum Creek, upstream of the existing weir.
- Conducted site survey by Stadia surveying methodology and established semi-permanent benchmark on nearby tree. Survey includes elevations of staff gauge zero mark, stilling well base, weir v-notch, and nearby haul road intersection with another haul road all relative to the established benchmark;
- Measured instantaneous flow in existing weir.

Plate 1 Stilling Well and Staff Gauge Installed Up-Stream of Weir (Looking Upstream)

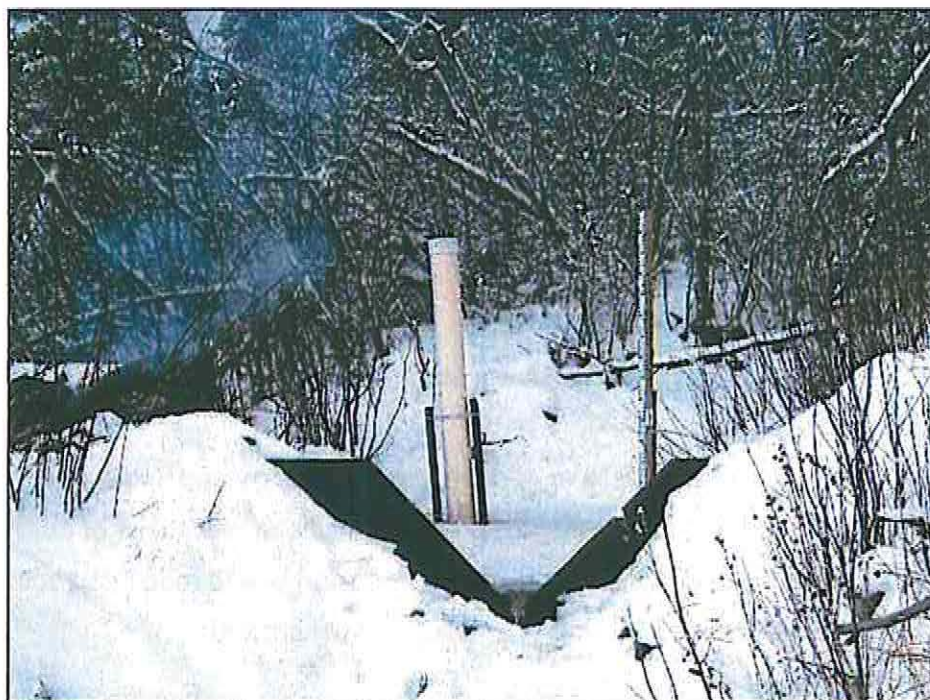
Plate 2 Stilling Well and Staff Gauge Installed Up-Stream of Weir (Looking Upstream)

Note: Well is suspended between three posts and posts are anchored together. The well will be leveled in the spring during the water level monitoring instrument installation.

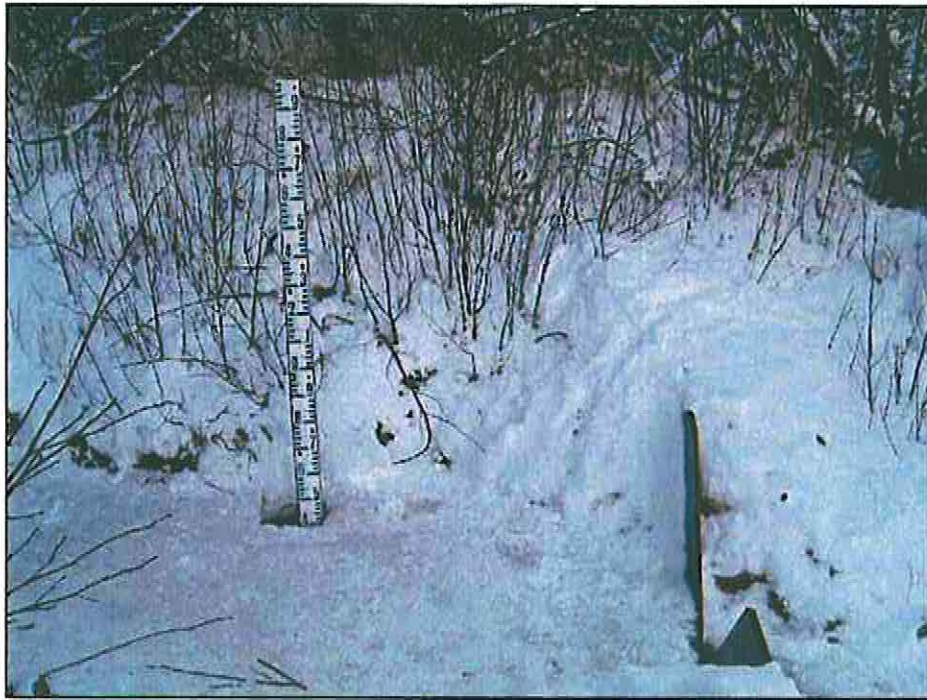
Plate 3 Staff Gauge Install (Water Level = 0.36m)

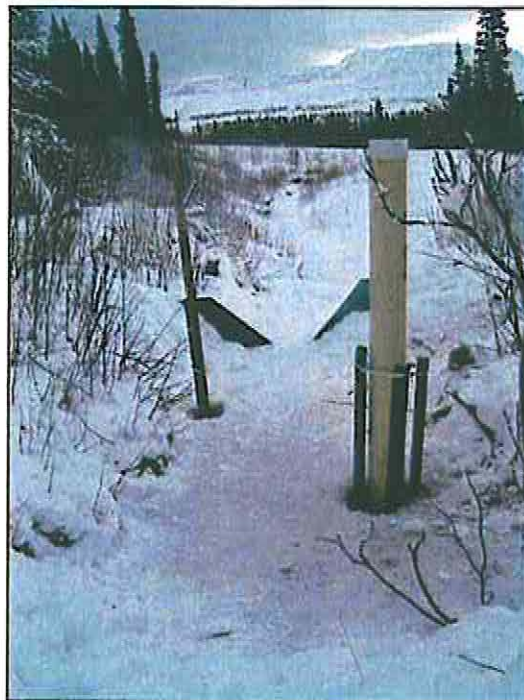
Plate 4 Stilling Well and Staff Gauge Installed Up-Stream of Weir (Looking Downstream)

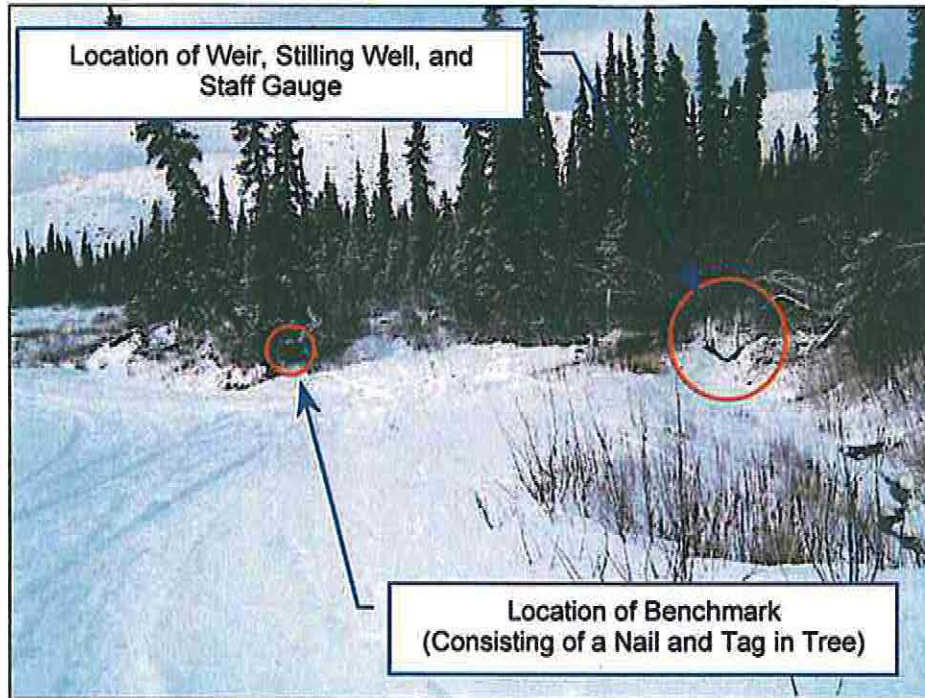
Plate 5 Overview of Monitoring Location and Survey Benchmark
