AMP Event #4 Response: 2007 Status Report

Project Reference Number
SRK 1CD003.091

January 2008

SRK Consulting (Canada) Inc.

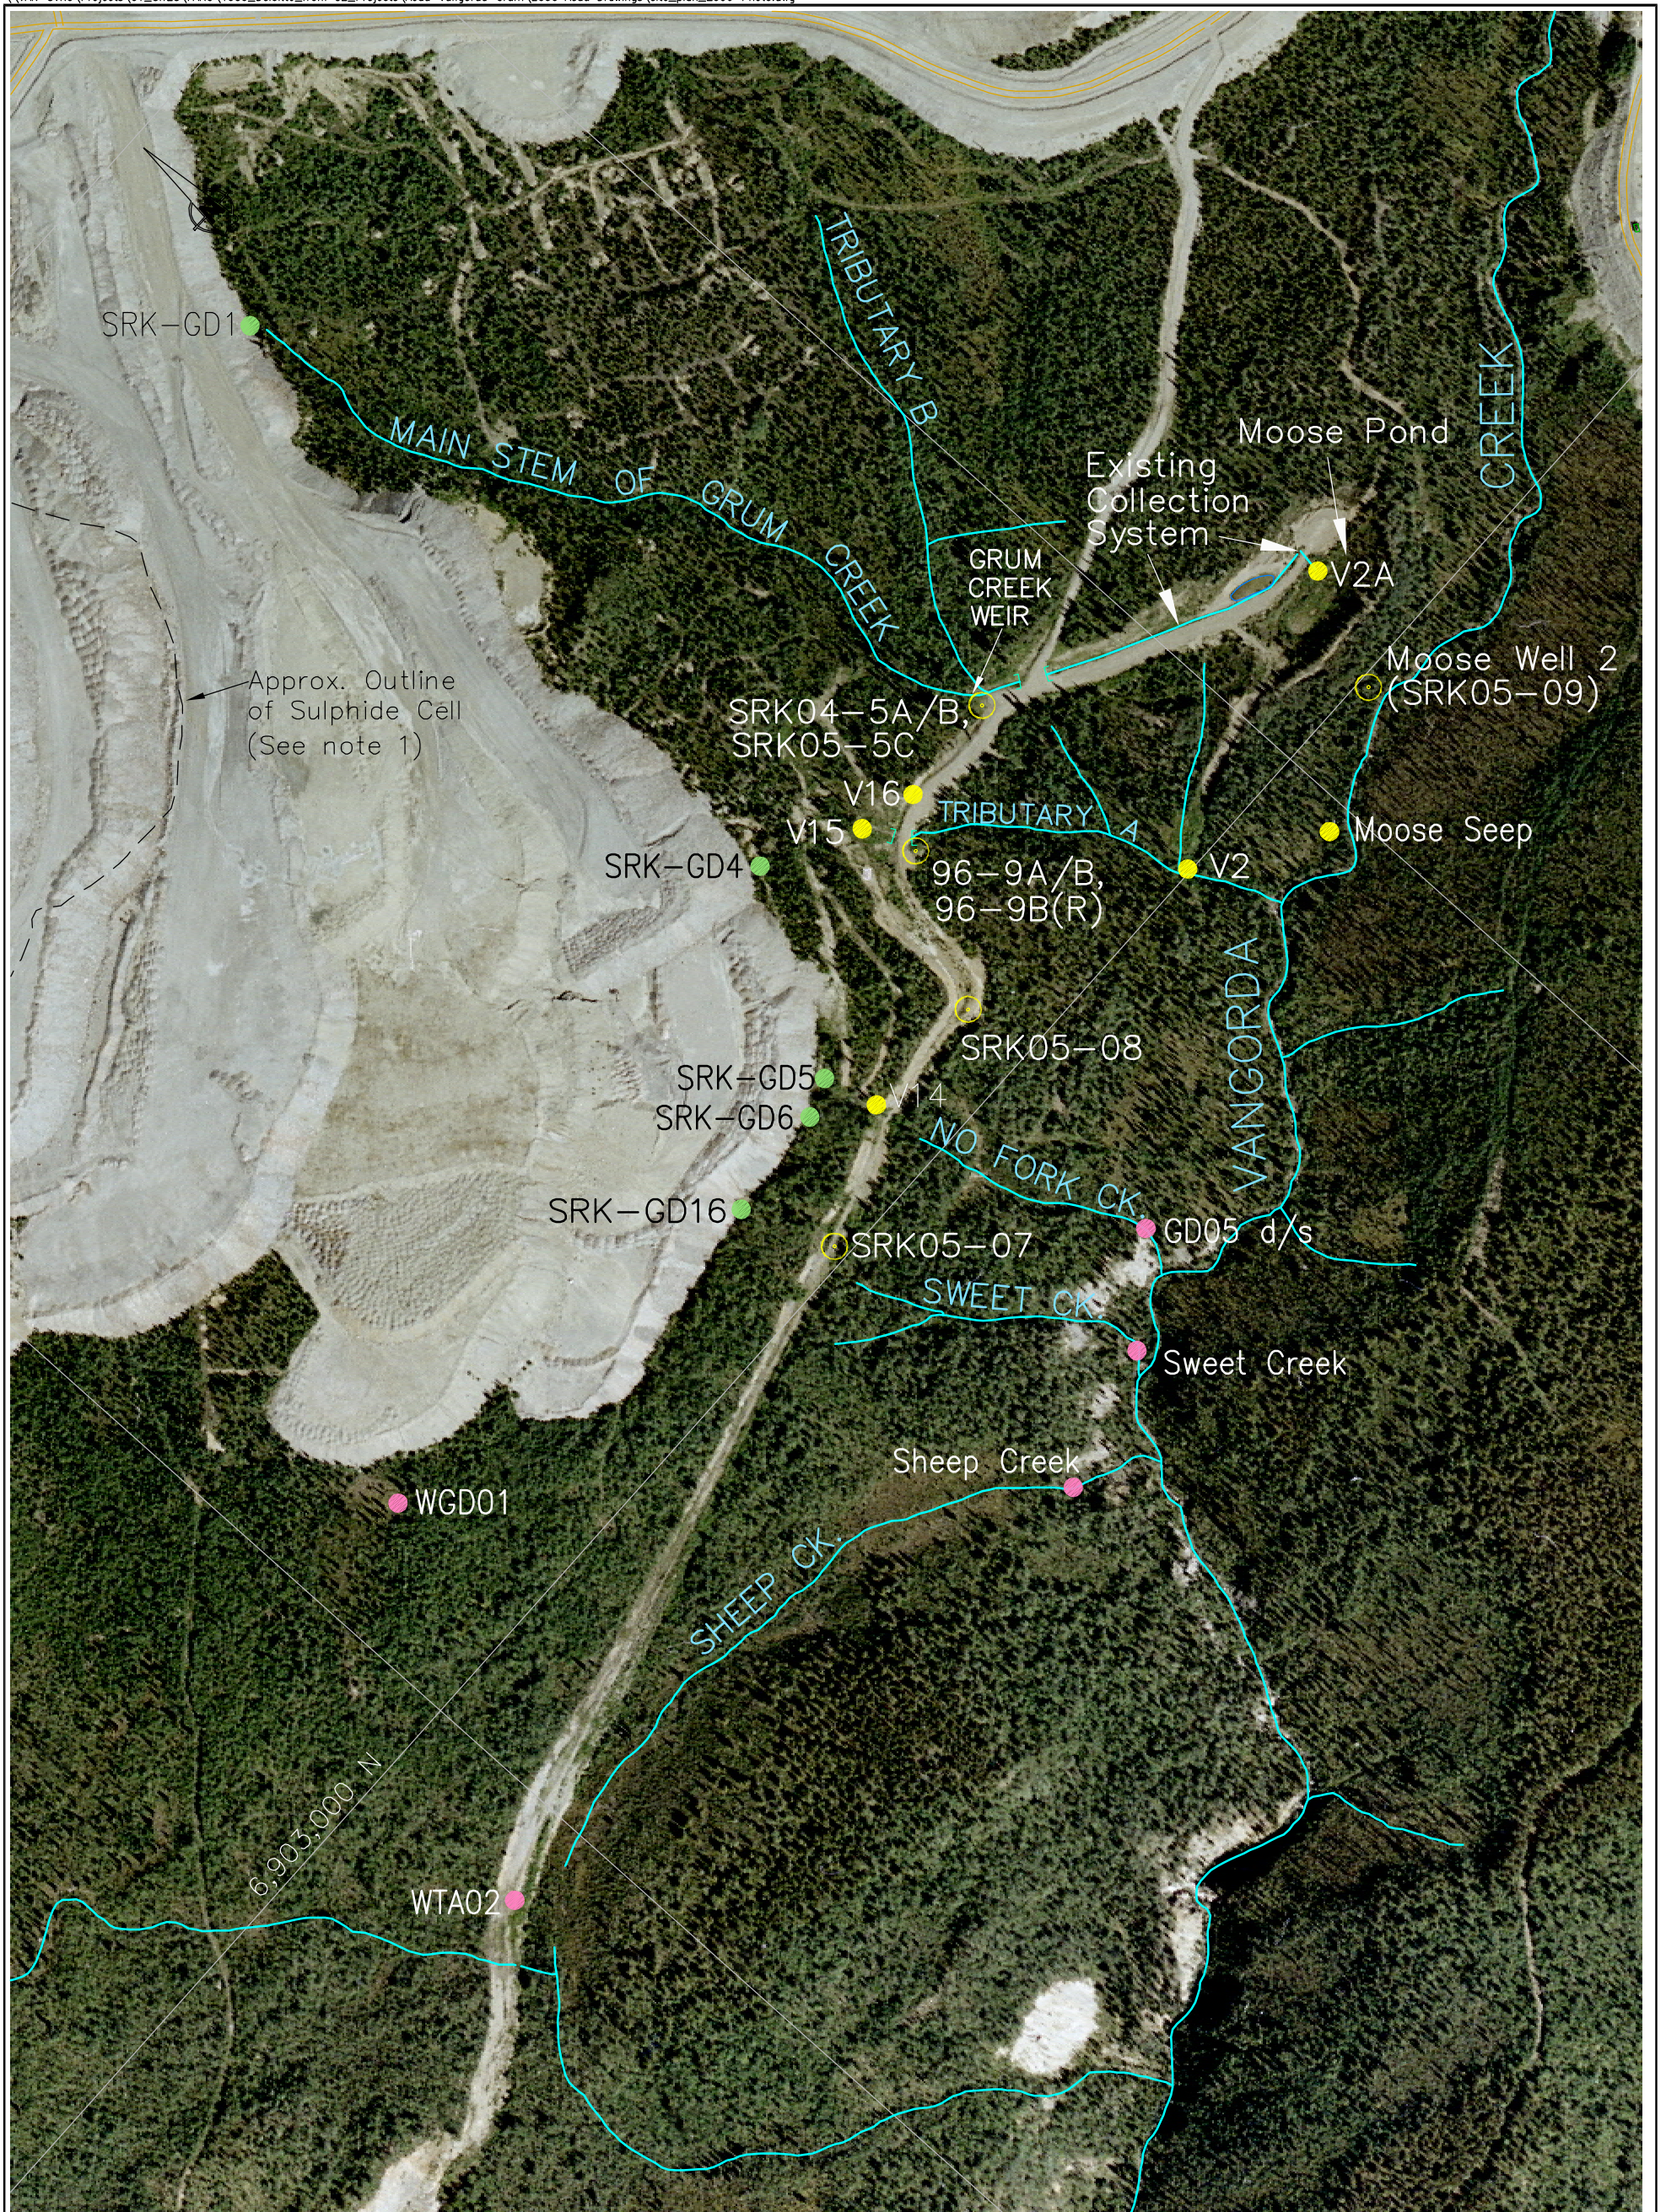
DATE: Jan. 2008	APPROVED: D.B.M.	FIGURE: 2.1
--------------------	---------------------	----------------

2007 Borehole and Water Sampling Stations

Monitoring of the nine Reference Water Quality Stations (RWQs) (Figure 2.1) identified in the AMP and in subsequent follow-up work was carried out by site environmental staff or by Gartner Lee Limited (GLL) during 2007. Table 2.1 provides a description of each of these stations.

Seepage from the toe of the Grum waste rock dump has been monitored as part of the semi-annual seepage survey that has been carried out since 2002. Seepage from the southern toe of the dump is monitored at stations SRK-GD1, SRK-GD4, SRK-GD5, SRK-GD6, SRK-GD-16 and SRK-GD21 (Figure 2.1).

Selected seepage monitoring stations downgradient of the Grum waste rock dump (GD05 d/s, Sweet Creek, Sheep Creek, Moose Seep) have been monitored on a spring/ fall basis since 2003. Two additional stations were added to the program starting in 2004 (WGD01 and WTA-02). Station locations are shown in Figure 2.1.

Five additional groundwater monitoring wells that are not included in the list of reference water quality stations were installed in 2004 and 2005. These five wells (SRK04-5A, SRK04-5B, SRK05-5C, SRK05-07, and SRK05-08) are located adjacent to the Grum Dump Toe Access Road, as shown in Figure 2.1.

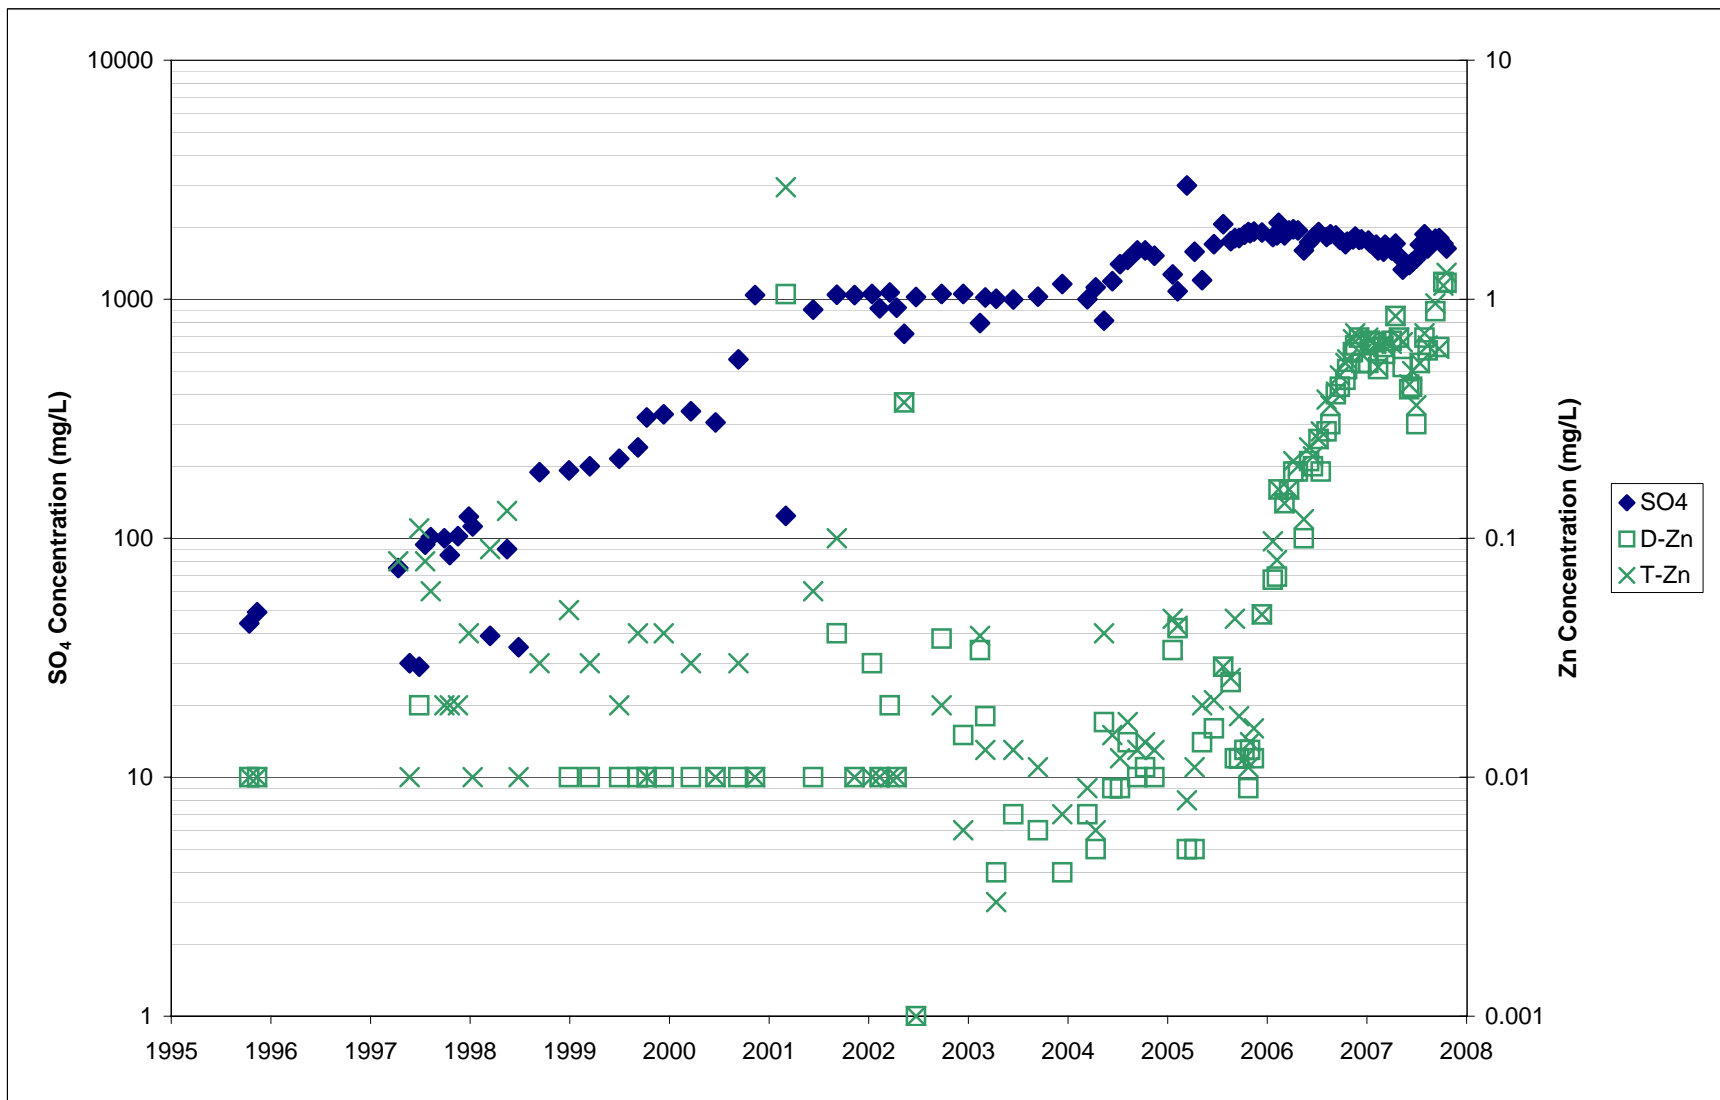
3.1

Note: Dissolved zinc concentrations are plotted at the detection limit where values were reported as less than detection.

Station V15 is located at the outlet of the Tributary A sedimentation pond, upstream of Station V2 (Figure 2.1), and has been a reliable sampling point since pond construction in 1995. Surface flow at V15 has been approximately 1/3 of the volume observed downstream at V2 in recent years. The V15 sedimentation pond is thought to be directly downgradient from the Grum sulphide cell via a groundwater pathway, and water chemistry at this location is expected to be a good indicator of the arrival and loading of oxidation products from the sulphide cell. Sulphate and total and dissolved zinc concentrations measured at V15 is shown in Figure 3.1.

Sulphate concentrations at V15 steadily increased over the 1995 through 2001 period. From 2001 through early 2004, sulphate concentrations at V15 were within a stable range (700 to 1050 mg/L). This stable period was followed by a period of increasing concentrations from around 1000 mg/L to around 2000 mg/L by June 2005, with a single high result of 2990 mg/L recorded in February 2005. Samples collected during the June 2005 through October 2006 period indicated sulphate concentrations in the range of 1600 to 2090 mg/L, and it appears that sulphate concentrations have stabilized at present. Future monitoring will be necessary to verify the observation of a stable trend.

Dissolved and total zinc concentrations at V15 were high variably from 1995 to 2002, typically in the range of 0.01 to 0.1 mg/L, with occasional values as high as 1 mg/L. This variability was the result of operational and post-operational water management, as discussed below for Station V2. Following the implementation of dump runoff control in 2002, zinc concentrations were lower and more uniform, ranging between 0.006 and 0.05 mg/L. Starting in 2006, there was a dramatic trend of increasing zinc concentrations from 0.07 mg/L in January 2006 to 0.68 mg/L in October 2006. Zinc concentrations then levelled off over the winter months and decreased to approximately 0.4 mg/L during the 2007 spring freshet. During the summer of 2007, the concentrations started to increase again, reaching 1.2 mg/L by October 2007. The pattern of increasing zinc concentrations appears to be a textbook case of breakthrough of an attenuated chemical species. Future monitoring at V15 is critical for understanding retardation factors and evolution of water chemistry downgradient of Grum Dump.

The dramatic and consistent rise in dissolved zinc concentration observed at V15 in 2006 and 2007 remains noteworthy. The data appear to show a classic case of breakthrough of attenuated chemical species, and the results reviewed to date do not suggest that the breakthrough process has run its course. It is reasonable to expect to see some measure of continued increase in zinc concentrations at V15.

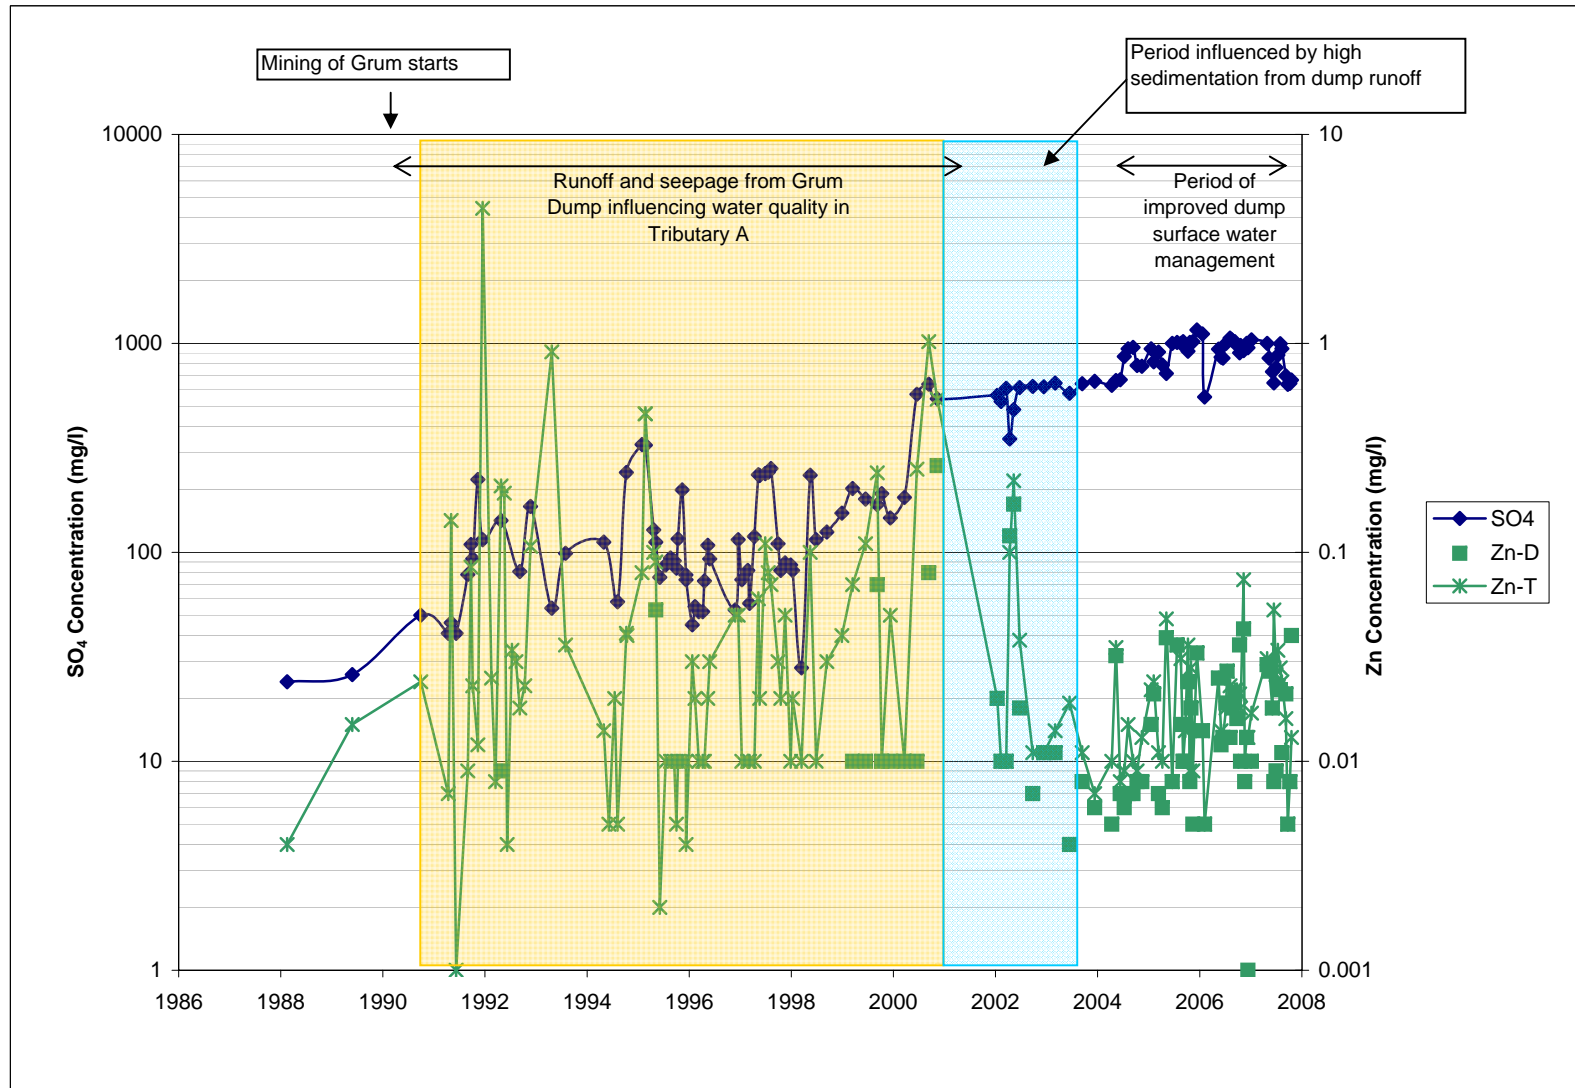
3.2

Note: Dissolved zinc concentrations are plotted at the detection limit where values were reported as less than detection.

Sulphate and zinc concentrations measured at Station V2 are shown in Figure 3.2.

Total and dissolved zinc concentrations were highly variable during mining operations, and runoff and erosion from the Grum Dump led to continued variable and elevated zinc concentrations at V2 during the period from the cessation of mining through 2002. Improved runoff management since 2002 resulted in total and dissolved zinc concentrations within a much narrower range at V2. Surface flow at V2 has been visually estimated to be about 3 times the volume observed upstream at V15 in recent years, which reflects in part a contribution from seepage losses from the Grum Creek diversion. In 2007, the range of zinc concentrations at V2 was similar to that observed in 2004 through 2006, indicating that the partial diversion of flows from the V15 sedimentation pond to Moose Pond was successful in controlling zinc concentrations in the downstream environment.

Despite the increase in zinc concentrations observed at Station V15, zinc concentrations at Station V2, downstream of this location, have remained very low throughout the monitoring period. Sulphate concentrations at Station V2 remain in excess of the initial trigger established in the AMP.

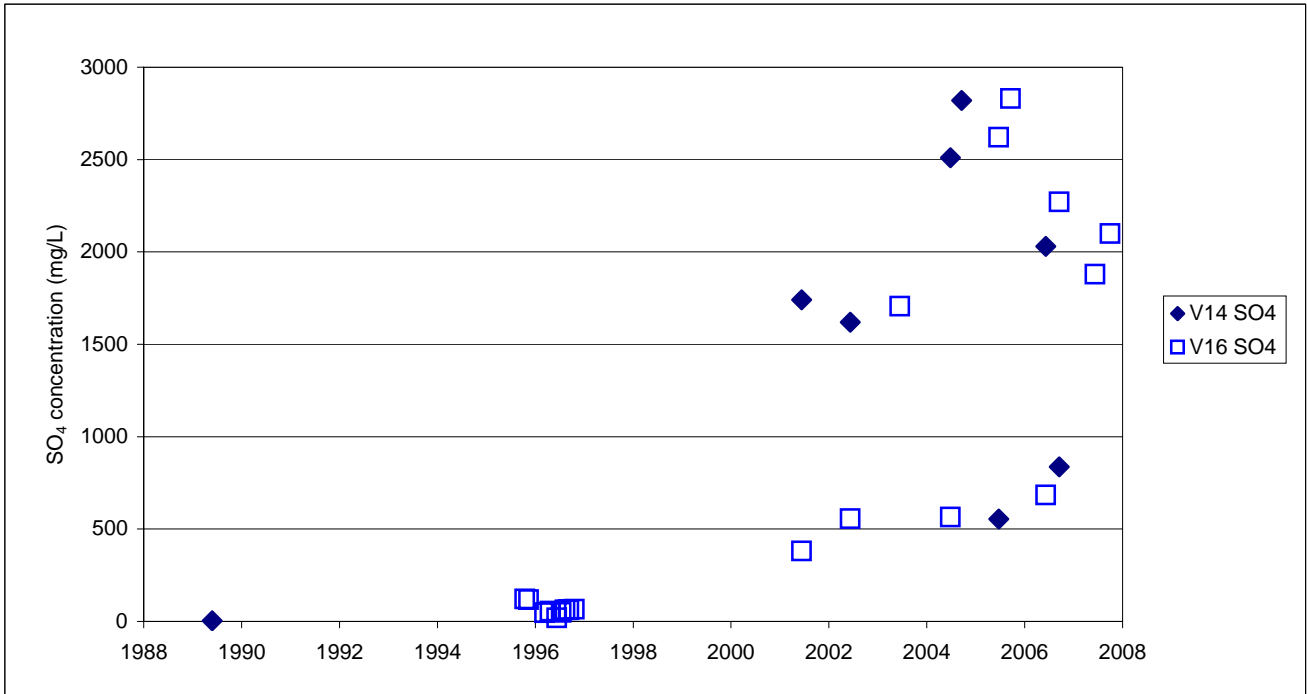
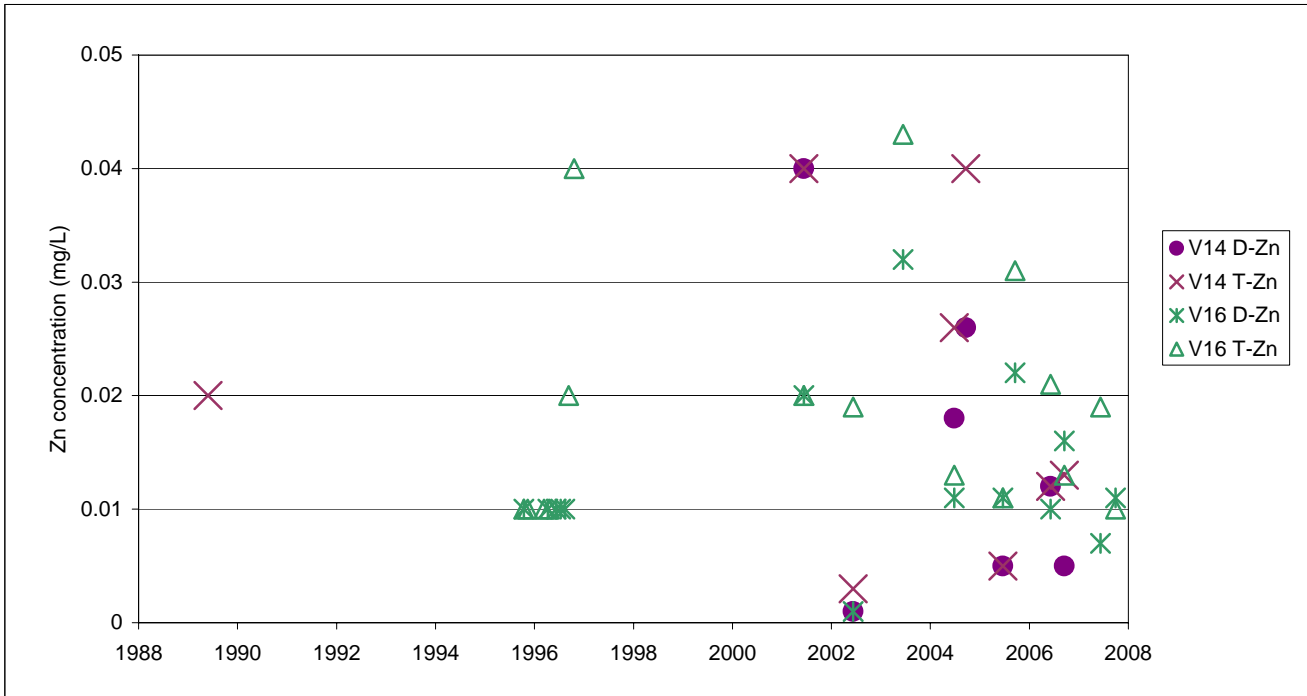
Figure:
3.4

Note: Dissolved zinc concentrations are plotted at the detection limit where values were reported as less than detection.

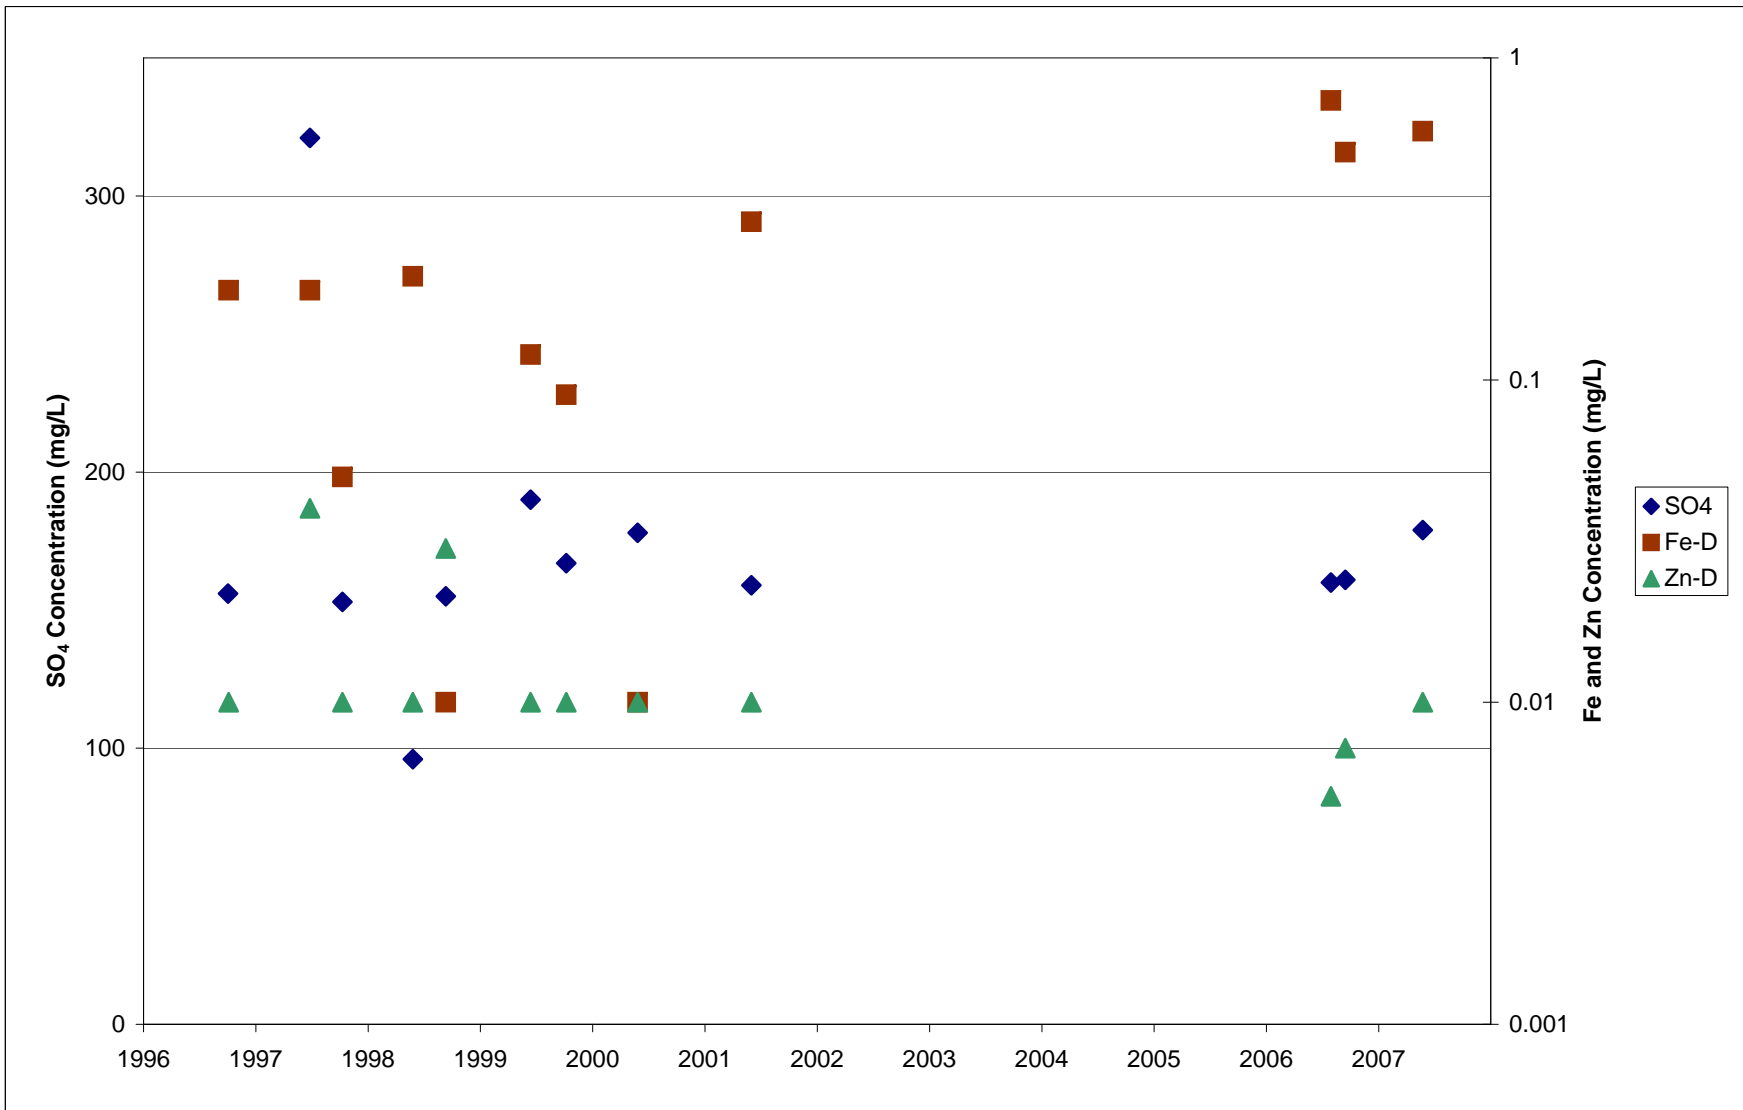
3.7

Note: Dissolved zinc concentrations are plotted at the detection limit where values were reported as less than detection.

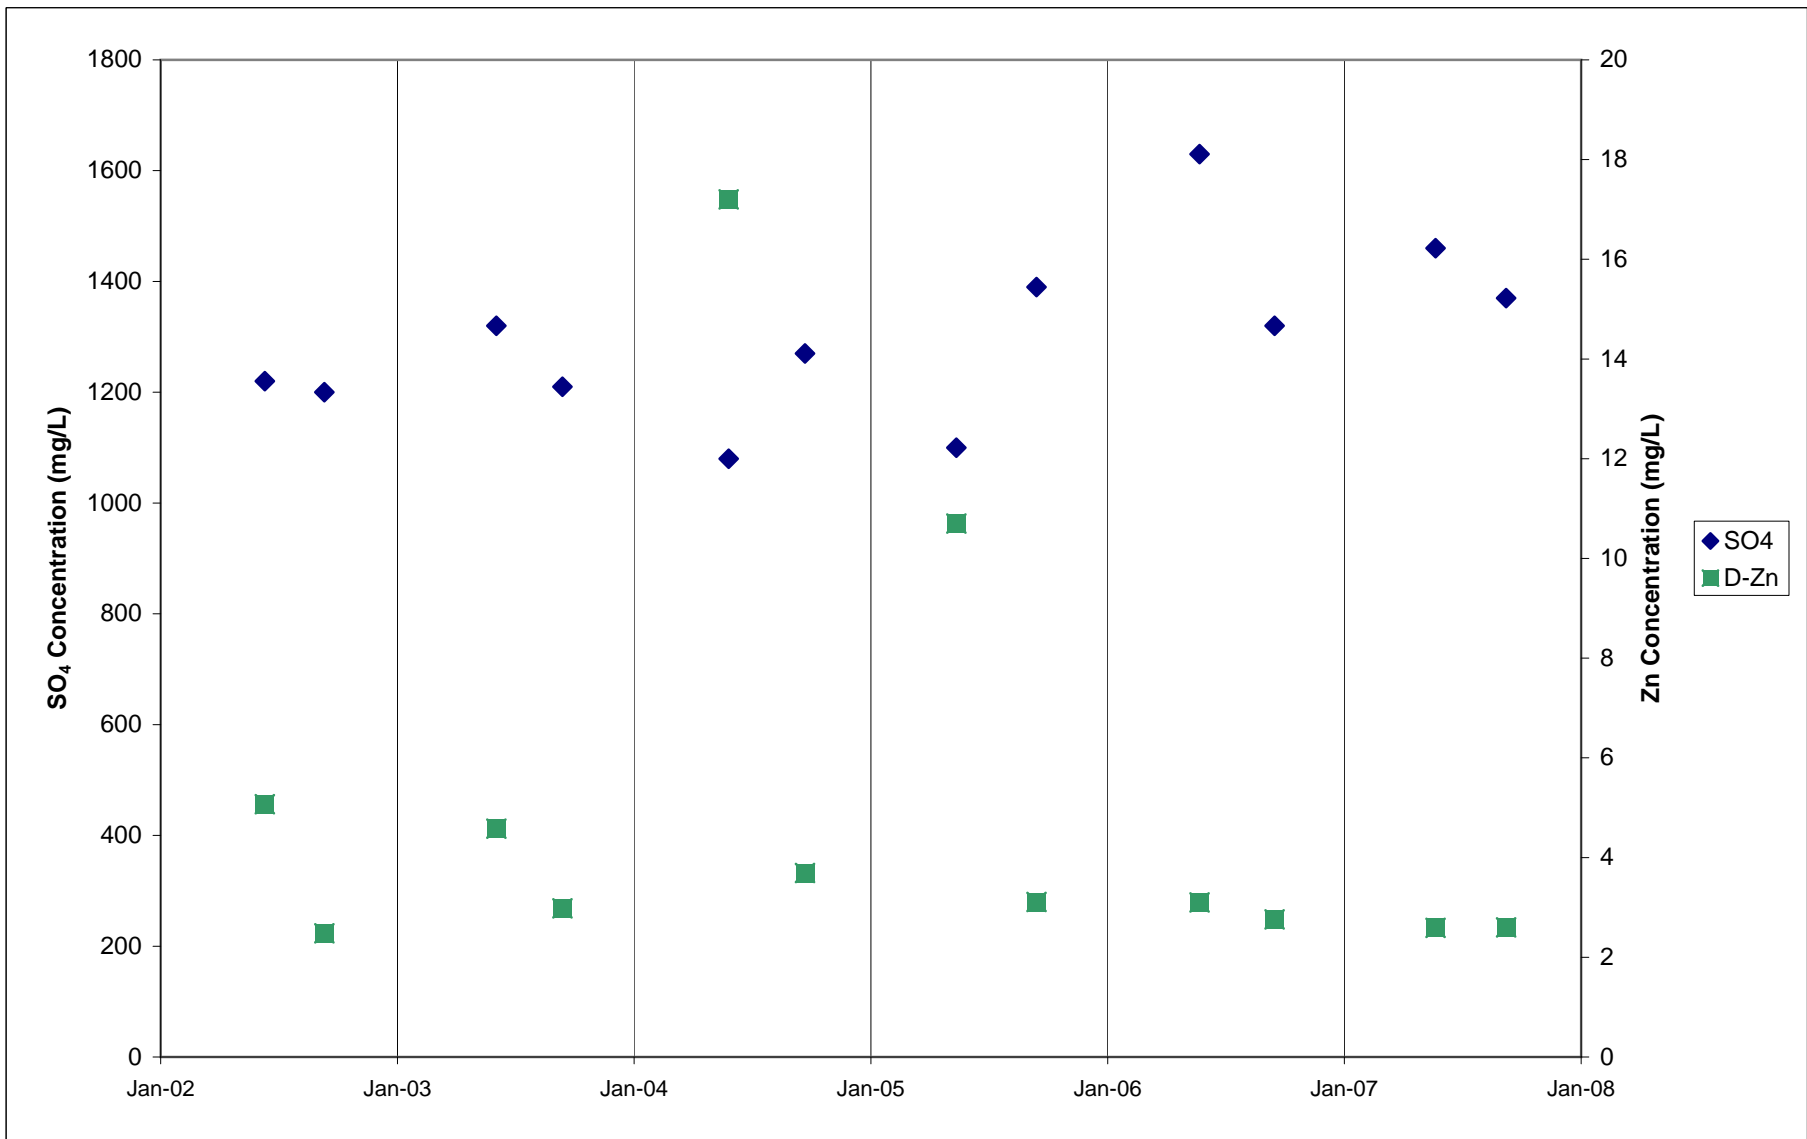
Figure:
3.8

**Zinc and Sulphate Concentrations
at SRK-GD01**

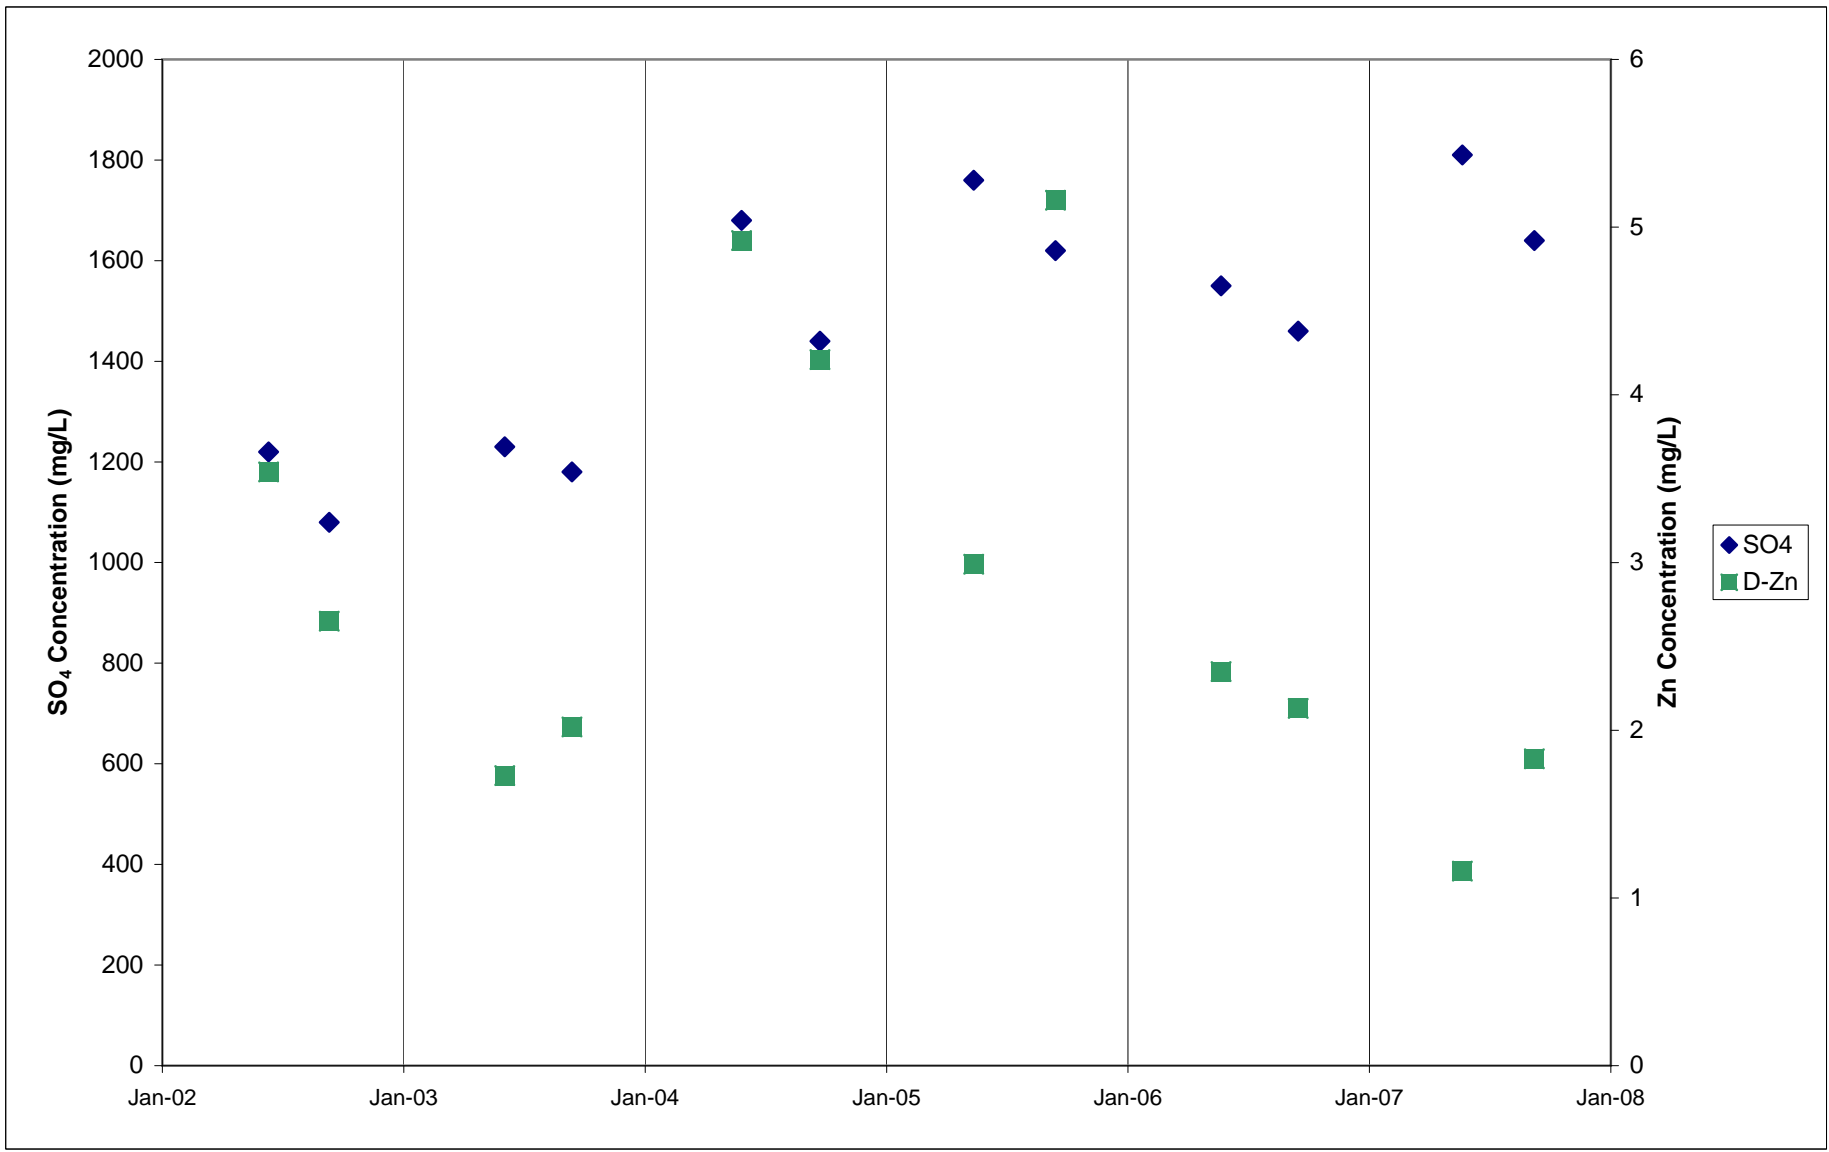
Figure:
3.9

**Zinc and Sulphate Concentrations
at SRK-GD05**

Flows at SRK-GD05 are low compared to flows in Grum Creek, but have been observed consistently during all sampling rounds. The seepage infiltrates into the ground within a few metres of the dump toe. However, emergent seepage is observed topographically downgradient in No Fork Creek at station GD05 d/s, with seepage volumes that exceed those observed at the toe on the basis of visual observation and crude field measurements. It is inferred that subsurface flow is more significant than surface flow at SRK-GD05, and that the No Fork Creek drainage is a preferred groundwater flowpath from Grum Dump to Vangorda Creek. Sampling results from No Fork Creek are discussed in Section 3.1.3 under station GD05 d/s.

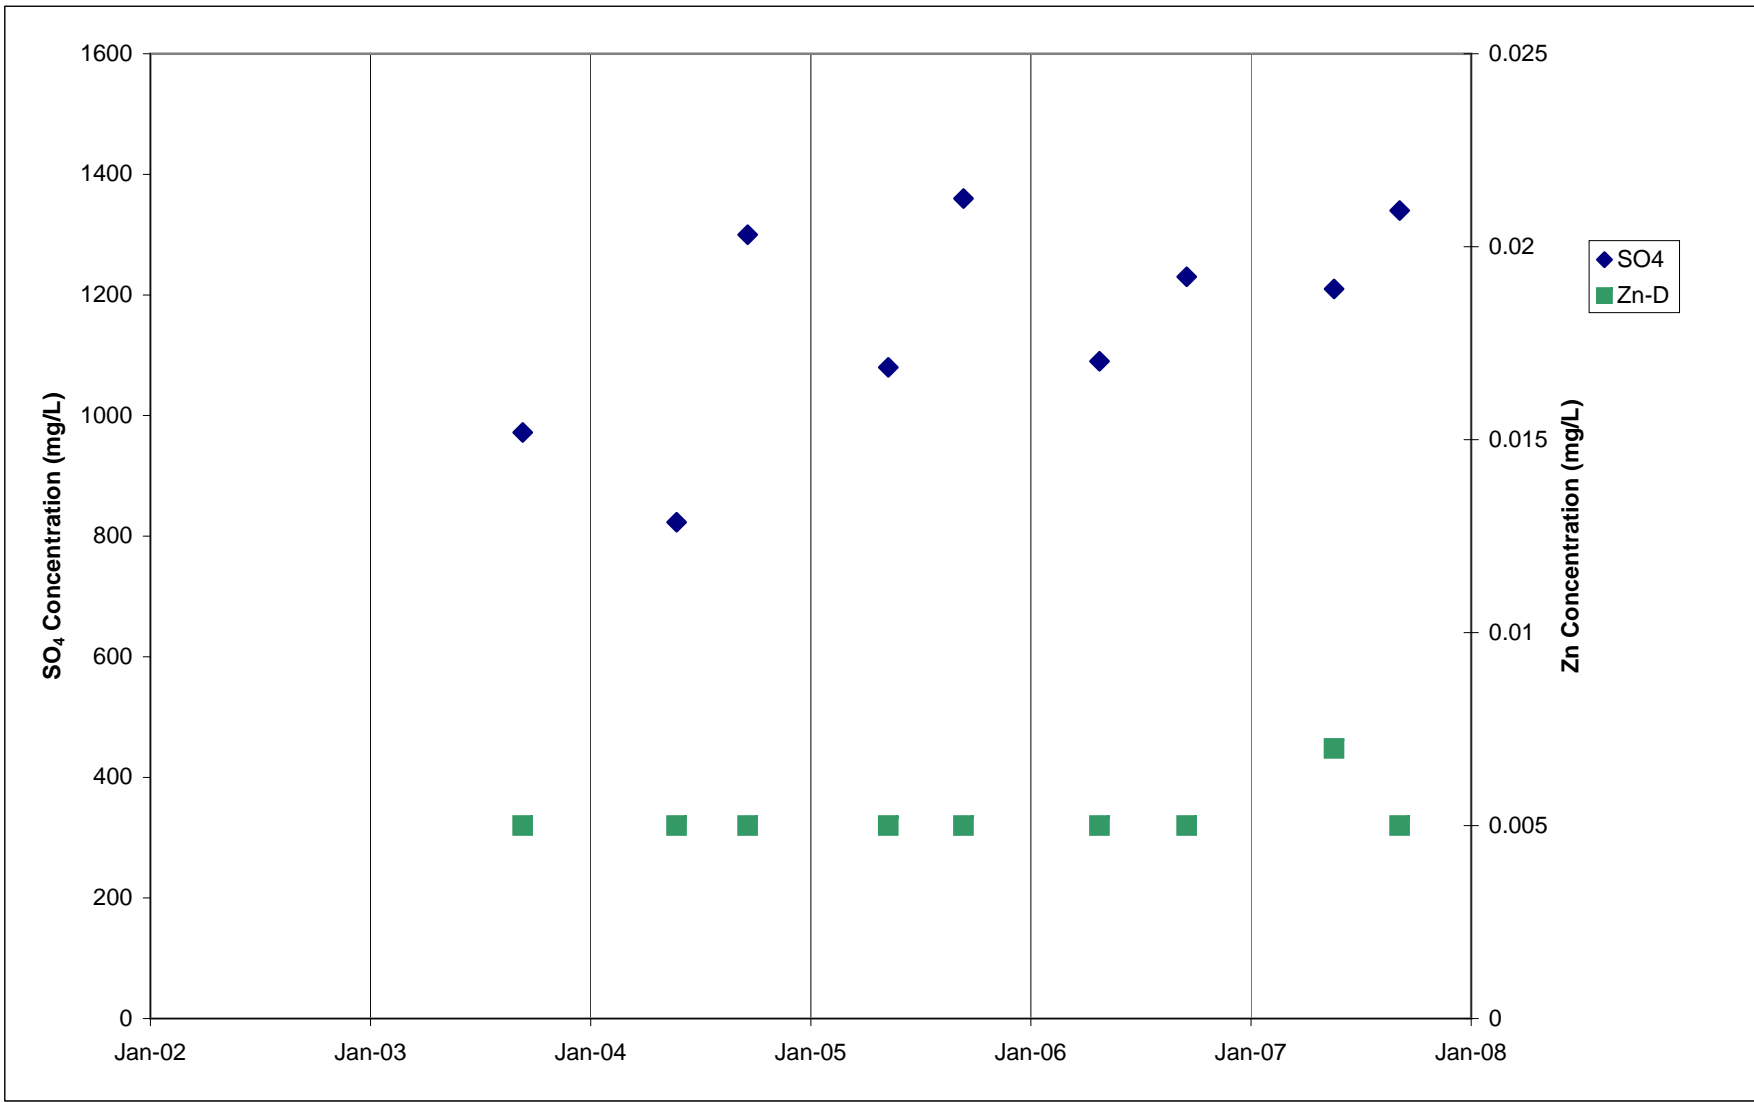
3.10

Note: Dissolved zinc concentrations are plotted at the detection limit where values were reported as less than detection.

Detection Limit = 0.005 mg/L Zn

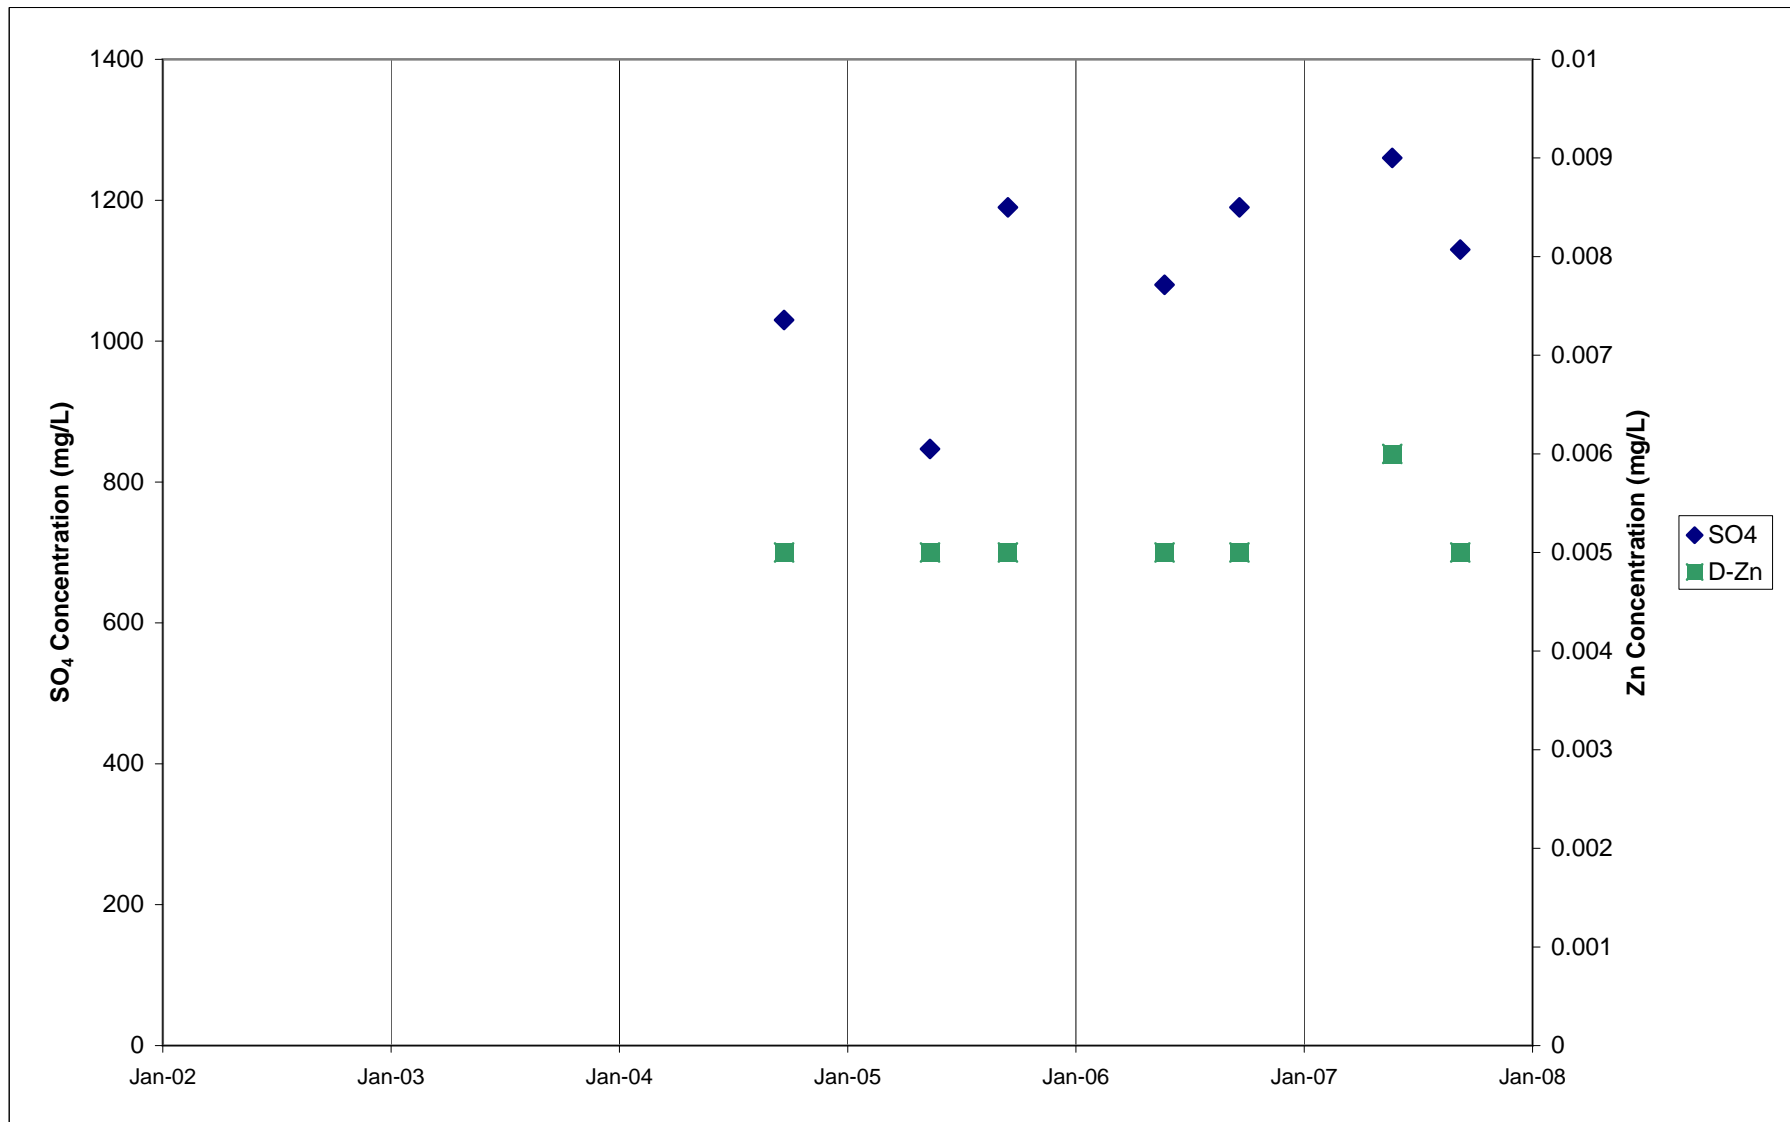
Figure:
3.11

Note: Dissolved zinc concentrations are plotted at the detection limit where values were reported as less than detection.

Detection Limit = 0.005 mg/L Zn
