AMP Event #4 Response: 2007 Status Report

Project Reference Number
SRK 1CD003.091

January 2008

SRK Consulting (Canada) Inc.

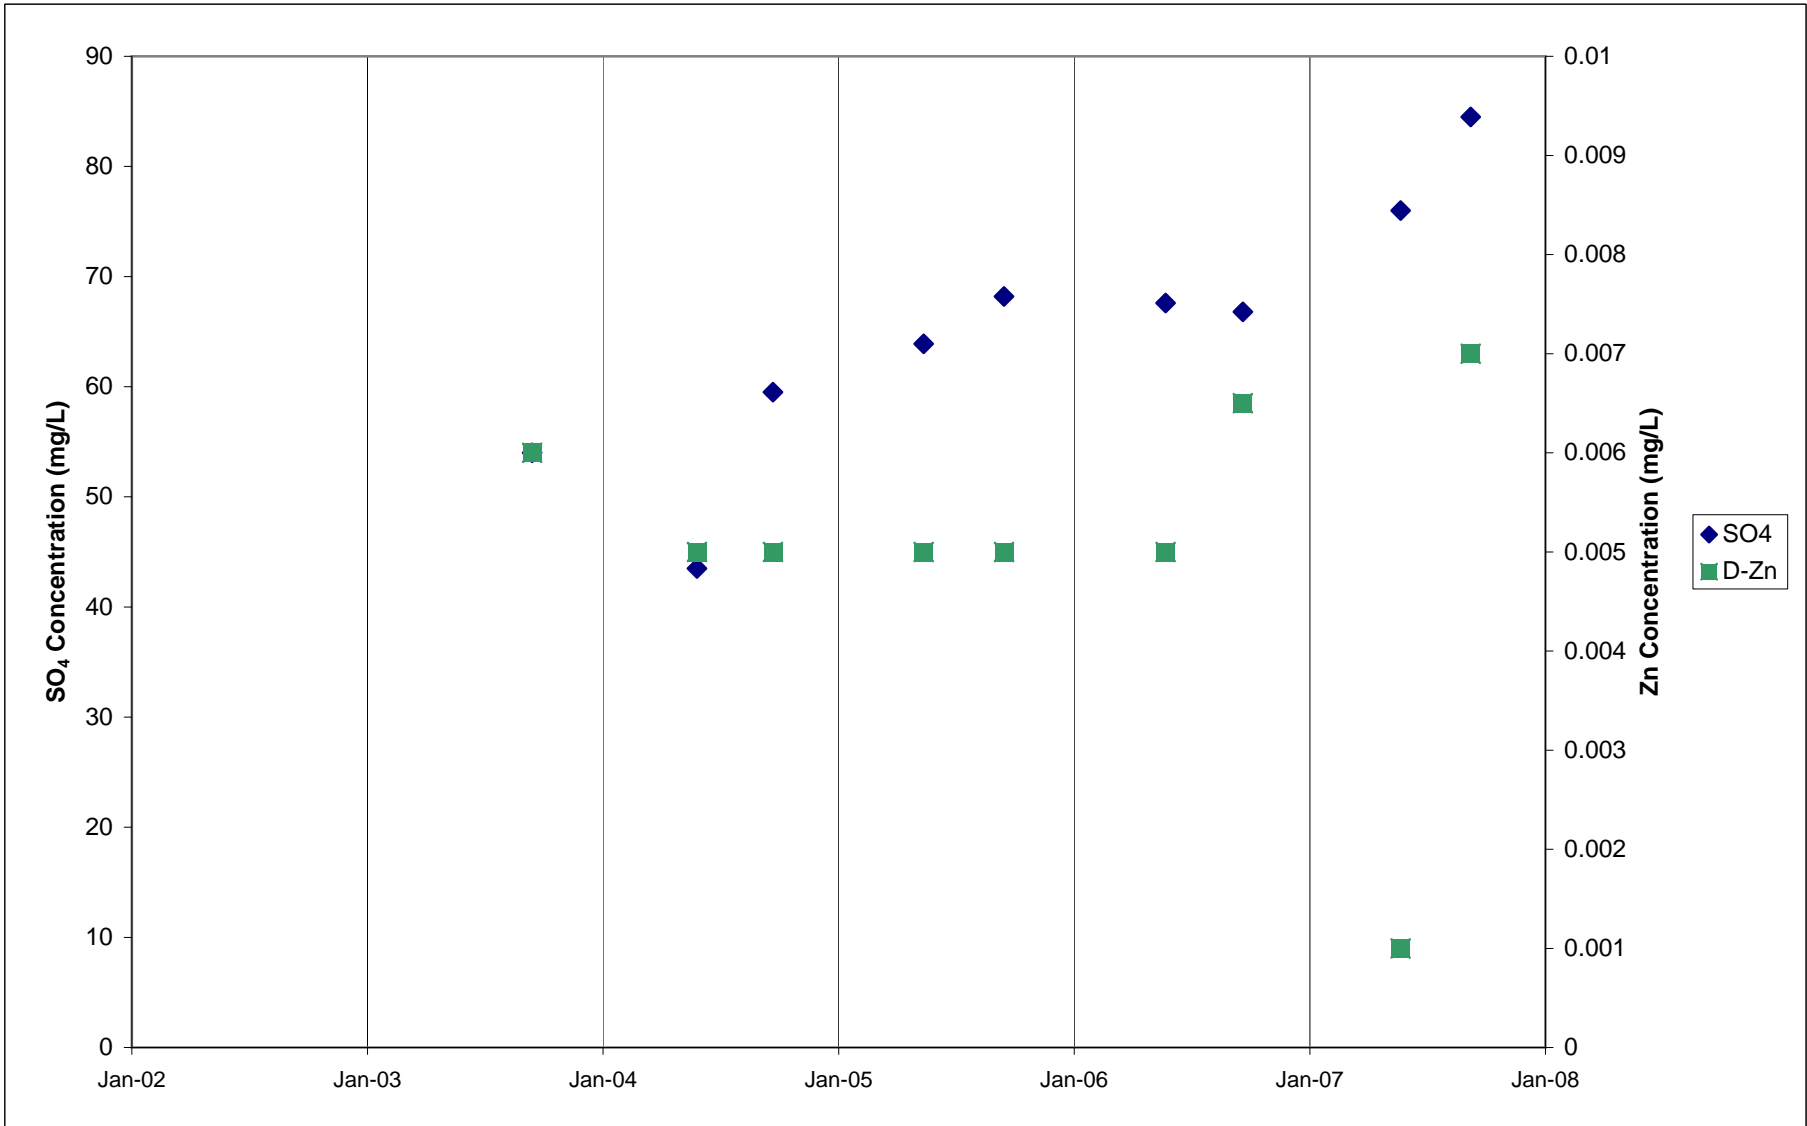
3.12

Note: Dissolved zinc concentrations are plotted at the detection limit where values were reported as less than detection.

Detection Limit = 0.005 mg/L Zn

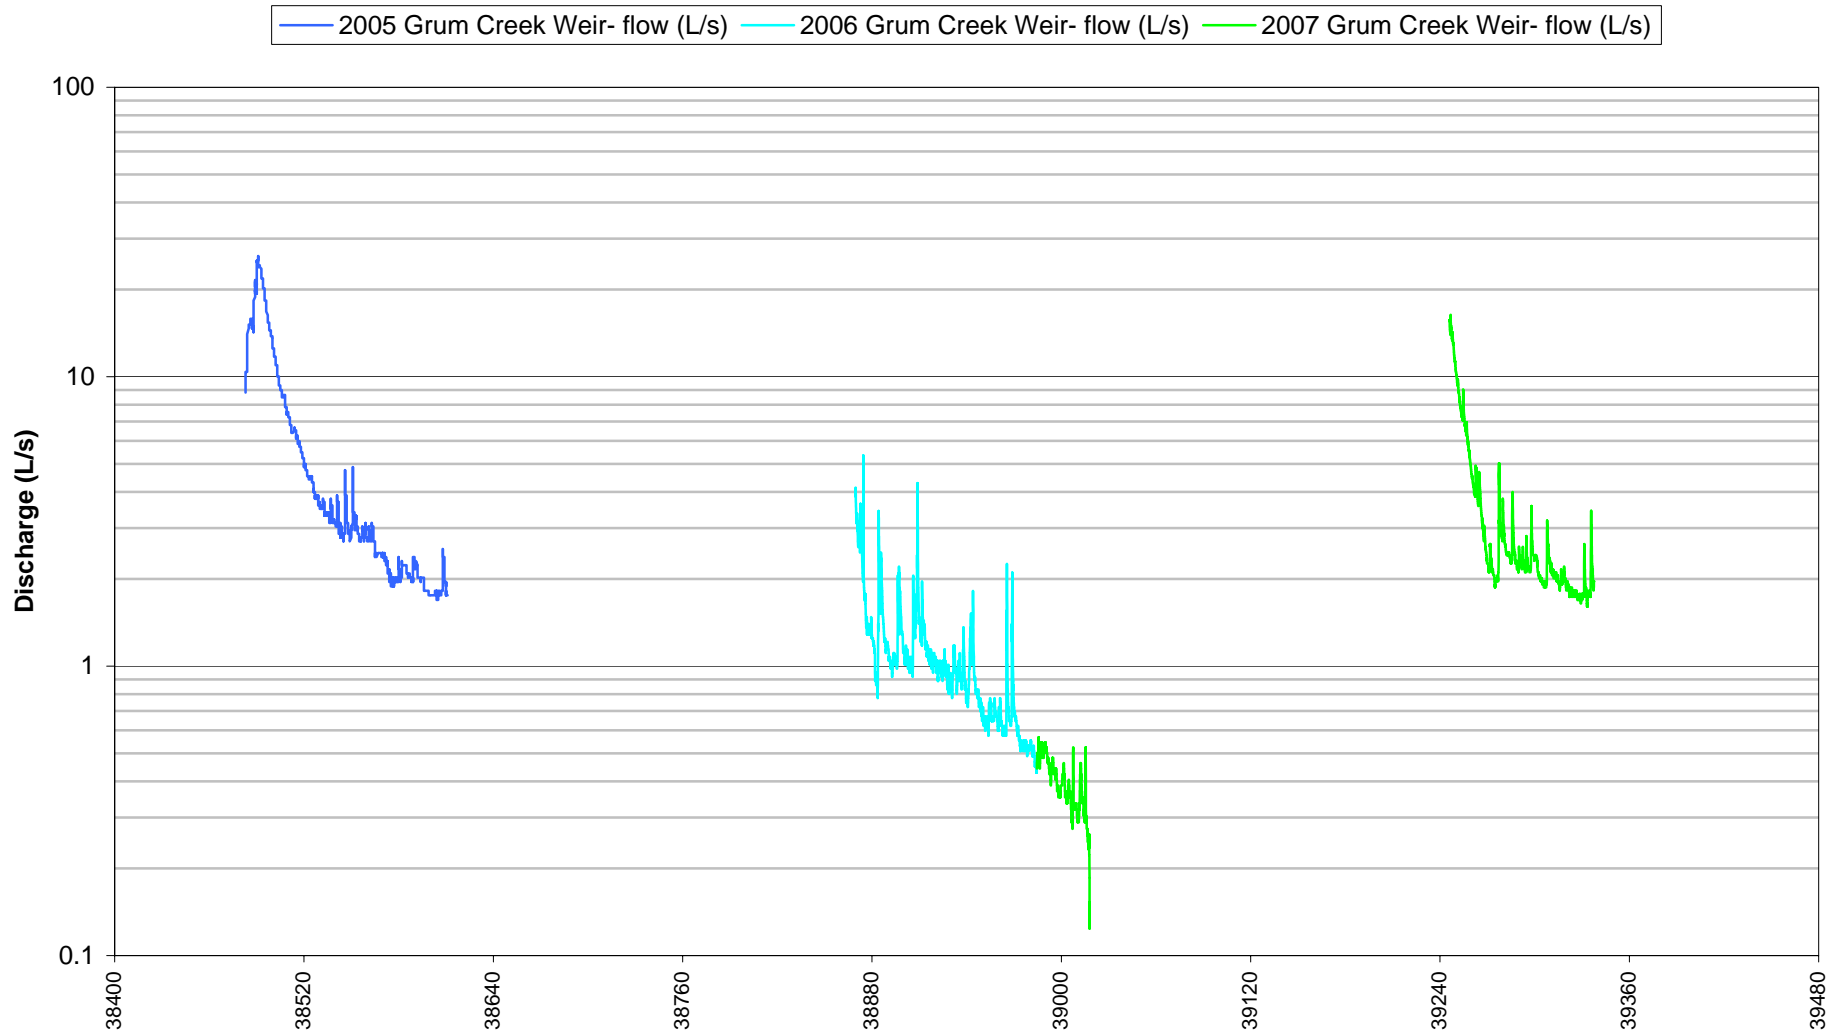
Grum Creek Discharge

**Grum Creek Weir
2005-2007 Flow Monitoring Results**

As mentioned previously, results of the 2007 flow monitoring at the Grum Creek weir were complicated by problems with the instrumentation and staff gauge over the winter months. Data from October 28, 2006 to June 12, 2007 were removed from the database due to erroneous pressure readings resulting from freezing conditions. Data from June 13, 2007 to September 12, 2007 was calibrated to match a spot flow measurement collected in September 2007.

Peak 2007 flows ranged from approximately 16 L/s during spring freshet to 3.3 L/s during the early fall, although it is noted that the true freshet peak may have been missed due to the problems with the instrumentation. Summer base flows in Grum Creek, for the period of August through September 2007, were around 2 L/s. This was similar to the results of the 2005 monitoring, and somewhat higher than results of the 2006 monitoring. At present, it is not clear whether the apparent differences in flow conditions between 2006 and 2007 are representative, or whether the differences are the result of systematic problems with the monitoring systems.

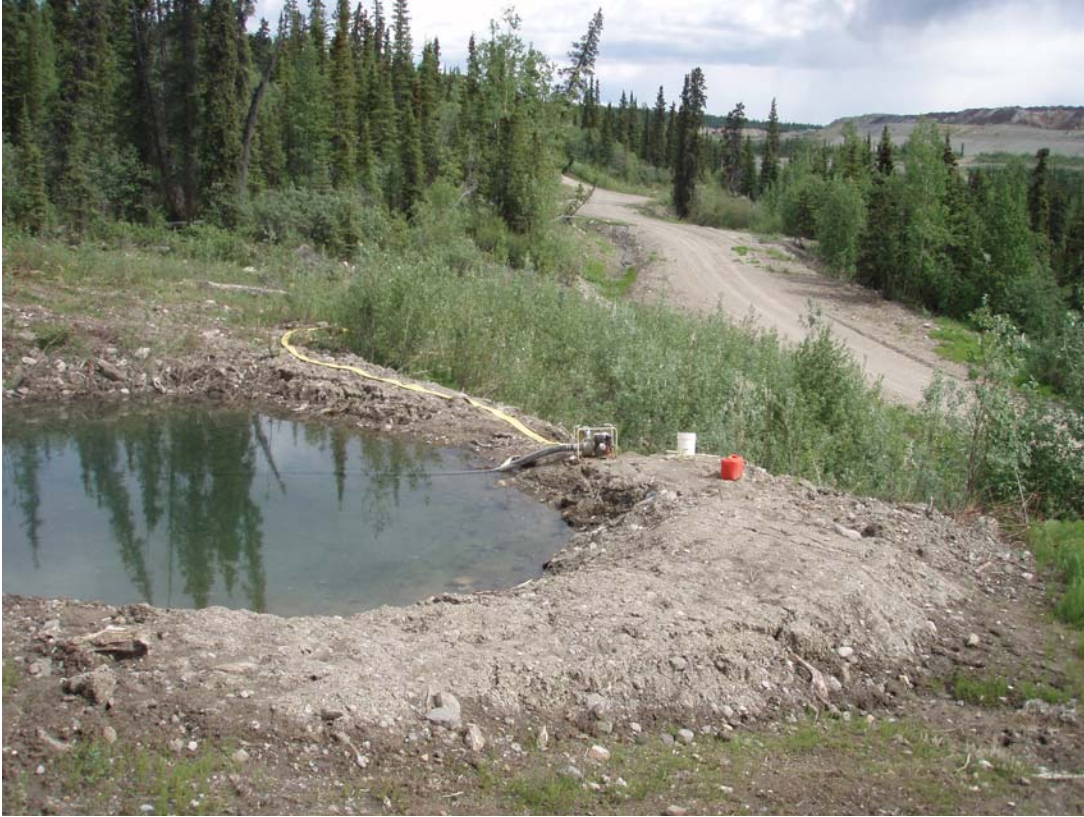
As shown on Photo 1, DT has built a soil berm around the southern perimeter of the pond to restrict outflow to V2. A small gas powered pump has been installed in the pond to periodically divert the seepage to V2A via the existing ditch below the V-Notch weir on Grum Creek (Photo 2). It was also noted that a small ditch located below the groundwater wells (SRK 04-5A/B and 05-5C) collects seepage from the catchment above the wells and directs the flow over to the existing Grum Creek ditch below the weir (Photo 3). A survey completed by DT on Wednesday June 20, 2007 confirmed that there is sufficient grade for the proposed ditch.

Photo 1: V-15 Sedimentation Pond looking east towards location of V-notch weir on Grum Creek.

The objective of the proposed ditch would be to divert any seepage that currently enters the existing sediment collection pond over to the existing ditch below the Grum Creek V-Notch weir. The ditch would be lined with a bentonite Geomembrane (GCL) to limit leakage and would have a trapezoidal configuration with sideslopes no steeper than 1.5:1 (H:V). The existing sediment collection pond would be retained to collect any sediment.

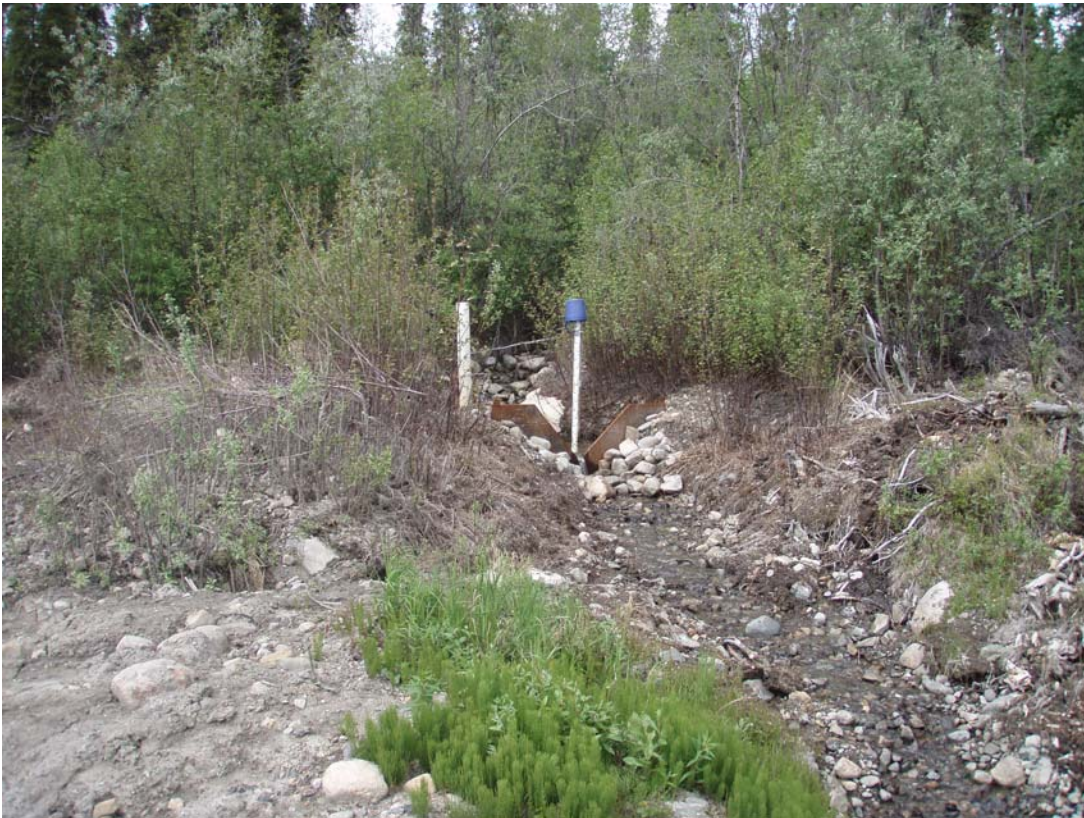
Photo 2: V-notch weir on Grum Creek.

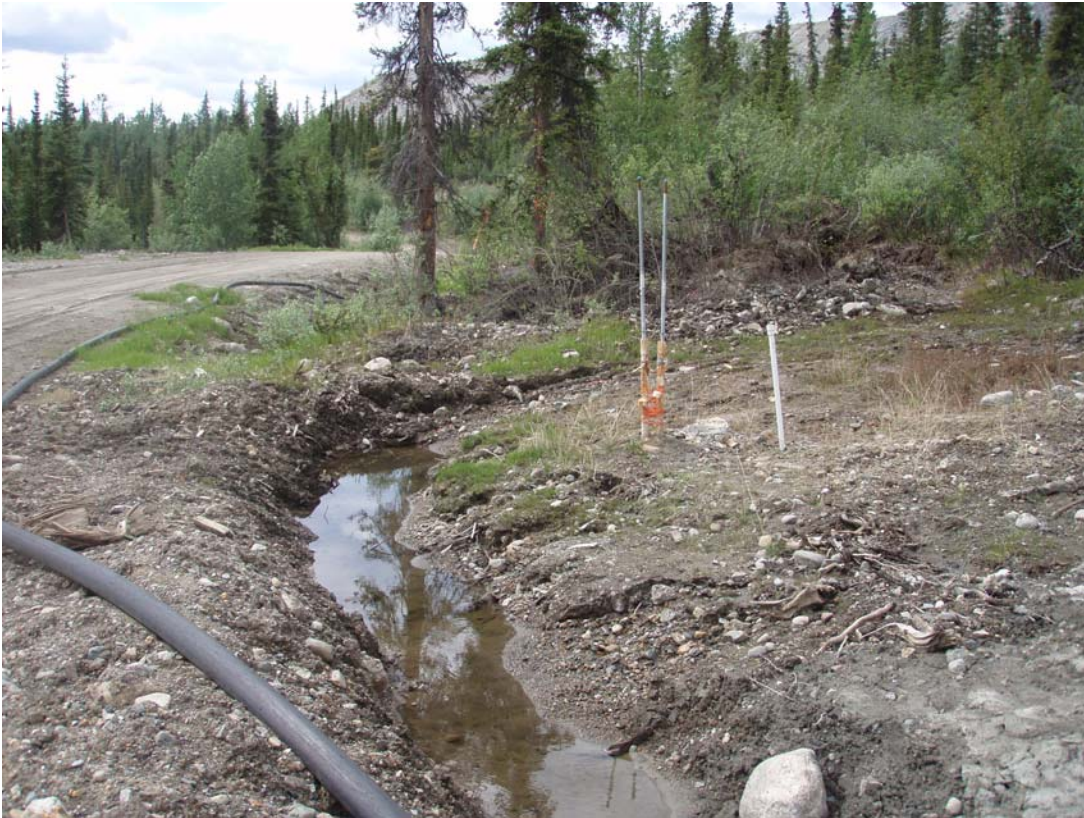
Photo 3: Seepage collection ditch below groundwater wells.

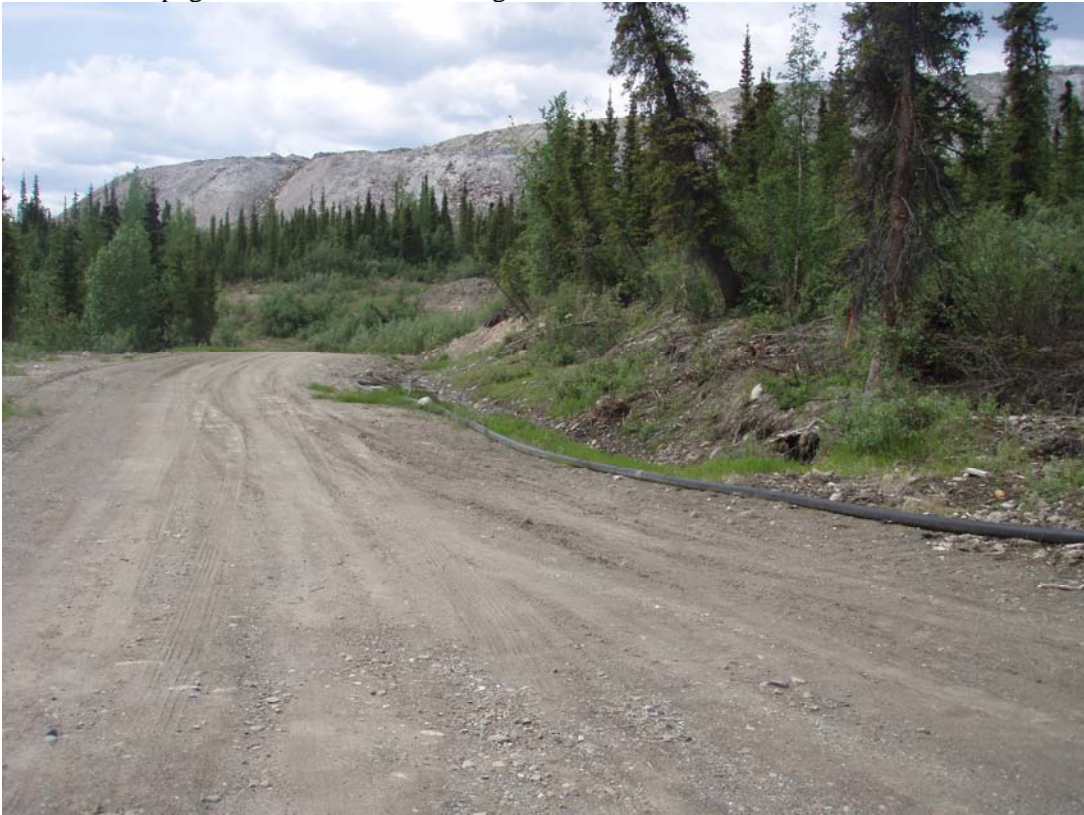
Photo 4: Bank along proposed ditch alignment.

Ground preparation for the ditch would involve clearing and grubbing the area along the proposed alignment shown on Figure 1. Earthworks would involve a cut and fill operation to provide a stable foundation for the ditch. The existing bank along the road would be moved out to establish a

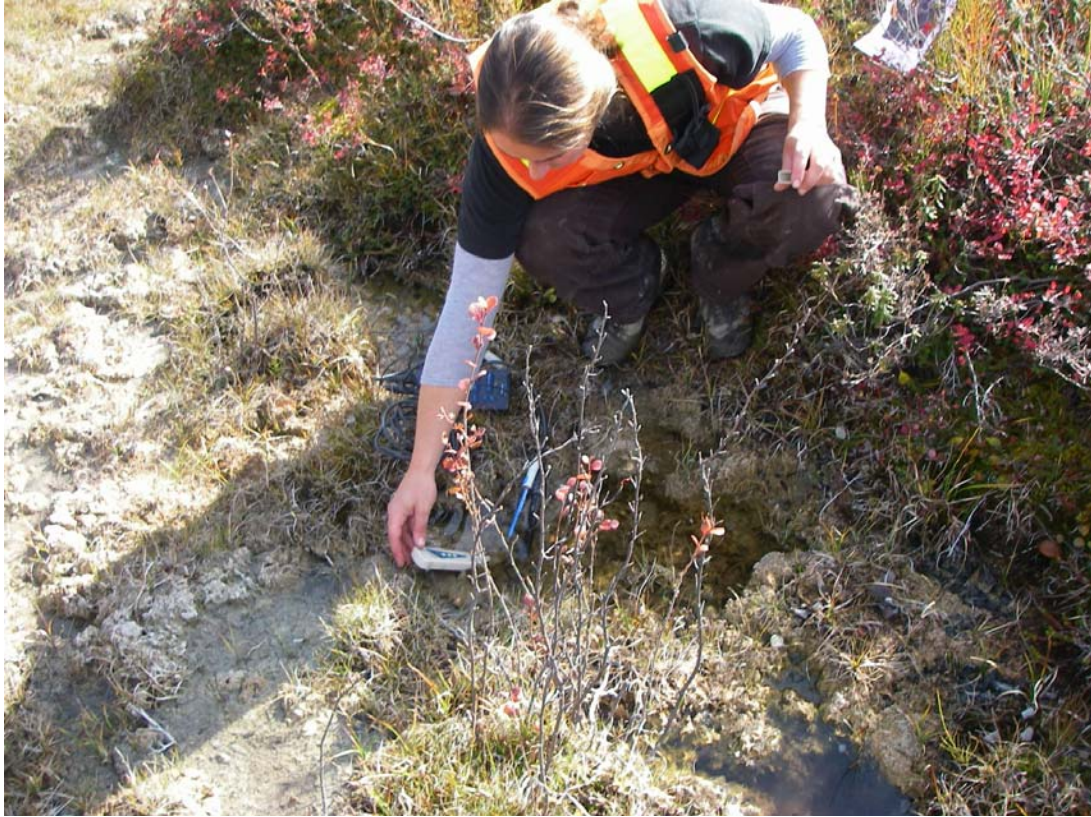
Photo C-1: pH monitoring during seep survey at Grum.

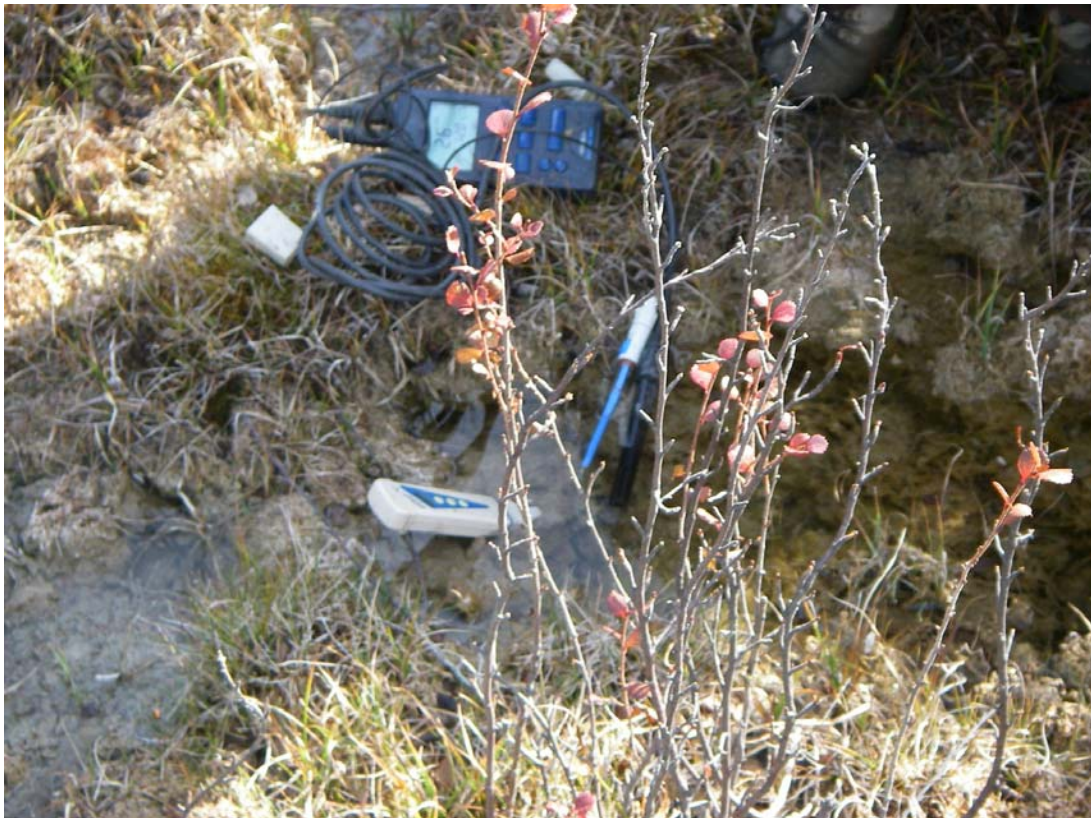
Photo C-2: Field pH, temperature, redox, conductivity and flow readings.

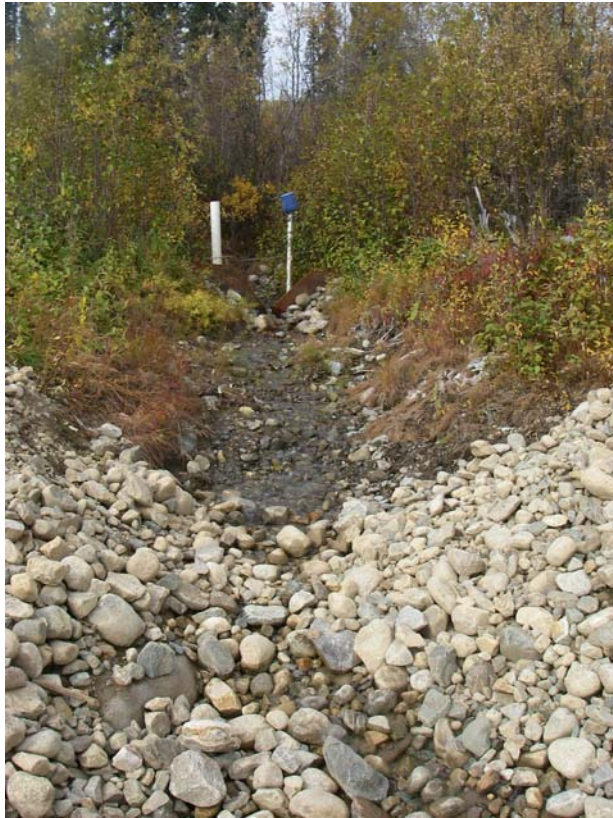
Photo C-3: View of Grum Creek below V-notch Weir.

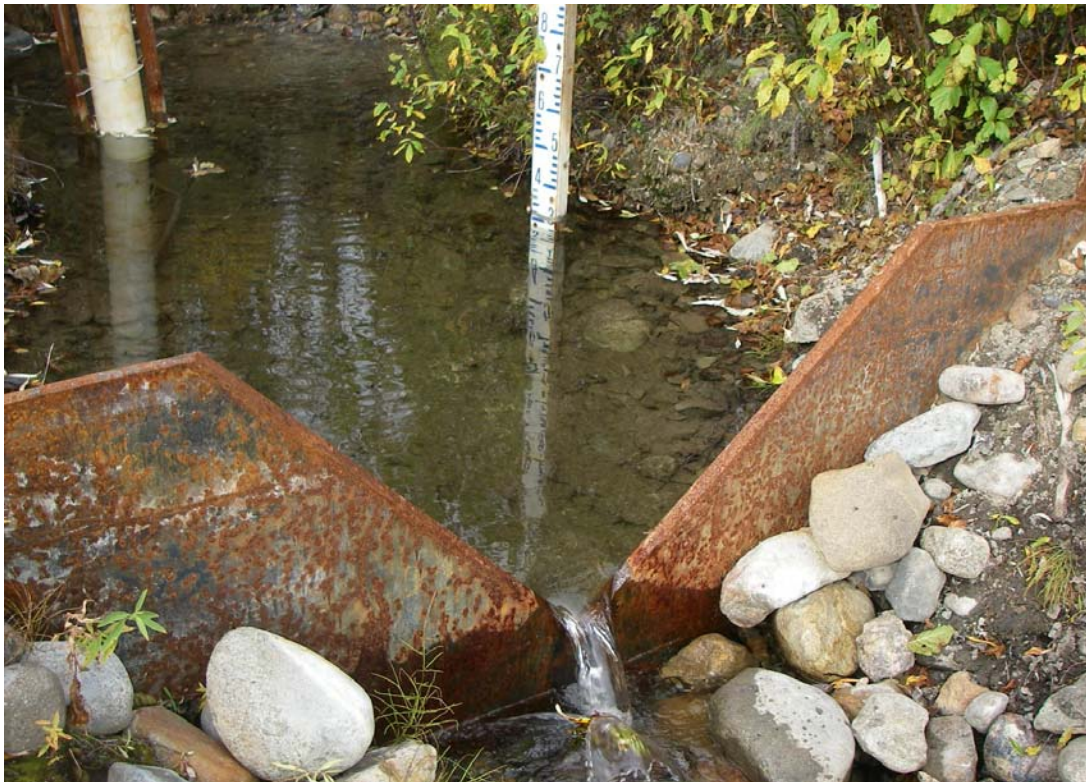
Photo C-4: V-notch weir and staff gauge on Grum Creek.

The data downloaded in 2007 indicated that freezing conditions had occurred around the sensor which resulted in erroneous pressure readings over the period October 27, 2006 to June 13, 2007. Once water temperatures rose above zero in mid June, 2007, readings returned to normal. However, it appeared that the snow pack had caused the transducer to shift vertically. The 2007 readings were then re-calibrated using water level and spot flow measurements collected in September 2007. The corrected results are presented and discussed in Section 3.2. In consultation with Deloitte and Touche Inc. (DTI), in 2008 SRK will undertake to reposition the sensor to minimize impact of the snow pack.

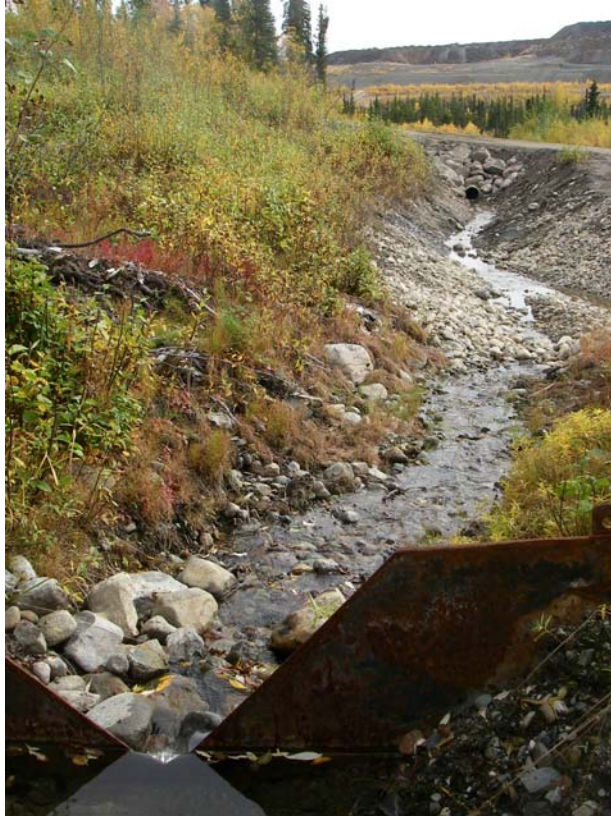
Photo C-5: View of Grum Creek below V-notch weir at confluence with diversion ditch from V-15.

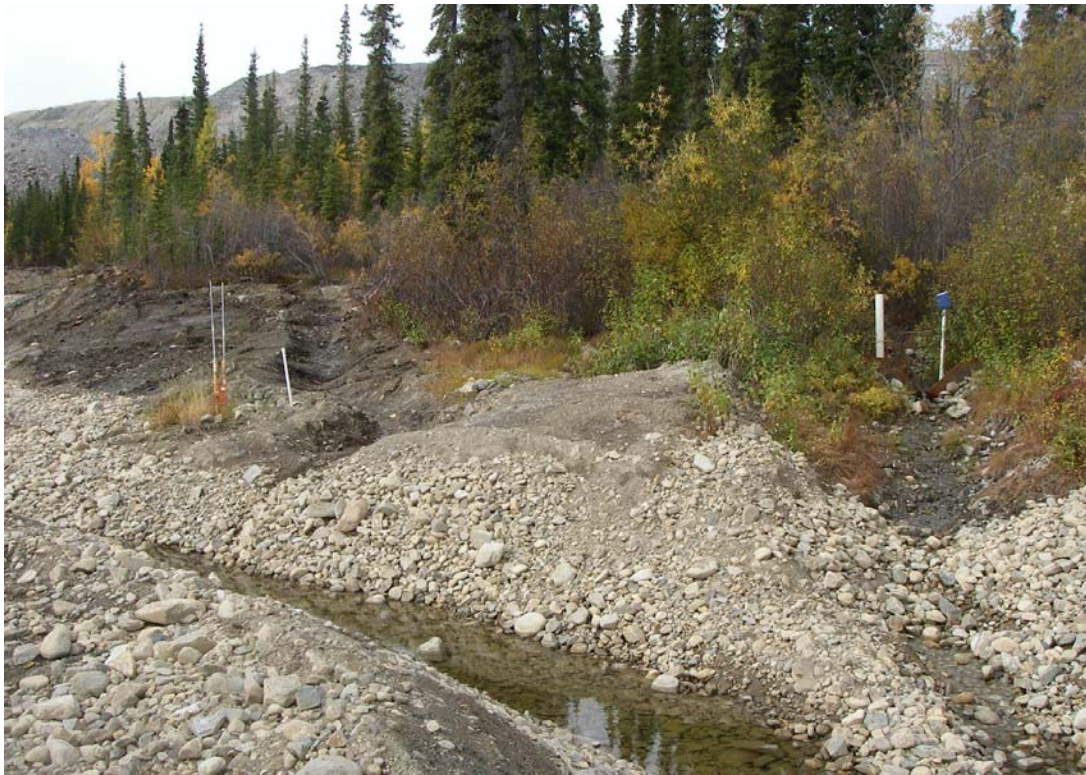
Photo C-6: Seepage flow in V-15 diversion ditch and confluence with Grum Creek.

This system was upgraded to a diversion ditch in August, 2007. A conceptual design for the diversion ditch is presented in Appendix B. Photos taken during the construction of the diversion ditches are presented in Appendix A of the 2007 Vangorda Geotechnical Inspection Report.
