# Faro Mine Complex Faro-Vangorda Haul Road Reclamation Cost Estimate

**2007/08 Task 20b - FINAL**

**Anvil Range Mining Complex  
Faro-Vangorda Haul Road  
Reclamation Cost Estimate**

**SRK Project Number 1CD003.100**

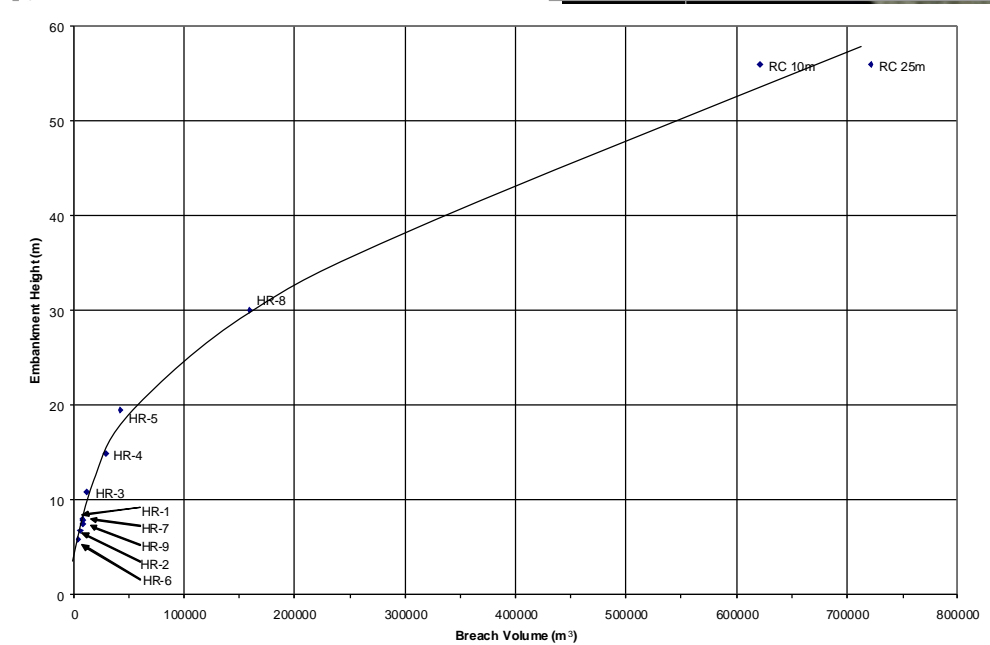
DRAWING NO.    SHEET    REVISION NO.  
Figure 1    -    A

Identifier	Embankment Height (m)	Breach Volume (m <sup>3</sup> )	Culvert (yes or no)	Creek (perennial or ephemeral)	Other Remarks
RC 10m	56.0	620,803	N	P	Rose Creek Rock Drain assume 10m width at base of excavation
RC 25m	56.0	721,576	N	P	Rose Creek Rock Drain assume 25m width at base of excavation
HR-8	30.0	159,653	N	P	Water partially pooled on u/s side of road, large flow from d/s side
HR-1	8.0	7,871	Y	E	No evidence of culvert on d/s side (buried?); culvert bent and flattened on u/s side
HR-2	6.7	6,449	Y	P	2 culverts; flow through 1 culvert only. Doesn't appear as though all of the water is flowing through the culvert on the u/s side.
HR-9	7.5	8,755	N	?	Not observed in field.
HR-3	10.8	12,582	Y	P	2 culverts; flow through 1 culvert only.
HR-4	14.9	28,688	Y	P	2 culverts; flow through only 1 culvert only.
HR-5	19.5	42,917	Y	P	Long till cover over culvert on d/s side; rock-lined trench built up to culvert on u/s side

HR-6	5.8	4,189	?	E	No evidence of culvert. Ponded area on u/s side of road; trickling flow seeping from toe of haul road on d/s side.
HR-7	7.9	8,543	Y	P	Culvert partially buried on u/s side of road.

DRAWING TITLE:  
Plan View of Haul Road and Potential Breach Locations

Figure 1 shows the locations of these ten drainages in plan view. Their locations relative to the Rose Creek rock drain, assuming the rock drain corresponds to kilometre 0, are also provided on the plan. Appendix A contains photos from nine of the ten drainages (there are no photos for HR-9). A table showing the embankment height, excavation or breach volume (calculated using GEMCOM software on the basis of certain excavation criteria) and information on the stream at each drainage location, is provided in the top right corner of Figure 1. For the RC drainage, two excavation options were assessed: one with a 10 m wide base and the other with a 25 m wide base. It is assumed that the 25 m wide base is most appropriate relative to pre-mining conditions but a 10 m wide base could be acceptable, subject to input on issues such as fisheries and peak flows in the north fork of Rose Creek.

Table 2.1 demonstrates that most of the fill excavation that would be required is associated with the RC and HR-8 drainages. In fact, based on a 25 m basal excavation width at the RC drainage, approximately 880,000 m<sup>3</sup>, or 88% of the total volume of potentially excavated material in the ten drainages (1,001,000 m<sup>3</sup>) are linked to the RC and HR-8 drainages. This information is illustrated graphically in the lower left corner of Figure 1.

- The graph on Figure 1 indicates that suggests that correlation between the height of the waste rock embankment and the embankment volume is approximately linear below an embankment height of 20 m. This is shown more clearly on Figure 5. The trend line curves to account for areas where the embankment height is greater than 20 m (RC and HR-8), as shown on Figure 1.

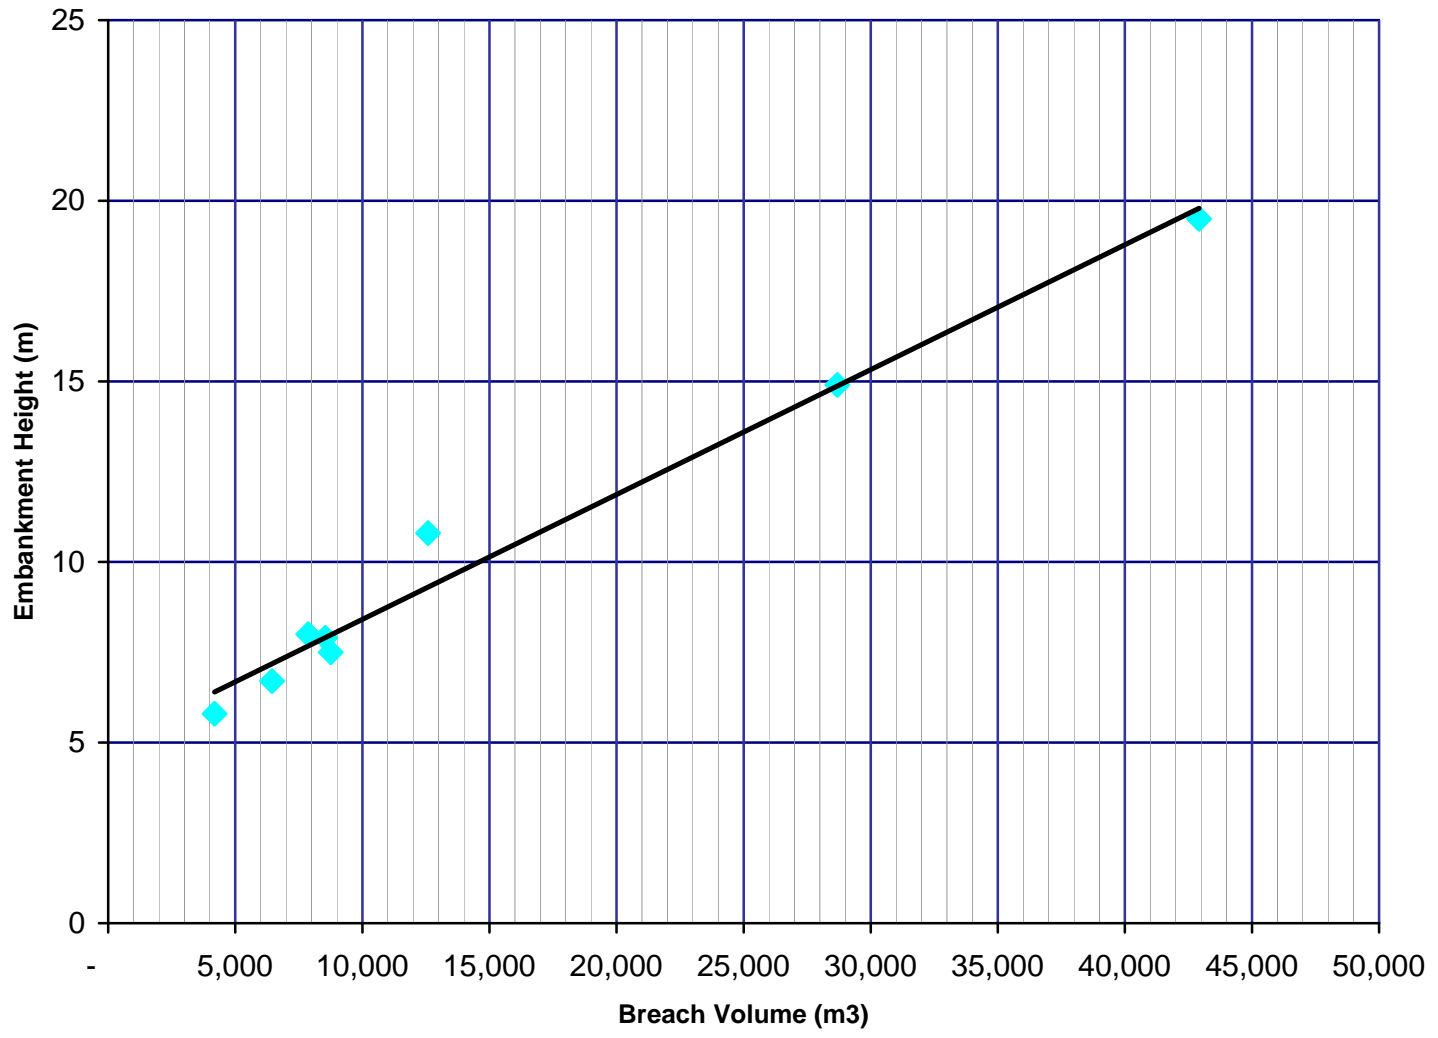
Date: May 2008	Approved: CCS	Figure: <b>5</b>
-------------------	------------------	---------------------

**Relationship between Embankment Height and Breach Volume**

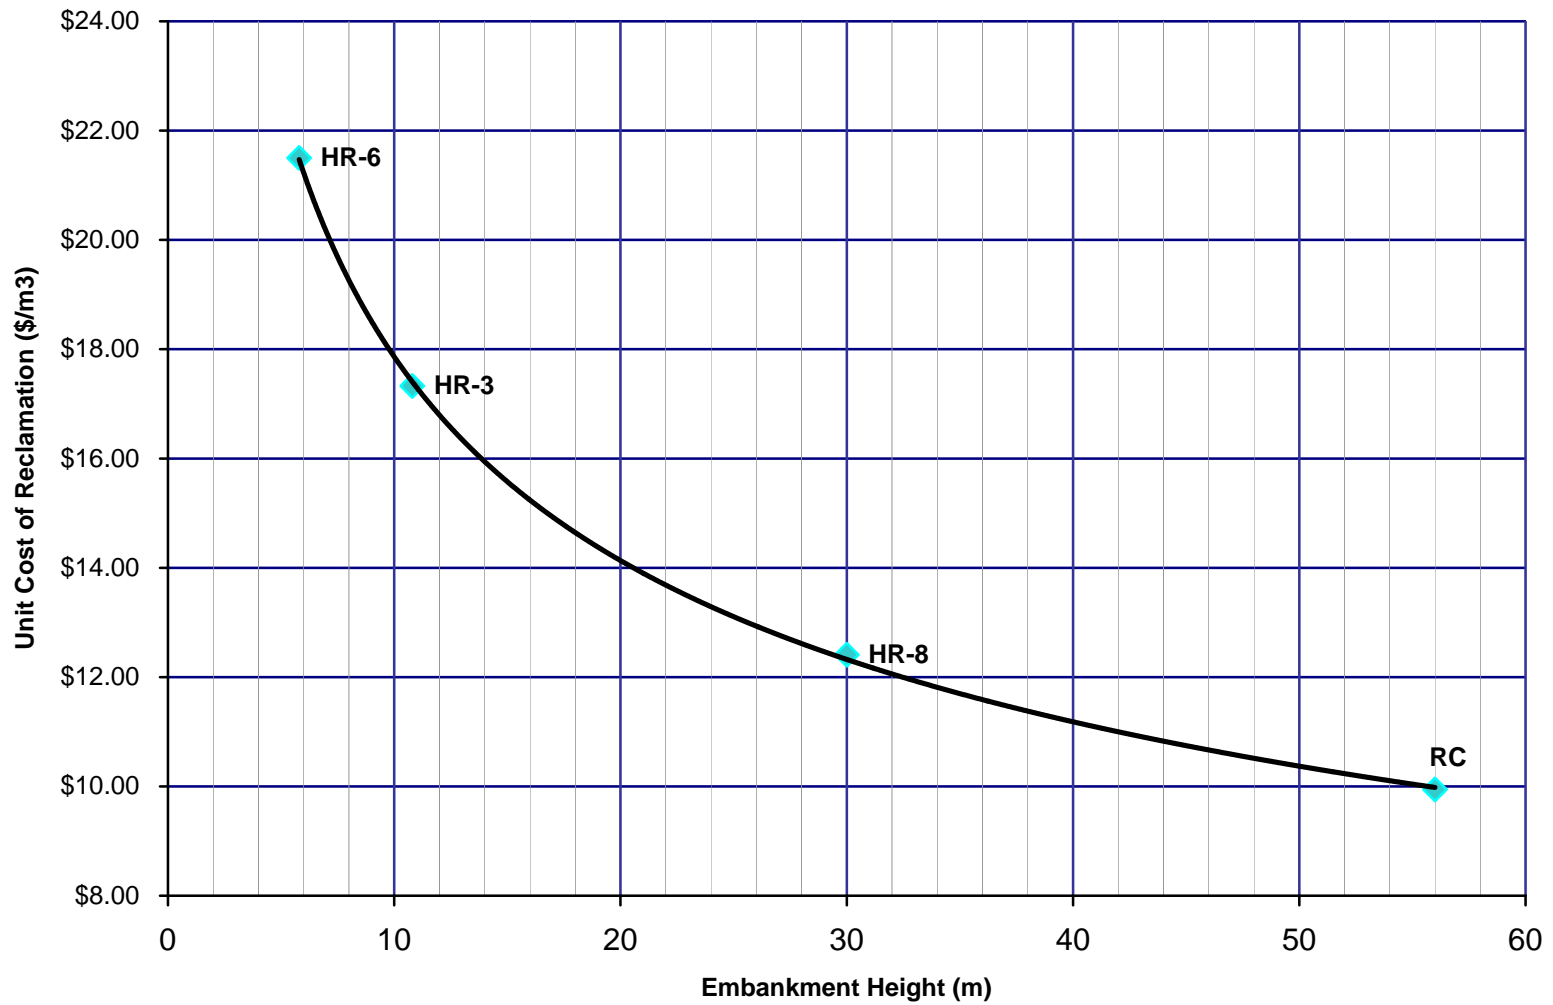
Figure: **6**

**Relationship between Unit Cost of Reclamation and Embankment Height**

- Figure 6 shows the correlation between unit cost of reclamation (which is primarily the cost of deconstruction, and has been calculated by dividing the reclamation cost by the embankment volume at drainages RC, HR-8 and HR-3) and the embankment height. The relationship follows a “power series” trend line and, as one would expect, the unit cost for reclamation is less at locations where the embankment is higher, primarily due to the efficiencies of handling larger volumes of material. The data point at a height of 5.8 m in Figure 6 corresponds to HR-6, the cost of which was selected to provide an optimum fit to the “power series” trend line defined by RC, HR-8 and HR-3. Therefore, this data point is actually an extrapolation and the unit cost, shown as \$21.50 on Figure 6, could conceivably be lower by \$2 or \$3. However, as discussed below, the impact of breaching the embankment where the embankment height is less than 20 m is relatively modest due to the correspondingly small embankment volumes.

The curve in Figure 6 has been used to provide an estimate of the unit costs of reclamation as a function of embankment height. The unit reclamation costs for HR-1, HR-2, HR-7 and HR-9 have been interpolated between the selected unit cost for HR-6 and the calculated unit cost for HR-3. Similarly, the unit reclamation costs for HR-4 and HR-5 have been interpolated between the unit costs for HR-3 and HR-8. The selected values have then been multiplied by the embankment volume at the respective drainage (Table 2.1) to obtain an estimate of the total reclamation cost at each drainage. The results are summarized in Table 5.1.

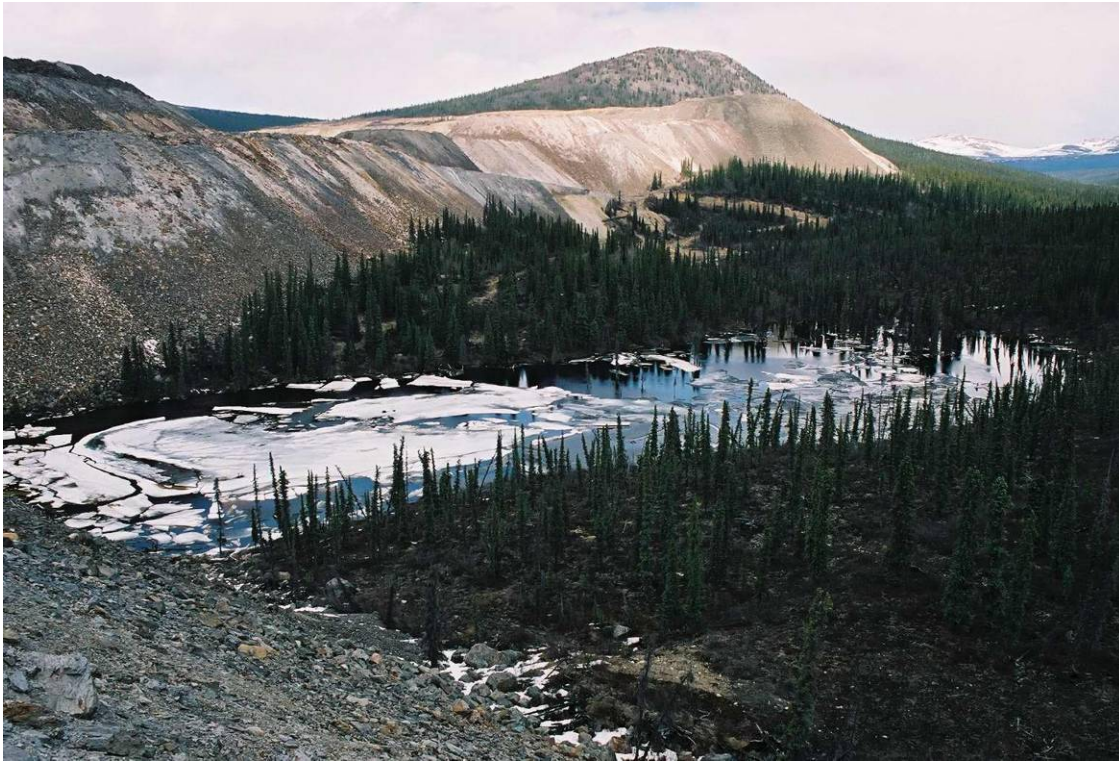
Photo 1: RC drainage, showing water ponded upstream of the Rock Drain (May 24, 2004).

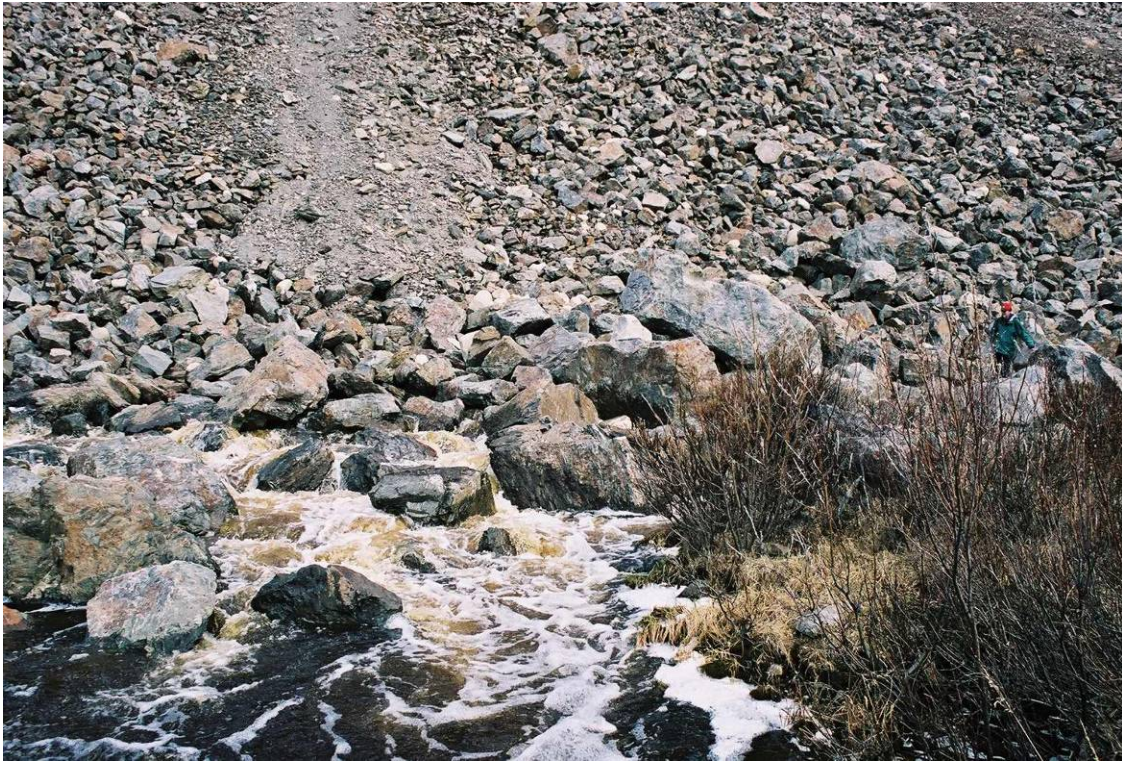
Photo 3: RC drainage showing water discharging from the Rock Drain (May 24, 2004).

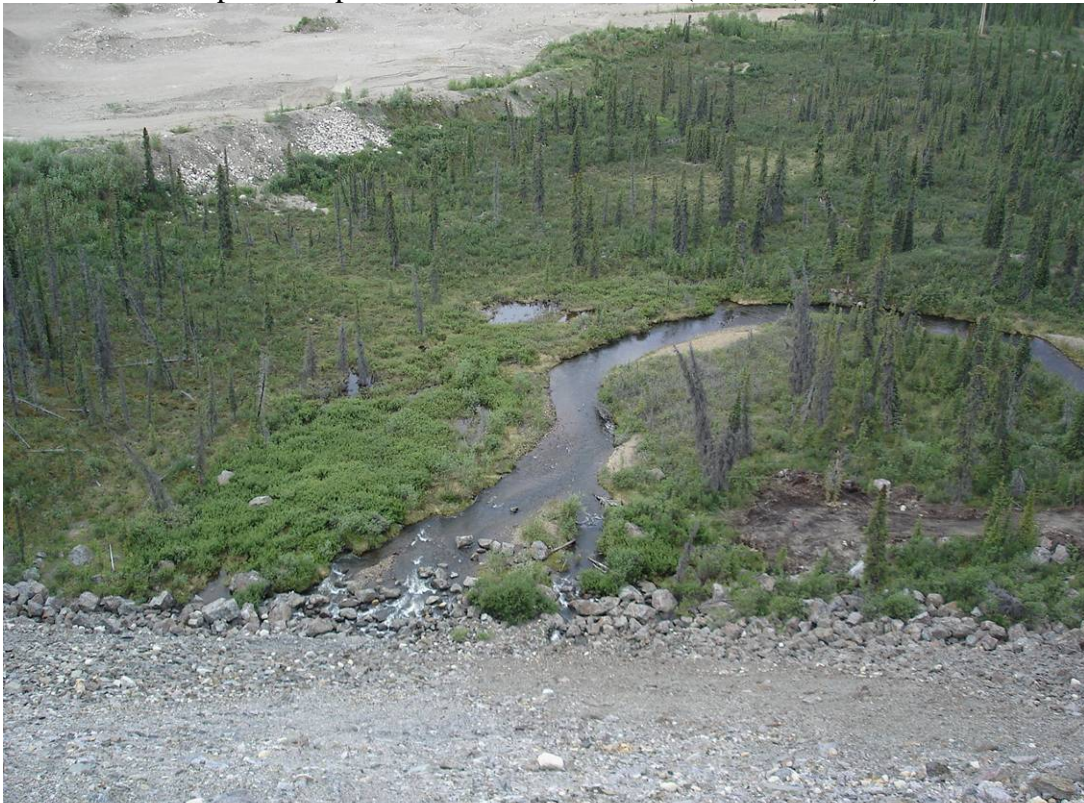
Photo 6: RC drainage showing water discharging from the Rock Drain (June 22, 2006).

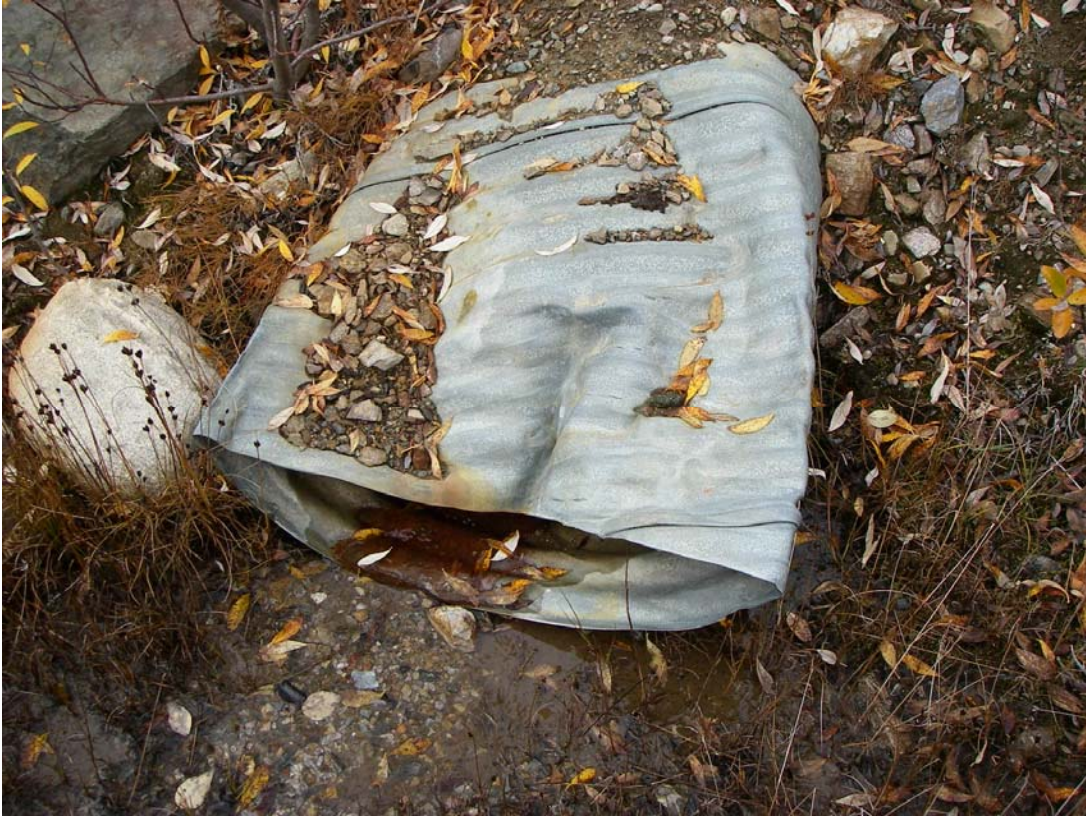
Photo 9: Corrugated pipe at the inlet of HR-1 (Sept. 16, 2007).

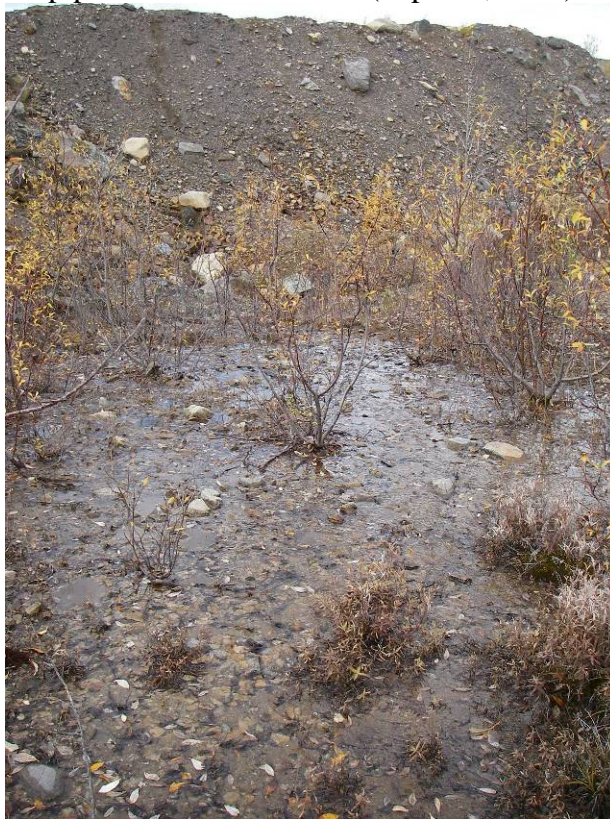
Photo 10: Diffuse drainage at downstream toe area of HR-1 (July 7, 2008).

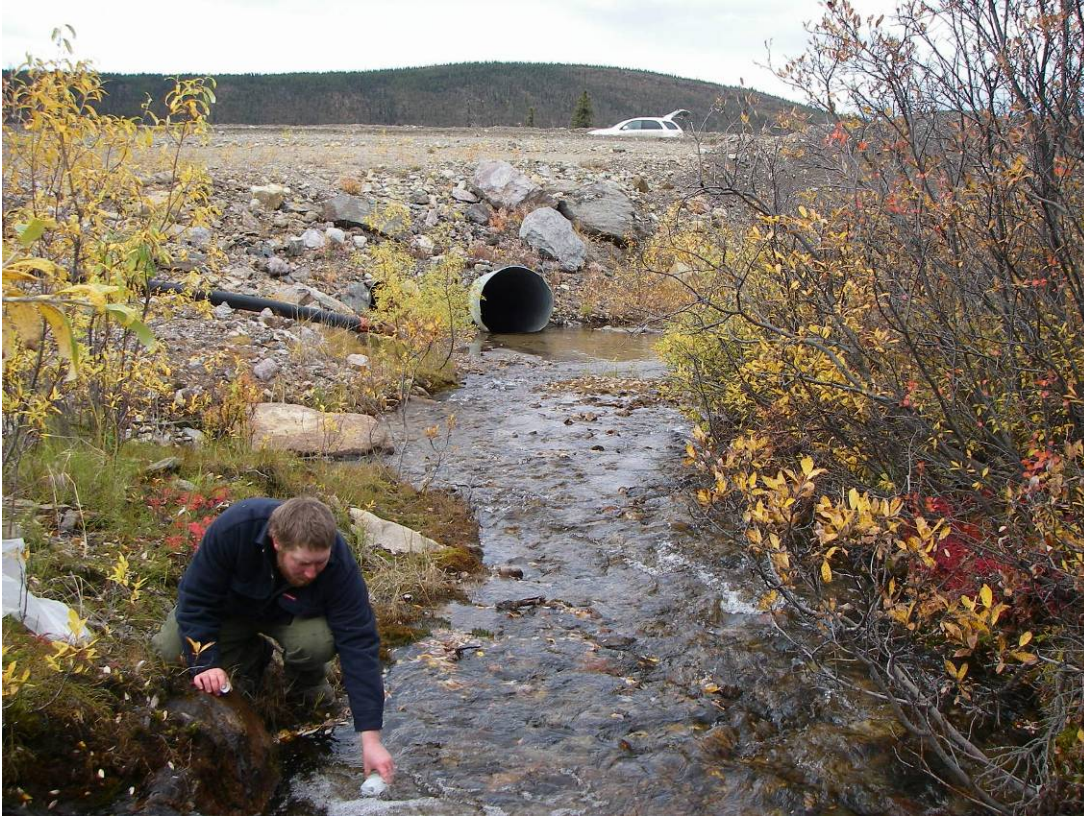
Photo 13: Looking towards two corrugated pipes at inlet of HR-2 (Sept. 16, 2007).

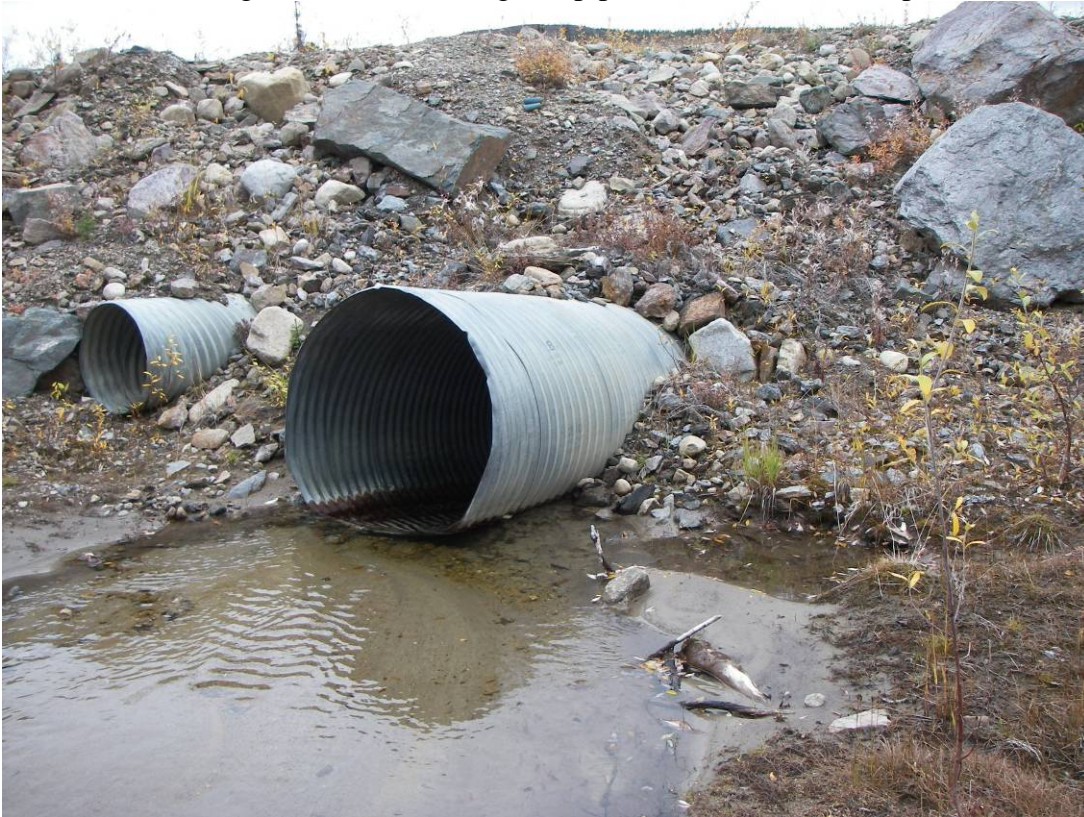
Photo 14: Corrugated pipes at inlet of HR-2 (Sept. 16, 2007).

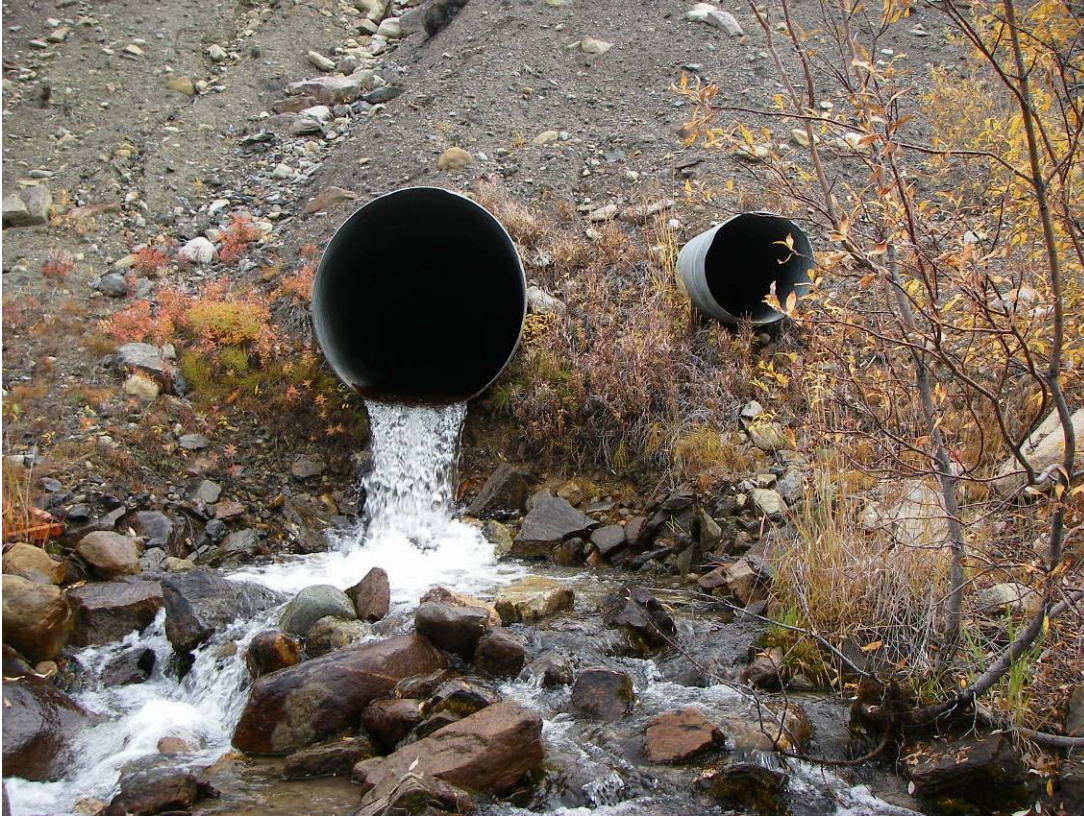
Photo 15: Discharge at outlet of HR-2 (Sept. 16, 2007).

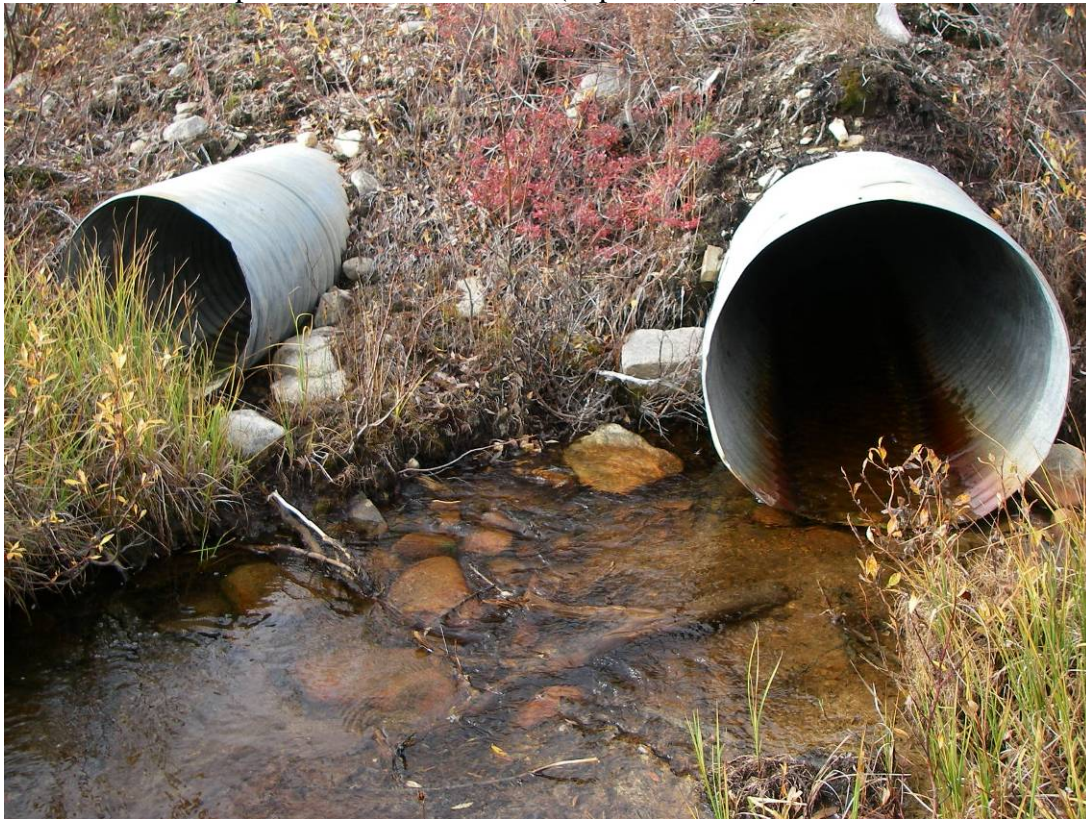
Photo 18: Corrugated pipes at inlet of HR-3 (Sept. 16, 2007).

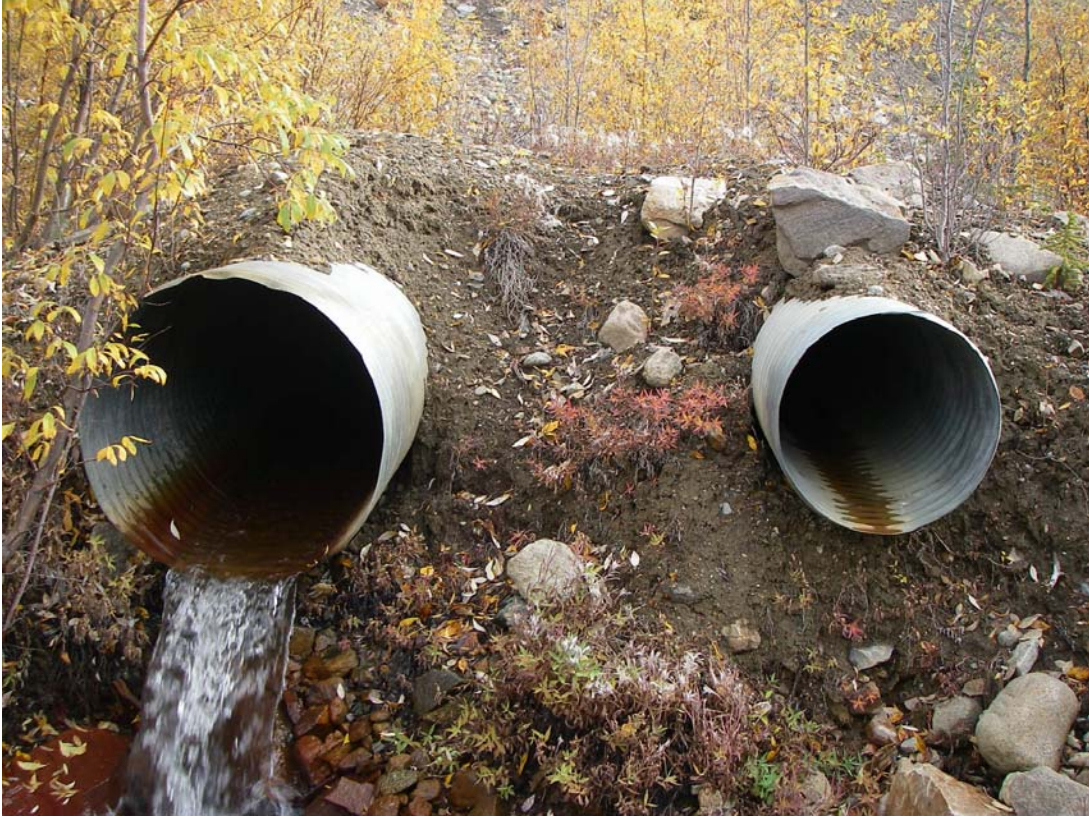
Photo 19: Discharge at outlet of HR-3 (Sept. 16, 2007).

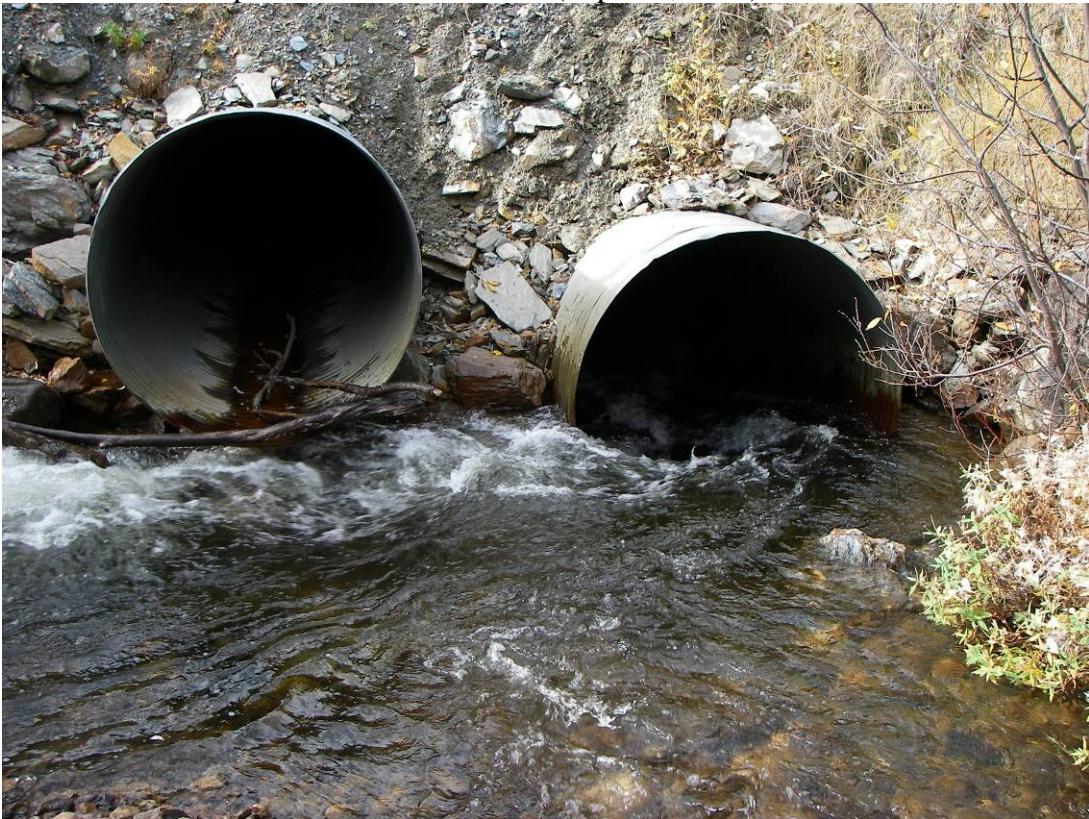
Photo 22: Corrugated pipes at inlet to HR-4 (Sept. 16, 2007).

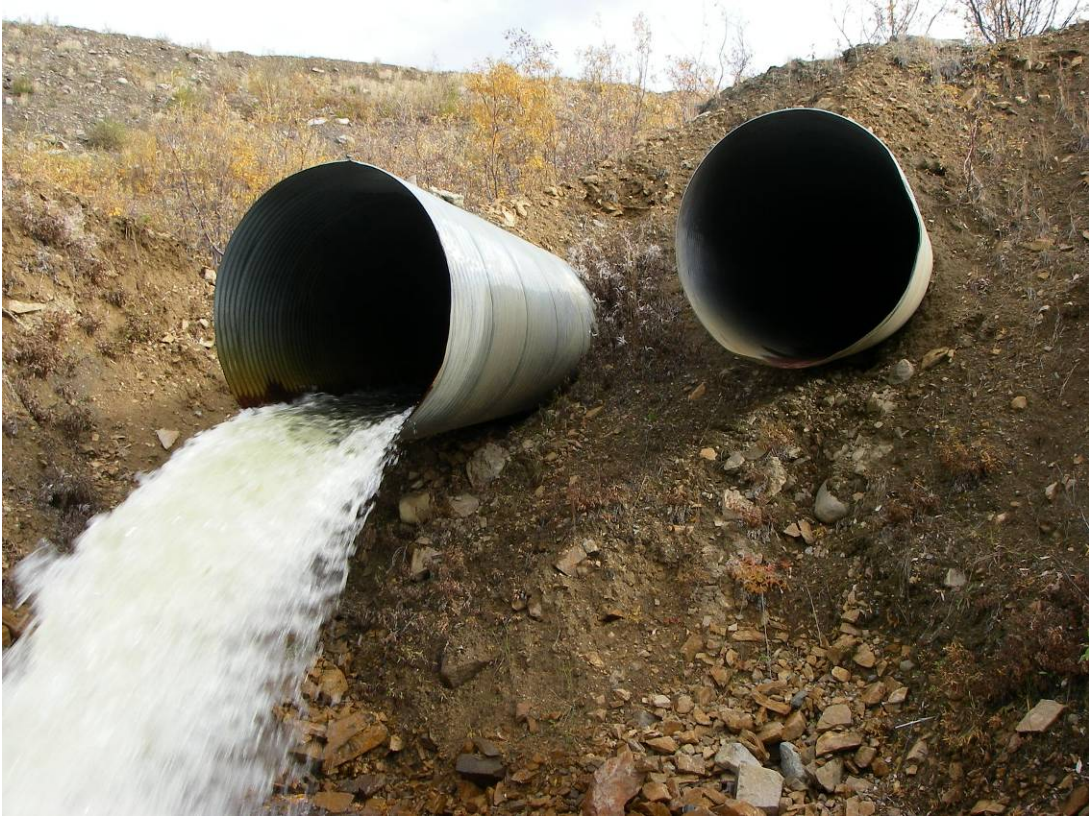
Photo 23: Discharge at outlet of HR-4 (Sept. 16, 2007).

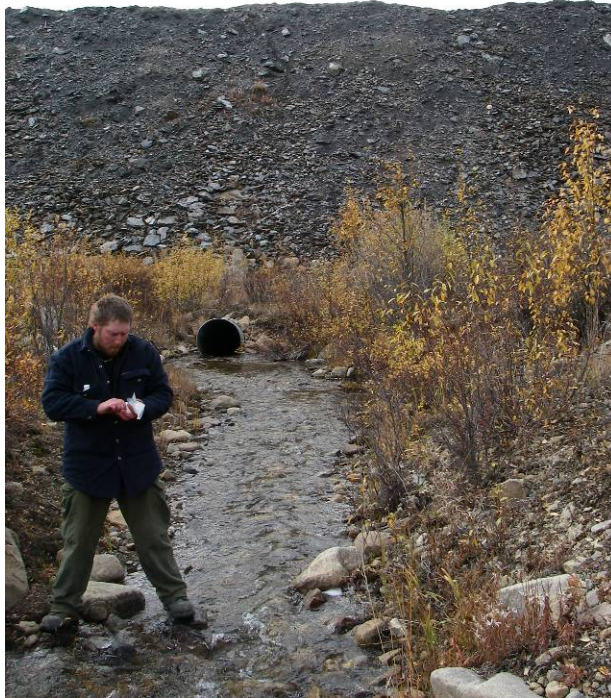
Photo 26: Corrugated pipe at inlet to HR-5 (Sept. 16, 2007).

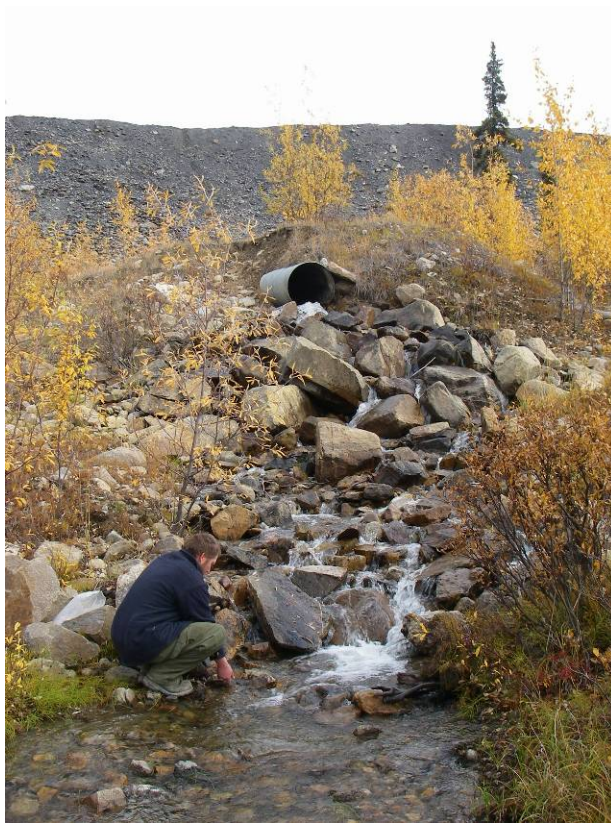
Photo 27: Discharge at outlet of HR-5 (Sept. 16, 2007).

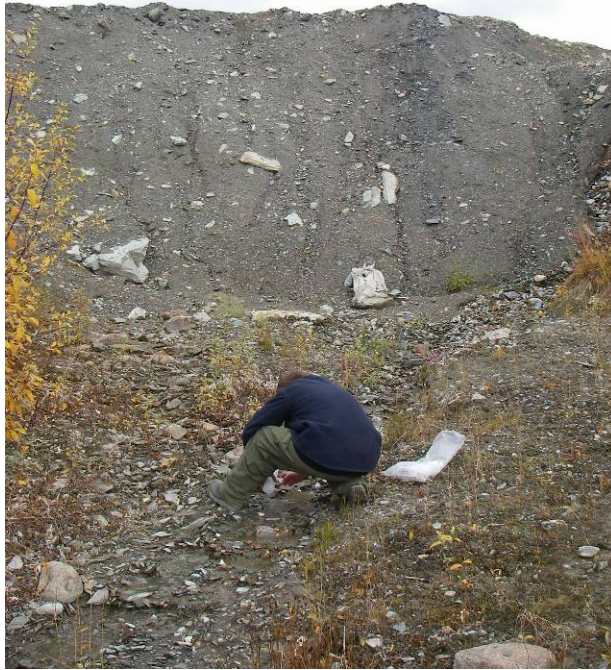
Photo 31: Diffuse drainage at downstream toe area of HR-6 (July 7, 2008).

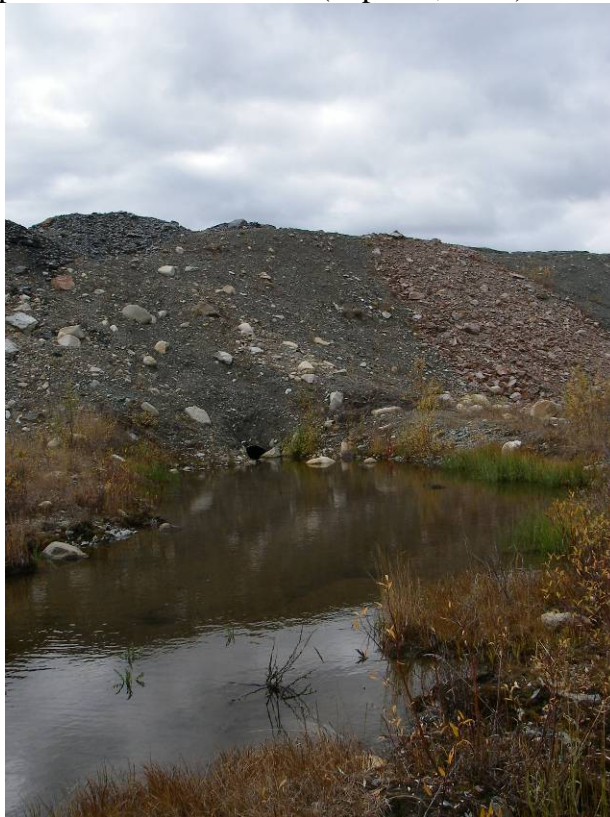
Photo 34: View of partially buried corrugated pipe at inlet to HR-7 (Sept. 16, 2007).

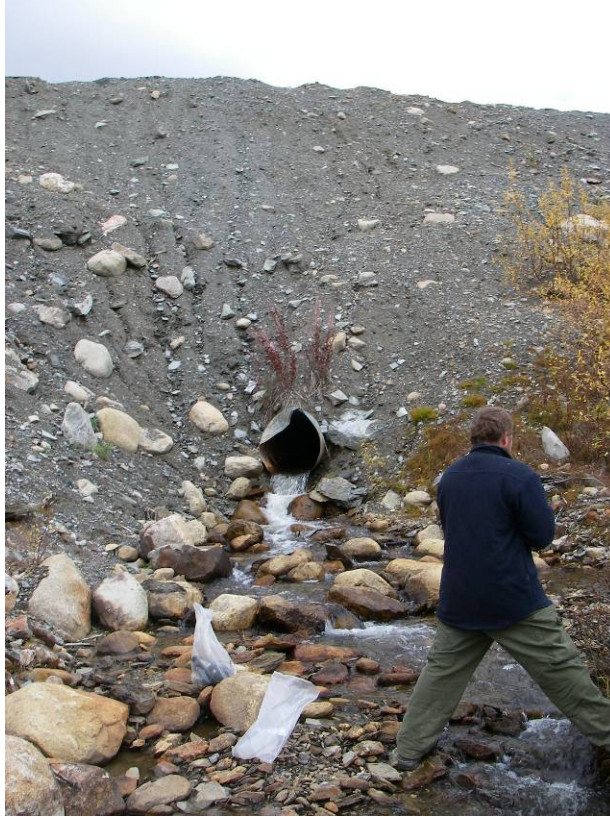
Photo 35: Discharge from corrugated pipe at outlet of HR-7 (Sept. 16, 2007).

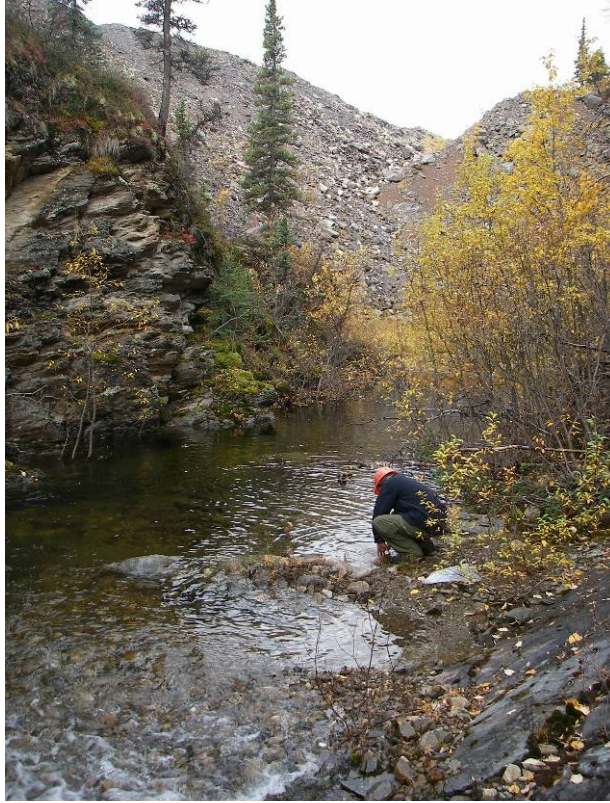
Photo 39: Discharge at outlet of HR-8 (Sept. 16, 2007).
