WorleyParsons Group

Government of Yukon Energy, Mines and Resources – Assessment and Abandoned Mines

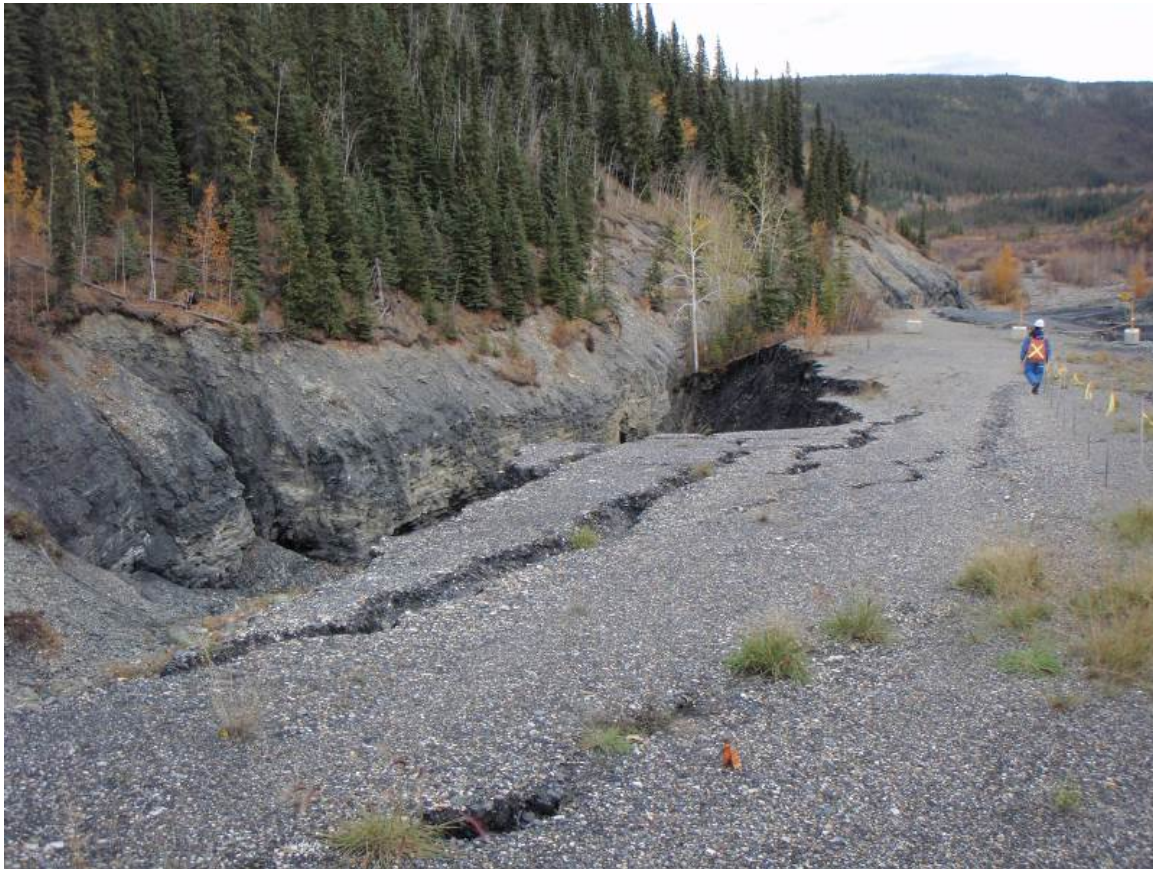
Photo A Closed Portion of Clinton Creek Site Access Road - Looking East (Downstream)

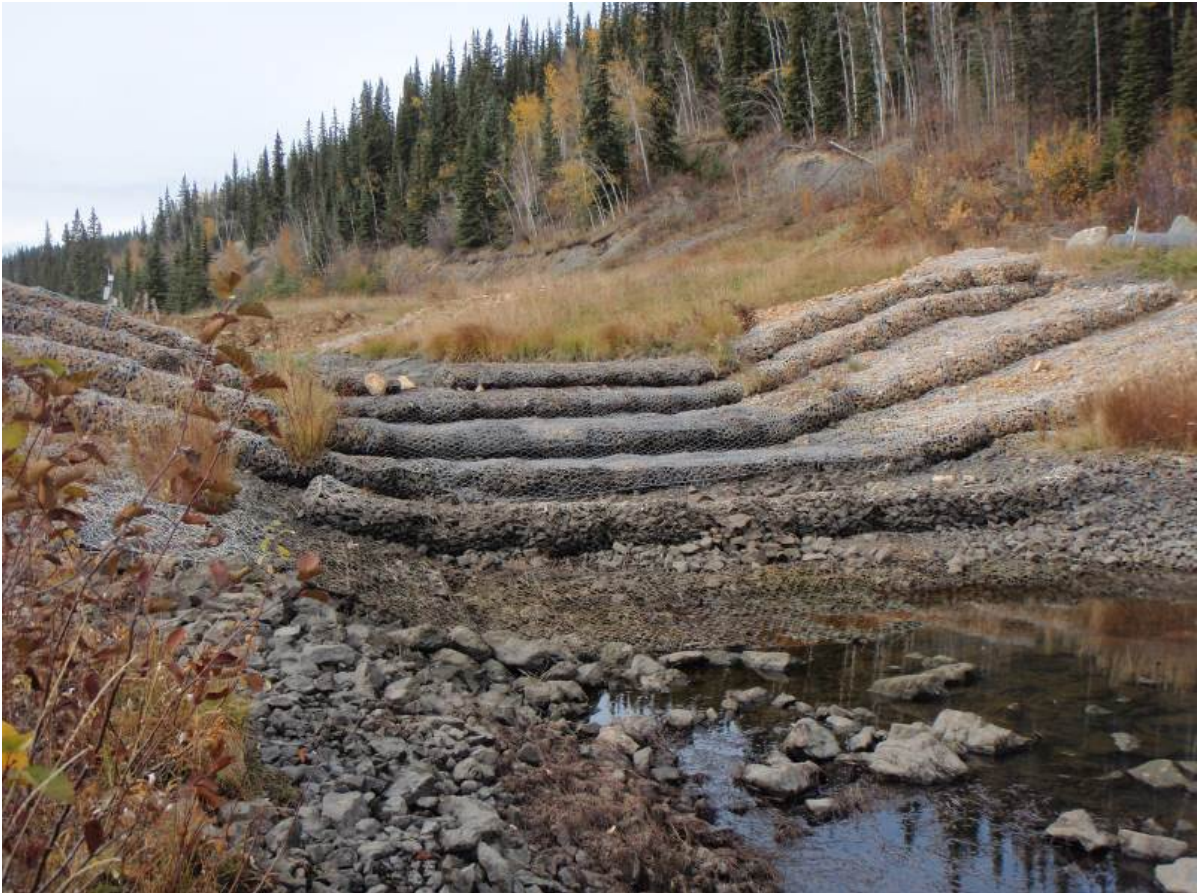
Photo B Drop Structure No. 1 Looking West (Upstream)

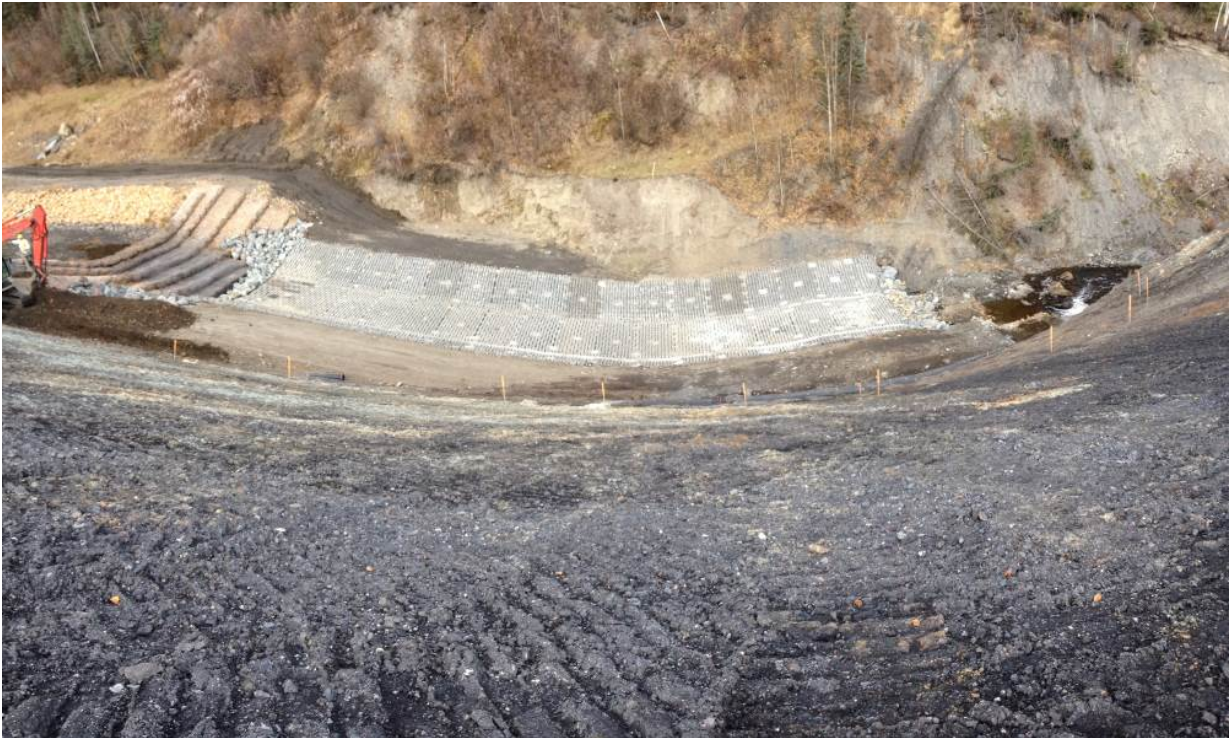
Photo C **Repaired Drop Structure No. 4 Looking North**

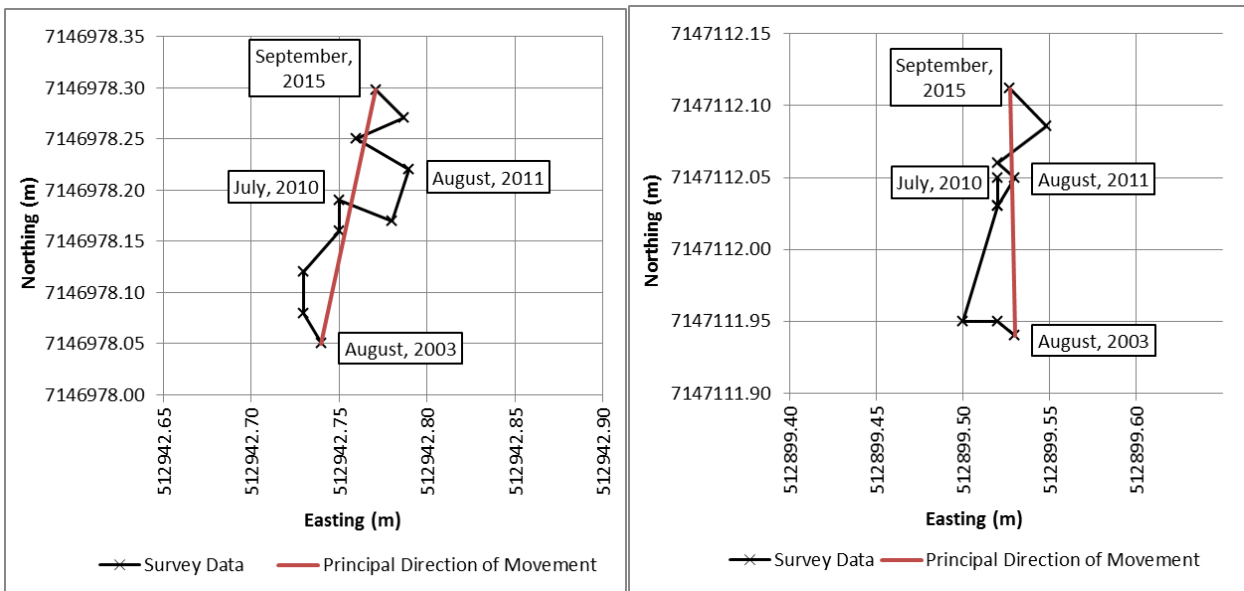
Figure I Principal Direction of Movement for Monitoring Point Nos. 223 (Left) and 1,195 (Right)

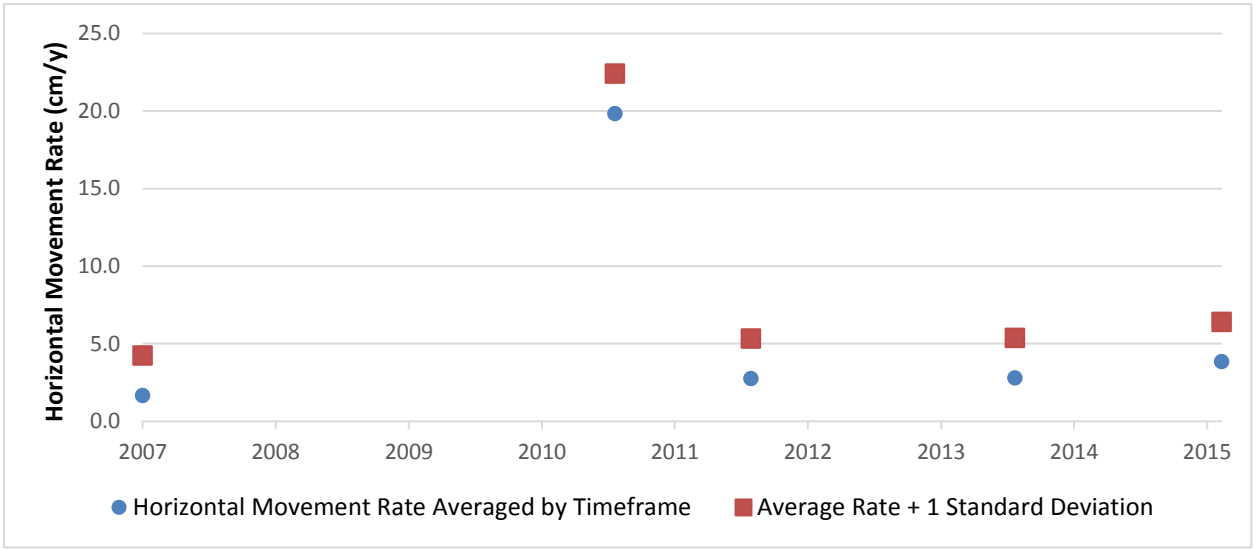
Figure J Average Waste Rock Dump Horizontal Movement Rates - Upper Slope

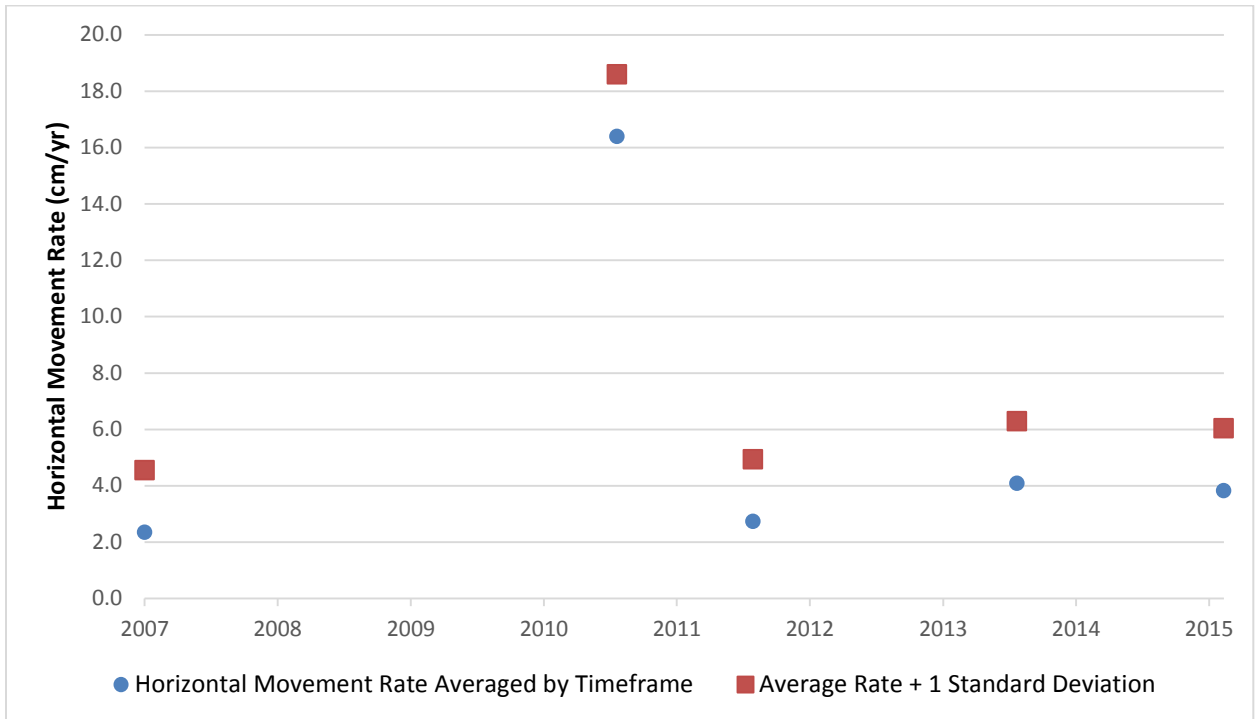
Figure M Average Tailings Pile Horizontal Movement Rates - North Lobe, Upper Slope

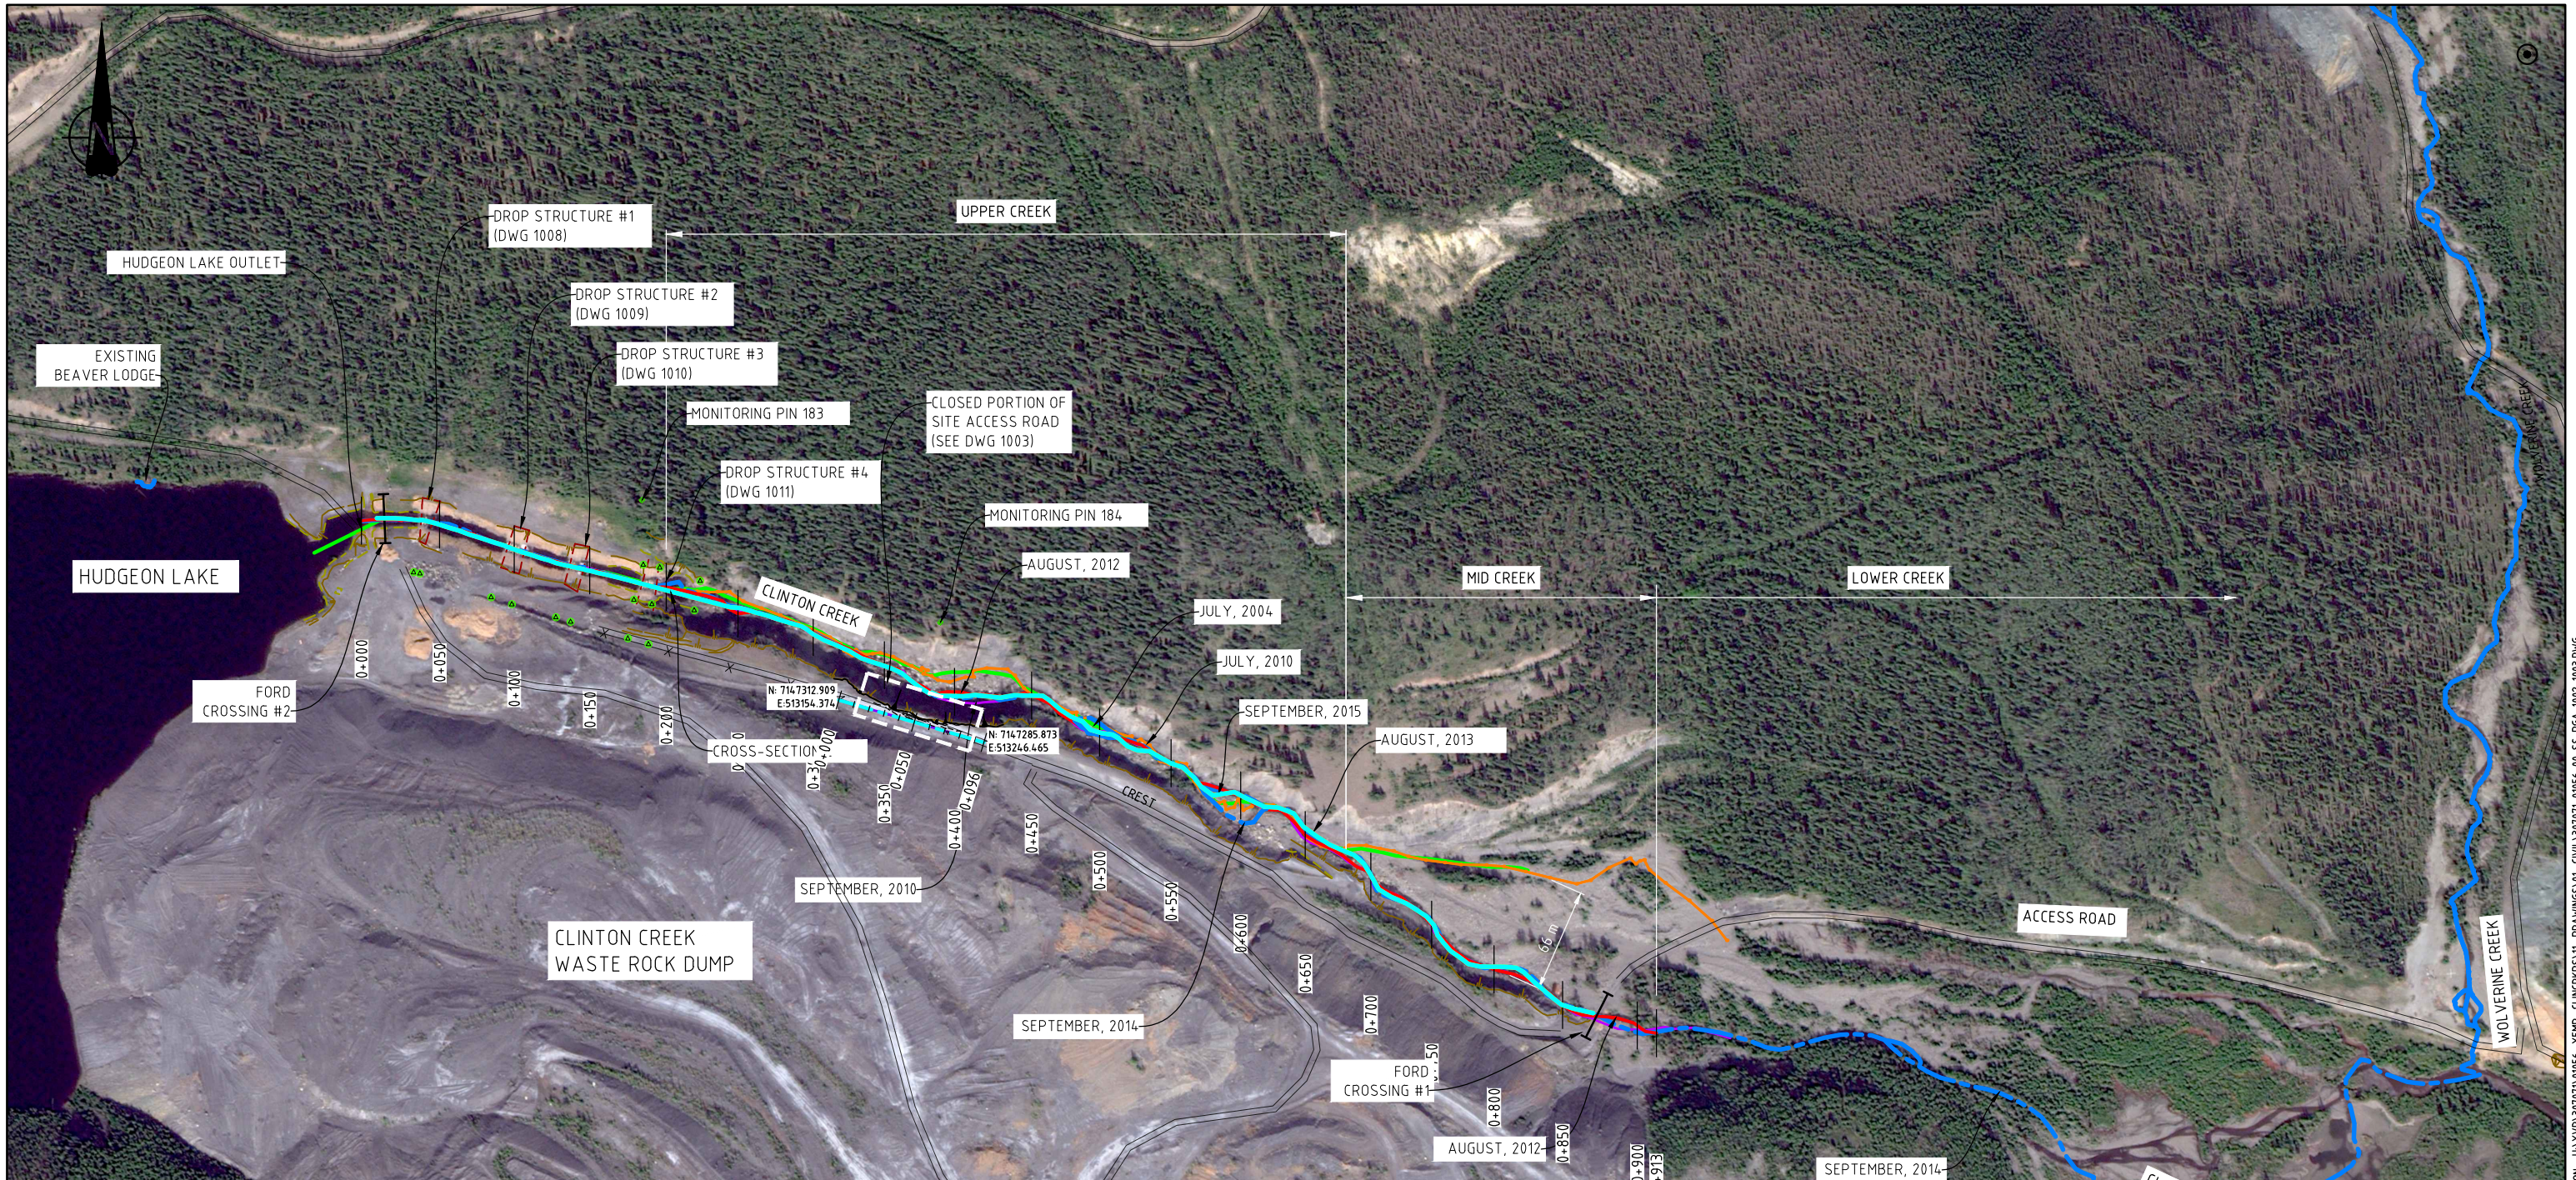
LOCATION: U:\YVR\307071\01056_YEAR_CLINTONCREEK\11_DRAWINGS\01_CIVIL\307071-01056-00-SS-DGA-1001.DWG
 USER NAME: jakgentiles
 PLOT DATE & TIME: 21/12/2015 9:32:21 AM
 SAVE DATE & TIME: 10/11/2015 12:53:18 PM

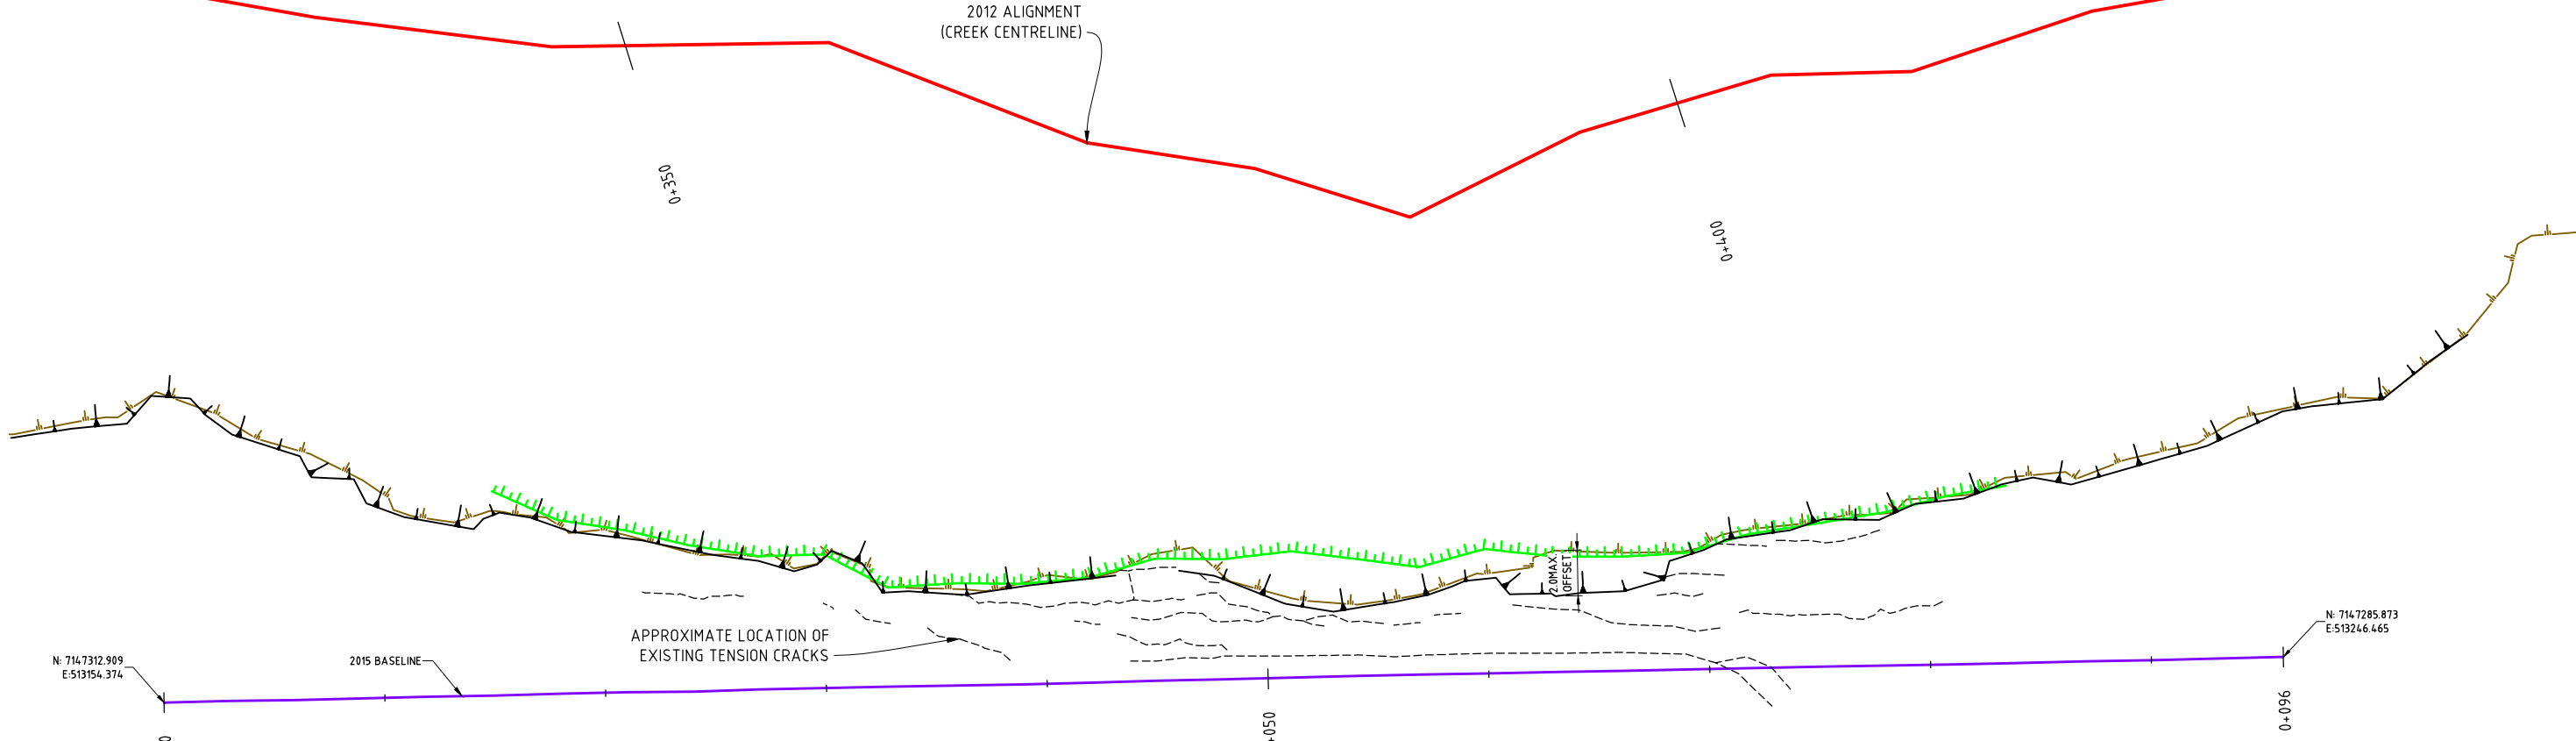
2015 TENSION CRACKS PLAN
1:150

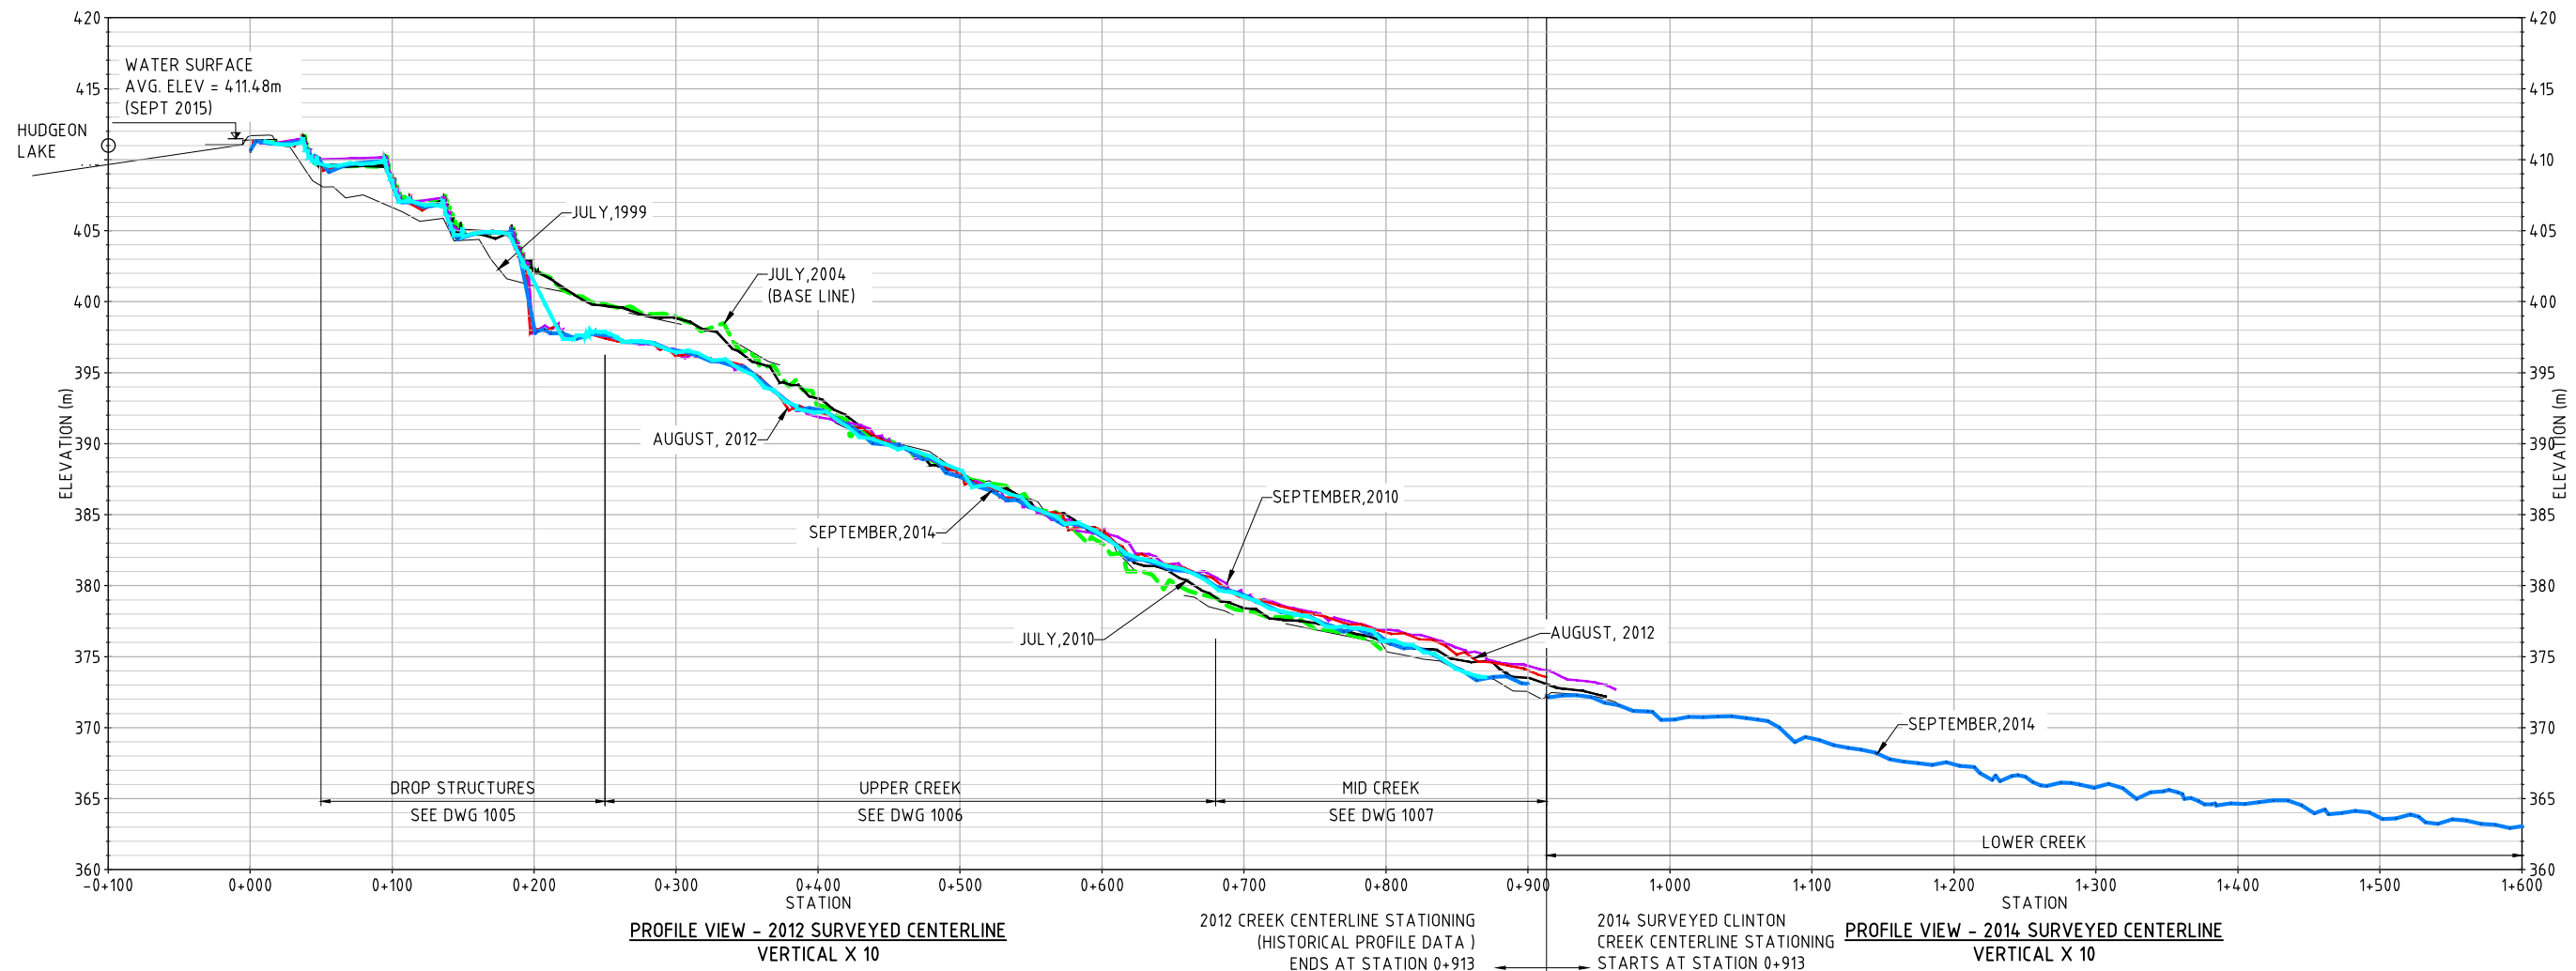
PROFILE VIEW - 2012 SURVEYED CENTERLINE VERTICAL X 10
 2012 CREEK CENTERLINE STATIONING (HISTORICAL PROFILE DATA) ENDS AT STATION 0+913
 2014 SURVEYED CLINTON CREEK CENTERLINE STATIONING STARTS AT STATION 0+913
 PROFILE VIEW - 2014 SURVEYED CENTERLINE VERTICAL X 10

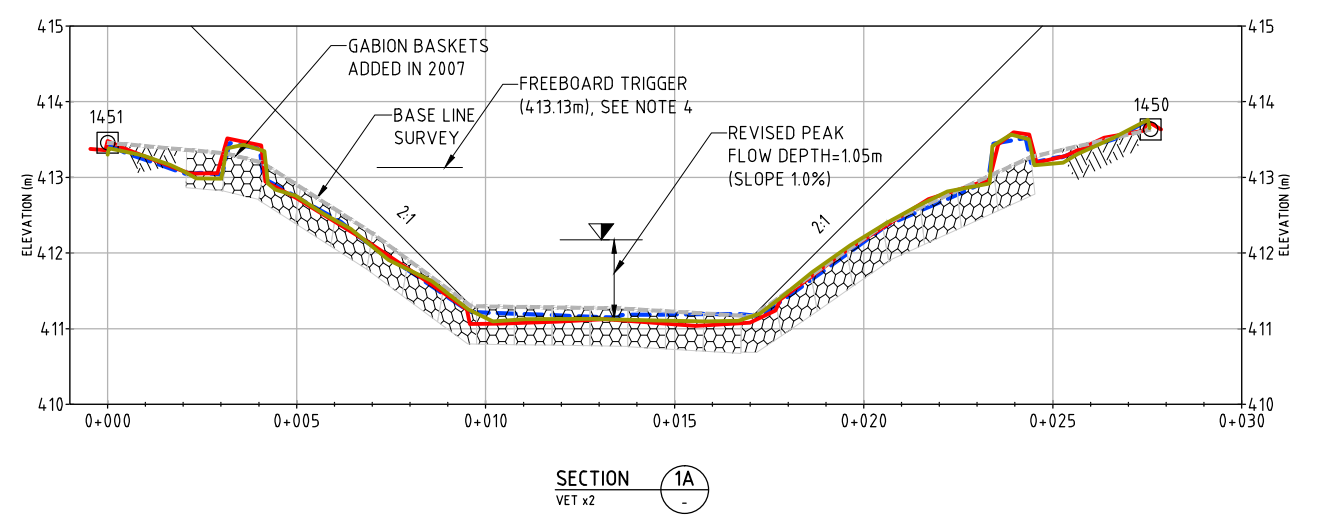
- NOTE 1: GABION FILL REMOVED FROM THIS CELL OF THE DRAWDOWN WEIR IN 2007 TO FACILITATE DRAWING DOWN HUDGON LAKE WATER LEVEL DURING LOW FLOW PERIODS.
- NOTE 2: REFER TO AECOM'S "FORMER CLINTON CREEK ASBESTOS MINE - EMERGENCY DROP STRUCTURE REPAIRS, CONSTRUCTION ACTIVITY REPORT, 2011" R94 FOR 2011 REPAIR DETAILS.
- NOTE 3: FREE BOARD TRIGGER SHOWN AT 300mm BELOW GABION BASKETS (REFER 2014 RECOMMENDATION DS-F).
- NOTE 4: FREEBOARD TRIGGER MEASURED FROM TOP OF BASKETS ADDED IN 2007.

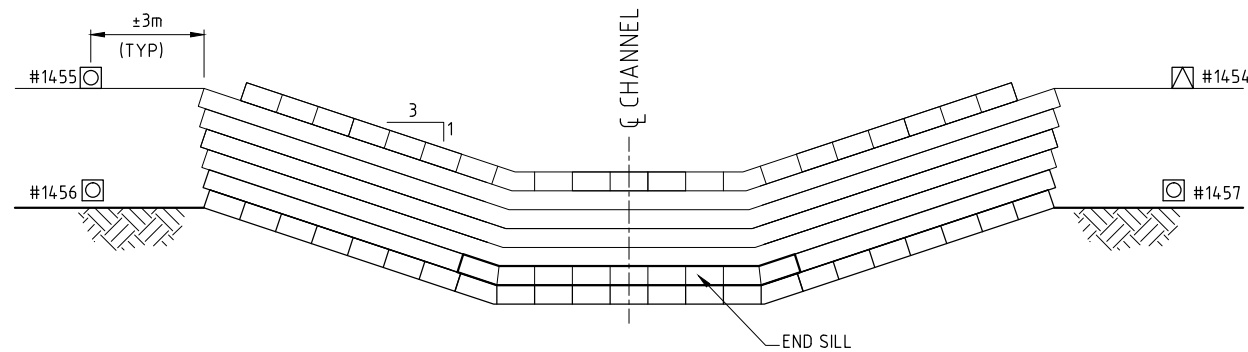
DROP STRUCTURE #2 END VIEW
SCALE: 1:200

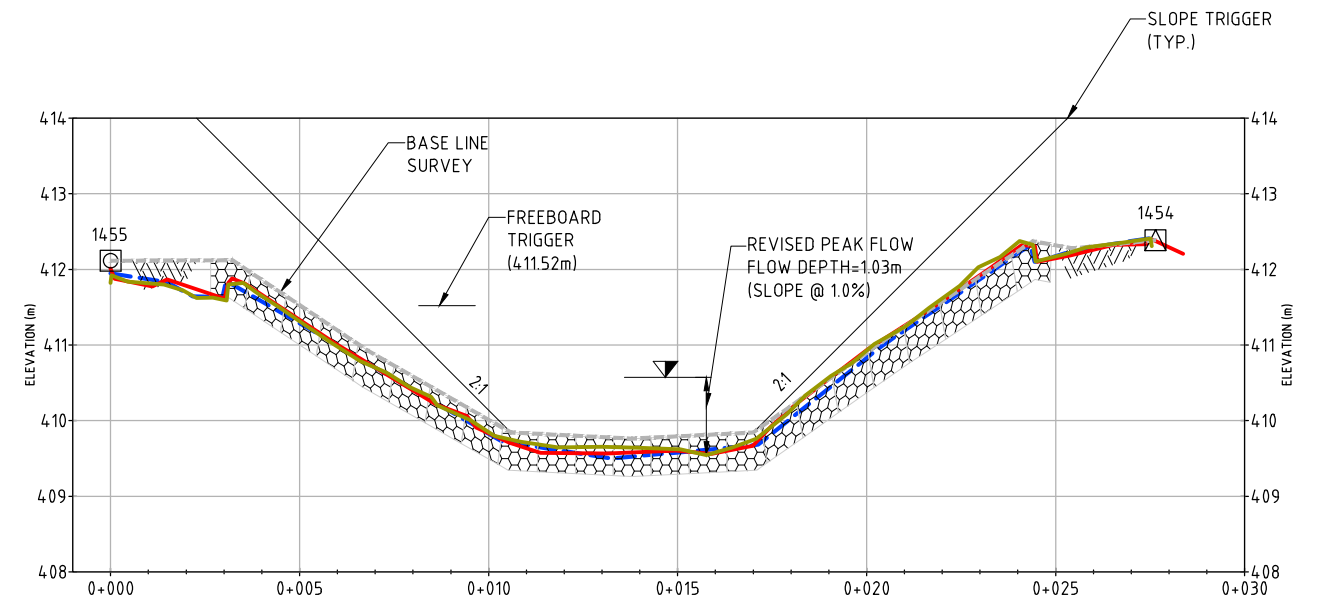
- ☒ CHANNEL CLOSURE MOVEMENT MONITOR INSTALLED IN 2012 (TYP.)
- ☒ CHANNEL CLOSURE MOVEMENT MONITOR (19mm Ø STEEL PIN) INSTALLED DURING 2006 SURVEY.

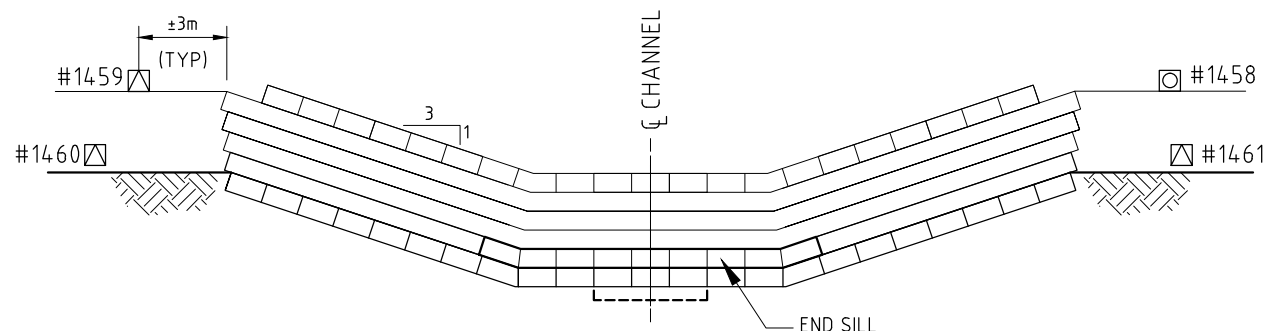
DROP STRUCTURE #3 END VIEW
SCALE: 1:200

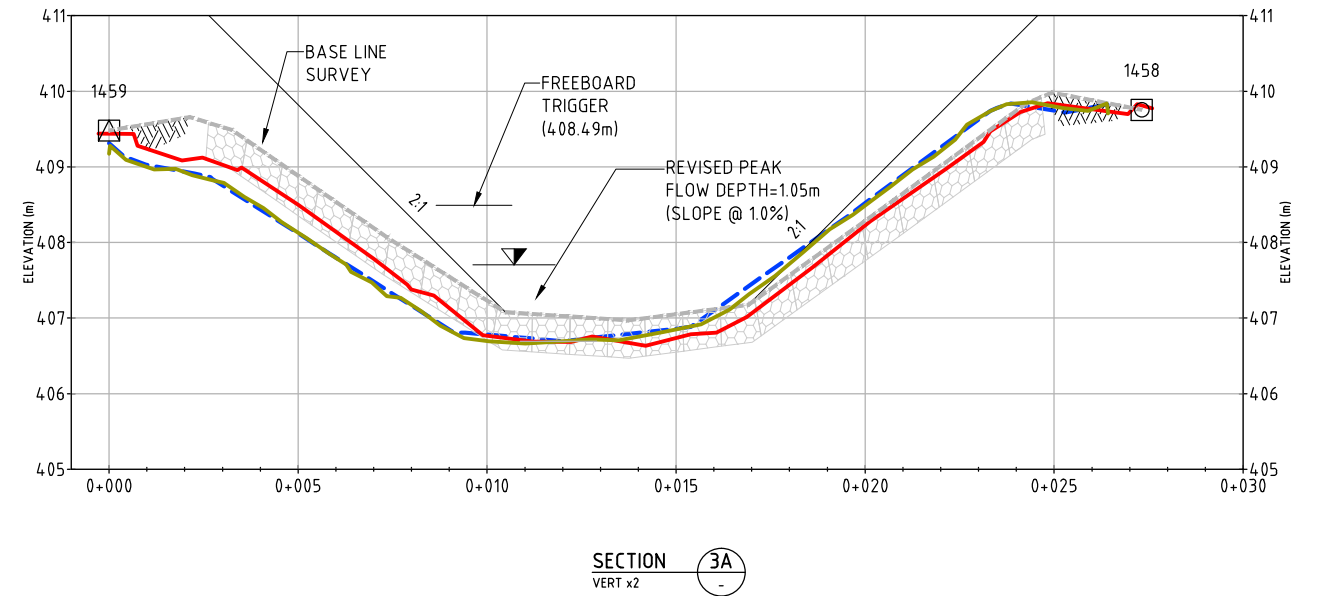
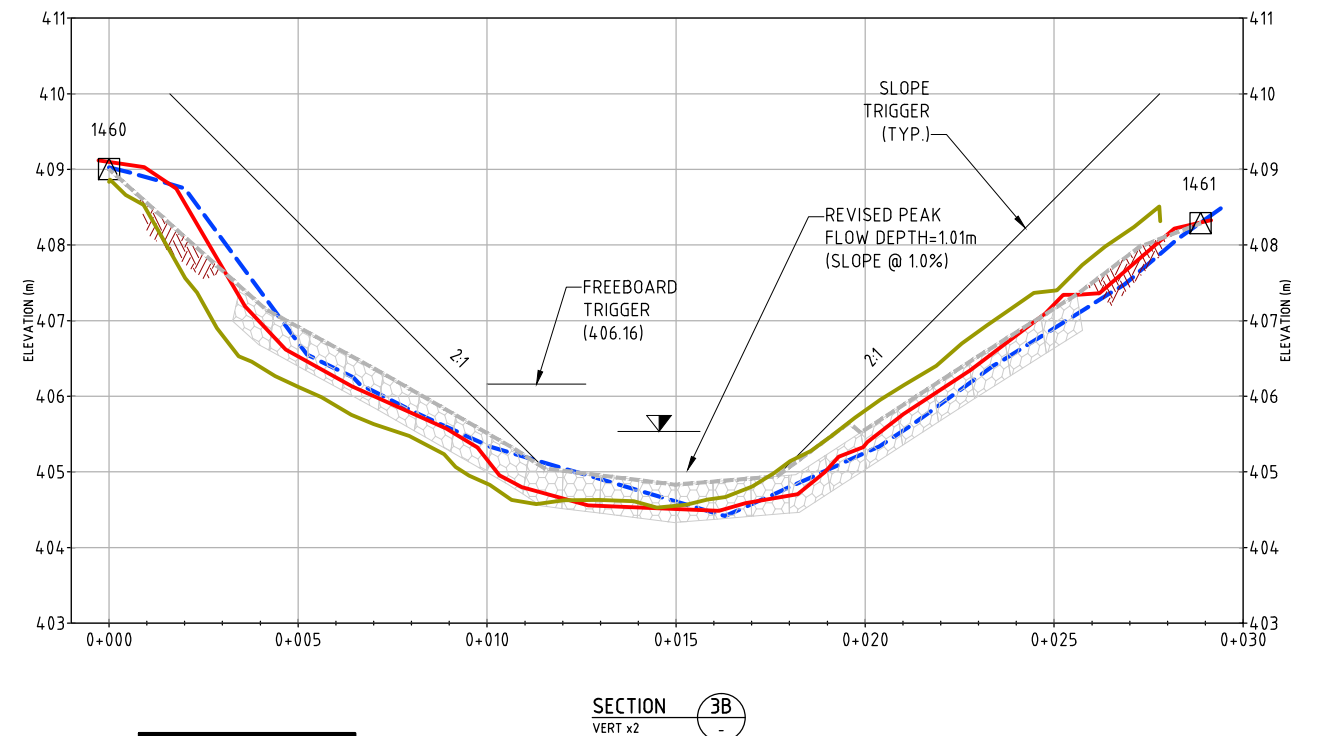
PRELIMINARY
DO NOT USE FOR CONSTRUCTION
Last Saved: Nov. 10/15 12:43pm

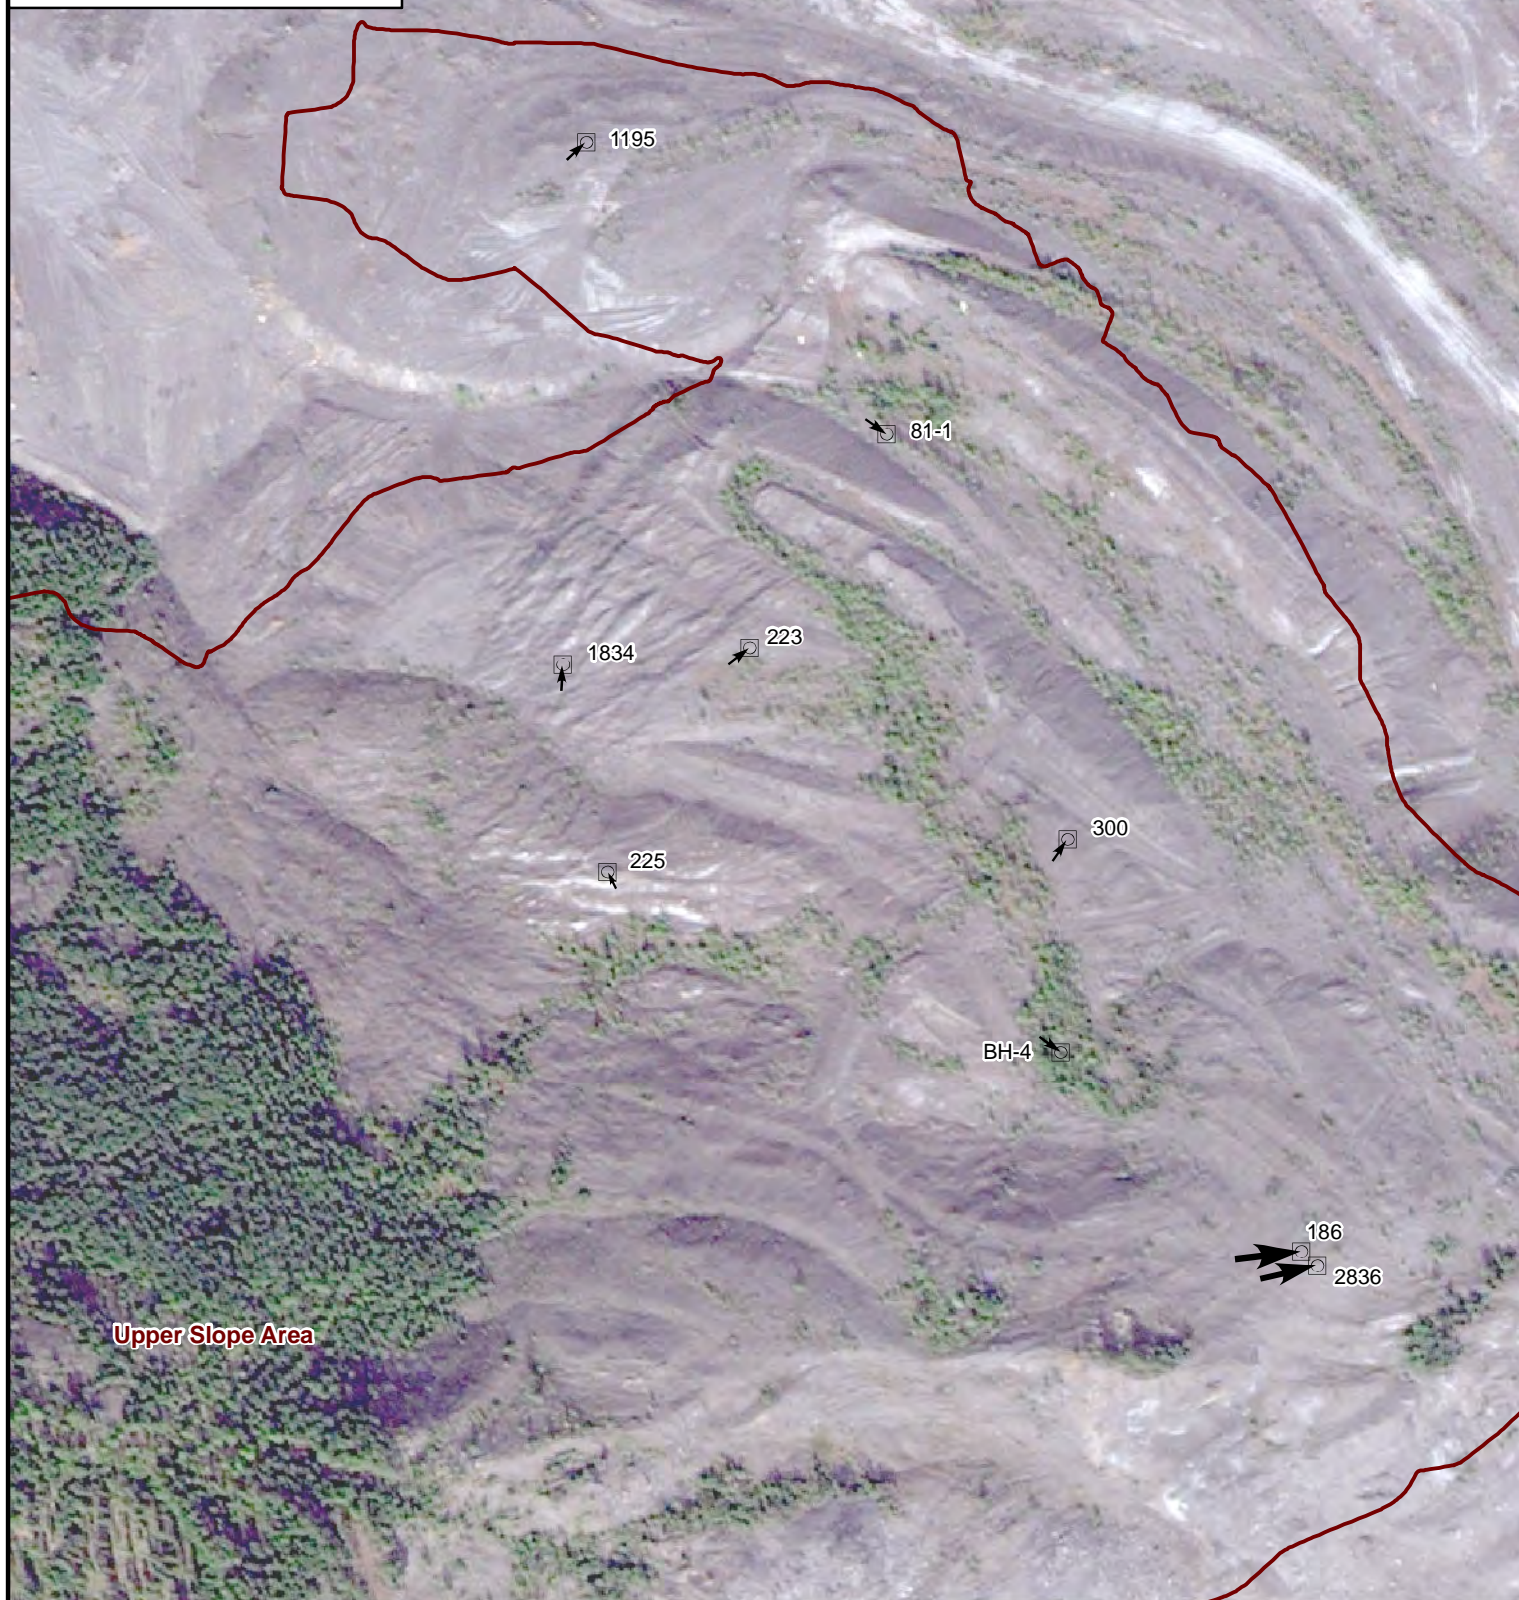
Movements 2014 - 2015

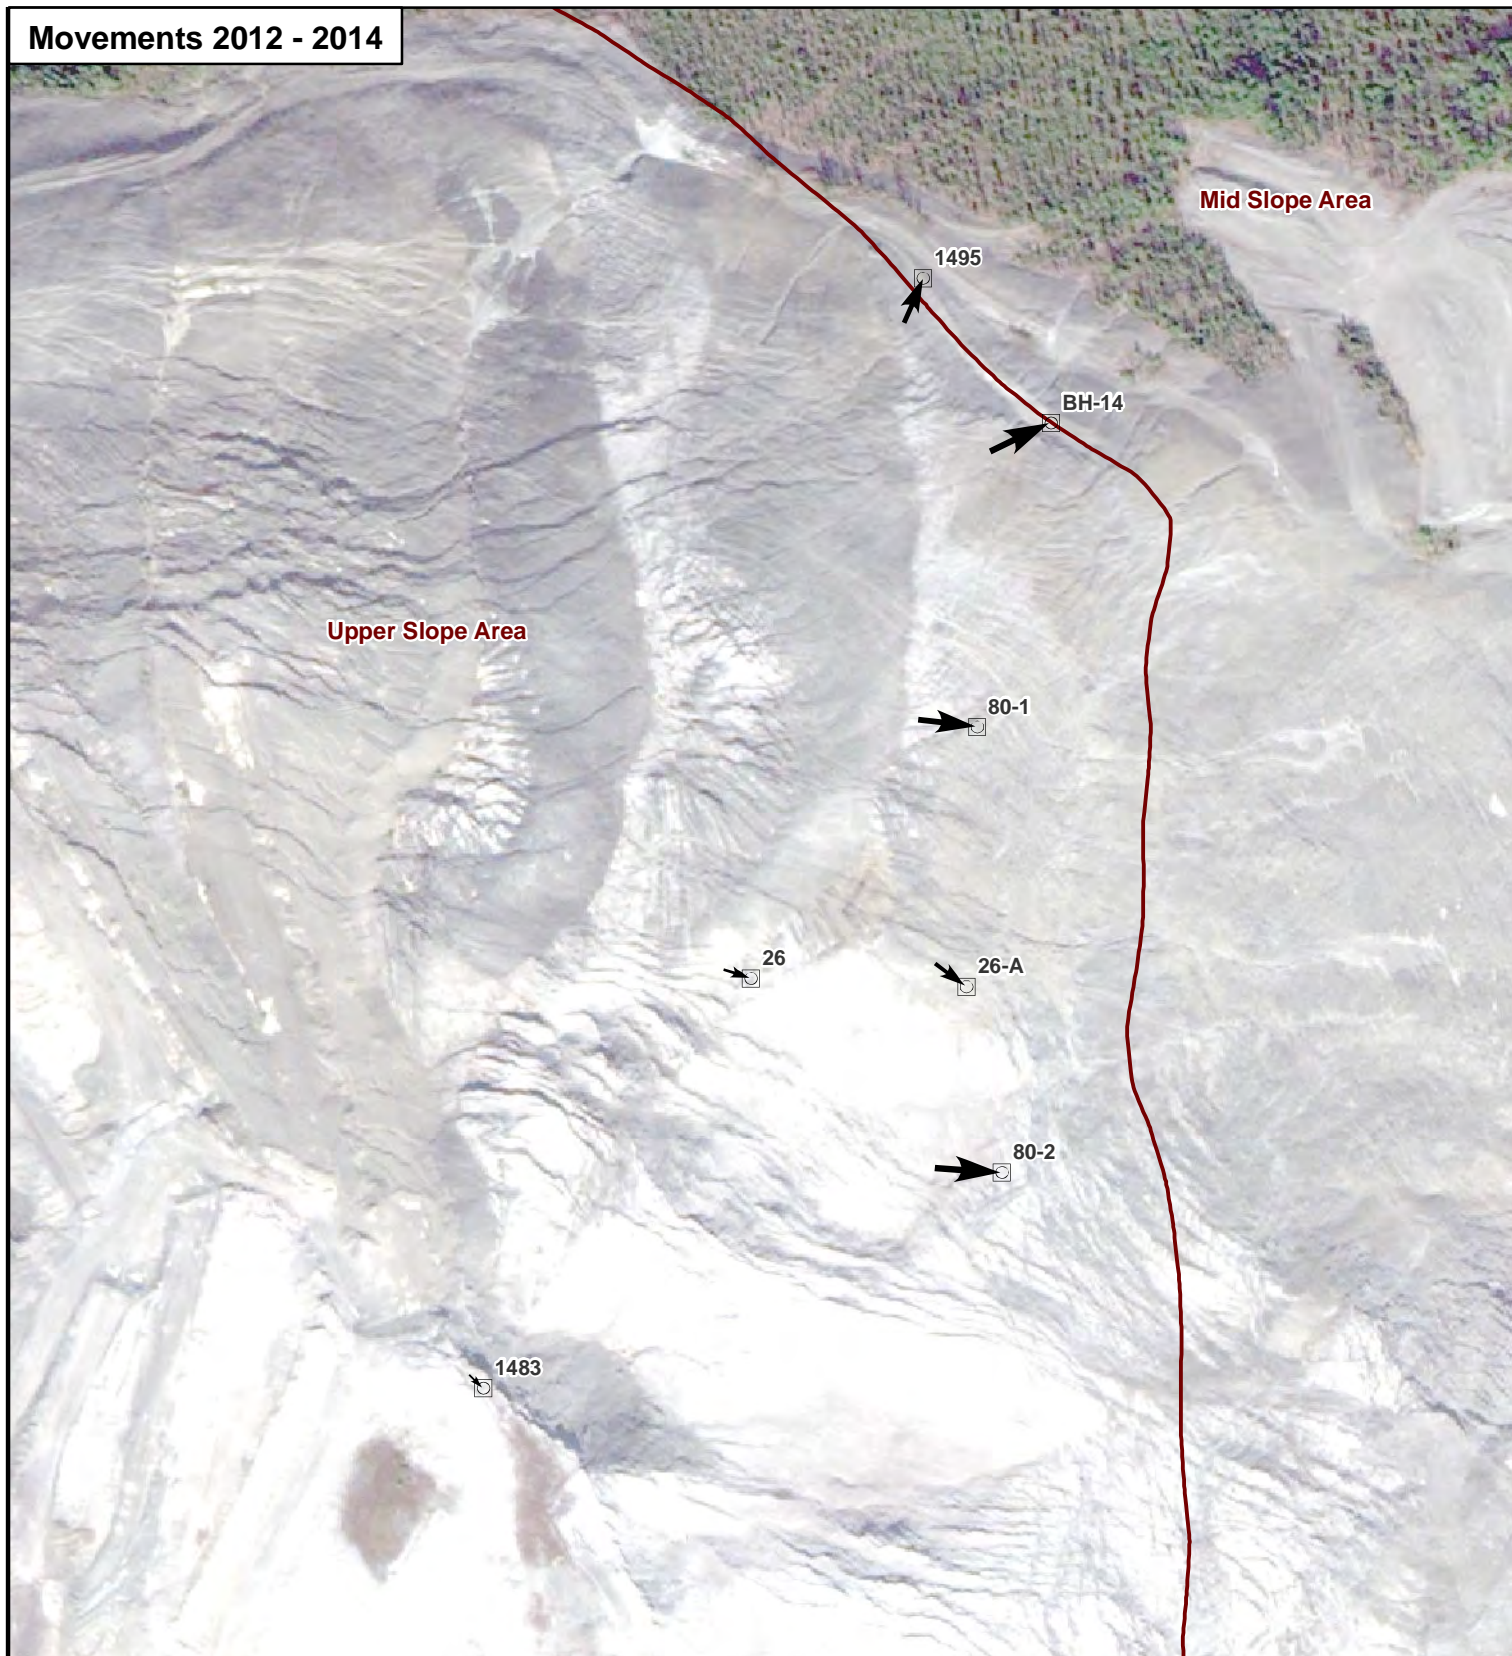
Movements 2014 - 2015

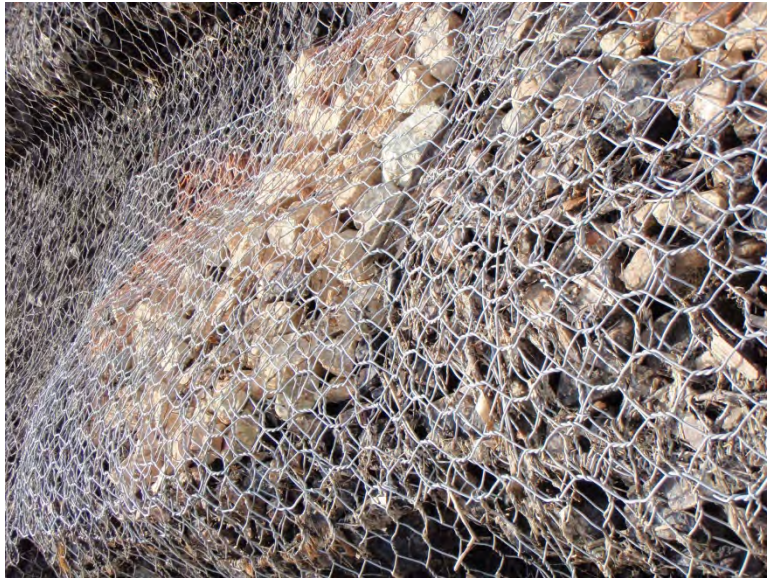
Photo 27: Repaired drop structure gabion basket looking southwest.

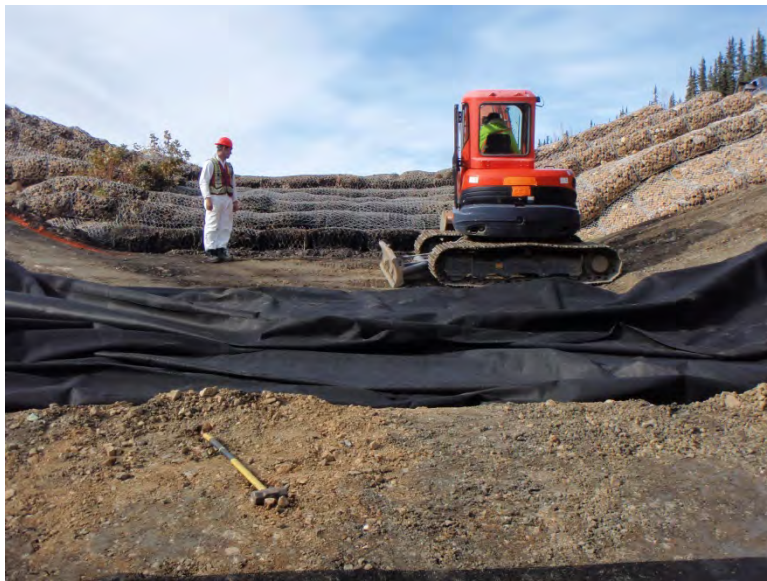
Photo 28: Drop Structure No. 4 transition to revetment chute looking west.
