**Elsa Reclamation and Development Company**  
**Keno Hill Mine**  
**Keno Hill Silver District**  
**Site Investigation and Improvements, Special Projects**  
**Fisheries Assessment Project**  
**September 17 – 19, 2008**

**March 31, 2009**

**Access Consulting Group**  
*A Member of Alexco Resource Group*  
#3 Calcite Business Center  
151 Industrial Road  
Whitehorse, YT Y1A 2V3

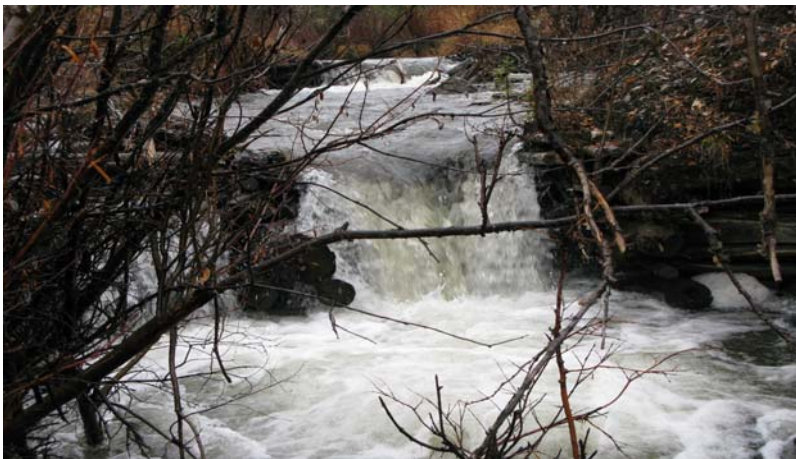
Approximately 300 metres upstream of the first barrier, a double barrier set was encountered. Two barriers, approximately 12 metres apart, are present. The downstream aspect barrier was estimated to constitute a drop of one metre while the upstream barrier was estimated to have a drop of 0.4 metres. Taken in conjunction, the two obstacles provided a formidable barrier to upstream fish movement."

According to the 2006 report, reference to the previous report in 1996, and substantiated by the current investigation, three barriers were present and are believed to provide a formidable, if not complete, obstacle to fish movement. Plates 1 and 2 following show the three barriers referred to in all reports. In Plate 1, both terminal upstream barriers (#3 & #2) can be seen.

**Plate 1 Upstream Barriers #2 & #3 – Christal Creek associated with Site C4. (Photo was taken during a high water event - 2008.)**

Only one side of each barrier will be removed, allowing adequate migratory access during virtually any time of the year. Only up to a meter of width or less should be removed in order to allow for fish movement. This will reduce the amount of sediment/materials flushed downstream over a contracted period. Once a section of the barrier is removed, it will begin to degrade naturally over time, minimizing downstream loading of suspended solids.

The two uppermost barriers are several metres apart. Opposing sides will be removed, in hopes that a resting pool will form naturally in between the two barriers, similar to that found in a vertical alternating-slot fish ladder.

Whenever possible, final touches will be applied manually to leave a natural looking, functional passage that will allow for fish migration at all water levels. Following removal, the barriers should be inspected on an annual basis for several years to monitor for degradation of the remaining portion of the barrier, and to check for blockages resulting from debris entering the barrier opening from upstream.

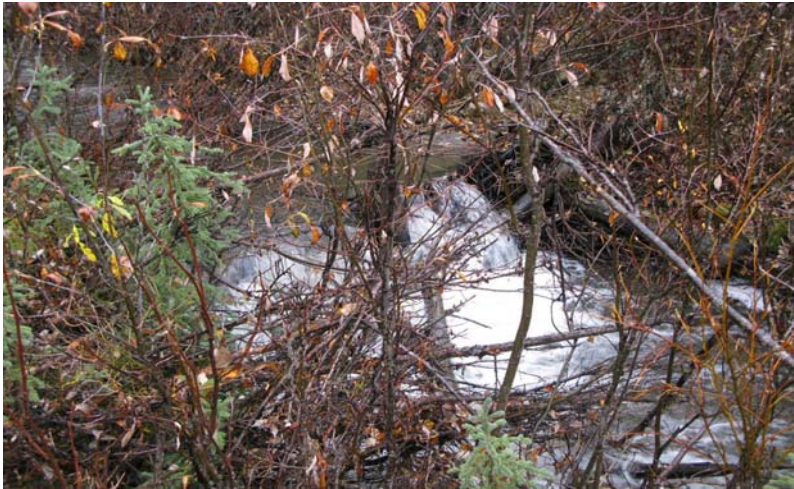
“Bridges across the creek, built in the 1960’s, and since collapsed, created a series of barriers to fish movement. At the site of the lower barrier observed in 1995, the creek has cut a new channel around the barrier causing the infilling of several deep pools downstream and the removal of the barrier. The in-filled downstream pools were suspected as having provided over-wintering habitat for a small group of Arctic grayling in 1995.

The 2008 ACG fisheries investigation substantiated the findings of the 2006 report regarding the location and condition of the barriers. Christal Creek, in the vicinity and upstream of sample site C4, was investigated for the presence of potential fish barriers in the form of wooden bridges, as had been previously reported. Four potential barriers had been

**Plate 2 Downstream Barrier #1 – Christal Creek associated with Site C4.**

*(Photo was taken during a high water event - 2008.)*
