## Design Options for Seepage Collection Grum Waste Rock Dump

Project Reference Number:  
SRK 1CD003.37

**DECEMBER 2003**

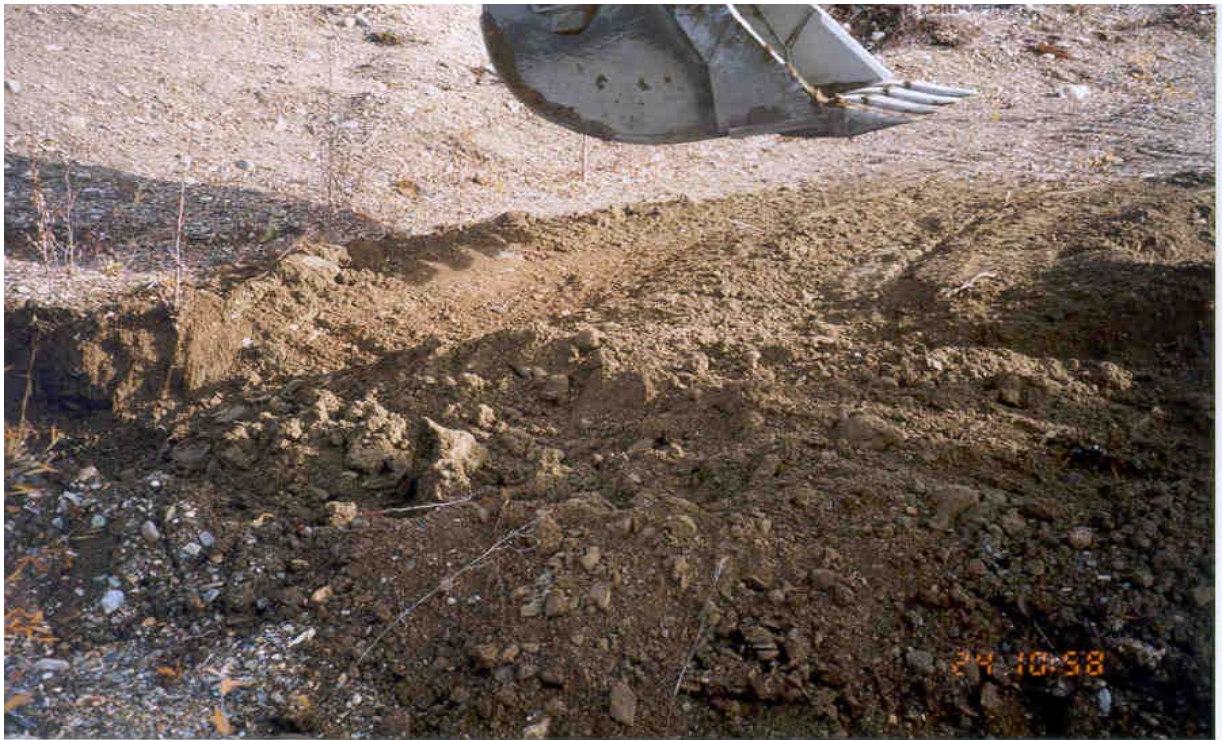
### TEST PIT NO. B-02-58

| DEPTH: | DESCRIPTION: | UCS | GRAD. | SILT CONT. | PLASTICITY | COLOUR | MOISTURE | RELATIVE DENSITY/ CONSIST. | SAMPLE | NOTES: |
|---|---|---|---|---|---|---|---|---|---|---|
| 5.2 - 5.5m. | Silt, sandy, some clay, gravelly | Sm | | | low | brown | moist | stiff | | Till |

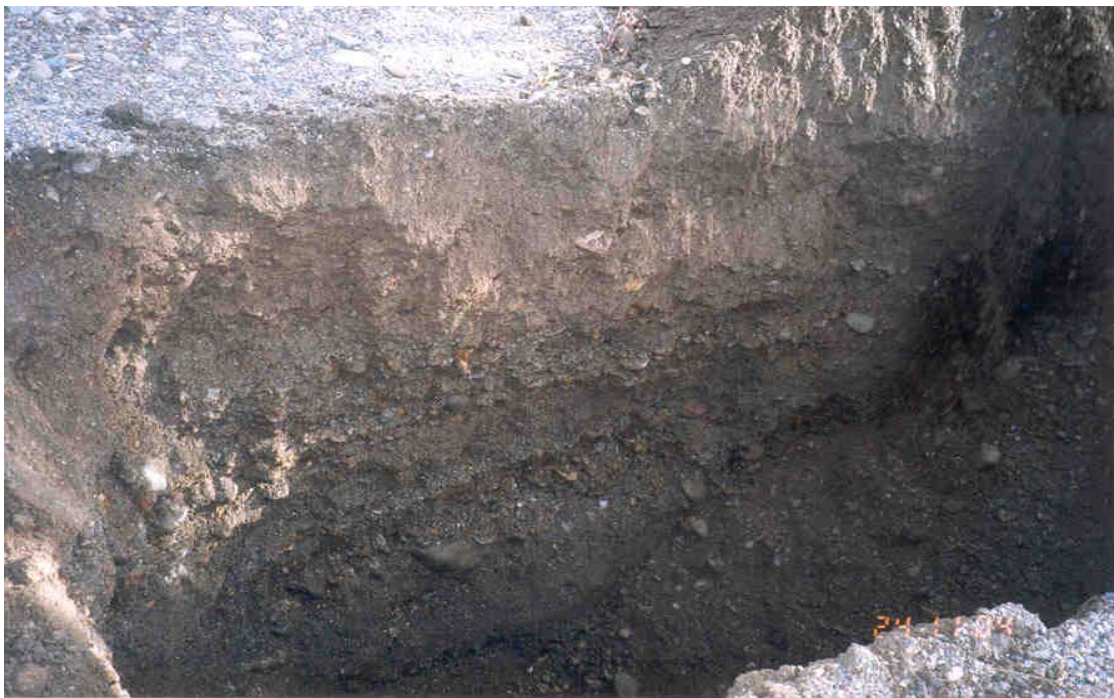
### TEST PIT NO. B-02-59

| DEPTH: | DESCRIPTION: | UCS | GRAD. | SILT CONT. | PLASTICITY | COLOUR | MOISTURE | RELATIVE DENSITY/ CONSIST. | SAMPLE | NOTES: |
|---|---|---|---|---|---|---|---|---|---|---|
| 2.2 - 2.5m. | Silt, sandy, some clay, gravelly | Sm | | | low | brown | moist | stiff | | Till |

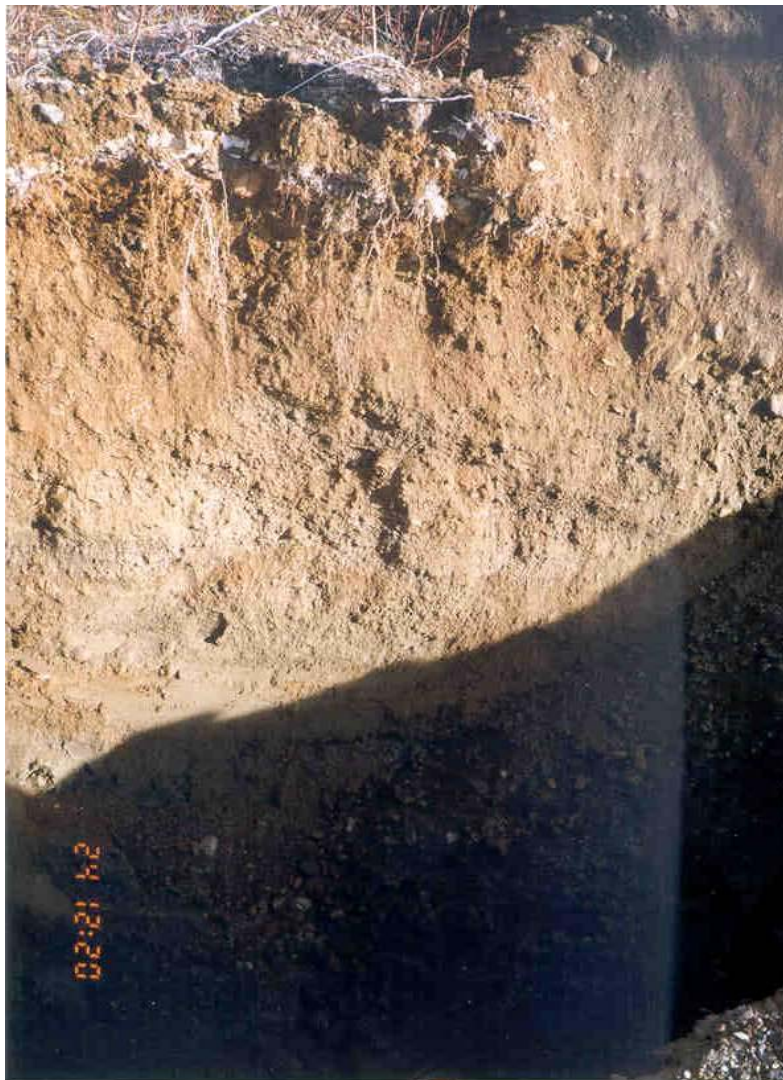
### TEST PIT NO. B-02-60

| DEPTH: | DESCRIPTION: | UCS | GRAD. | SILT CONT. | PLASTICITY | COLOUR | MOISTURE | RELATIVE DENSITY/<br>CONSIST. | SAMPLE | NOTES: |
|---|---|---|---|---|---|---|---|---|---|---|
| 1.5 - 2.0m. | Silt, sandy, some clay, gravelly | Cl | | | low | brown | moist | stiff | | |

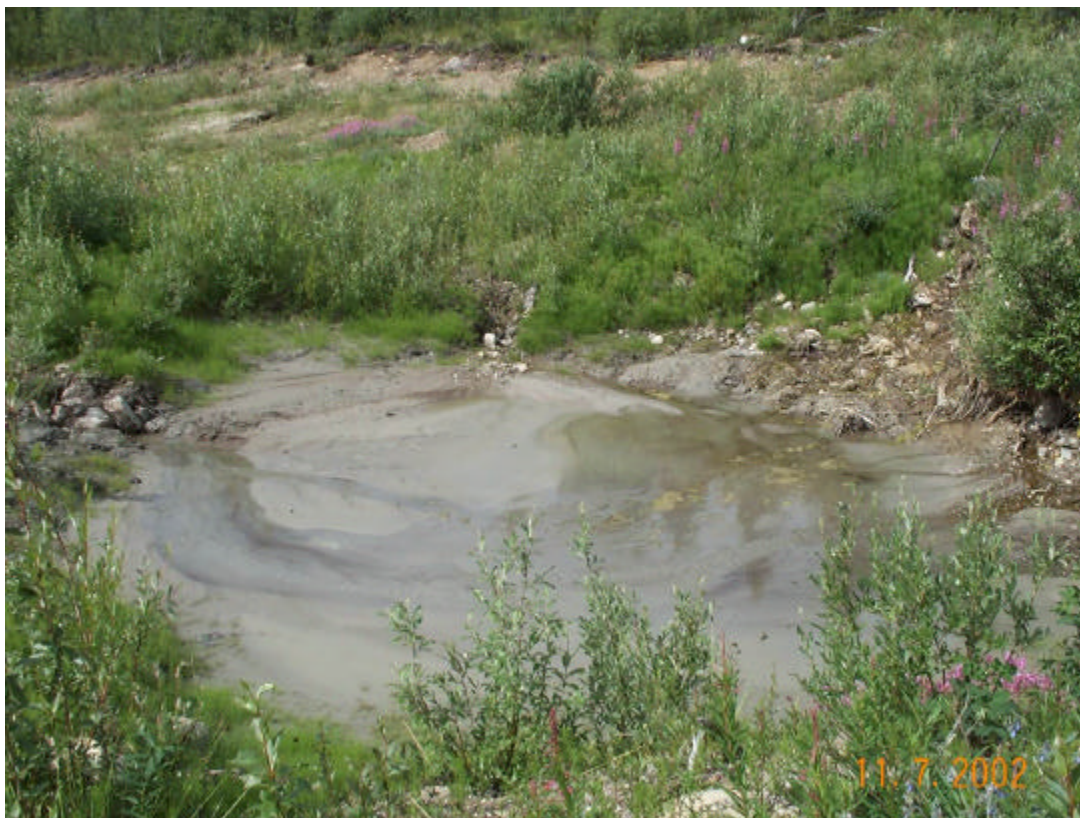
Photo 1: Sedimentation Pond upstream of V15
