2007 Supplemental Geochemical Studies Report

2007/08 - Task 28

*Project Reference Number
SRK 1CD003.092*

Title: Anvil Range Mining Complex: 2007 Supplemental Geochemical Studies Report–
2007/08 Task 28- DRAFT

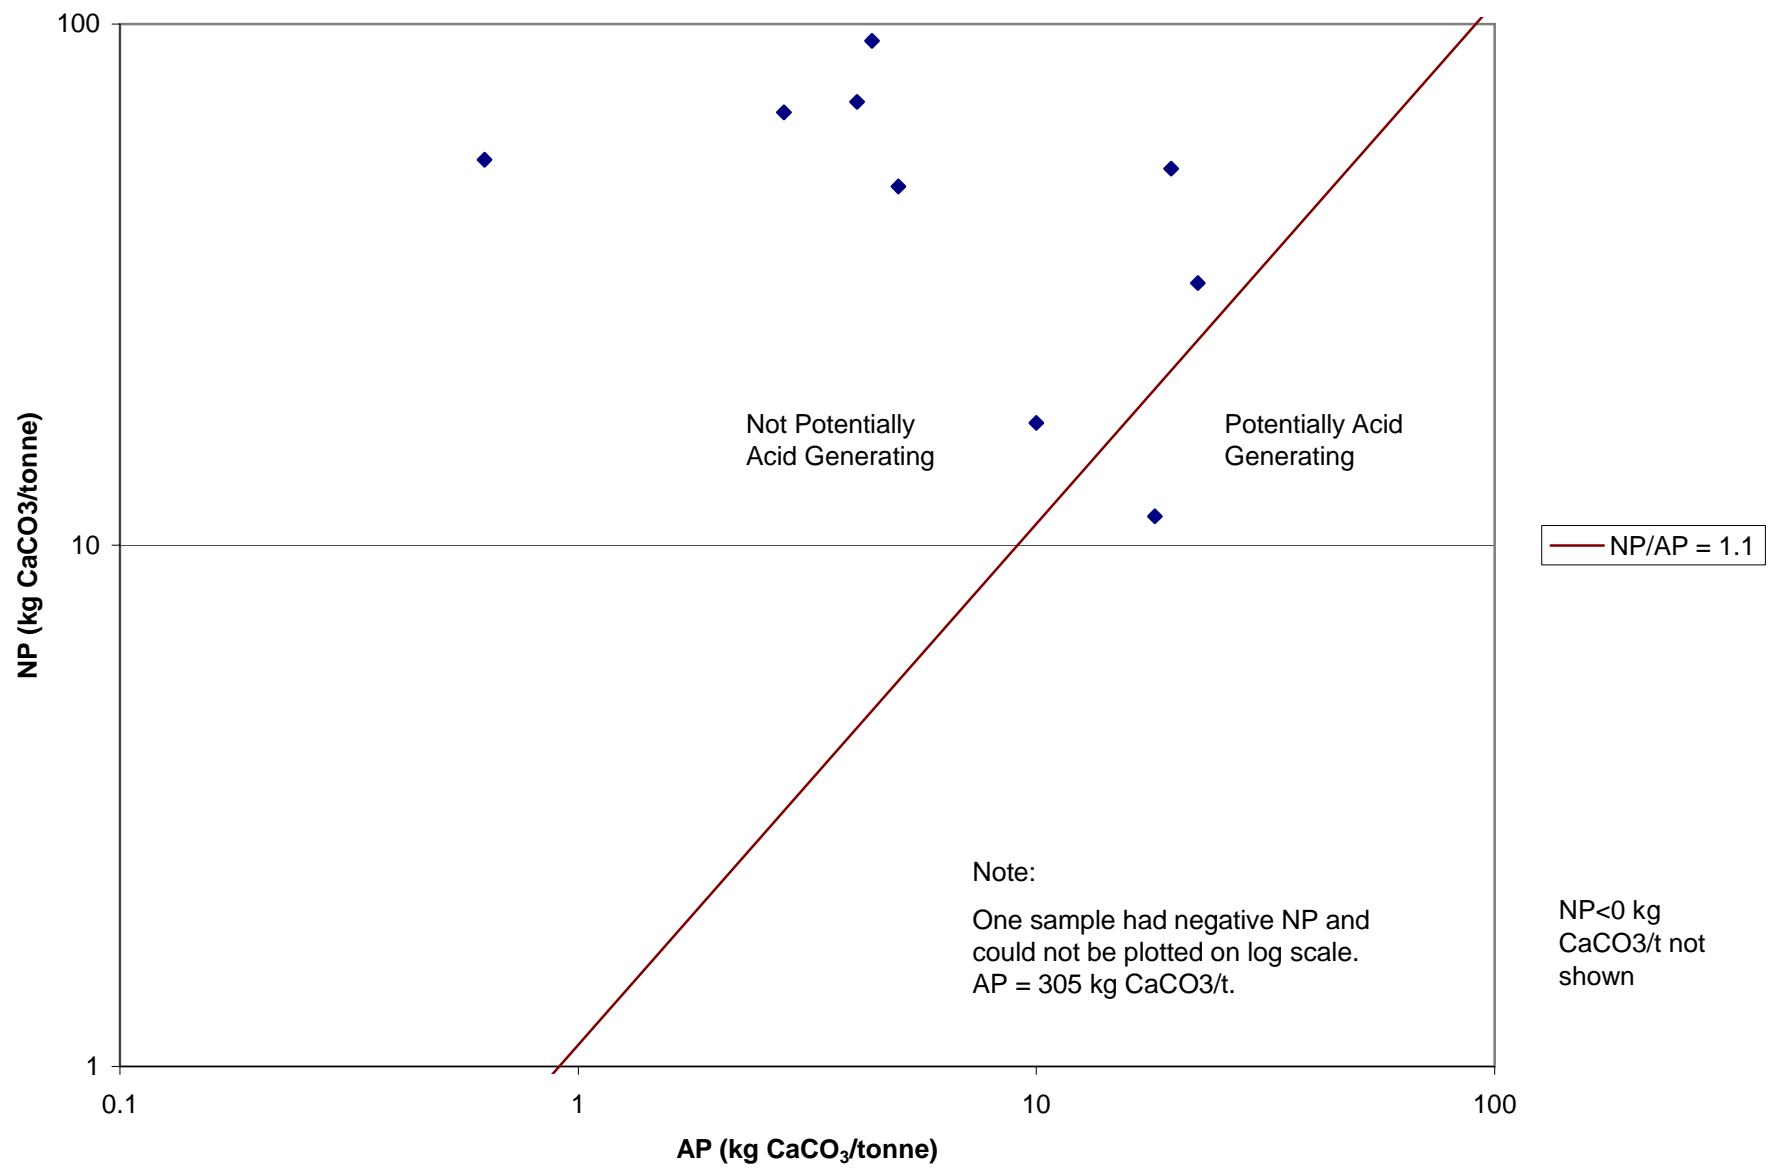
Figure: **3**

Two of the samples tested had NP/AP ratios of less than 1.1 and are considered potentially acid generating (PAG). The sulphide-sulphur content of one of these samples (HRM-05-C) was 9.8%, the reported NP was negative, and the rinse pH was 3.14, which demonstrated that the local material was already acidic. This sample was taken from an area (approximately 1 m²) containing weathered massive sulphides, and significant amounts of sulphide were noted in the sample during collection. It was chosen for ABA testing to

NP vs AP
