Faro Mine Complex 2007 Supplemental Geochemical Studies Report

2007/08 - Task 28 - FINAL

<u>Title:</u>	Faro Mining Complex: 2007 Supplemental Geochemical Studies Report– 2007/08 Task 28- FINAL
<u>Consultant:</u>	SRK Consulting (Canada) Inc.
<u>Status:</u>	Final
<u>Date:</u>	September 2008
<u>Size:</u>	11 Pages of text (including cover, introductory and reference list); 3 Appendices containing 63 pages (including 9 non-standard 11 x 17 pages and 6 flysheets).
<u>Digital File:</u>	PDF format; 9.1 MB

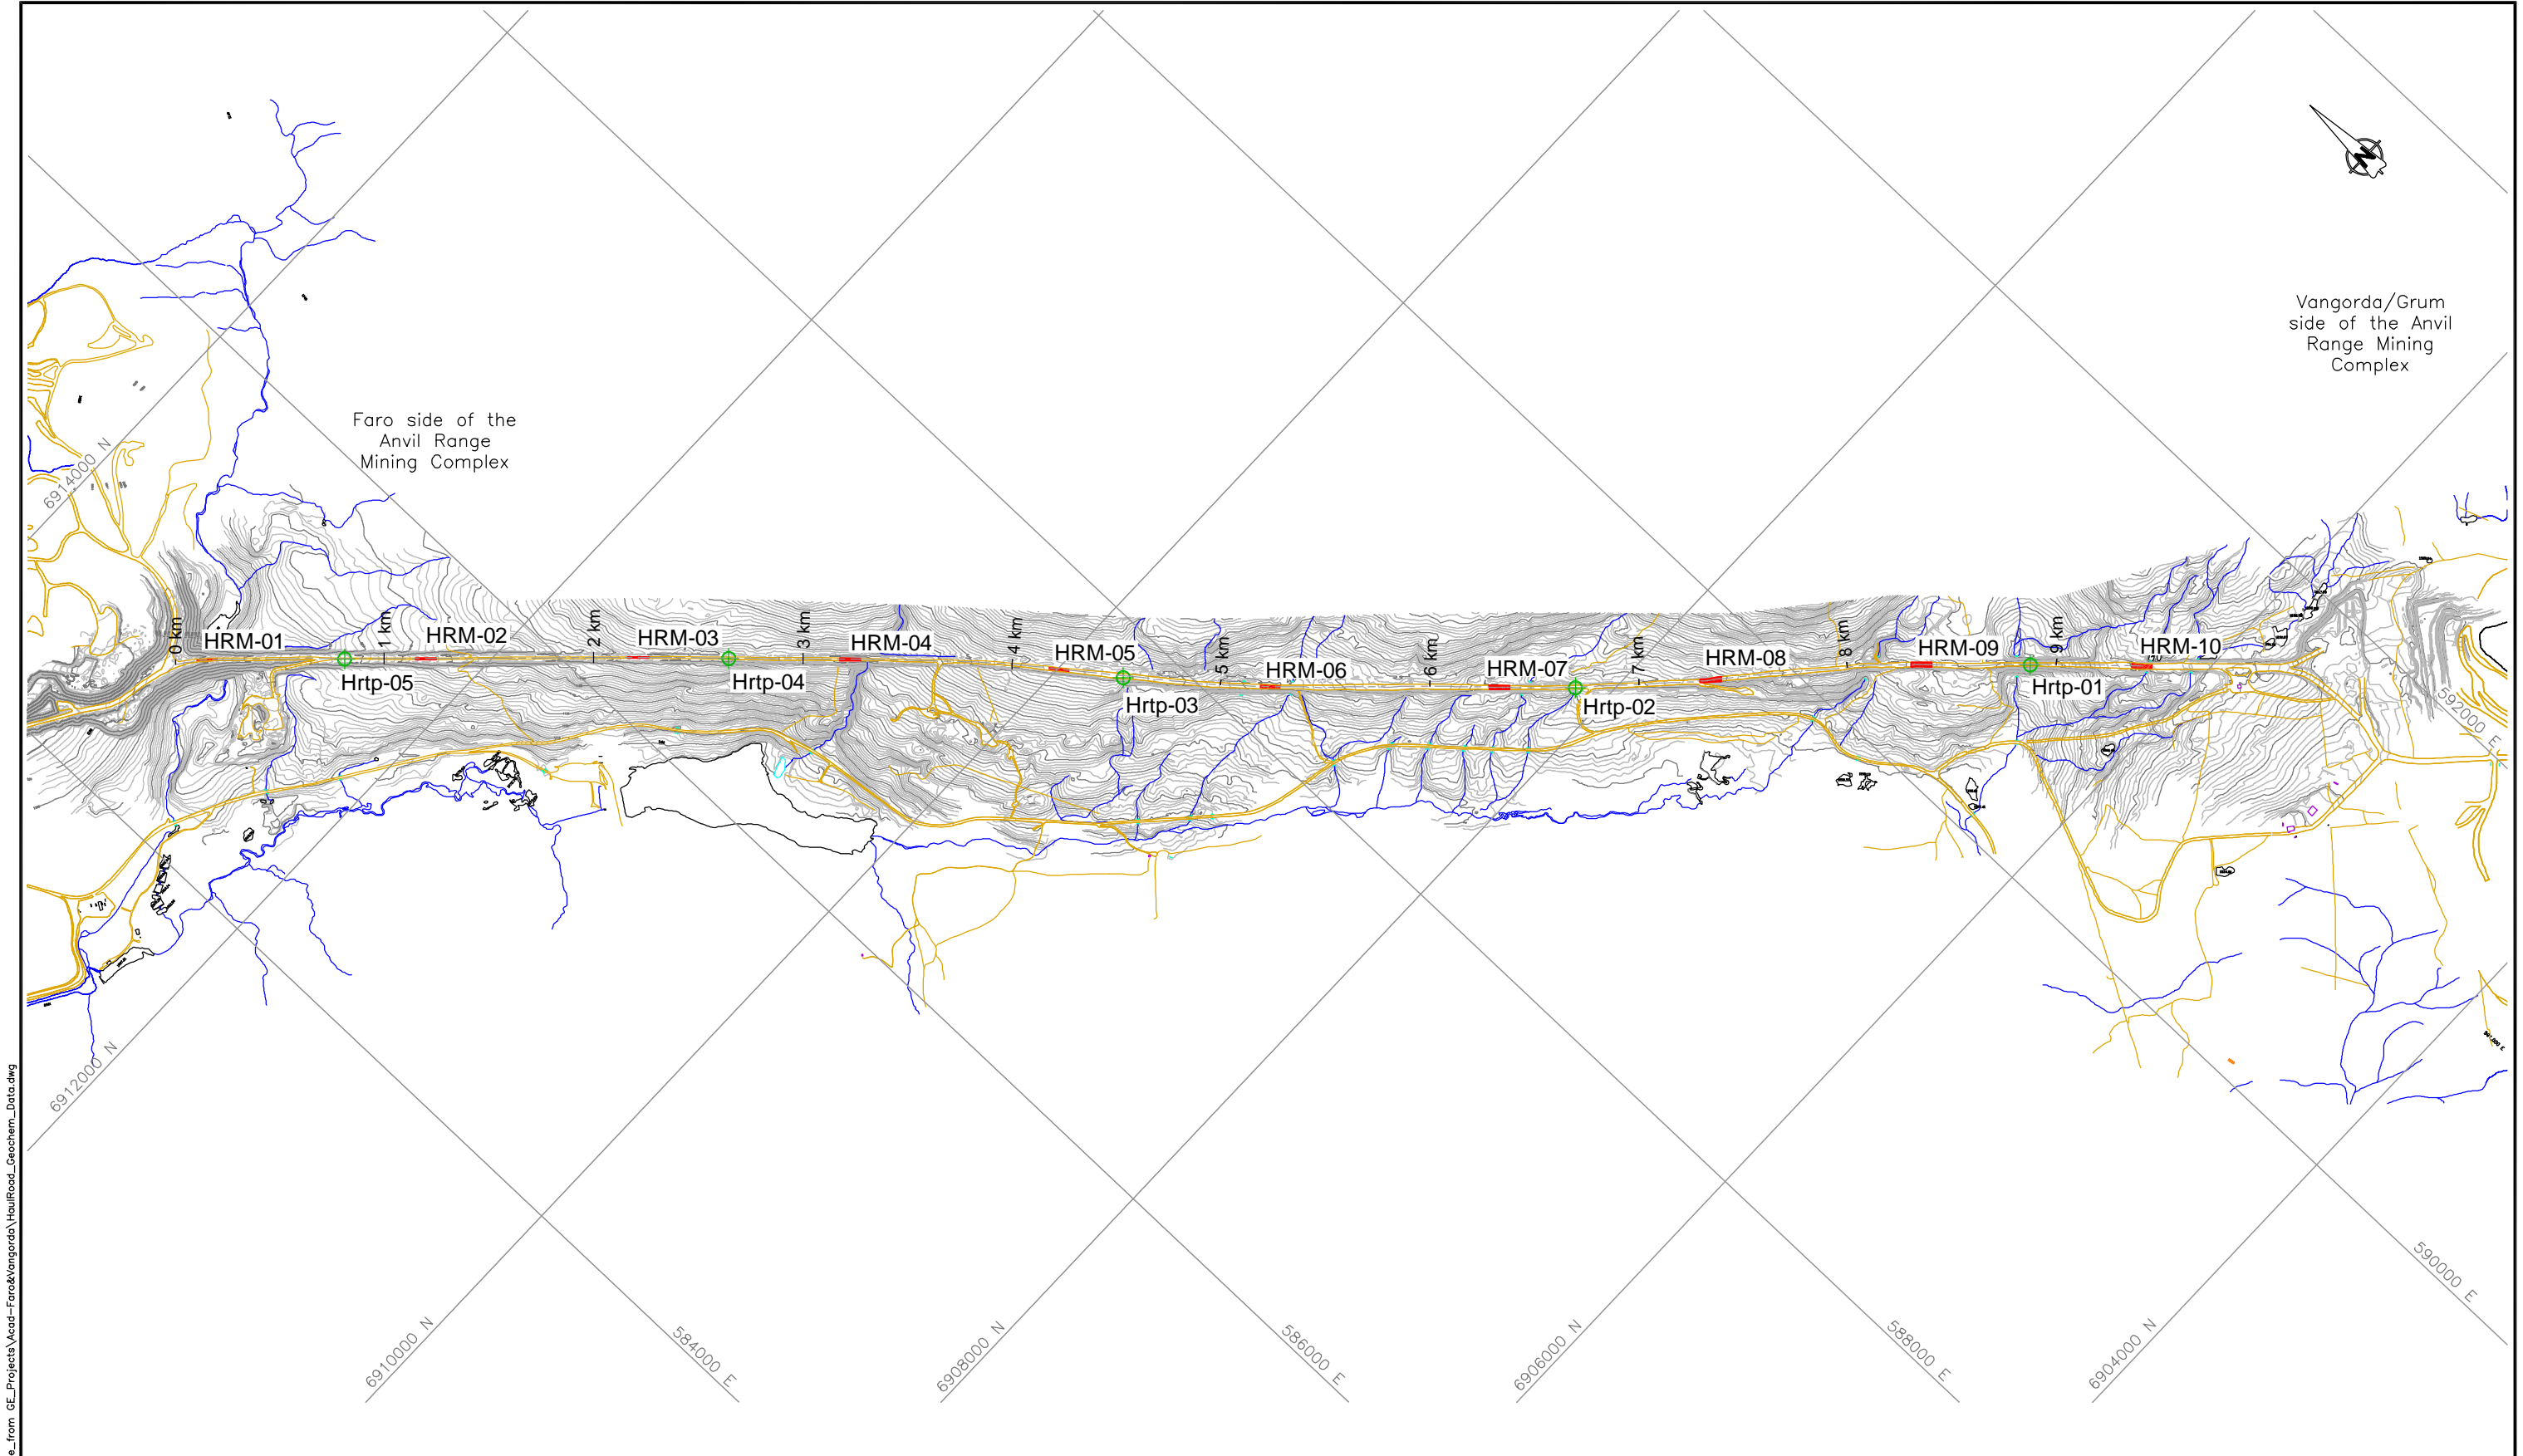
Haul Road Geochemical Study		
Haul Road Geochemical Sampling Locations		
DATE: Mar. 2008	APPROVED: M.C.C.	FIGURE: 1

Detailed waste rock characterization programs completed at the Faro site in 2002 included a series of test pits along the surface of the haul road (SRK, 2004). Locations of 2002 test pits are shown on Figure 1 and results are provided in Attachment 1. Sulphide minerals were identified in some of these test pits, indicating that some of the material used to construct the Haul Road has potential for metal leaching and/or ARD. However, there was some question whether the 2002 samples accurately represented the bulk composition of the Haul Road foundation or whether sulphides observed in the 2002 test pits were either localized or typical of near-surface road bed material. As a result, a follow-up investigation was proposed for 2007 to assess whether measurable contaminant leaching was occurring from the Haul Road, and to further evaluate the extent of Haul Road construction fill containing sulphide minerals.

A total of 23 samples were collected from the ten mapped intervals along the length of the Haul Road (Figure 1). Contact tests (rinse pH and conductivity) were performed on the samples by SRK staff. All samples were sent to Cantest Ltd. (Burnaby, BC) for analysis by aqua regia digestion and ICP-MS for a full suite of elements, including sulphur.

Rock types encountered during surface mapping included calc-silicates, biotite schist, chloritic schist, quartz porphyry, till, and phyllite mixed with sulphides (Attachment 3). These rock types occurred in different proportions along the length of the Haul Road. Sulphide minerals were present in massive sulphide cobbles, in association with quartz veins in schists, and as a component of quartz porphyry rocks. Sulphides were observed at several of the sites that were mapped along the Haul Road, although visual estimates of sulphide abundance never exceeded 1%. Evidence of sulphide weathering (i.e. local rusty staining) was observed, particularly of massive sulphide cobbles, but these occurrences were localized. Large areas (i.e. meter scale) of sulphide weathering were not observed.
