**An assessment of Fish Resources in the Area surrounding the
Keno Hill Mine Complex**

**Frank Patch
Type II Project Manager
Assessment and Abandoned Mines
Government of Yukon**

**WHITE MOUNTAIN ENVIRONMENTAL CONSULTING
January, 2006**

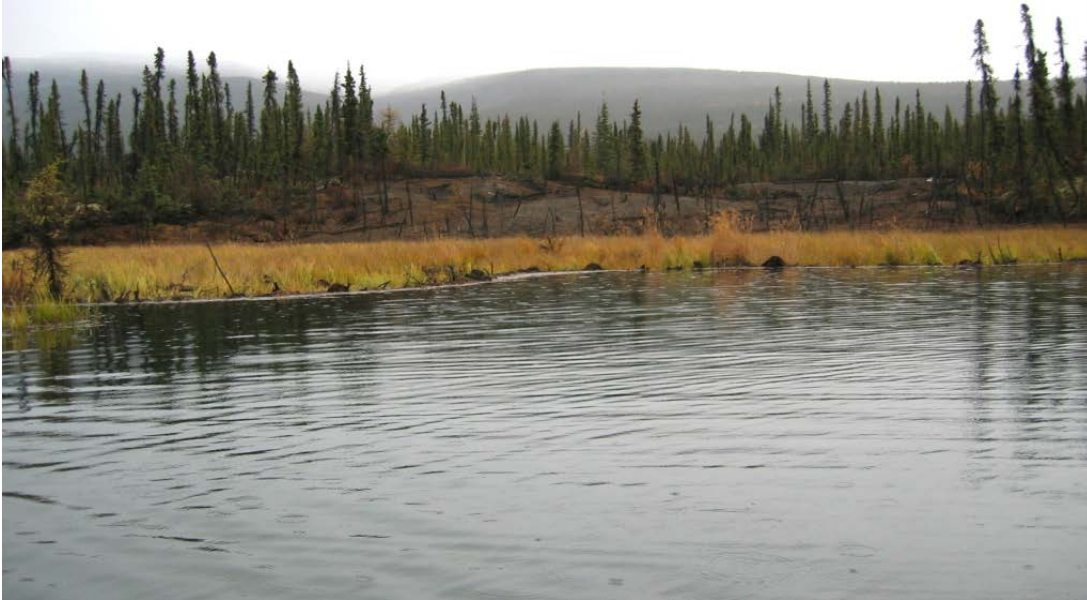
Photo 1: The beaver dam at the outflow of Christal Lake during September, 2006. The non-vegetated area in the background is tailings from the late 1950's that will be eroded in the event the beaver dam fails.

An old tailings pile exists immediately downstream of the beaver dam on the north east corner of the lake (photo 1). The tailings originated from a mill that operated on the east side of Christal Lake from 1956 to 1958. Tailings are also visible at the north end of the lake, in the lake; these were dumped on the ice during spring when the mill was in operation (photo 2). The tailings within the lake are at present stable. The tailings below the beaver dam are at risk of being washed into Christal Creek if the beaver breaches on the east side.

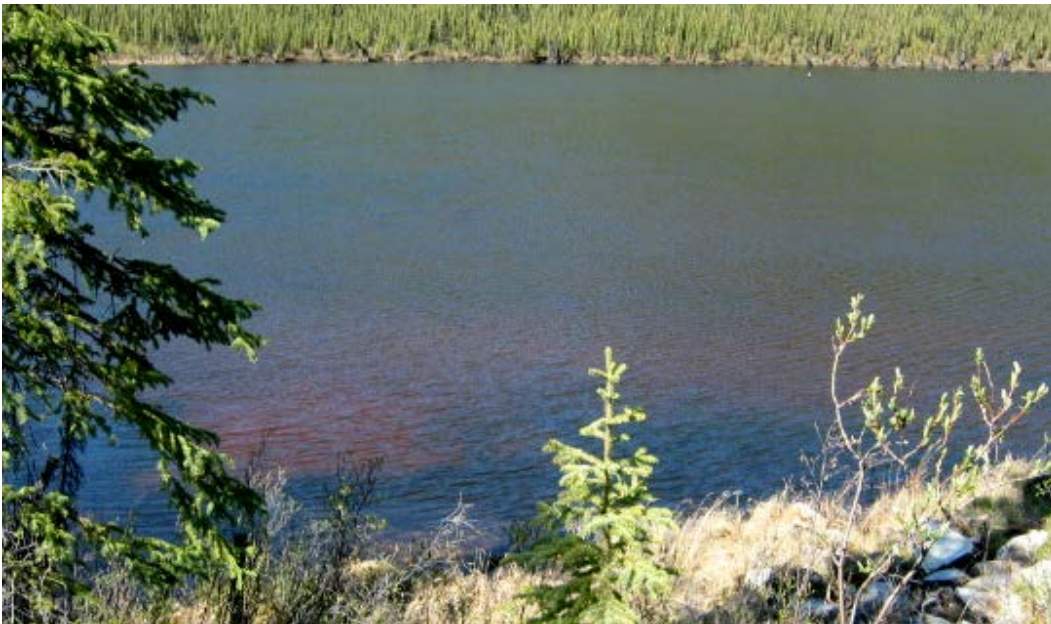
Photo 2: Tailings, visible as red, deposited into Christal Lake during the late 1950's are still visible at the north end of the lake. June 2006.

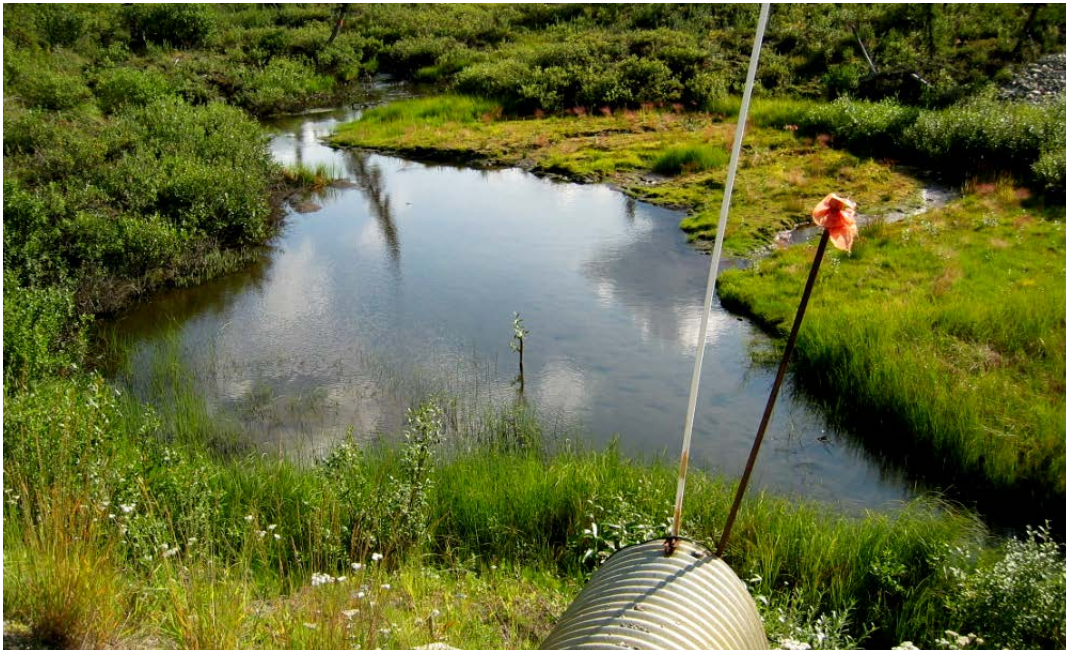
Photo 3: The shallow pool upstream of the Keno Road crossing at site KV 6 during August, 2006.

Site KV 6 is located at the Keno Road crossing of Christal Creek. Habitats in this study reach have been modified by the road crossing, a pool created on the upstream side of the road bed (photo 3) and alterations to winter flow through the culvert have created unnatural habitats to the native creek habitats downstream of the road. Remnants of the black mat that had been common throughout Christal Creek in 1995 were observed only

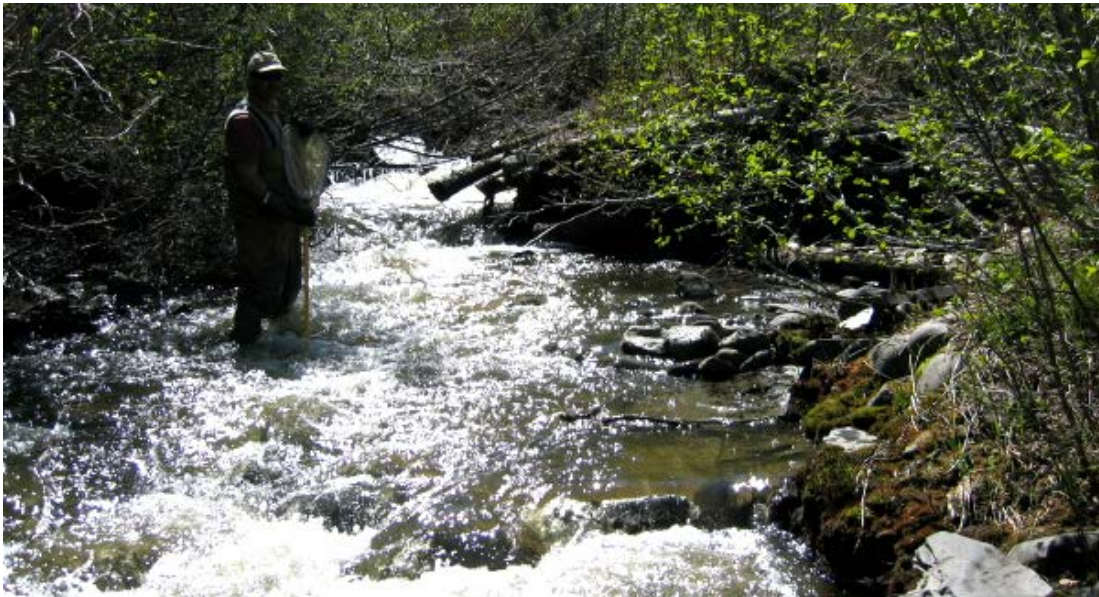
Photo 4: Christal Creek site C4 during June of 2006 at the site of the 1995 barrier. During the 1995 investigations the creek flowed on the right side of the photo over a 1.5 meter barrier. The flowing channel on the left has been cut some time since 1995.

Bridges across the creek, built in the 1960's and now collapsed have created a series of barriers to fish movement. The lower barrier observed in 1995, no fish were recorded upstream of this barrier in 1995 (Sparling and Connor 1995) and the pools below have changed at some time between 1995 and 2006. The creek has cut a new channel around the old barrier and the pools down stream of the old barrier have filled in (photo 4). The pools were suspected as having provided over winter habitat for a small group of Arctic grayling in 1995.

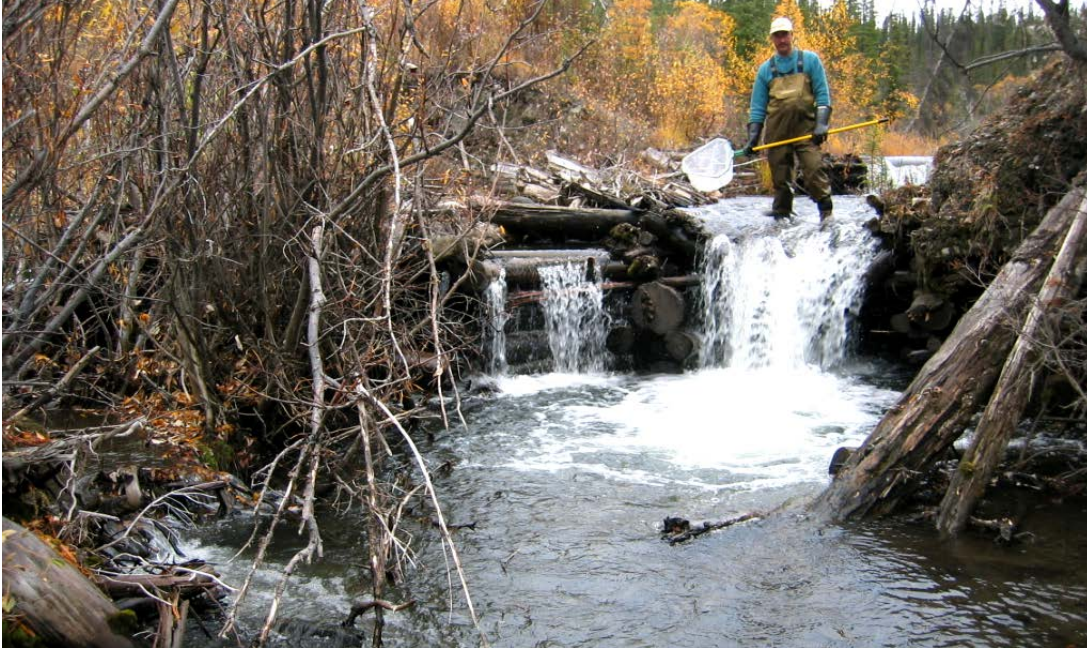
Photo 5: Intact barriers on Christal Creek during August of 2006, at the upstream end of site C 4. A second barrier is visible in the background and both are higher than 1 meter. No Arctic grayling were recorded upstream of this barrier in 2006.

A series of three other barriers, all upstream of the washed out barrier remain in place. The first, approximately 230 meters upstream from the original barrier, a small stick jam created over old bridge timbers has created a partial barrier that acts as a barrier during low water, Arctic grayling were recorded above this barrier in 2006. No fish were captured upstream of the second and third extant barriers, separated by 30 meters, and located a further 370 meters upstream of the washed out barrier. Both of these barriers likely limit fish migration during all seasons (photo 5). Arctic grayling were the only fish found in this reach during the 2006 investigations (Tables 2 and 3) and although moderately common they were not as common as and more widely dispersed than in 1995.

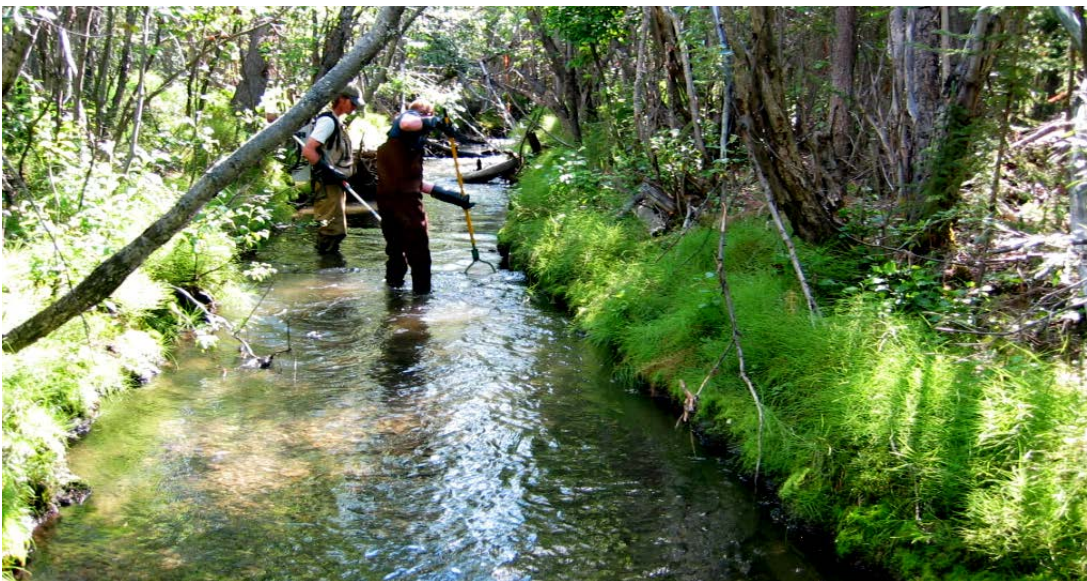
Photo 6: Christal Creek at site KV 7 during August of 2006.

Site KV 7 at the Hanson Lake Road crossing has also had all remnants of the fine black mats that were apparent in 1995 removed. This site has very limited fish cover and mostly fine substrates (photo 6). Conductivity at this site was high (>700 ms/sec) during all three sampling periods in 2006 and no fish were recorded. The high conductivity did limit the effectiveness of electro-fishing. The only fish recorded at this site during 1995 was a single Arctic grayling juvenile.

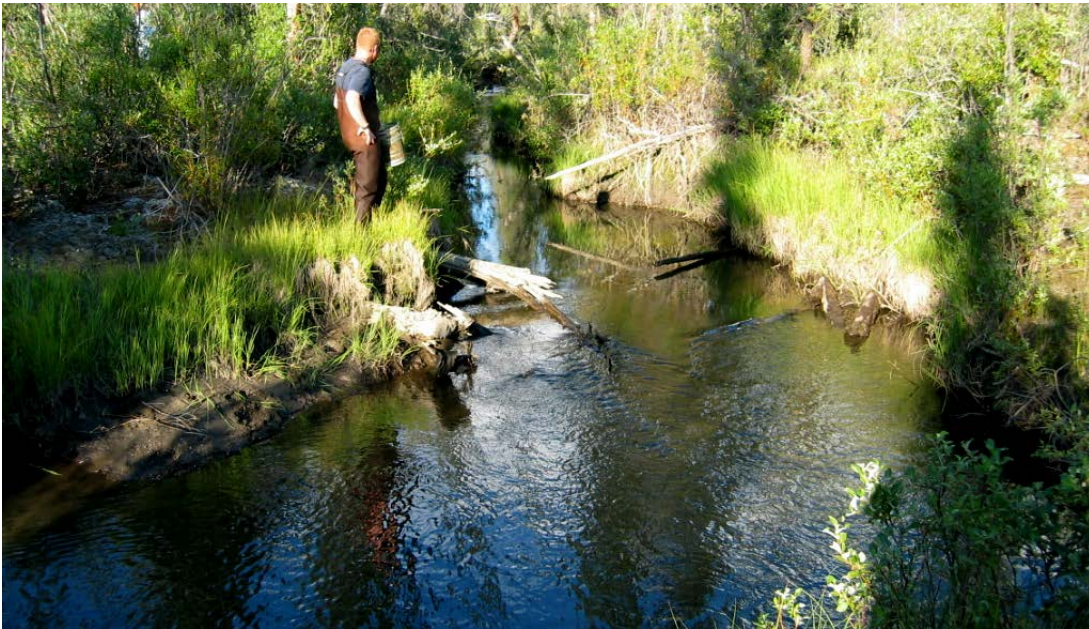
Photo 7: Site KV 8, Christal Creek flows as a narrow and confined channel before entering a series of pools 50 meters upstream of the South McQuesten River, August 2006.

Christal Creek at site KV 8 was investigated from the confluence with the South McQuesten River upstream for a distance of 265 meters. Within this reach the creek flows in a narrow, deep and confined channel before opening into a series of pools for extending 50 meters before entering the South McQuesten River (photo 7). The site has good, but small fish habitats that were very lightly utilized. During August and September, 2006 small slimy and occasional juvenile Arctic grayling, sub-adult burbot were recorded (tables 2 and 3). A group of six adult Arctic grayling were observed but not captured, in the lower pool during the August investigation. No fish were recorded at this site during spring evaluations, however water levels were high fishing was difficult.

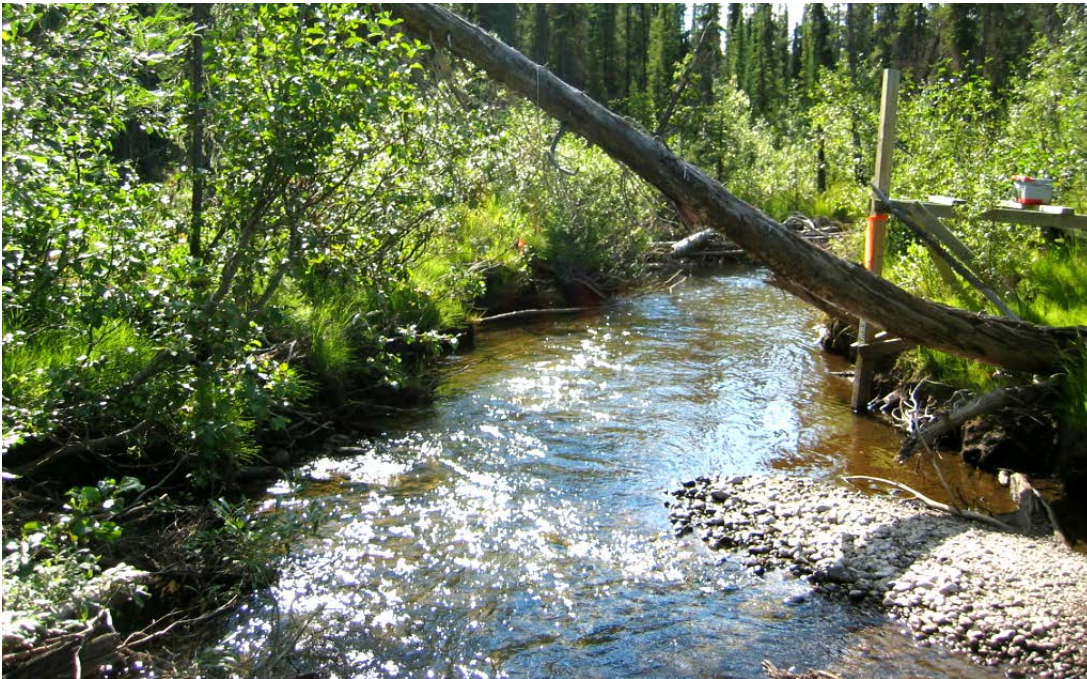
Photo 8: Lower Flat Creek, showing water staff gauge, 90 meters upstream of the South McQuesten River. This reach was the lower 60 meters of the block net fish survey 100 meter reach.

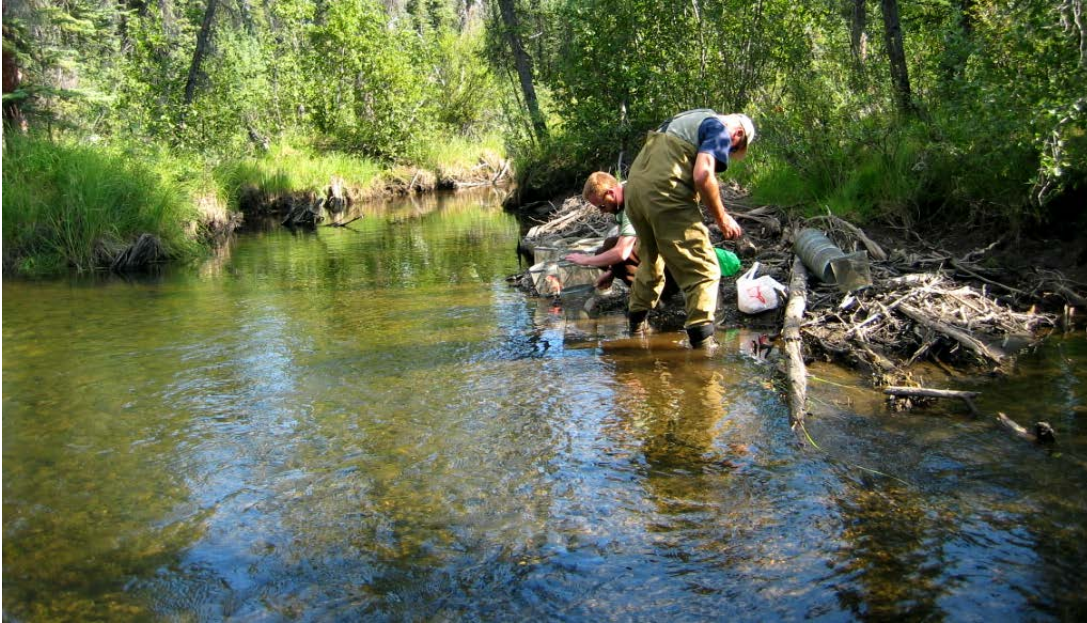
Photo 9: Flat Creek as it enters the South McQuesten River, August 2006.

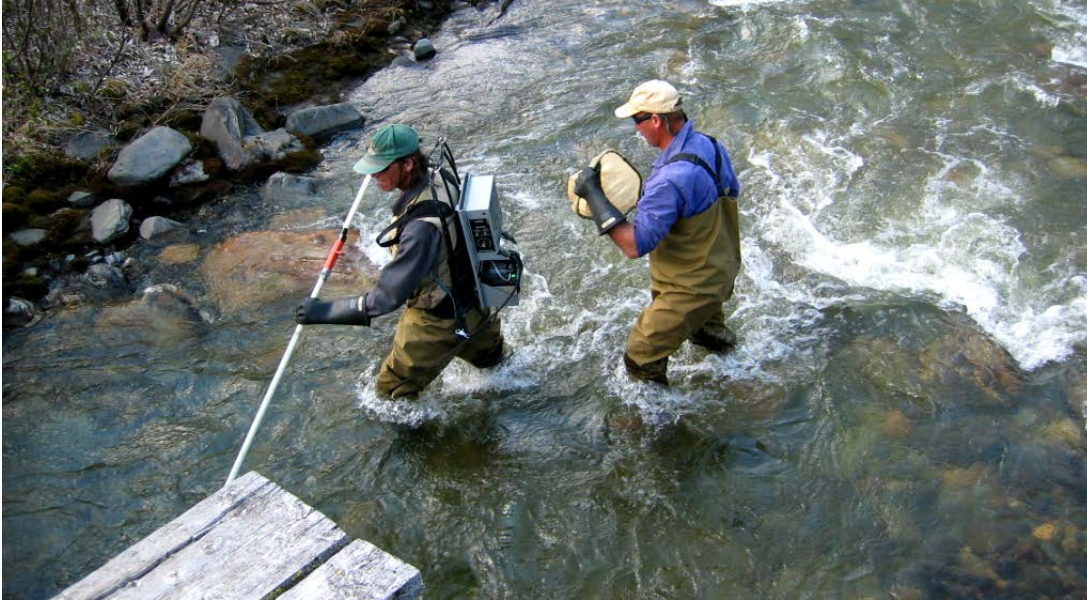
Photo 10: Lightning Creek site LgT K. Electro-fishing below the abandoned bridge at the downstream end of the Keno campgrounds, June 2006.

Habitats have stabilized at both sites. Site LgT K consists of fast flowing rapids over highly compacted boulders with plunge pools associated with both the culvert and the old bridge. A collection pool upstream of the culvert creates the widest section of the reach. The lower reach, site LgT D has a much slower flow with gravel substrates.

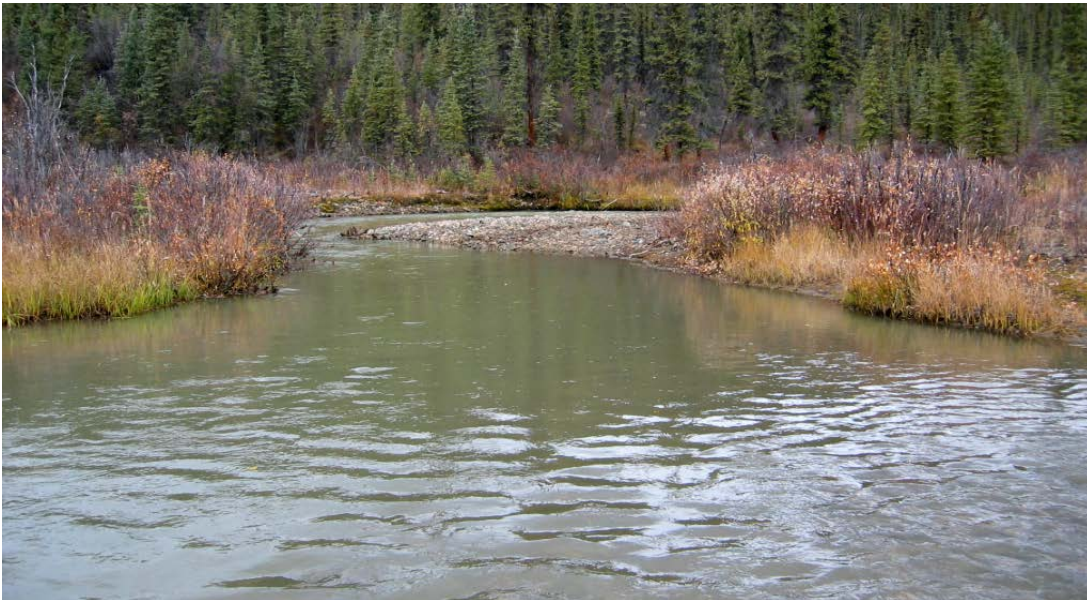
Photo 11: Lightning Creek looking upstream from the Duncan Creek Road ford during September, 2006.

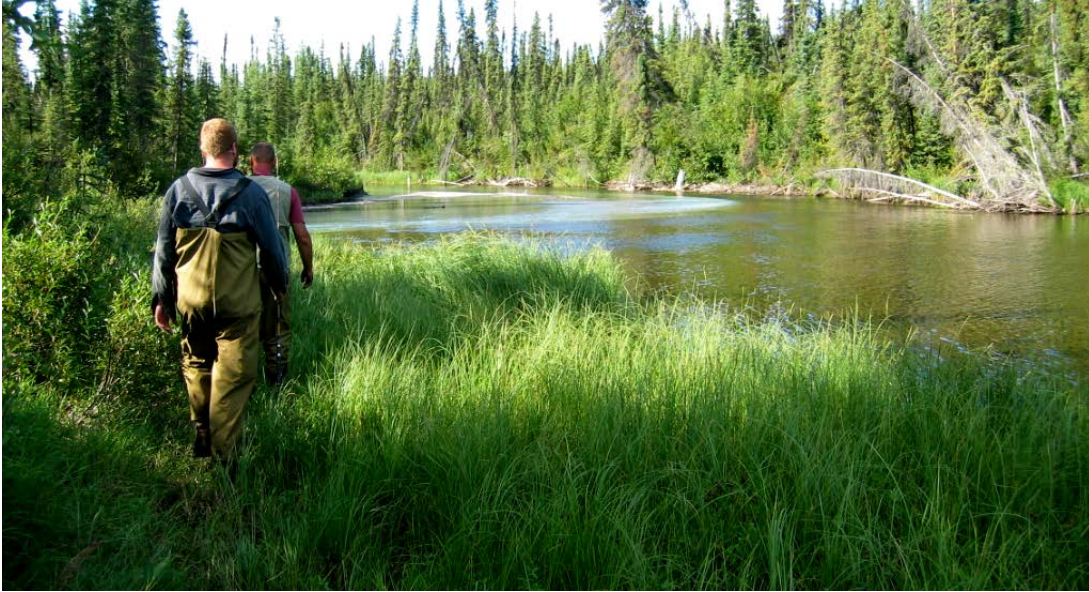
Photo 12: Cache Creek entering the South McQuesten River just downstream from the outlet of McQuesten Lake. The turbid plume from Cache Creek was clearly visible during August, 2006.

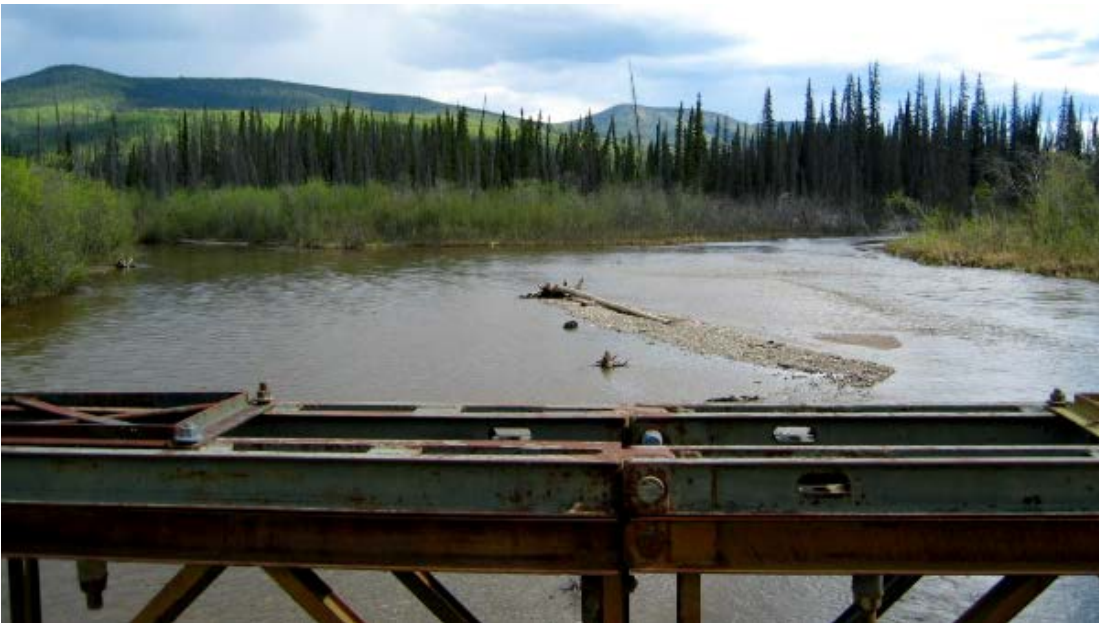
Photo 13: the confluence of the South McQuesten River (right) and Haggart Creek as seen from the Haggart Creek bridge in June, 2006.

Fish utilization of the South McQuesten was in general, found to be much greater downstream of the confluence of Haggart Creek both in terms of the number of fish captured and in species diversity than upstream of the confluence. No chinook salmon juveniles were recorded upstream of the confluence with Haggart Creek, however they were recorded downstream of the confluence (photo 13).
