# Historical Review

Of  
Former  
United Keno Hill  
Mines Limited  
Quartz Claims

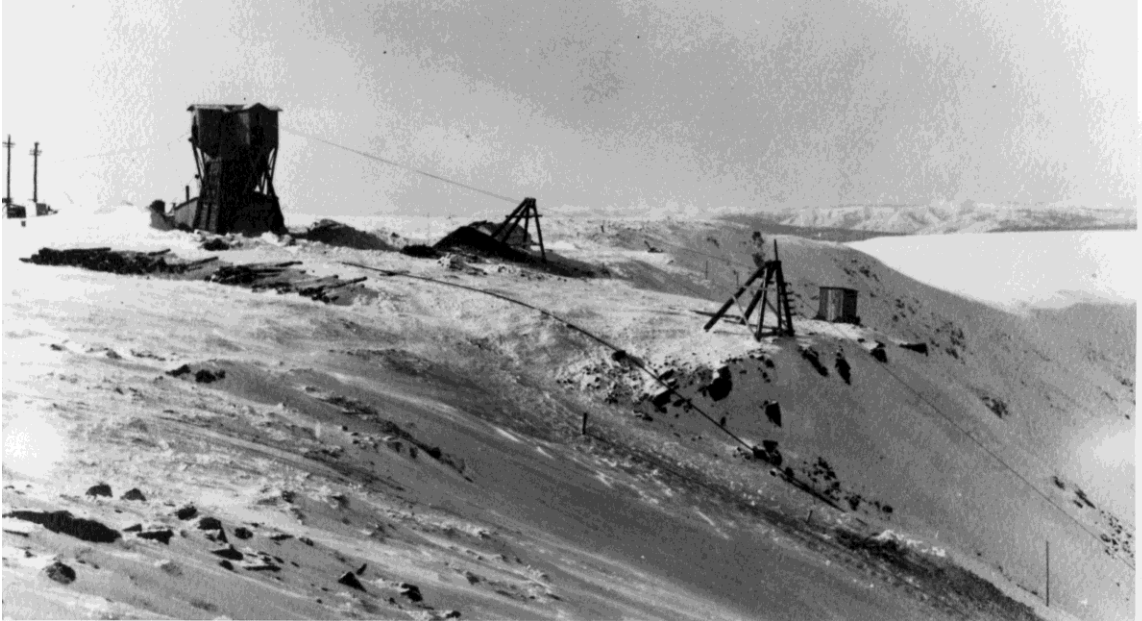
There is an outhouse in the photos at the edge of the cirque. Dr Aro Aho noted there was a rope for the men to follow during strong winds to prevent them from slipping over the edge.

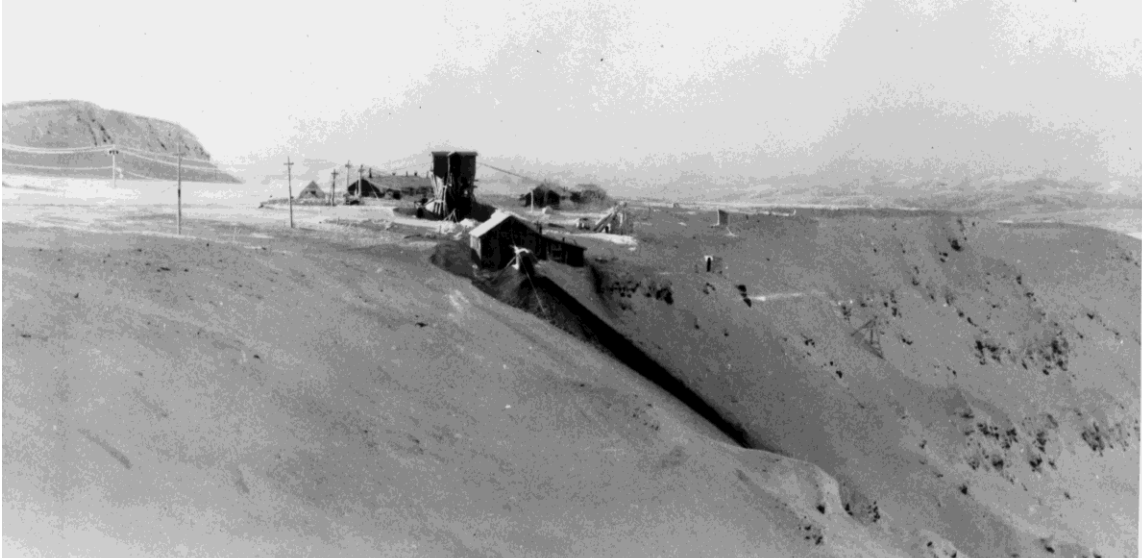
*Hoist house, a few buildings, portal and dump at the mine site on Keno Hill  
Schellinger Fonds, photo 5831  
Courtesy of Yukon Archives*

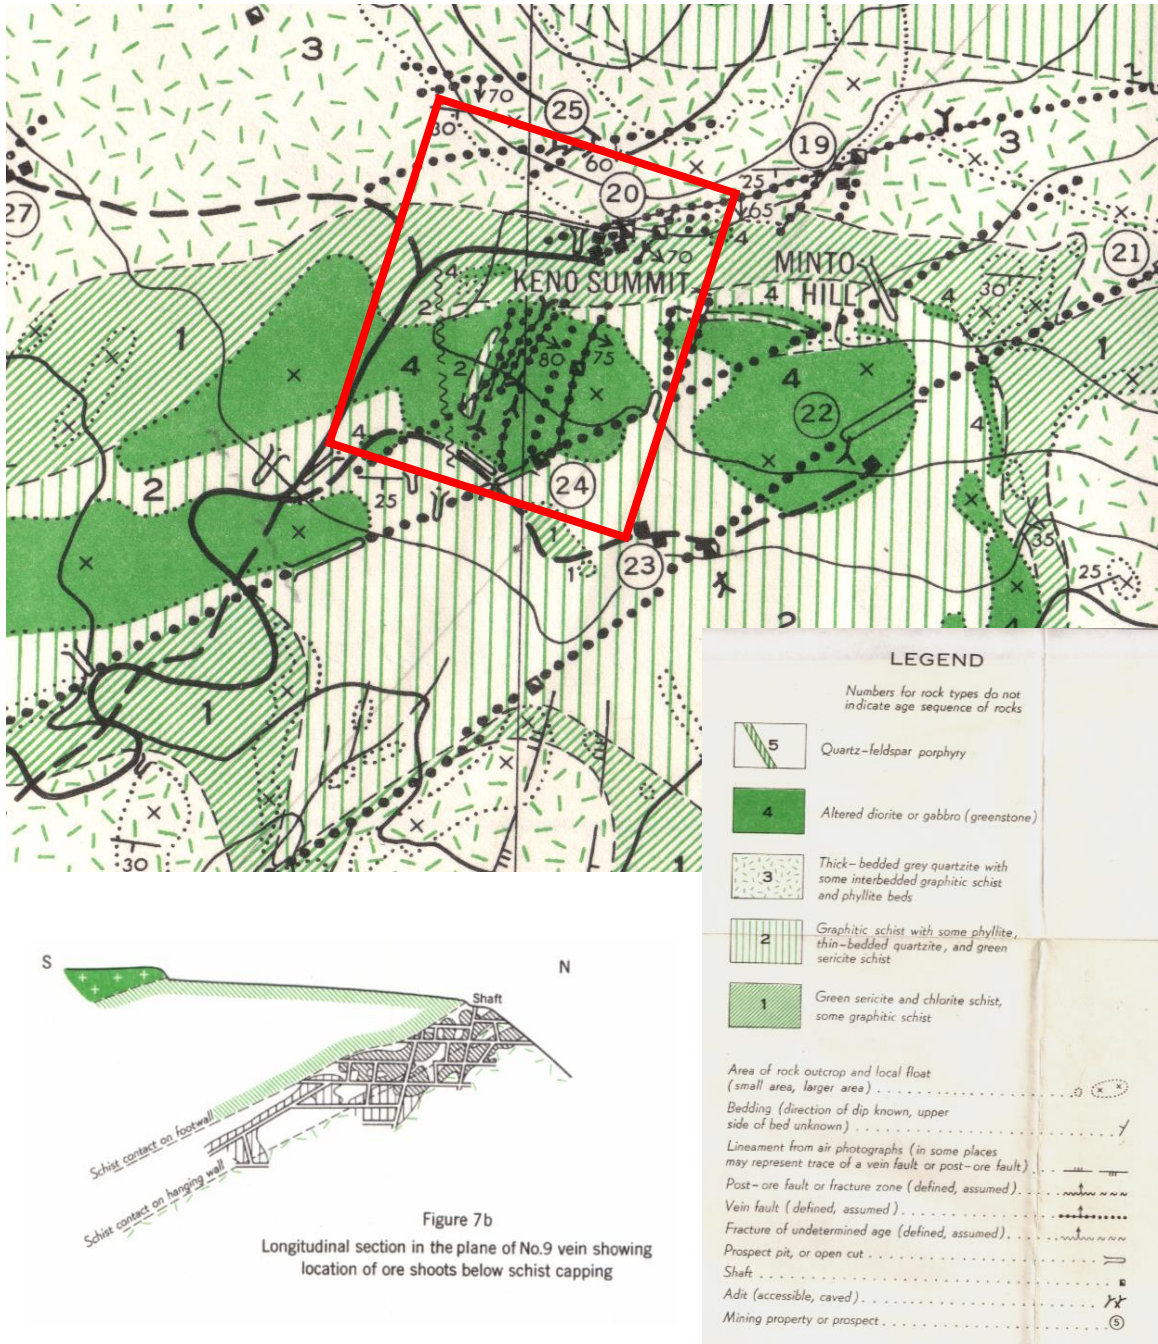
Geological Survey of Canada Paper 55-30 By R. W. Boyle Ottawa 1956 Part of figure 5

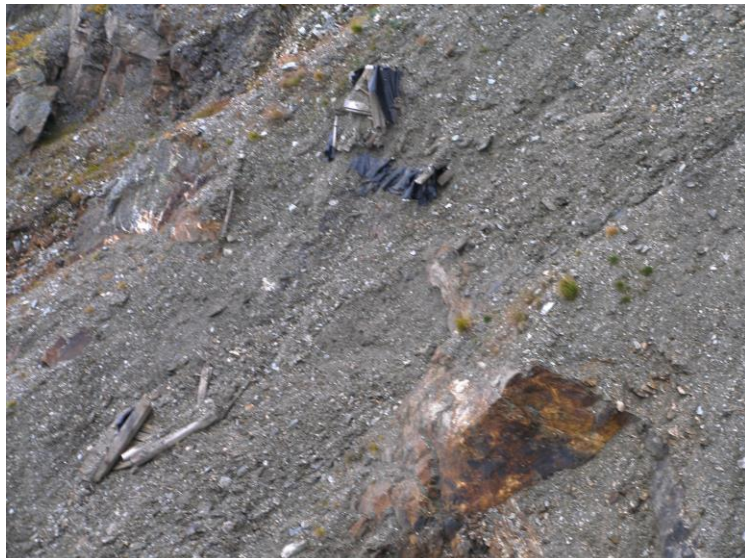
### # 6 Vein Shaft Building

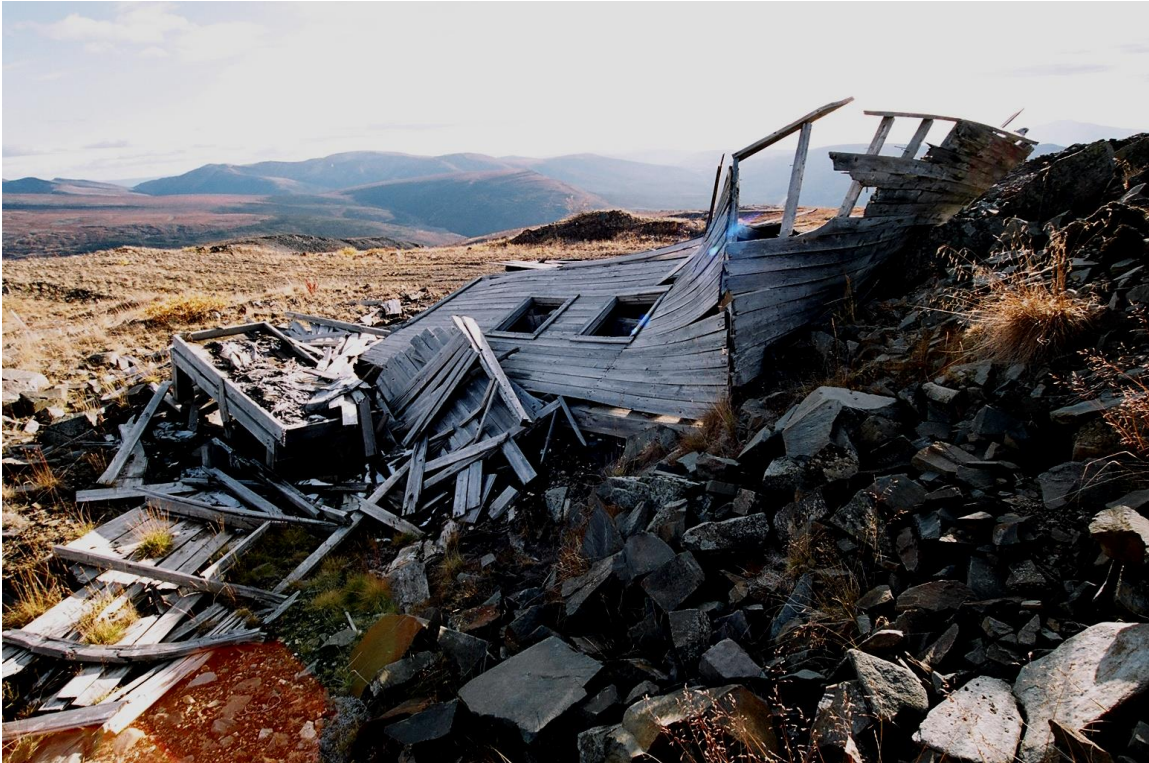
The walls are constructed with 2x4 studs that are sheathed on the exterior with 1x6 shiplap boards. The building had a gable roof with 2x6 rafters that were sheathed with 1x6 shiplap boards. No other exterior sheathing was evident.

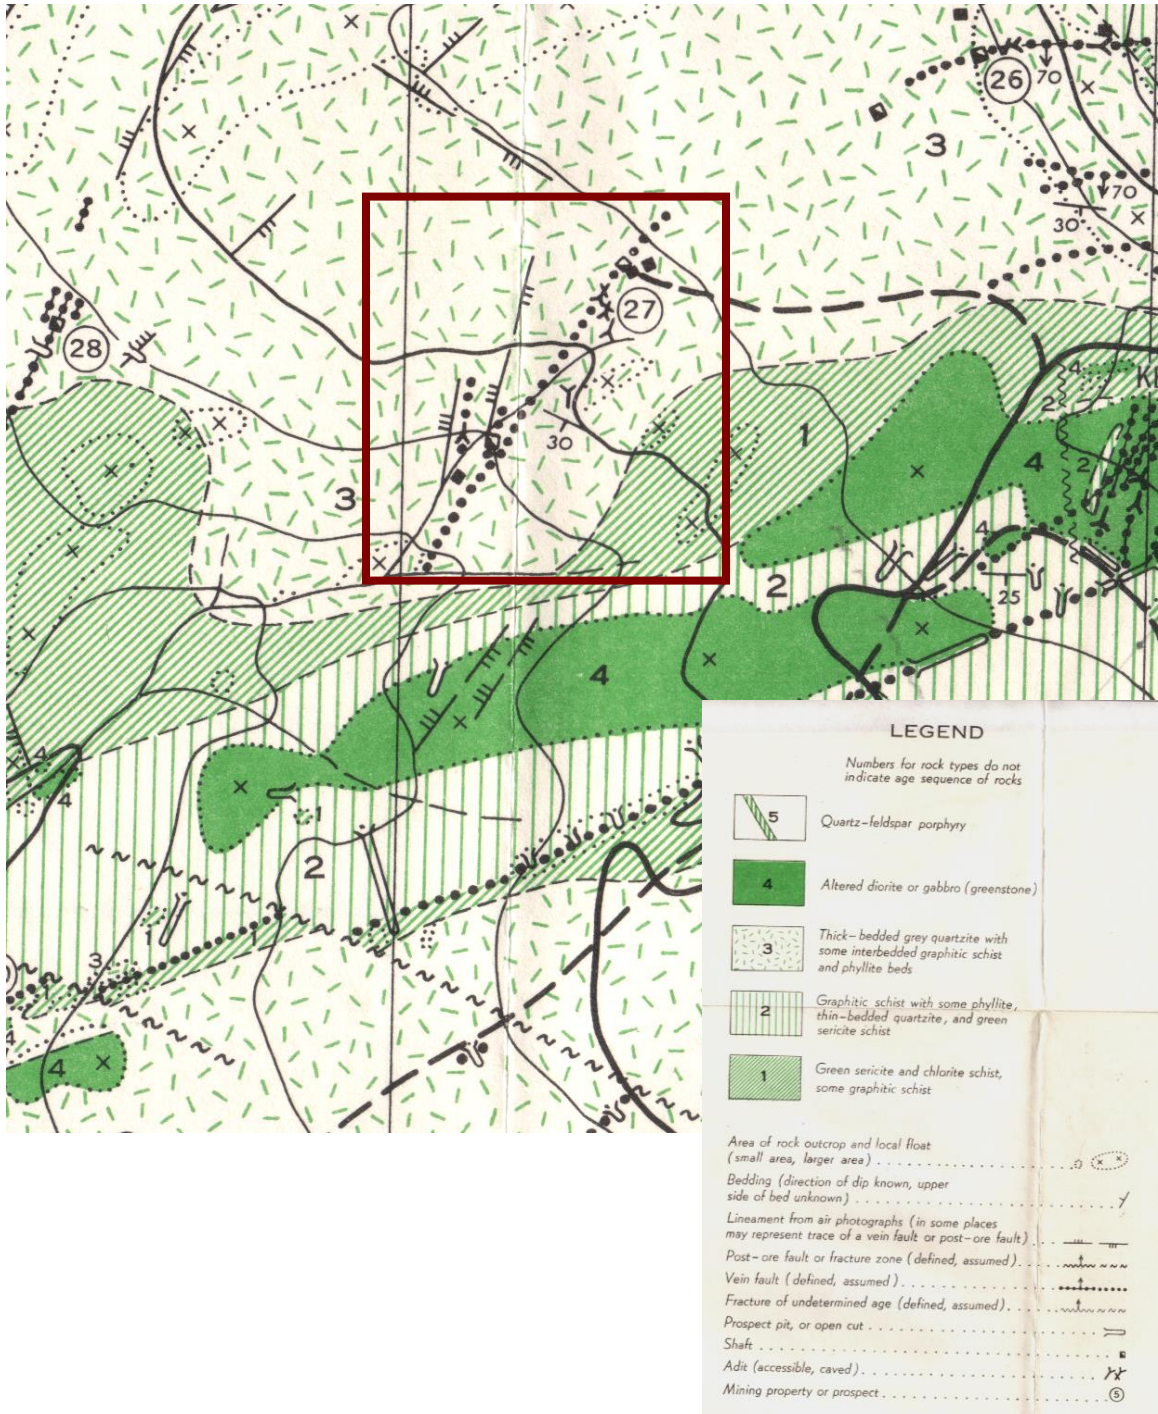
Geological Survey of Canada Paper 55-30 By R. W. Boyle Ottawa 1956 Part of figure 5

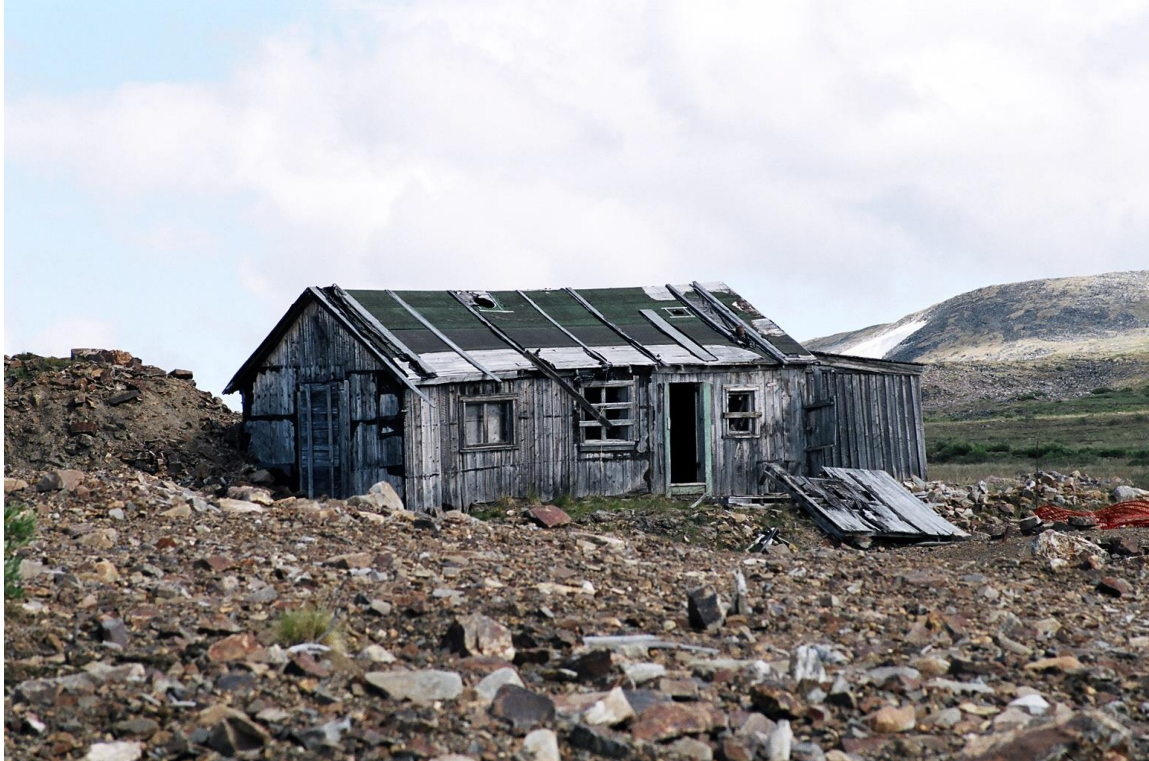
There are two additions built off the east and north walls.

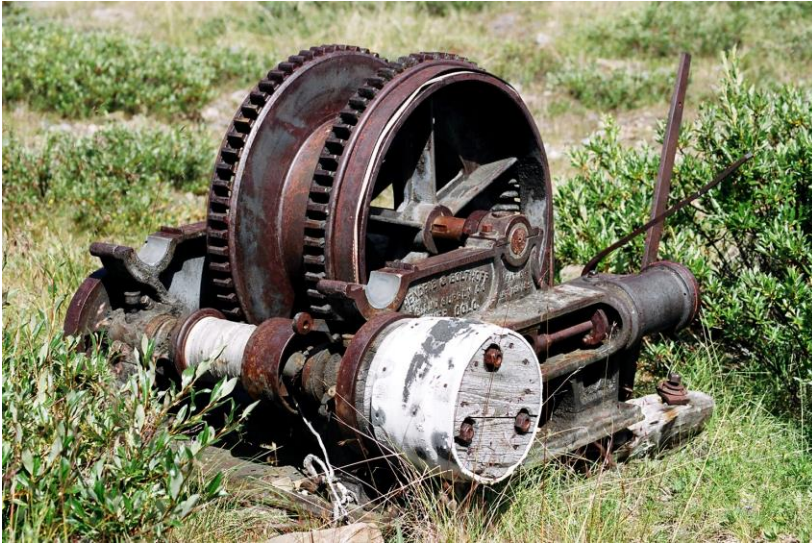
There is an old winch located approximately 150 meters southeast, on the other side of the main trench that runs north to south by building #1. "HENRIE & BOLTOFF MFG AND SUPPLY CO. DENVER COLD manufactured the steel one cylinder winch. PAT. D May 18 1897.

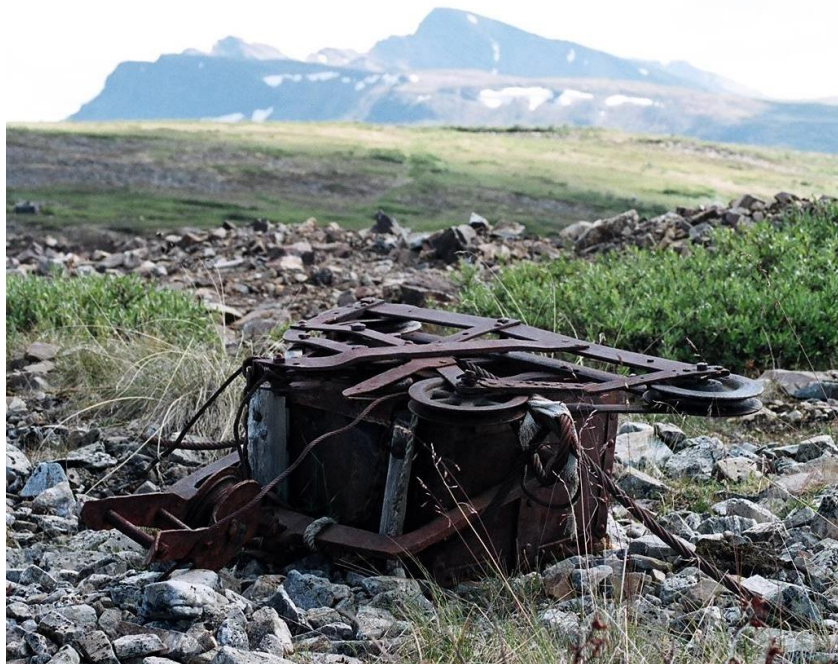
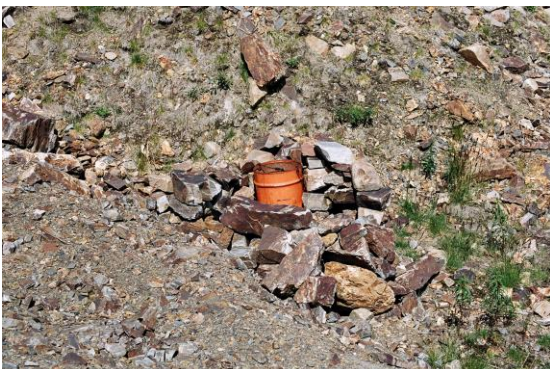
Southeast of building #1 is an outhouse located behind a large pile of ground. Flat stones have been piled 1 meter high and there is a 15-gallon fuel keg that is used for a toilet.

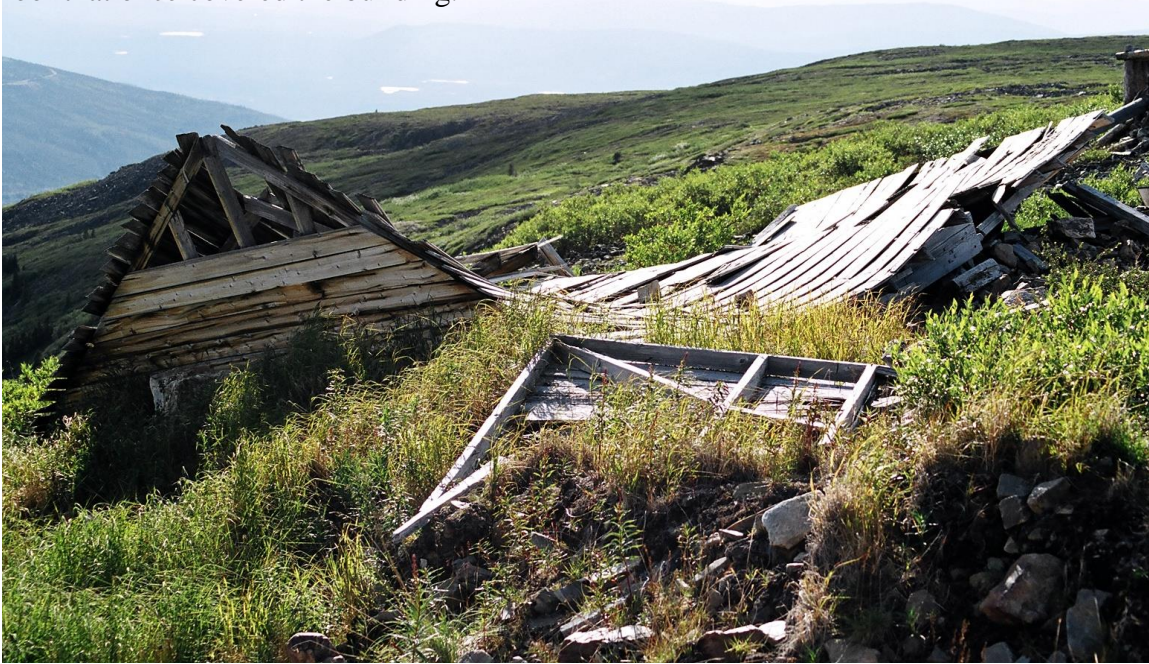
The walls are constructed of 2x4 studs with 1x6 shiplap boards used for exterior sheathing. The roof is constructed with 2x4 trusses that are sheathed in with 1x6 shiplap boards. There is no evidence of any roofing material having been used. It looks as though some of the material from the building has been savaged.

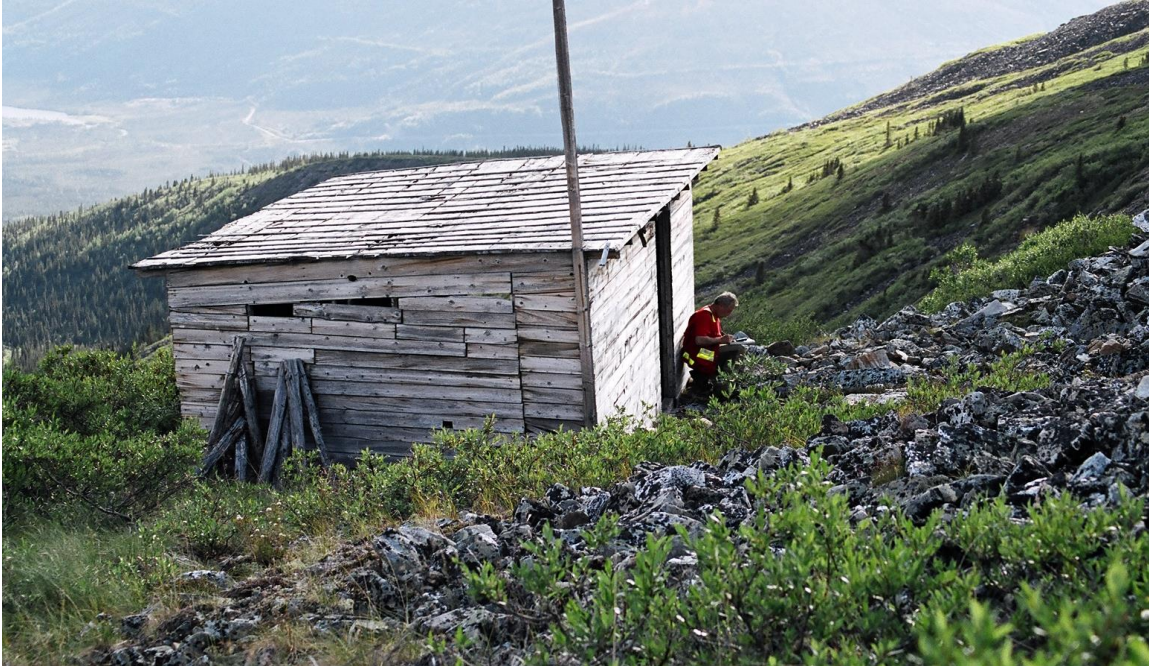
There is an almost flat shed roof that is built with 2x4 trusses and sheeted over with a combination of 1x8 and 1x10 planks. There are some remnants of black tar paper, most likely used as roofing material.

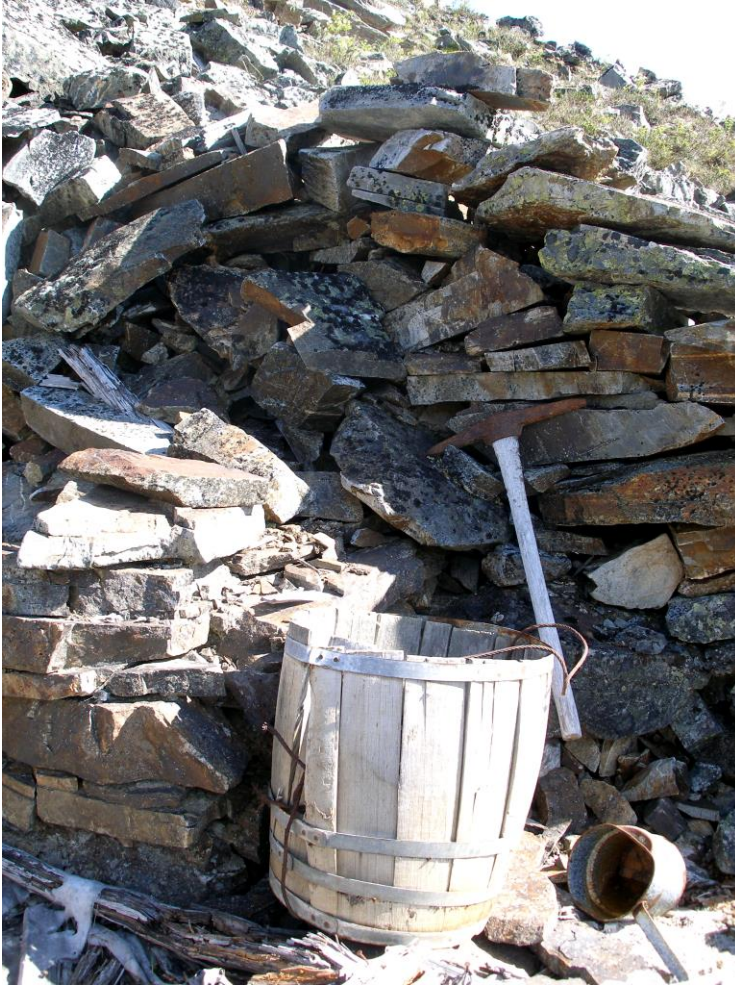
Artifacts at the shaft include a pickaxe that is leaning against the rock wall, along with wooden buckets with wire handles and a few cooking pots.

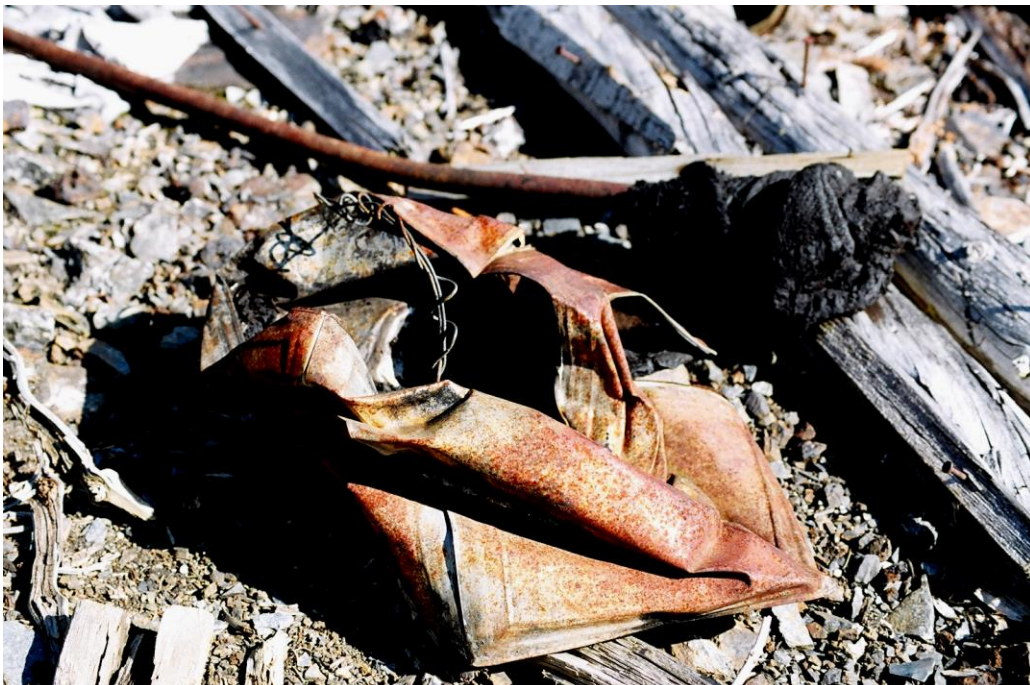
*Shamrock building #4*

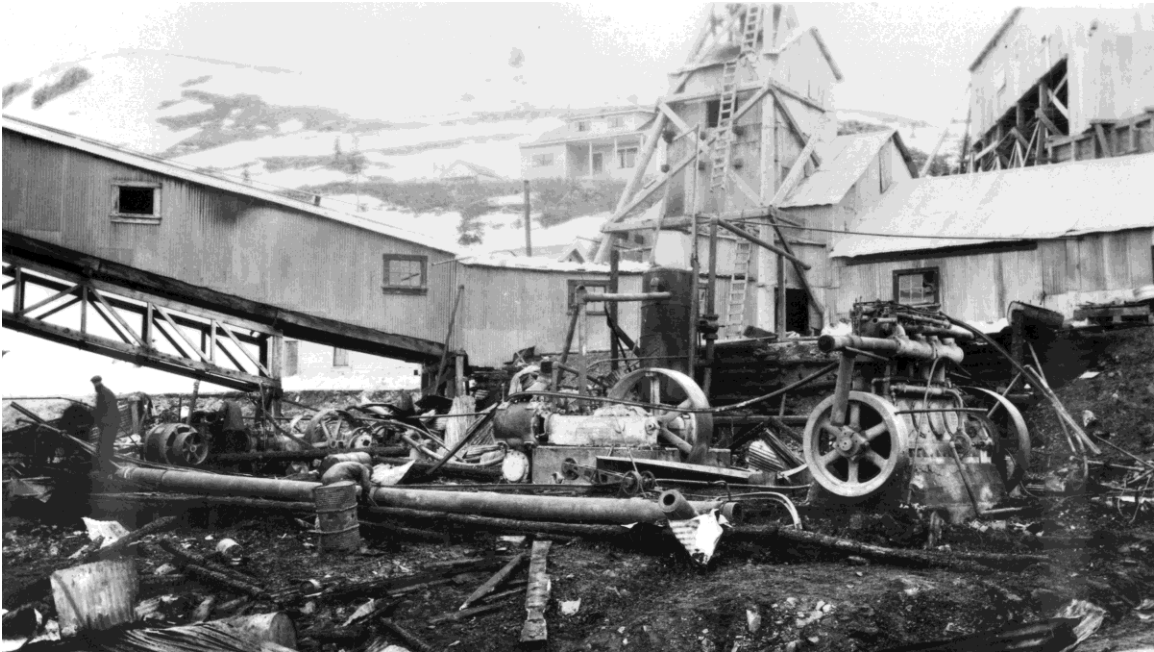
*Photo shows Northwest Wernecke shaft and mill, the mine manager's house can be seen at the top of the photo. A fire burned down the compressor house, men are visible working.*

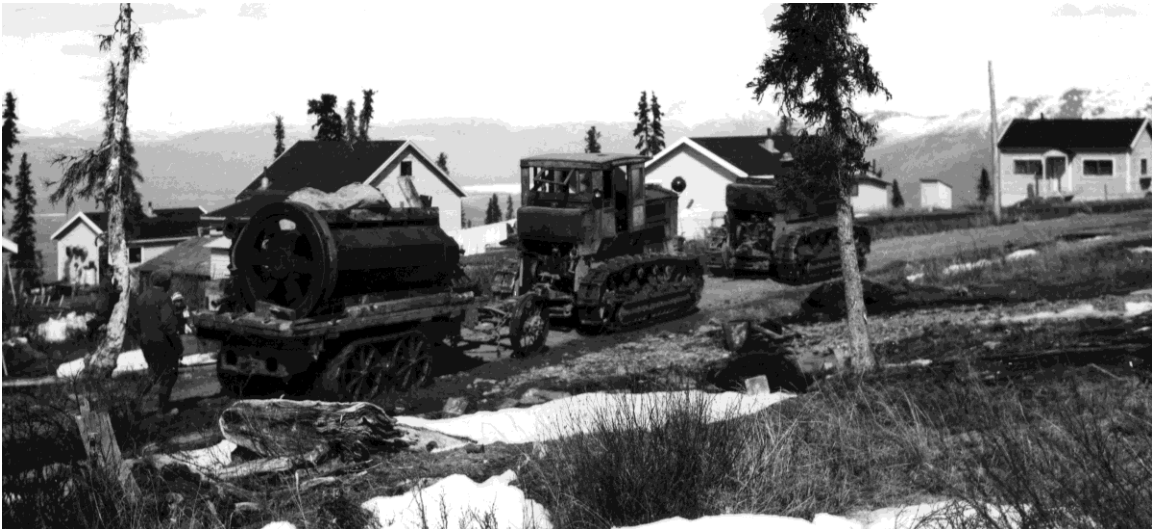
*Wernecke Street Scene. A view of two cats hauling in tandem a trailer with a new 100hp Enterprise mine compressor to replace the one destroyed by the fire in the diesel room fire of 1927. The fire of 1927 caused \$50,000.00 worth of damage.*

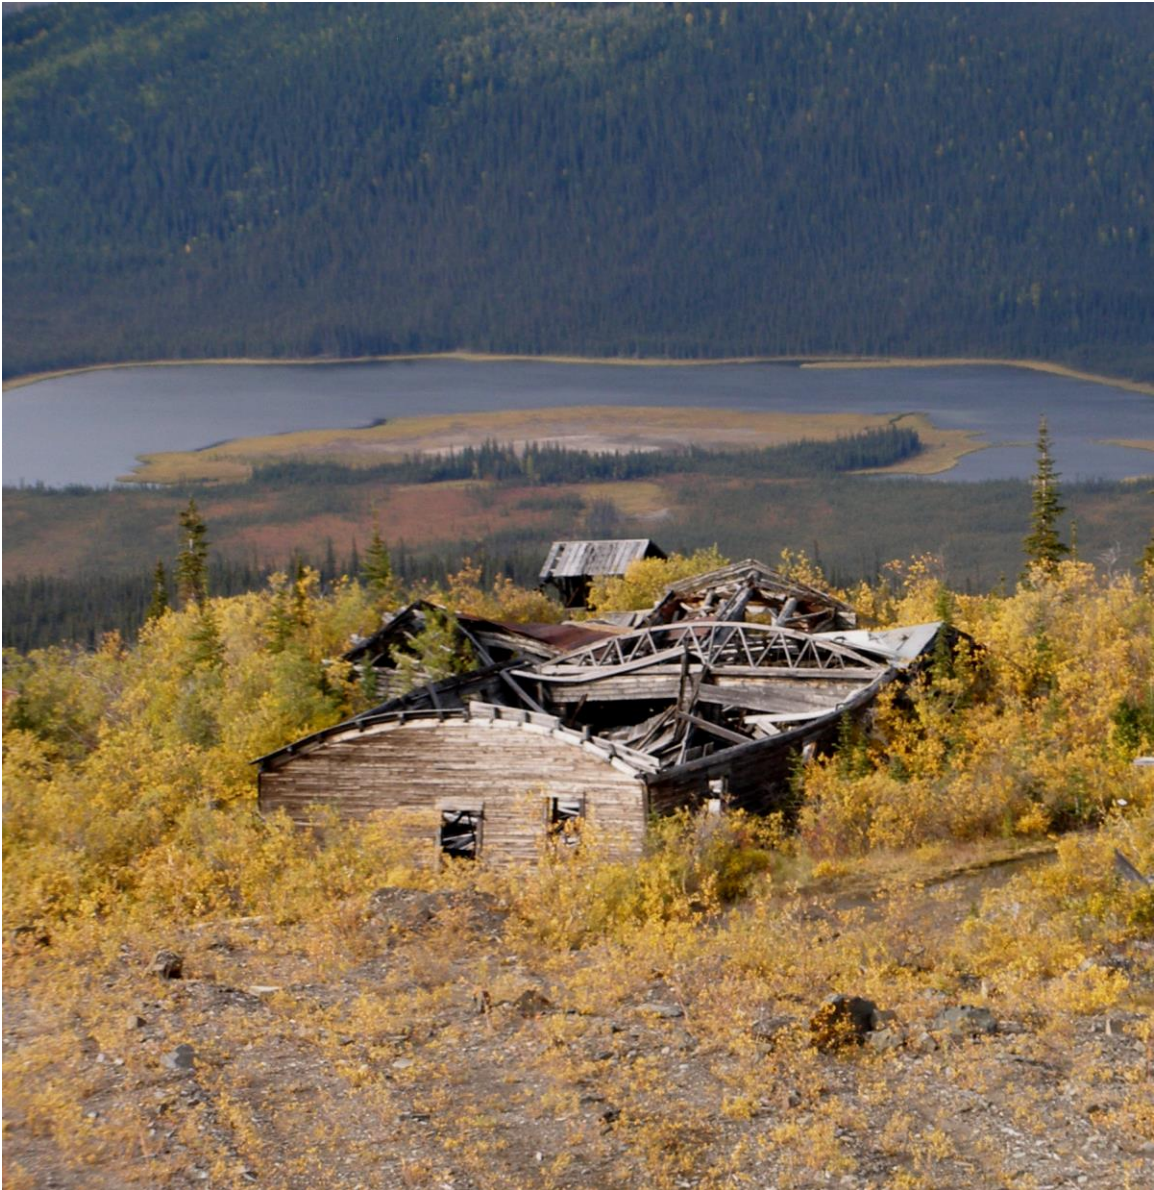
The original log structure forms a “T” shape with the leg of the “T” pointed in a northeasterly direction. The log construction is all hand hewn with saddle notched corners and sod roof. Later poles and heavy corrugated metal was added to the sod roof.

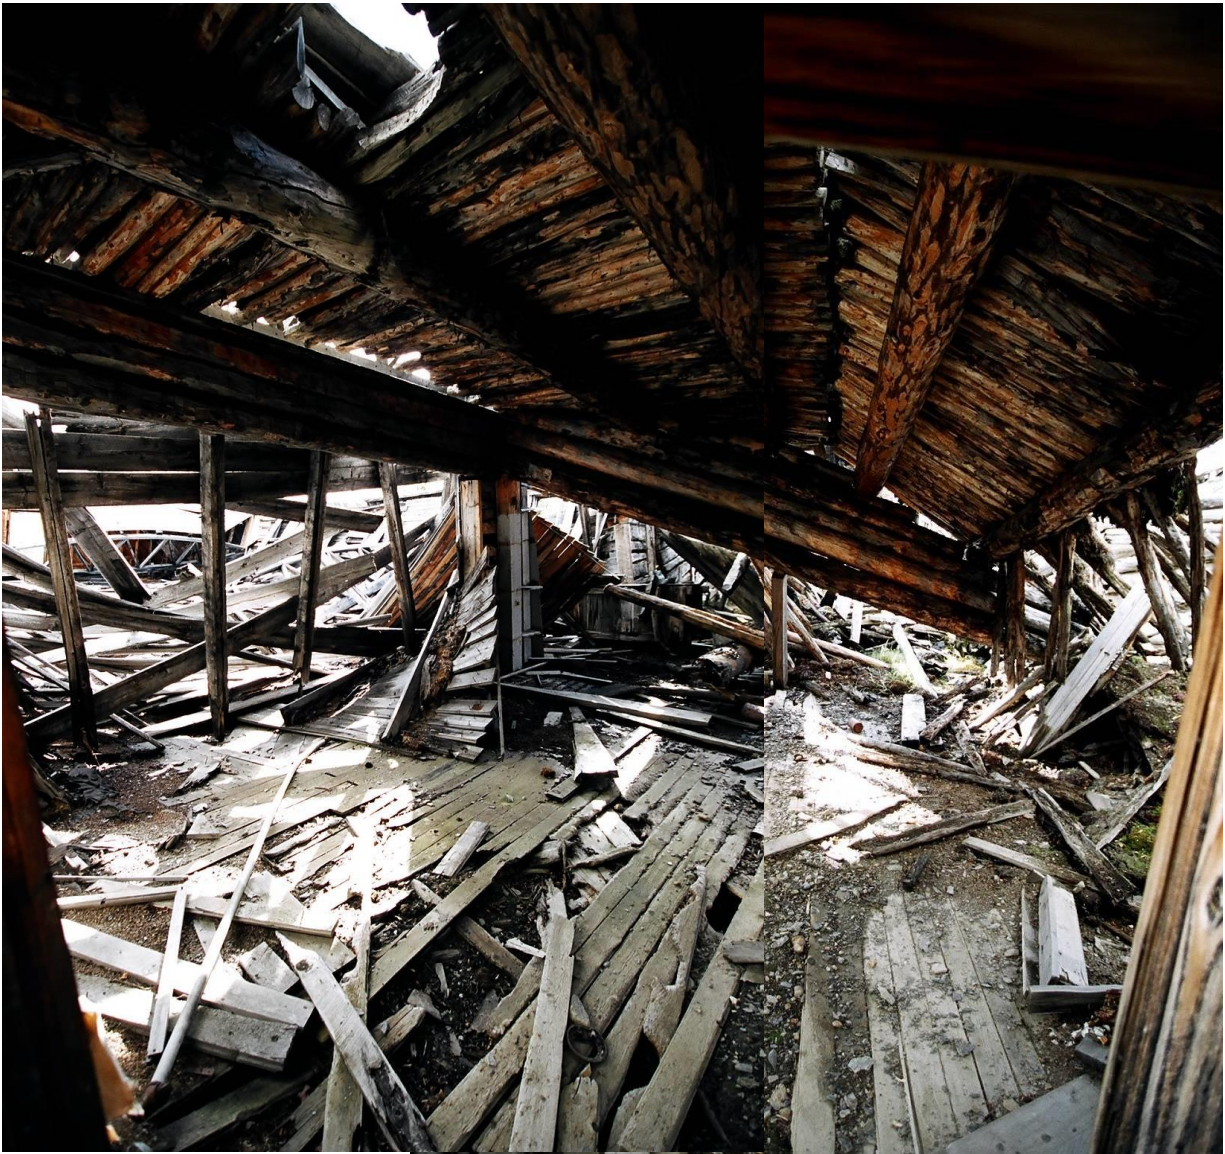
There are three sets of three purloins that span the roof structure from east to west, with the north log addition having the same style with three log purloins in a gable roof. Smaller log poles were split in half and laid with the flat side down on purloins and then sod was added to cover the split poles.

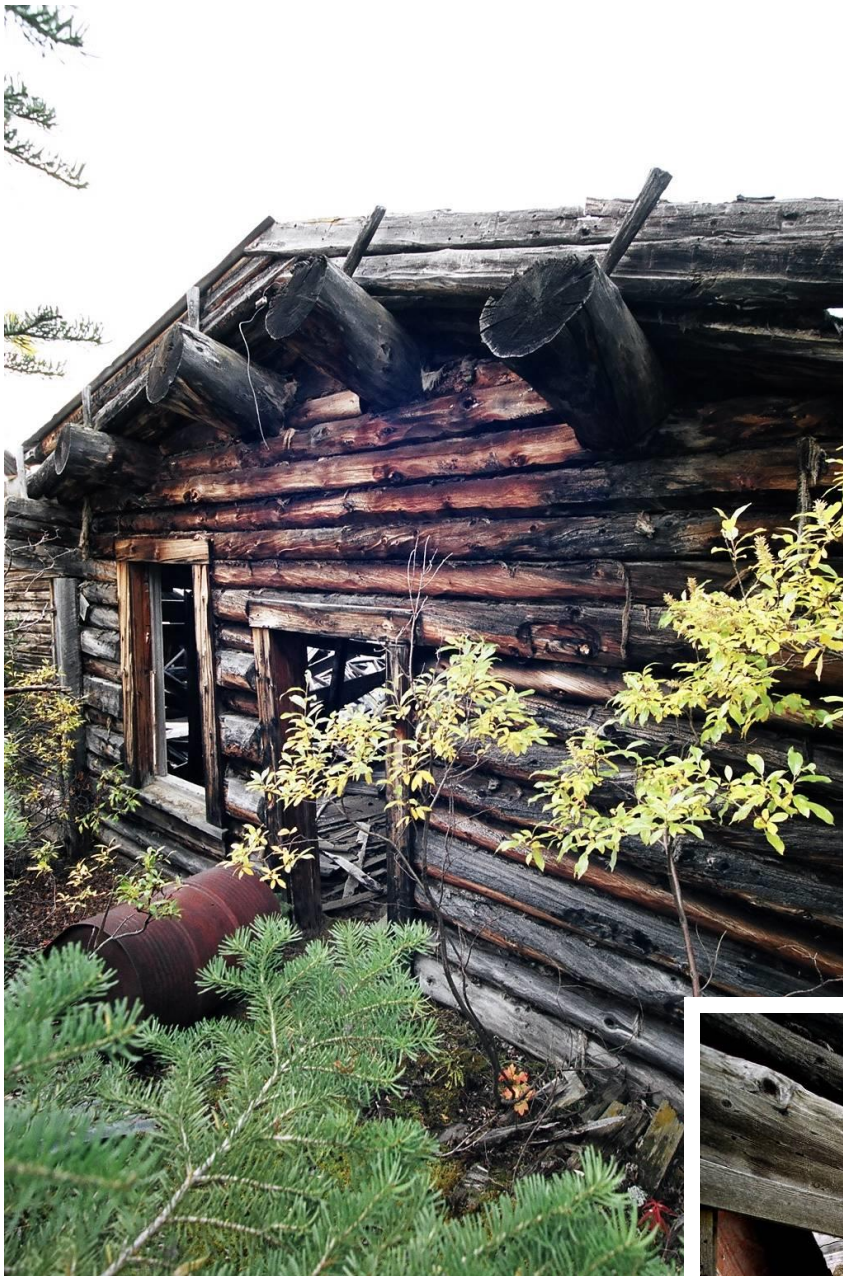
Small poles were doveled onto the purloins and boards were placed and nailed on edge to contain the sod roof.

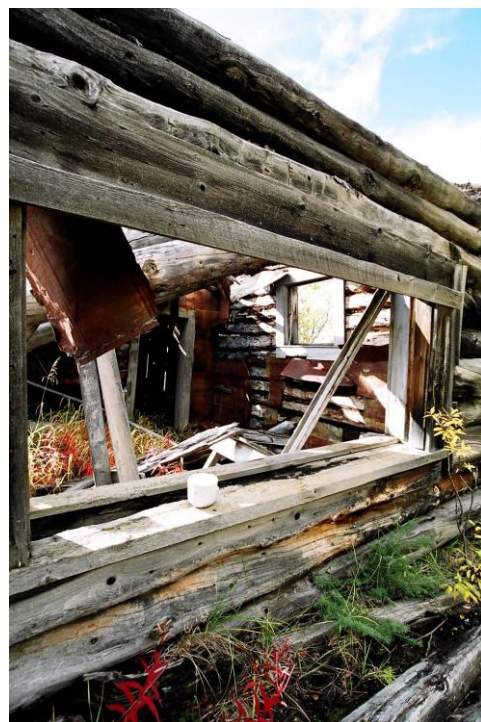
*Historical Review of Former United Keno Hill Mines LTD, Quartz Claims  
Wernecke Camp and Sadie Ladue Site 21. Keno Hill. Volume 1*

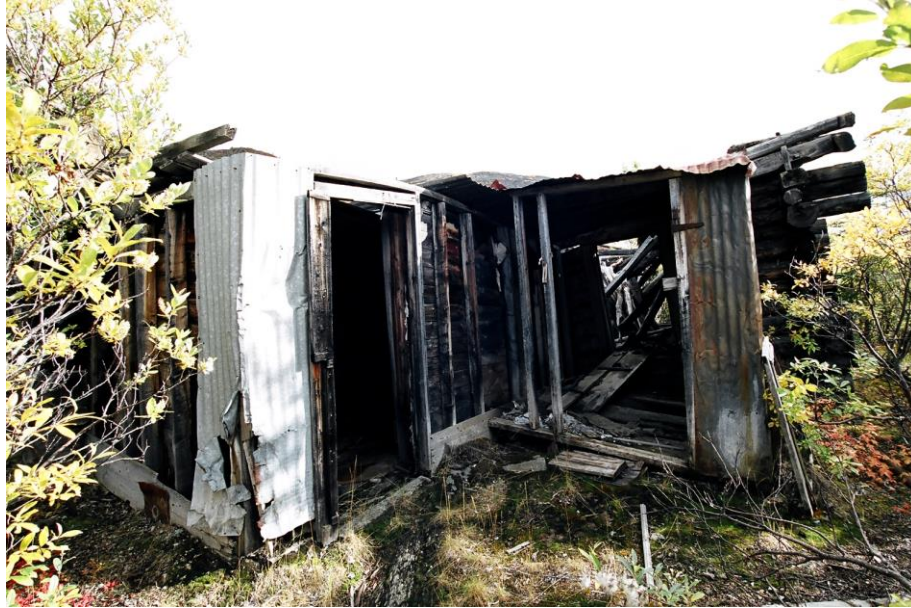
The walls are 2x4 studs sheathed with 1x6 and 1x8 plank boards. The shed roofs are 2x4 rafters also sheathed with 1x6 and 1x8 boards and heavy gage corrugated metal. The exterior is also heavy corrugated metal clad. There is entry to the kitchen through the left shed door.

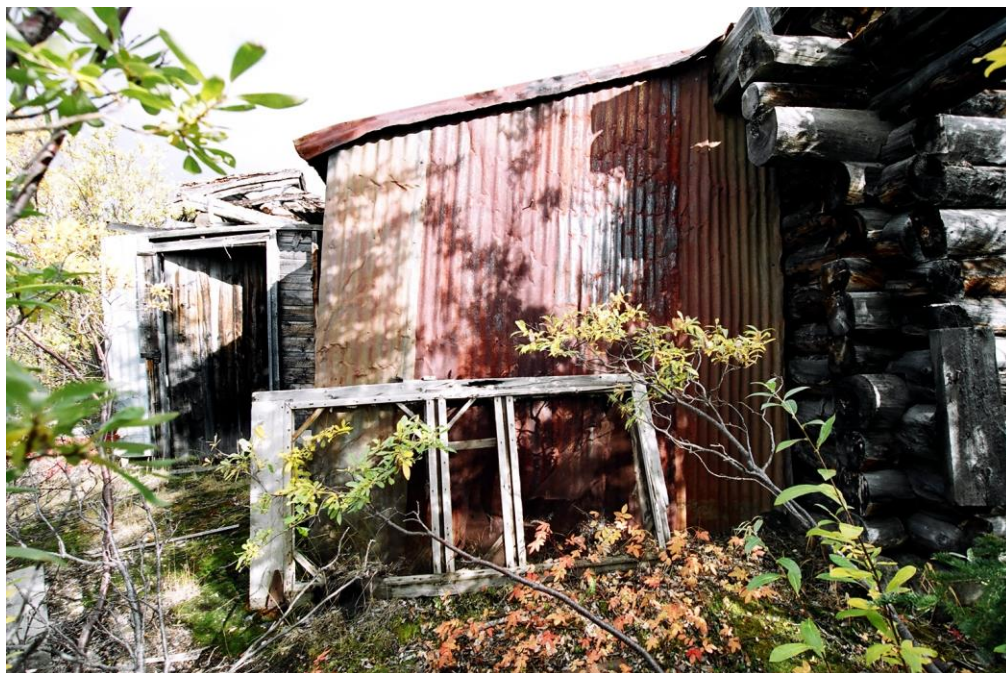
*Historical Review of Former United Keno Hill Mines LTD, Quartz Claims  
Wernecke Camp and Sadie Ladue Site 21. Keno Hill. Volume 1*

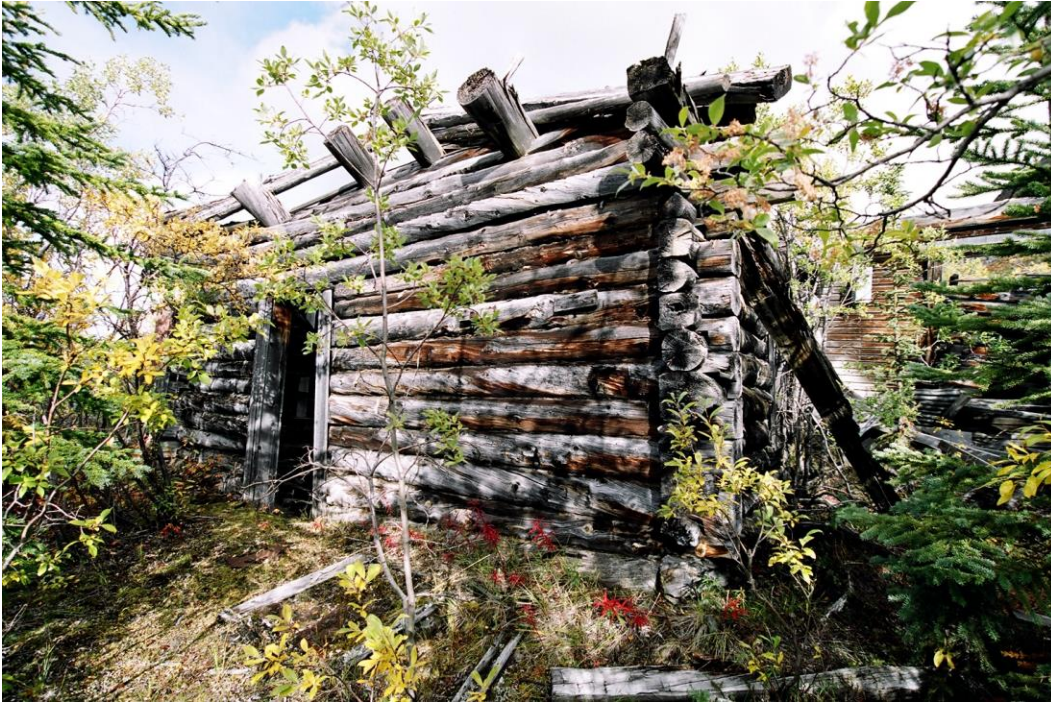
Extending from the south side of the log building is the frame mess hall. This addition was cut into the south side of the log wall. The openings in the log walls were reinforced by the addition of 8x8 timbers that were bolted into place around the frame.

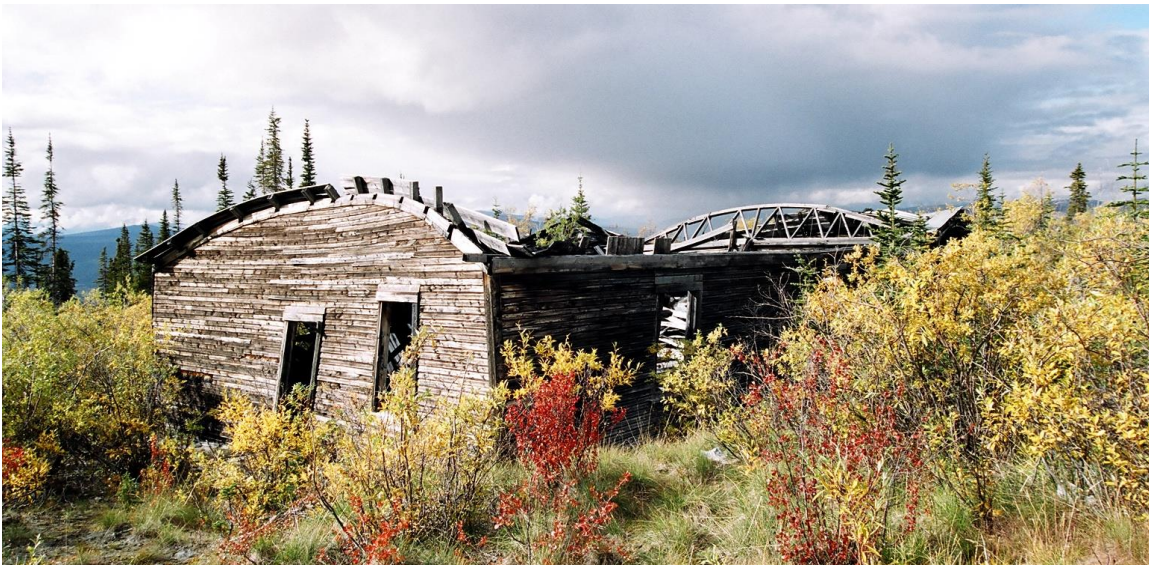
*Historical Review of Former United Keno Hill Mines LTD, Quartz Claims  
Wernecke Camp and Sadie Ladue Site 21. Keno Hill. Volume 1*

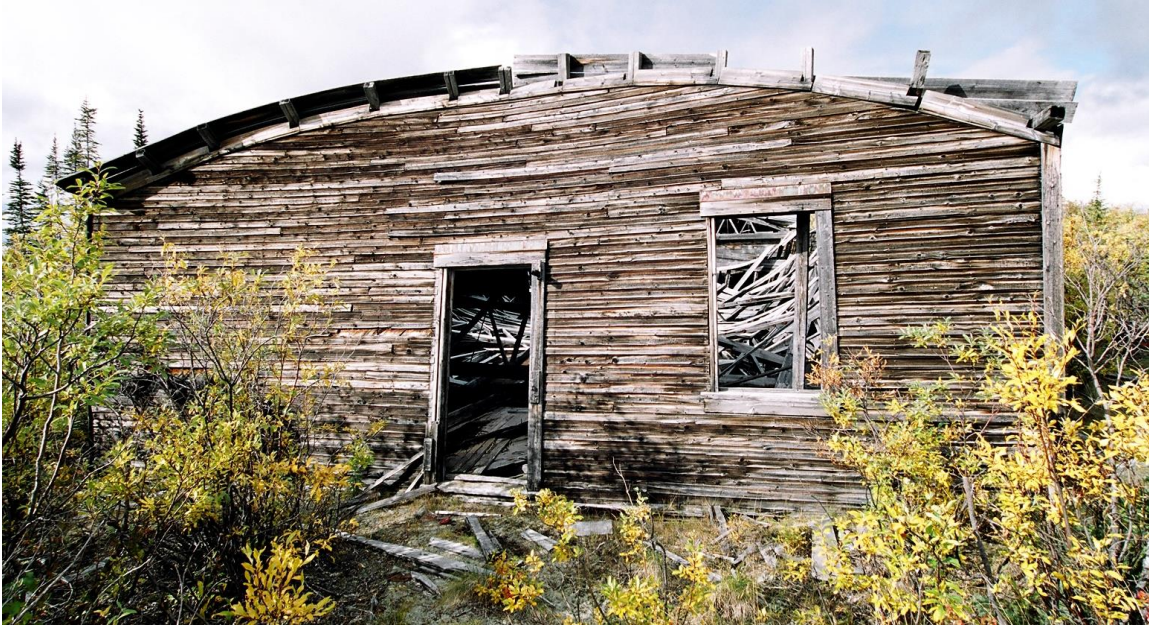
The arched trusses have collapsed. These are built from 2x4s and 2x8s and then are cross-braced many times with 2x4s. The trusses were reinforced with vertical steel rods that were threaded on both ends allowing them to be tensioned appropriately to strengthen the frame truss.

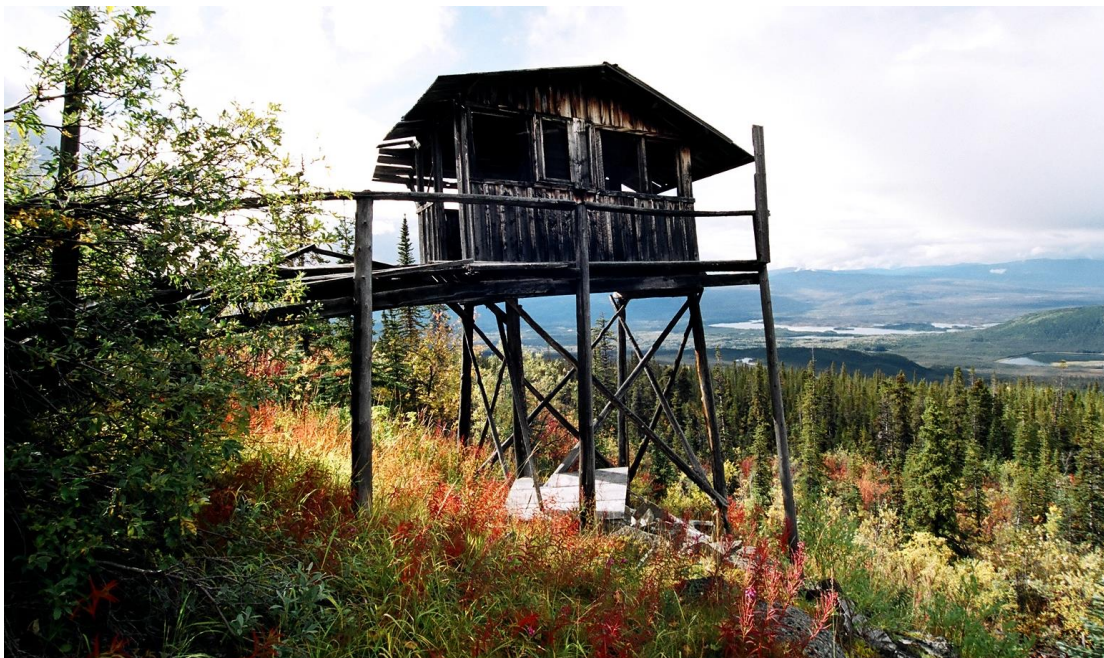
*Northwest Wernecke kitchen outhouse B3*

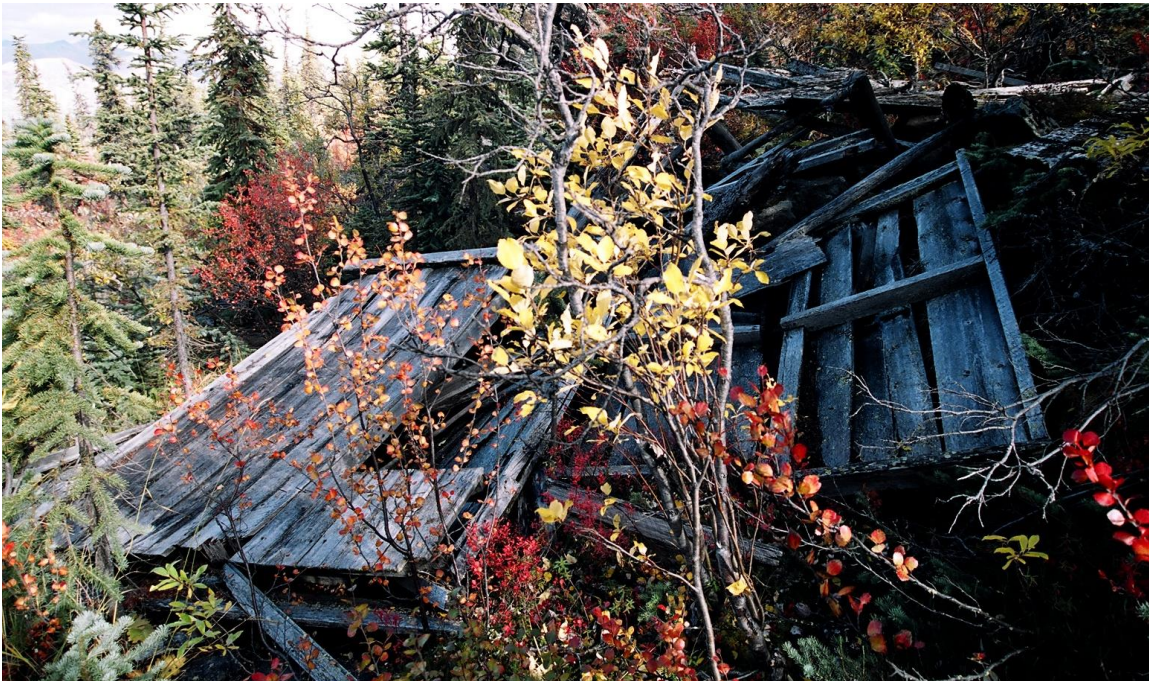
On this pole structure the frame floor was built using 2x4s for floor joists and covered with 1x10 planks.

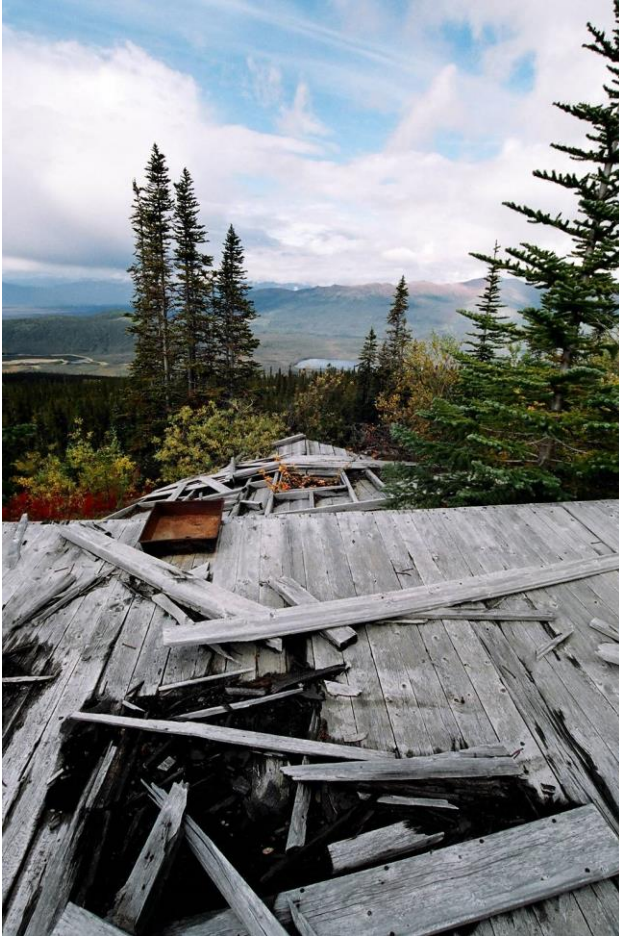
The floor foundation is comprised of 2x8s on two-foot centers that have been run into the hillside, and nailed to trees on the lower side.
