# Historical Review

Of  
Former  
United Keno Hill  
Mines Limited  
Quartz Claims

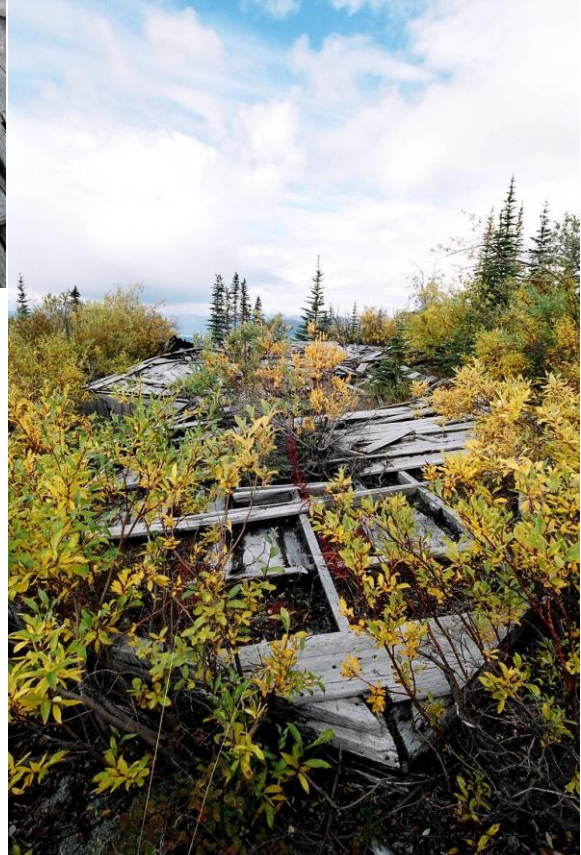
The area is very hazardous to walk through given the decay of the wood and the nails that are protruding.

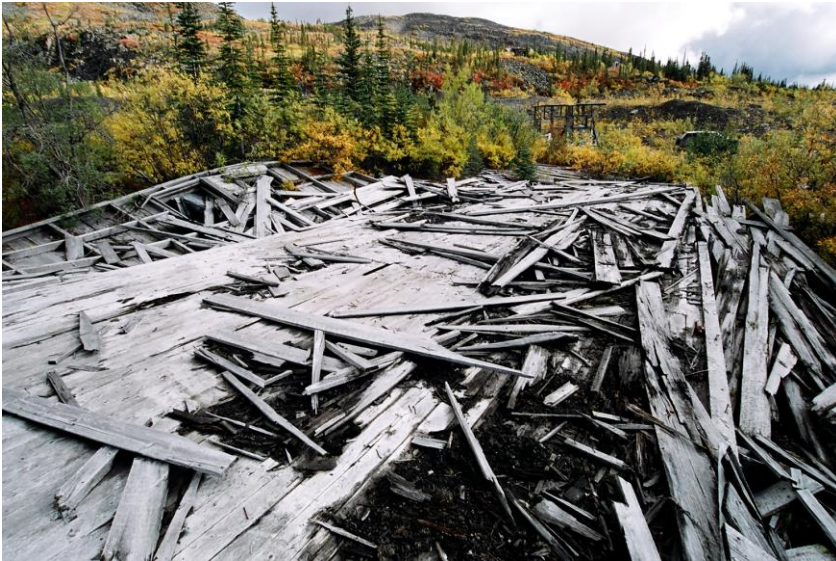
There is a good possibility that what we are calling a storage shed was a bunkhouse, given that there is an outhouse located behind to it.

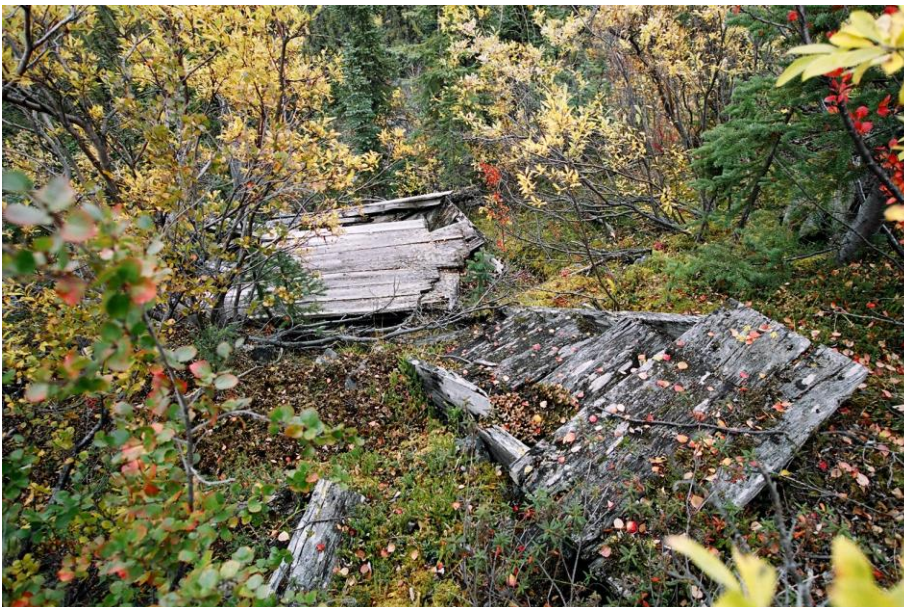
There is a considerable amount of tin scattered about the outhouse, possibly used for exterior roofing or siding.

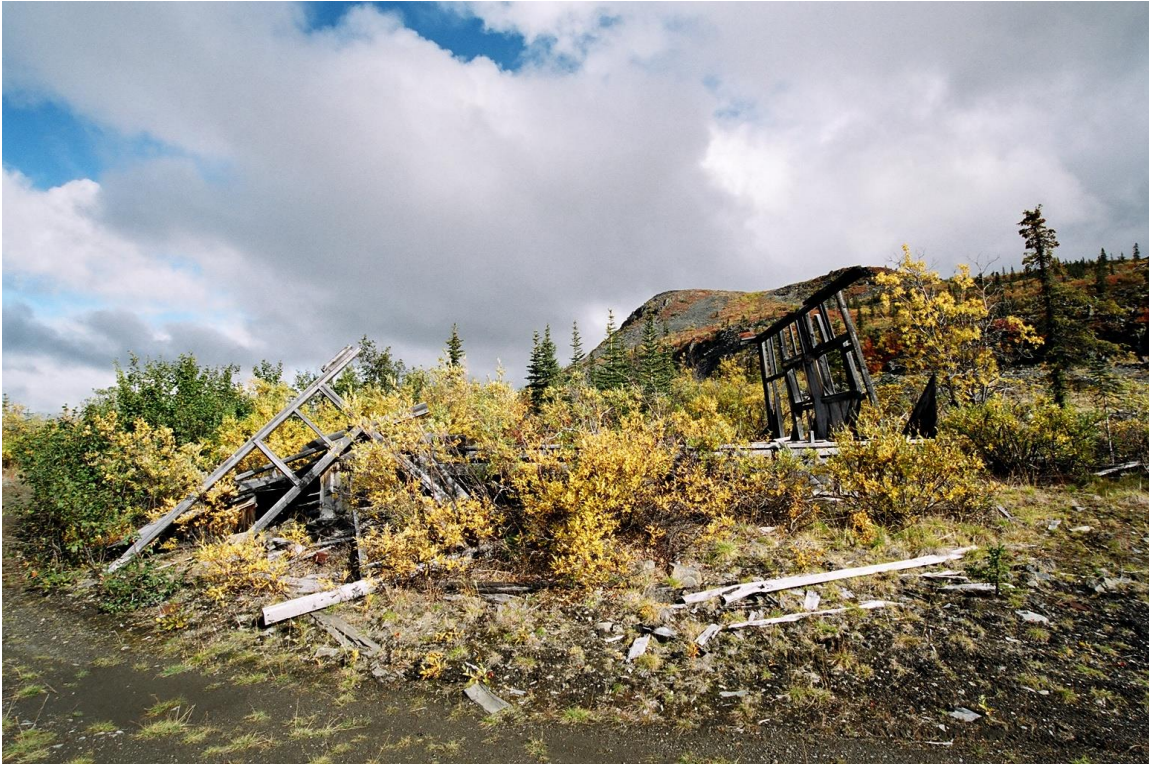
The floor joists are comprised of 2x6 boards placed on two-foot centers and sheeted with 1x10 rough-cut plank boards and re-sheeted with 1x3 tongue and groove fir flooring.

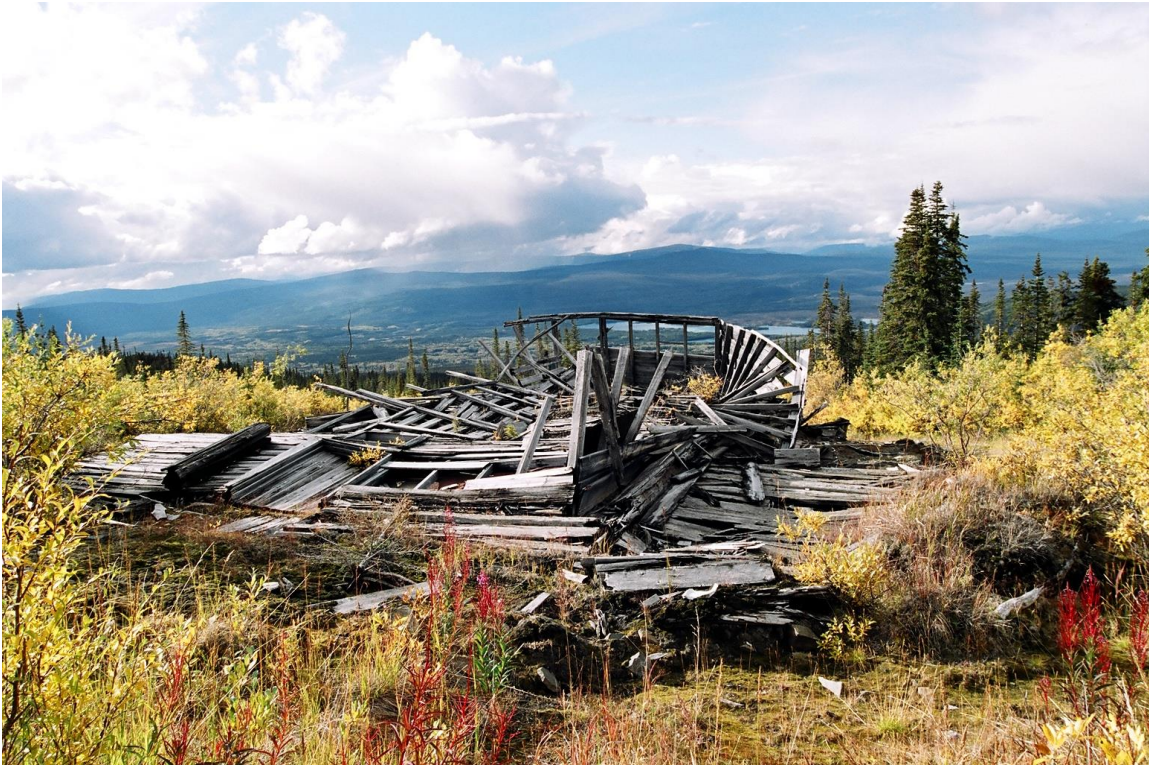
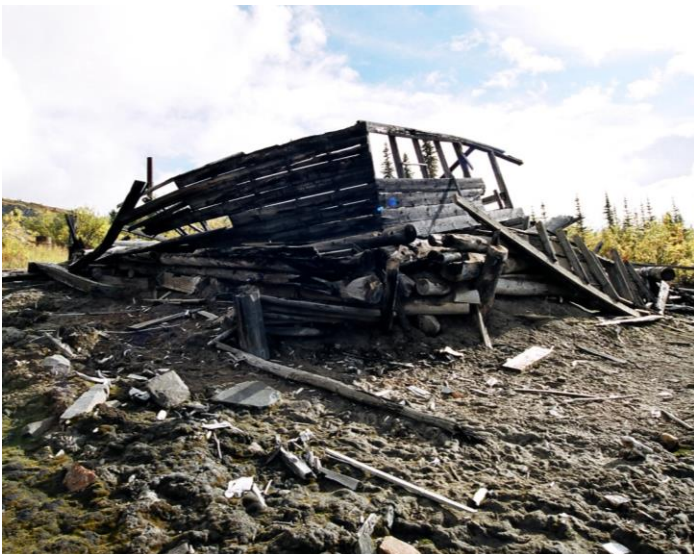
The foundation is constructed of logs that have been placed directly on the ground. The logs are notched three rounds high, with 2x8 boards used as floor joists.

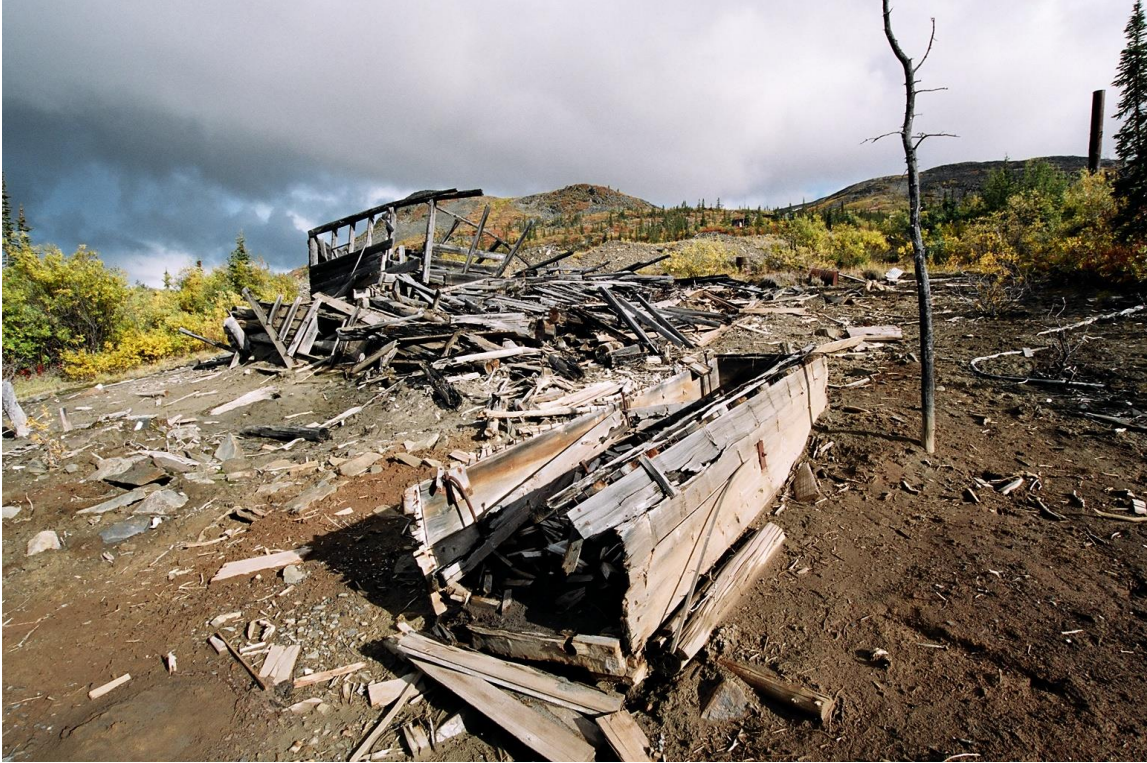
There is a heavily built; 13.6x1meter chute or feed box that is 2.5 meters to the north west of the buildings northwest corner. This chute is constructed with 2x10 rough-cut planks and the joints are screwed together.

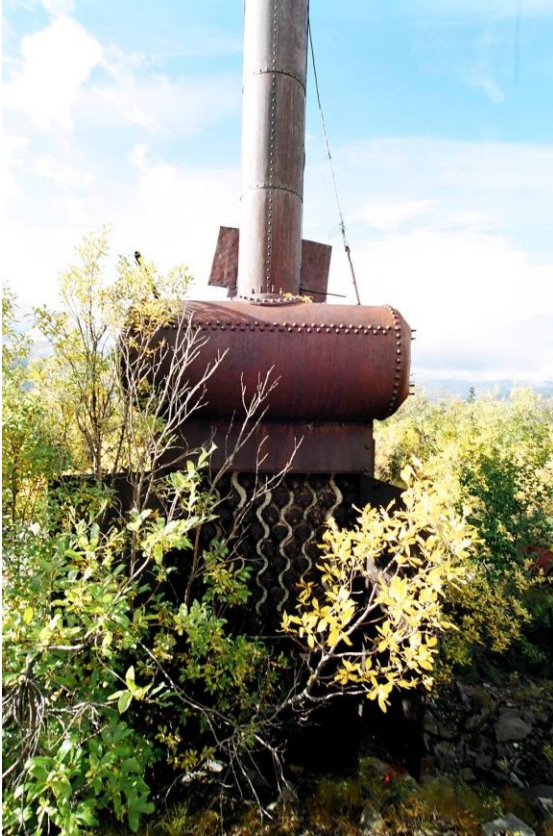
The building has collapsed or has been torn down.

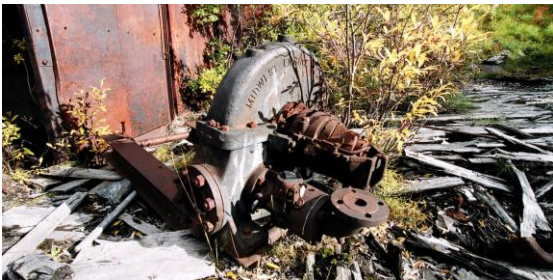
On the south side the boiler there is a 2-inch Midwest water pump.

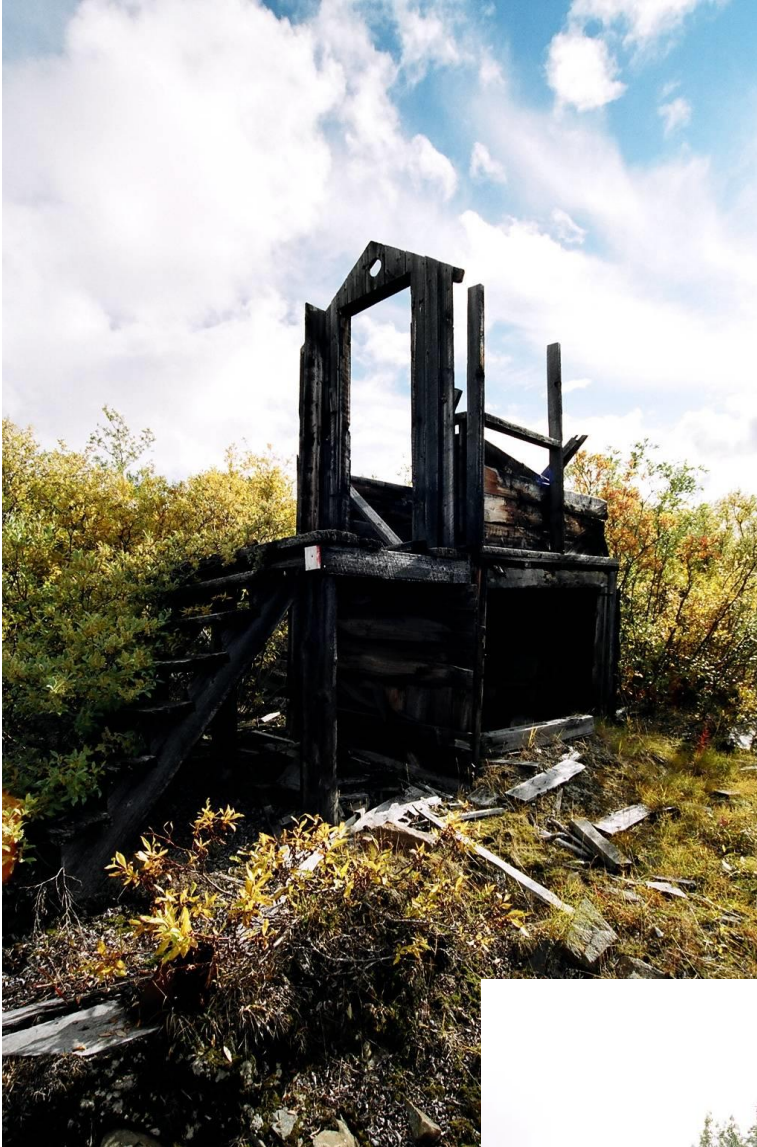
The pipe box from the boiler house enters into a 60-gallon drum located under the southwest end of the shower house. This drum was used as a homemade header /receiver tank for the hot water delivered by the boiler house. The riveted drum is marked with a tag “US Signal Corp 26”.

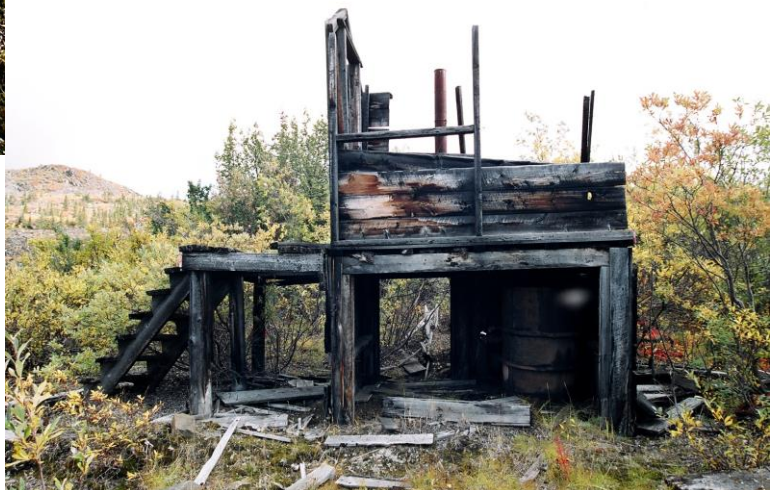
The pony walls are sheathed with vertical 1x8 boards with the north and south ends cross-braced with 2x4 boards. The floor joists are 2x6, with a sub-floor of 1x8 boards that run lengthways to the building and a second floor of 1x8 boards that run in the opposite direction.

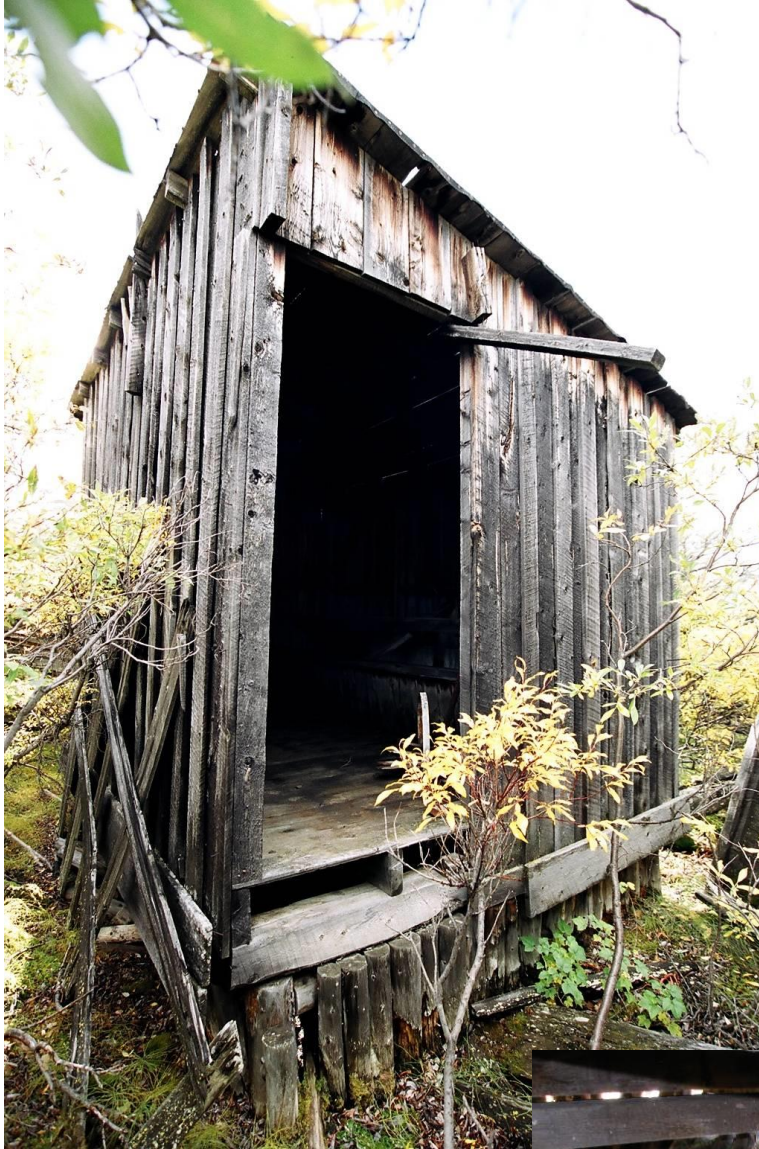
The foundation (below) is made of 4 to 6 inch log poles that have been placed vertically into the ground with logs nailed on the inside for bracing.

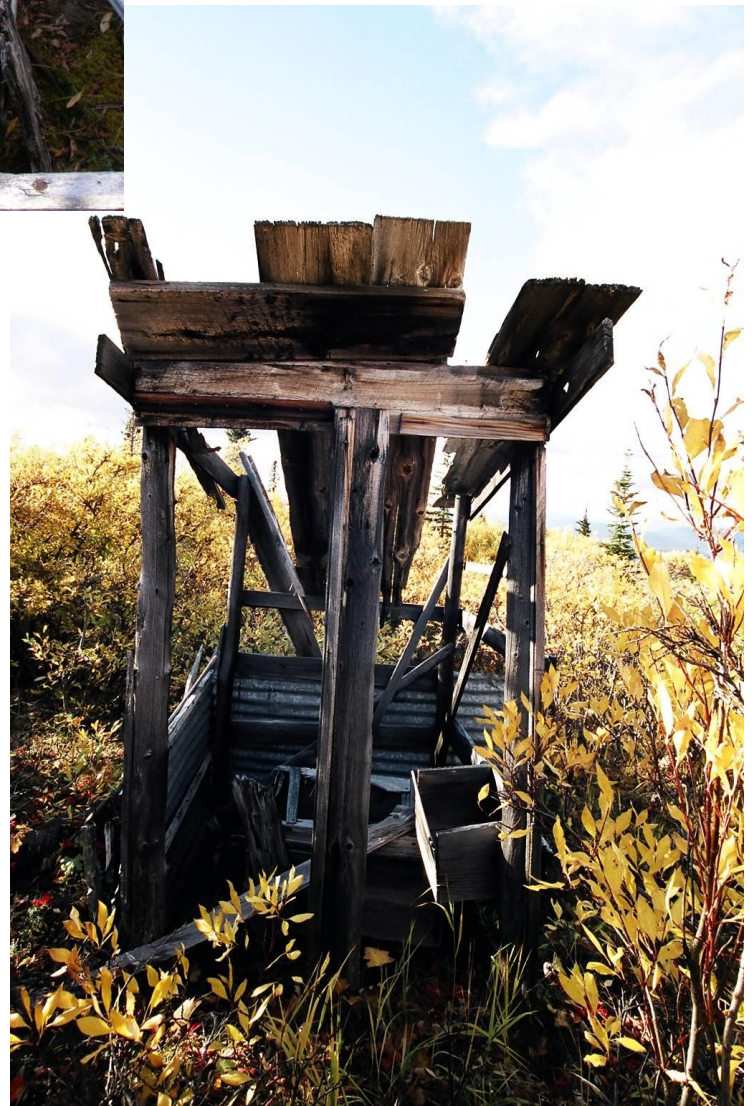
*Southwest Wernecke Stone House B13*

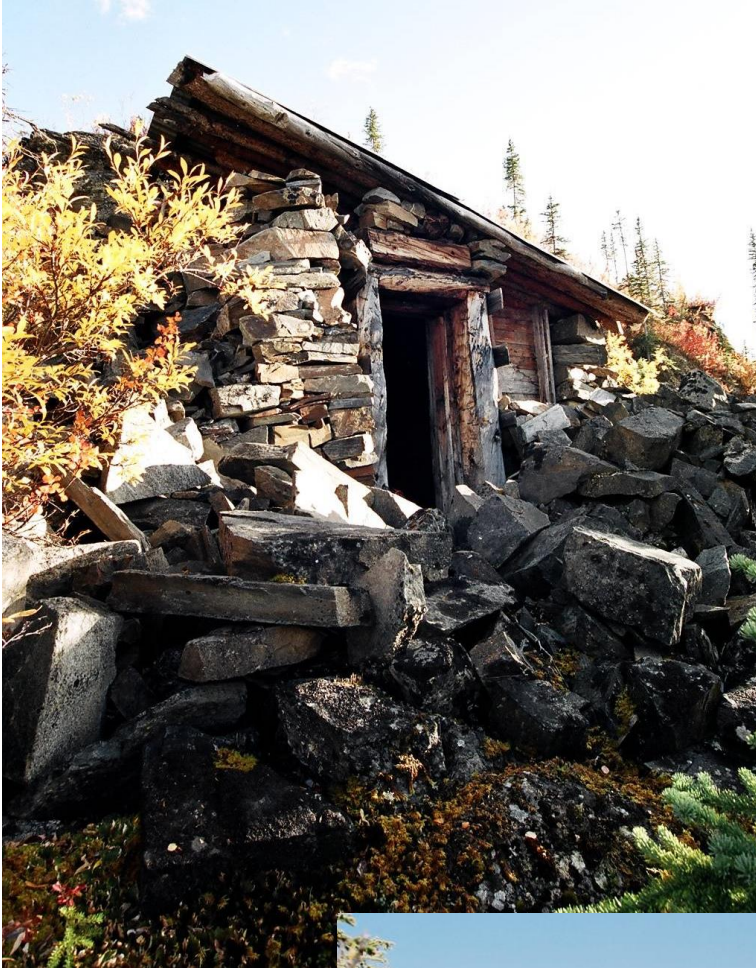
A wood frame structure that makes up the inside of the stone house is built with a combination of hand hewn logs and frame material.

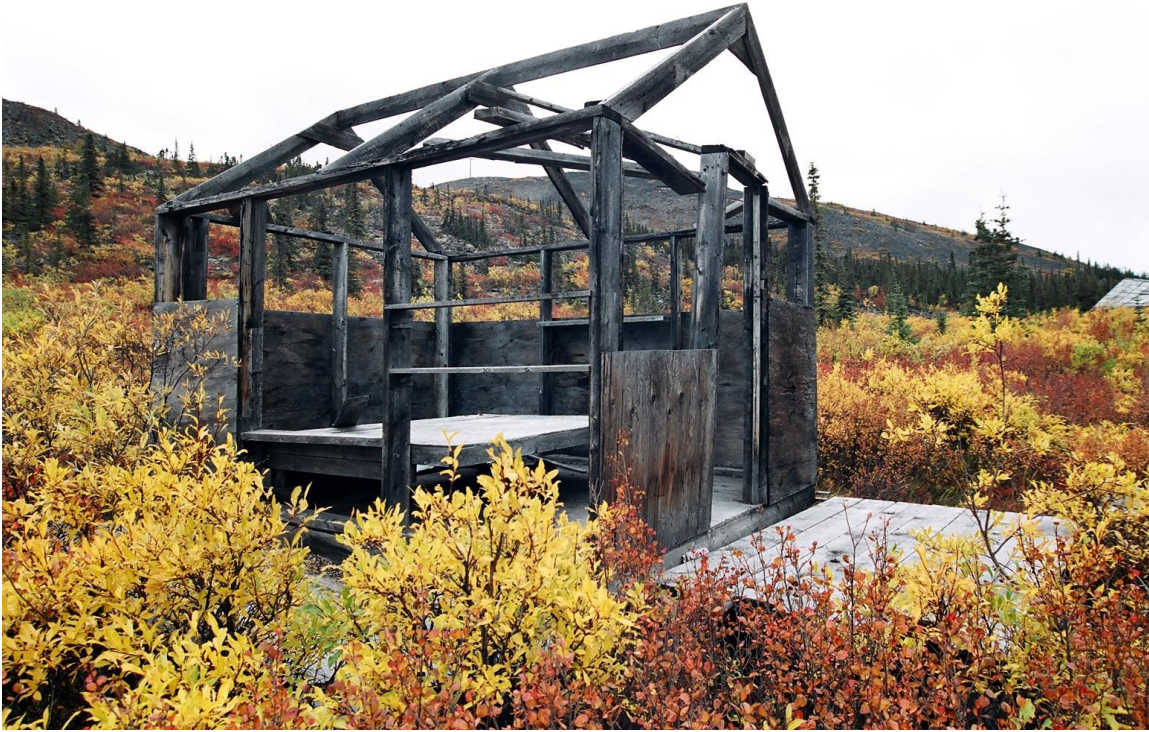
The foundation of the tent frame is three 3x6 x 3.5 meter beams that are set on flat rock. The floor joists are 2x6 on 24 inch centers, which are then sheeted with three quarter inch plywood for the floor.

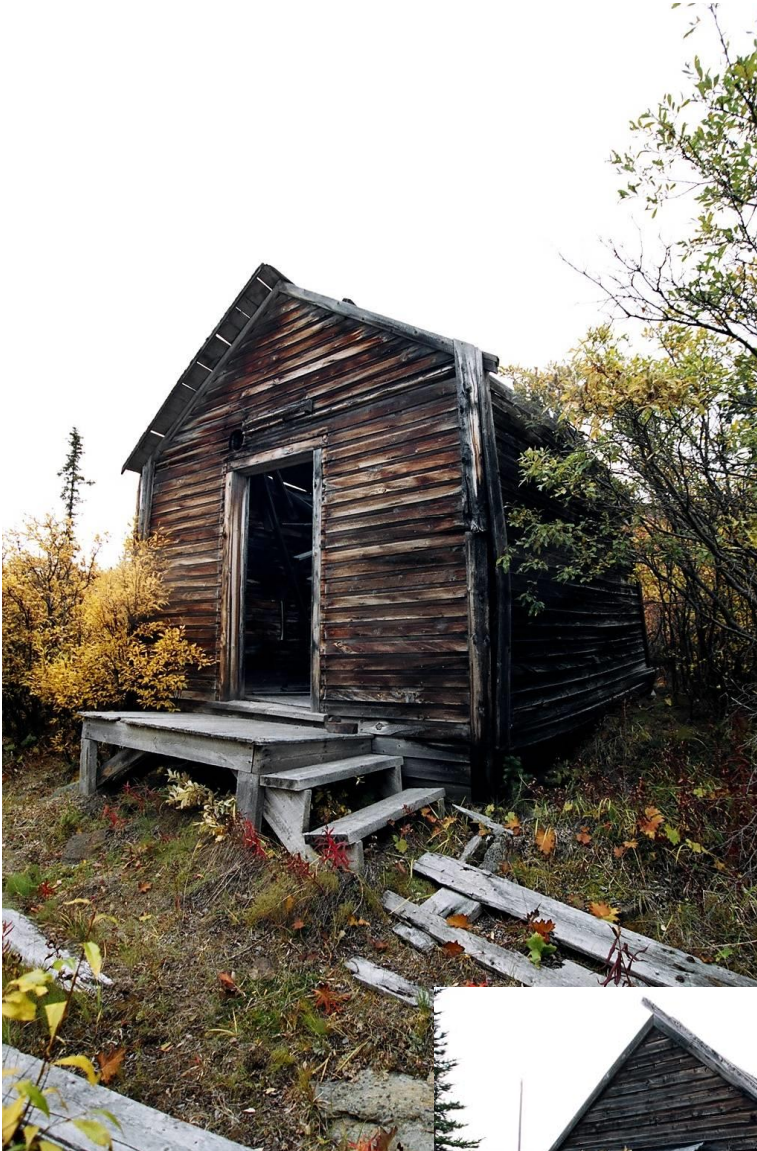
The foundation of the building is comprised of 8x8 timbers that have been placed directly on the ground, the west end is blocked with timber to level the foundation.

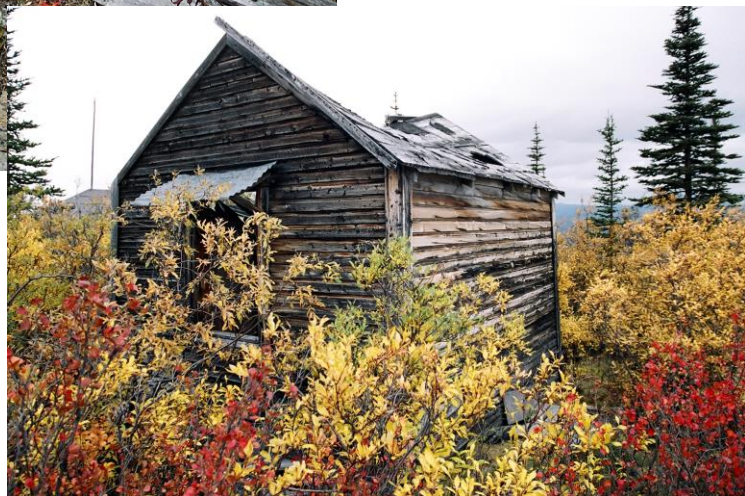
*Historical Review of Former United Keno Hill Mines LTD, Quartz Claims  
Werneck Camp and Sadie Ladue Site 21. Keno Hill. Volume 1*

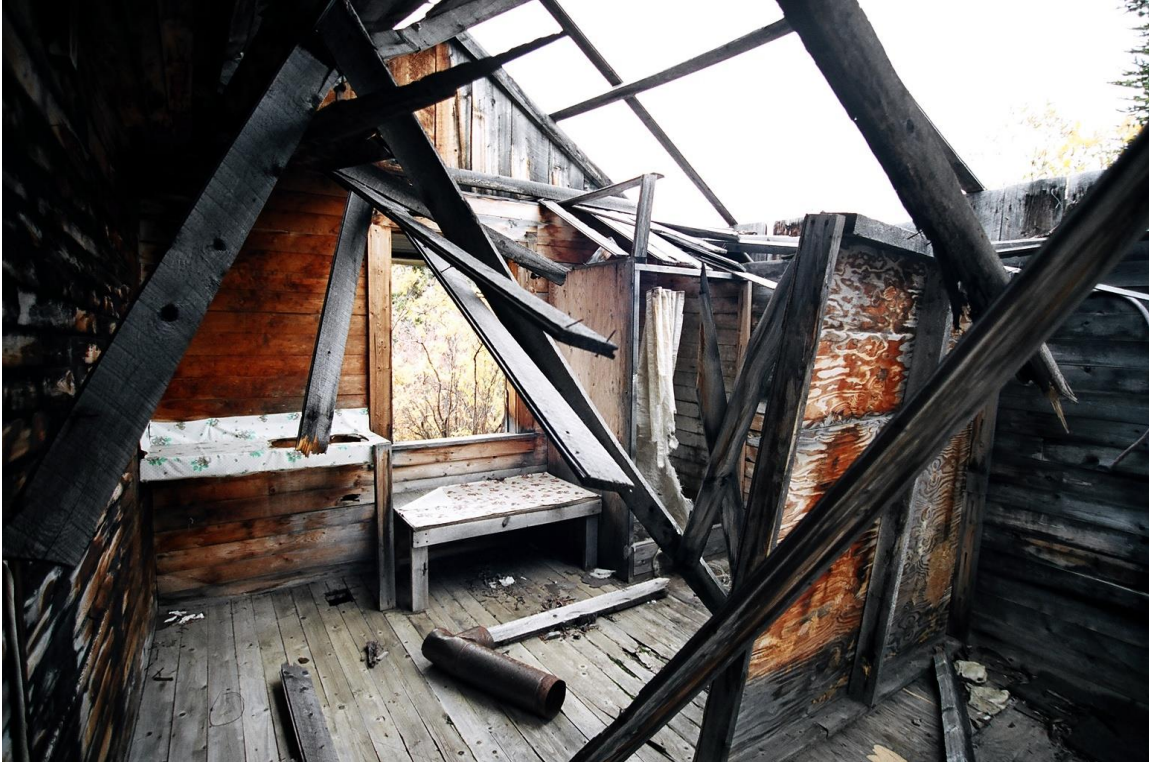
The rafters are 2x4, covered with 1x10 boards. The doorway is centered in the west wall that has a 1 meter by 2 meter porch extension with steps that lead off to the south.

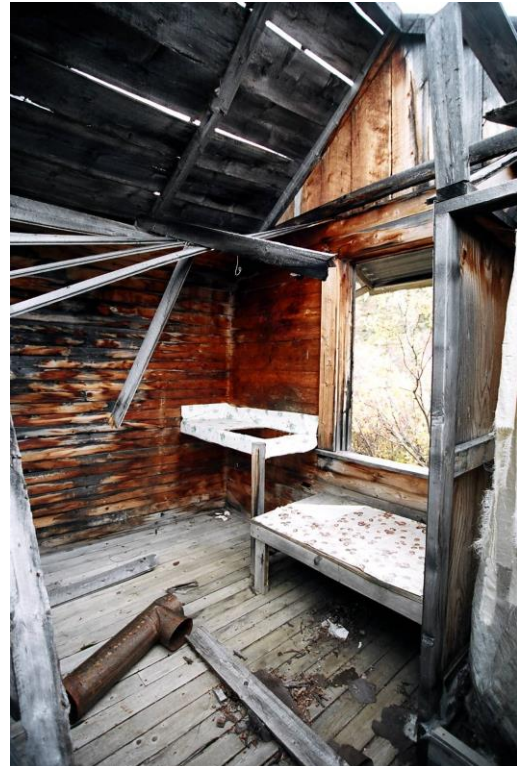
*Northeast Wernecke Mine Managers House B3*

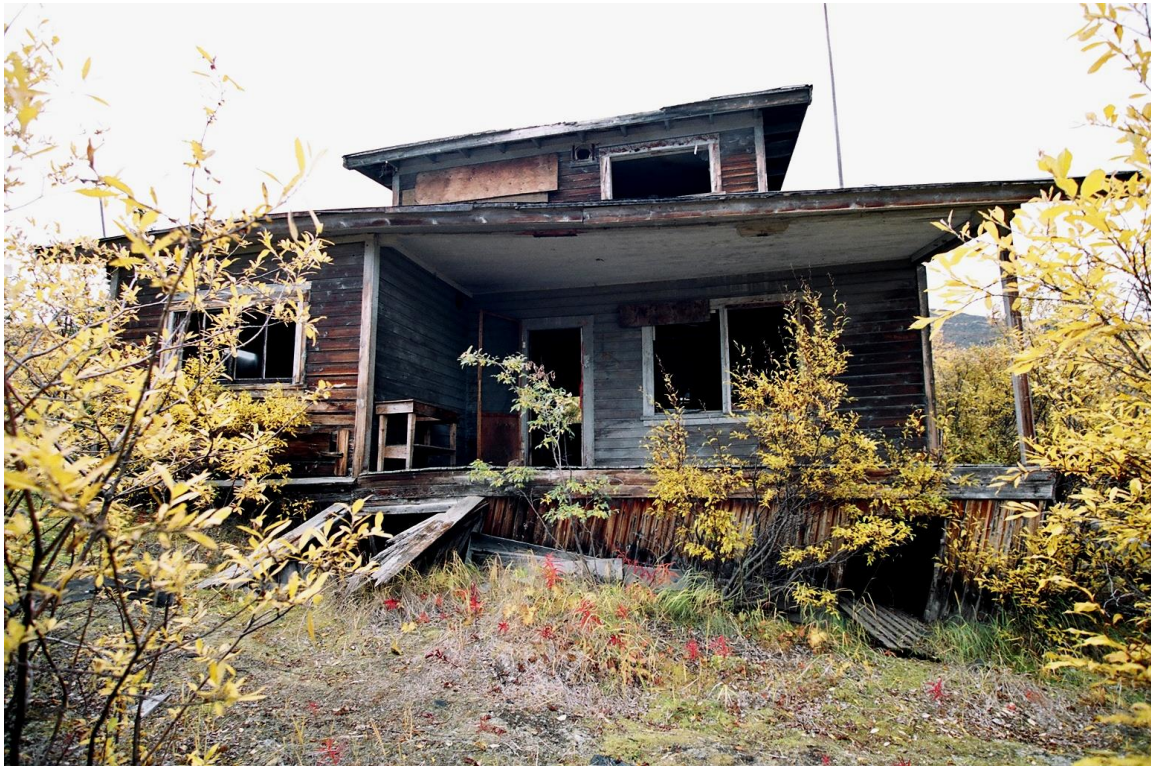
The walls are constructed of 2x4s, the interior walls are sheeted with veneer panels.

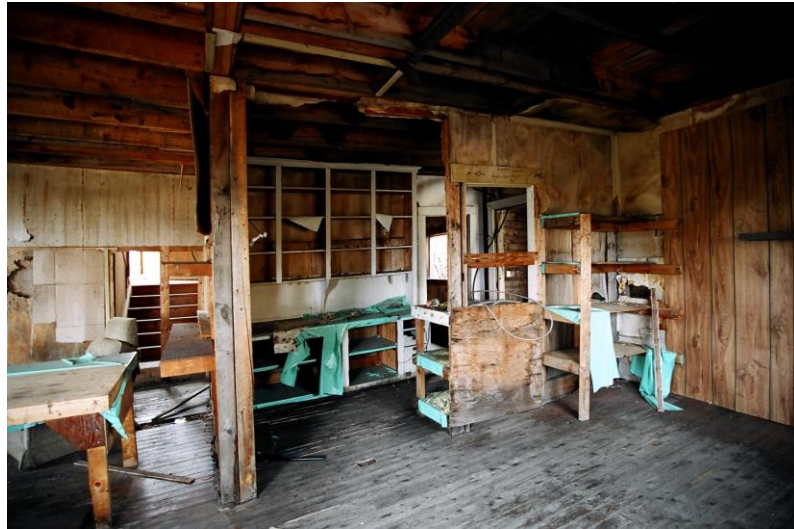
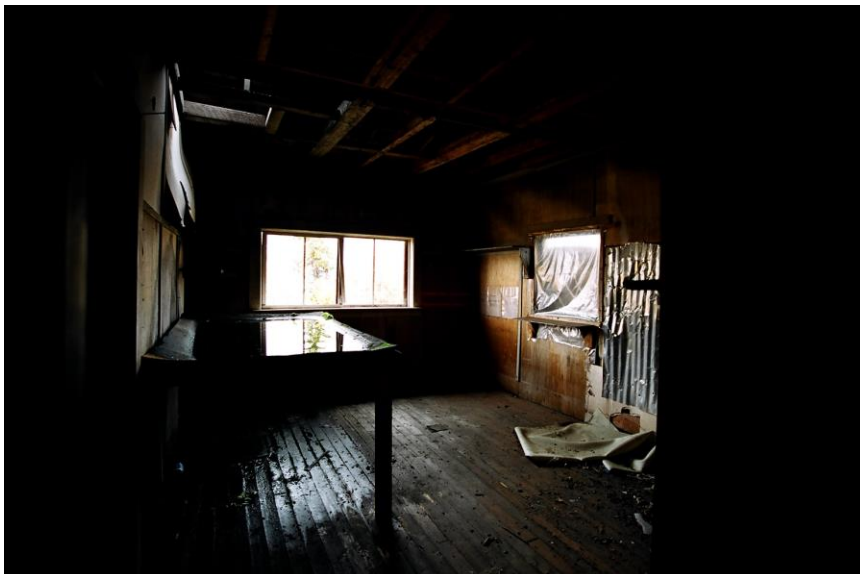
The asphalt roofing has deteriorated and there is significant water damage to the interior.

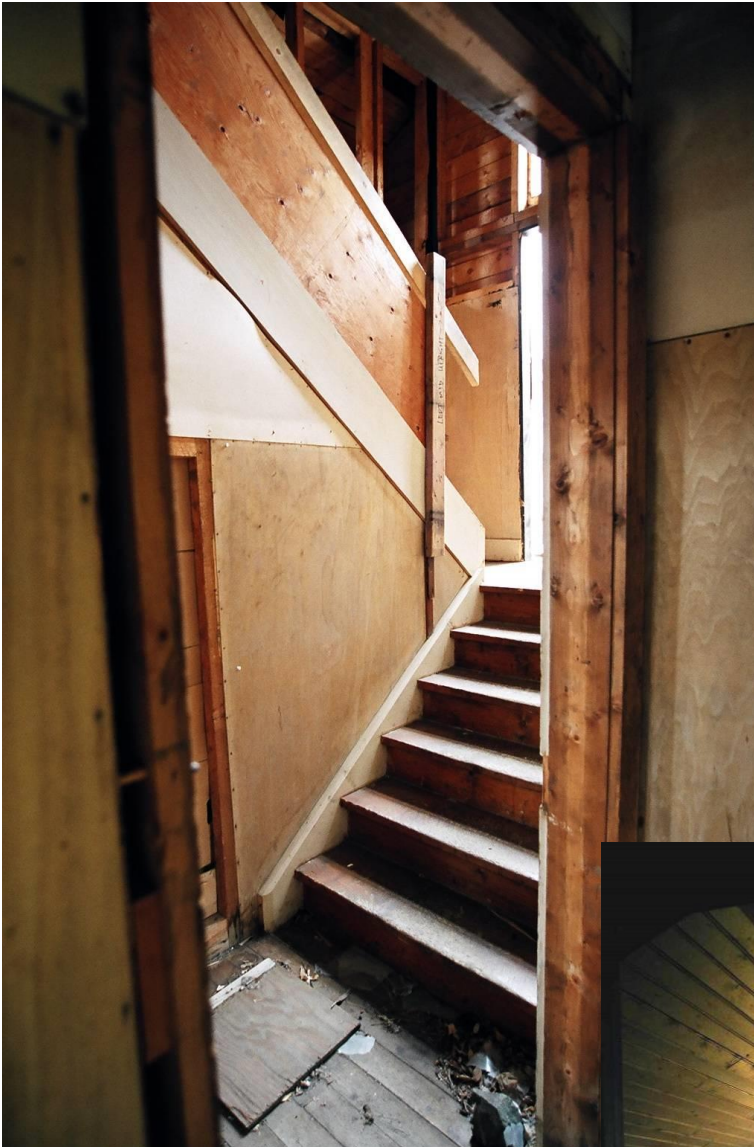
The stairwell is on the north wall with a doorway at the top the first flight of stairs leading out to the plywood addition. The doorway was most likely put in during the 1980's to access the addition.

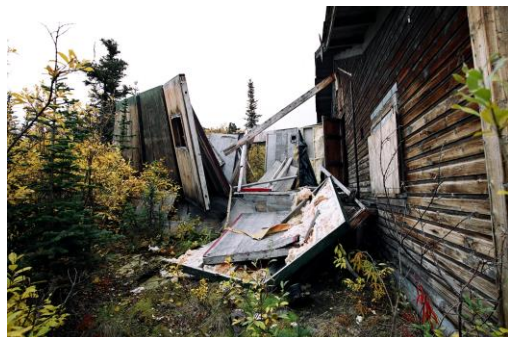
*Northeast Wernecke Sauna B4*

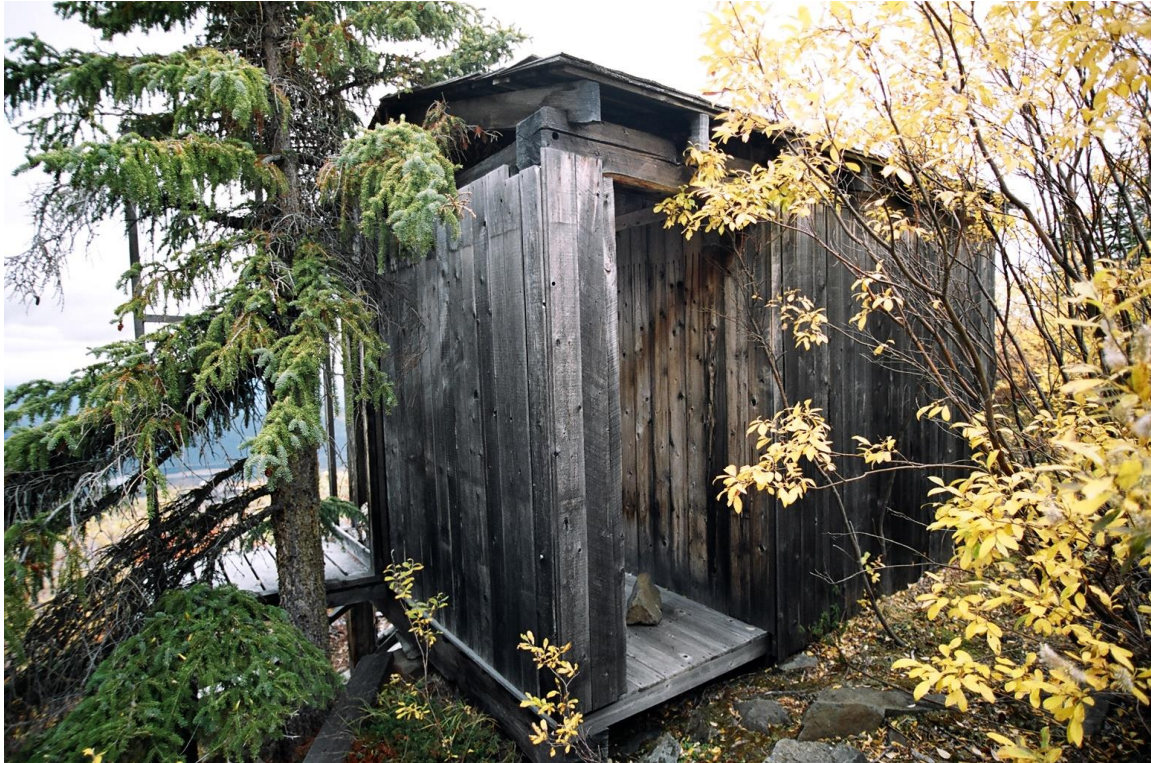
The foundation is built with 8x8s that run out from the bank and rest on vertical 8x8 beams placed on stone footings.

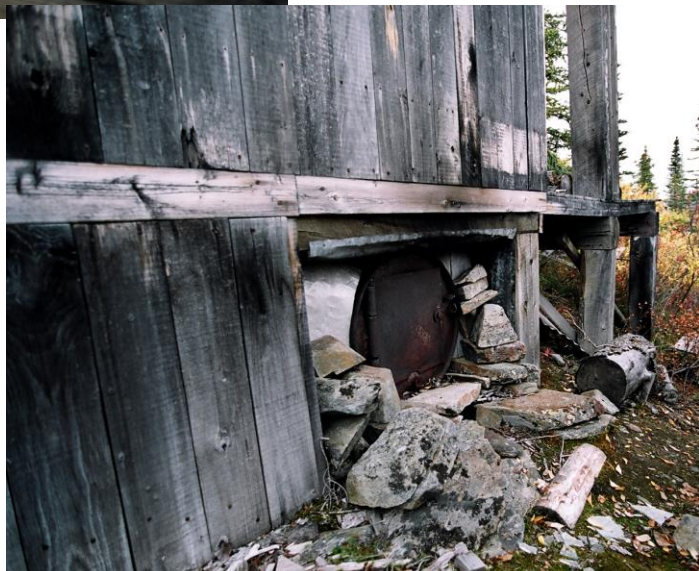
*Northeast Wernecke Mine Managers Outhouse B5*

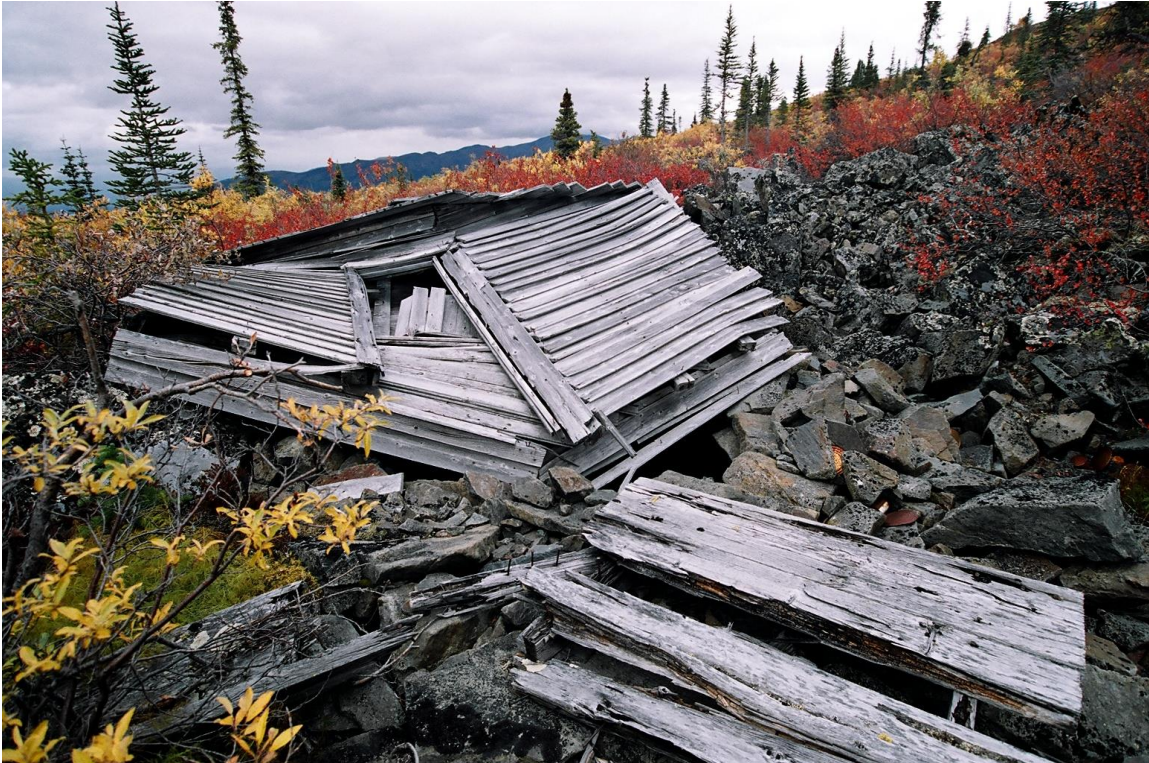
The frame building has fully collapsed to the north. The floor joists are constructed using 2x6 planks and sheeted with 1x3 tongue and groove fir boards. The walls have 2x4 studs covered on the exterior with 1x4 boards, 1x10 planks were used to cover the shed style roof.

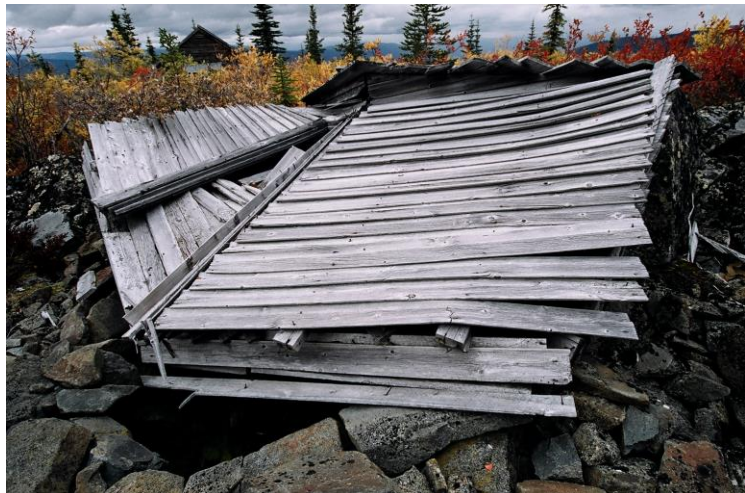
*Northeast Wernecke Outhouse B 6*

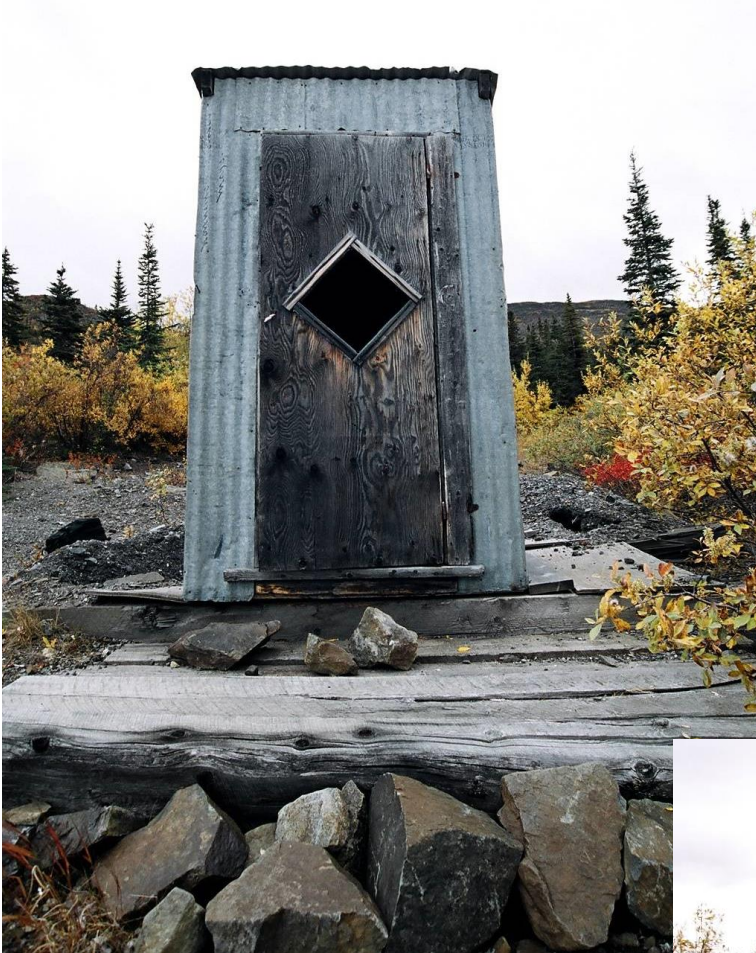
Heavy 2x10 planks and 4x6 are laid across the vent raise opening on which the outhouse was constructed. Plywood was placed over the frame and was covered lightly with surrounding gravel.

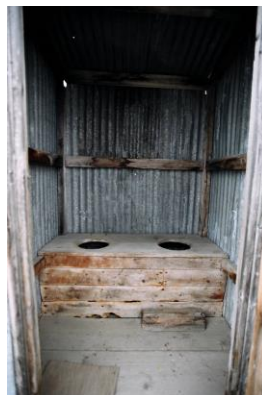
*Northeast Wernecke Residence B7*

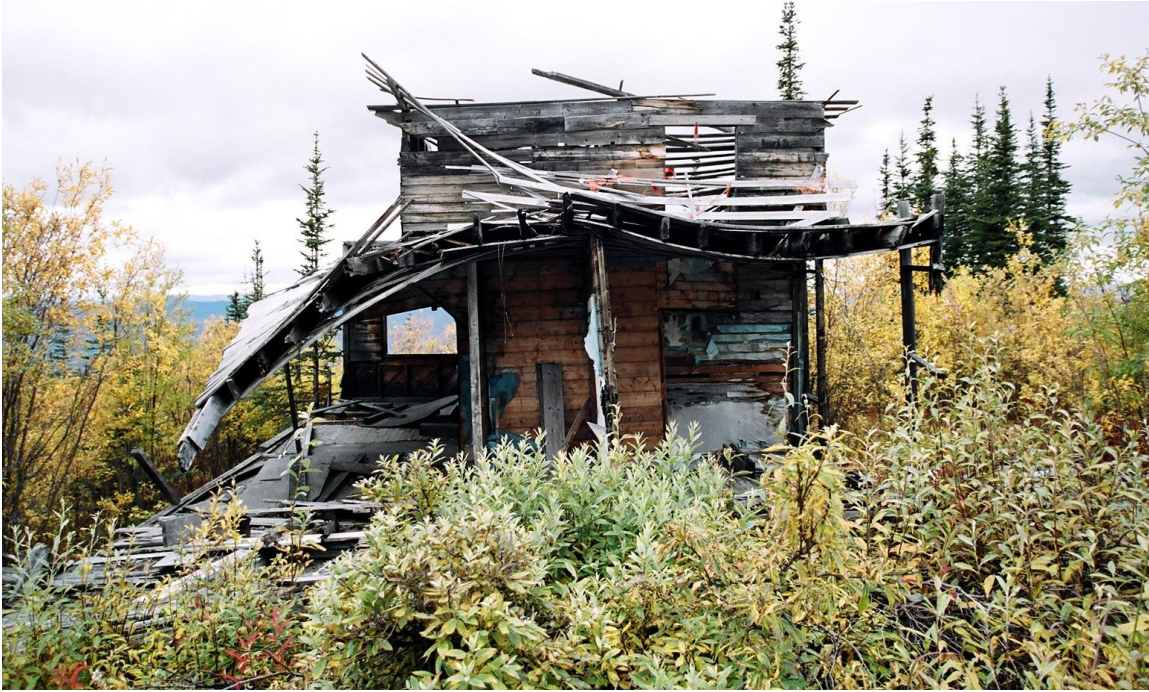
The foundation is constructed of 6x6 beams that run from the bank and extending west supported by 2 meter vertical 6x6 posts.

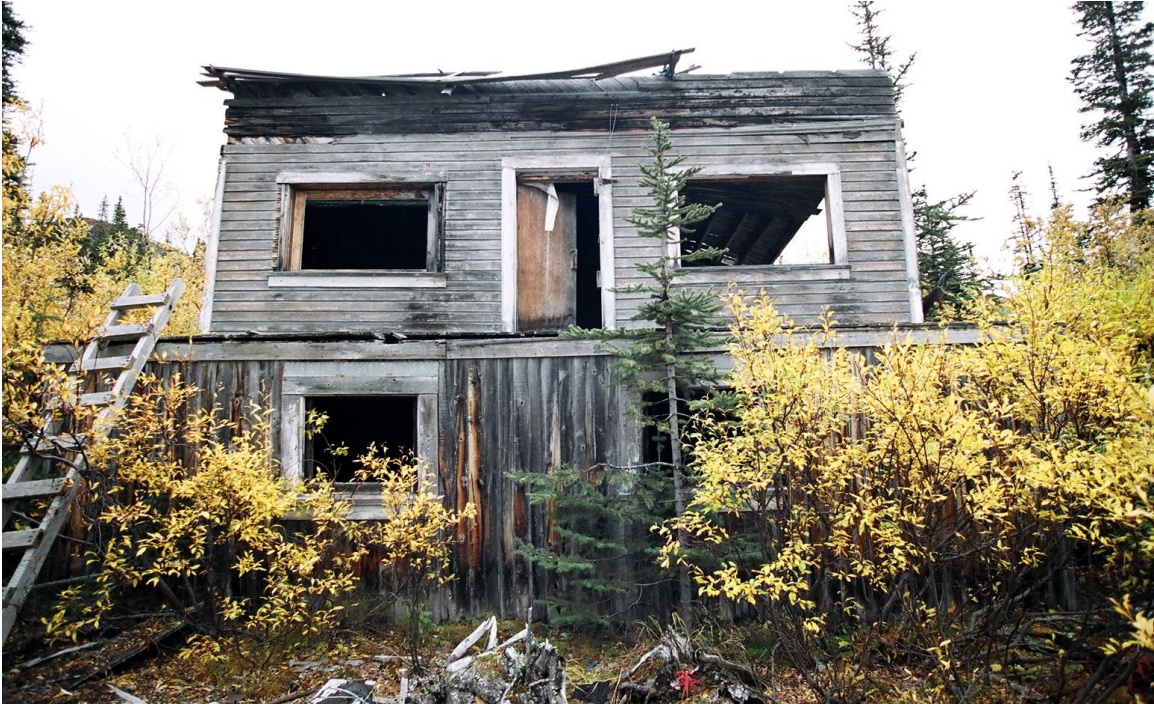
Because of the poor condition of this building we were unable to get further accurate measurements of the buildings rooms and features.

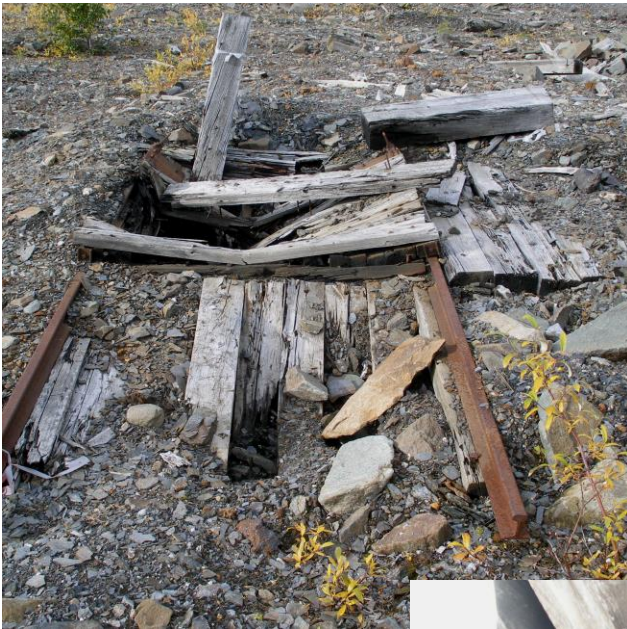
This shaft is located 15.6 meters due west, down slope of the transfer station. This was the haulage shaft for the underground workings at the Wernecke site, the shaft is in poor condition with the top rounds severely deteriorated.

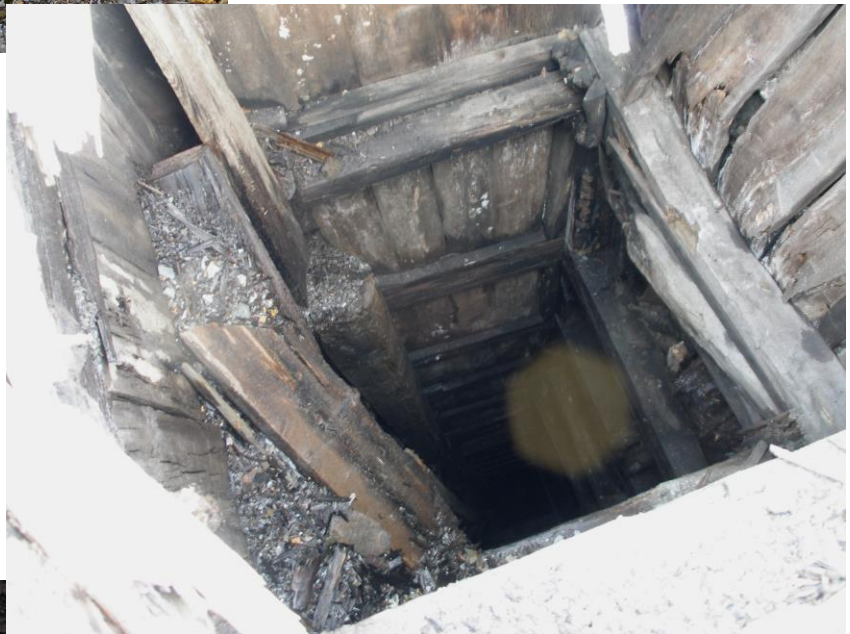
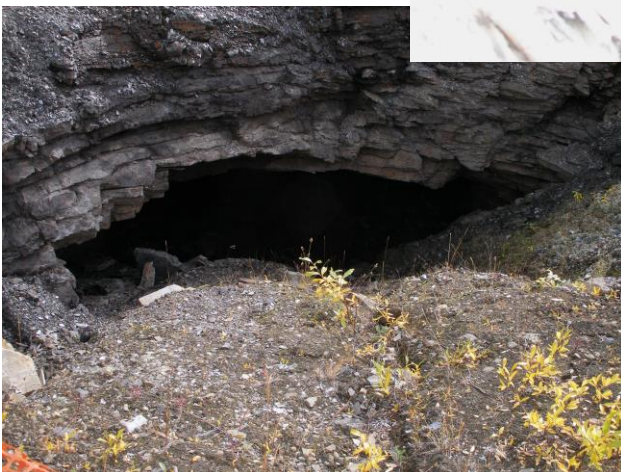
Extending 58 meters to the south of the Ladue shaft was a collapsed Stope. This was also filled in at the same time as the shaft.
