# Historical Review

Of  
Former  
United Keno Hill  
Mines Limited  
Quartz Claims

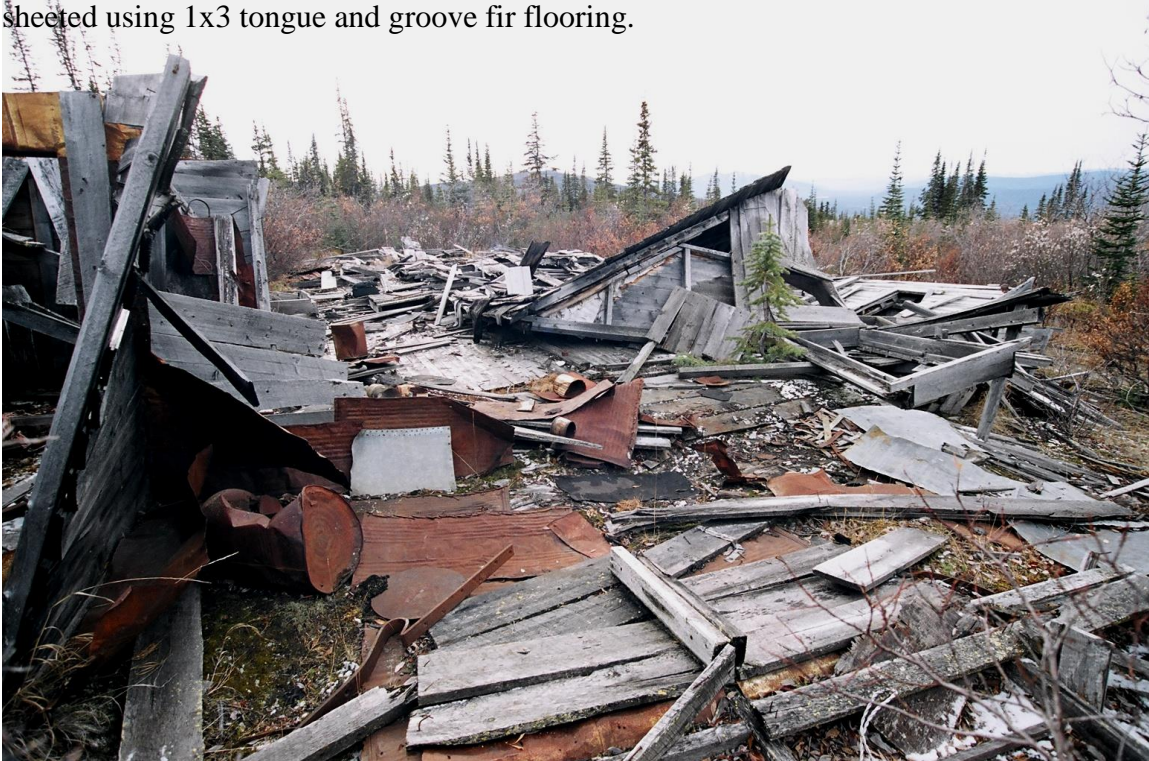
The building has collapsed and most of the lumber has been salvaged. The walls and roof have been built with a combination of 2x4 and 2x6 frame material. The roof has several layers of material consisting of canvas, burlap, black tarpaper, and split open, square metal pails.

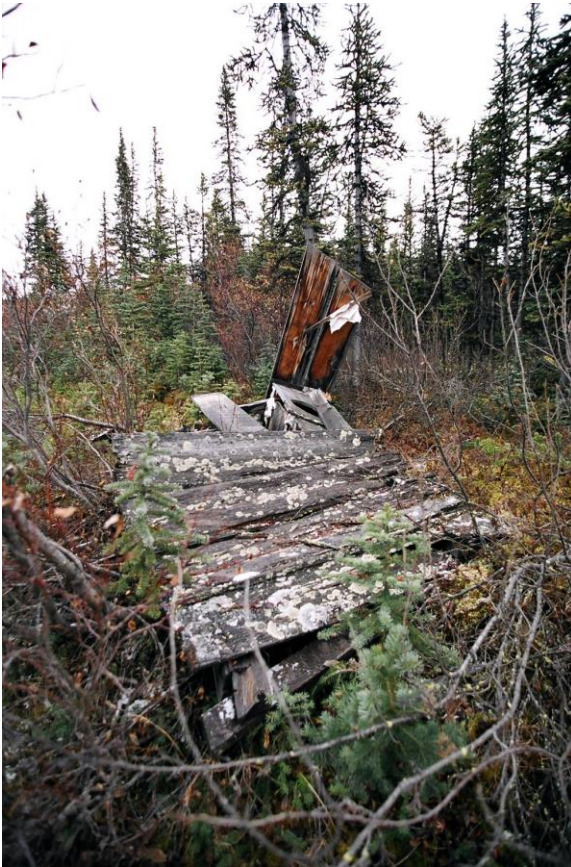
The outhouse is located approximately 20 meters south east of building #1 and is located across a small creek.

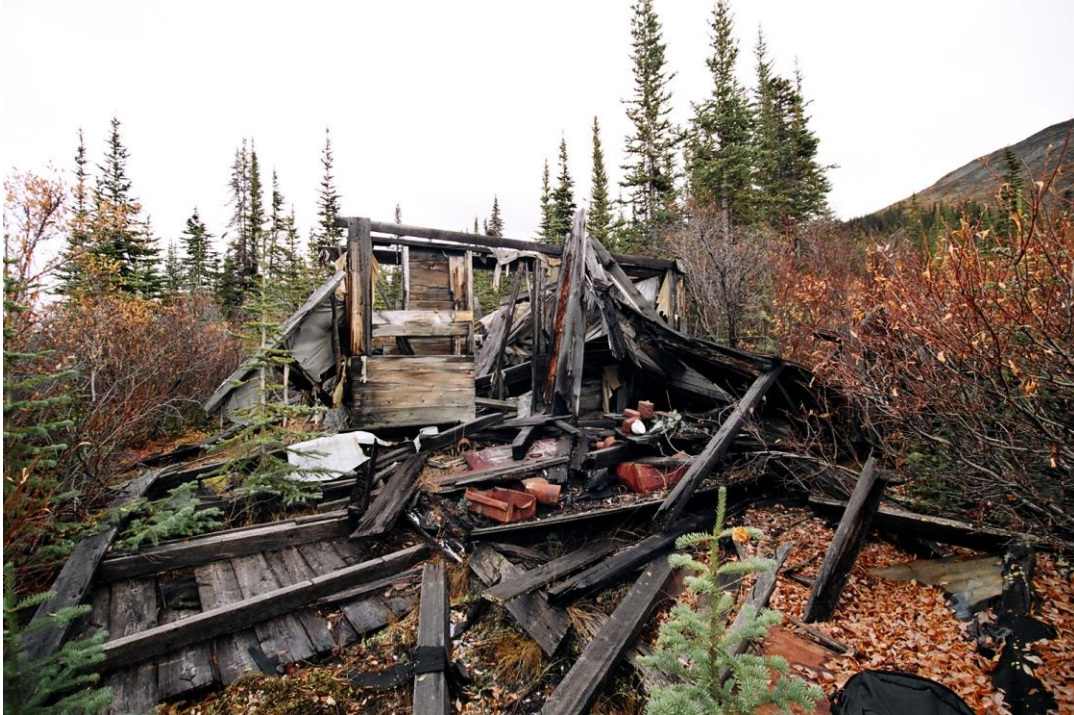
The foundation is built of 2x6 floor joists that have been laid directly on the ground. The floor itself is a combination of 1x8 planks and split open dynamite boxes that have been notched back together and covers the entire floor. The southern porch area has plank boards, also covering 2x6 floor joists.

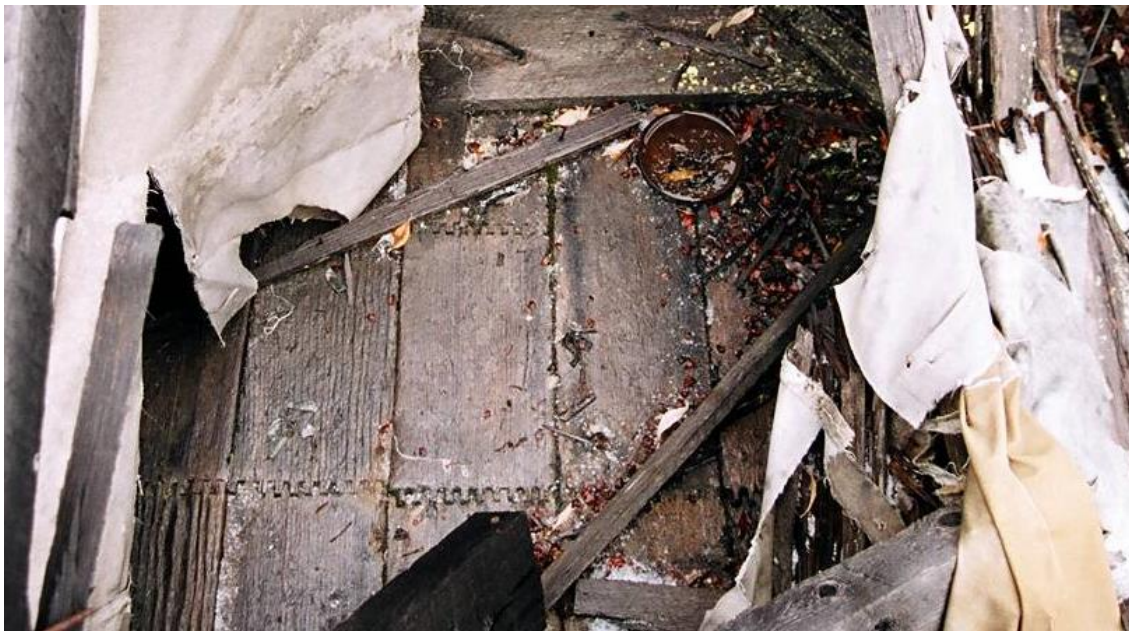
*Historical Review of Former United Keno Hill Mines LTD, Quartz Claims  
Wernecke Camp and Sadie Ladue Site 21. Keno Hill. Volume 1*

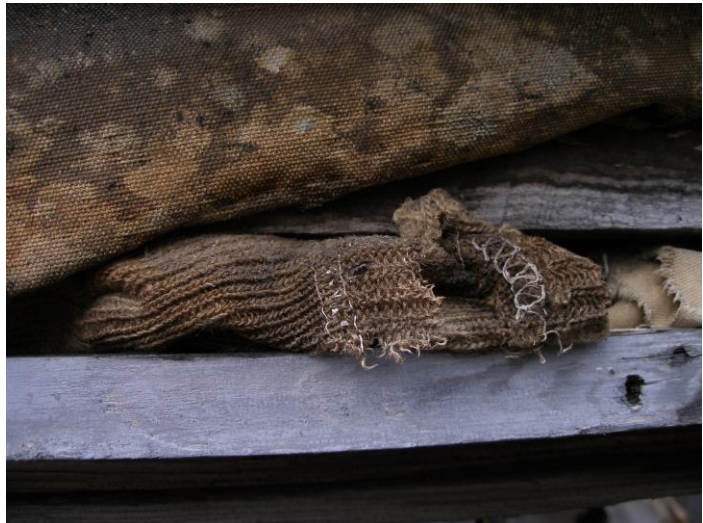
The builder was extremely resourceful utilizing whatever material was on hand. He used tin and boards from shipping crates to burlap, canvas and long Johns for chinking around the windows.

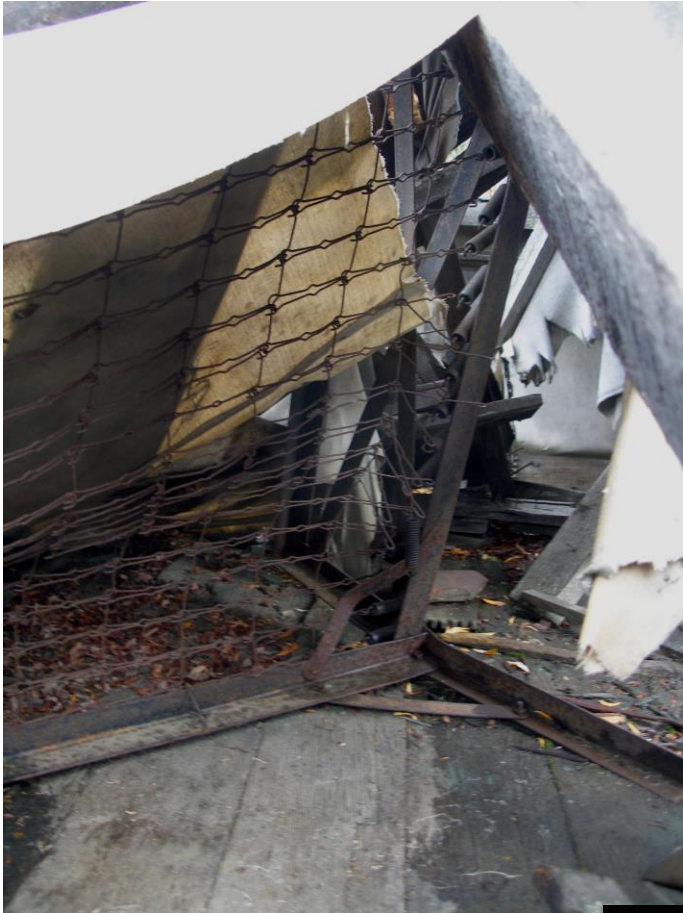
A bed frame, broken glass bottles and tin containers of various shapes and sizes were found in and around the building.

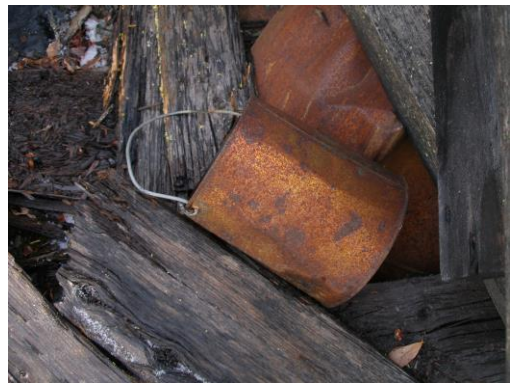
Tin cans and tin containers were fashioned for many uses by the old-timers, wire handles were added to tin cans.

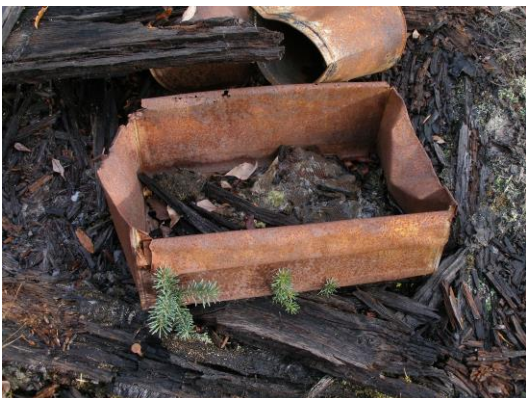
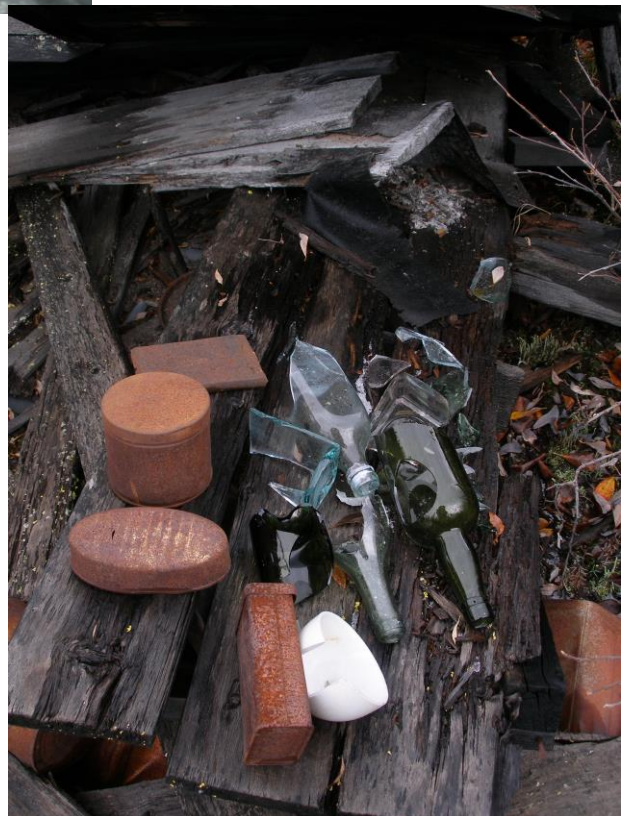
*Southeast Wernecke B3*

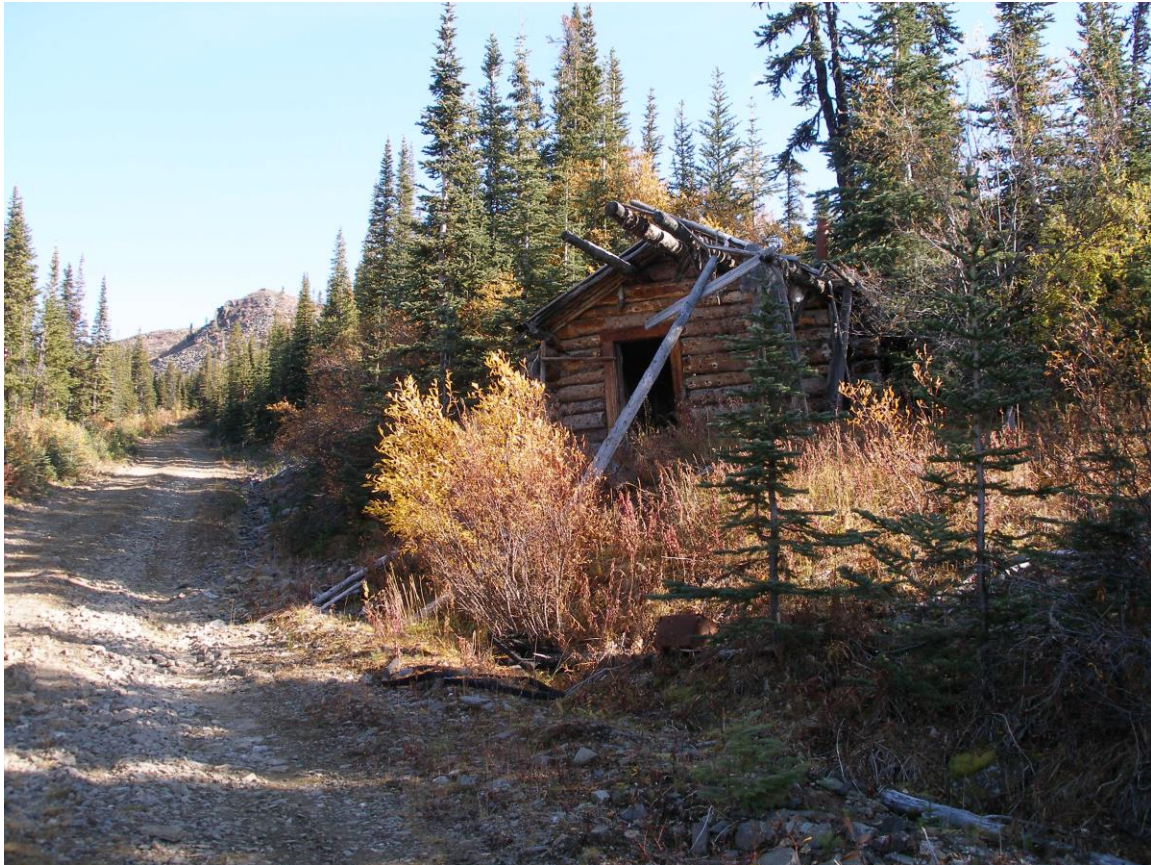
Corners of the log walls are saddle notched with the interior log walls hewn flat with an axe, the exterior log walls were left untouched.

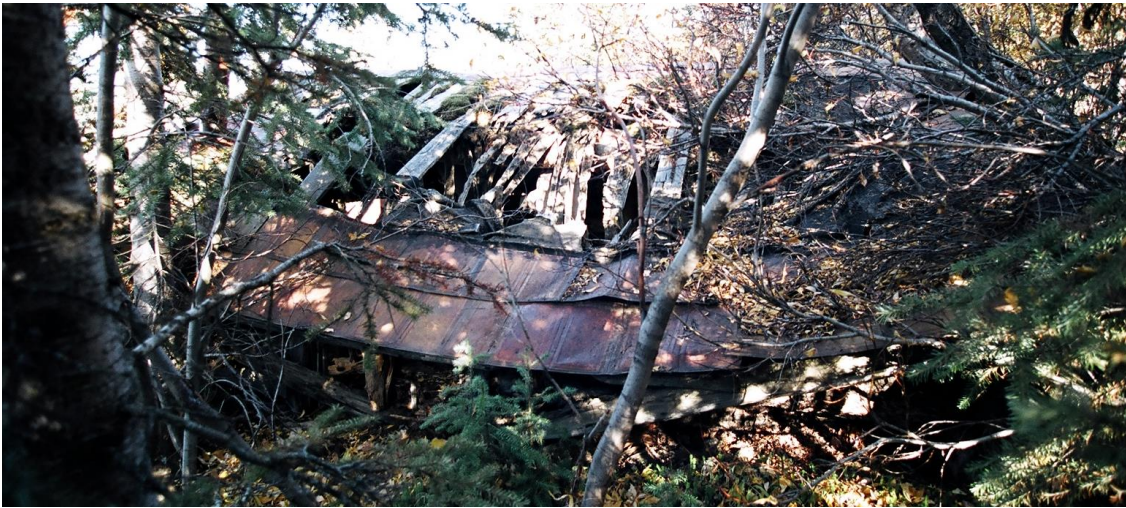
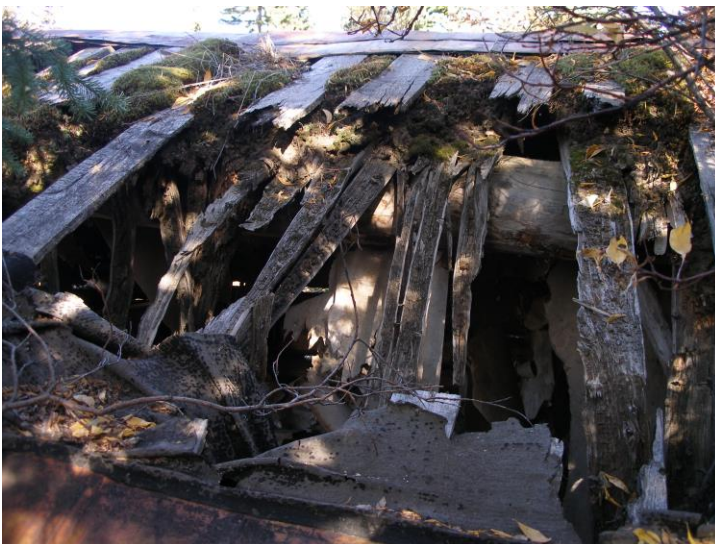
There is a hand made bed frame and a cupboard remaining inside of this cabin. No other artifacts were found.

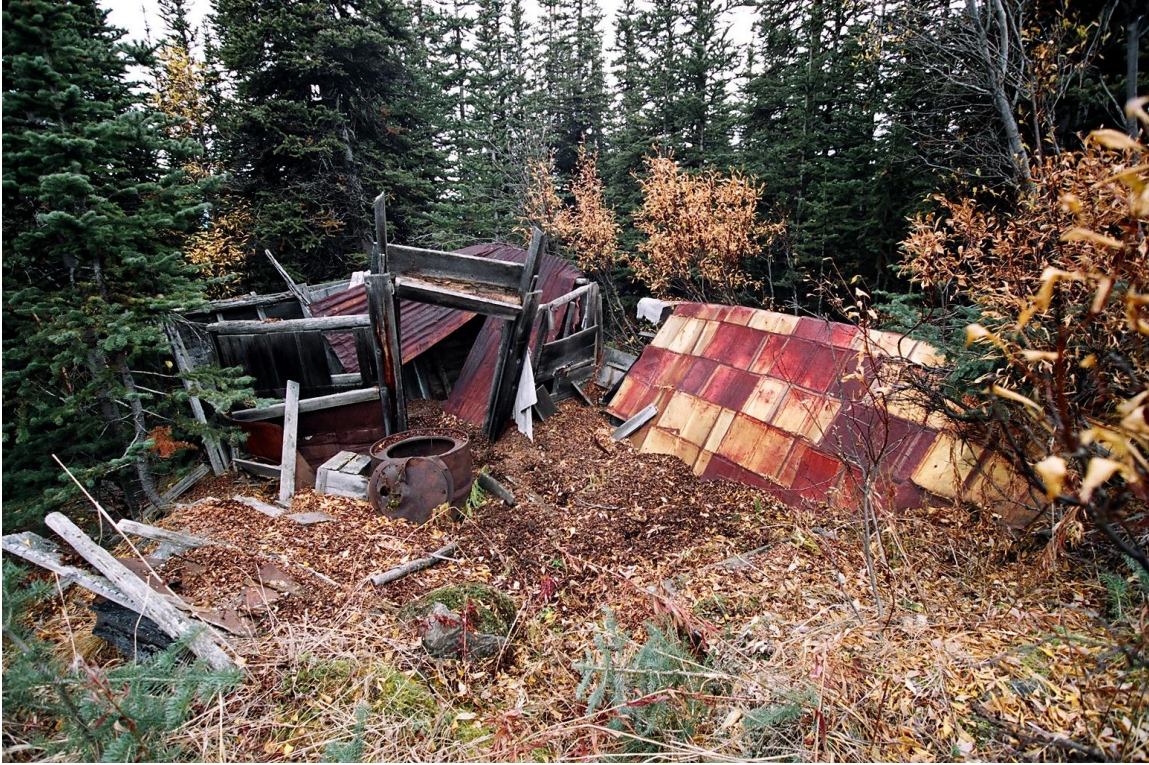
The foundation and construction of the building is a combination of log poles and frame sheeted with a hodgepodge of material.

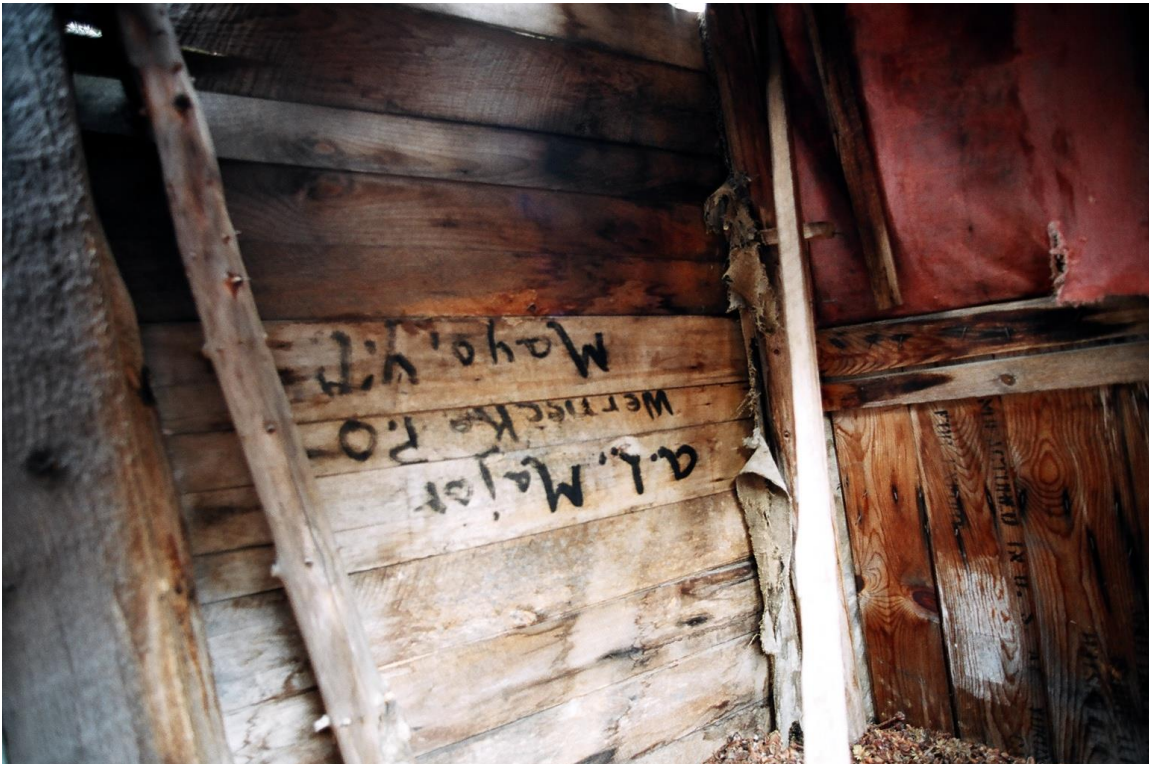
*Southeast Wernecke B6*

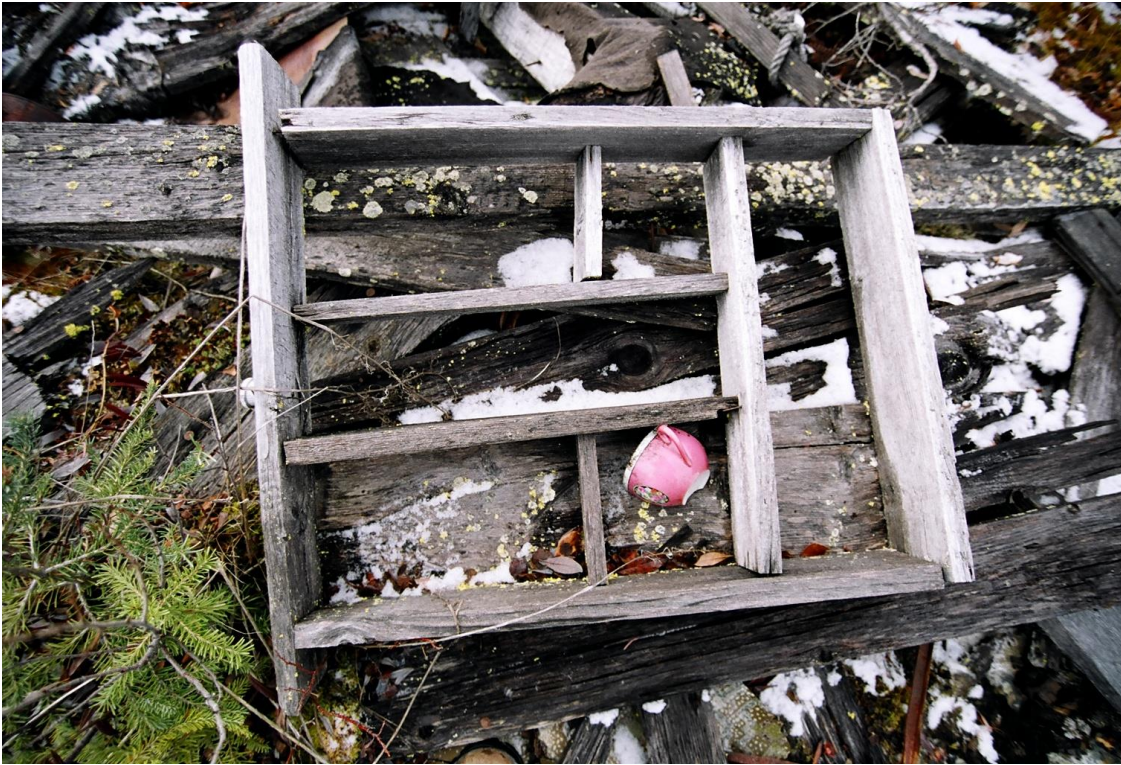
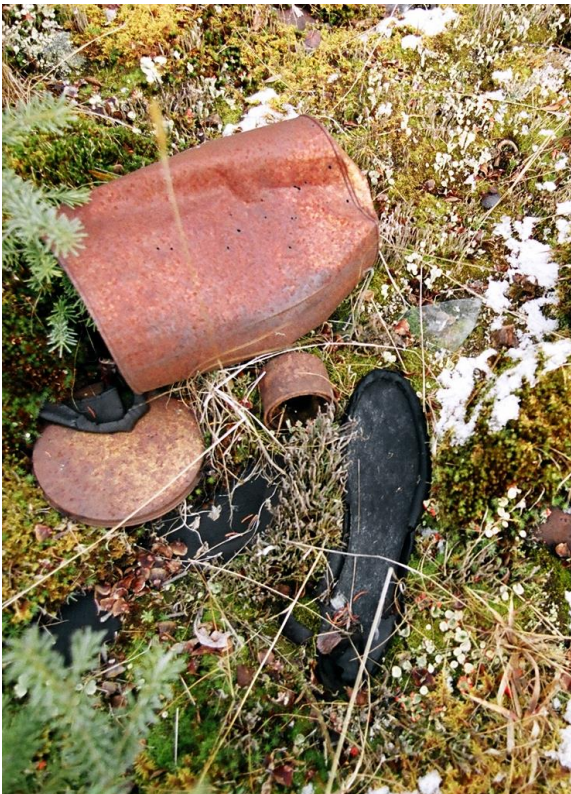
At the time of inspection we could not tell what style of roof covered this building.

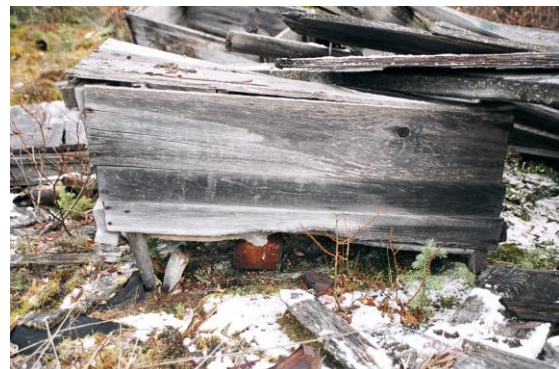
*Southeast Wernecke B7*

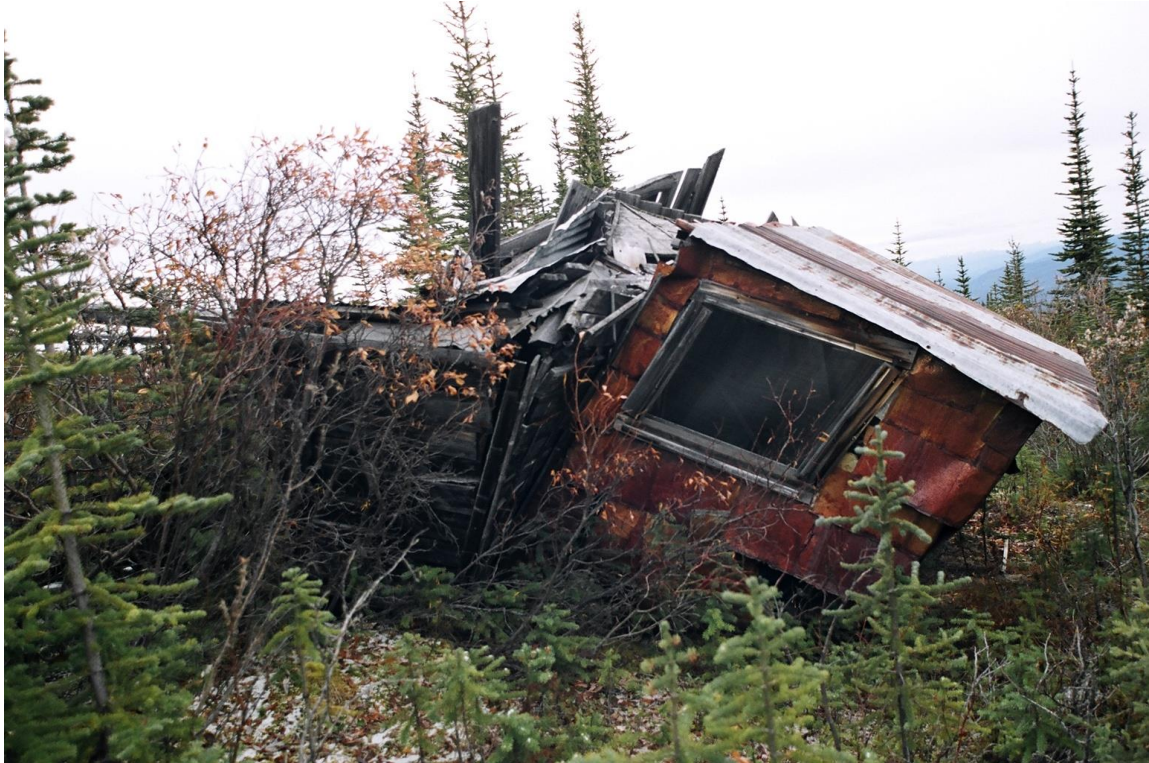
The building has been pushed off its original foundation, which were 6x6 timbers laid directly on the ground, the foundation size is 4.6 meters by 5.5 meters.

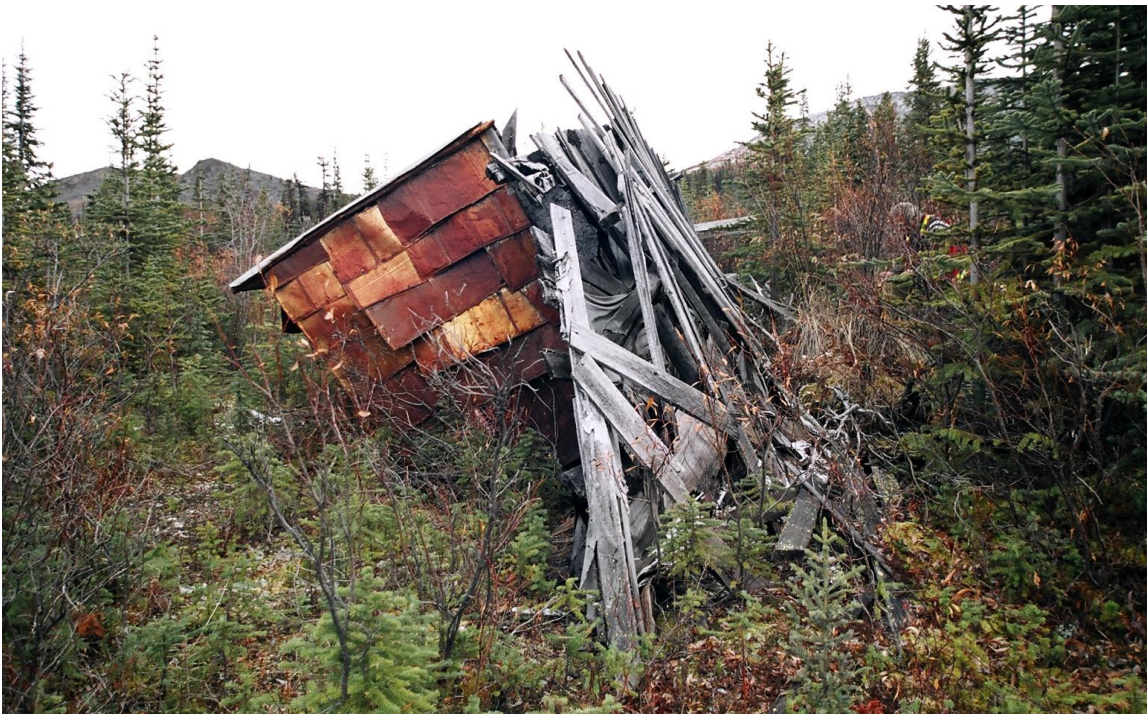
The porch remain close to there original shape, but is cantered dramatically to the north. The construction of the porch is 1x6 boards nailed over a 4x4 frame foundation that is placed directly on the ground. The 2x4 stud walls are sheeted with 1x6 and 1x8 shiplap boards throughout.

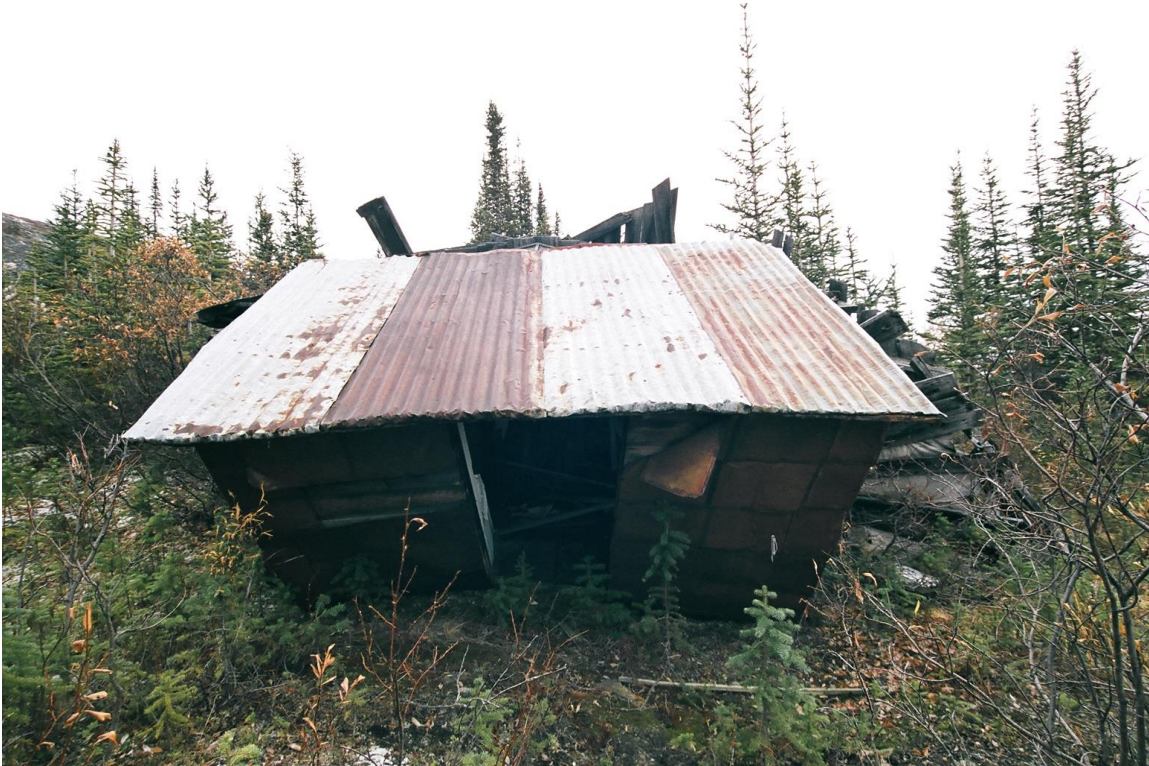
The exterior porch walls are covered with split open metal pails.

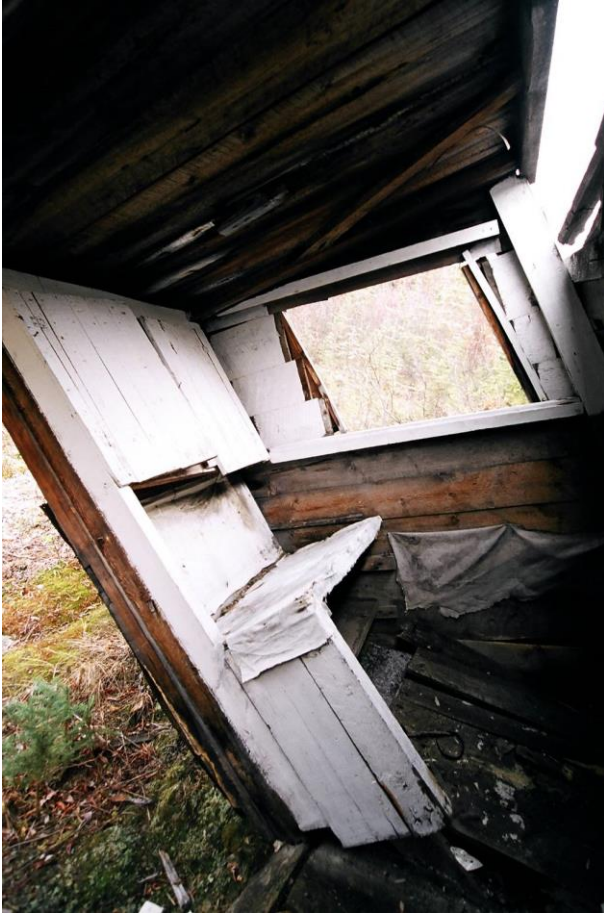
There is a small closet located in the northwest corner of the porch and a cupboard on the north wall next to the main entrance.

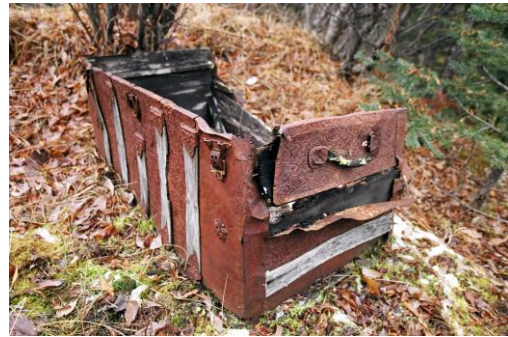
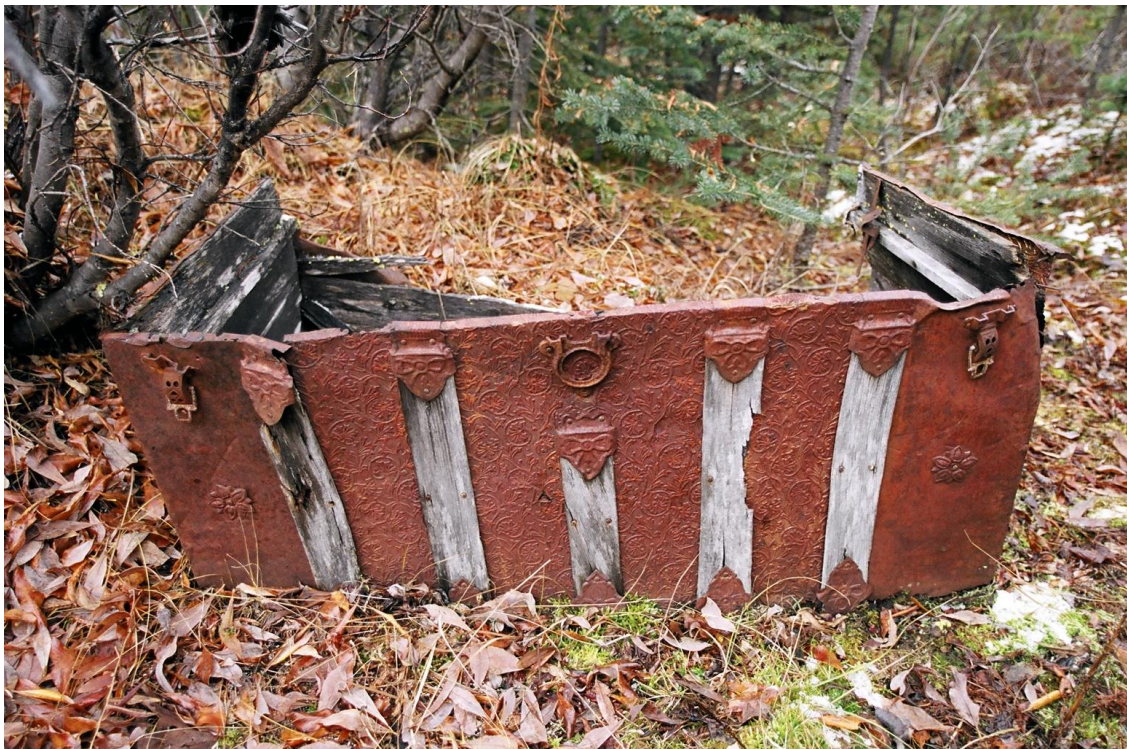
*Southeast Wernecke Shaft*

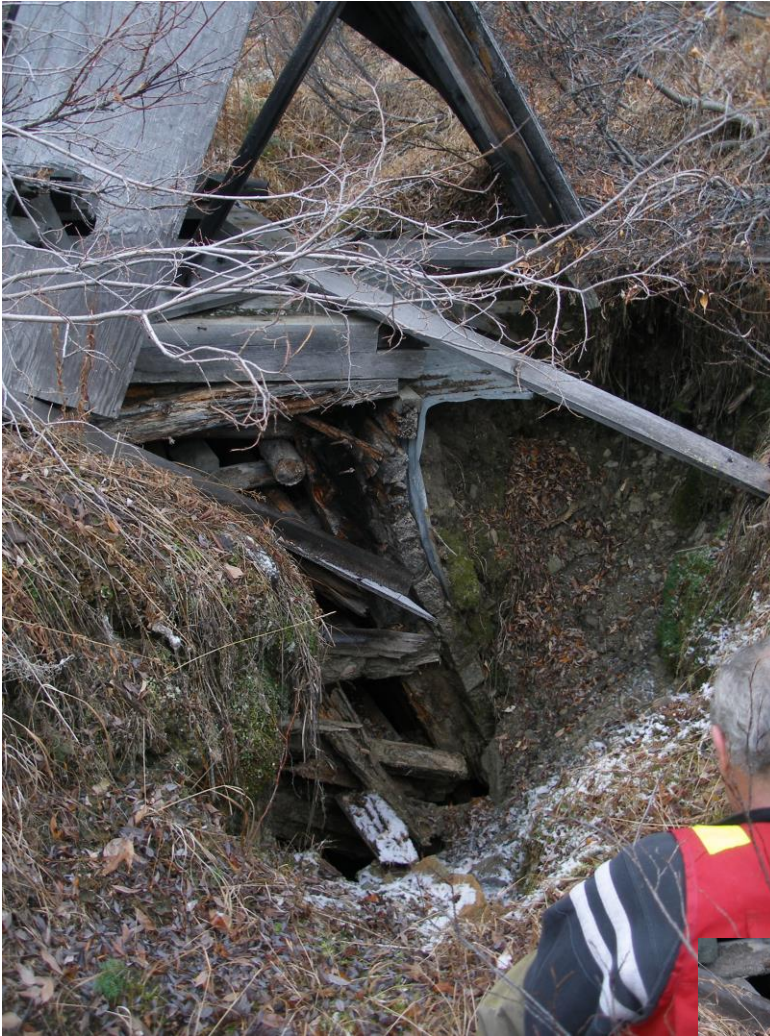
The shaft house foundation are 8x8 beams that have been corner notched and then spiked together to form a 3 meter by 3meter square.

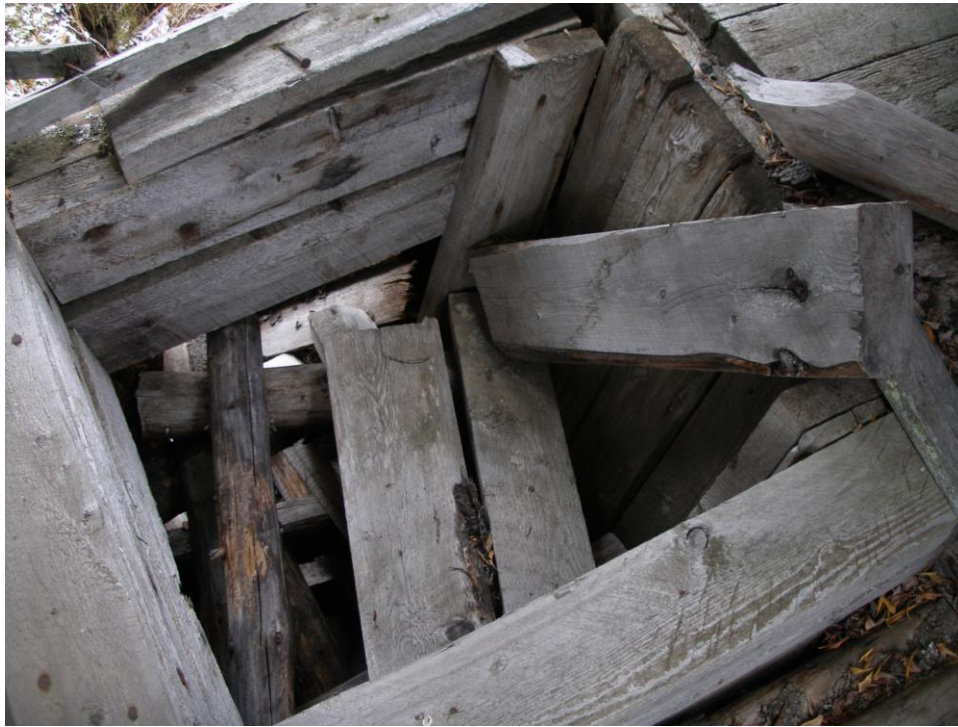
The date of the shaft is unknown and is not found on the Geological Survey of Canada Paper 55-30 by R. W. Boyle Ottawa 1956 Part of figure 5. So it's most likely constructed after 1956.

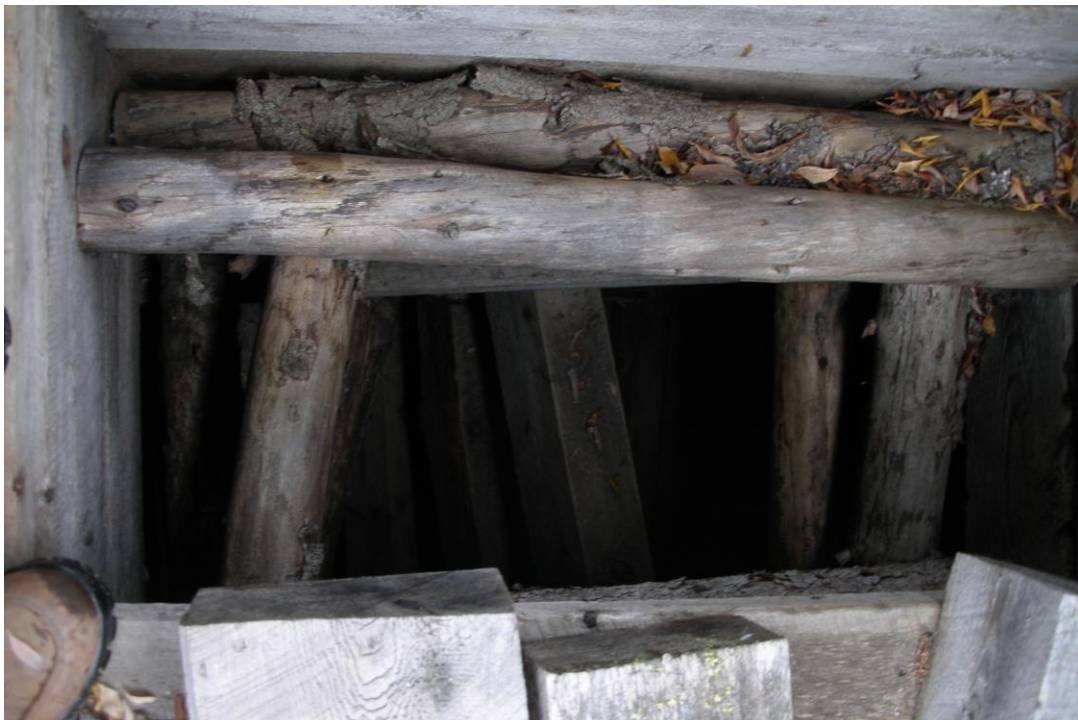
*Southwest Wernecke Residences B1*

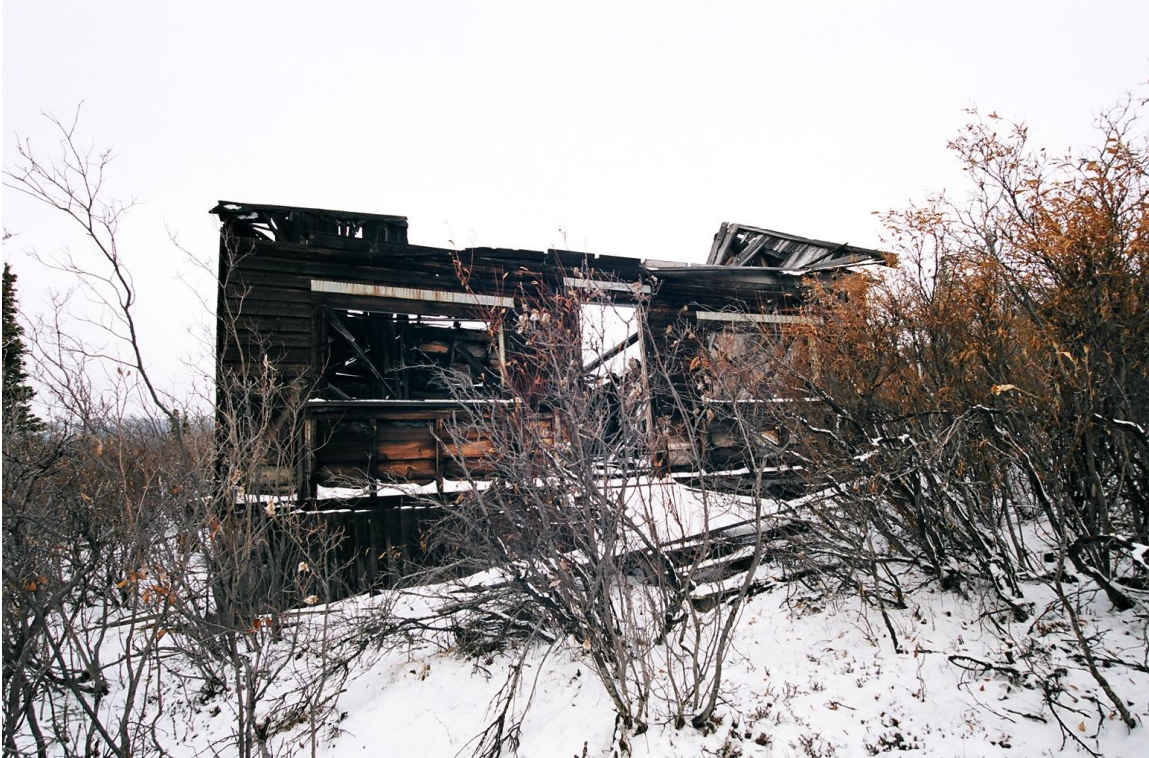
The foundation of the residence is constructed on 6x6 upright posts that are placed directly on the ground.

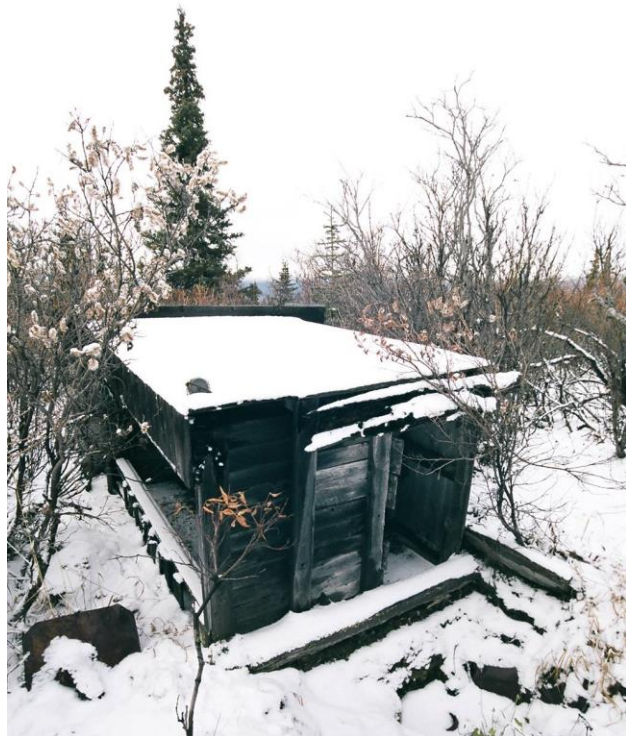
*Southwest Wernecke Residence B2*

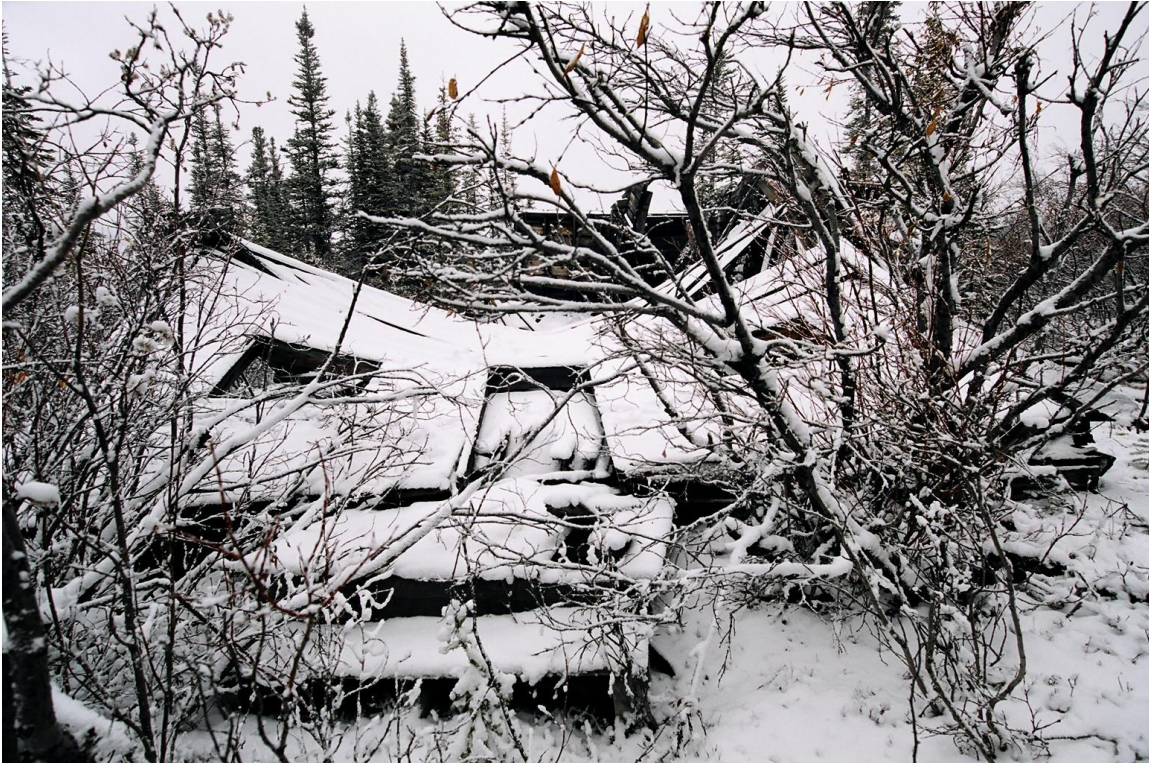
These joists were then sheathed with 1x3 tongue and groove flooring.

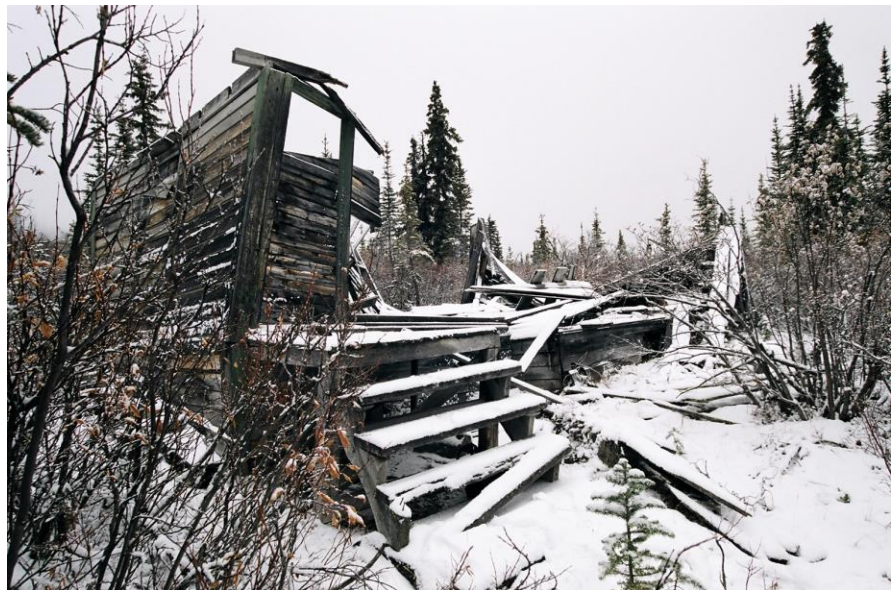
*Southwest Wernecke Residence B3*

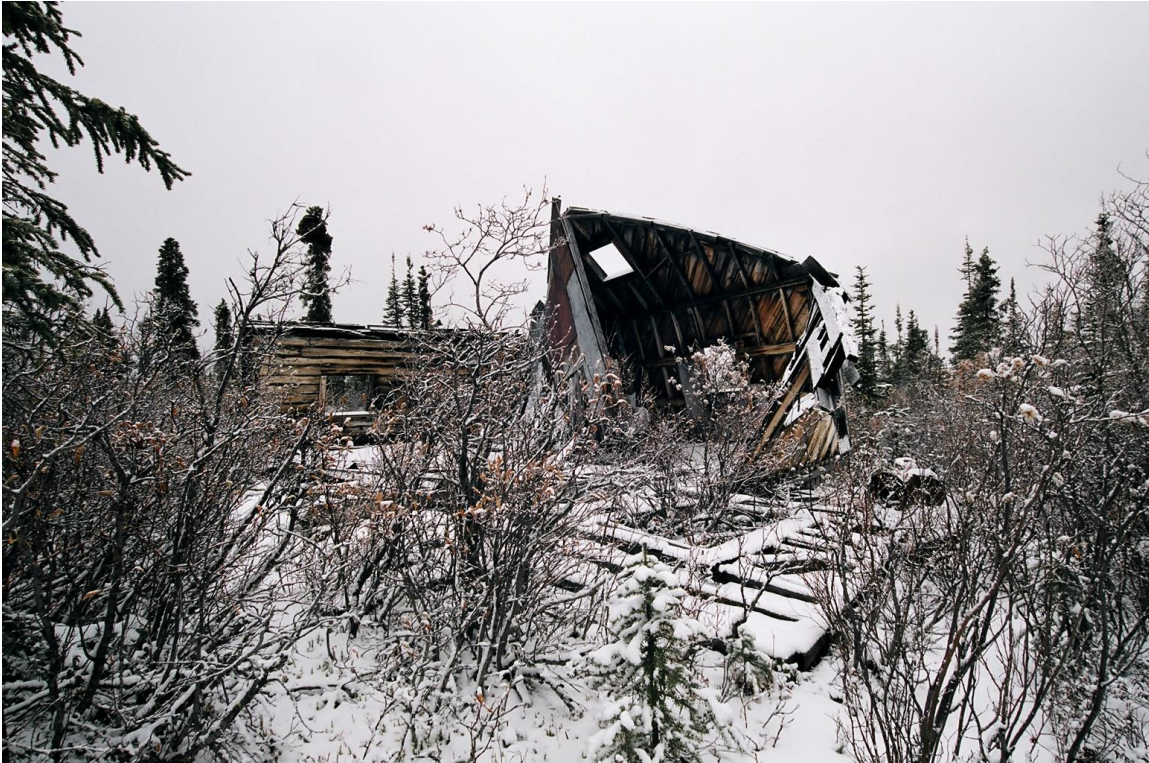
The foundation of the building is frame 6x6 placed directly on the ground, the floor joists are 2x6 sheeted over with 1x3 tongue and groove flooring.

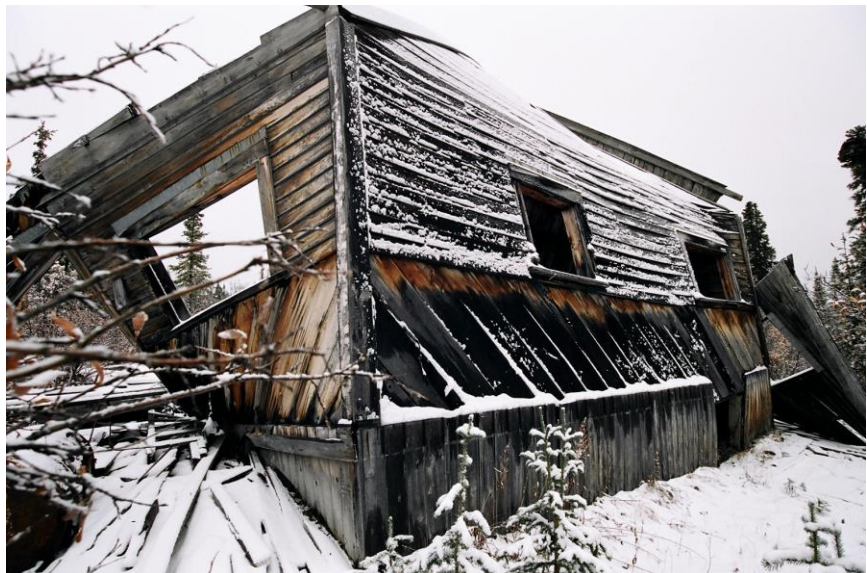
vertically with 1x6 shiplap boards. The rough cut 2x4 wall studs have been placed on to foot centers with horizontal bracing every four feet.

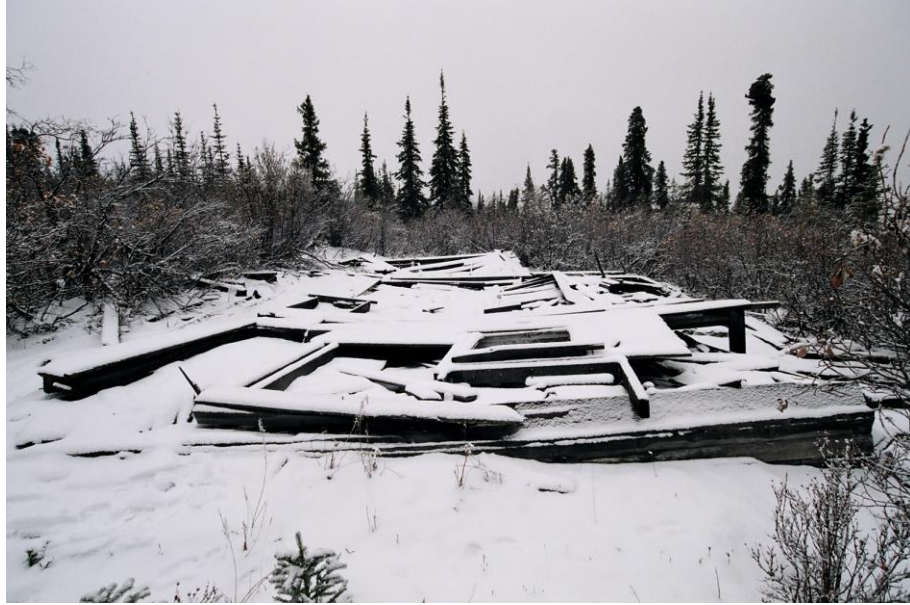
From the remains we can tell the building had a gable style roof, with a doorway situated in the north wall of the building.

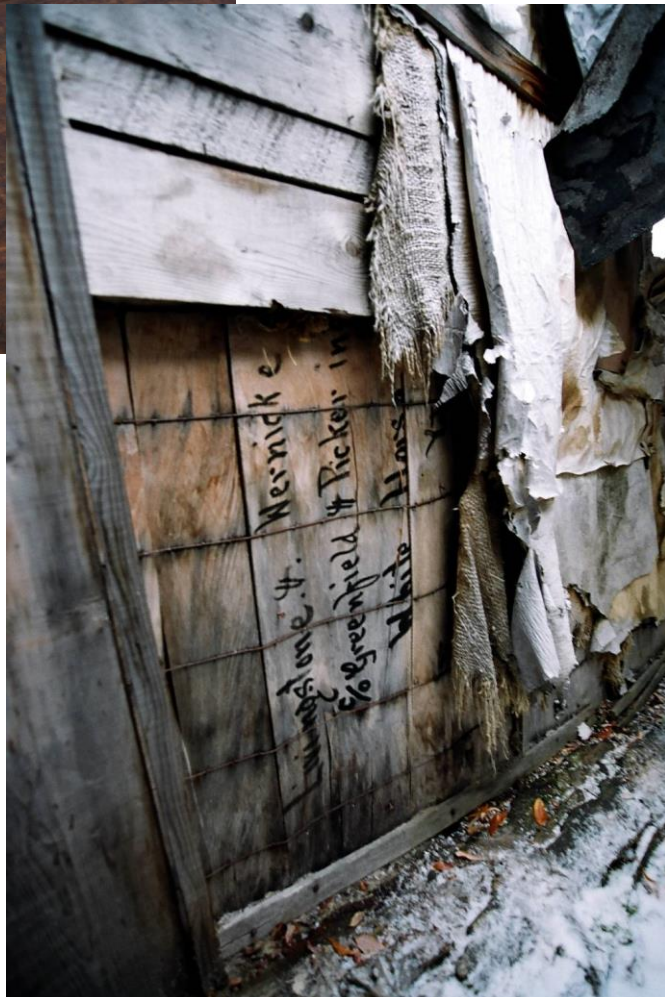
*Southwest Wernecke Barrel Shed B 7*

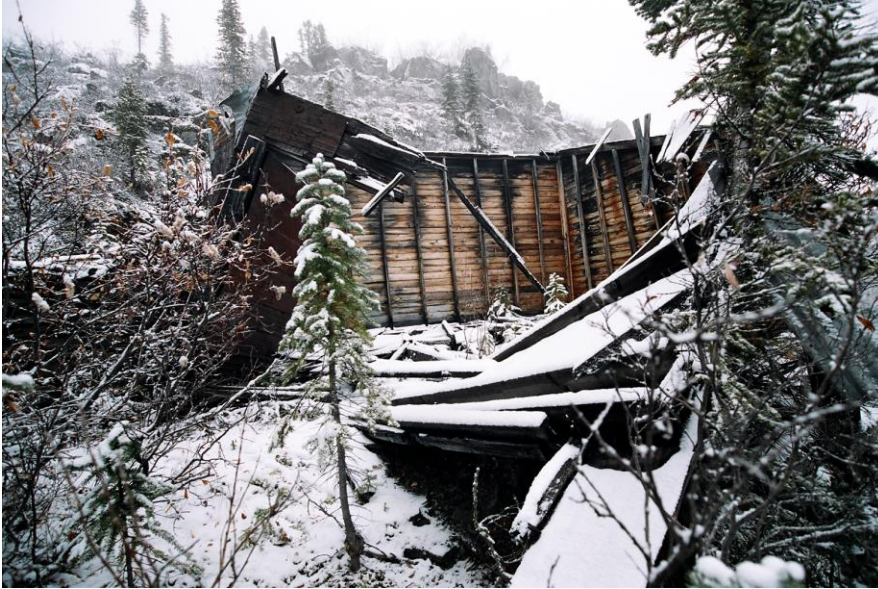
One of the most outstanding features of this building is the amount of material that was excavated from the nearby hillside to create the foundation the building was constructed on.
