# Historical Review

Of  
Former  
United Keno Hill  
Mines Limited  
Quartz Claims

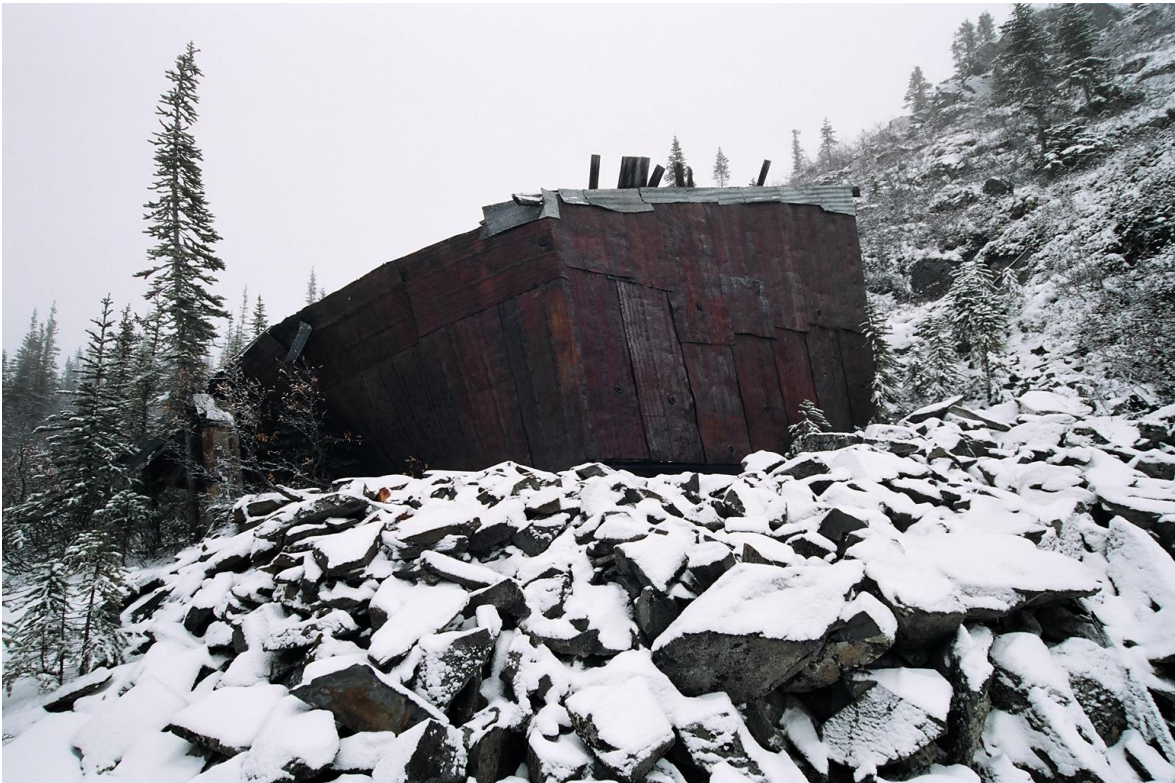
One of the most outstanding features of this building is the amount of material that was excavated from the nearby hillside to create the foundation the building was constructed on.

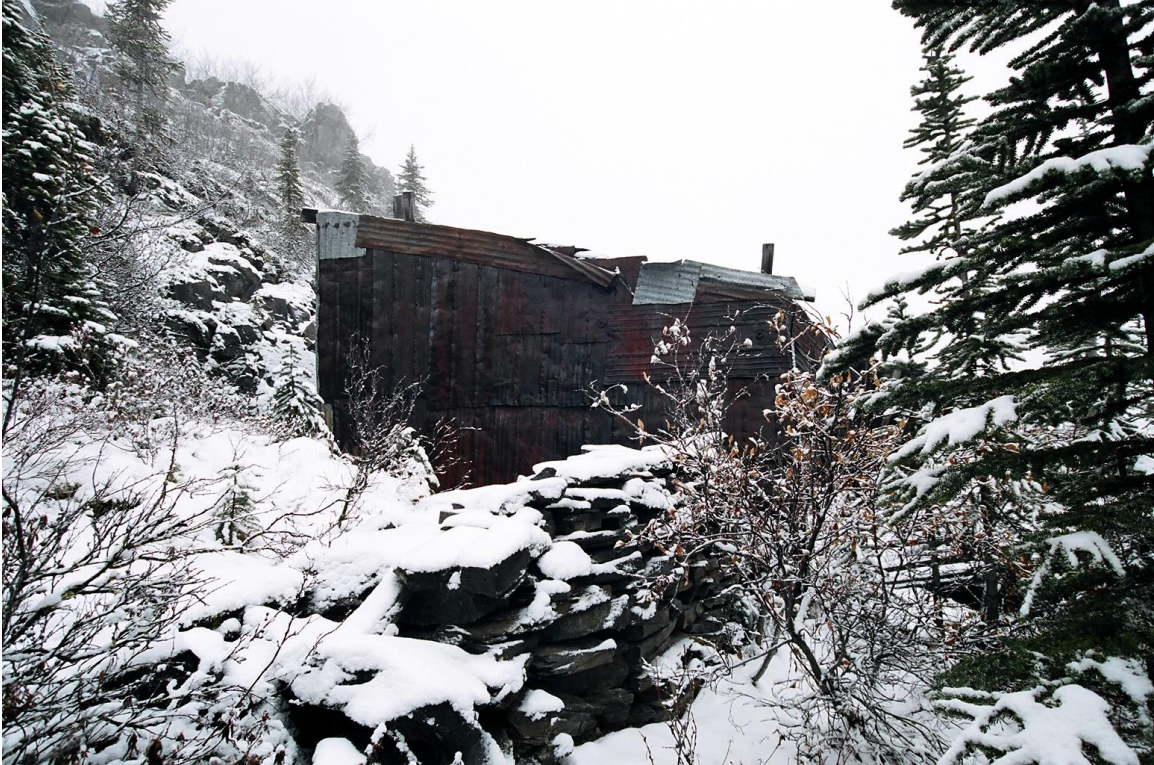
Flat rock was hand stacked at the south and east ends of the building to form retaining wall.

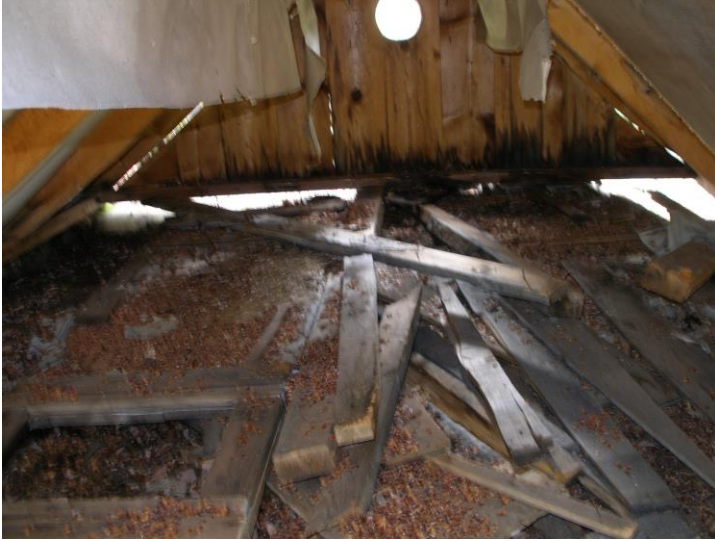
There is evidence of a foundation, floor, and wall material associated with the remains; these are lying inside of the collapsed gable roof.

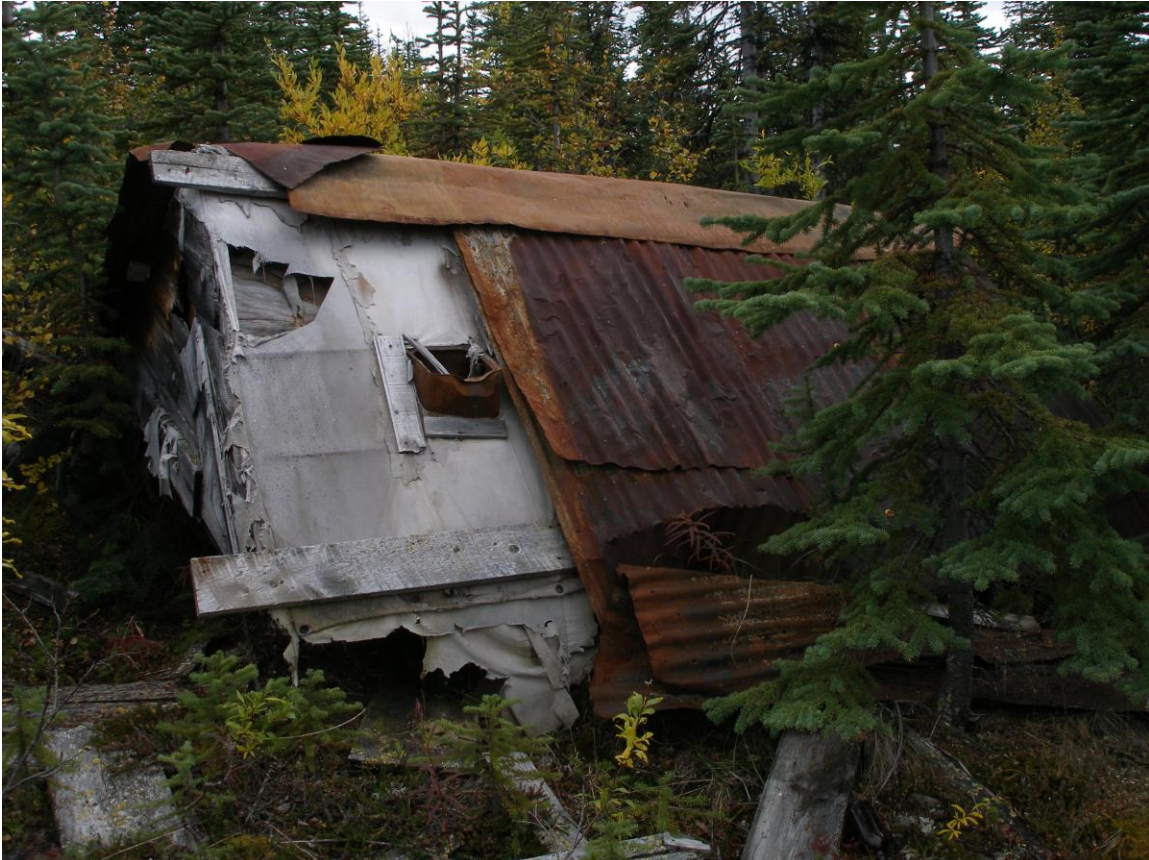
The chimney safety in the northwest corner of the roof is made from a square oil can. There are ventilation holes in the north and south ends of the gable roof.

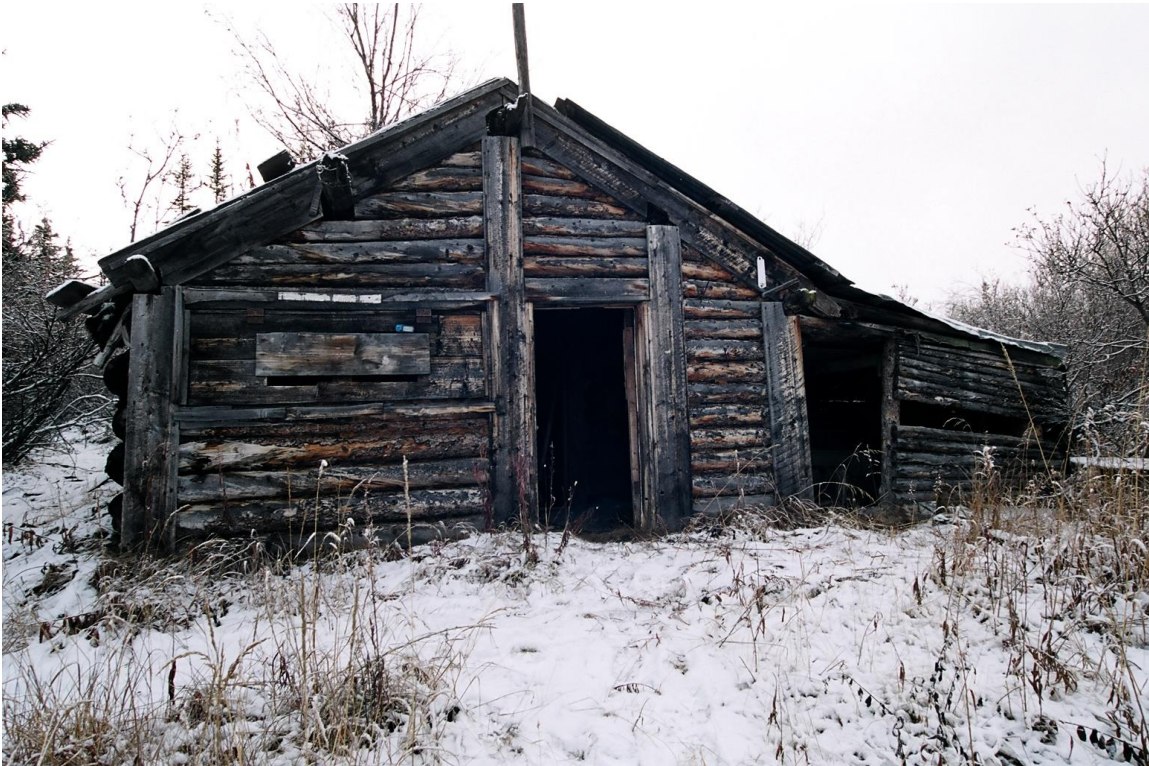
The main log building is saddle notched together at the corners. The north porch and west storage addition have Yukon style corners.

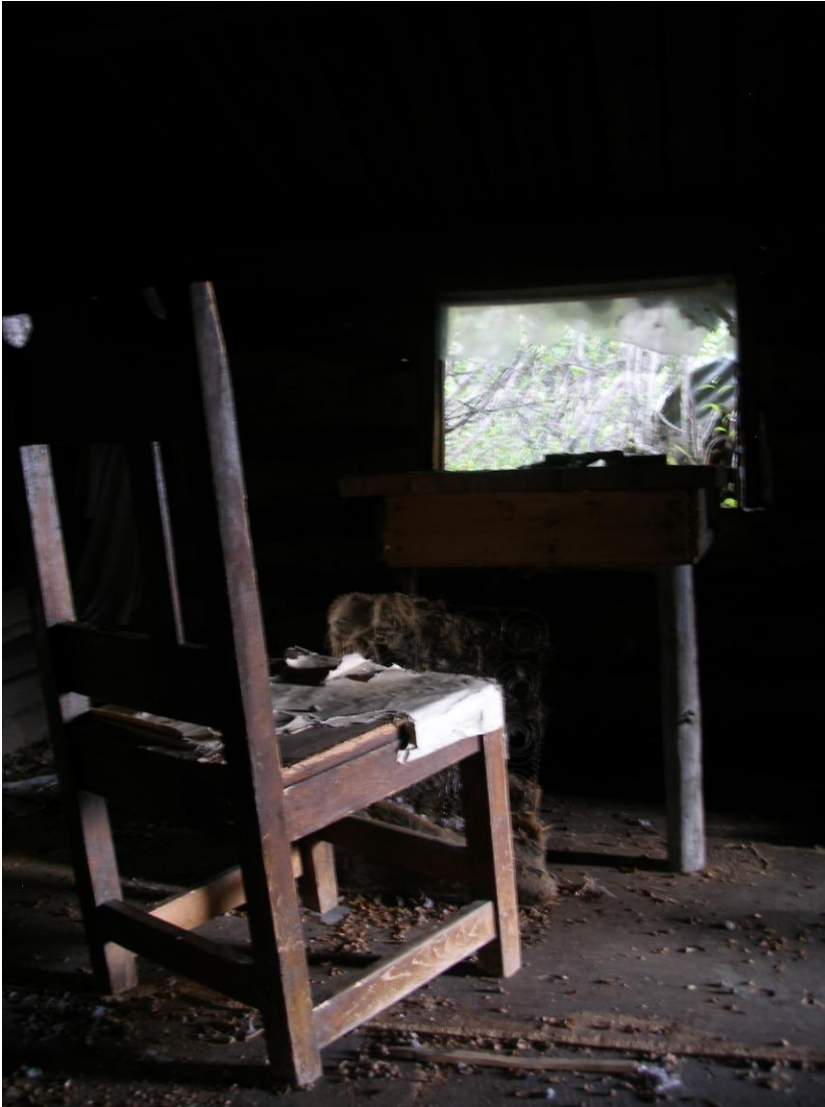
The floor is constructed of 2x8 and 2x4 boards lain on the ground and sheeted over with 1x10 planks, an additional layer of plywood has been placed over the main cabin floor.

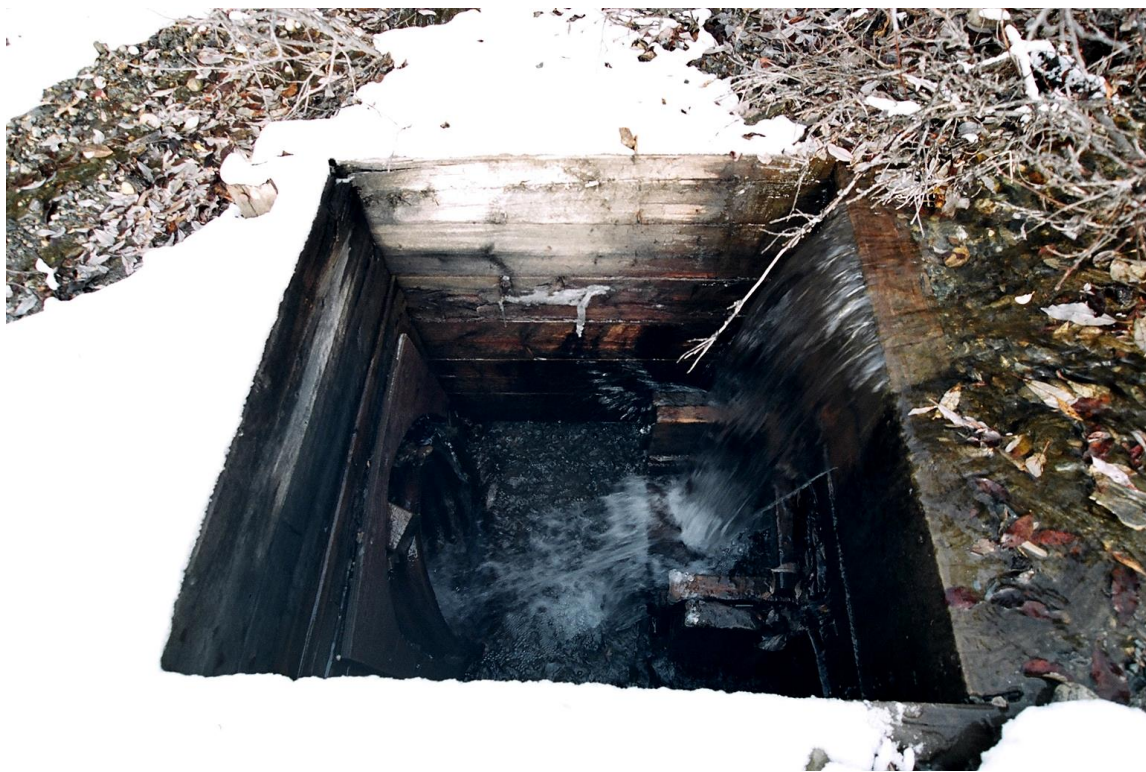
*Historical Review of Former United Keno Hill Mines LTD, Quartz Claims  
Wernecke Camp and Sadie Ladue Site 21. Keno Hill. Volume 1*

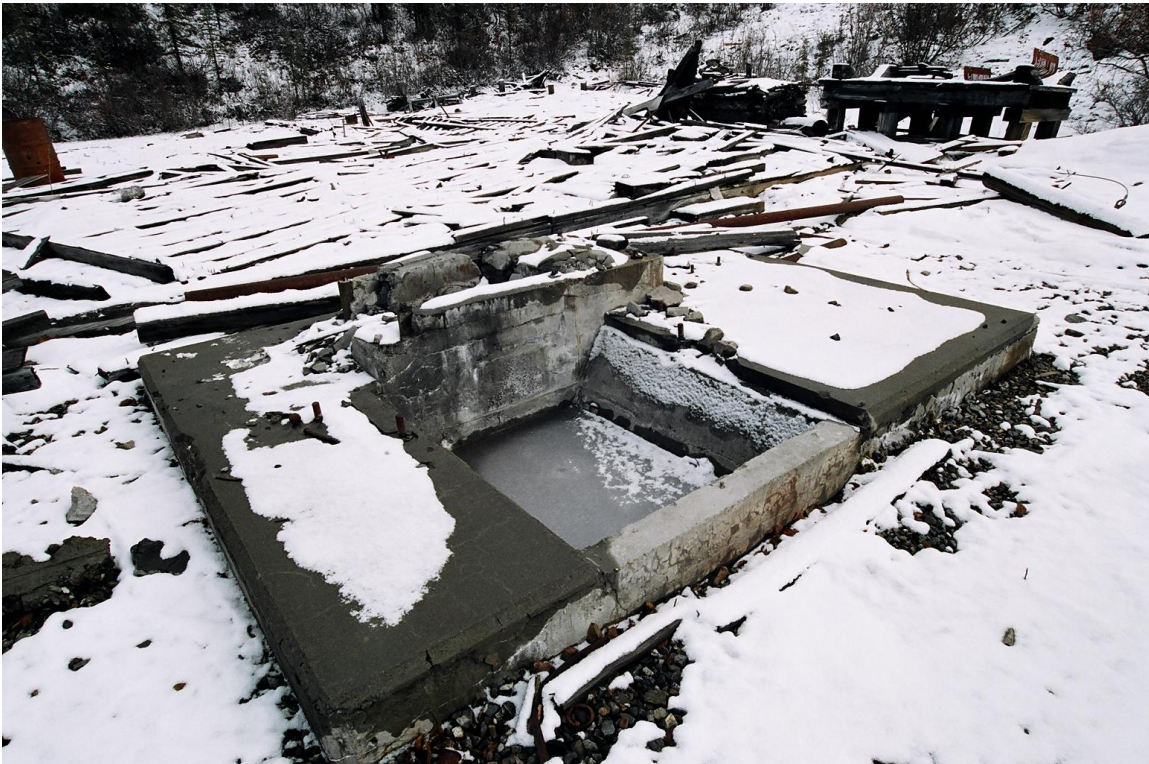
Ten meters south of were the sub station stood is another 8meter by 5.5 meter foundation with a large cement pad in the south west corner.

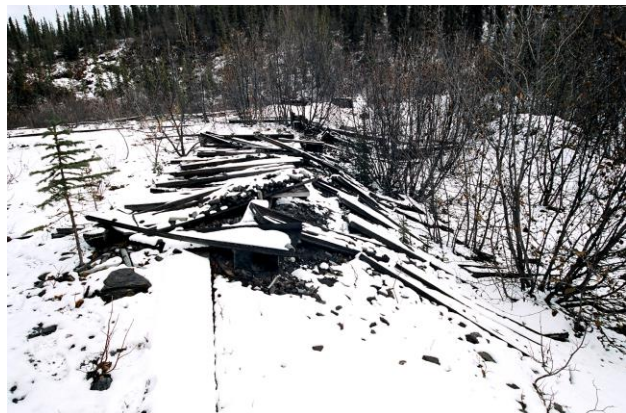
The dump size is approximately 93 meters across with the track still in place at the ore dump. The cribbing on the ore dump itself has broken in the middle and has sloughed to the south, making the area above very unsafe.

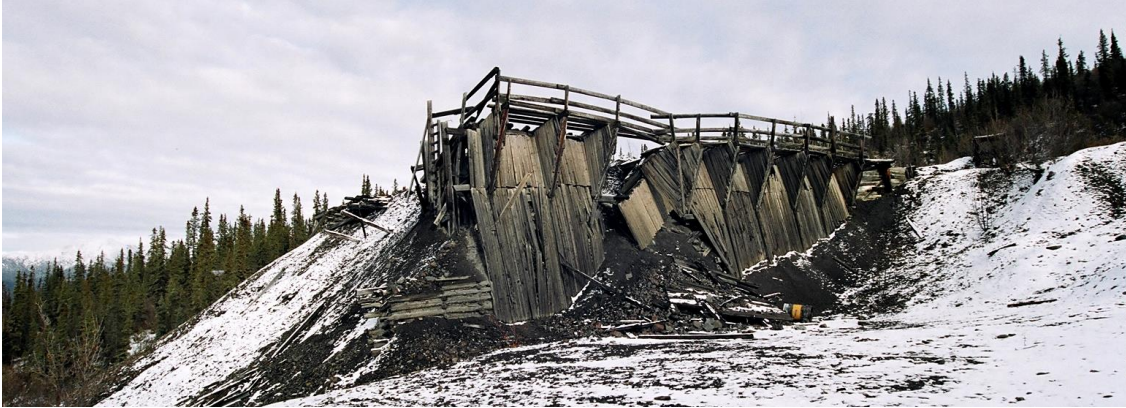
### *Sadie Ladue Building 1*

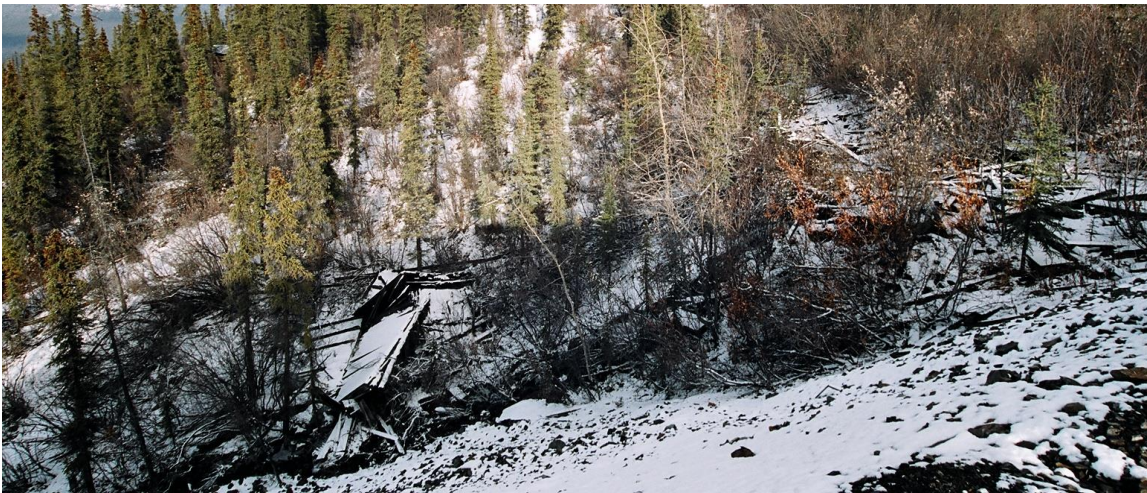
This building has logs around the base and log pole frame for the walls sheathed with 1x8 planks on the exterior. There is no evidence of a floor or a foundation at the top of the gulch, only boards scattered around which could be the remains of other buildings as well. There is evidence of 2x4 roof rafters, black tar paper over the 1x8 board roofing, which was then sheathed with corrugated aluminum roofing and a six inch Yukon safety in the south west corner of what used to be the roof. This was one of the most difficult buildings to discern its shape and composition.

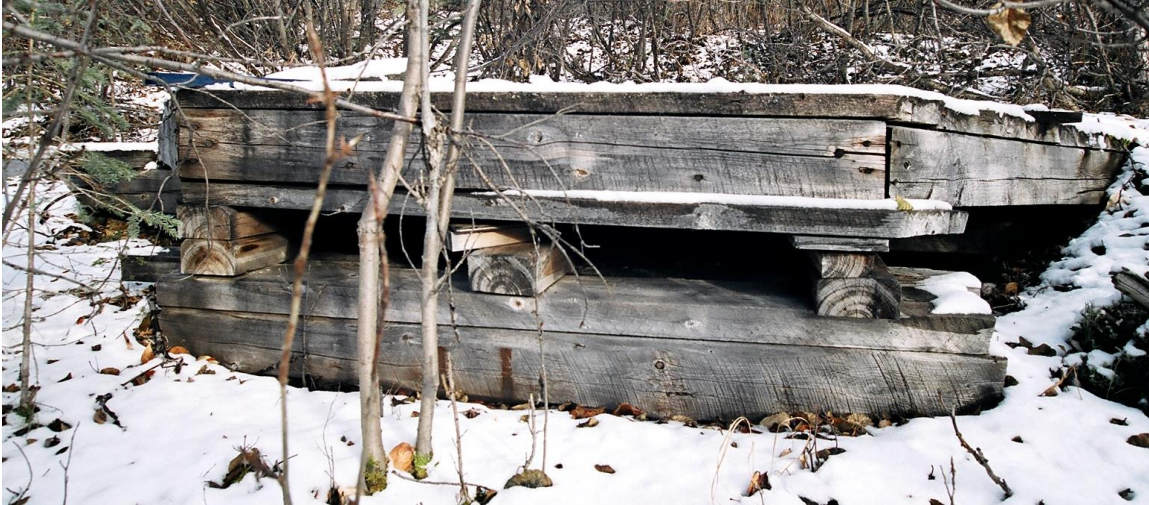
### *Sadie Ladue Outhouse B2*

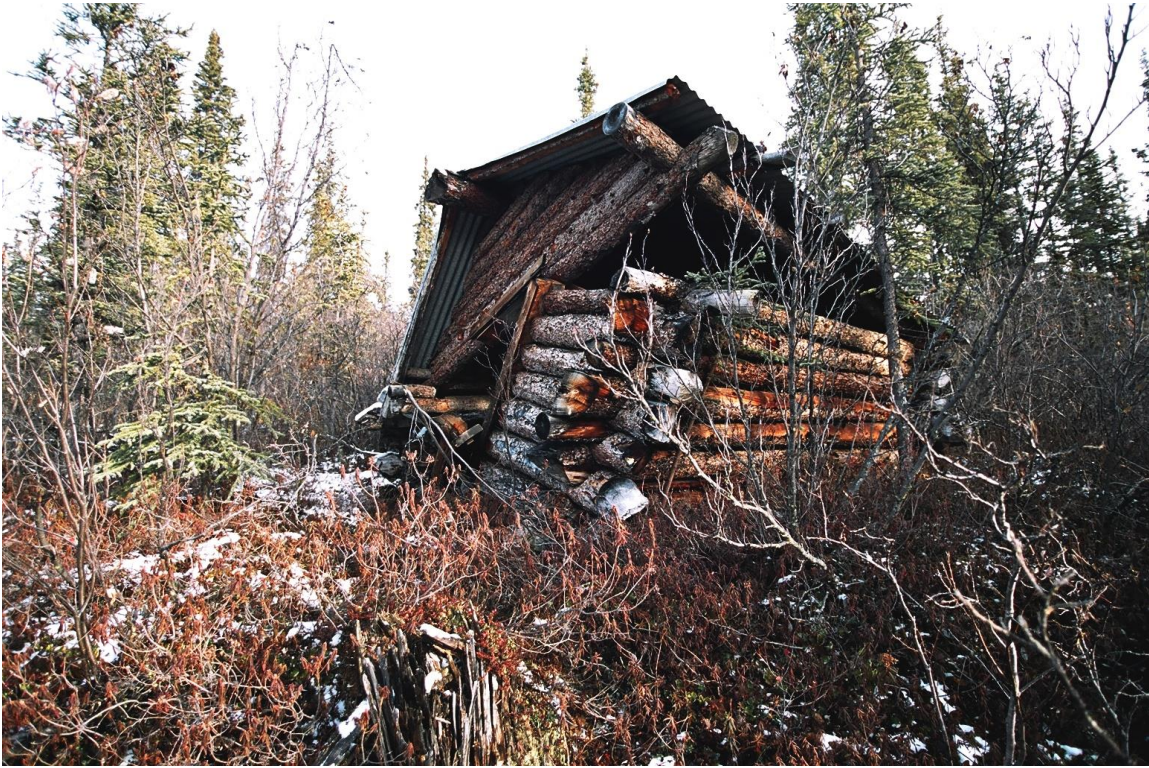
The gable roof has a log ridge pole supporting the log rafters. The log rafters have been notched into the main ridge pole with three rafters on each side of the roof and cross braced from the ridge pole down to the top round of the log wall and sheeted in with heavy corrugated metal.

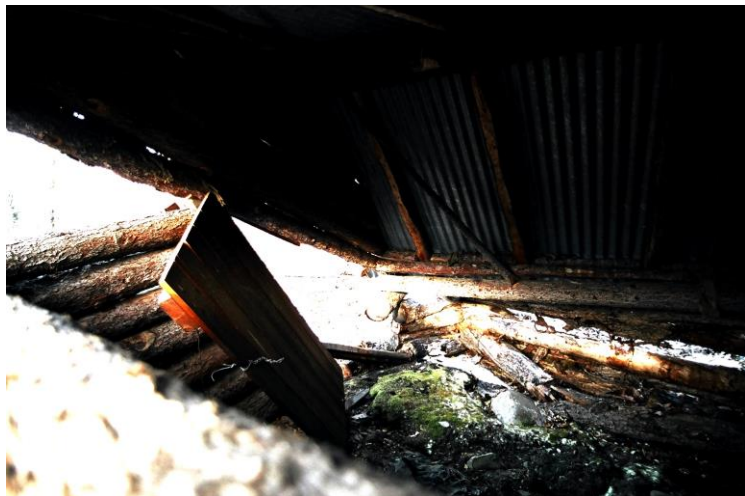
*Historical Review of Former United Keno Hill Mines LTD, Quartz Claims  
Wernecke Camp and Sadie Ladue Site 21. Keno Hill. Volume 1*

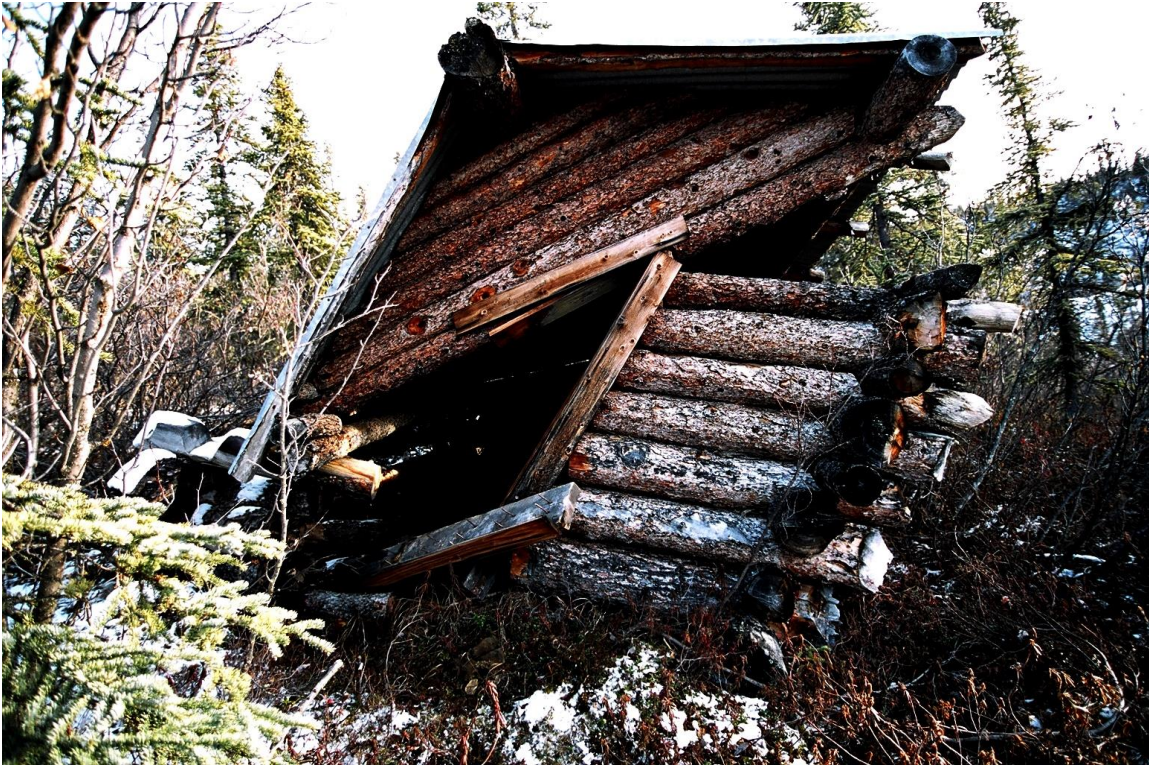
There are two identifying names written on the door frame with pencil, one we think might be Dr. Aho 1961 and the other Tom Casten 1979.

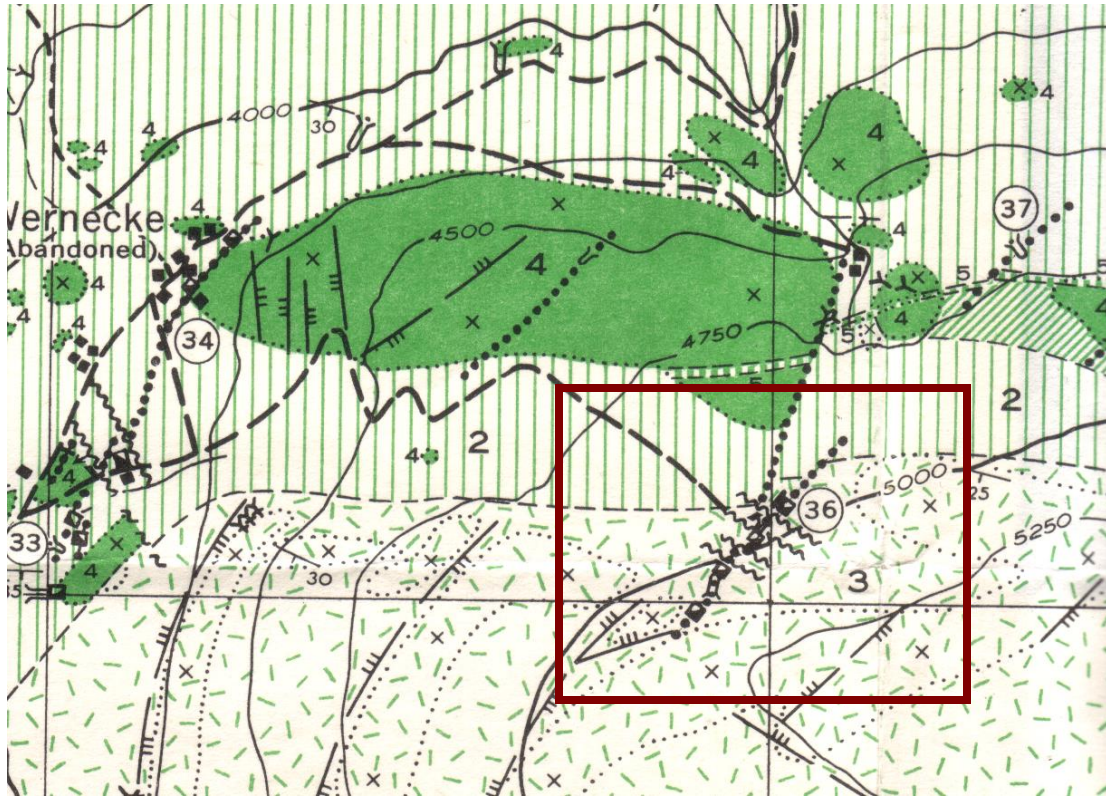
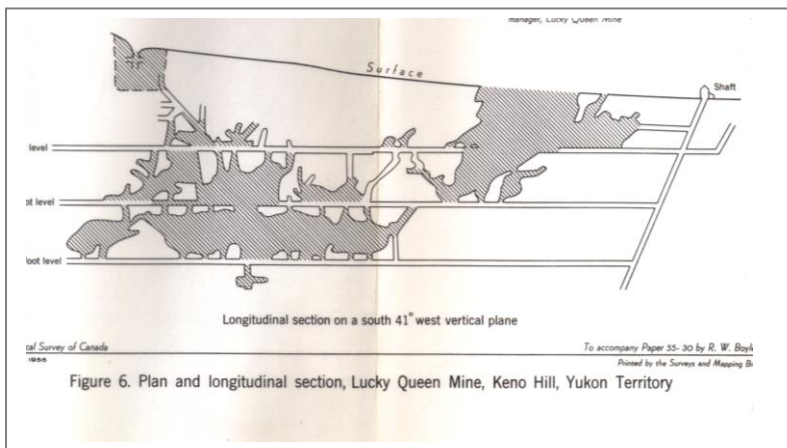
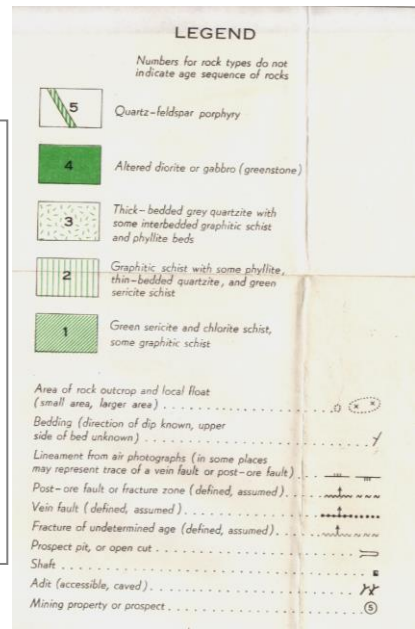
Geological Survey of Canada Paper 55-30 By R. W. Boyle Ottawa 1956 Part of figure 5

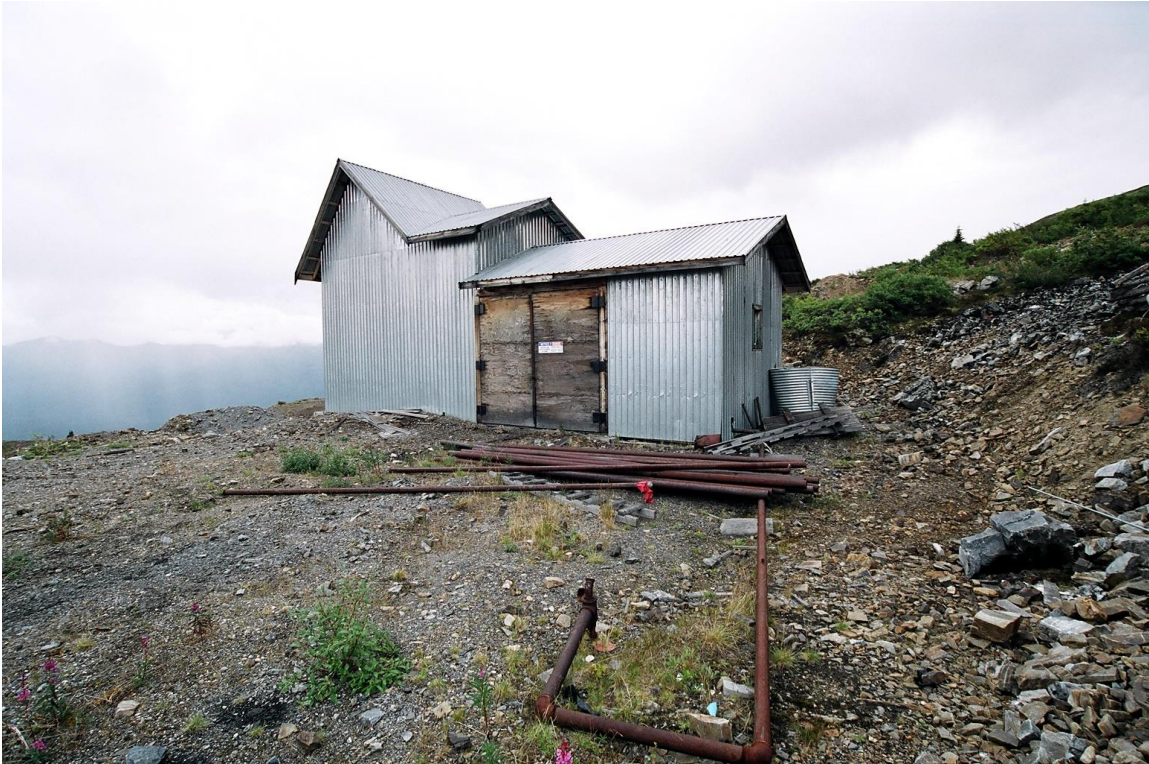
The head-frame foundation is placed on cement pads with rough 2x6 flooring, 2x6 frame walls and roof, there are 3 gable style roofs that make up the building. The taller rectangular building is where the Headframe is located and runs north to south and is intersected with a cross gable roofed structure running east to west.

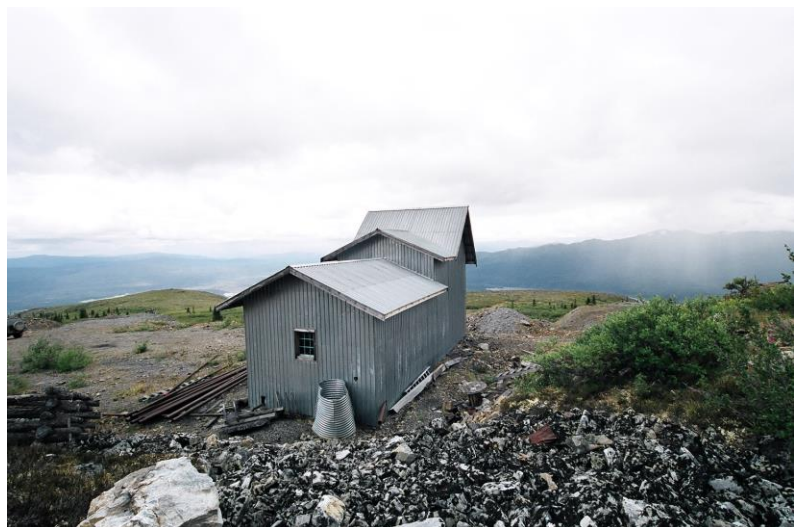
This second roof intersects the main one midway with the peak of the second roof tied in halfway on the east slope of the first roof. There is a third gable roof that attaches to the east side of the middle building approximately 1.5 meters below the eaves.

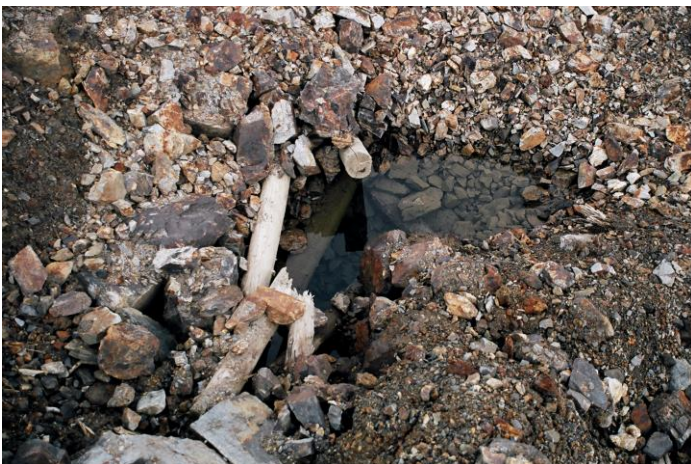
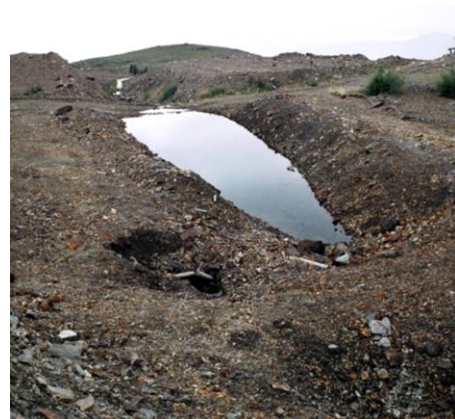
**Public Safety Conditions and Concerns**

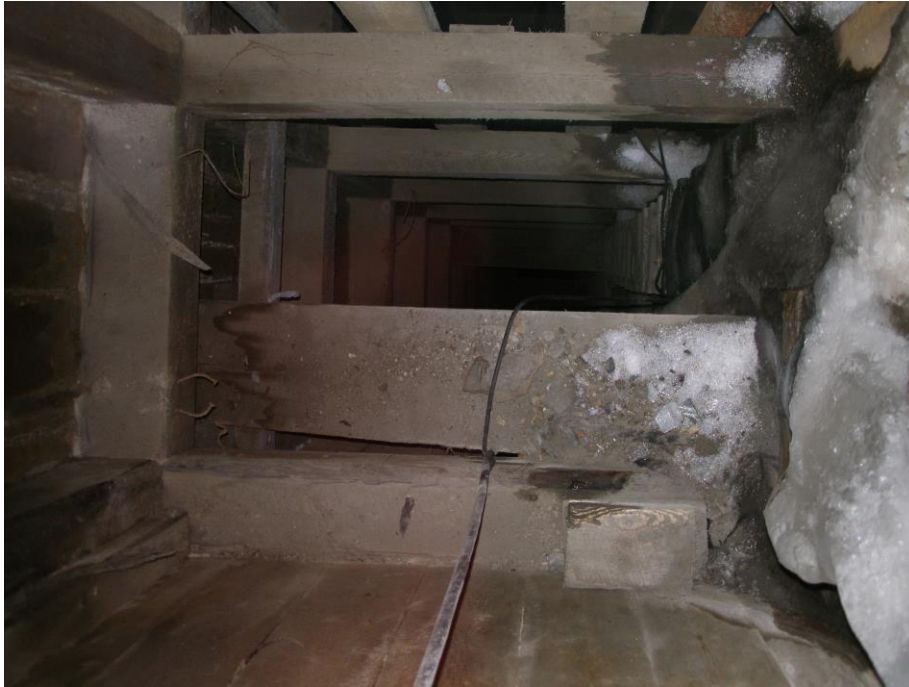
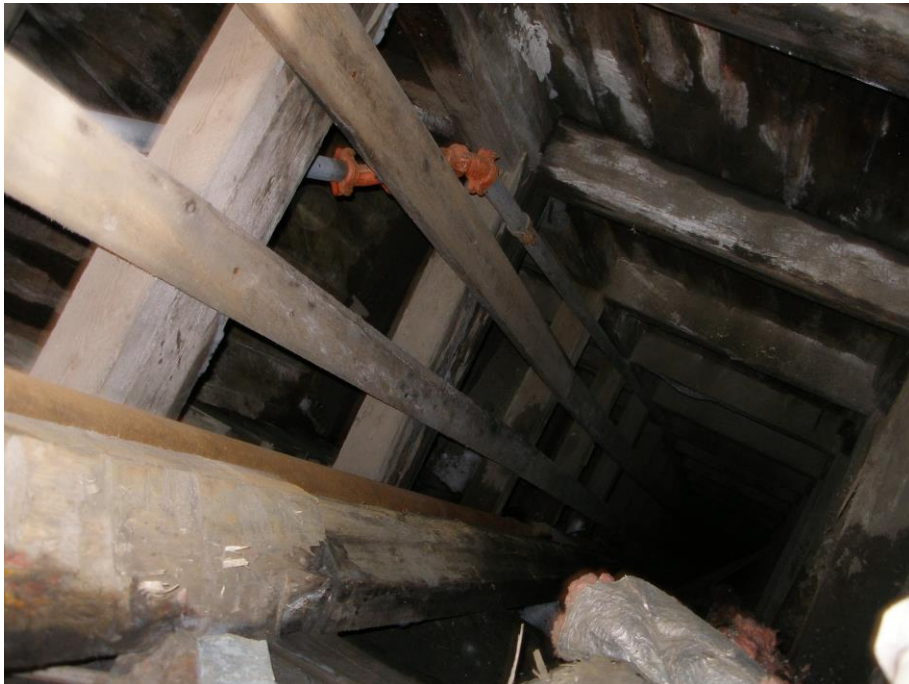
Lucy Queen Headframe remains open to public access. The manway and the access to the back of the skip guides are open and is a serious safety issue.

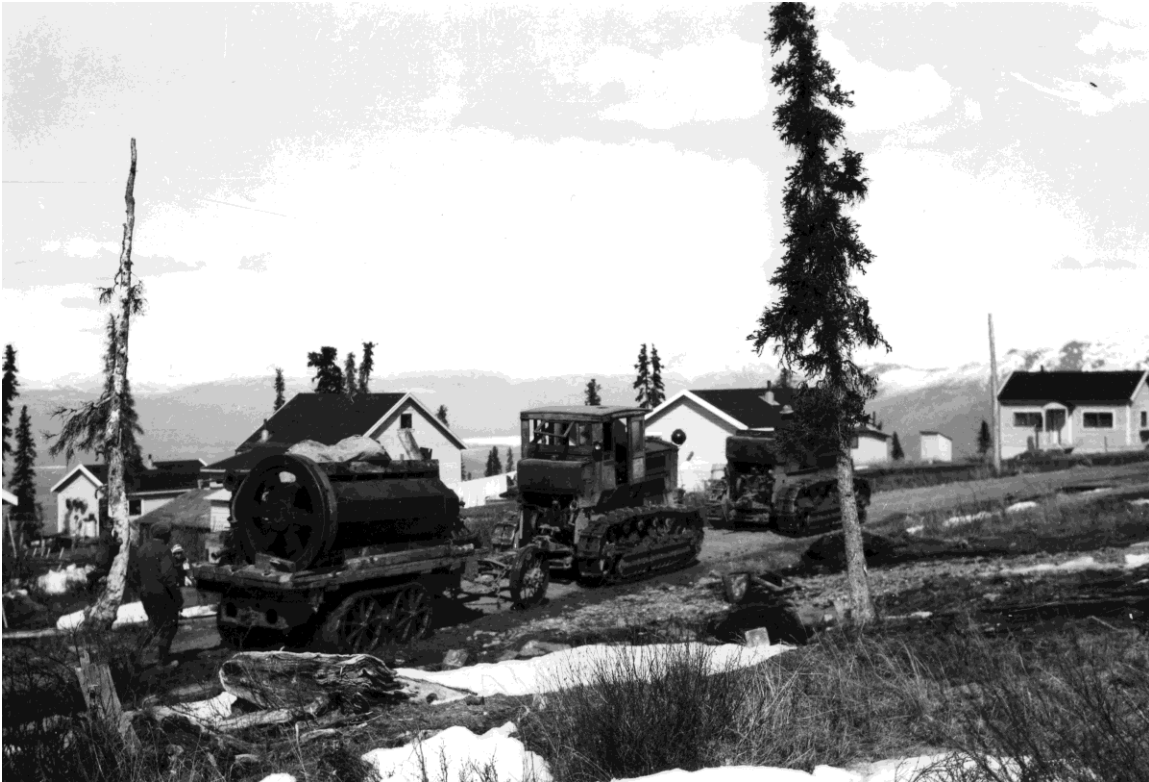
*Wernecke Street Scene*

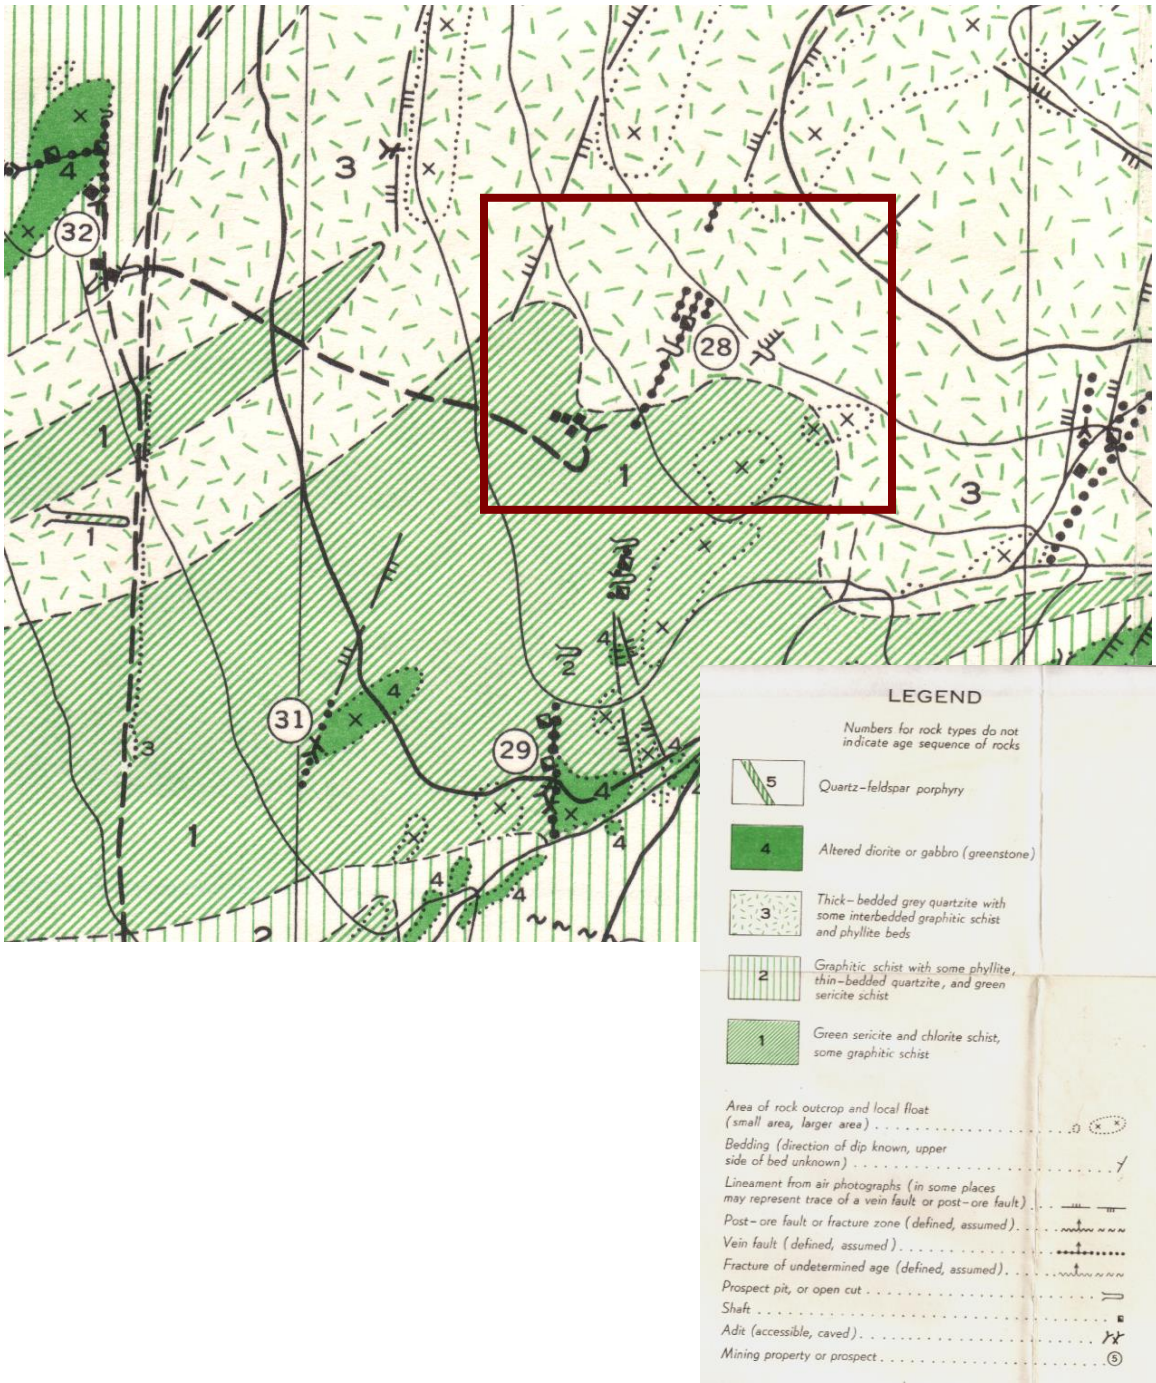
Geological Survey of Canada Paper 55-30 By R. W. Boyle Ottawa 1956 Part of figure 5

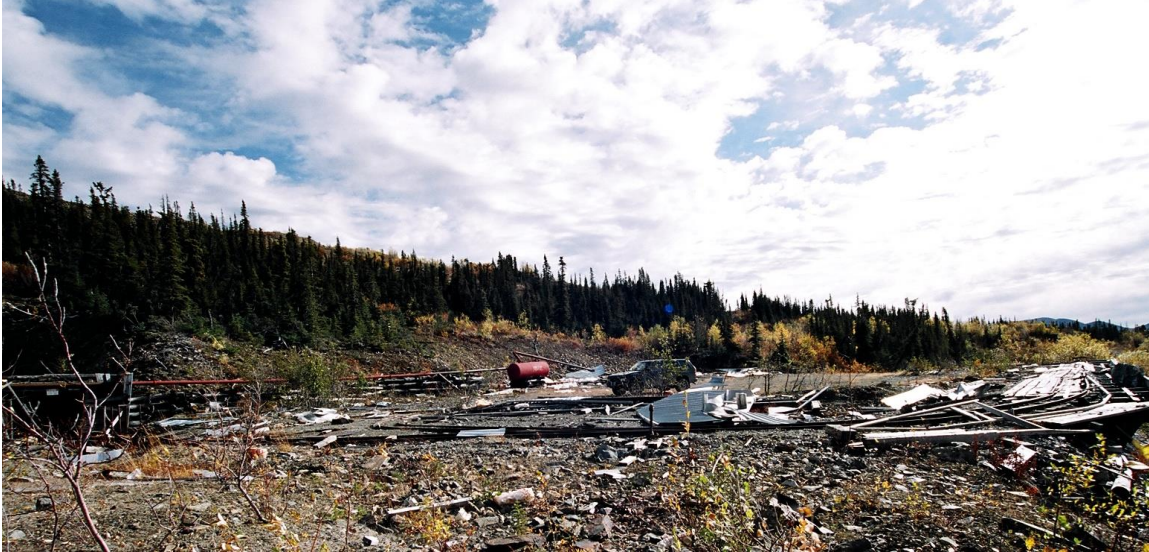
The Generator and compressor building has also been removed leaving only the remnants of the floor foundation, this was set on .5x.5 meter cement pads with 4x6 beams used for the frame base structure.

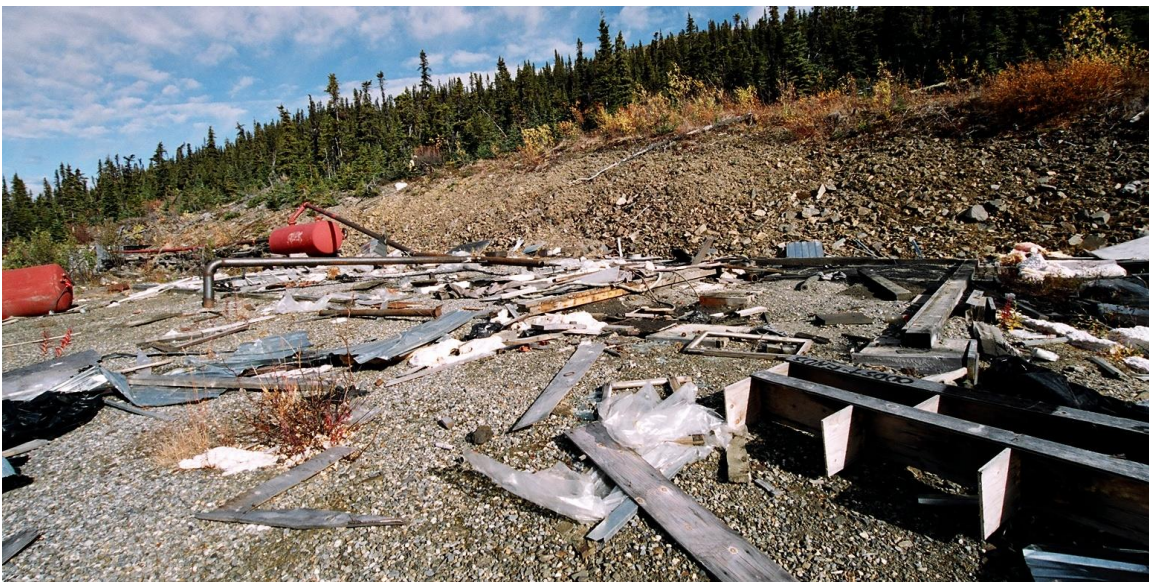
There are two receiver tanks left on the adit dump with approximately 40 meters of 6 inch pipe.

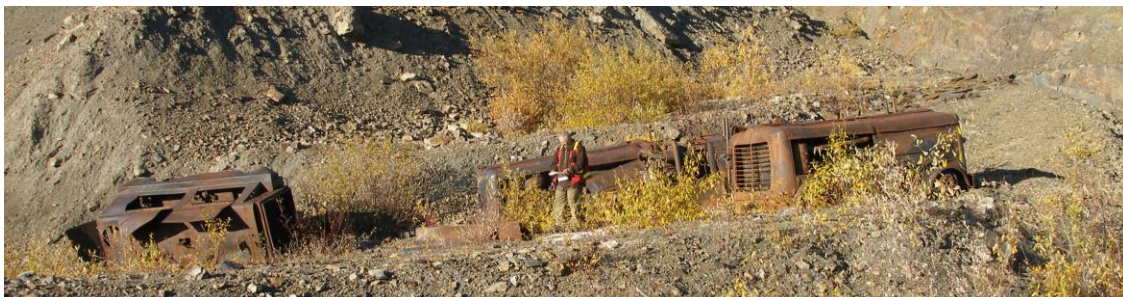
*Historical Review of Former United Keno Hill Mines LTD, Quartz Claims  
Black Cap, Shepherd and Lucky Queen Site 25. Keno Hill. Volume 1*

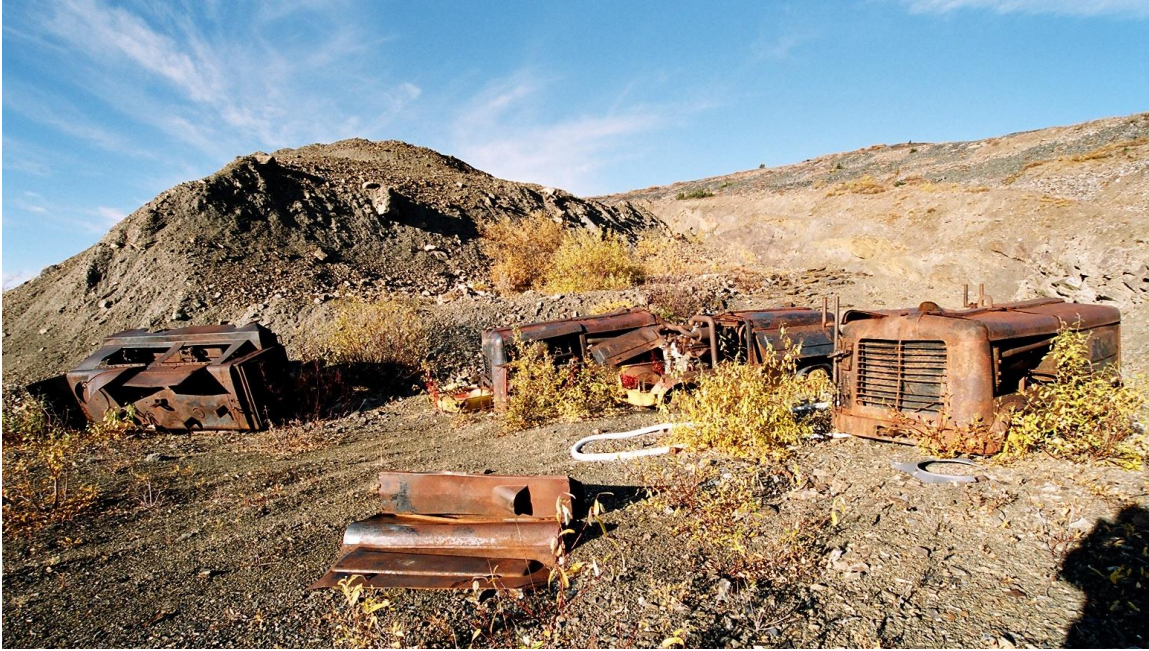
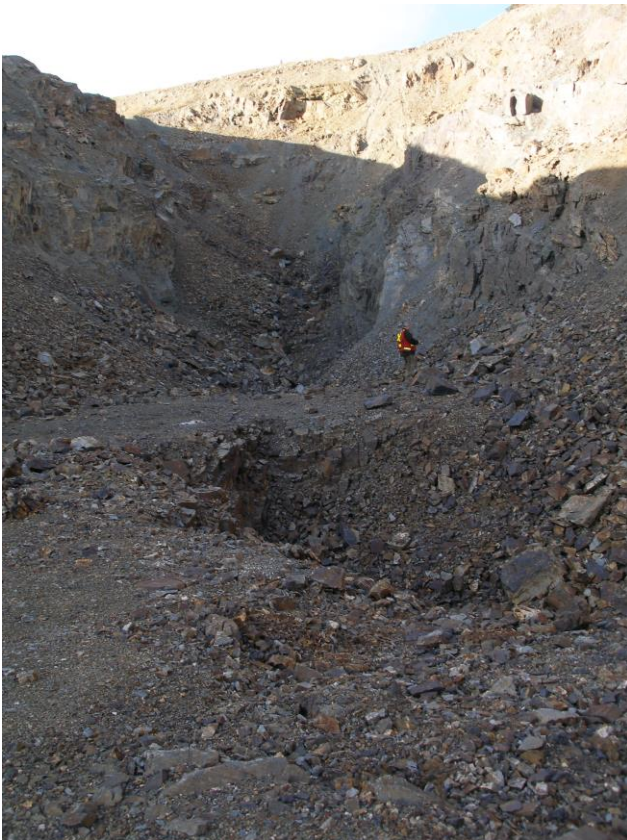
The compressors lay on the east corner of a large waste dump area that measures 225 meters east to west with a large talus slope extending down on to it from the north.

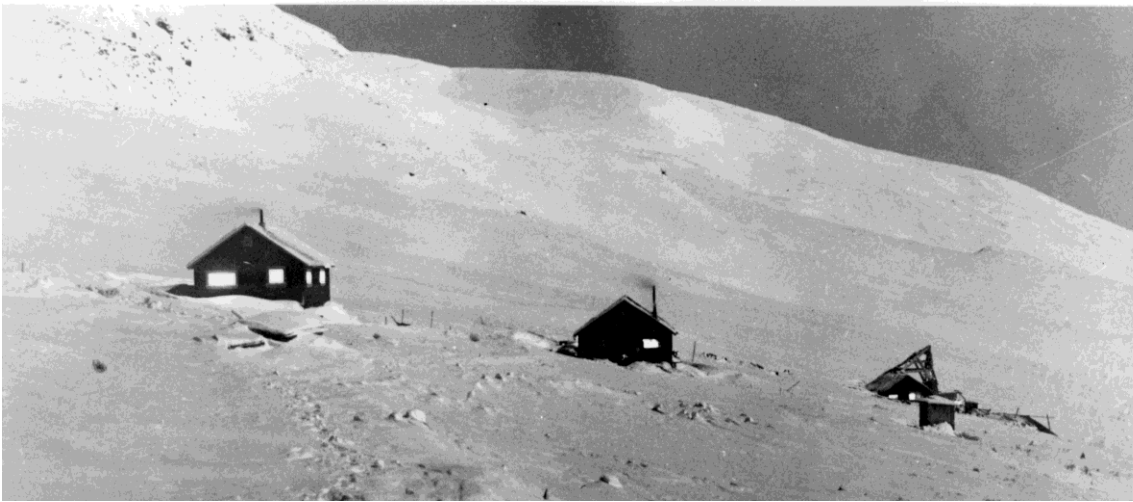
*Historical Review of Former United Keno Hill Mines LTD, Quartz Claims  
Keno 700 Camp, Site. Keno Hill. Volume 1*
