# Historical Review

Of  
Former  
United Keno Hill  
Mines Limited  
Quartz Claims

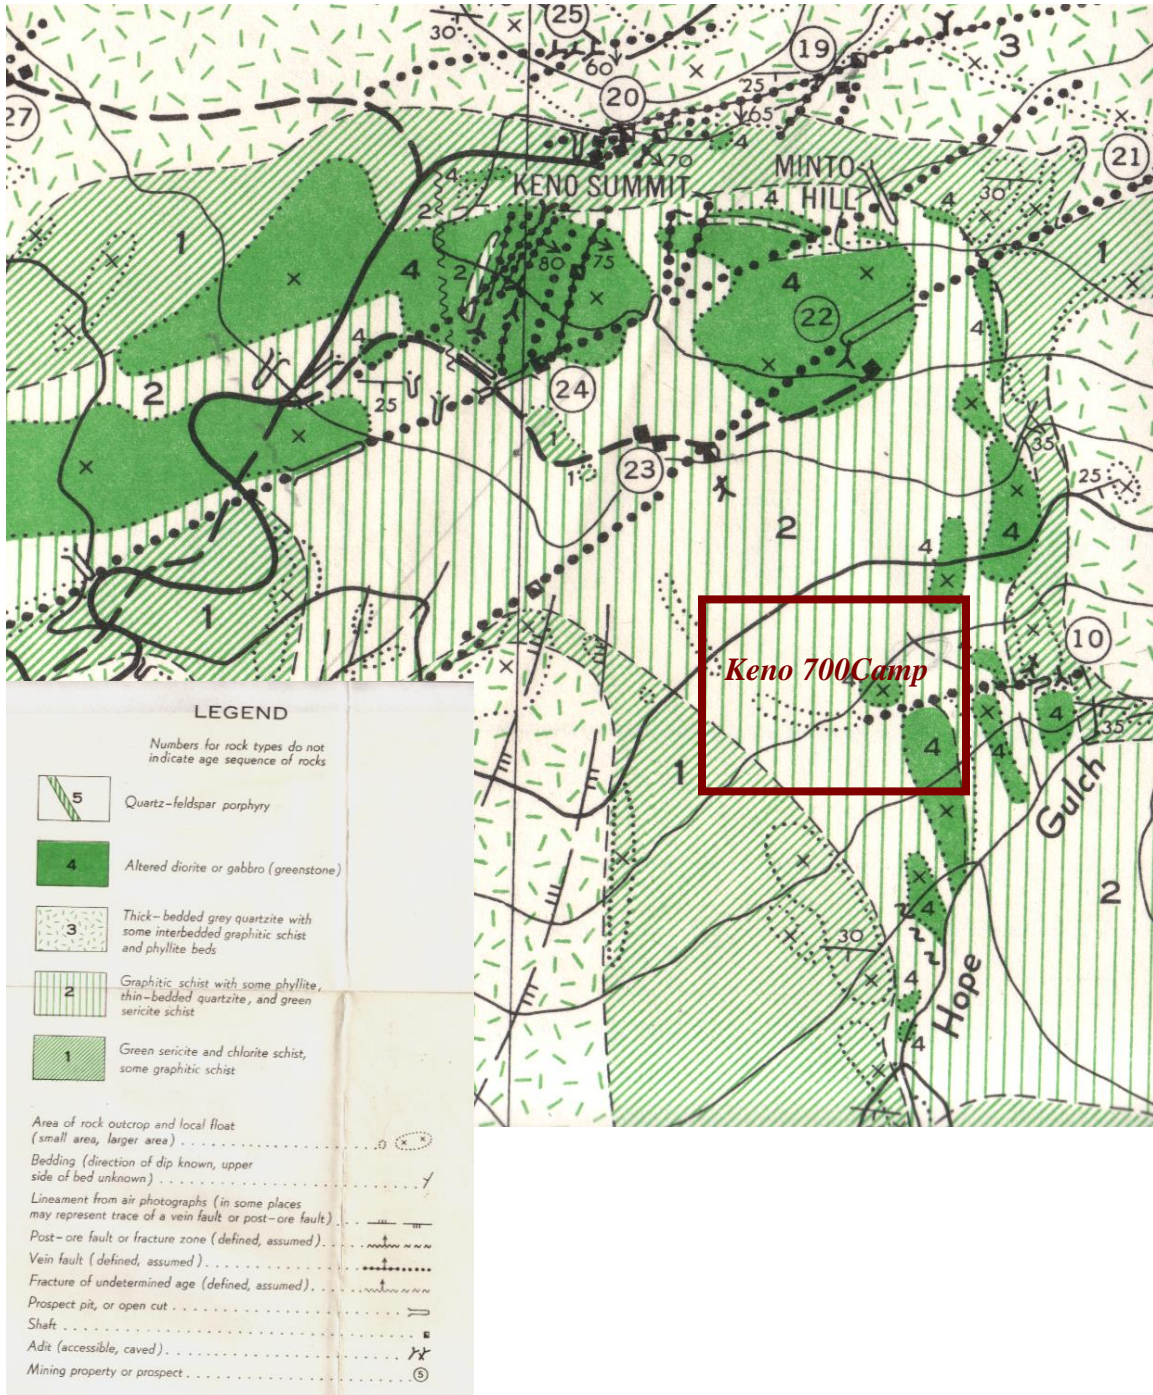
Geological Survey of Canada Paper 55-30 By R. W. Boyle Ottawa 1956 Part of figure 5

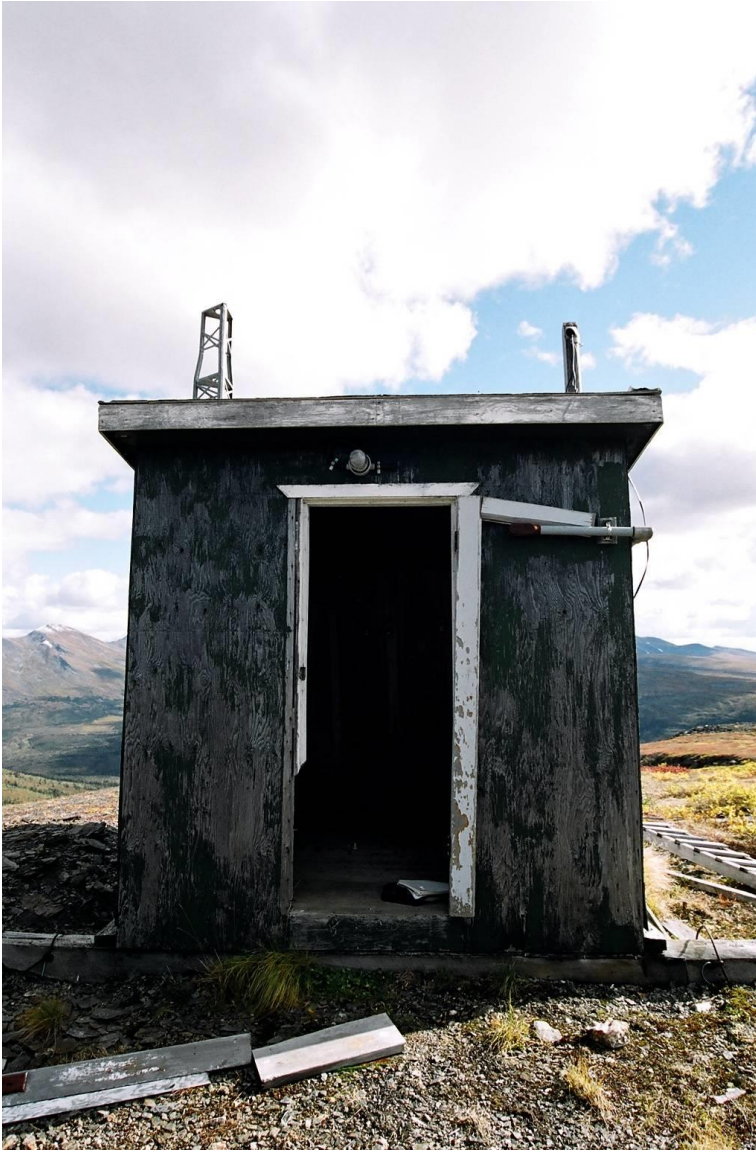
The foundation of the transmitter shack is built with 8x8 timbers joined together into a skid assembly so the building could be dragged to its present location or for possible later removal.

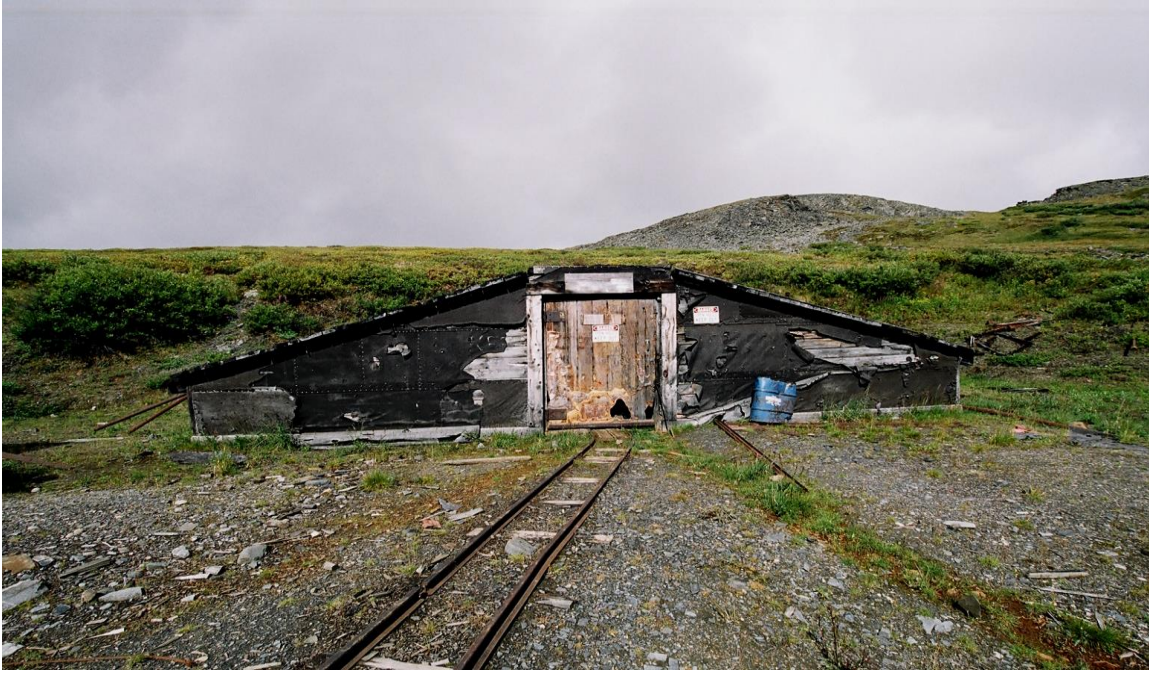
The foundation of the portal is 8x8 beams that have been placed directly on the ground. The east and west wall studs are logs that are 1 meter tall, and have been capped with 4x6 beams.

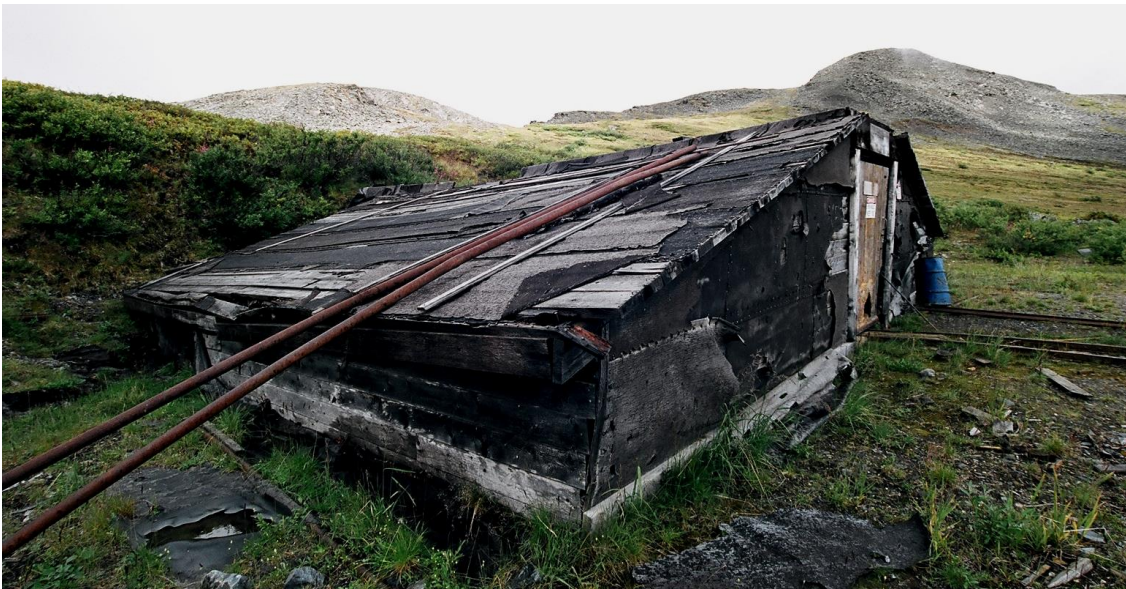
*Historical Review of Former United Keno Hill Mines LTD, Quartz Claims  
Keno 700 Camp, Site. Keno Hill. Volume 1*

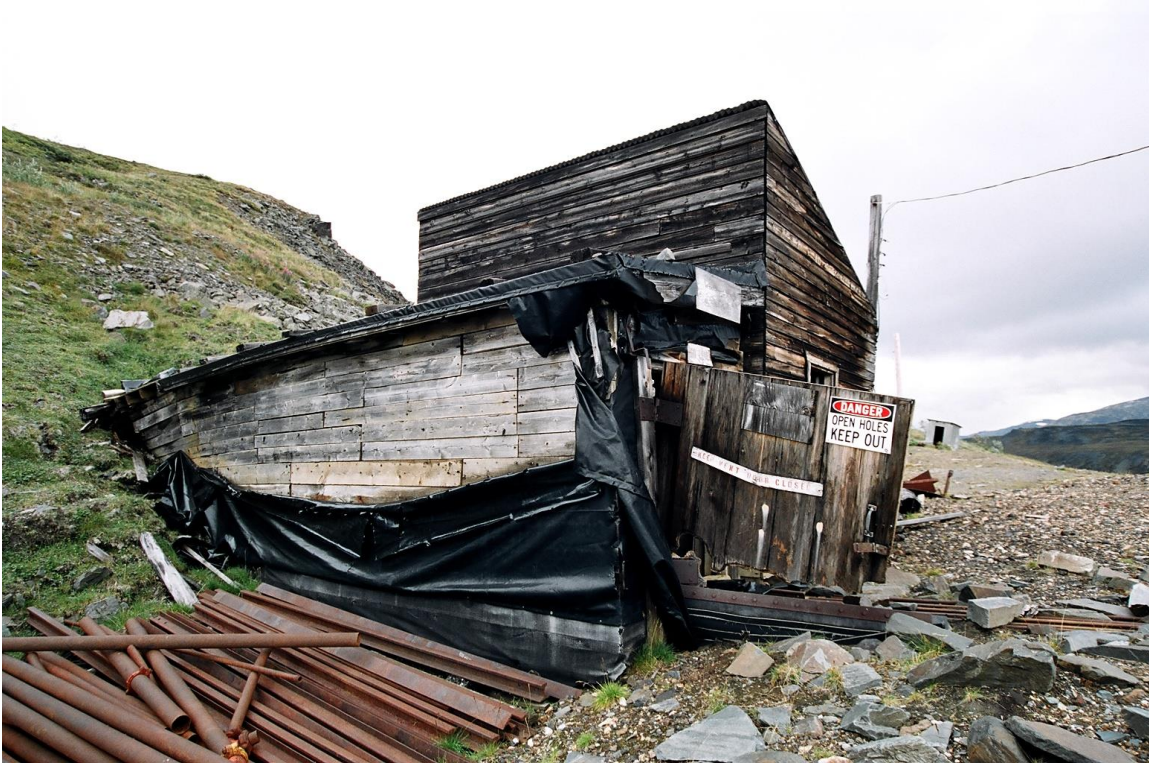
The foundation for the adit portal is 8x8 beams placed directly on the ground. The wall studs are 2x6 and the portal roof rafters are two 2x6 planks nailed together for strength.

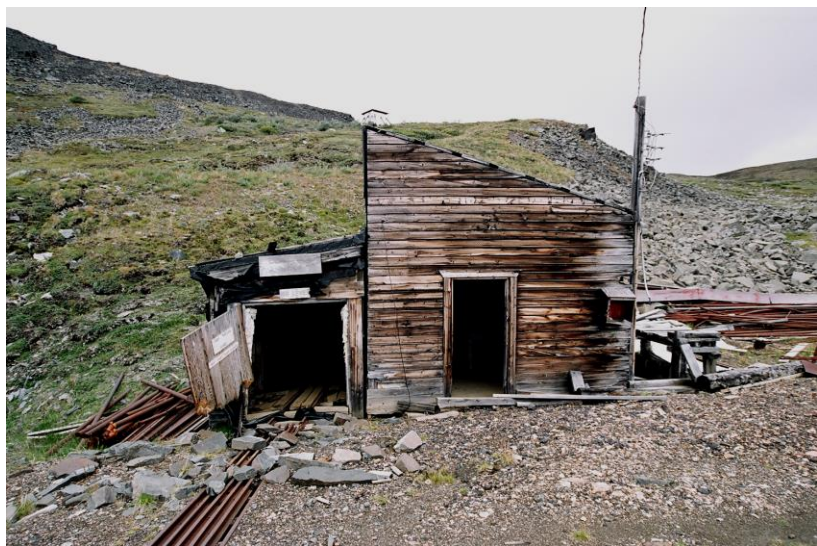
*Historical Review of Former United Keno Hill Mines LTD, Quartz Claims  
Keno 700 Camp, Site. Keno Hill. Volume 1*

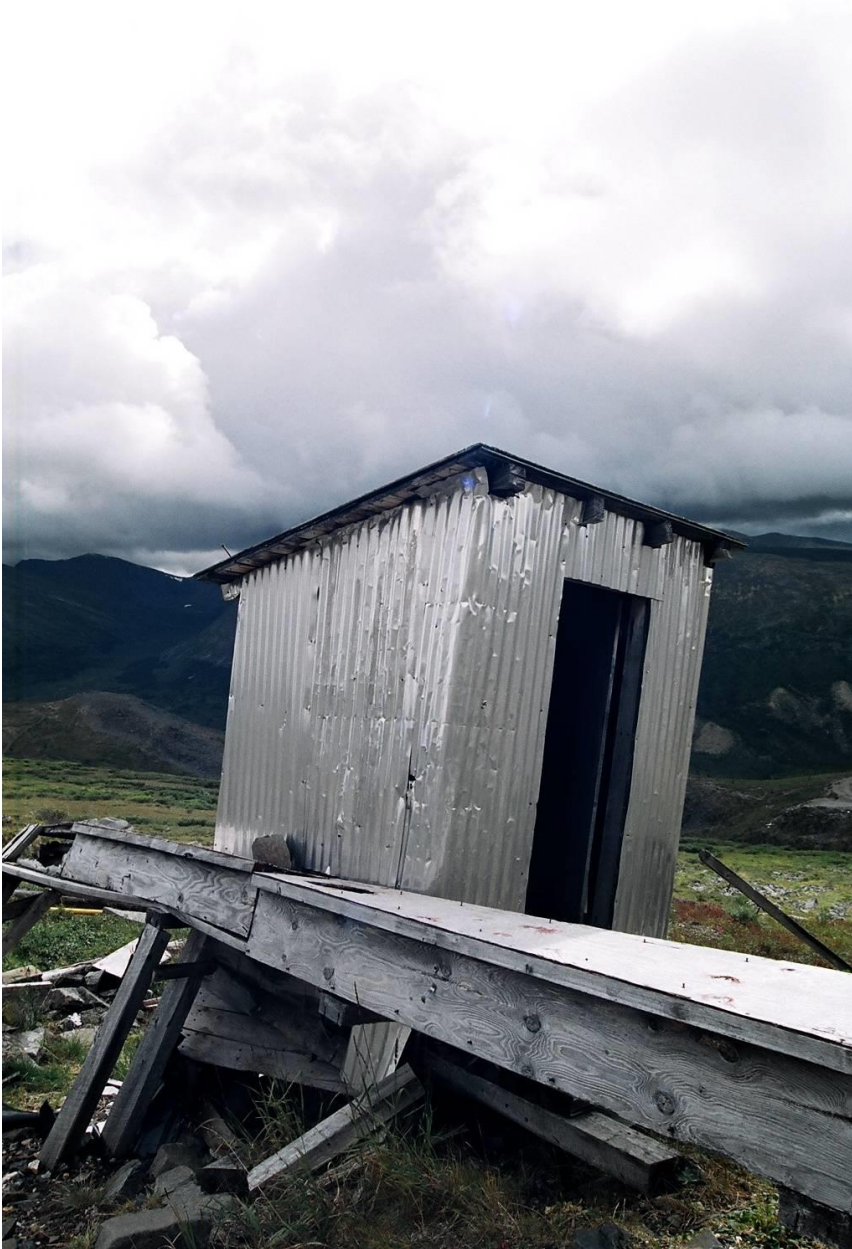
The floor is sheeted with a combination of 2x6 and 2x8 planks.

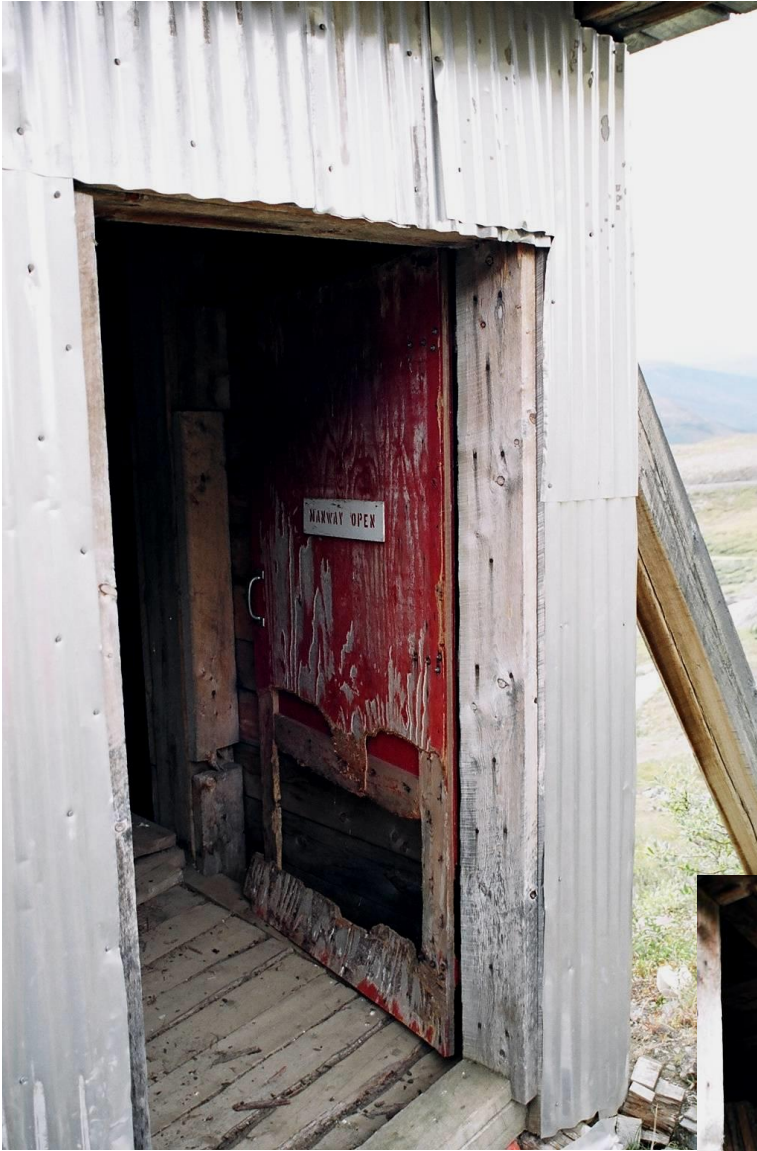
The vent raise building is constructed with 8x8 timber frames, the foundation on the east and south are 8x8s stacked on top of one another until level.

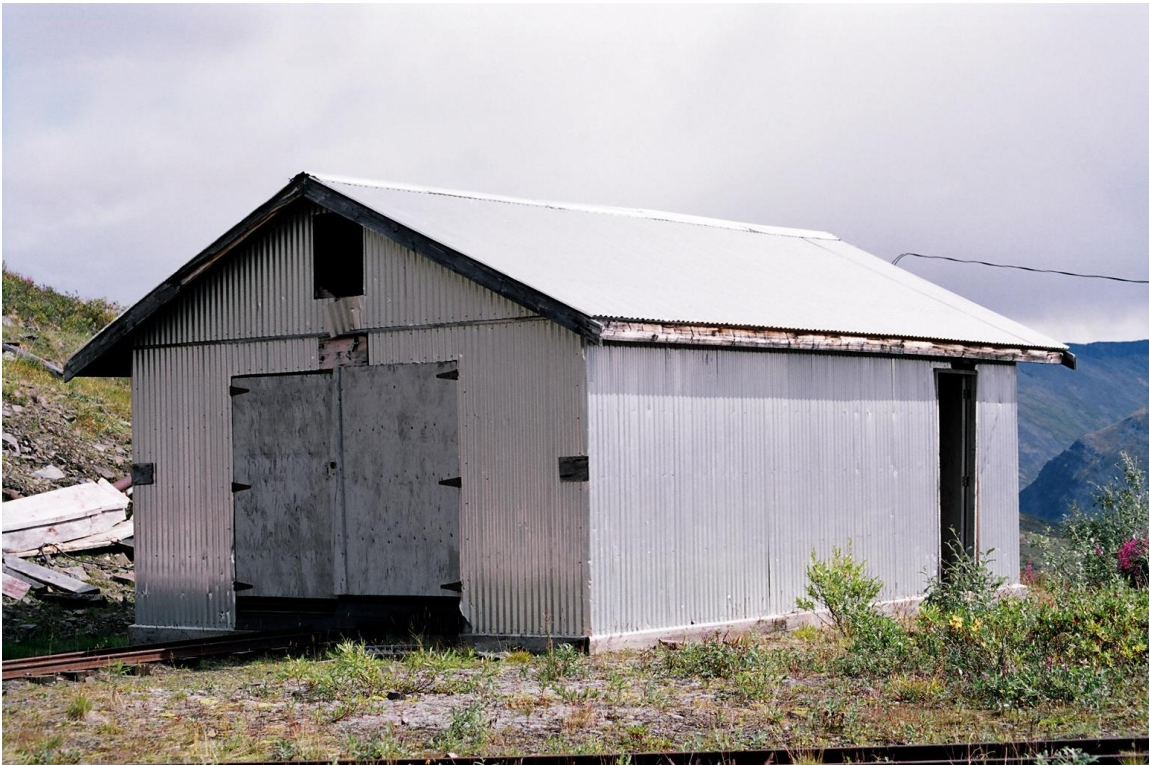
The building is partitioned with a maintenance shed behind the double doors and a lunch room at the back of the building. The rail ends within 1 meter of the partition wall which also holds the electrical panels and switches for the mine adit and shop area.

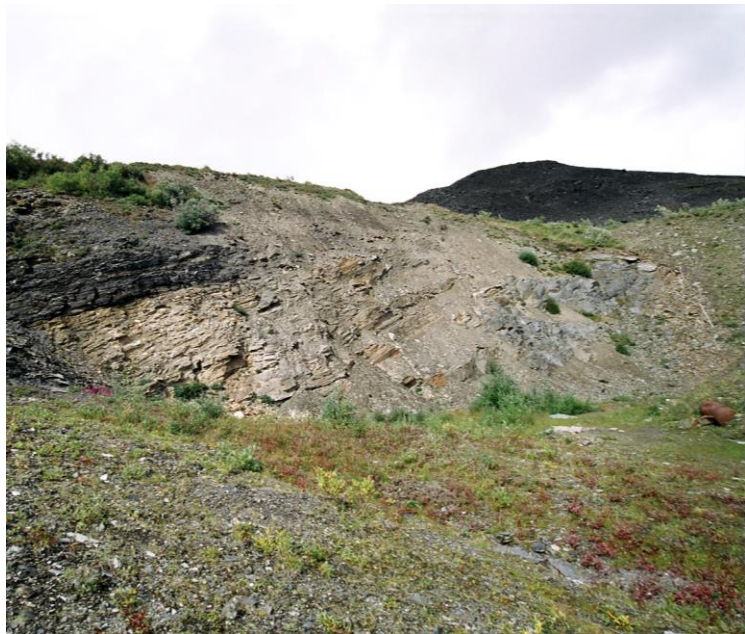
*Keno 700 Staff Residence B-1*

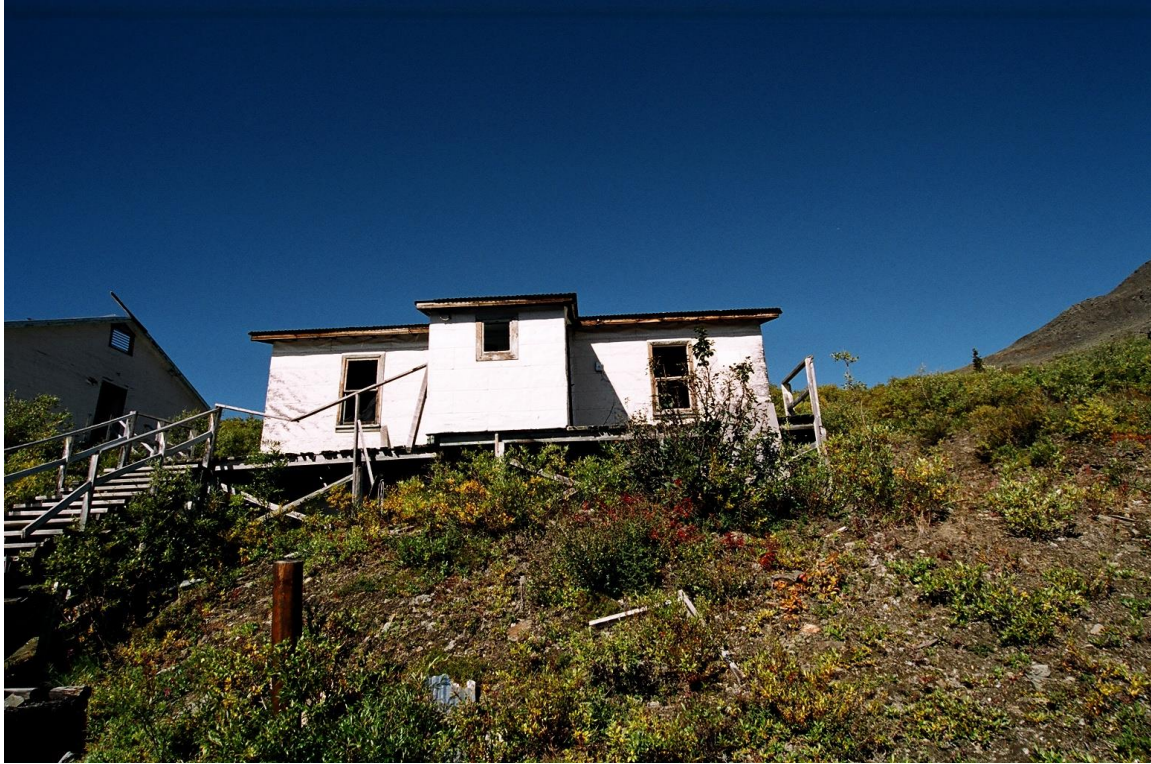
The floor has then been sheeted diagonally to the floor joists with 1x6 tongue and groove boards.

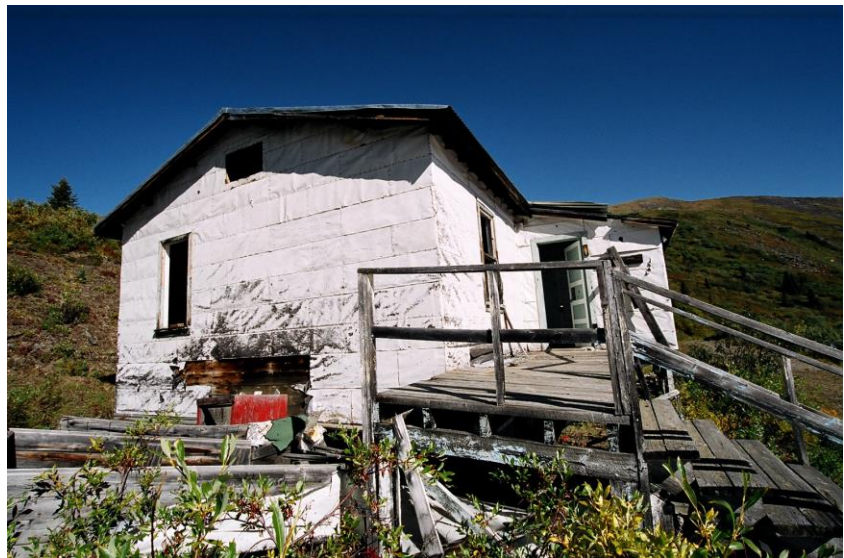
The exterior of the foundation walls are clad with corrugated aluminum roofing, laid horizontally around the base of the building, the rest of the exterior walls are sheeted with white asbestos siding that is so common on the older buildings. The walls are constructed of 2x4 studs with 1x6 shiplap boards as interior and exterior sheeting.

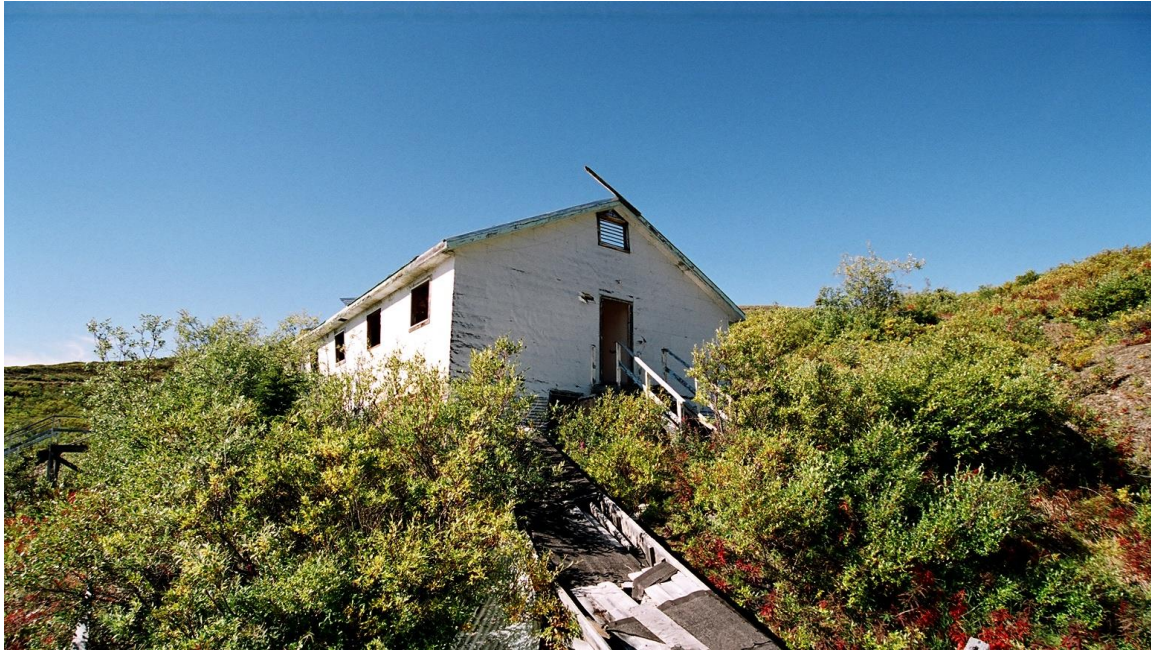
There are three main beams that form the foundation that run north to south. These beams have been laminated together by using 2x8 planks, staggered and then spiked together to form the continuous long beam.

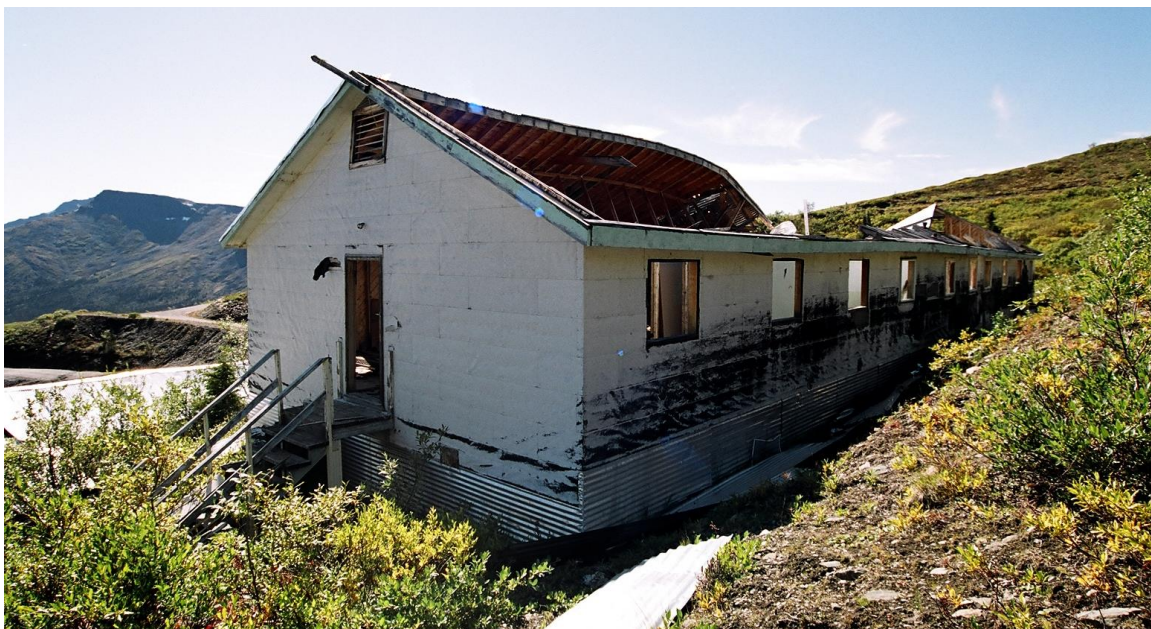
The floor joists are 2x10 planks that span east to west over the long laminated beams. The floor joists are cross braced every two meters, from the center laminated beam down to the base of the east and west pony walls.

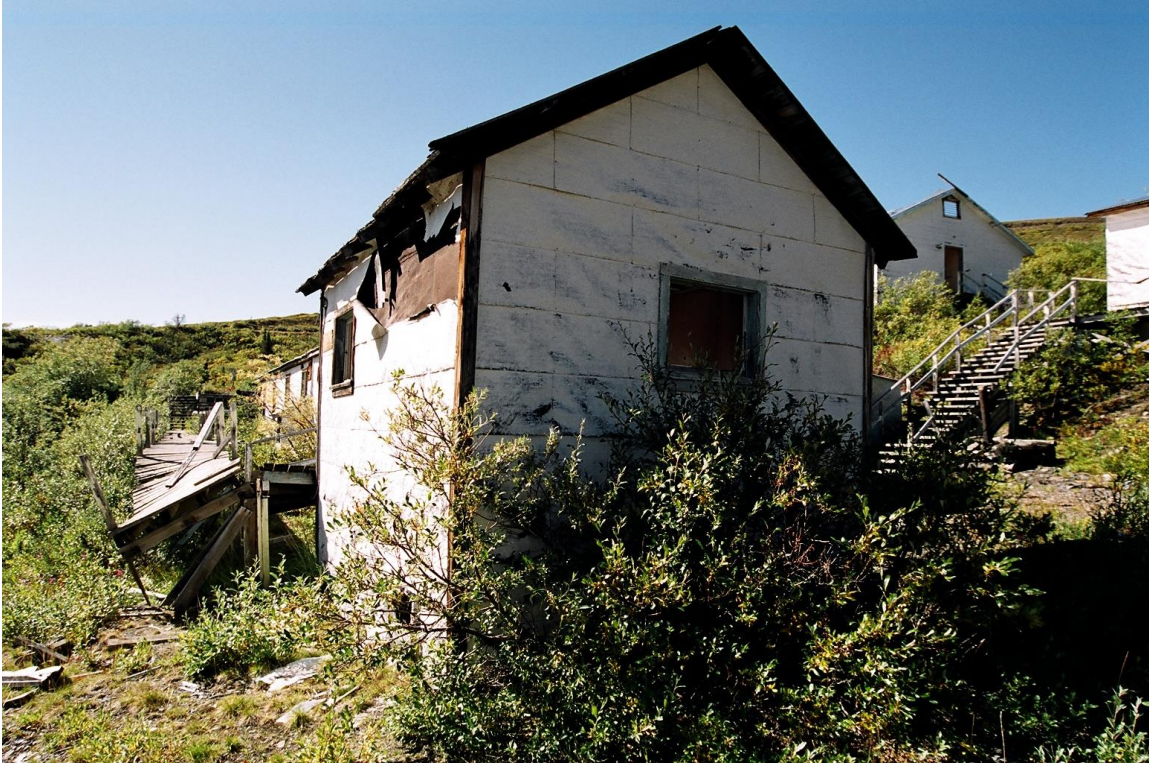
The walls are constructed using 2x4 studs, on 16 inch centers. The walls have been insulated with a black fiberglass insulation batting.

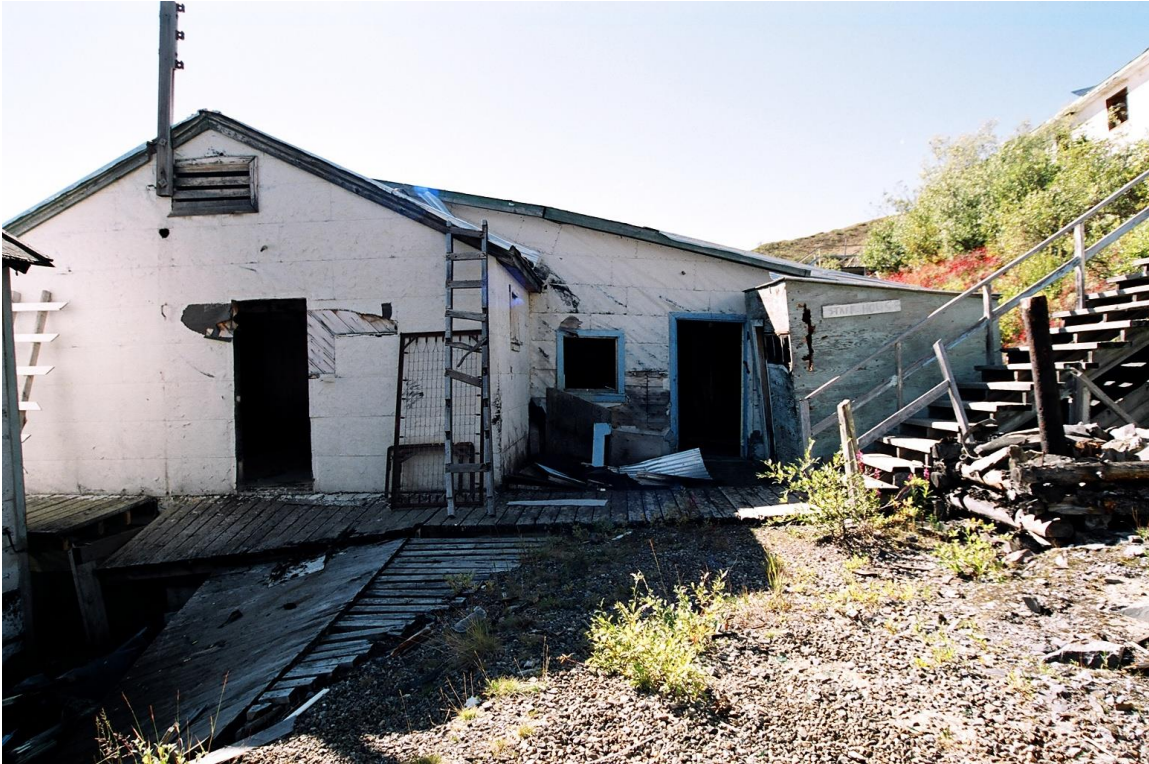
The frame foundation of the cook shack is on .3x.3 x 1.1 meter tall cement pillars and have four 2x8 planks laminated into beams running north to south. Over these beams 2x8 floor joists are laid.

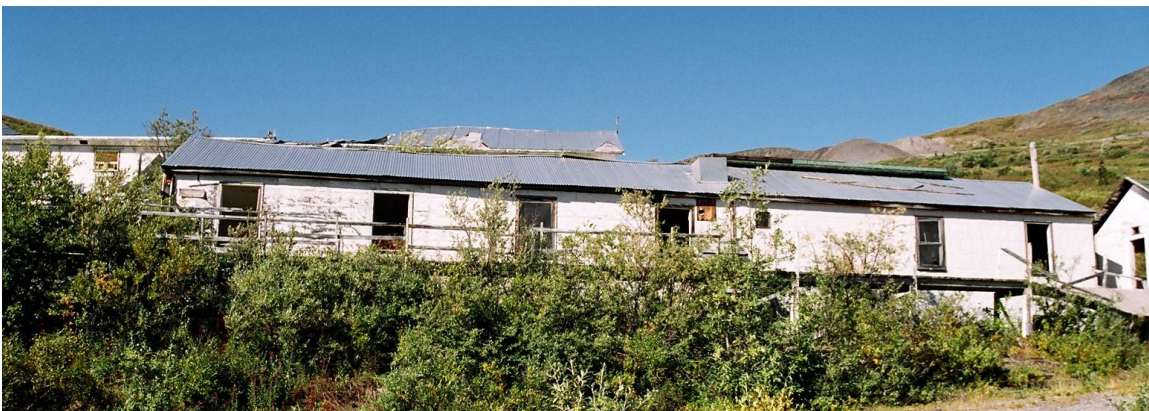
*Historical Review of Former United Keno Hill Mines LTD, Quartz Claims  
Keno 700 Camp, Site. Keno Hill. Volume 1*

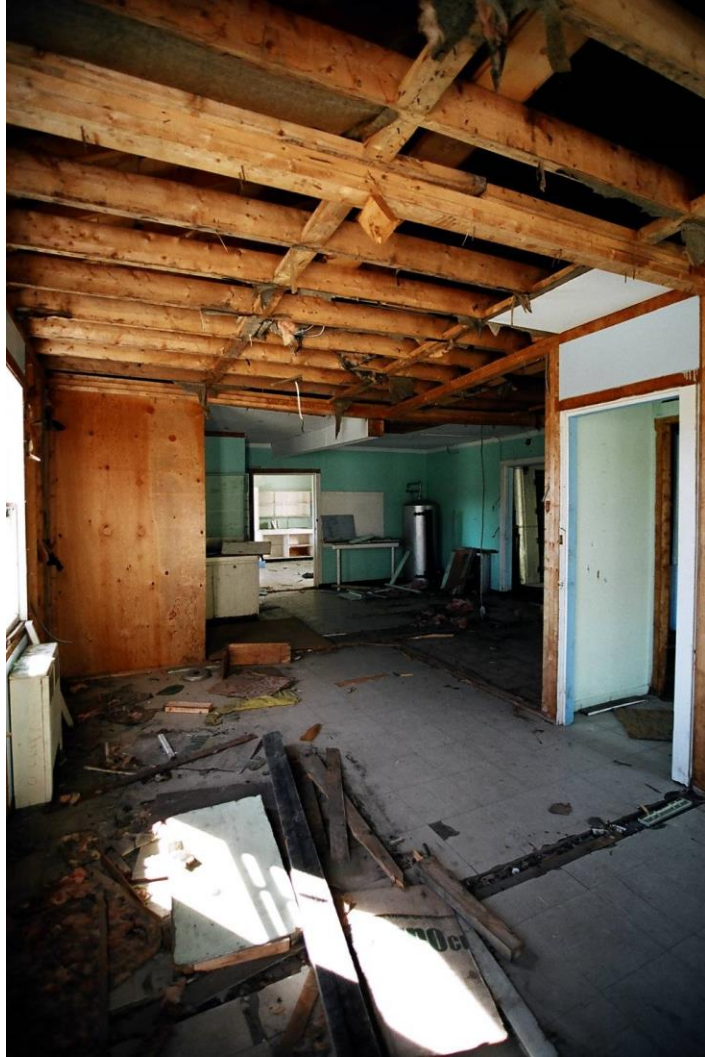
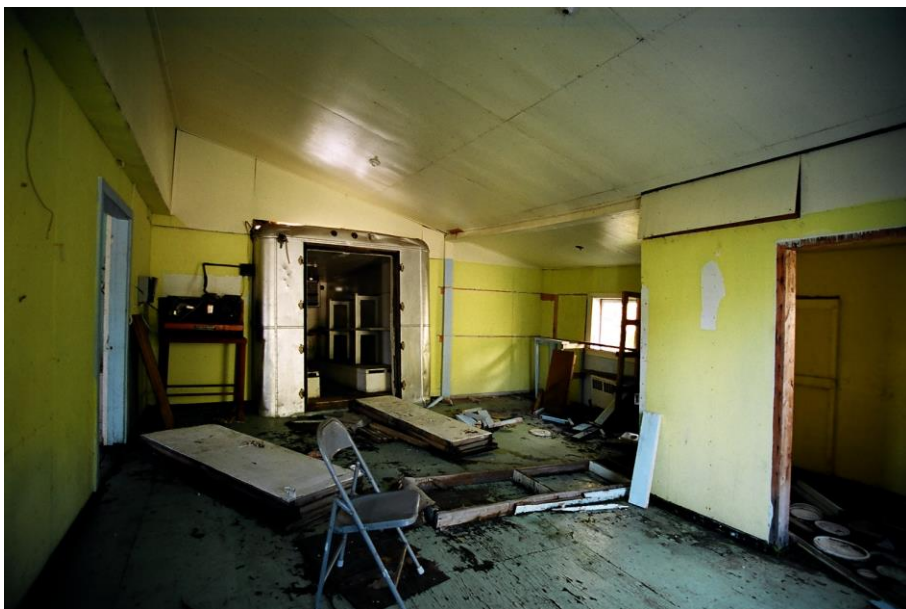
The interior material is consistent throughout the main building.

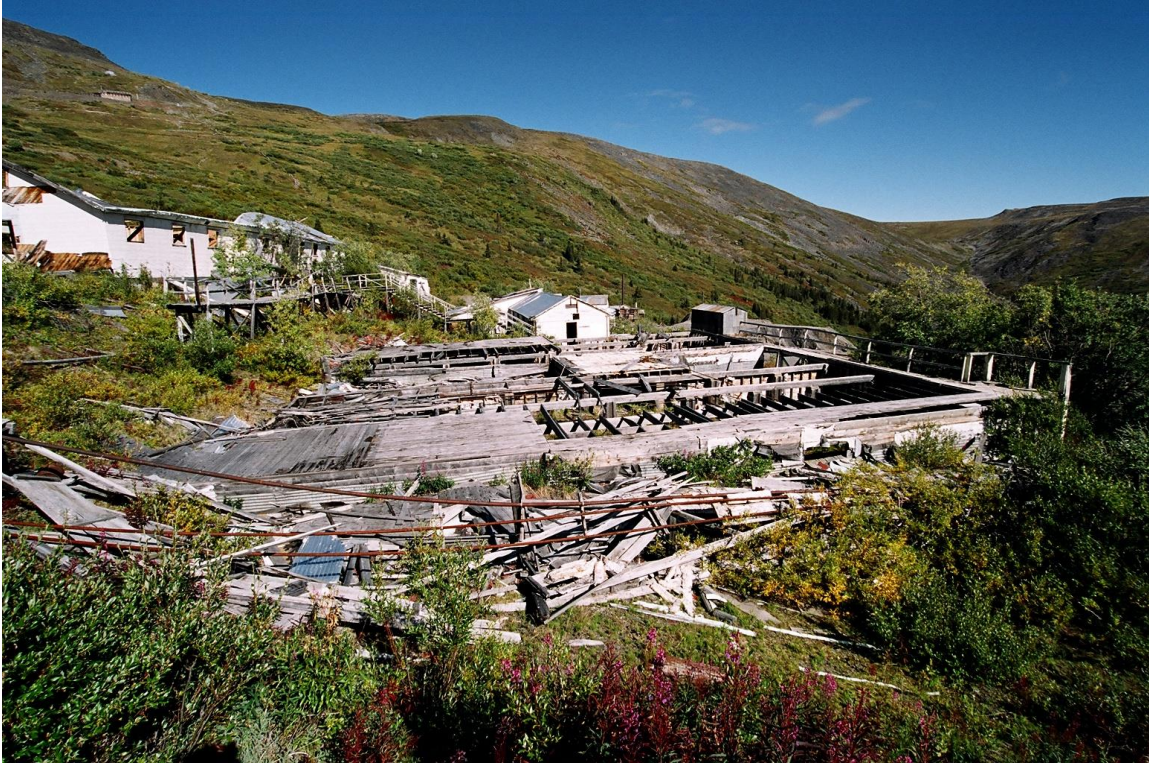
There are three rows of cement pillars placed 2.7 meters apart for each bunkhouse and they run east to west. There are two extra cement pillars placed 10.5 meters from the west end of the two bunkhouses. There are two more from the east end of the bunkhouses, these pillars are placed between the two bunkhouses and are the supports for the shared washroom.

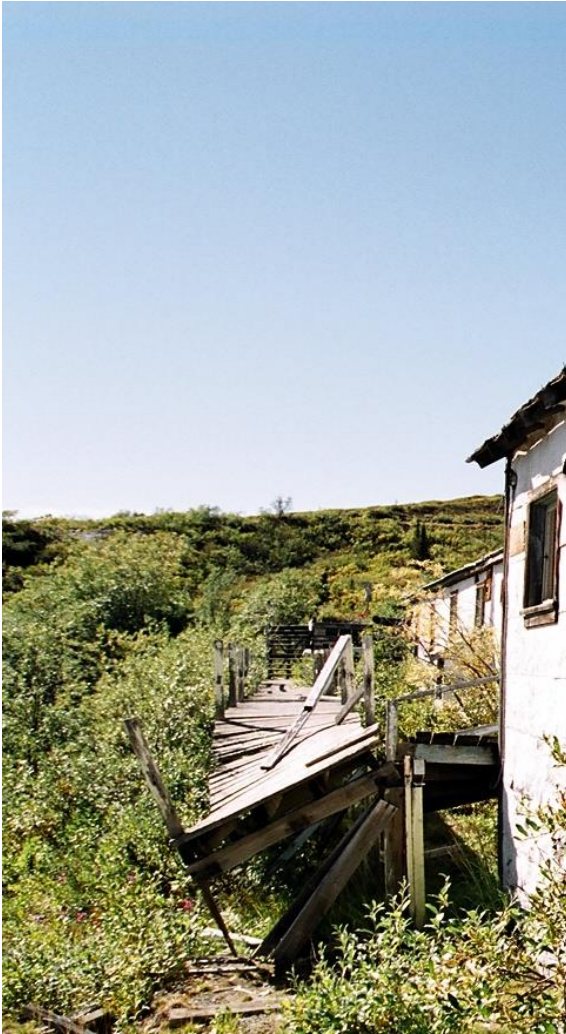
Off the east end of the bunkhouses is a 1.4 meter wide board walk that connects the two bunkhouses to building #4 (mess hall). The board walk then turns to the west and accesses the center of the bunkhouse (B-#2), the boardwalk also continues north along the west wall of the mess hall until it reaches building #3. Here again it turns to the west between building #3 and the north wall of the mess hall and accesses the Staff house,(B#1).

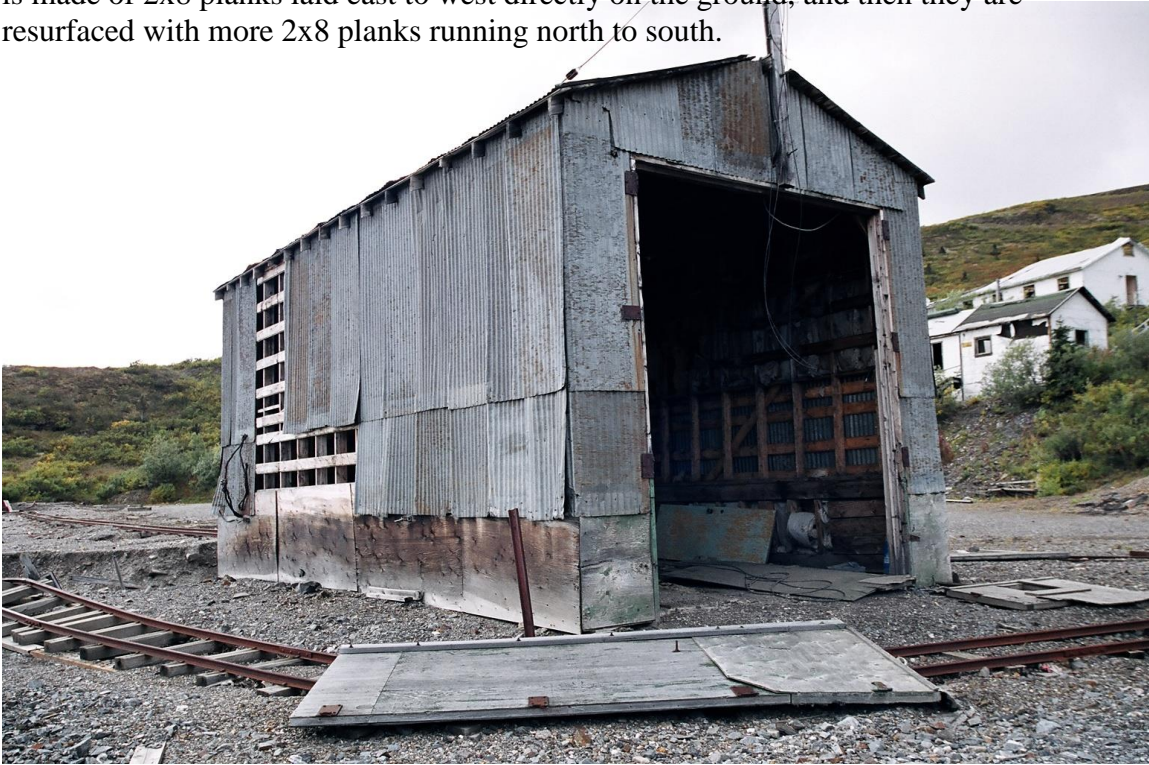
Solid one meter long 8x8 blocks are stacked up on both east and west walls to almost the height of the ceiling. These are located in the center of the east and west walls and were used for supporting crossbeams that could lift heavy weights with chain hoists.

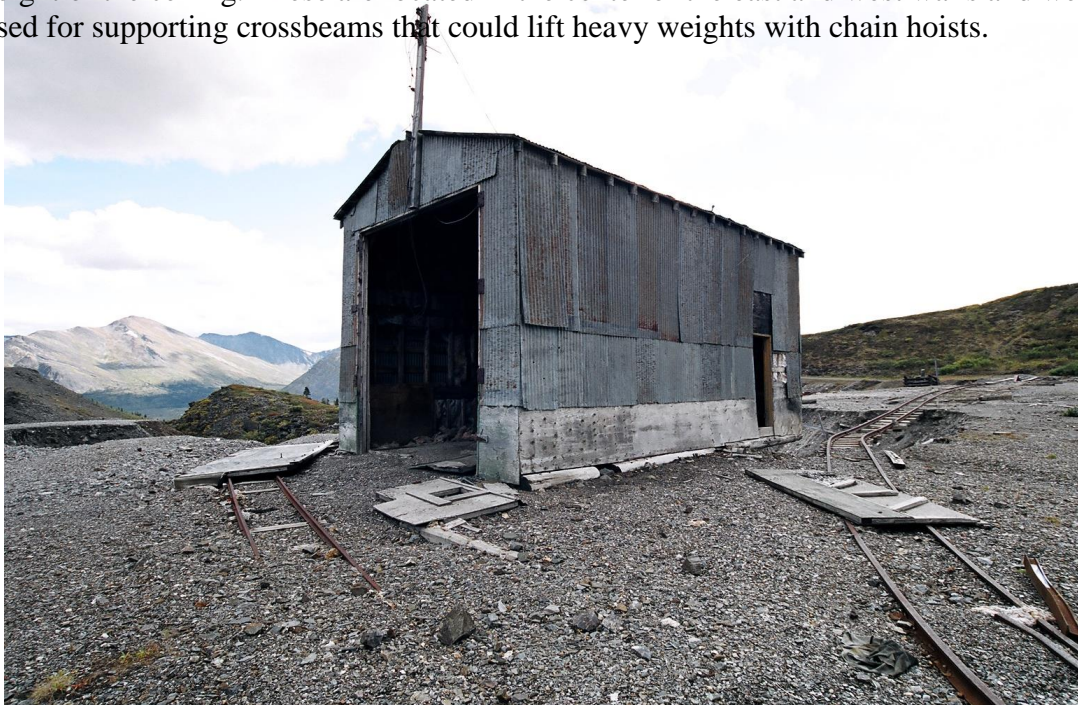
*Historical Review of Former United Keno Hill Mines LTD, Quartz Claims  
Keno 700 Camp, Site. Keno Hill. Volume 1*

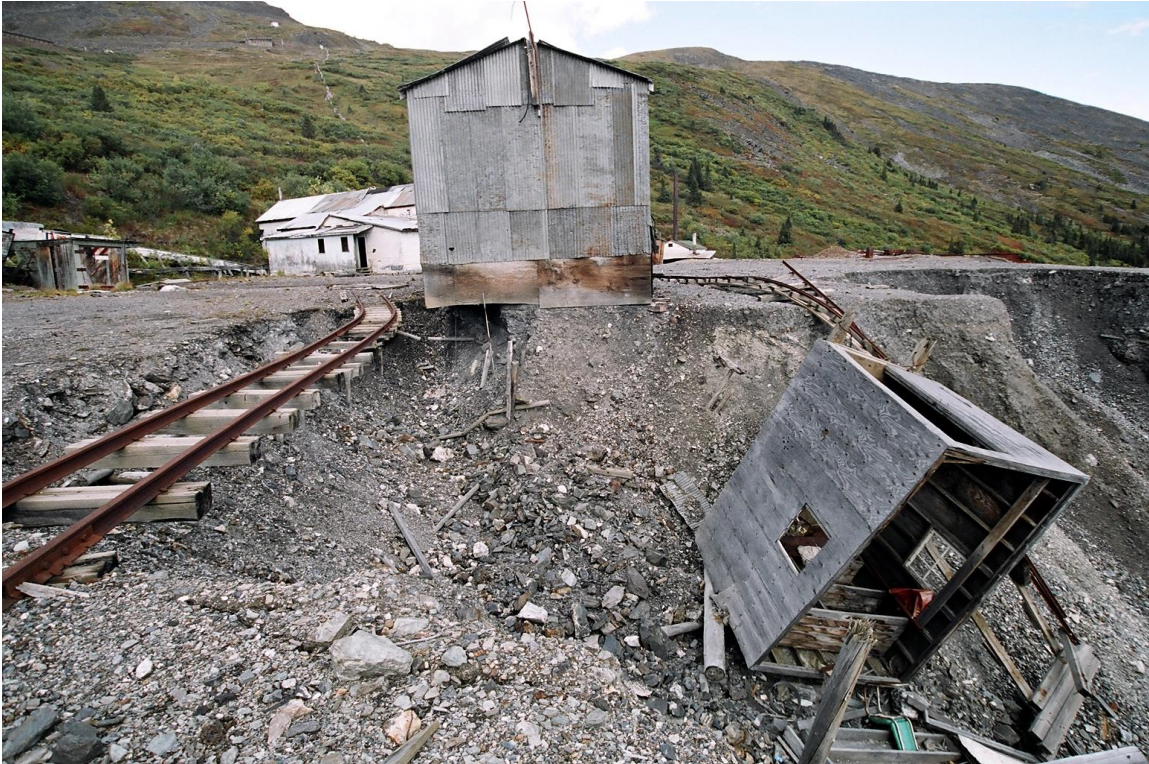
From the top of the 2x8 stud pony wall 2x6 studs were then used to finish the walls. These walls were then strapped horizontally with 1x6 and sheeted vertically with corrugated metal roofing material.

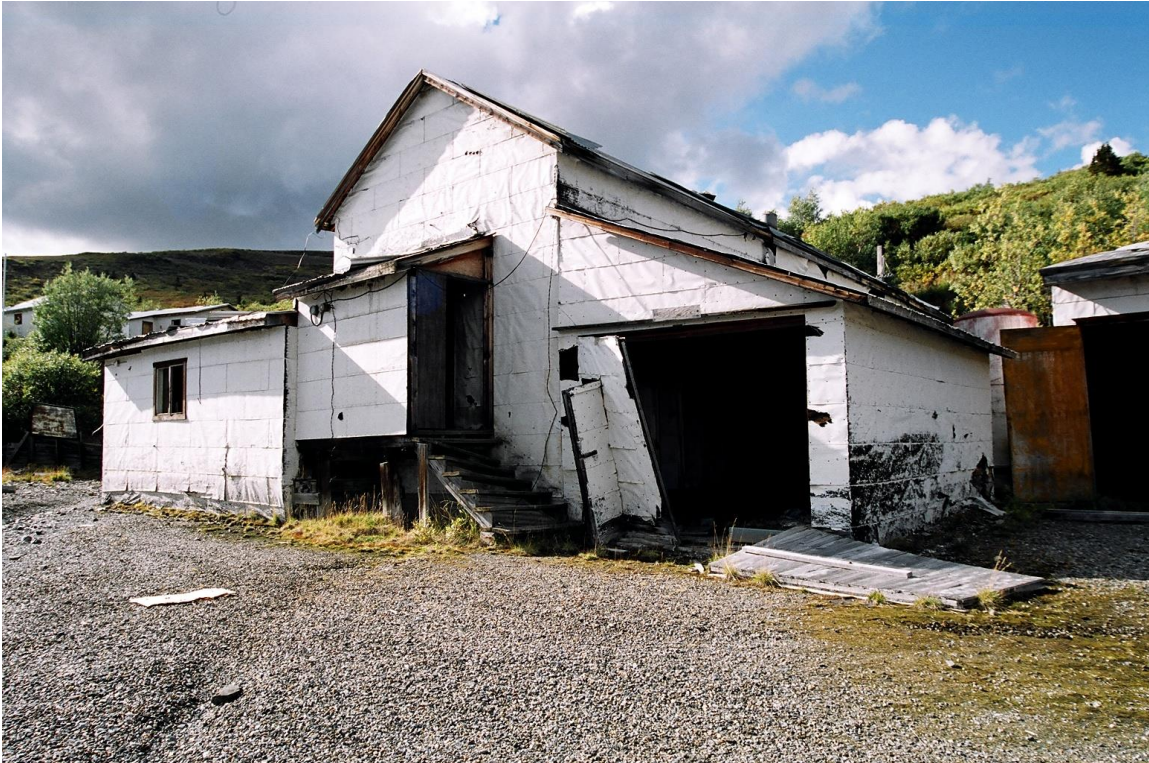
The foundations are 2x6 stud pony walls that have been placed on 8x8 beams that rest directly on the ground.

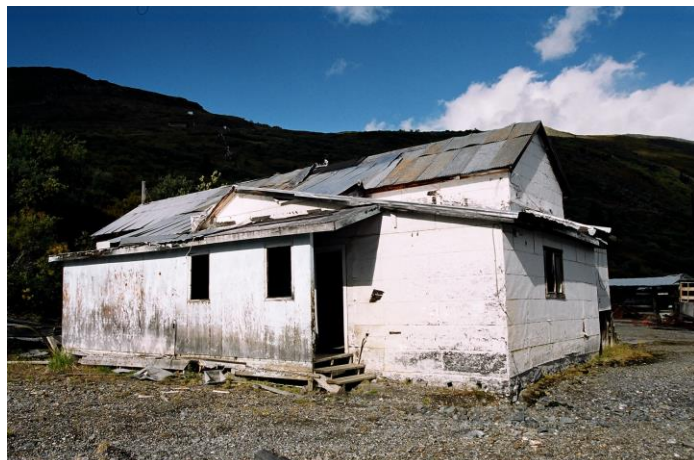
*Historical Review of Former United Keno Hill Mines LTD, Quartz Claims  
Keno 700 Camp, Site. Keno Hill. Volume 1*

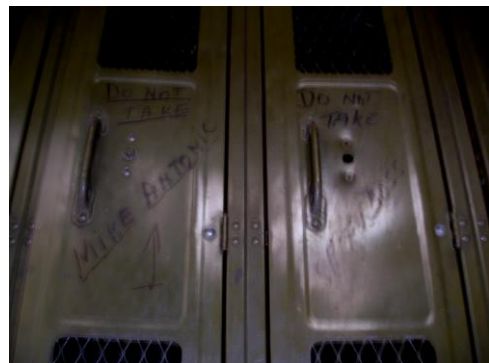
*Keno 700 power plant*

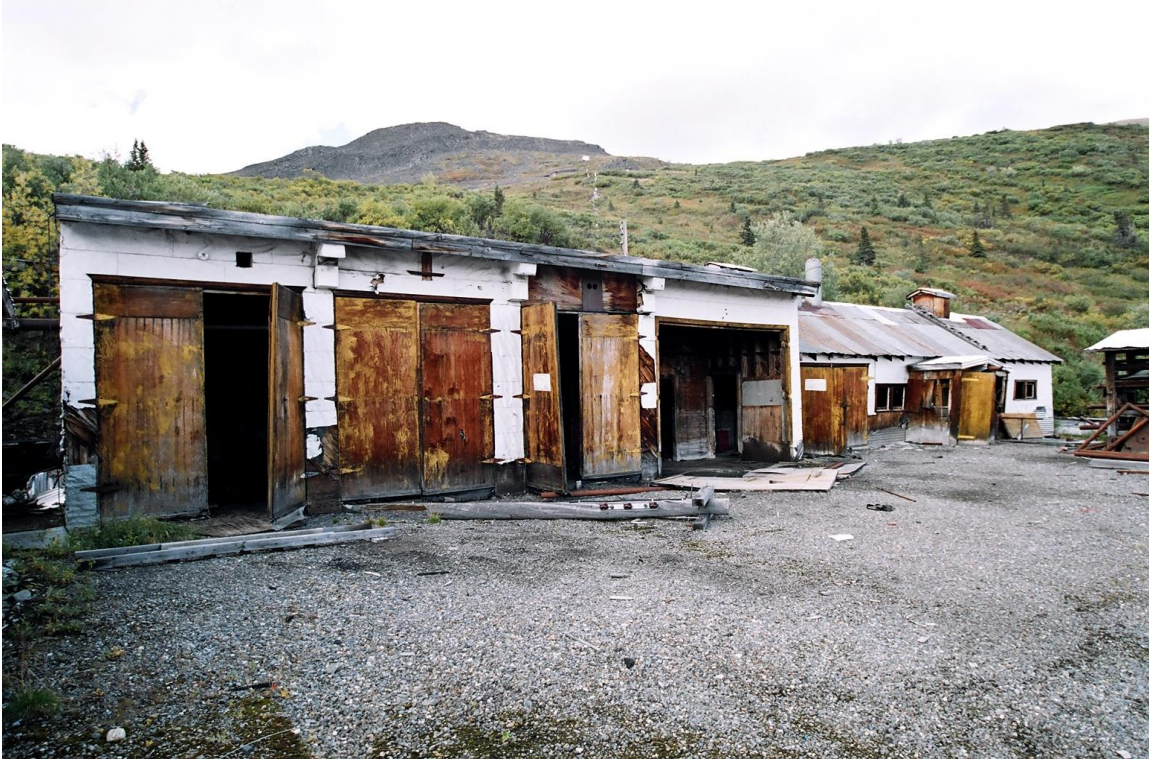
There are two different style roofs covering the compressor and power plant building.

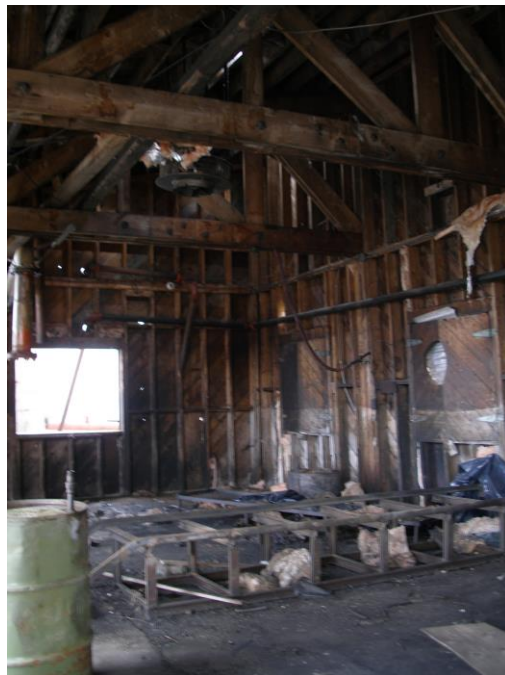
The interior walls are 2x6 studs on 16 inch centers. There are pieces of insulation and interior sheeting scattered around this section of the building, indicating that materials are being salvaged.
