# Historical Review

Of  
Former  
United Keno Hill  
Mines Limited  
Quartz Claims

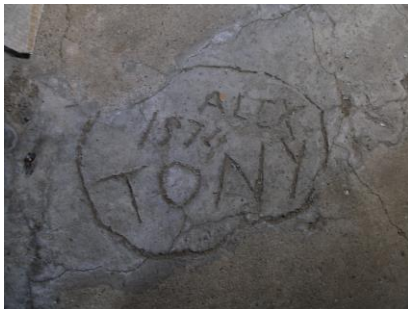
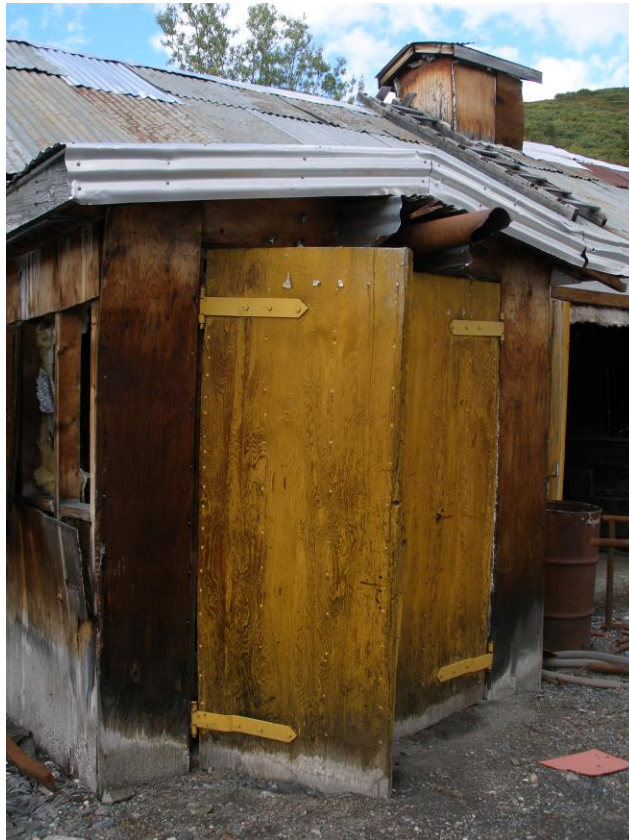
*Machine Sheds #1 and #2*

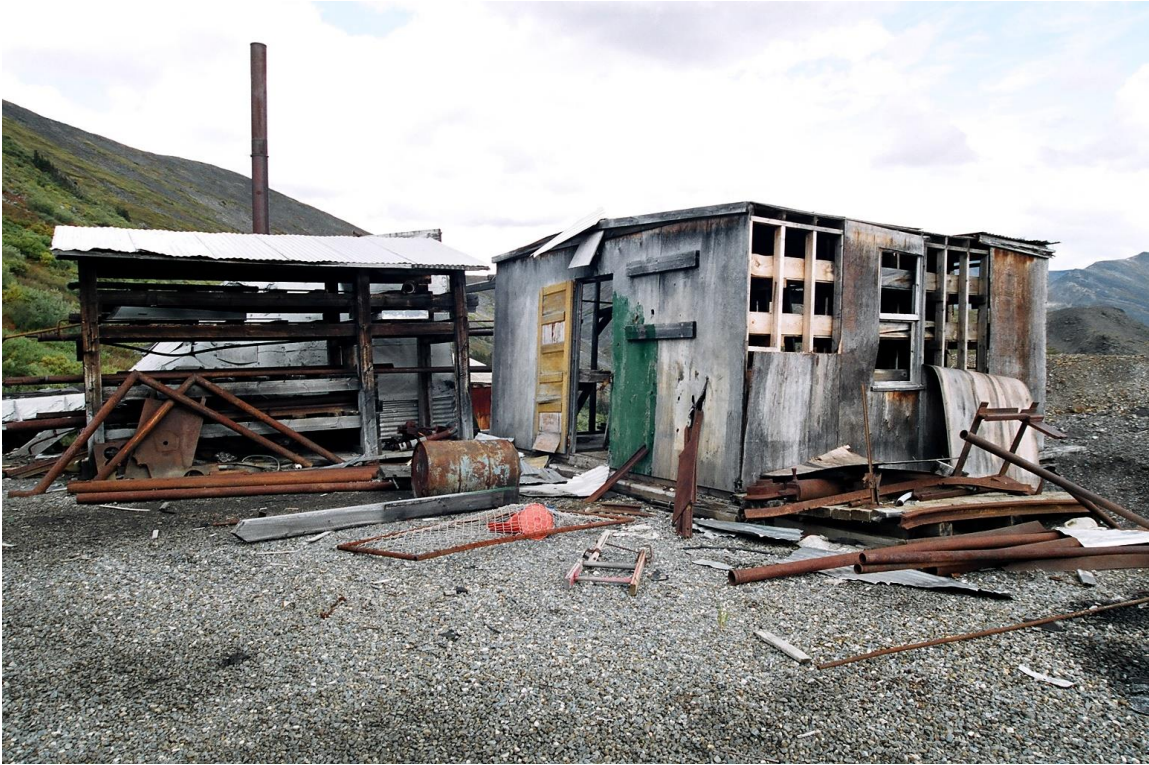
The floor joists are 2x4 boards that have then been sheeted over with 1x8 shiplap boards. The walls are constructed with 2x4 studs on 16 inch centers, with the exterior of the walls being sheeted over with 3/8 plywood. The interior of the building is strapped horizontally on two foot centers with 1x8 boards.

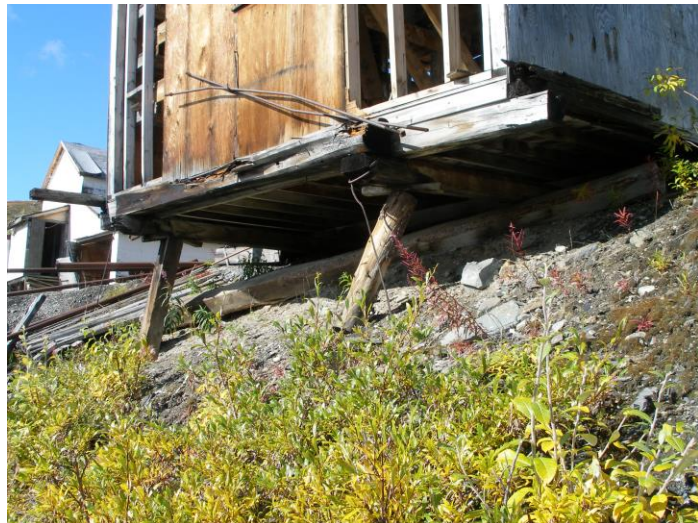
There is a wooden storage rack next to the shed that holds pipe and metal.

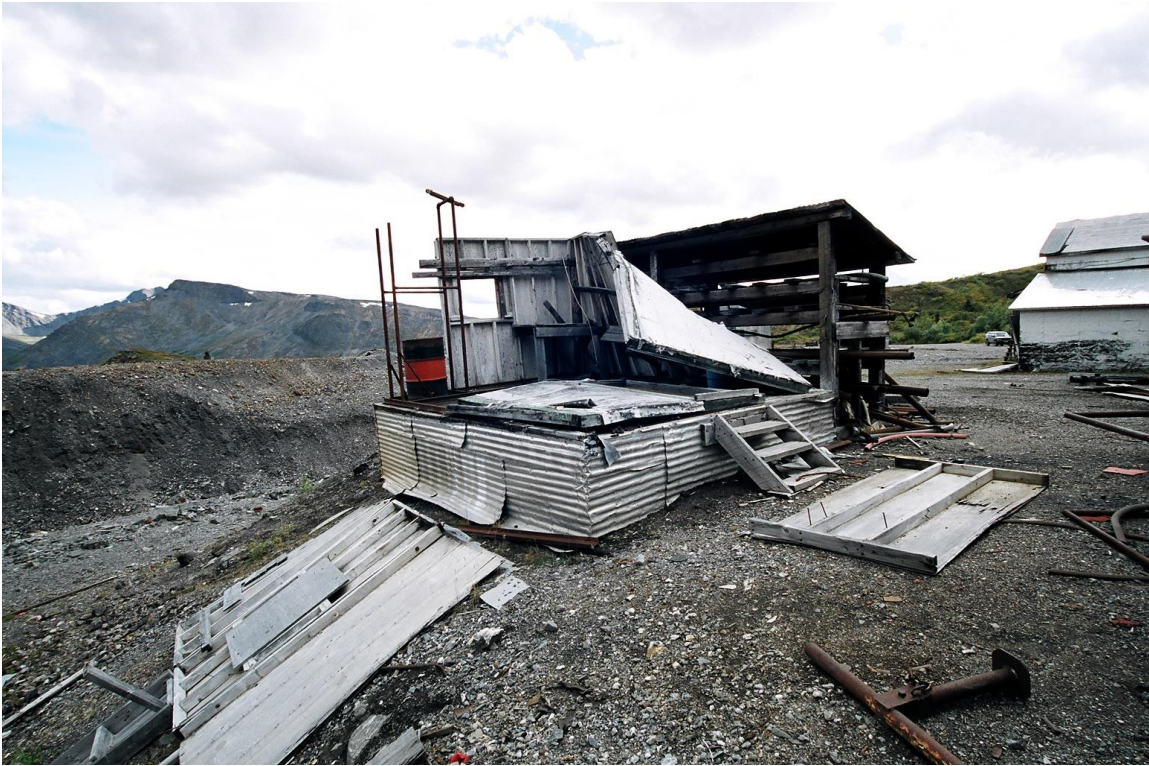
The floor has been sheathed in with 1x6 shiplap boards and then sheathed a second time with 1x3 tongue and groove fir laid in the opposite direction.

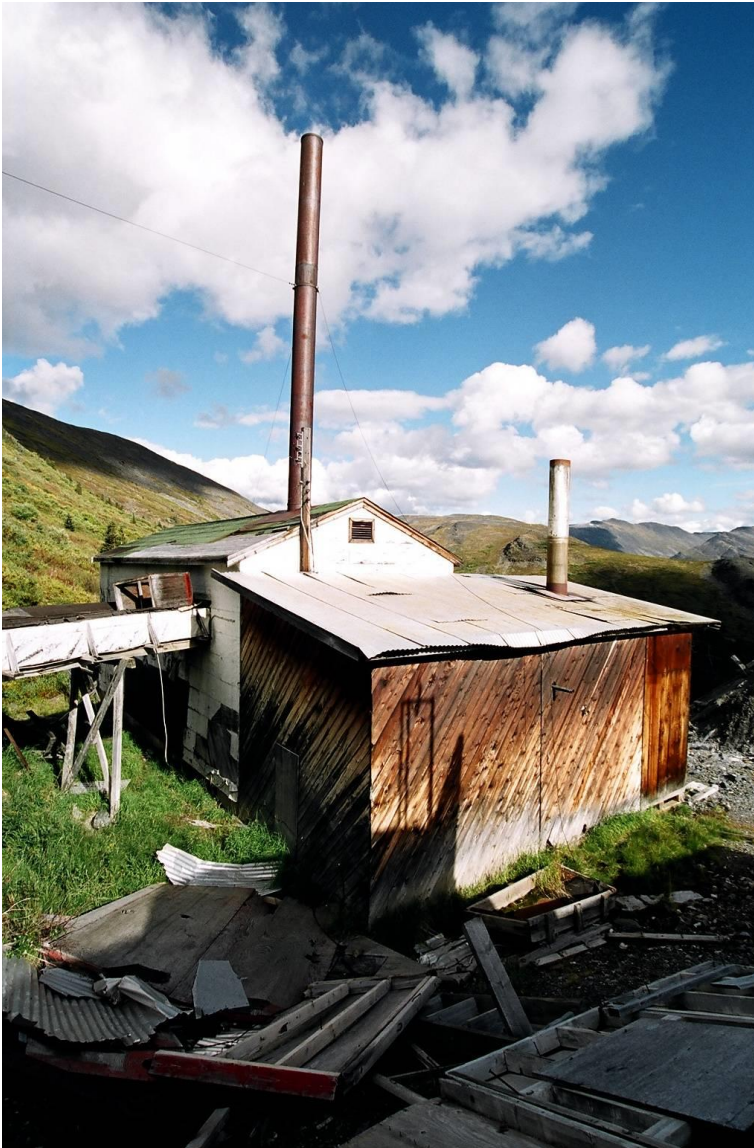
The foundation on the south addition is constructed with 8x8 beams that are running east to west and then cross braced every 1.5 meters with more 8x8s going north to south.

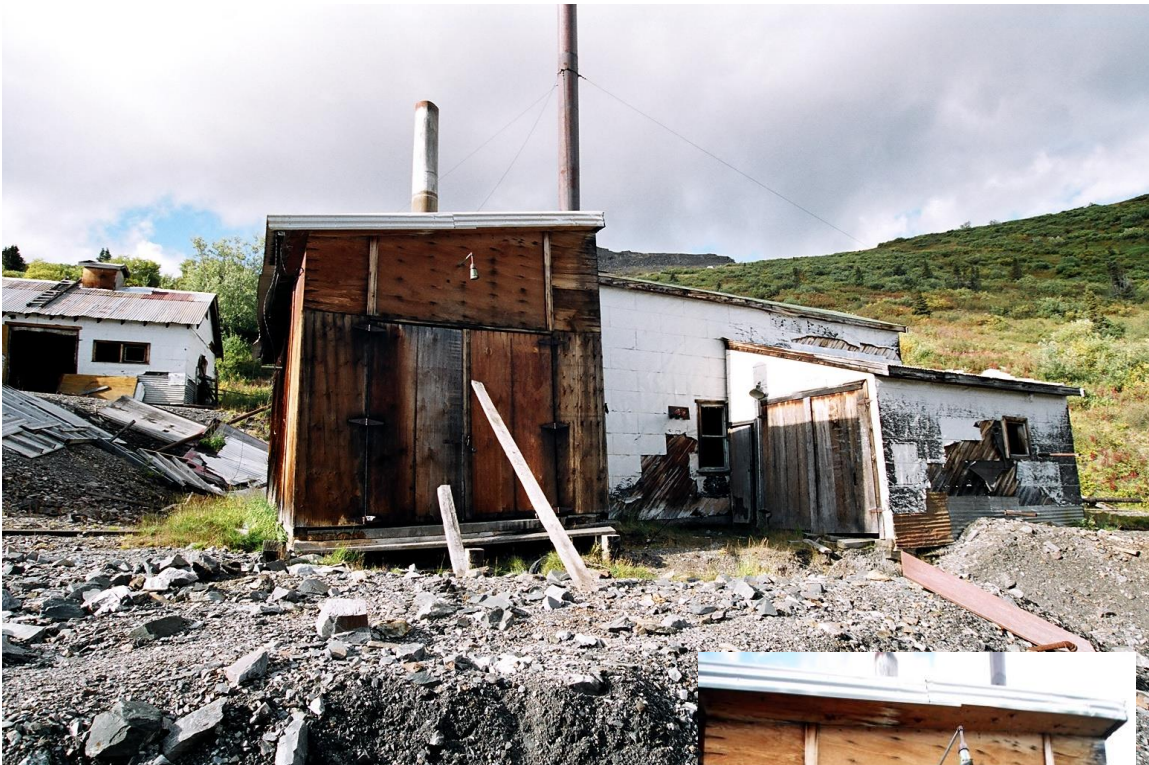
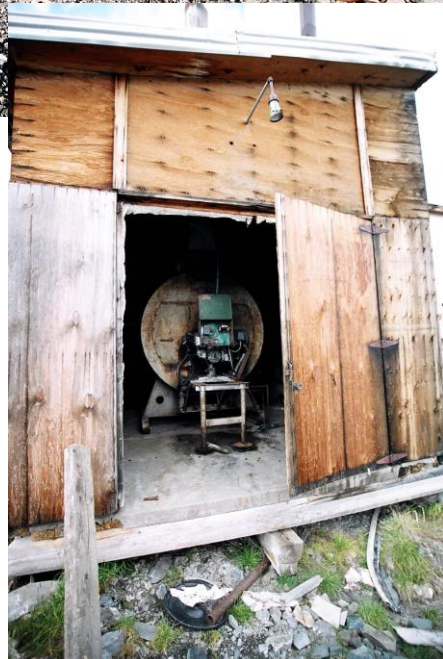
We could not tell what dimension of frame material was used to build the trusses that cover the main boiler house because the ceiling was sheeted in completely with plywood paneling.

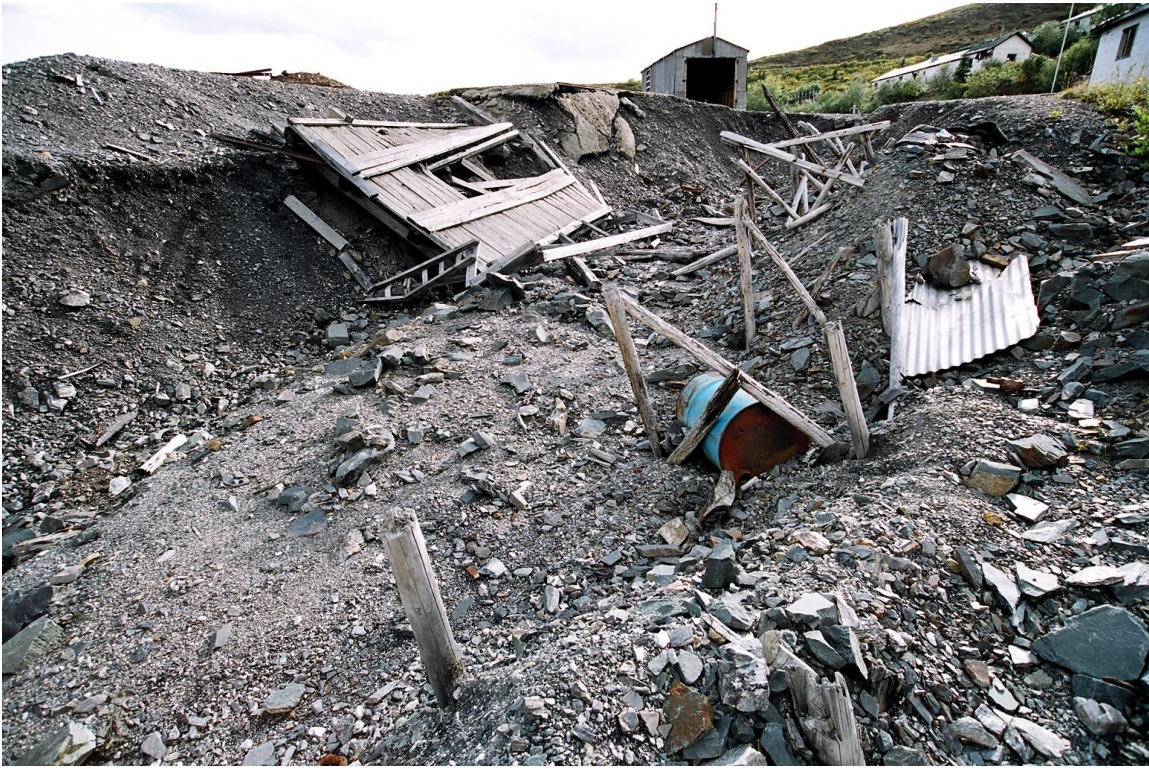
There is a wood and metal sled found by the south wall of the boiler house.  
There are various forged and cut metal around the sheds, cat tracks, rail and metal drums.

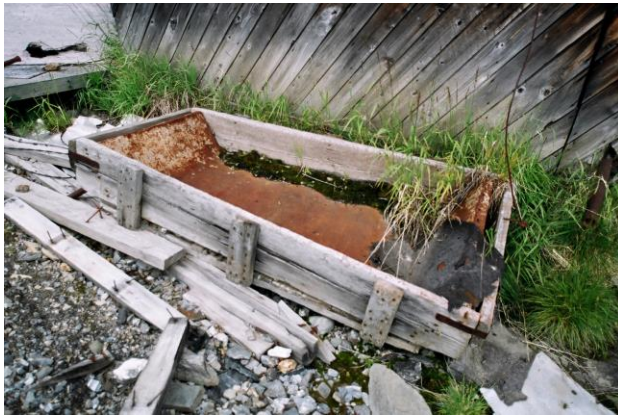
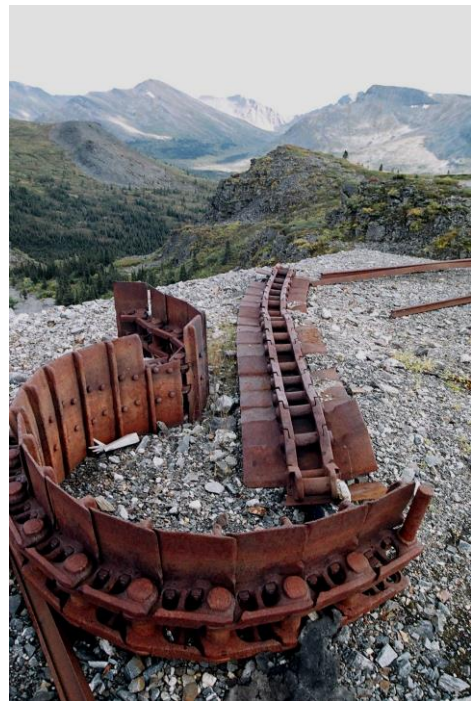
## PUBLIC SAFETY/KENO HILL 2007
