To: Justin Stockwell, Lorax Environmental Services Ltd.
Cc:
From: Diane Lister
Date: September 30, 2011
RE: **Mount Nansen Closure: Synopsis of Field Work
Lorax Proposal J907-7 / YG Contract #C00010368**

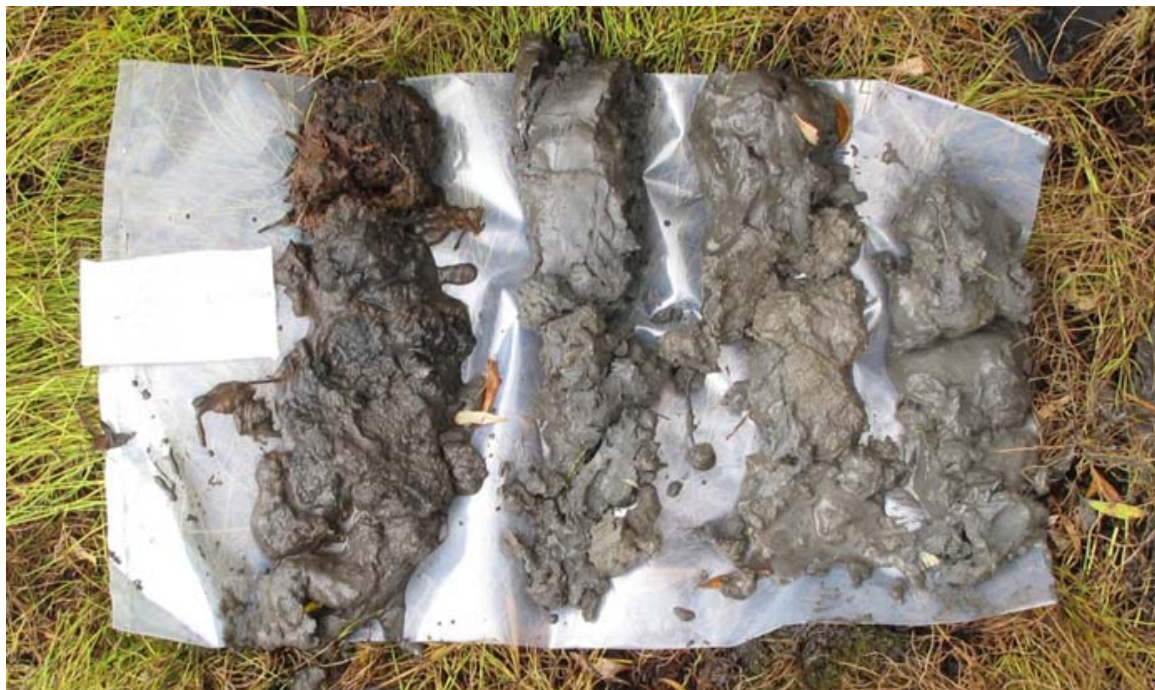
Photo 2. Sediment cores from a vegetated site up-gradient of Pond #1, showing tailings slimes and local sand within the lower intervals (the 3 right-most cores). Each core represents 15-20cm of sample depth.

4. Pond #1 Investigations: Mid-pond sediment cores from three sites in the lower Pond #1 area were taken with a hand auger to supplement the shoreline hand auger samples taken in 2010. Flotation tubes along with personal flotation devices, provided by EDI and Altura, were used to access the middle of the pond. The cores extracted with the auger from the centre of Pond #1 appear to be tailings slimes similar in composition to the shoreline sample collected in 2010. At the three mid-pond sites augered, the tailings range in approximate thickness from 60cm to greater than 80cm, while the single auger hole from 2010 at the shore of Pond#1 indicated at least 45cm of tailings (frozen ground encountered at 45cm depth). Three on-land auger sites up-gradient of the pond were completed and cores contained lenses of grey fines resembling tailings, along with a significant proportion of intercalated sand. Descriptions of the sediment

cores from the hand auger sites are provided in Table 4, and site locations are shown in Figure 3. In all, six auger core samples from the Pond #1 area were retained, sealed in plastic bags and placed in cold storage for subsequent elemental analysis (see Table 5 for sample listing). Suggested analyses are listed in the Recommendations section of this memorandum.

3. More detailed analysis of water quality results
4. Compile sediment core information from Pond #1, and carry out elemental analysis on the six sediment core samples currently in cold storage. In consultation with Lorax, recommended analyses include acid-base accounting, total and inorganic carbon, and trace and ultra-trace ICP via aqua-regia digestion, with follow-up AA analyses on elements exceeding the method upper detection limits. Conduct sampling of Pond #2 during 2012 field season; hand augering is considered viable in water depths up to 0.6m. Obtaining sediment samples in deeper water bodies requires techniques beyond the scope of Altura’s capabilities.

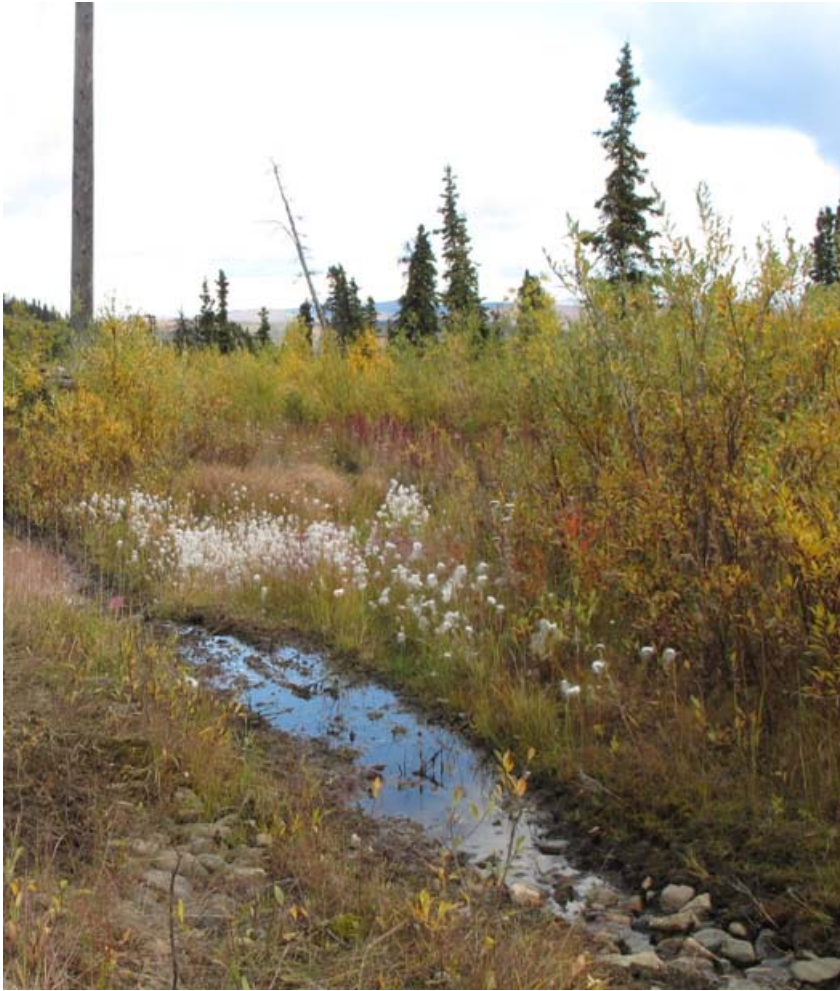
Photo 3. Cotton grass (likely *Eriophorum brachyantherum* or *E. scheuchzeri*) seed collection site along pipeline access trail east of mill area.

8. Small quantities of seed sufficient for research purposes were collected from scrub birch (*Betula glandulosa*), willow (*Salix sp.*), and cotton grass (likely *Eriophorum brachyantherum* or *E. scheuchzeri*); refer to Table 6 for summary of locations, species, and potential research application. Spruce trees were surveyed for presence of ripe cones, but there appears to have been little or no cone production in 2011 (2010 was a very high-yield year).

5. Utilize collected seed in fall 2011 and during 2012 field season (direct seeding trials and trial-scale nursery propagation).

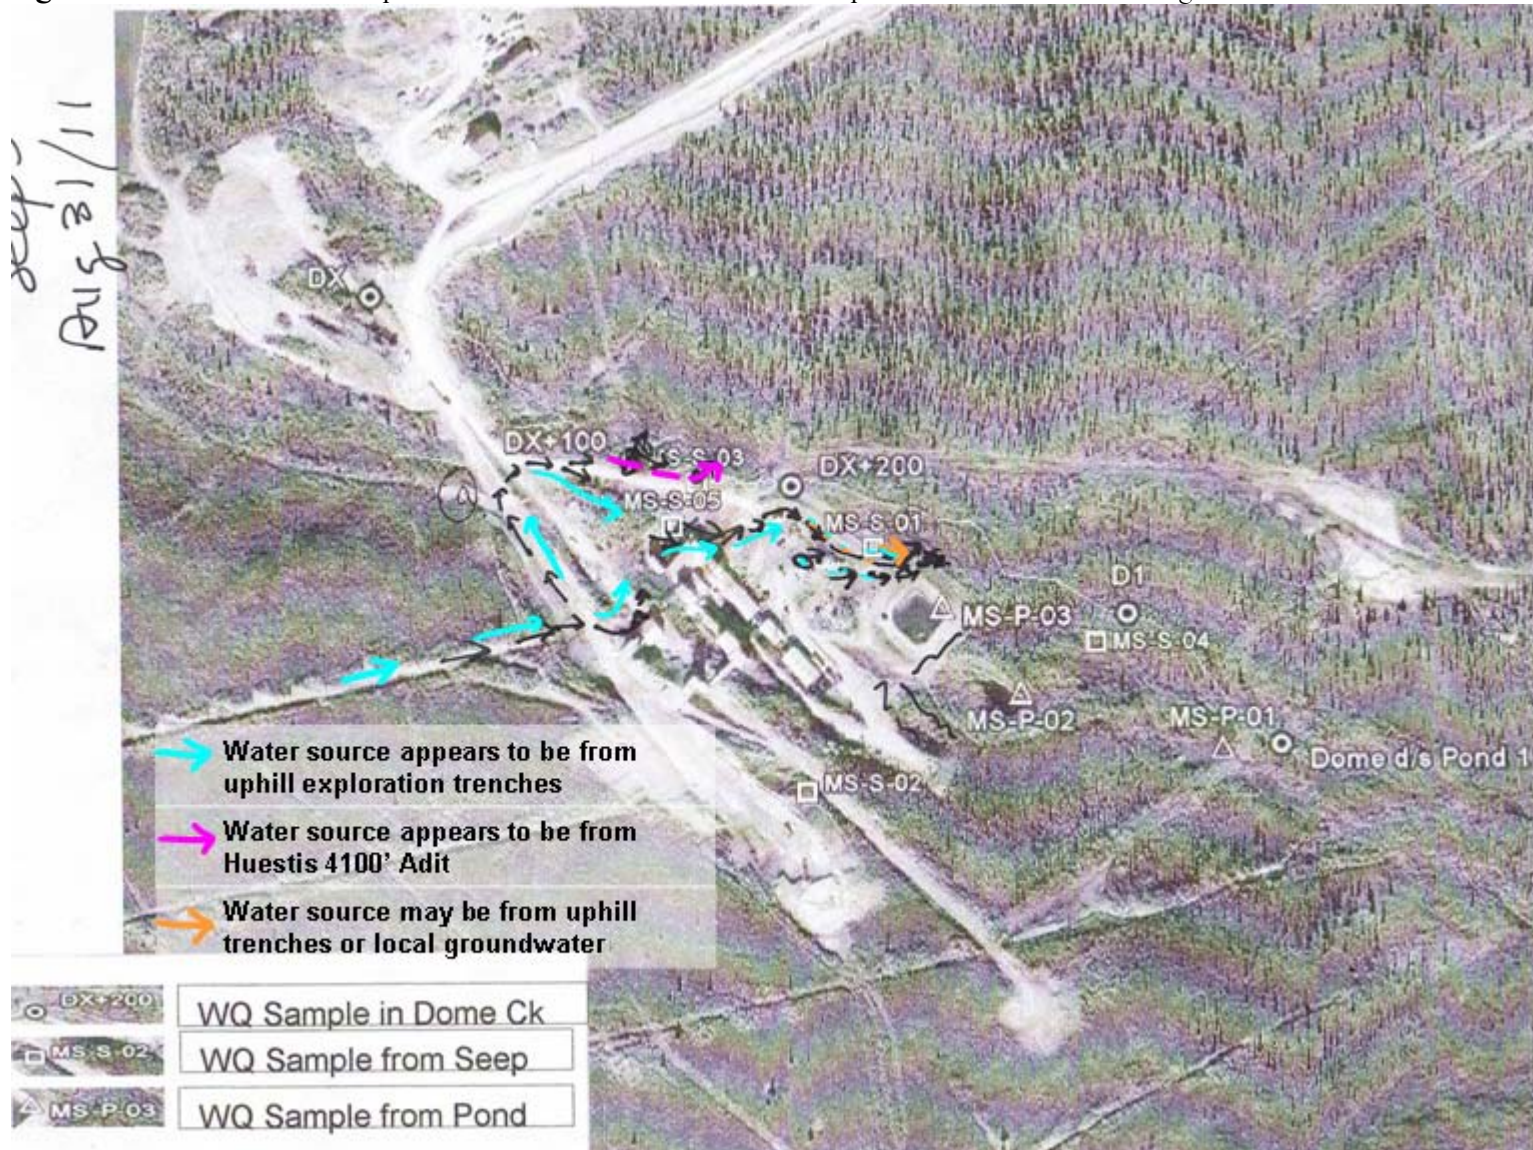
Figure 1. Field sketch map of observed surface water flow and seep conditions in mill area, August 31, 2011.

2. Seepage Flow Sketch Map through Mill Area: the abundance of seeps due to recent rainfall events made for good conditions to record flow paths down through the mill platform. Certain seeps of substantial flow, not observed during July 2010 mill characterization work, were observed in particular on the working platform immediately in front of the mill buildings on the lower platform. Figure 1 shows a field sketch map of observed flows and seeps.

1. Convert sketch map of mill area local seeps and flows into GIS or similar format
2. Carry out flow measurements immediately upstream and downstream of “DX+100” station to better refine the visual flow estimates (given seasonal considerations suggest with salt or other tracer)

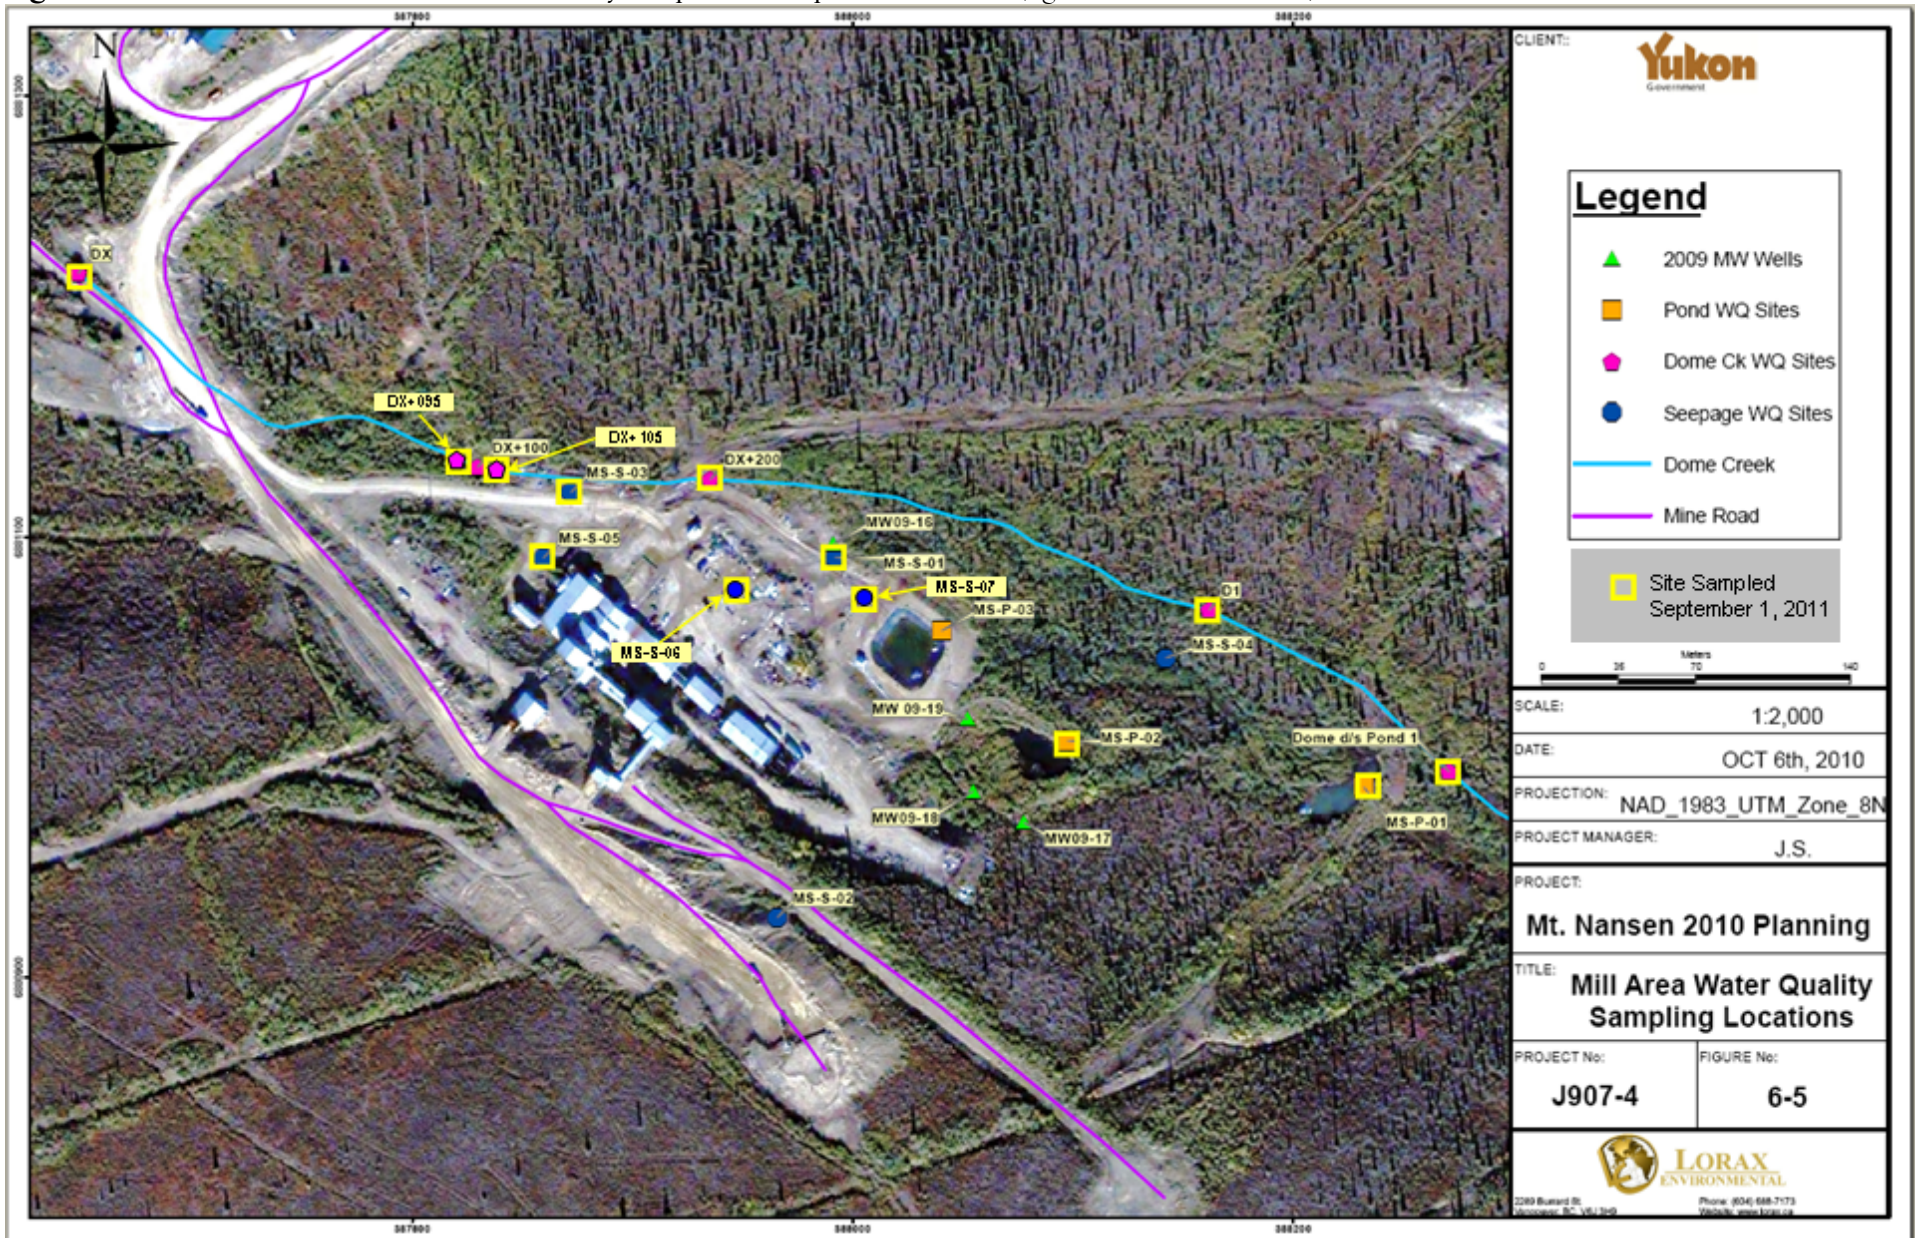
Figure 2. Location of Mill Area Water Quality Sample Sites, September 1, 2011 (figure from Lorax, 2011)

3. Water Quality Sampling: See Table 3 and Figure 2 for sample locations; included 4 sites on Dome Creek between station DX and downstream of Pond #1, 5 seeps in the area of the mill, and Pond #1 (lower pond) and Pond #2 (middle pond). Samples were taken utilizing established site protocols and using prepared bottles and equipment provided by Exova laboratory. Results, given in Appendix A, have been briefly reviewed to ensure data adequacy, and in general appear similar to those of the 2010 mill characterization campaign (tabulated in Appendix E-2 of the report *Mount Nansen Mine Geochemical Assessment in Support of Closure Plan Options* [Lorax 2011a]). In the 2011 results, of note is the following:

- Station "DX+100" on Dome Creek was previously identified in 2010 as a location of conductivity spike and flow increase (possibly a major influx of Huestis 4100' adit flow). On September 1 this same area was sampled on Dome Creek immediately upstream and downstream at stations denoted "DX+95" and "DX+105". Over this 8 to 10 m reach, dissolved zinc abruptly increases downstream from 0.004 mg/L to 2.03 mg/L with corresponding increases in electrical conductivity, total alkalinity and dissolved sulphate, among other parameters. Flows between these two stations were visually estimated to increase from 100 L/min to greater than 200 L/min. These increases in concentration and volume are consistent with a zinc and sulphate enriched inflow to Dome Creek between these two sample sites; this inflow is suspected to be originating from the historic Huestis 4100' adit.

- Dissolved chloride levels at virtually all sites were below the 0.5 mg/L detection limit with the exception of Pond #2 and Dome Creek station D1 (1.6 and 4.7 mg/L respectively), potentially indicating a local influence from the immediate mill area.

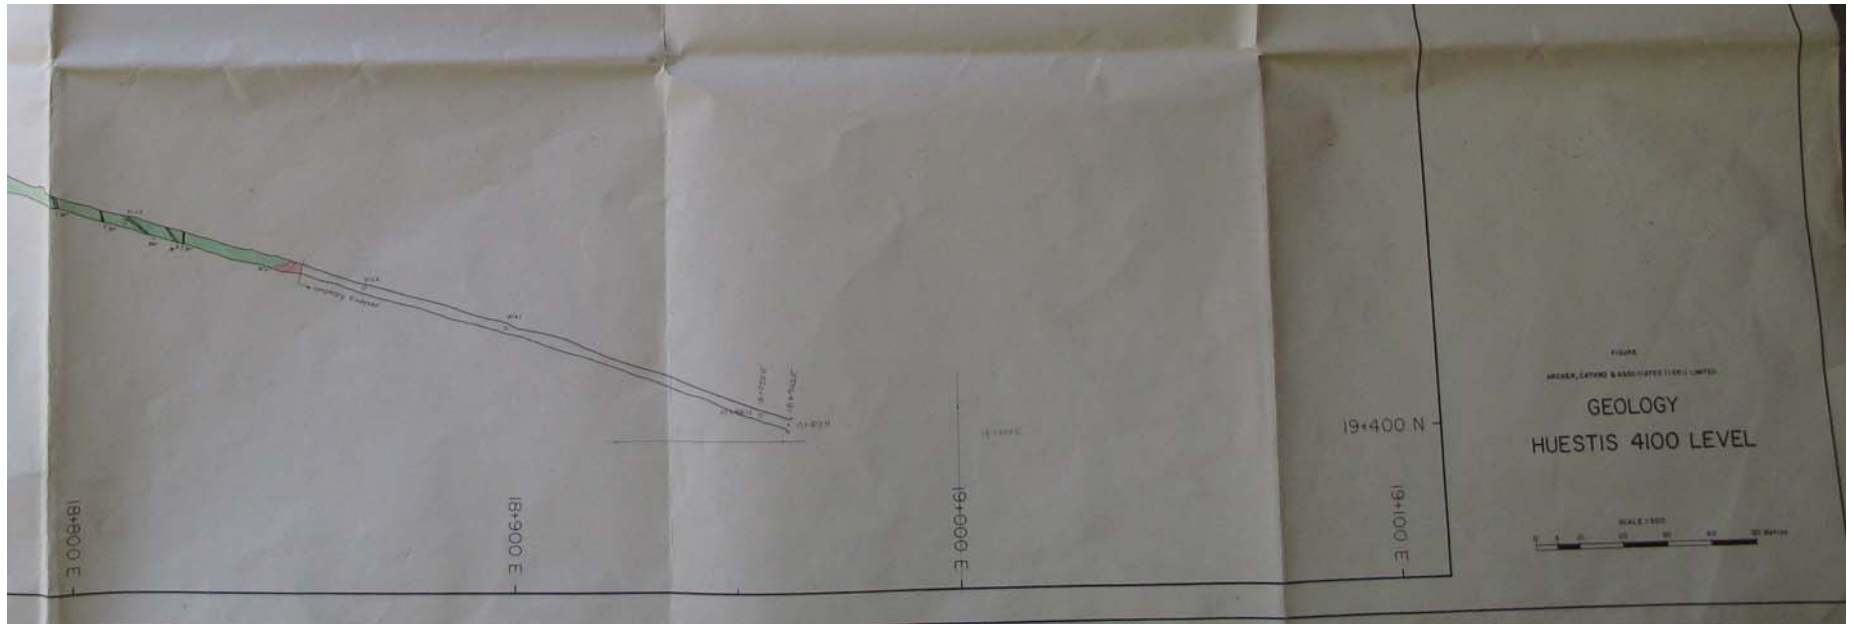
Figure 4. Heustis 4100' Geology Map (based on Altura's site experience this map likely accompanied an Archer Cathro annual property report, c. 1985)

6. The vault and office area was inspected for maps related to location of the lower Huestis adit (denoted 4100' in circa 1979 photographs previously provided to Altura by Assessment and Abandoned Mines. Three relevant maps were located: 1) a circa 1985 geological map of Huestis 4100' adit by Archer Cathro found in a map drawer of the vault (Figure 4); 2) a 1998 "Mill Area As-Built" with pencil and ink annotations found on the wall in the former mill management office (see Figure 5); and 3) numerous older underground development maps from the 1960's and 1970. The first two aforementioned maps were photographed for future reference and left at site (on table in old engineering office) and are shown in Figures 4 and 5. Other documents of interest included a 1989 Environmental Update Report for the project by Norecol Environmental Consultants Ltd. found and left in the vault, which included 1987 water quality sampling data for several drainages in the area, along with a station location map.
