## **MOUNT NANSEN SITE**

### **FISHERIES AND AQUATICS EXISTING CONDITIONS REPORT**

204-105 TITANIUM WAY  
WHITEHORSE, YUKON  
PROJECT NO. 16-249  
FEBRUARY, 2018

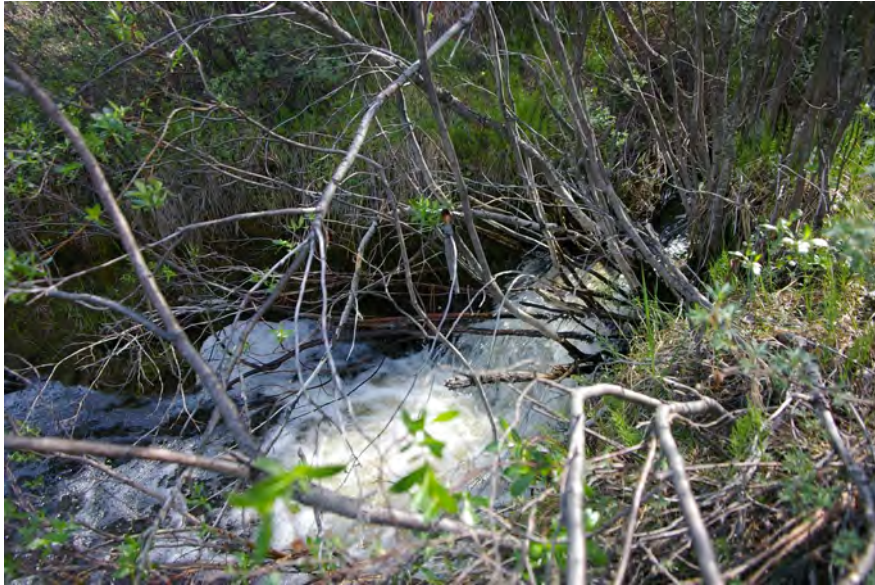
**Photo 1:** View of the 45 cm cascade located at the outflow of Dome Creek to Victoria Creek. Photo taken June 20, 2012.

Dome Creek was accessed at its outflow into Victoria Creek, and was assessed upstream approximately 845 m to the point of crossing at the Site access road (Figure 4.1). Only one potential barrier was noted, which occurs at the outflow of Dome Creek into Victoria Creek (Photo 1), a 45 cm cascade with a total pool depth of 58 cm where the channel of Dome Creek is supported by vegetation at the edge of an undercut bank of Victoria Creek. This cascade was determined to be a temporary barrier that could change in the future with stream erosion.

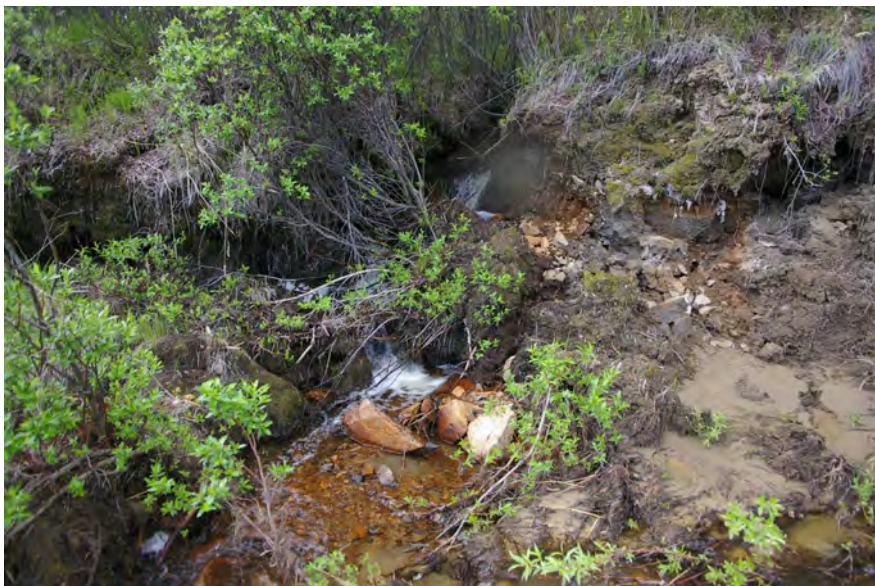
**Photo 2:** View of the series of cascades located at the outflow of Pony Creek into Back Creek. Photo taken June 23, 2012.

Pony Creek was surveyed from its outflow into Back Creek upstream approximately 438 m to an area where a defined channel was no longer visible (Figure 4.1). Several barriers were observed within the creek, the largest of which was a stepped cascade at the outflow of Pony Creek into Back Creek. This cascade consisted of four adjacent drops measuring 28 cm, 51 cm, 58 cm, and 68 cm (upstream direction) having pools beneath measuring 17 cm, 32 cm, 56 cm, and 50 cm, respectively (Photos 2 and 3). Further upstream, two additional potential barriers were observed: a cascade with two adjacent drops measuring 18 and 28 cm (Photo 4); and a cascade with a drop of 46 cm (Photo 5). ELR electrofished the length of stream from Back Creek to the point the channel became undefined (327 seconds effort). All areas of the creek within this length were fished, due to the narrow width of the creek. Electrofishing settings used in Pony Creek are summarized in Table 4.2, below.

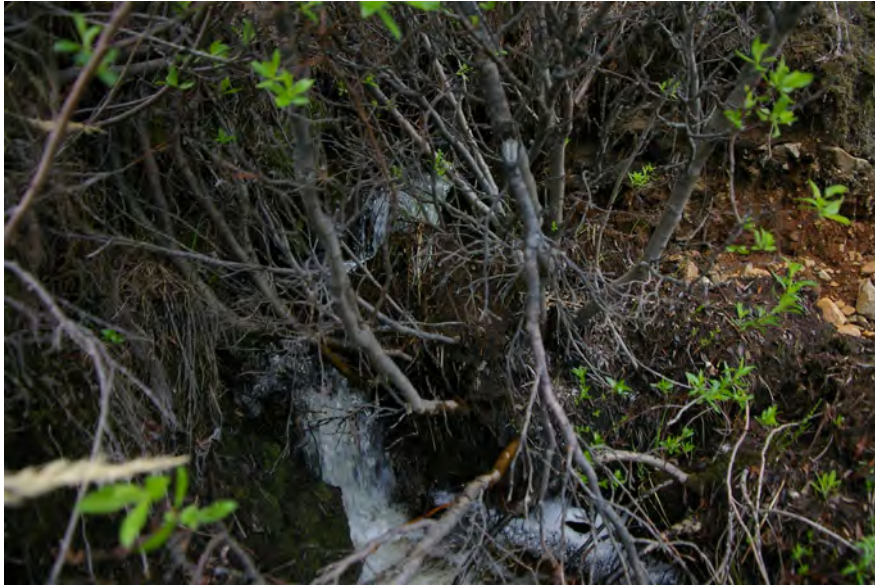
**Photo 3:** Alternate view of the series of cascades located at the outflow of Pony Creek into Back Creek. Photo taken June 23, 2012.

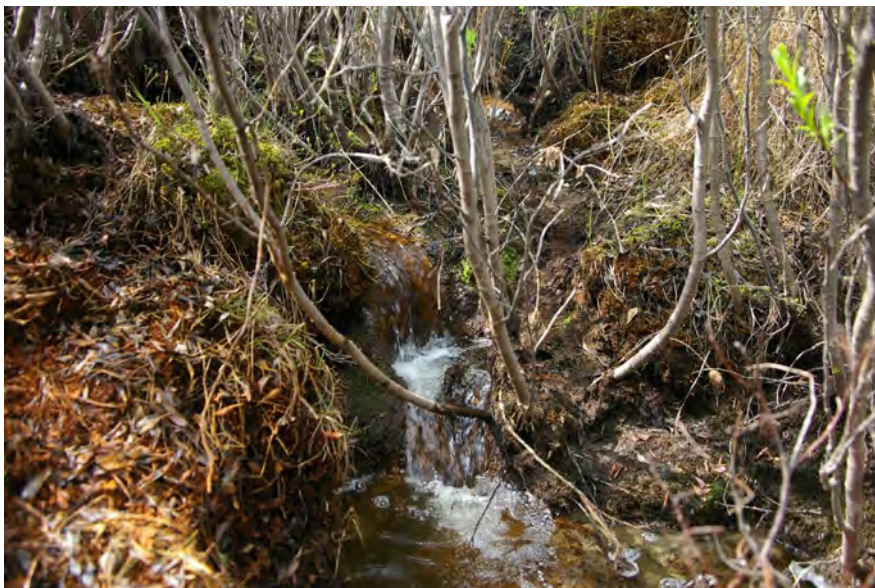
**Photo 4:** View of the 5th cascade identified on Pony Creek (18 and 28 cm drops). Photo taken June 23, 2012.

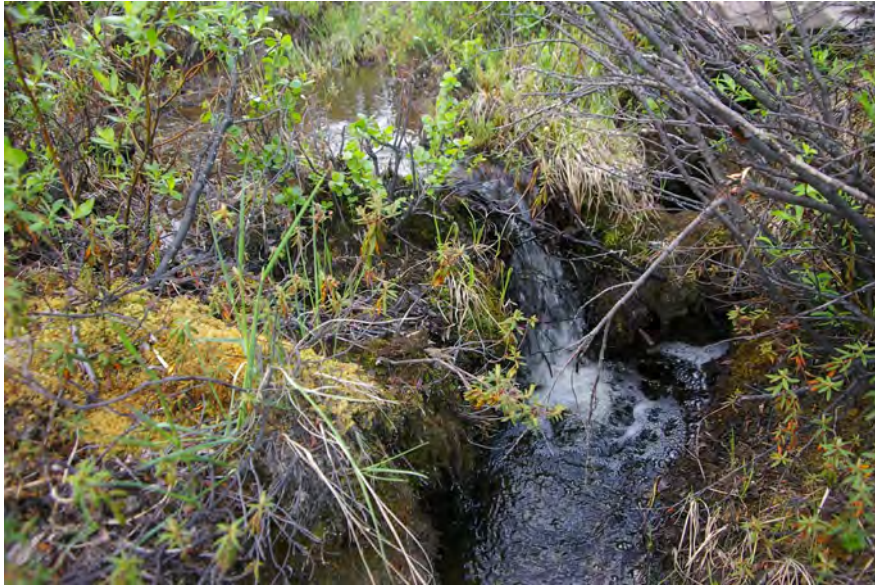
**Photo 5:** View of the sixth cascade identified on Pony Creek (46 cm). Photo taken June 23, 2012.

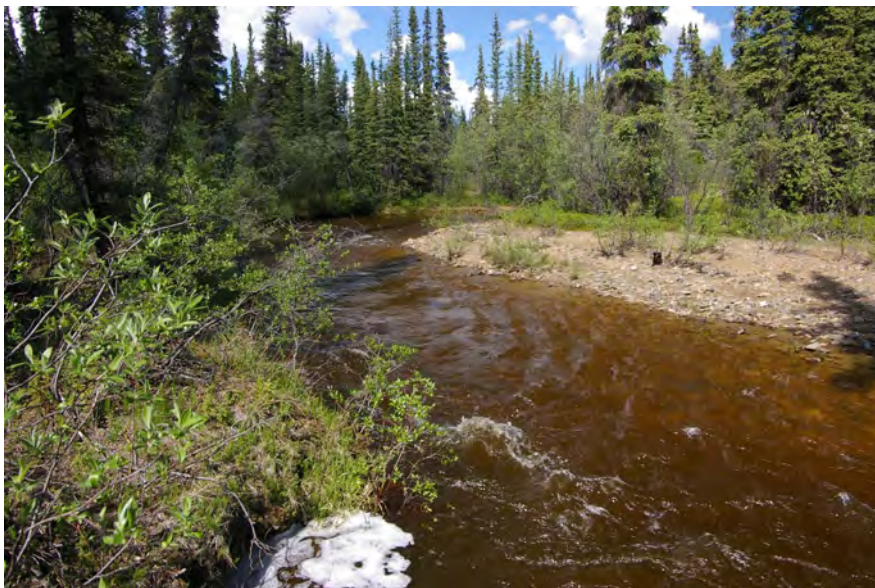
**Photo 6:** Representative photo of conditions in Victoria Creek in June of 2012. Photo taken June 21, 2012.

ELR assessed Victoria Creek from June 21-23. At the time, water levels in Victoria Creek were very high, making fisheries assessment difficult (Photos 6 and 7). Seine netting or snorkel surveys were not possible under the high water conditions. ELR did attempt electrofishing, although fast currents resulted in conditions that were difficult and even unsafe in most areas. Three areas of Victoria Creek were assessed: 457 m upstream and 143 m downstream from the confluence with Back Creek; and 148 m downstream from the confluence with Dome Creek. A total electrofishing effort of 1,094 seconds was expended at this time over a length of 738 m of stream (703, 260, and 131 seconds, respectively), resulting in the capture of only one juvenile Burbot (280 mm) and one adult Arctic Grayling (292 mm). The fast currents and high water levels are thought to have influenced the ability to capture fish in Victoria Creek.

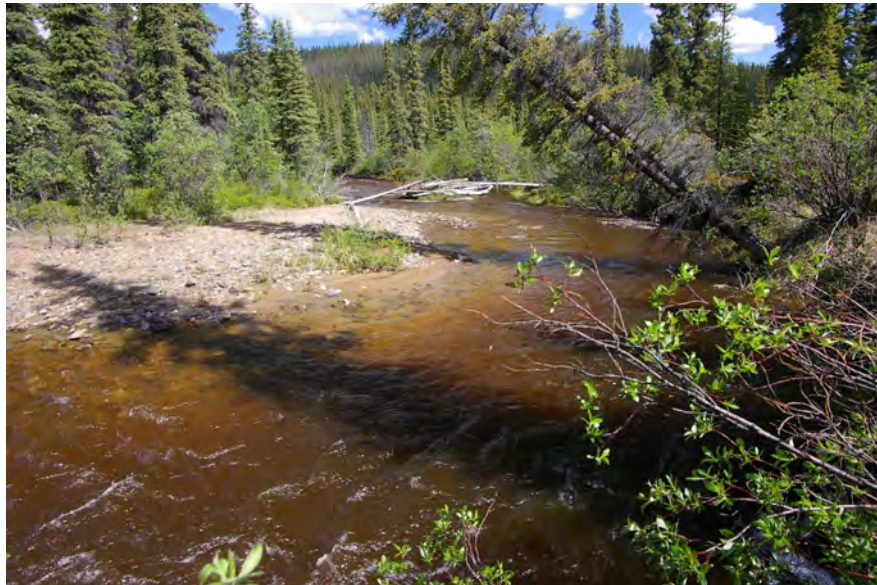
**Photo 7:** Representative photo of conditions in Victoria Creek in June of 2012. Photo taken June 21, 2012.

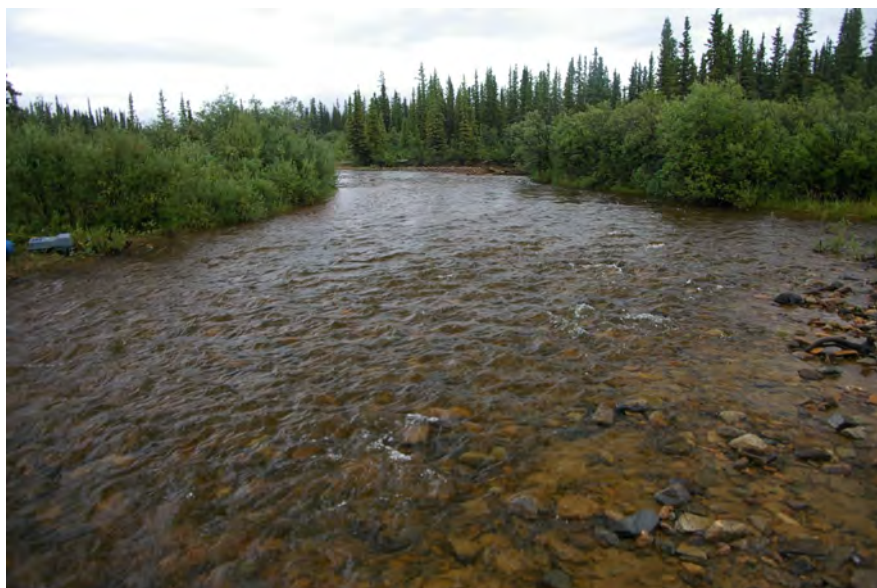
**Photo 8:** Representative photo of conditions in Victoria Creek in July of 2012. Photo taken July 24, 2012.

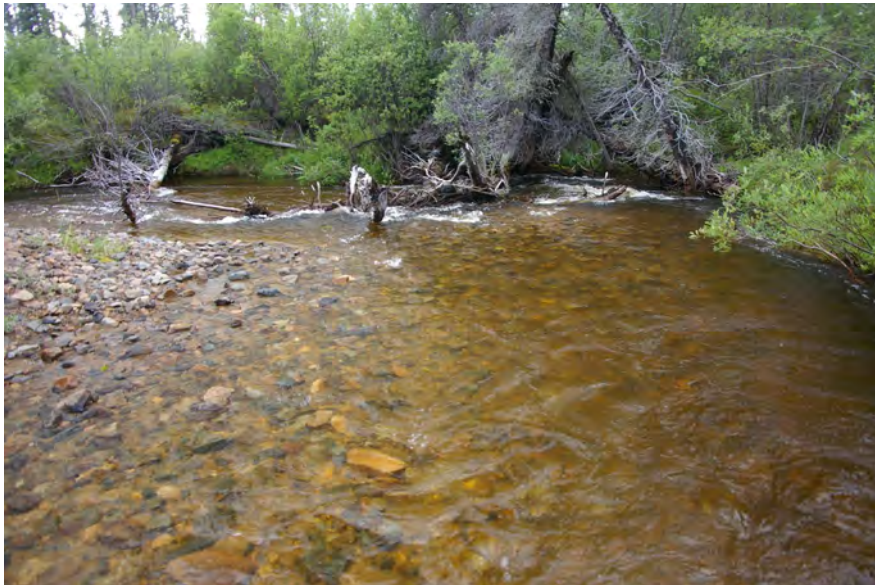
**Photo 9:** Representative photo of conditions in Victoria Creek in July of 2012. Photo taken July 24, 2012.

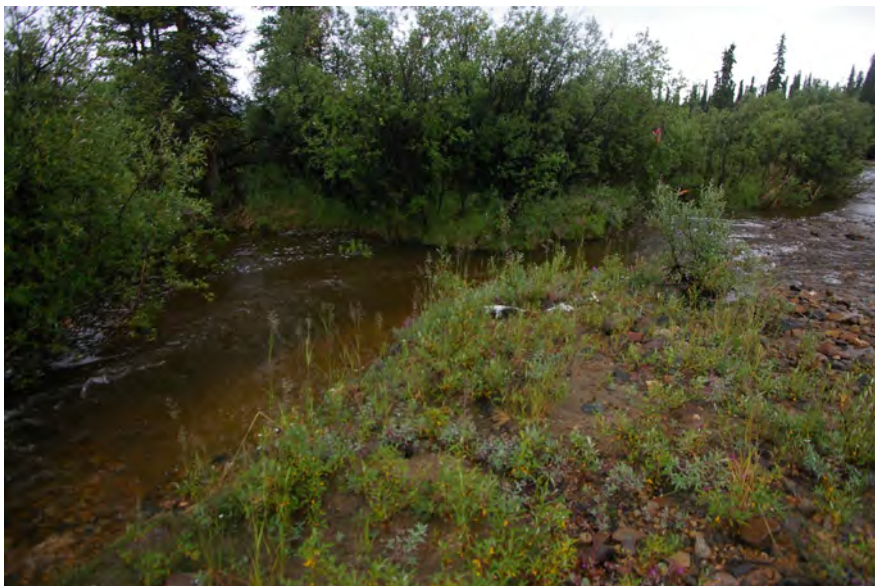
**Photo 10:** Representative photo of conditions in Victoria Creek in July of 2012. Photo also shows the main channel pool where several adult Arctic grayling were captured using a seine net. Photo taken July 24, 2012.

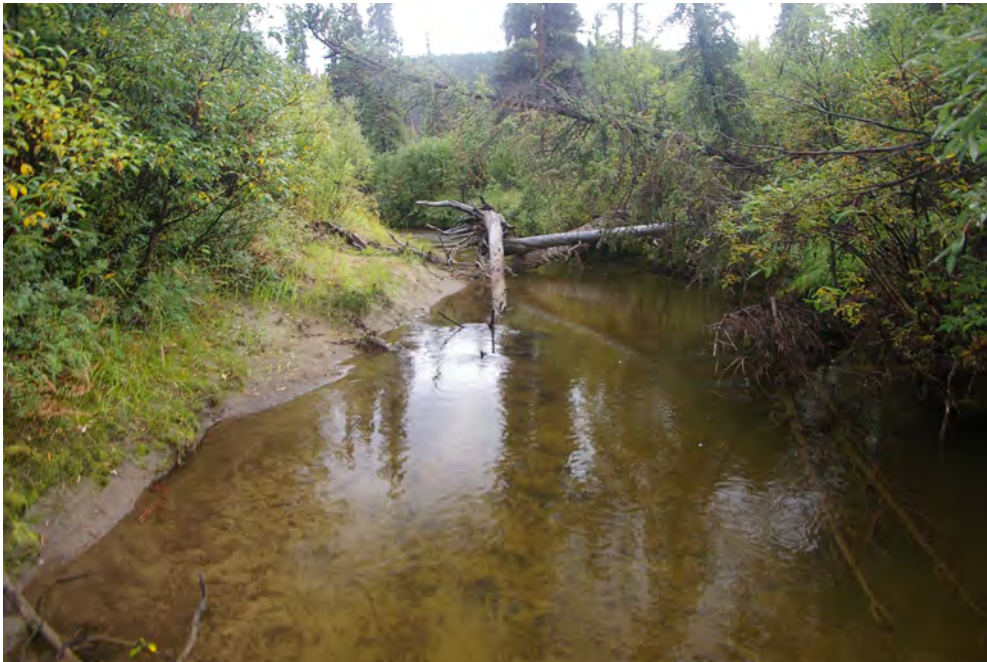
**Photo 11:** Representative photo of conditions of Victoria Creek in in August of 2013. Photo taken August 22,2013, Downstream view from sample site V1.

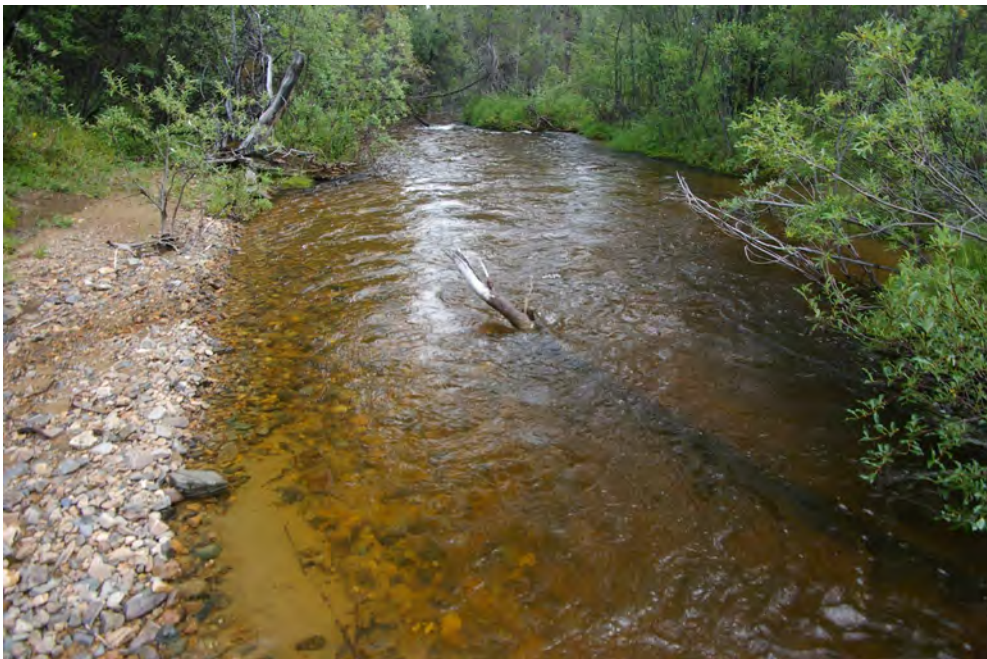
**Photo 12:** Representative photo of conditions of Victoria Creek in in August of 2012. Photo taken July 25,2012, Downstream view from sample site V2.

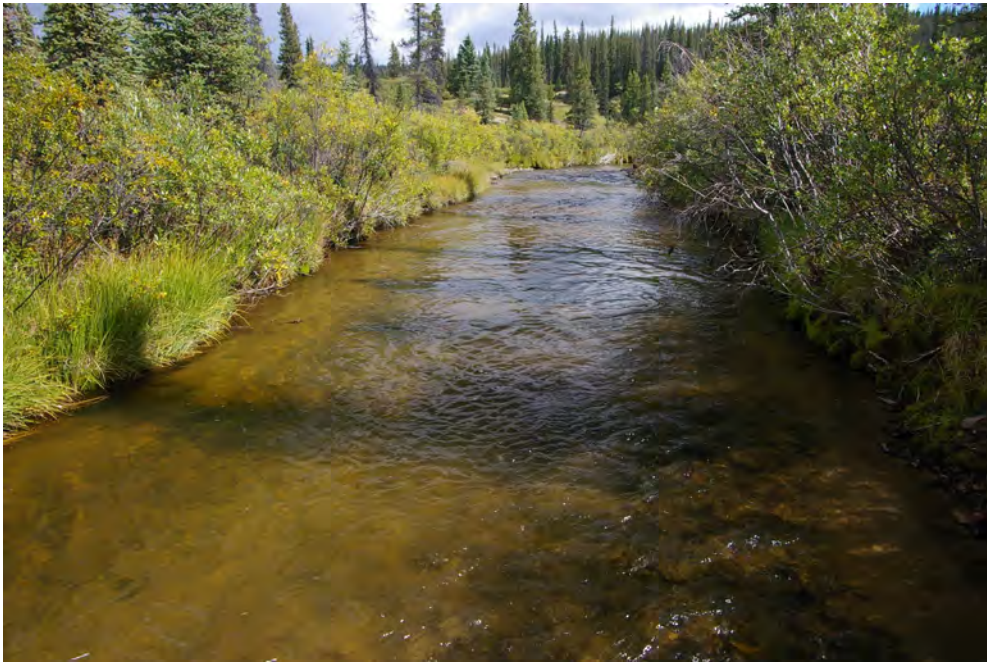
**Photo 13:** Representative photo of conditions of Victoria Creek in in August of 2013. Photo taken August 22,2013, Upstream view from sample site V3.

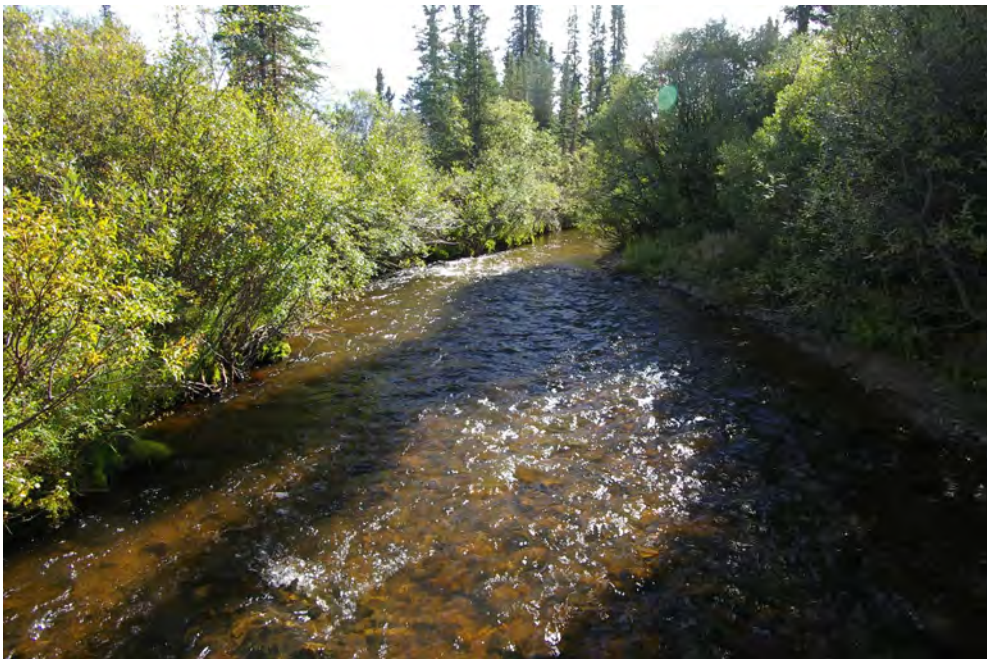
**Photo 14:** Representative photo of conditions of Victoria Creek in in August of 2013. Photo taken August 22,2013, Upstream view from sample site V4.

The Victoria Creek channel downstream of the Minnesota Creek confluence had mean channel and wetted widths of 6.5 m and 4.65 m, respectively (Photo 14). Mean residual pool depth was 0.85 m and mean bankfull depth was 0.71 m. The mean gradient of the stream in the area surveyed was 1.25%. Substrate was dominated by cobble and sand, with D95 and D measured to be 7 cm and 14 cm, respectively. Total cover at Site V4 was estimated to be 8%, which consisted of deep pools (4%), and overstream vegetation (2%), and with some large woody debris (1%), undercut banks (1%). Crown closure ranged from 1-20%, consisting of grass, shrubs, and mature conifer forest.

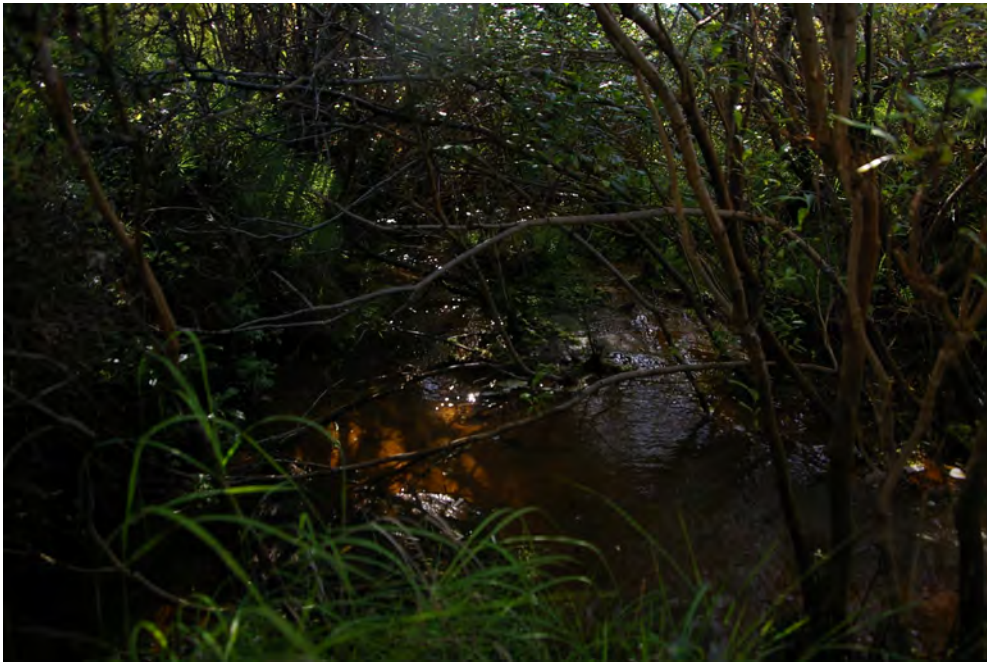
**Photo 15:** Representative photo of conditions of Dome Creek in in August of 2013. Photo taken August 29, 2013. Upstream view from sample site D1.

Upper Dome Creek had a mean channel and wetted widths of 1.4 m and 0.5 m, respectively (Photo 15). Mean residual pool depth was 0.28 m and mean bankfull depth was 0.39 m. Gradient in the area of Site D1 could not be measured due to heavy vegetation cover, but was similar to that of lower Dome Creek (estimated at 2-4%). Substrate in upper Dome Creek was dominated by fines, with no larger substrate materials occurring. The assessed channel had a riffle-pool habitat distribution. Total cover at Site D1 was estimated to be 90%, comprised entirely of overstream vegetation. Accordingly, crown closure was measured to be between 71% and 90%, primarily composed of tall shrubs.

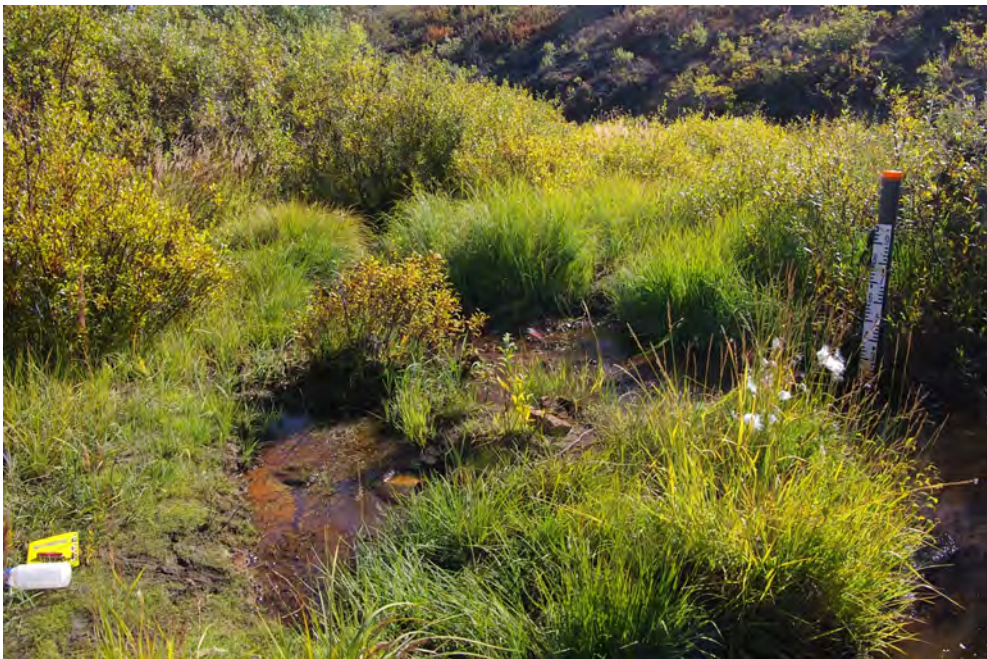
**Photo 16:** Representative photo of conditions of Dome Creek in in August of 2013. Photo taken August 29, 2013. Downstream view from sample site D2.

The channel at middle Dome Creek (below the Dome Creek diversion) had mean channel and wetted widths of 1.2 m and 0.725 m, respectively (Photo 16). Mean residual pool depth was 0.21 m and mean bankfull depth was 0.36 m. The mean gradient of the stream in the area surveyed was 3.75%. Substrate in middle Dome Creek was dominated by cobble and fines, and the assessed channel had a riffle-pool habitat distribution with isolated runs. Total cover at Site D2 was estimated to be 50%, comprised entirely of overstream vegetation. Crown closure was measured to be between 21% and 40%, consisting primarily of tall shrubs.

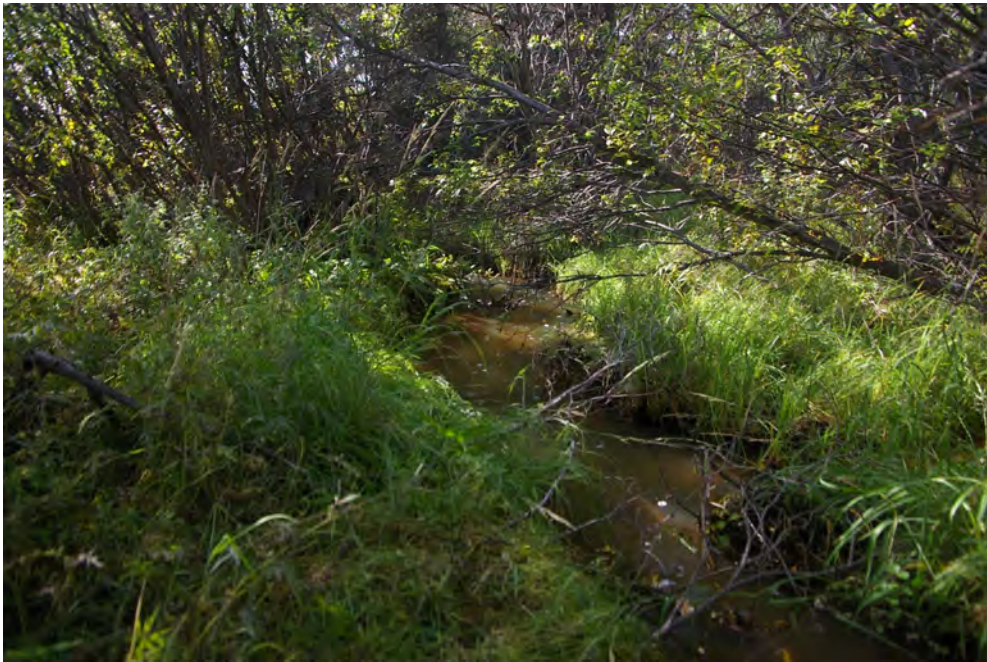
**Photo 17:** Representative photo of conditions of Dome Creek in in August of 2013. Photo taken August 29, 2013. Downstream view from sample site D3.

The channel in lower Dome Creek had a mean channel and wetted widths of 1.3 m and 0.83 m, respectively (Photo 17). Mean residual pool depth was 0.33 m and mean bankfull depth was 0.41 m. The mean gradient of the stream in the area surveyed was 3.5%. Substrate in lower Dome Creek was dominated by fines, and accordingly specific substrate size measurements were not possible. The assessed channel had a riffle/run habitat distribution. Total cover in the area of Site D3 was estimated at 47%, consisting entirely of overstream vegetation. Crown closure was measured at 71-90%, consisting primarily of grass, shrubs, and mature conifer forest.

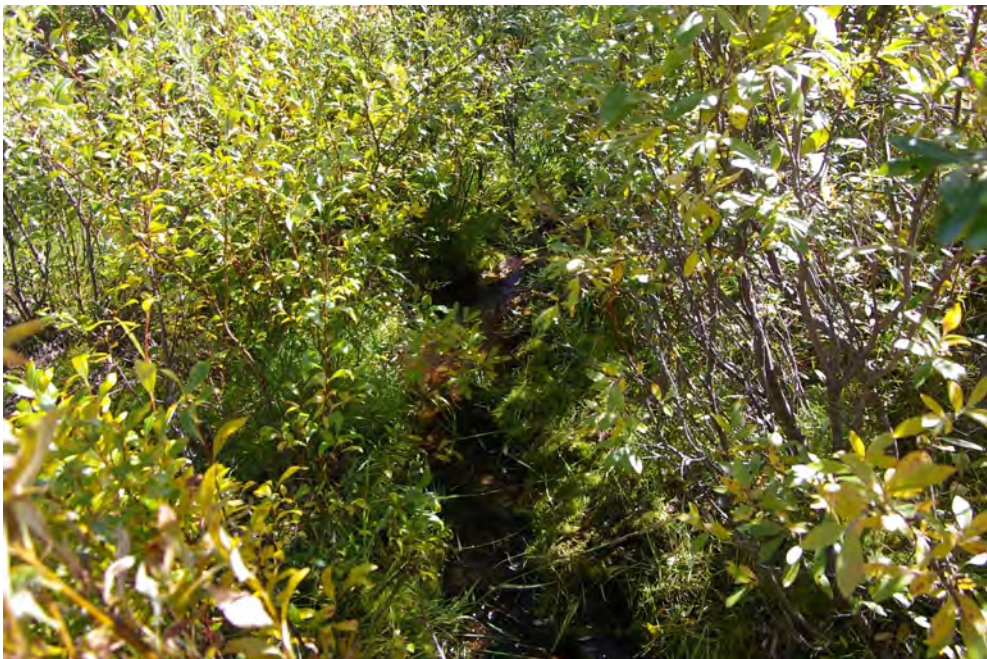
**Photo 18:** Representative photo of conditions of Pony Creek in in August of 2013. Photo taken August 28, 2013. Upstream view from sample site P1.

Upper Pony Creek was the narrowest stream inventoried during the 2013 assessment (Photo 18). In the area surveyed, Pony Creek had mean channel and wetted widths of 0.78 m and 0.42 m, respectively. Mean residual pool depth was 0.19 m and mean bankfull depth was 0.31 m. The mean gradient of the stream in the area surveyed was 4.5%. Substrate in upper Pony Creek was dominated by gravel and fines, with D95 and D measured to be 5 cm and 11 cm, respectively. The assessed channel had a riffle-pool habitat distribution. Total cover was estimated to be 65%, dominated by overstream vegetation (60%), small and large woody debris (2% each), and undercut banks (1%). Crown closure was measured at 41-70%, primarily grasses and tall shrubs.

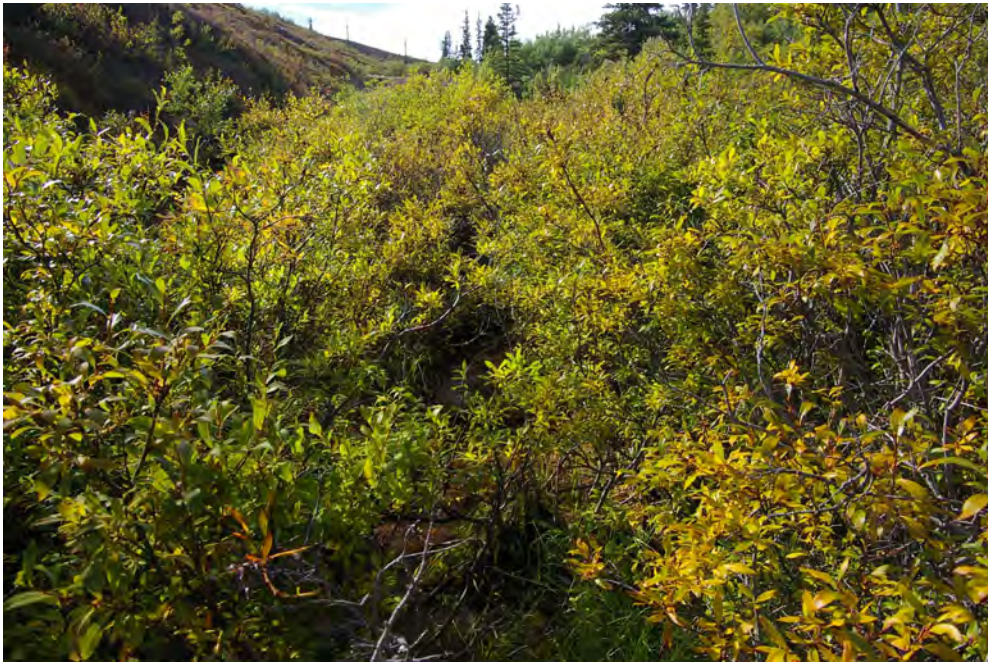
**Photo 19:** Representative photo of conditions of Pony Creek in August of 2013. Photo taken August 28, 2013. Upstream view from sample site P2.

Lower Pony Creek in the area surveyed had mean channel and wetted widths of 2.01 m and 0.74 m, respectively (Photo 19). Mean residual pool depth was 0.2 m and mean bankfull depth was 0.24 m. The mean gradient of the stream in the area surveyed was 6.25%. Substrate in lower Pony Creek was dominated by cobble and gravel, with D95 and D measured to be 4.5 cm and 10 cm, respectively. The assessed channel had a riffle-pool habitat distribution. Total cover was estimated to be 75%, dominated by overstream vegetation (70%), and undercut banks (5%). Crown closure was measured at 21-40%, primarily grasses and tall shrubs.

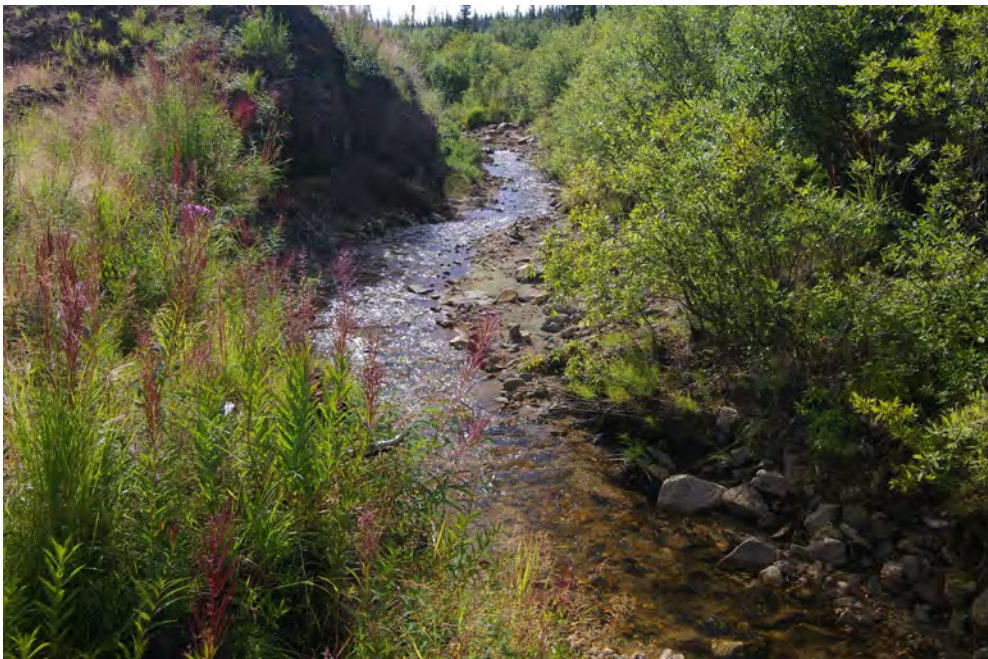
**Photo 20:** Representative photo of conditions of Back Creek in August of 2013. Photo taken August 22, 2013. Upstream view from sample site B1.

Back Creek at Site B1 had mean channel and wetted widths of 2.75 m and 1.44 m, respectively (Photo 20). Mean residual pool depth was 0.09 m and mean bankfull depth was 0.43 m. The mean gradient of the stream in the area surveyed was 4.1%. Substrate in lower Pony Creek was dominated by cobble and gravel, with D95 and D measured to be 10 cm and 18 cm, respectively. The assessed channel had a mostly riffle habitat distribution. Total cover was estimated to be 3%, consisting of overstream vegetation (3%) and undercut banks (<1%). Crown closure was measured to be between 0% and 20%, consisting of grasses and tall shrubs. The overall fish habitat value in upper Back Creek was considered to be poor due to low cover availability and homogeneous habitat features.

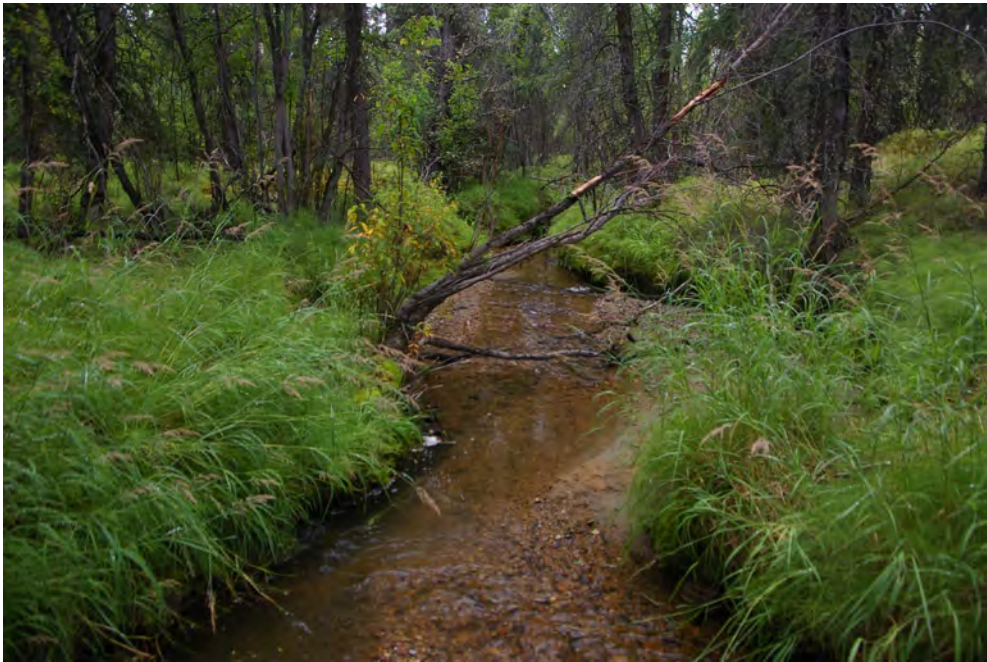
**Photo 21:** Representative photo of conditions of Back Creek in in August of 2013. Photo taken August 21, 2013. Upstream view from sample site B2.

Back Creek at Site B1 had mean channel and wetted widths of 1.6 m and 1.1 m, respectively (Photo 21). Mean residual pool depth was 0.16 m and mean bankfull depth was 0.43 m. The mean gradient of the stream in the area surveyed was 2.6%. Substrate in lower Back Creek was dominated by gravel and sand, with D95 and D measured to be 3.5 cm and 9 cm, respectively. Total cover was estimated to be 41%, consisting of overstream vegetation (35%), small woody debris (2%), and large woody debris (<1%). Crown closure ranged from 71-90%, consisting of grass, shrubs, and mature conifer forest. *In-situ* water quality results revealed higher conductivity in lower Back Creek compared to upper Back Creek (376.4 to 761  $\mu\text{scm}^{-1}$ ). Other water quality variables were found to be similar. The overall fish habitat value in lower Back Creek was considered to be good due to high cover availability and heterogeneous habitat features.

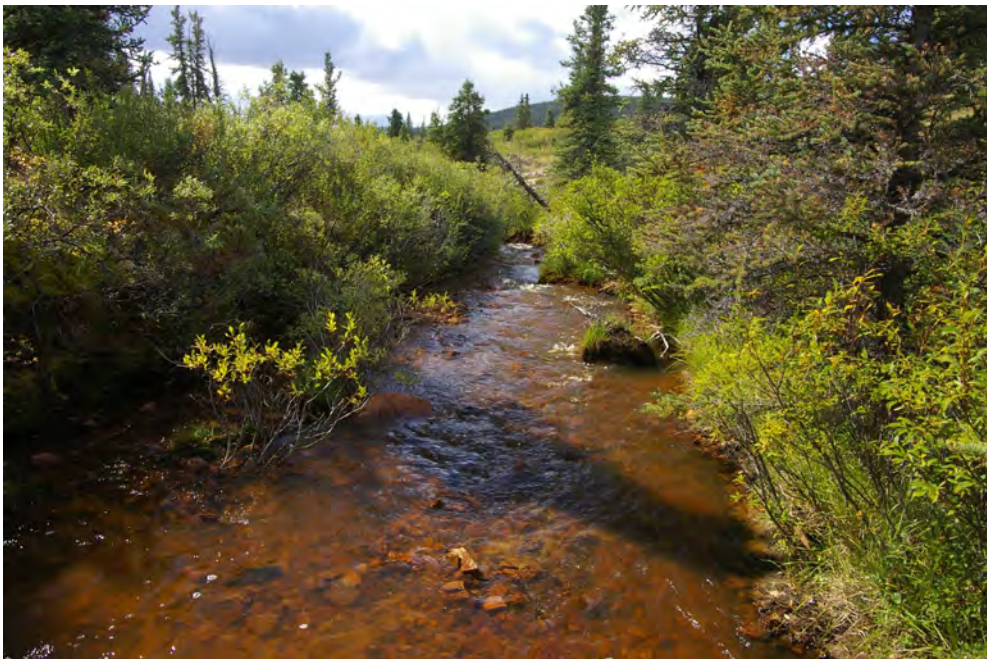
**Photo 22:** Representative photo of conditions of Minnesota Creek in in August of 2013. Photo taken August 22, 2013. Downstream view from sample site M1.

Minnesota Creek at Site MI had mean channel and wetted widths of 3.13 m and 2.28 m, respectively (Photo 22). Mean residual pool depth was 0.22 m and mean bankfull depth was 0.34 m. The mean gradient of the stream in the area surveyed was 2.8%. Substrate at of Minnesota Creek was dominated by cobble and sand, with D95 and D measured to be 10 cm and 16 cm, respectively. Total cover was estimated to be 27%, dominated by overstream vegetation (25%), and with some large and small woody debris (one % each). Crown closure was measured to range from 1-20%, consisting primarily of grass, shrubs, and mature conifer forest. The overall fish habitat value of Minnesota Creek was considered to be poor due to low visibility from the presence of fine sediment likely caused by metal precipitate, and poor habitat availability due to partly to embedded substrates.
