# **Mount Nansen Care and Maintenance Project**

## **Project Proposal**

**April 3, 2018**

**Government of Yukon  
Energy, Mines and Resources  
Assessment and Abandoned Mines**

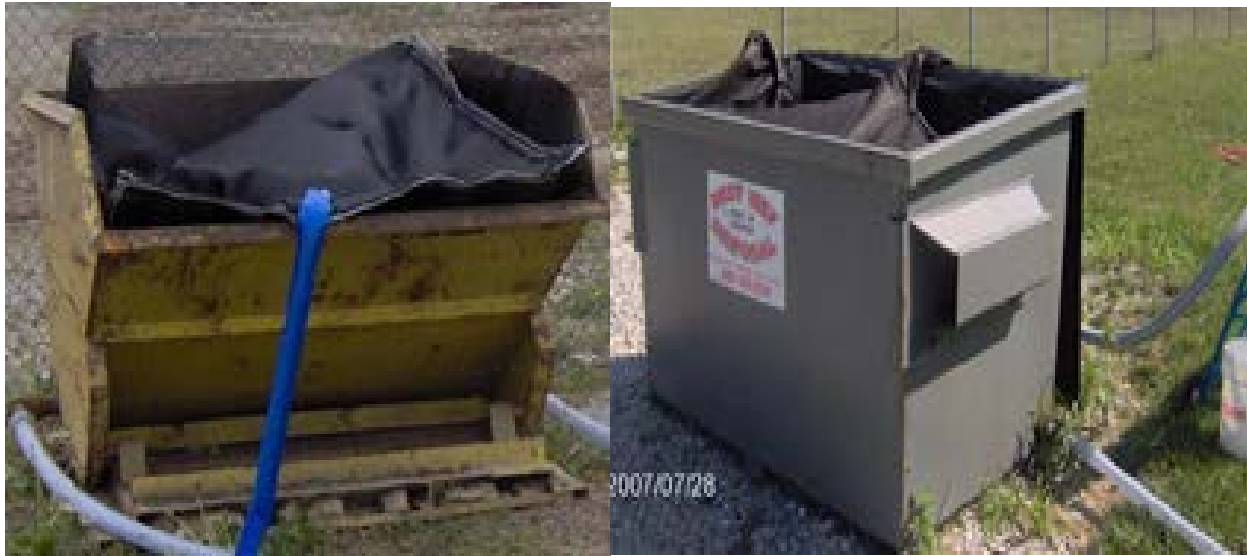
**Figure 5.1-5: Waste Disposal Hoppers for Geotube® solids (from J. Dallaire, personal communication, March 20, 2017)**

Approximately 22 Geotube<sup>®</sup> bags will be filled with WTP solids per year (approximately 1 each 17 days). Following solids dewatering and drying, filled Geotube<sup>®</sup> bags will be transported (either with or without the hopper) to the TSF using a forklift, and deposited within the dedicated management area located within the TSF. Based on the estimated solids production rate, Geotube<sup>®</sup> bag filling and exchange will take place approximately once every two weeks. Over four years of sludge production, an estimated Geotube<sup>®</sup> management area of 400 m<sup>2</sup> will be required, unless Geotubes<sup>®</sup> are to be stacked for the optimization of space.

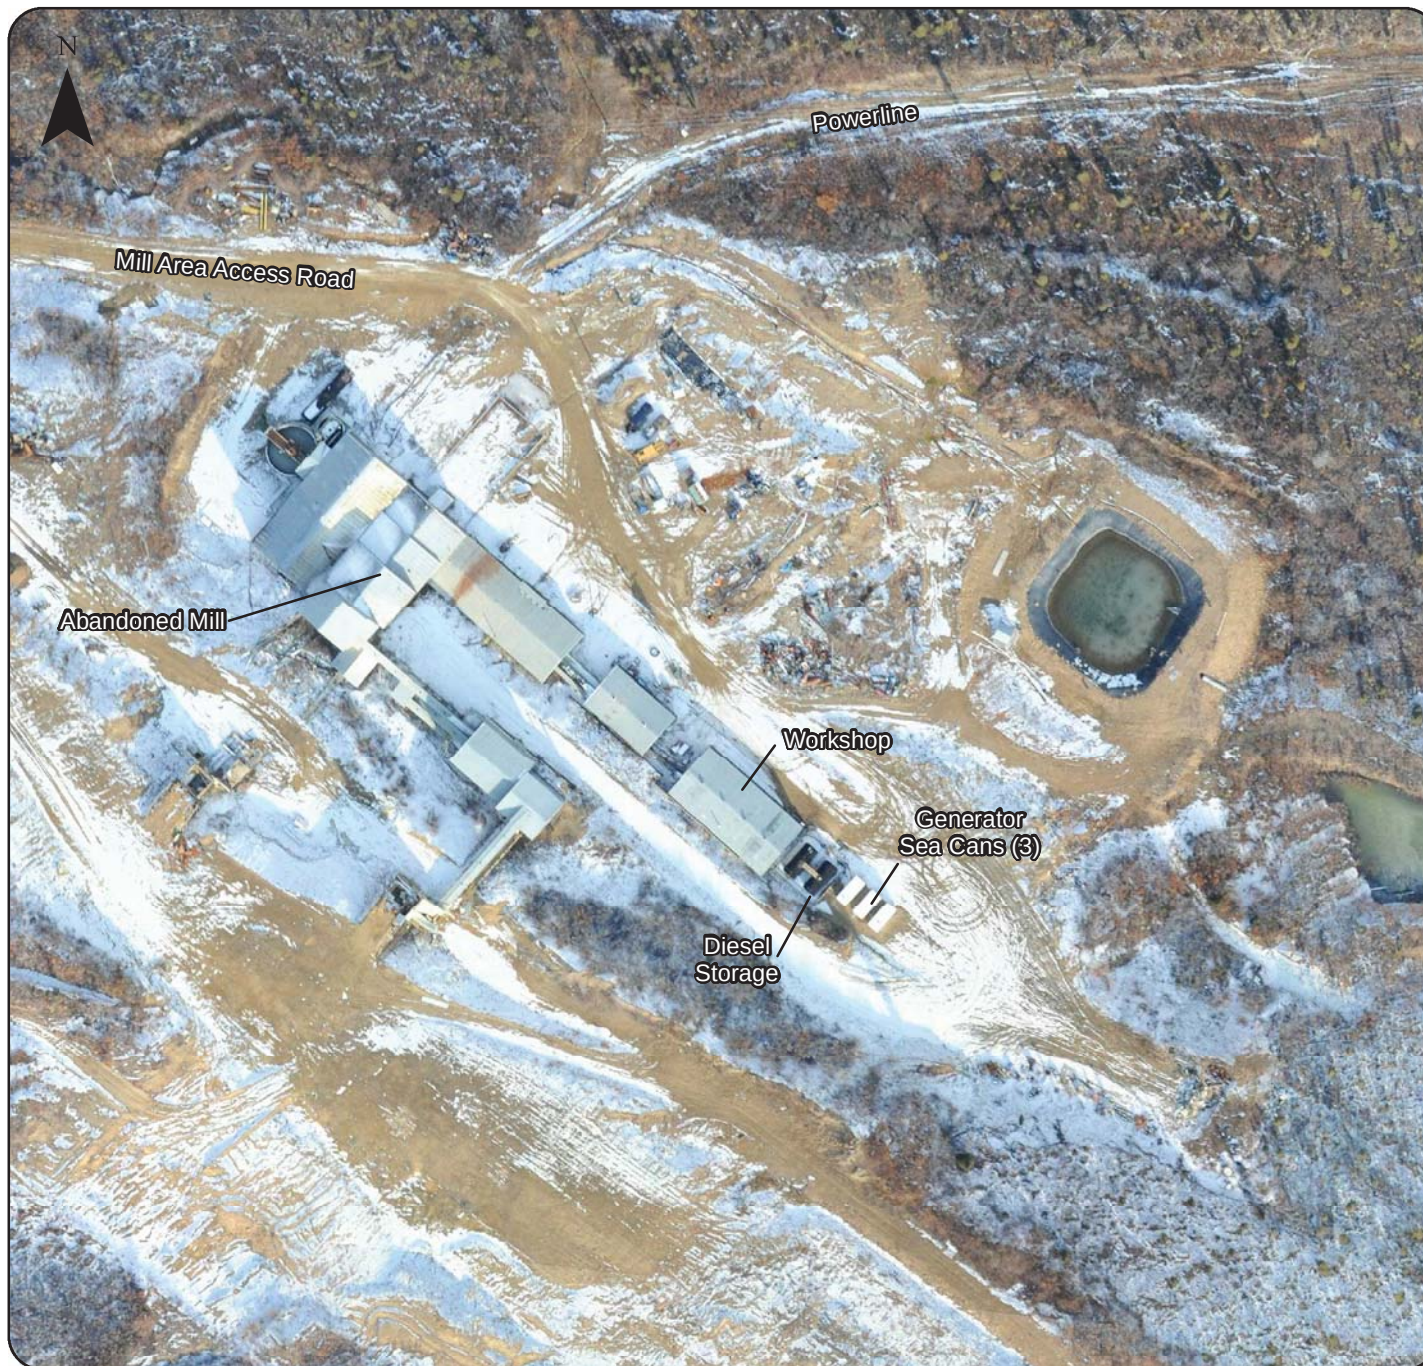
Figure 5.2-1

Diesel is used to power the generators on-site, as well as fuel the heavy equipment used to complete daily Site operations tasks. There are two aboveground single-walled steel 49,000 L storage tanks located beside the workshop (Figure 5.2-1) and the tanks are situated within a secondary concrete containment area. The storage tanks supply diesel directly to the generators as well as to a heater in the workshop. The storage tanks are also connected to a diesel pump that is used for fueling equipment.

Waste oil and other fluids (e.g., hydraulic fluid, antifreeze) from the generators and equipment are stored on-site within a dedicated containment area adjacent to the generator sea-cans (Figure 5.2-1). Waste fluids (e.g., engine oil) are transported to Whitehorse for disposal at a permitted facility when volumes on-site are between approximately 140 L to 180 L.

The Site is equipped with two 175 kW primary generators that are run separately to provide power to all areas of the Site. The generators are located in sea can containers adjacent to the workshop (Figure 5.2-1). The electrical distribution system consists of several kilometres of overhead power line as well as a variety of transformers, breakers and switching systems. Electricity is generated at 480 volts and transformed up to 4,160 volts for distribution around the Site. The generators will be inspected at least twice daily (e.g., for appropriate fluid levels). Once a generator has run its determined cycle (i.e., approximately 500 hours), it will be powered down and the other generator will be put on-line to provide power to the Site. All regular maintenance (e.g., oil changes, oil filter changes, belt changes, replacement of batteries, etc.) will be completed by Site operations personnel. All maintenance recommendations and schedules supplied by the manufacturer will be followed to ensure reliable service from the generators. An additional 175kW back-up generator is also located in a sea can and is available for use if and when both primary generators are not working. A power failure alarm is installed to notify Site operations personnel of any power failures, including a module located on the second floor of the bunkhouse to notify Site operations personnel of a power failure should it occur at night. Emergency response and contingency procedures to be implemented in the event of a power outage are detailed in the Mount Nansen Site Operations Emergency Response Plan (see Appendix 5E).

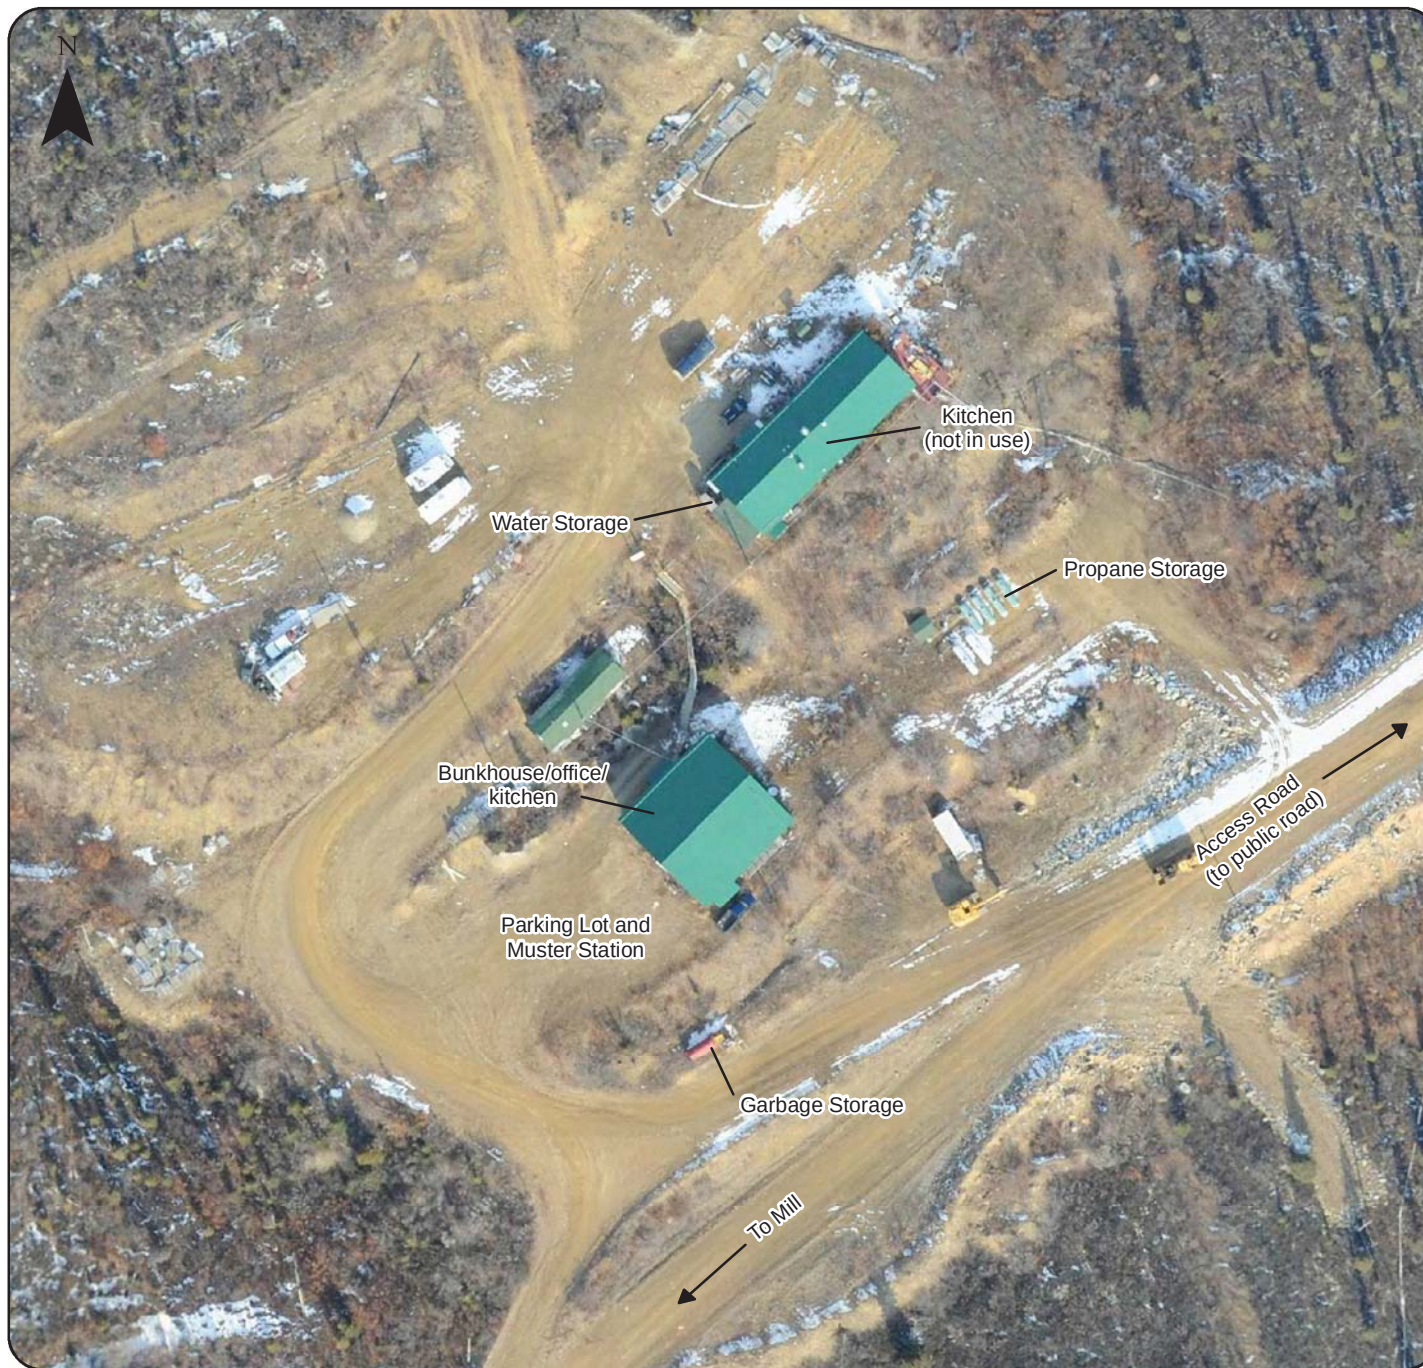
Figure 5.2-2

Gasoline is used to power some of the light vehicles/equipment necessary to carry out Site operations. The gasoline storage tank is located adjacent to the bunkhouse and is an aboveground double-walled steel storage tank with a capacity of 4,500 L (Figure 5.2-2).

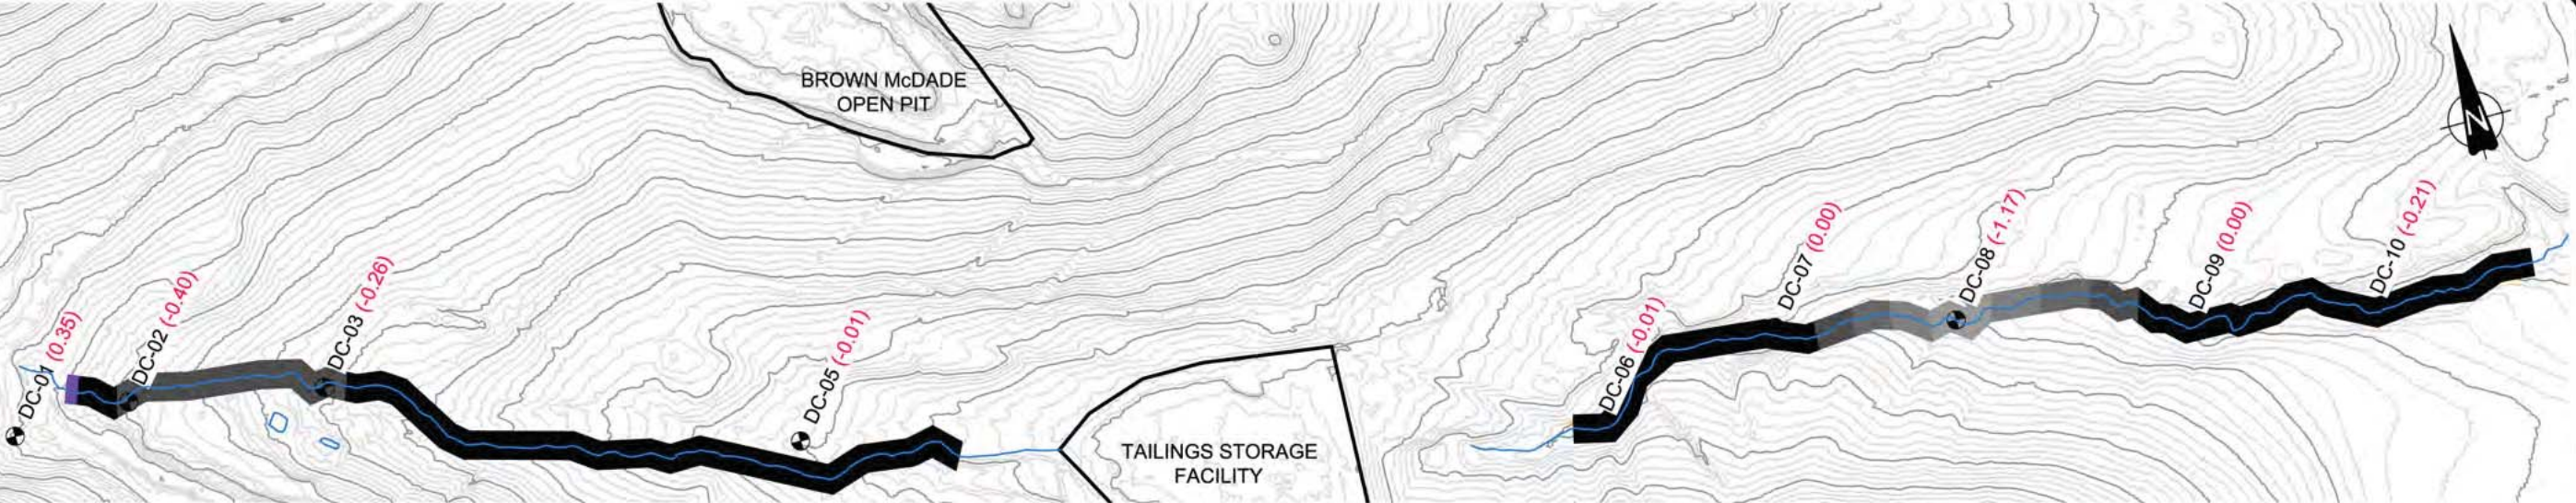
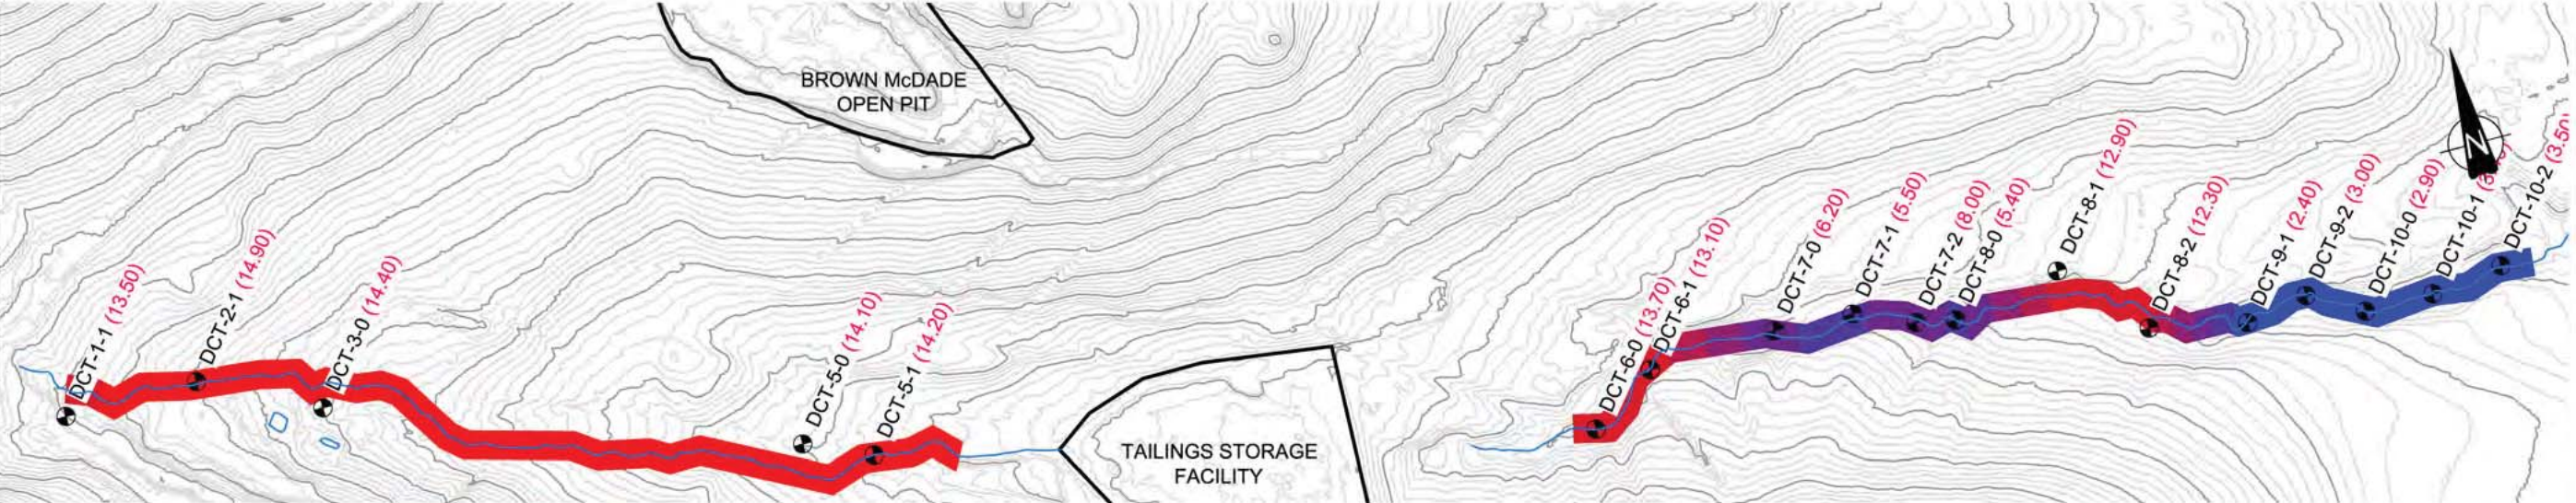
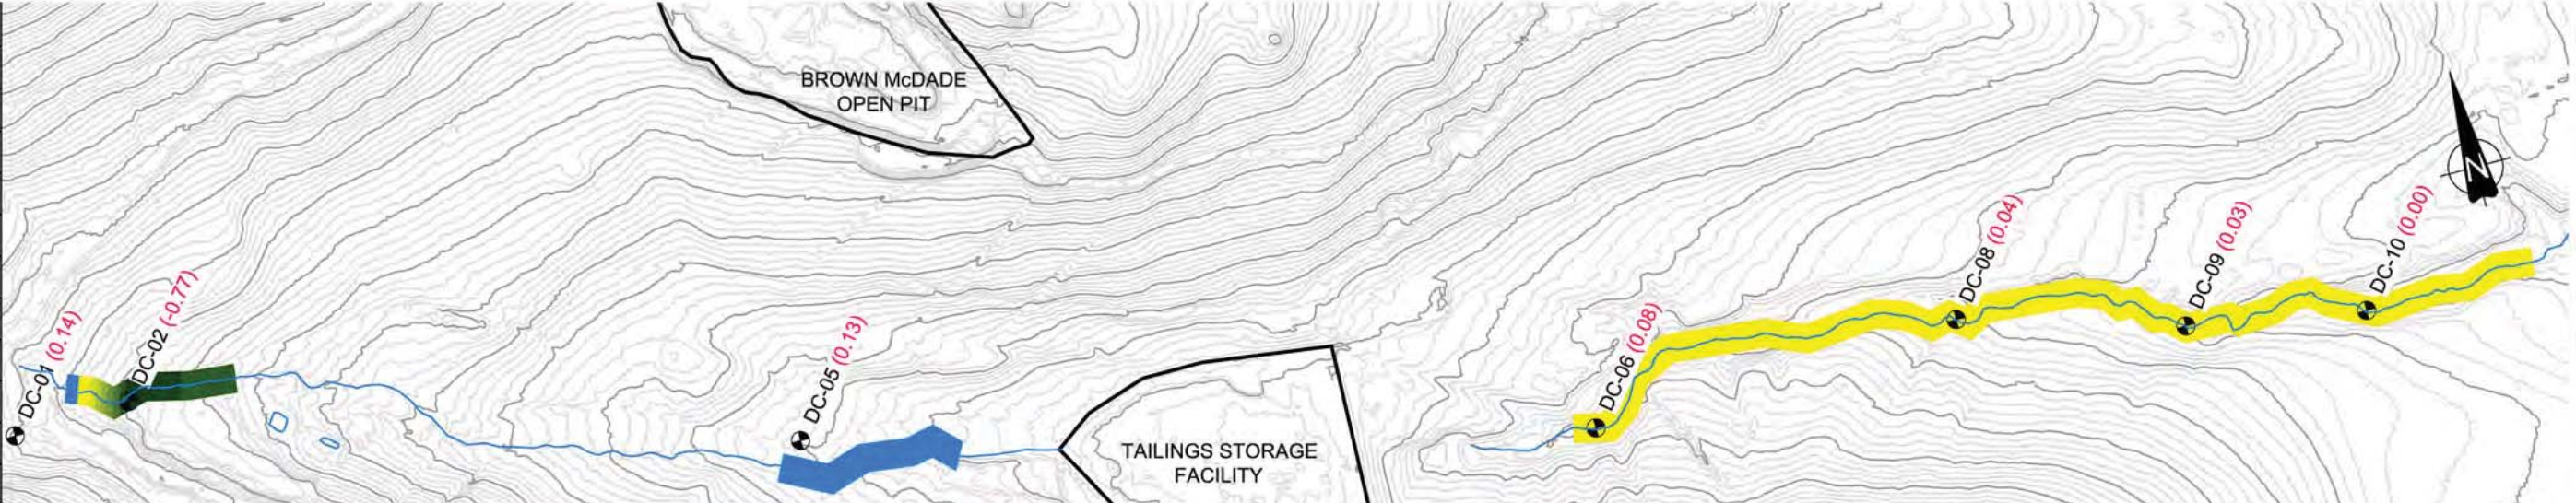
Both Dome and Pony creeks demonstrated a pattern of low, positive gains from groundwater. One notable exception was a reach of Dome Creek near the Huestis Adit, which had the most negative seepage rate (loss) from Dome Creek (Figure 6.7-3 and Figure 6.7-4).

**Comments:**  
Vertical gradient - positive indicates upwards flow at the creek bed; and  
- negative indicates downwards flow at the creek bed.  
Seepage flow - positive indicates groundwater entering creek; and  
- negative indicates groundwater leaving creek

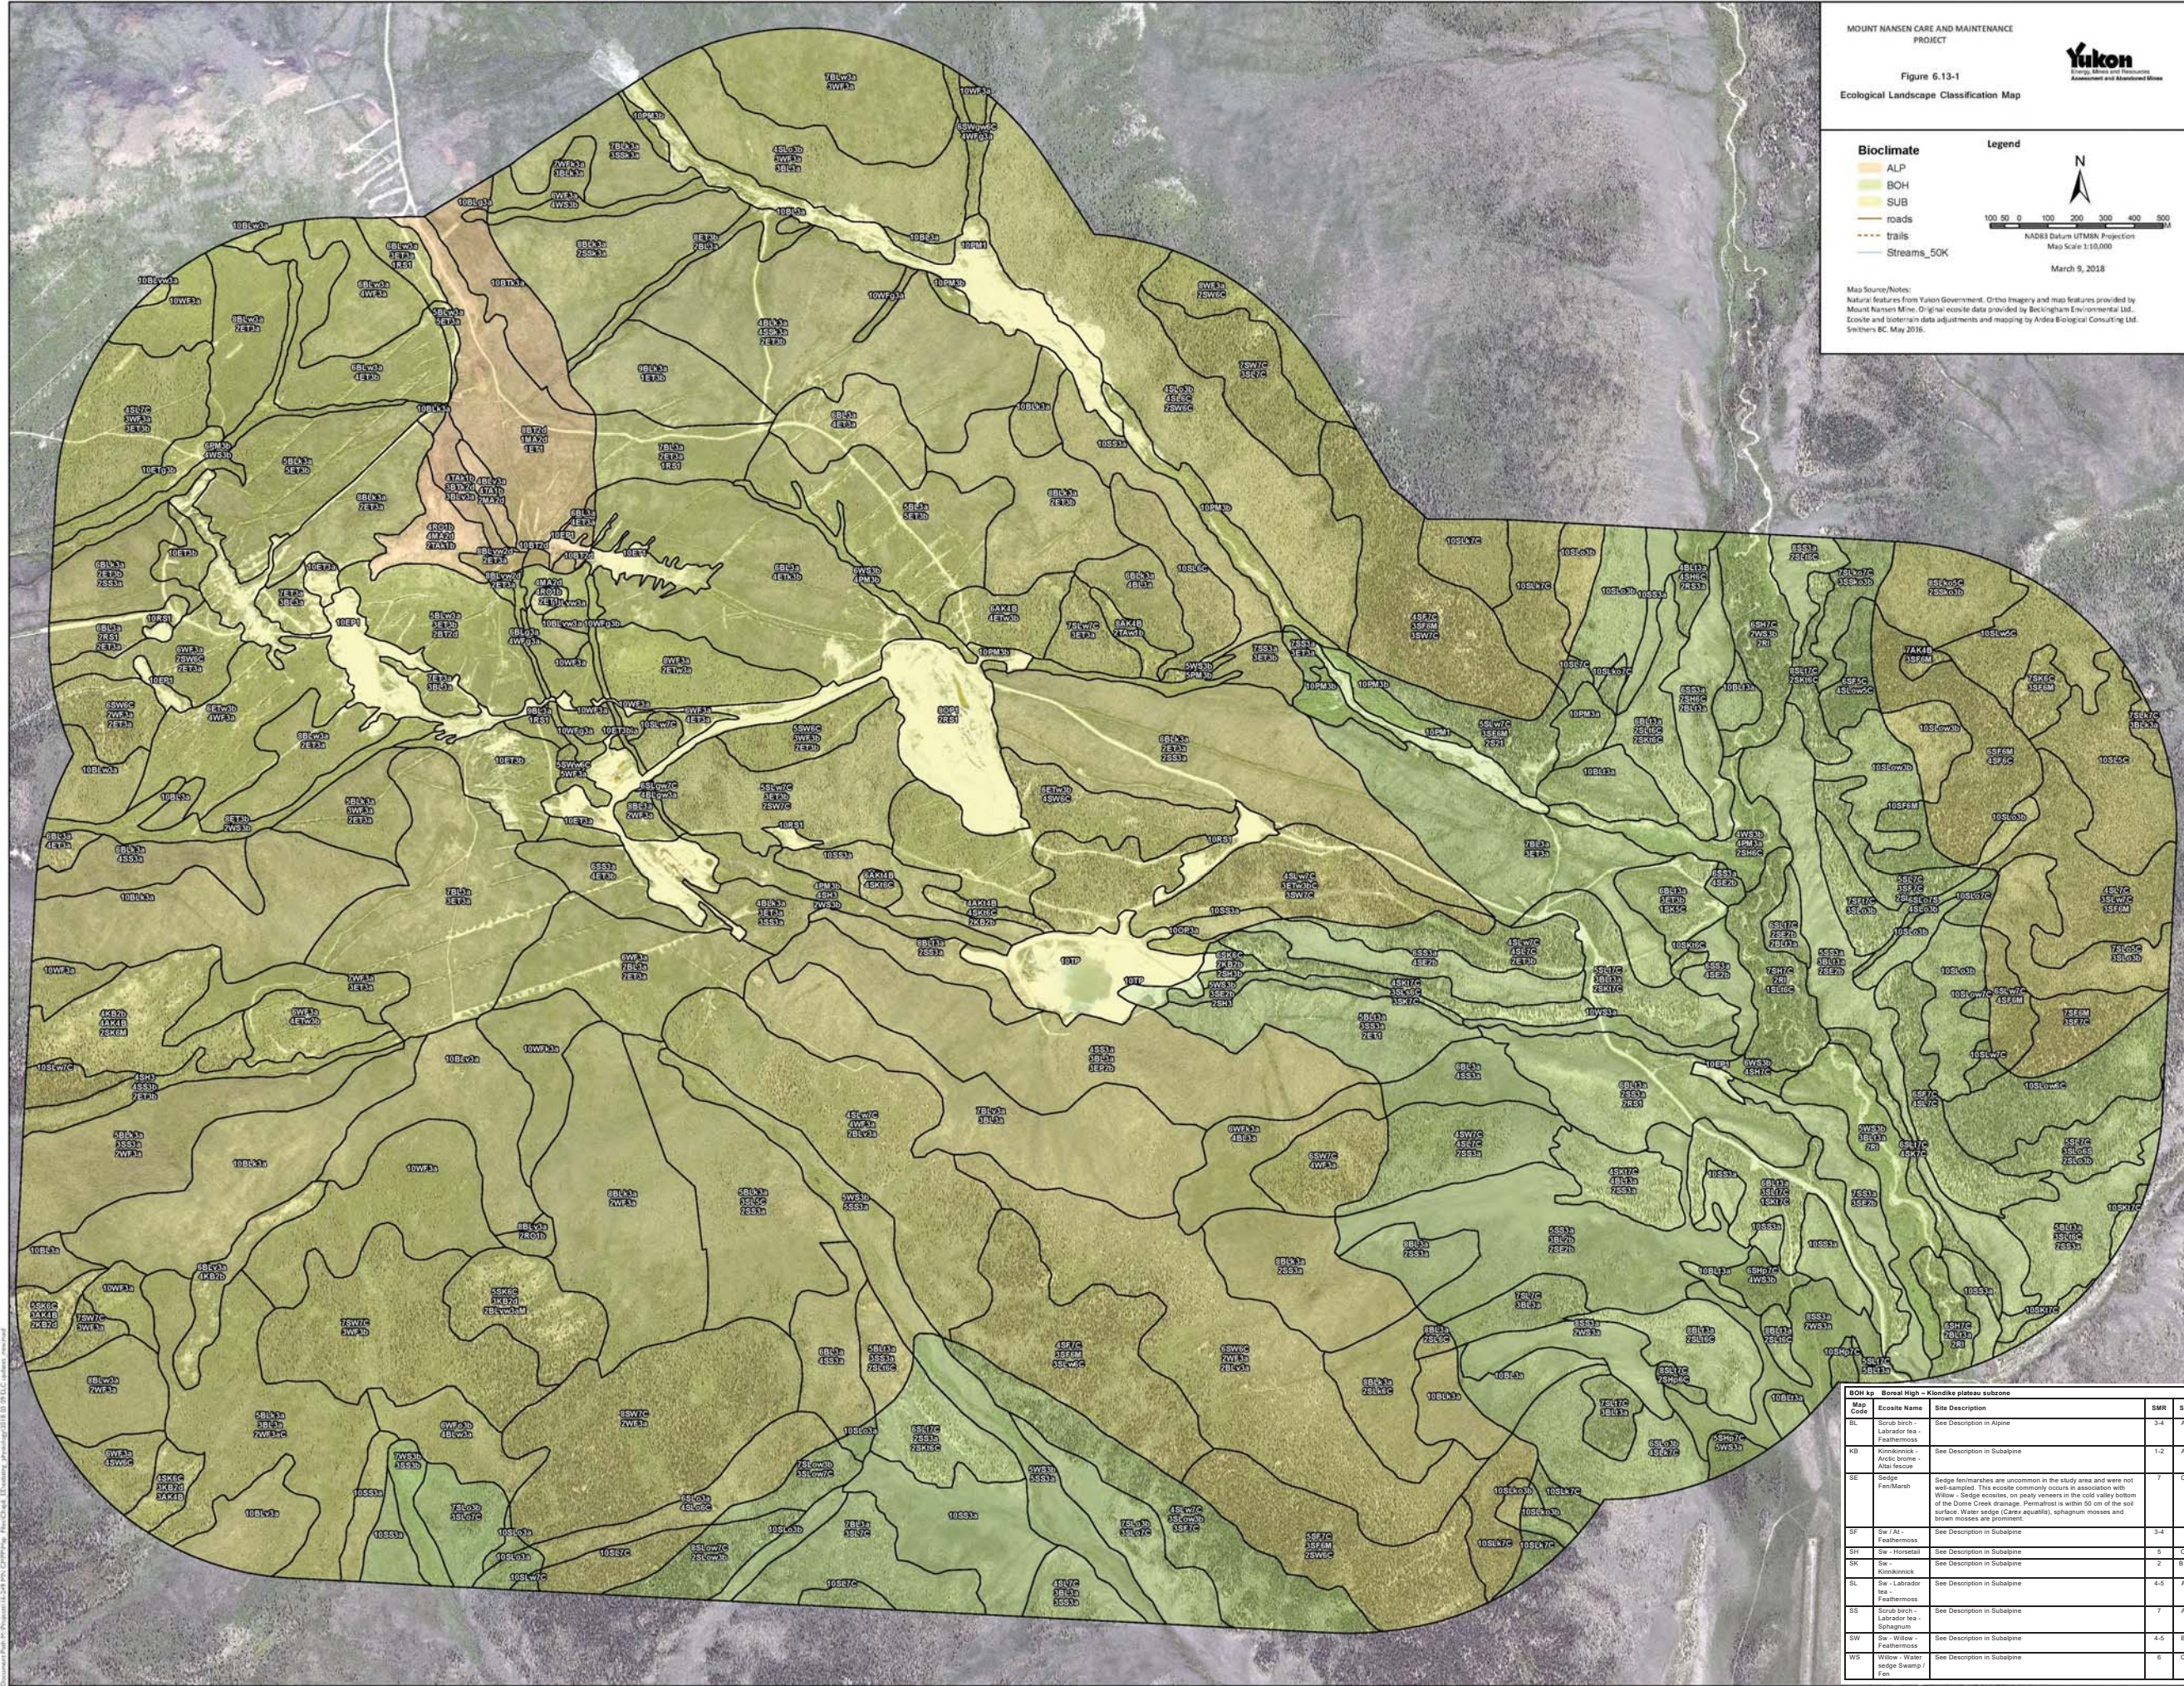
Figure 6.13-1  
Ecological Landscape Classification Map

The Ecological Landscape Classification (ELC) program completed between 2012 and 2014 identified three bioclimate zones in the LSA: 1) boreal high; 2) subalpine; and 3) alpine (ELR 2016; Figure 6.13-1). The boreal high is the largest bioclimate zone in the LSA, occurring in mountain valleys and plateaus from approximately 450 meters above sea level (masl) to 1,100 masl. This zone consists largely of coniferous and mixed wood forest associations influenced by frequent fires. The subalpine zone occurs at elevations above the boreal high, occurring between 1,100 masl and 1,500 masl. Trees are more sparse in these areas, with shrub associations becoming more common. The alpine zone consists of non-forested landscapes found in the highest elevations of the LSA, above 1,500 masl. The three bioclimate zones identified in the ELC program were further delineated into major landscape types made up of ecosites. Ecosites are determined by a number of factors, including the dominant tree, shrub, herb and non-vascular plant species that occur within the LSA and also include non-vegetated land cover types (e.g., anthropogenic land cover such as mining related terrain and roads). Figure 6.13-1: Ecological Landscape Classification Map and Table 6.13-1 presents a summary of the ecosites within the LSA.

The Scrub birch - Labrador tea - Feathermoss was the most common ecosite mapped within the LSA, making up approximately 30% (915 ha) of the total area and occurring primarily within the Subalpine bioclimate zone. The next most common ecosite was the White spruce - Labrador tea - Feathermoss upland forest type, which made up almost 18% (552 ha) of the LSA, split almost evenly between the Subalpine and Boreal High bioclimate zones. Wetland types were also quite common within the LSA, making up almost 13% (390 ha) of the total area, and Scrub birch - Labrador tea - Sphagnum ecosite making up almost 10% of the LSA (308 ha).

Anthropogenic ecosites are a relatively high proportion of the LSA, making up over 14% (444 ha) of the area. The most extensive anthropogenic type was the Exploration Trenching ecosite, comprising almost 9% (273 ha) of the Mount Nansen LSA.
