REPORT NO. 118027/2

**FINAL REPORT - PHASE 2 DRILLING PROGRAM, NFRC REACH,
FARO MINE, YT**

Assessment and Abandoned Mines, YG

January 2015

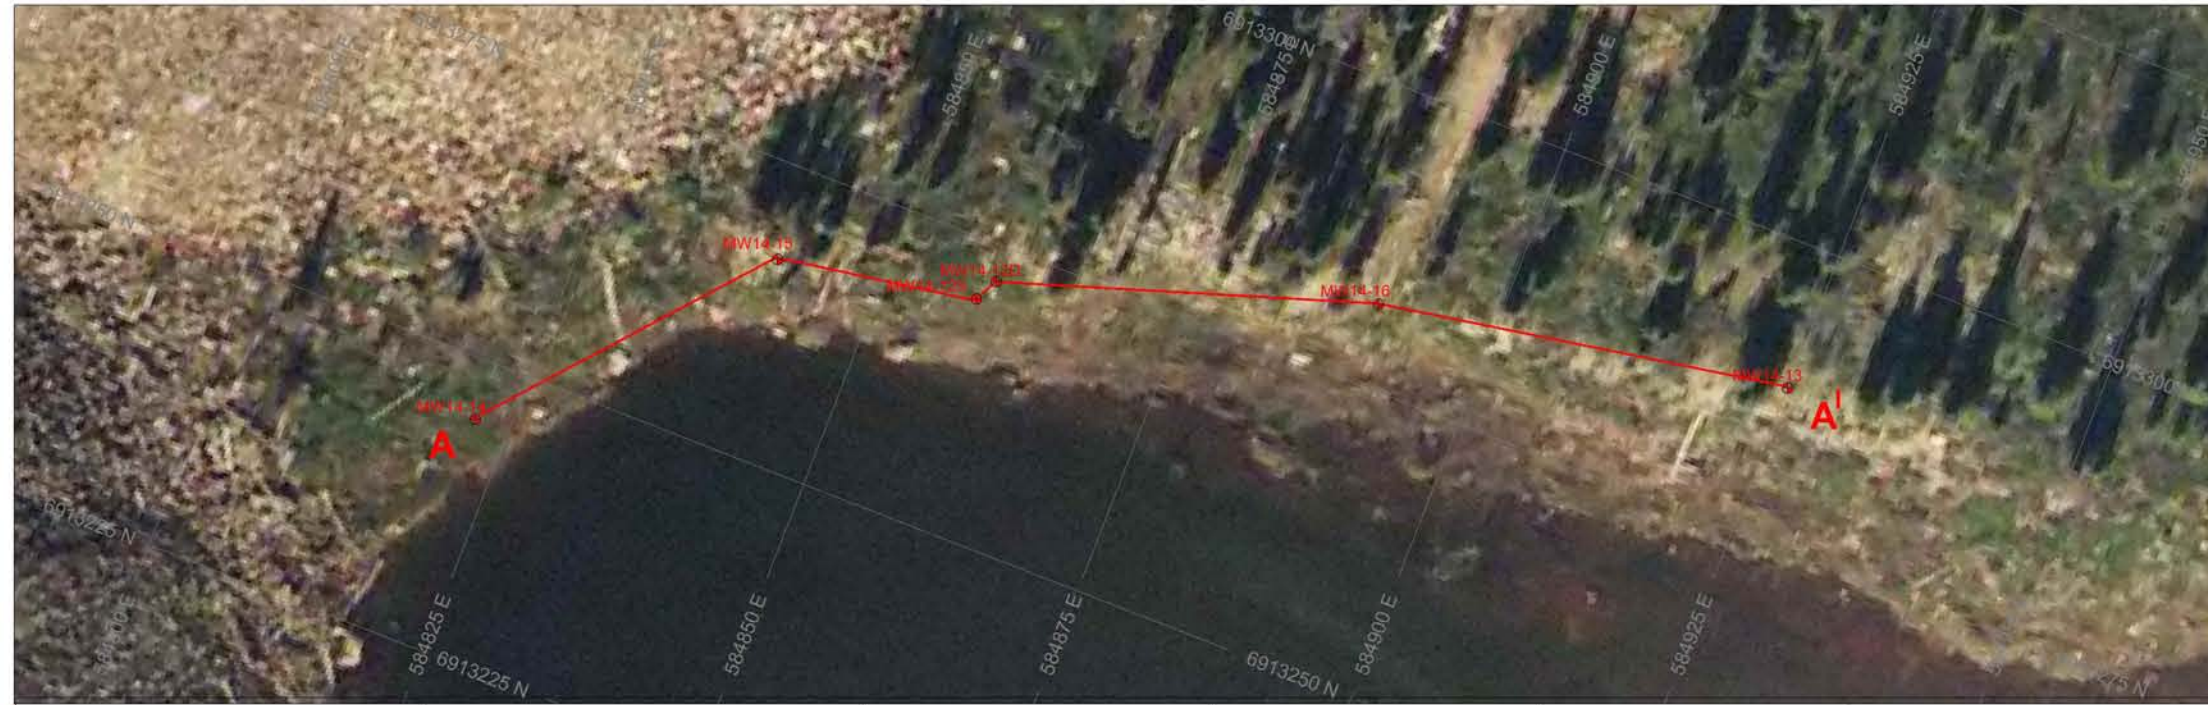
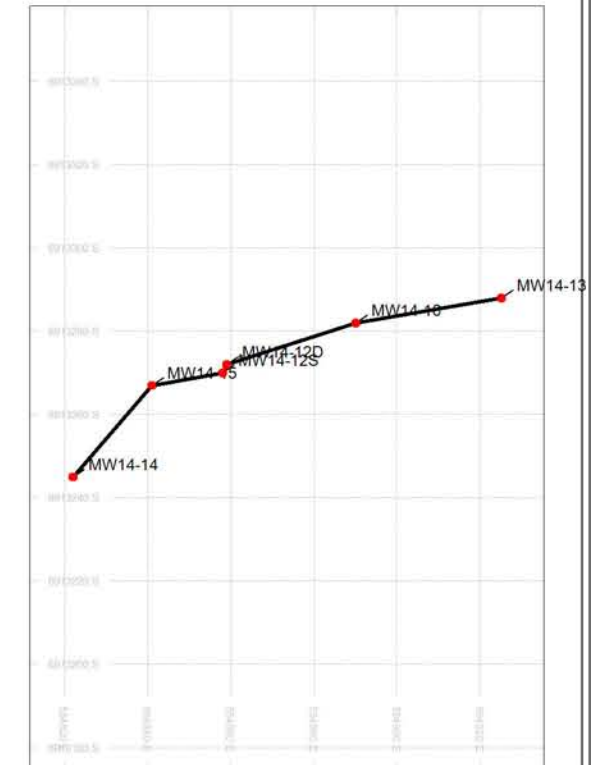
Figure: 3 - 2

MW14-14	MW14-15	MW14-12S	MW14-12D
MW14-16	MW14-13

topography was used to develop several hydrostratigraphic sections across the study area (Figure 3-2 to 3-5). The alignment of these sections in plan view is also shown in Figure 3-1.

The static groundwater levels observed on July 28, 2014 in the various wells and the inferred groundwater level contours are shown in Figure 3-6. Geodetic groundwater levels are also shown on the cross-sections depicted on Figures 3-2 to 3-5.

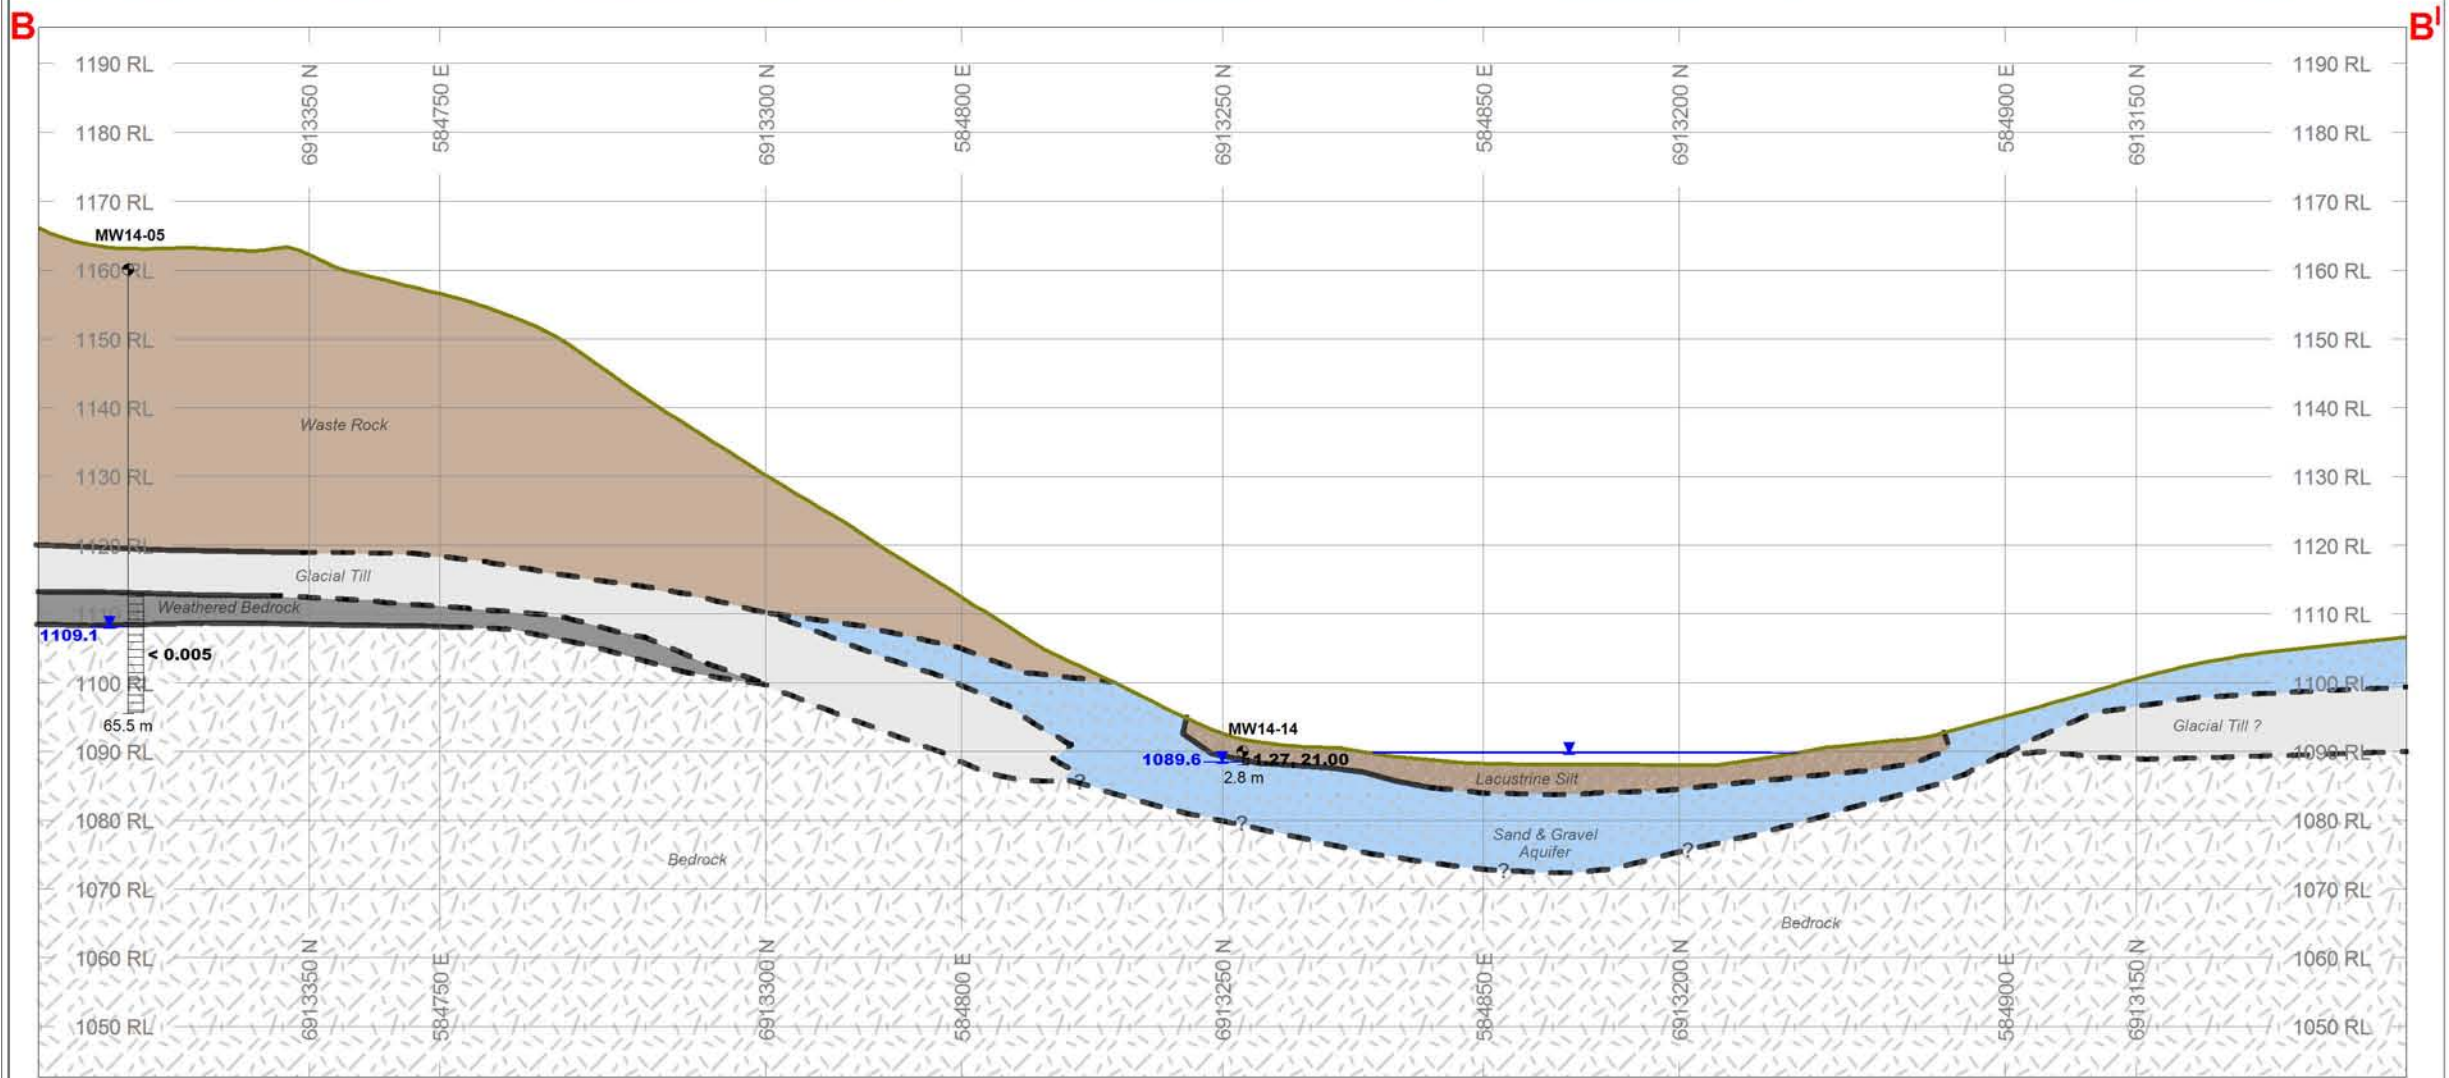
Figure: 3 - 3

REF. PT. E, N	584825 m	6913250 m
EXTENTS	344.5 m	152.7 m
SECTION TOP, BOT	1195 m	1043 m
TOLERANCE +/-	50 m

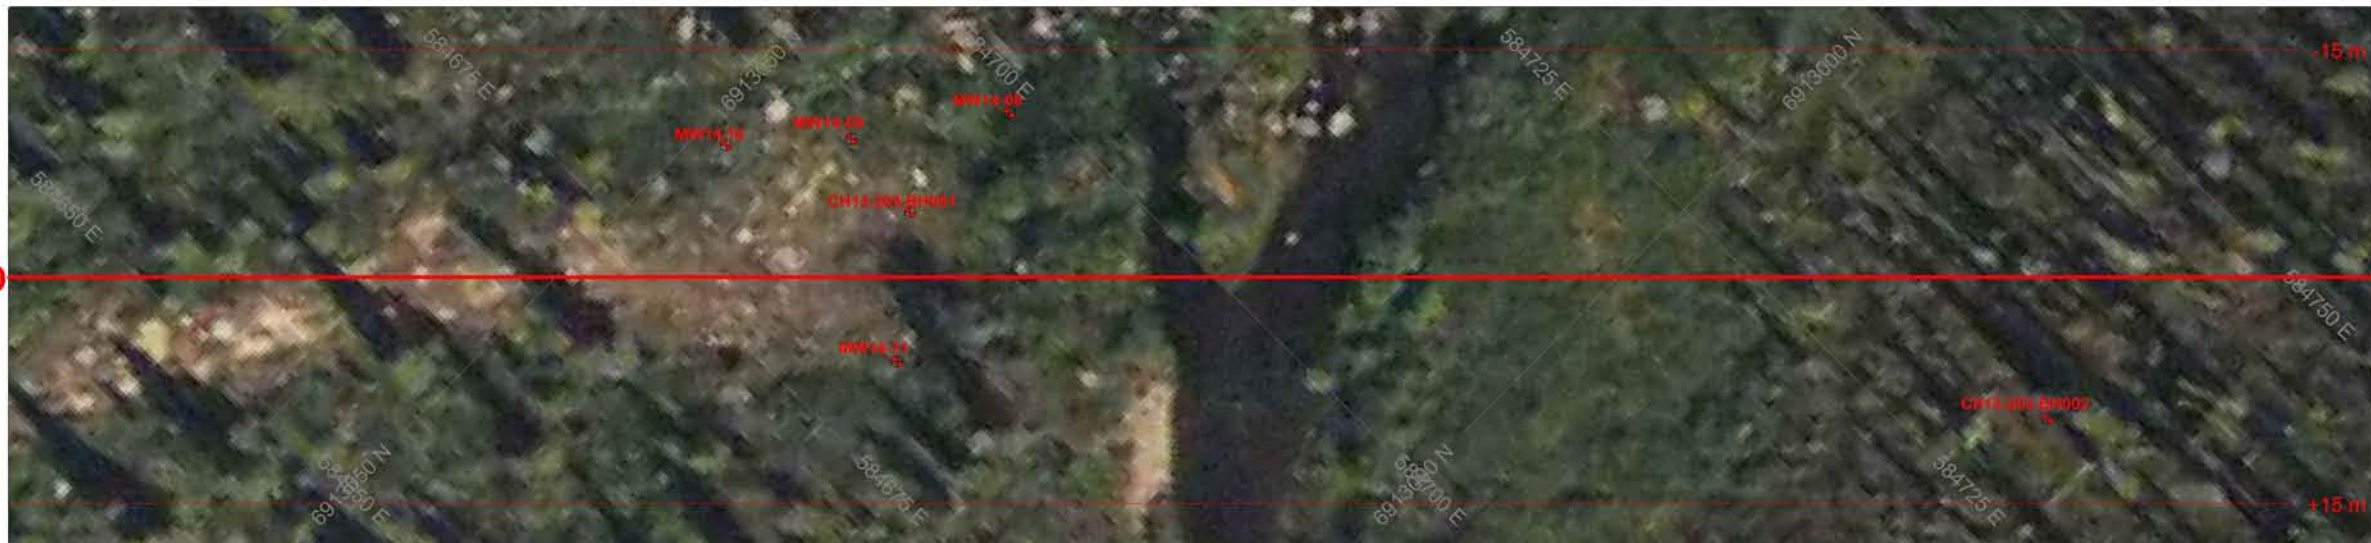
Figure: 3 - 4

Figure 3-4 shows the inferred hydrostratigraphy observed across the NFRC valley in the NF2A area immediately downstream of the rock drain. Note that the inferred stratigraphy for the deeper sediments in this area is primarily based on the two geotechnical holes drilled in 2013 by CH2MHill. According to those drill logs the fine-grained, low permeability surficial sediments are underlain by a more permeable well graded sand and gravel unit with +/- 5% silt (similar to the unit observed upgradient of the rock drain). The depth to bedrock in this area ranges from about 10-11m below ground surface on the west side of NFRC to ~7-8m on the east side of NFRC.

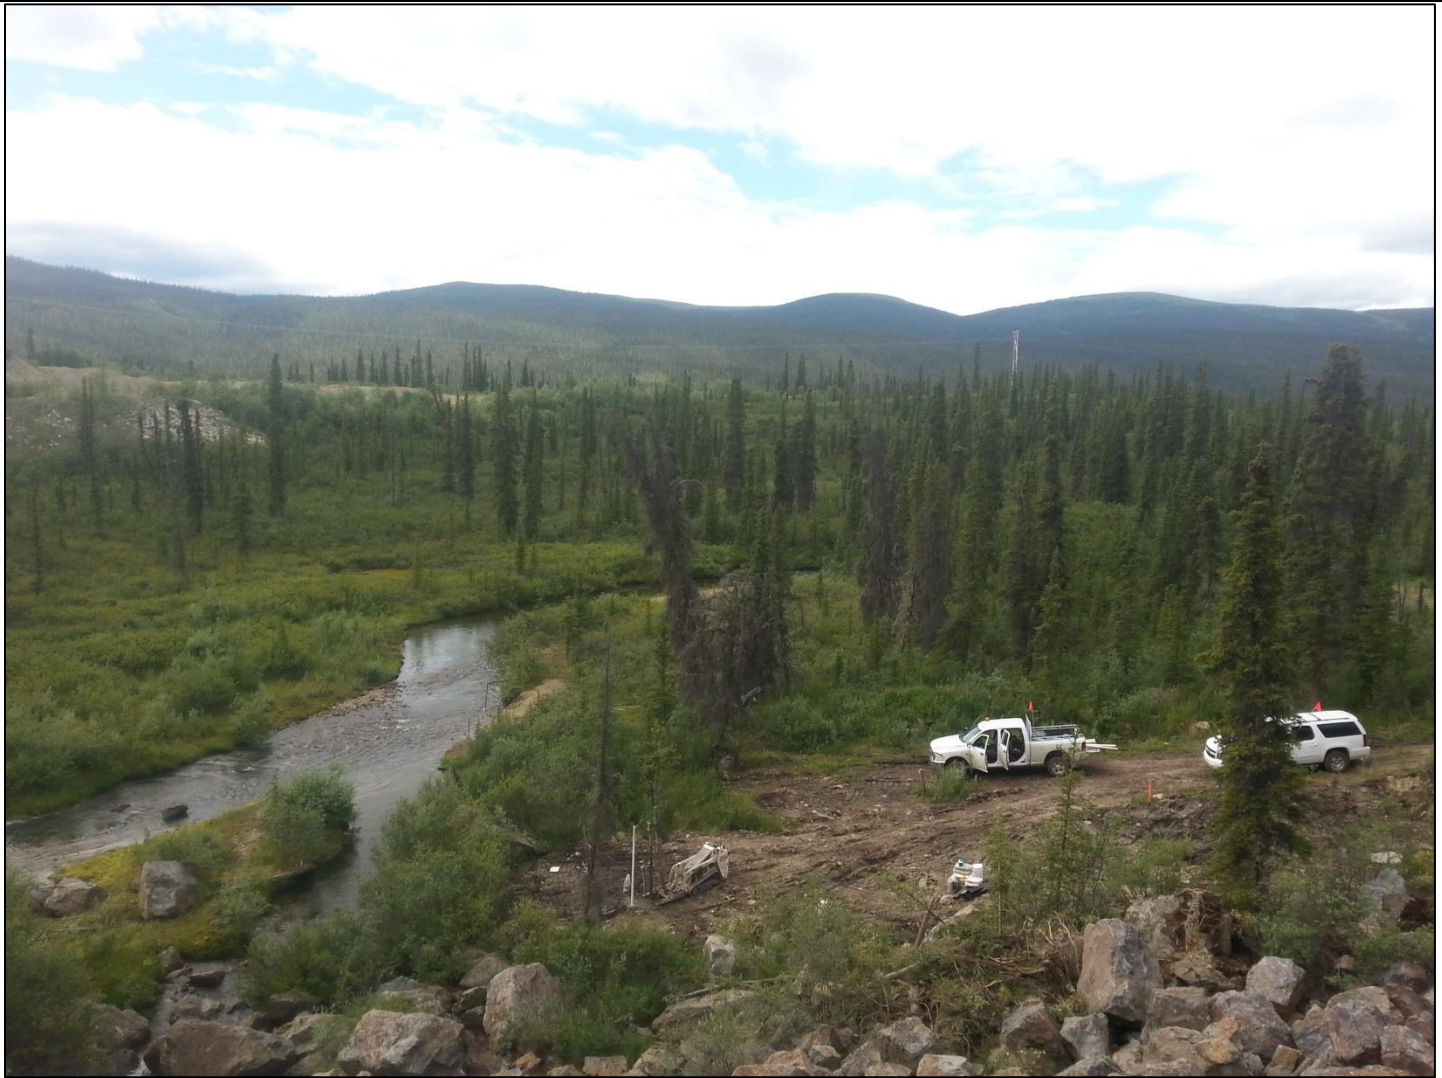
Photo A1: Drill area on the downstream side of the rock drain. The drill is visible near the bottom center of the picture at MW14-08.

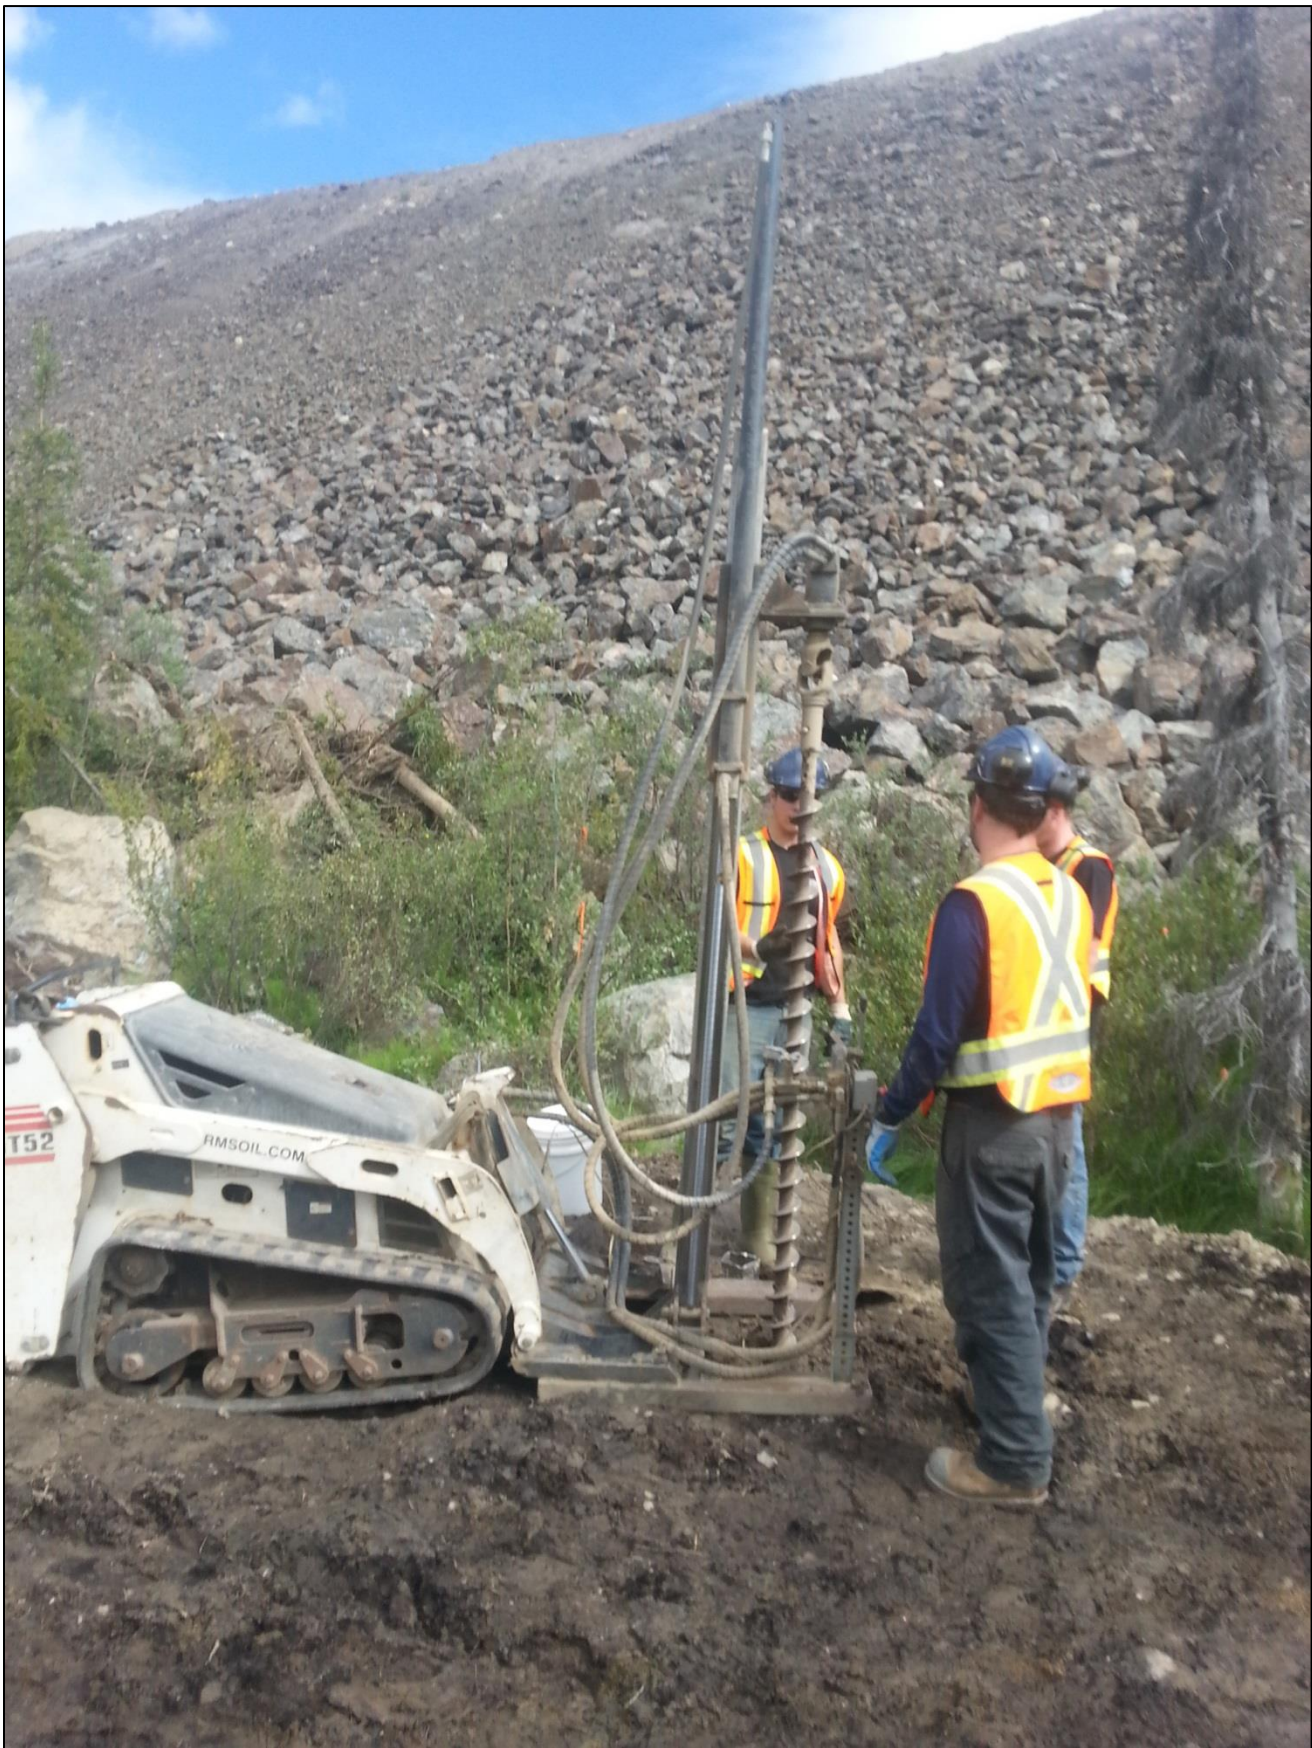
Photo A2: The drill at MW14-08, set up to drill with solid stem auger and preparing to insert the first auger flyte into the ground. The drill is powered with hydraulics from the modified Bobcat.

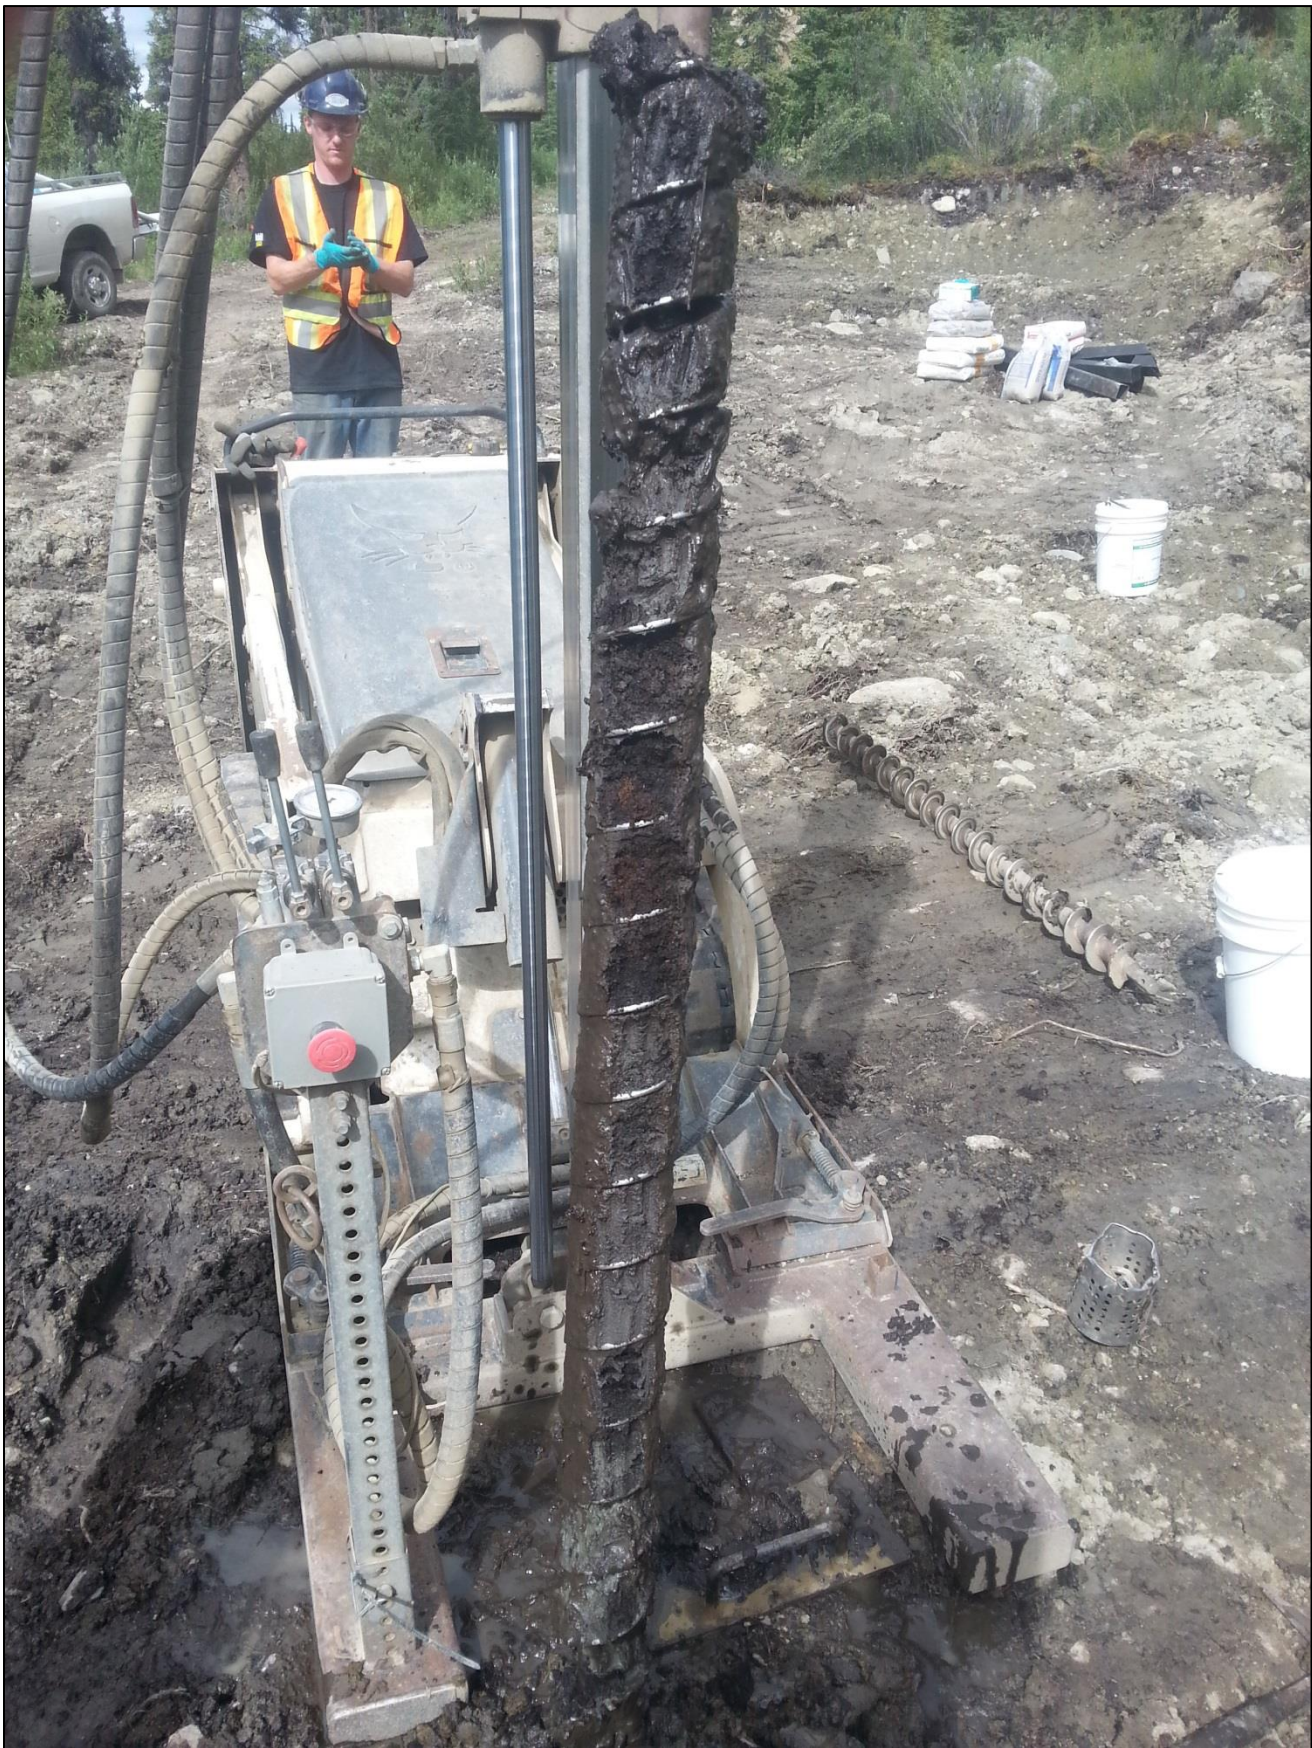
Photo A3: Sediment retrieved on auger flyte at MW14-08 (5-10 ft depth). The auger is screwed into the ground and then lifted straight out of the borehole, causing the sediment to stay in the grooves. The borehole is left unsupported and thus solid stem augers are only suitable in cohesive soils.

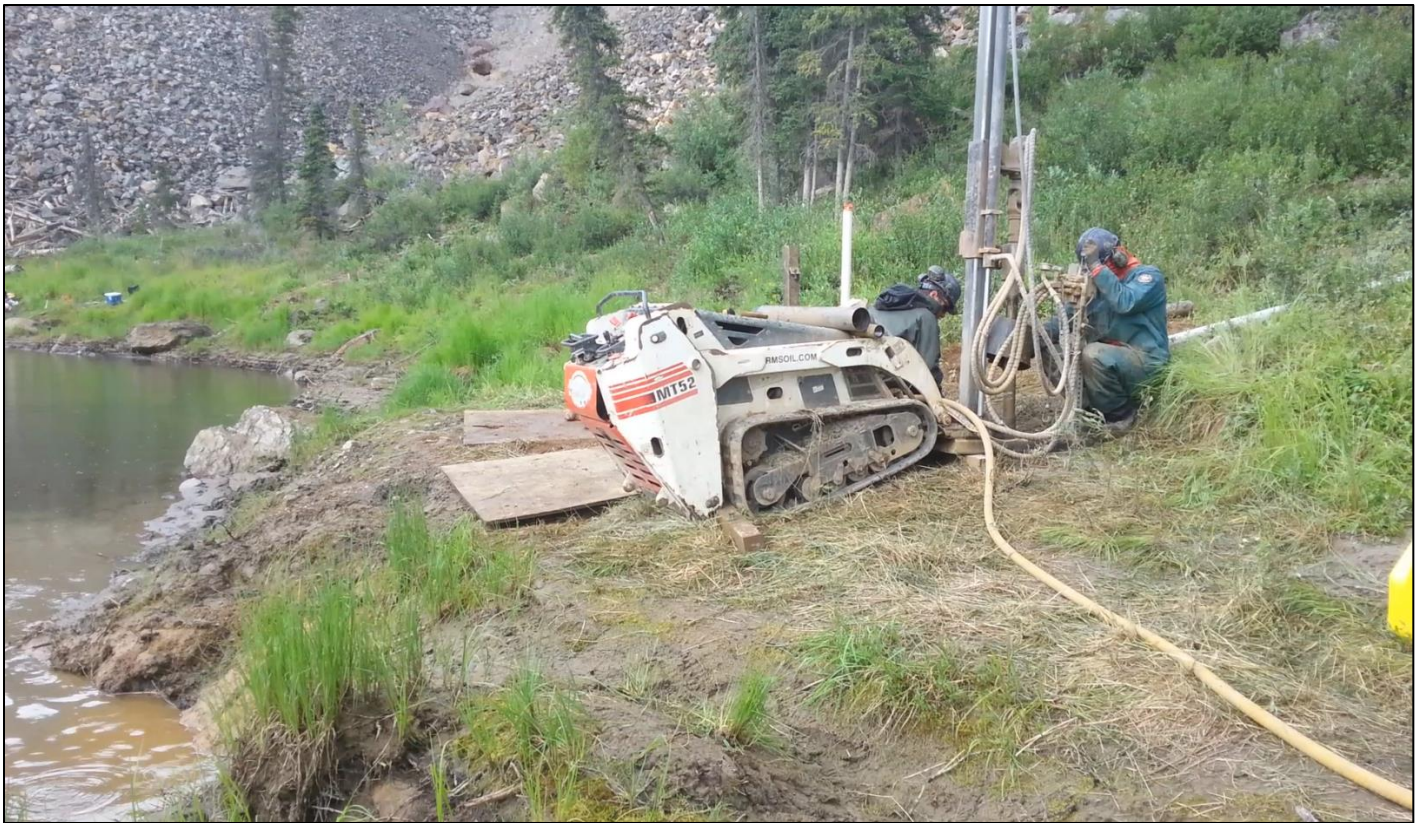
Photo A4: Drilling with ODEX at MW14-12D. Compressed air is fed from an air compressor upslope of the pond area.

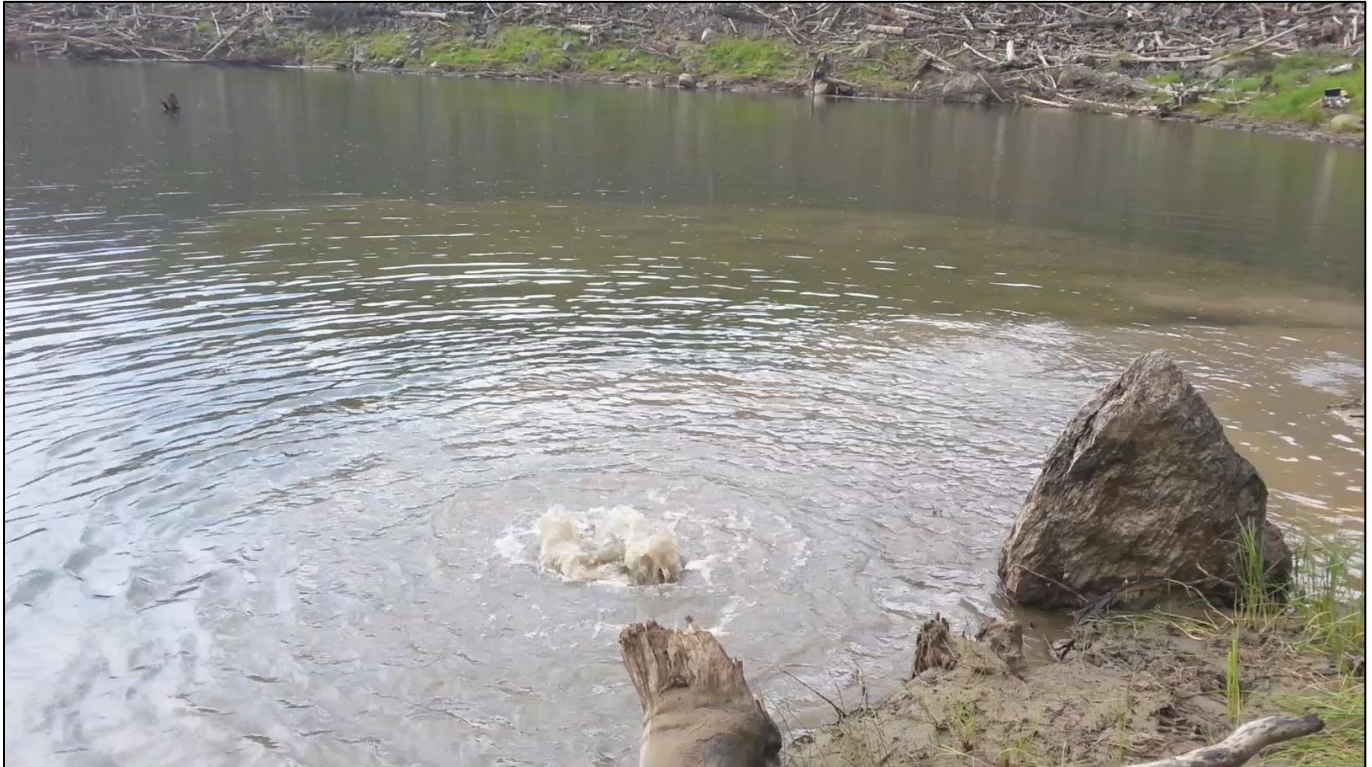
Photo A5: The compressed air injected into the formation at MW14-12D bubbles out in four different locations along the pond, thereby proving a strong hydraulic connection between the sand aquifer and the pond.

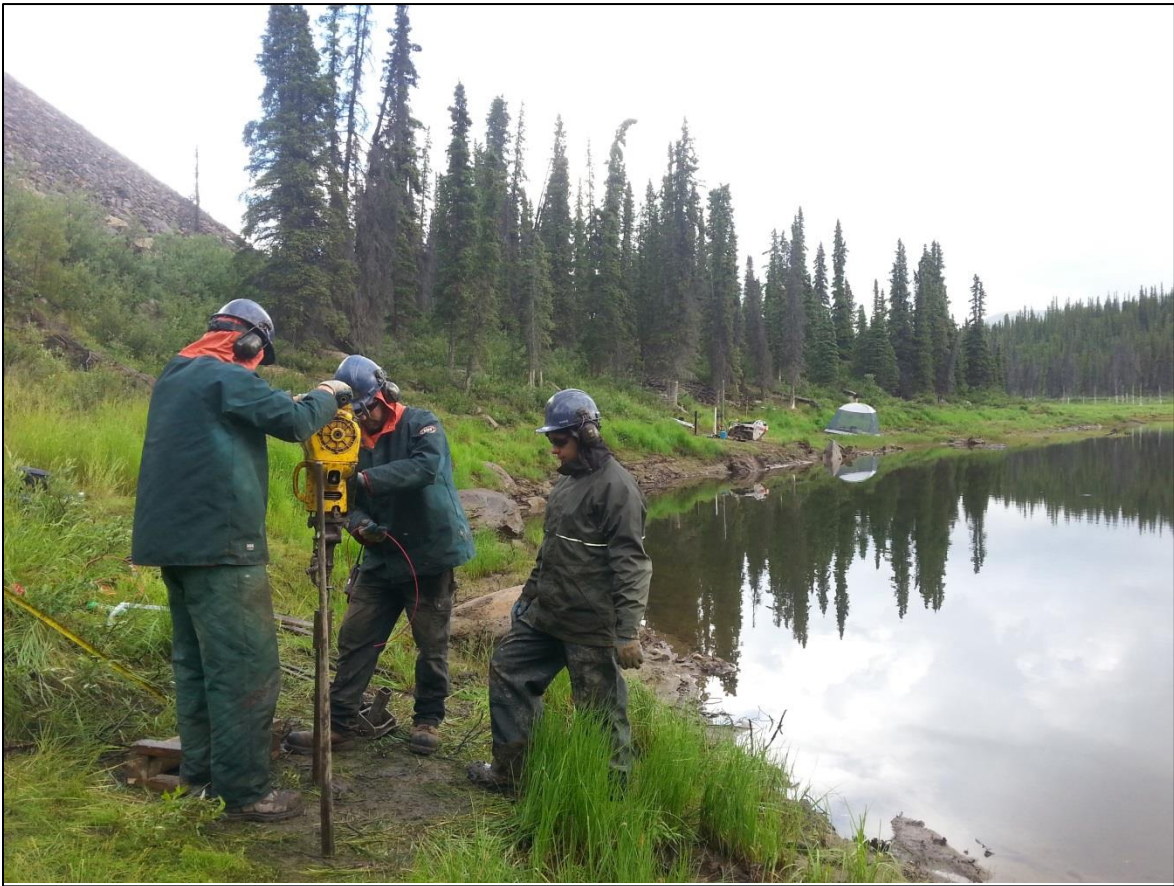
Photo A6: Drillers at MW14-14, advancing a Waterloo profiler tip into the borehole with a Pionjär 140 hammer drill. The Waterloo profiler allowed the team to obtain a water sample from below the depth of refusal.

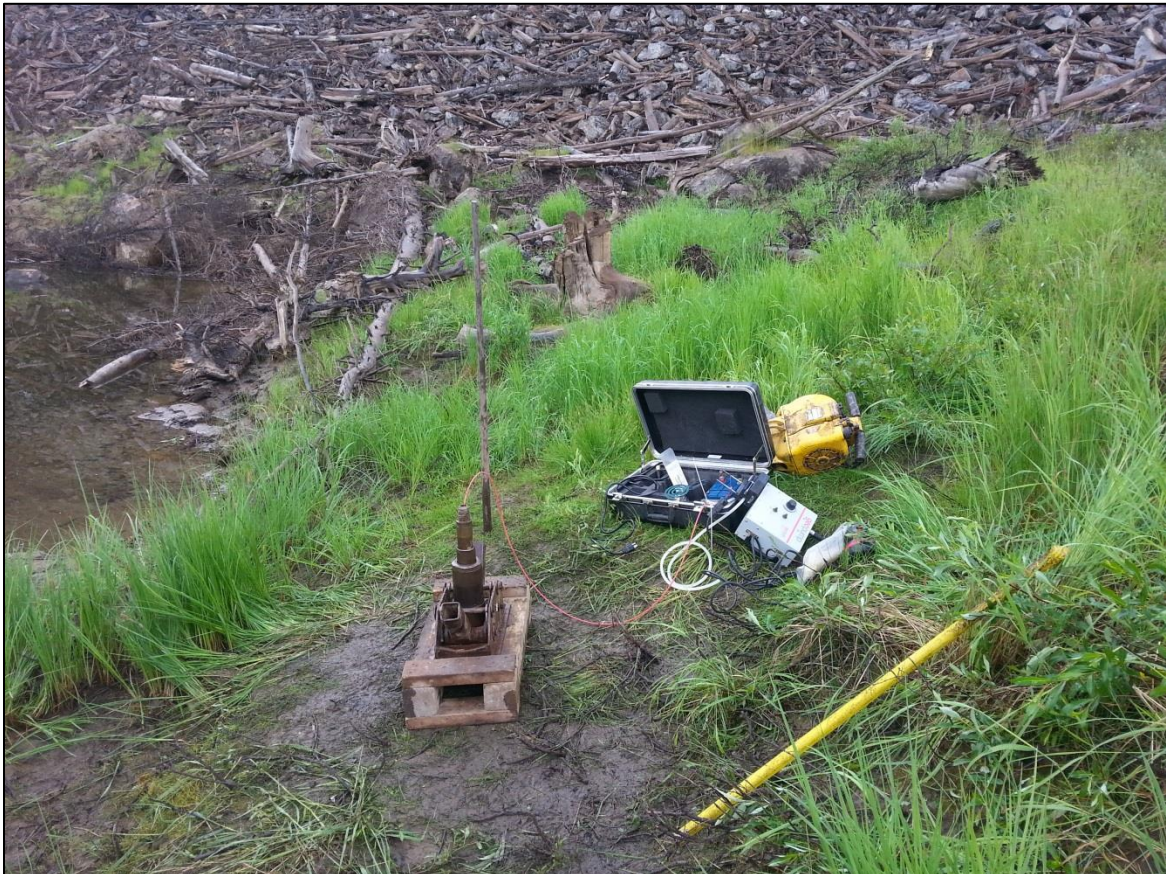
Photo A7: Using a peristaltic pump connected to the Waterloo profiler, a water sample is obtained from the sand aquifer at MW14-14. This was the water sample that contained 21 mg/L dissolved zinc.

Groundwater in the sediments of the NF1 pond area showed varying degrees of impact of WRD seepage. Depth-discrete sampling during drilling at MW14-14, located at the toe of the Intermediate Dump indicated significant variations in zinc with depth (Figure 3-2). A groundwater sample taken in this borehole at a depth of 10.5 ft (3.2m) using a Waterloo sampler showed a zinc concentration of 21 mg/L (sample labelled "MW14-14 deep" in Table 3-2). Unfortunately, several attempts at installing a deep piezometer at this location failed with the available handheld equipment due to refusal of the Pjonjar in the gravelly silt (this site was not accessible with the Bobcat rig). The monitoring well
