# **ROSE CREEK TAILINGS IMPOUNDMENT SEISMIC STABILITY ASSESSMENT**

*Addendum*

**M09237A03**

**Anvil Range Mining Complex, Yukon  
Rose Creek Tailings Impoundment  
Seismic Stability Assessment Addendum**

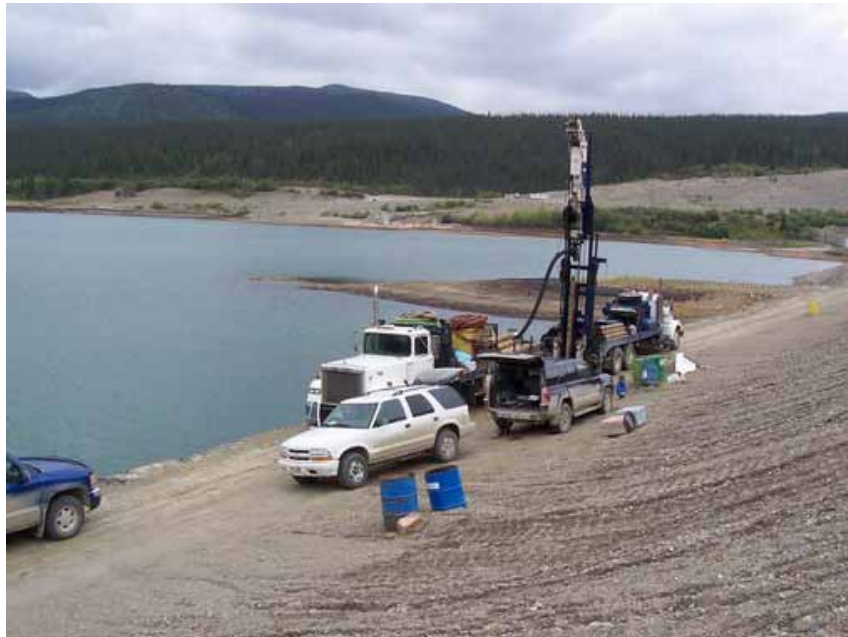
Photo II-1 BPT at the Intermediate Dam Downstream Berm Using HAV180 Drill Rig and Instrumented Casing

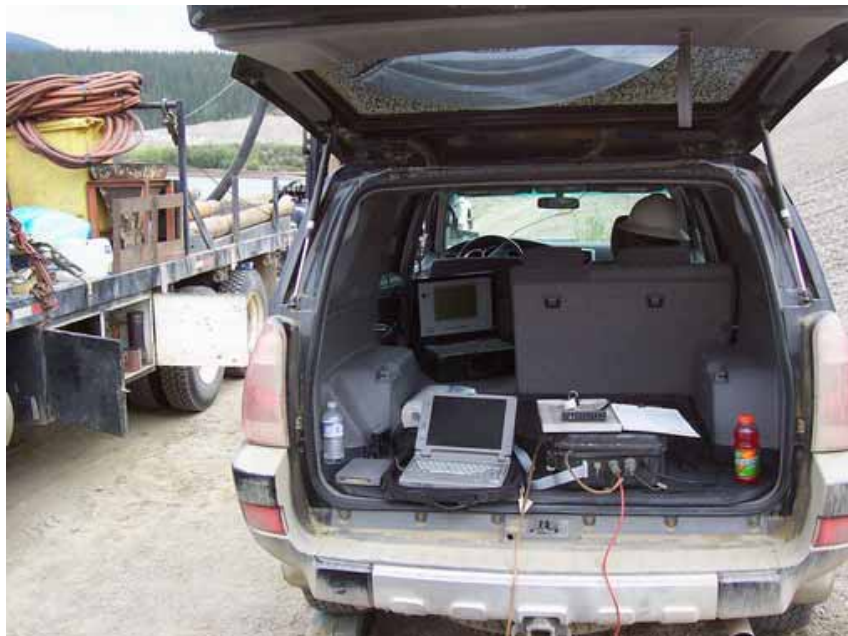
Photo II-2 PDA Data Acquisition System and Monitoring Equipments at the Intermediate Dam

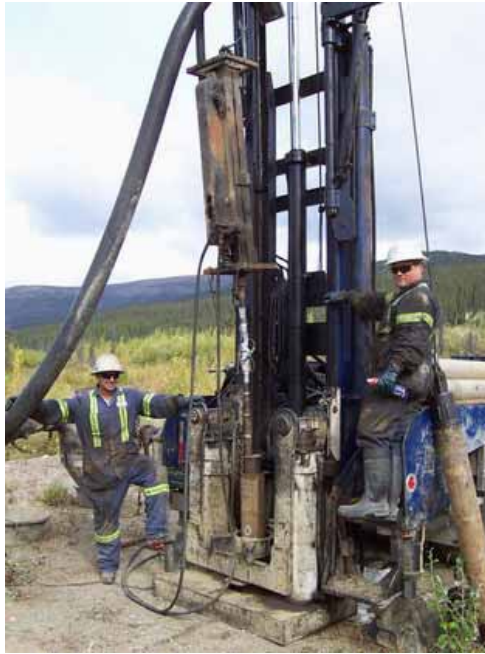
Photo II-3 SPT Data Set up with Automatic Trip Hammer and Instrumented Rod for Energy Measurements During Becker Open Hole Test at the Cross Valley Dam

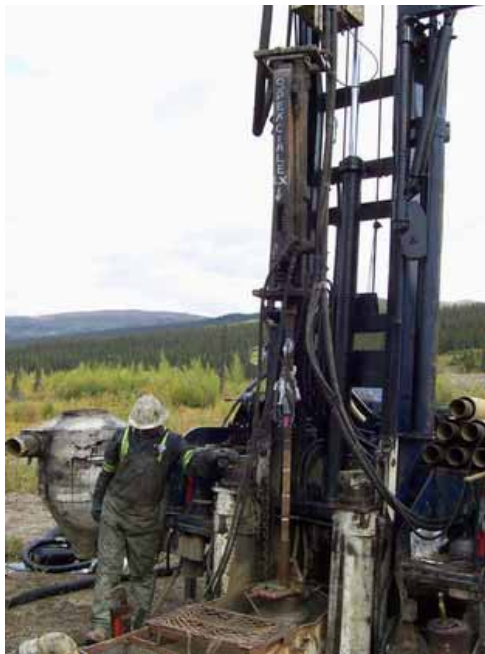
Photo II-4 Photo II-5 SPT Data Set up with Automatic Trip Hammer and Instrumented Rod for Energy Measurements During Mud Rotary Drilling at the Cross Valley Dam

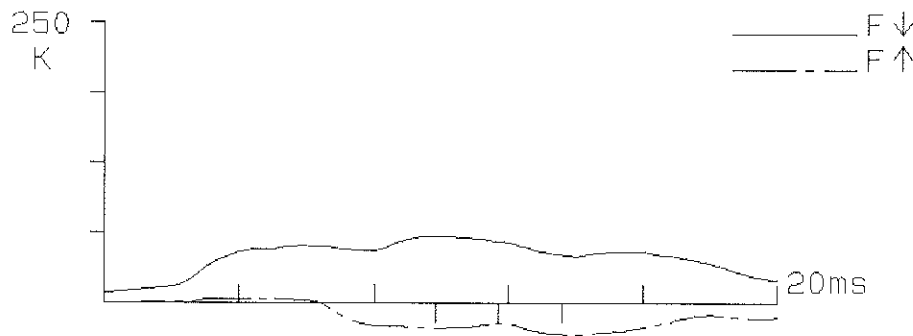
ROSE CREEK, BPT05-04

BN 15/338  
 CSX 4.46 Ksi  
 EFV 1.710 Kip-ft  
 ETR 20 %  
 BPM 96.9 BPM  
 VMX 3.8 ft/s  
 SFT 0 Kips  
 FMX 54 Kips  
 RA2 27 Kips  
 DMX 0.67 inch  
 LP 28.00 ft  
 LE 32.00 ft  
 AR 12.10 in2  
 EM 30004 Ksi  
 SP 0.493 K/ft3  
 WS 16800 ft/s  
 F 34 A 34

# R Miner Dynamic Test

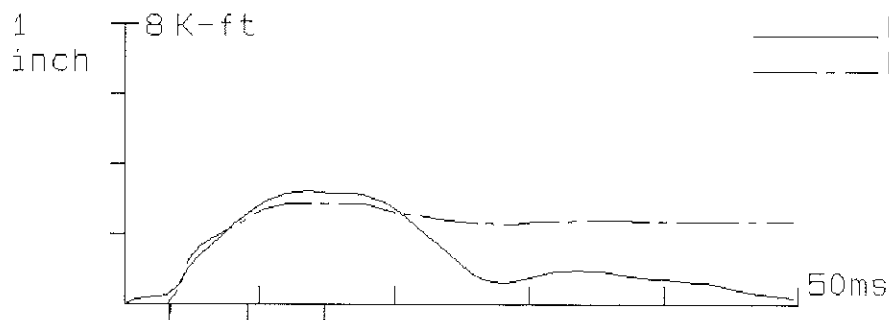
ROSE CREEK, BPT05-04

# R Miner Dynamic Test

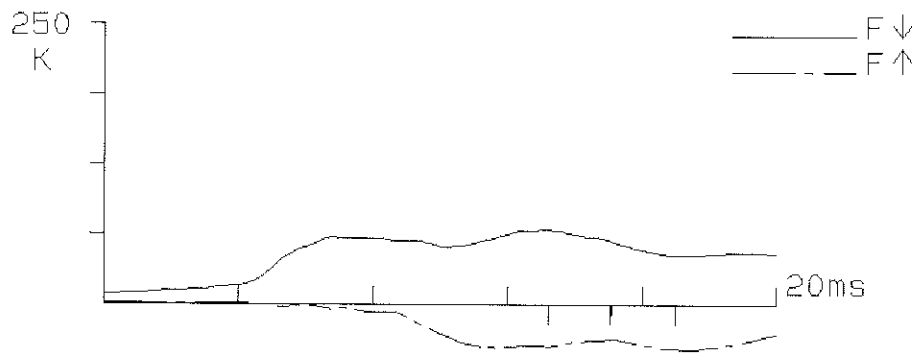
ROSE CREEK, BPT05-05

CSX 4.71 Ksi  
EFV 1.890 Kip-ft  
ETR 23 %  
BPM 97.4 BPM  
VMX 4.8 ft/s  
SFT 0 Kips  
FMX 57 Kips  
RA2 20 Kips  
DMX 0.89 inch  
LP 28.00 ft  
LE 32.00 ft  
AR 12.10 in2  
EM 30004 Ksi  
SP 0.493 K/ft3  
WS 16800 ft/s  
F 34 A 34

# R Miner Dynamic Test

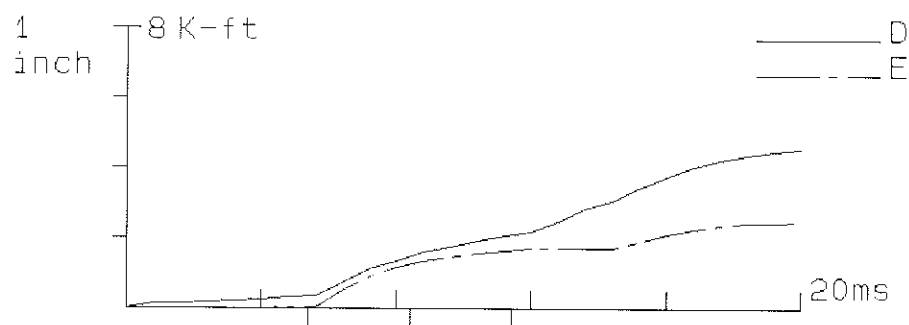
ROSE CREEK, BPT05-05

# R Miner Dynamic Test
