Environment Canada  
Environmental Protection Service  
Pacific Region  
Yukon Branch

A SURVEY AND COMPARISON OF  
ARSENIC CONCENTRATIONS IN WATER, SOILS  
AND VEGETATION BETWEEN THE VENUS MINE PROPERTY  
AND THE MOUNT NANSEN PROPERTY, YUKON

Benoit Godin and Tim R. Osler

October 1985

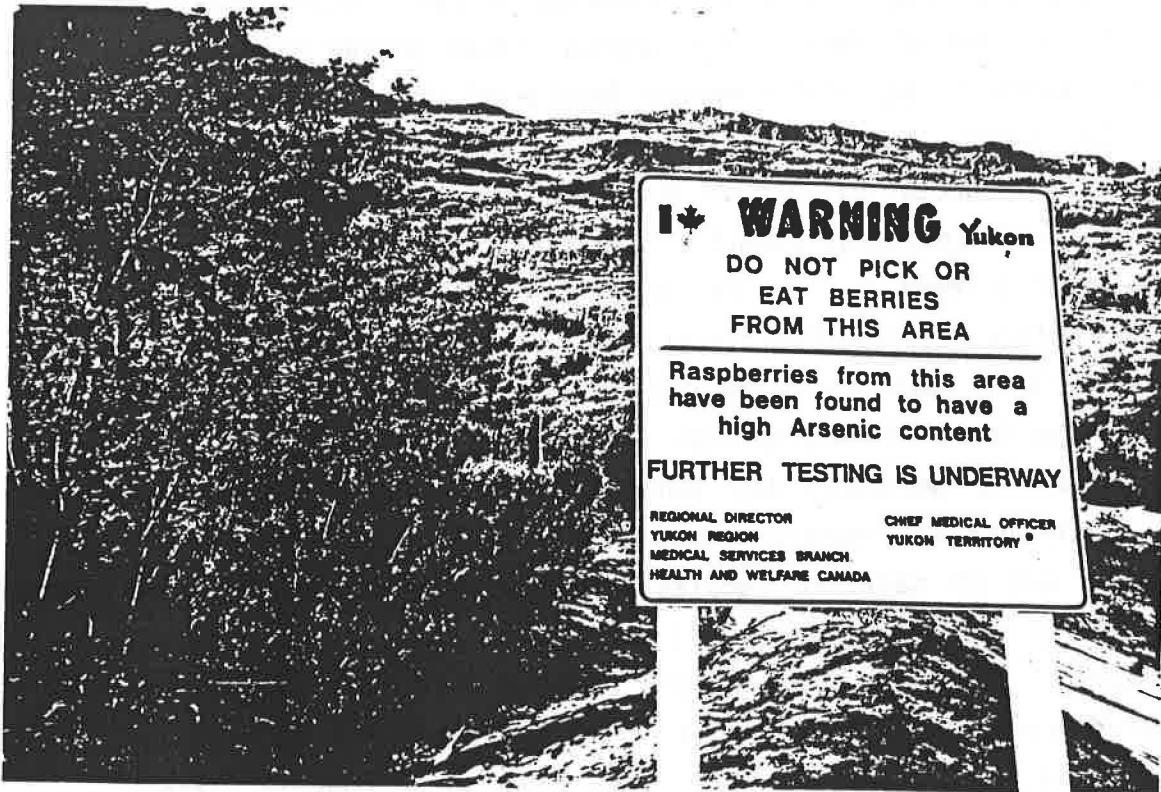
FIGURE 1 WARNING SIGN ERECTED AT THE ARSENIC CONTAMINATED AREA OF THE ABANDONED VENUS MINES TAILINGS PONDS.

Within two weeks, warning signs were posted in the area (Figure 1), printed notices were circulated to Carcross residents and a media campaign informed Whitehorse area residents of the concerns of possible arsenic contamination in the berries. Free clinics were set up in affected communities of the Territory to test hair and fingernail samples for arsenic. Results of these samples proved negative.

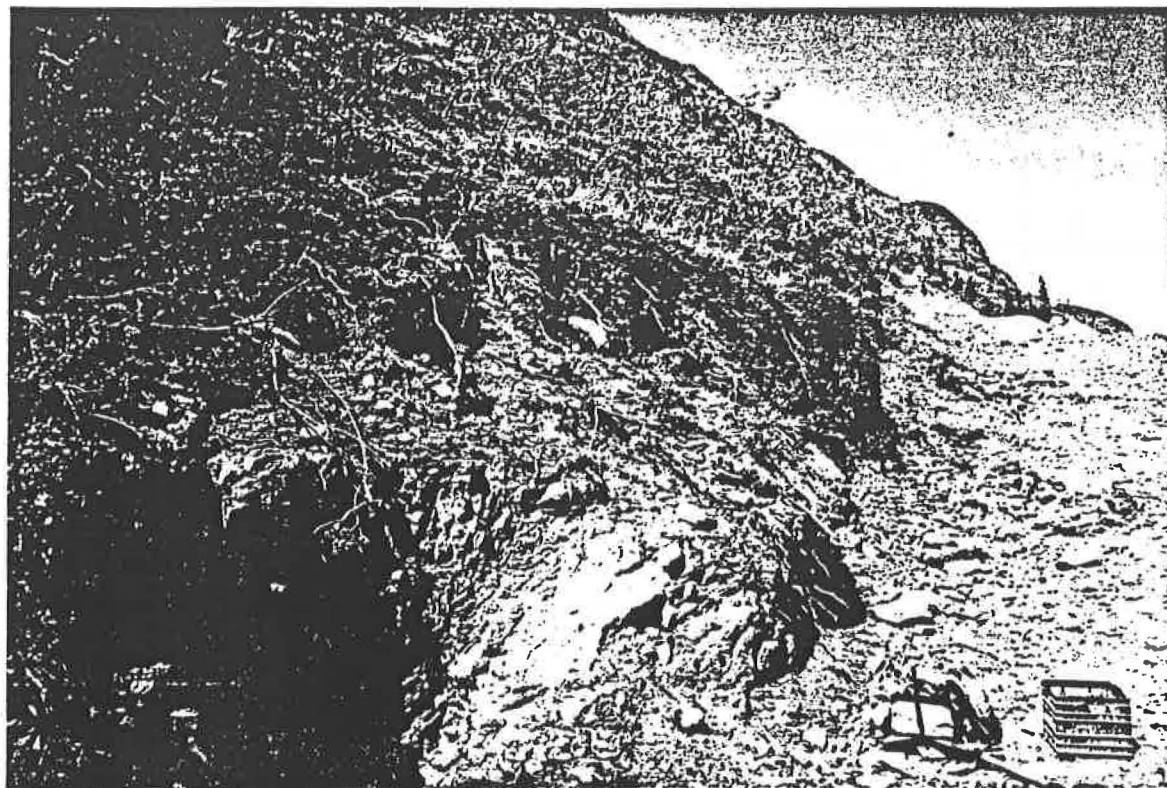
FIGURE 7 STATION 4, VENUS MINES PROPERTY. THE ABANDONED INCLINED ADIT ON THE MONTANA MOUNTAIN HILLSIDE ABOVE THE ABANDONED TAILINGS PONDS.

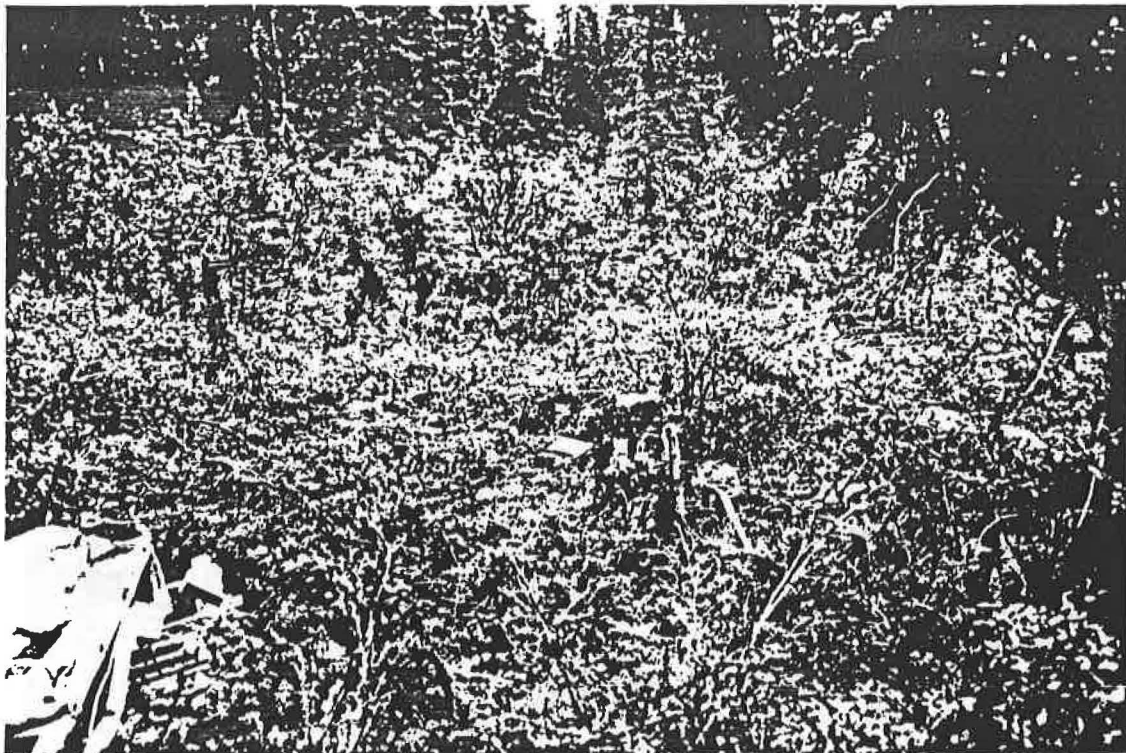
FIGURE 12 STATION 10, MOUNT NANSEN PROPERTY. UNDISTURBED DOME CREEK  
UPSTREAM OF STATION 9 AND ABOVE INFLUENCE OF ABANDONED MINE  
SITE.
