Clinton Creek Waste Dump and Tailings Piles
1984 Site Visit

REPORT ON 1984 SITE VISIT

PROJECT: CLINTON CREEK MINE WASTE DUMP AND
TAILINGS PILES

LOCATION: CLINTON CREEK, YUKON TERRITORY

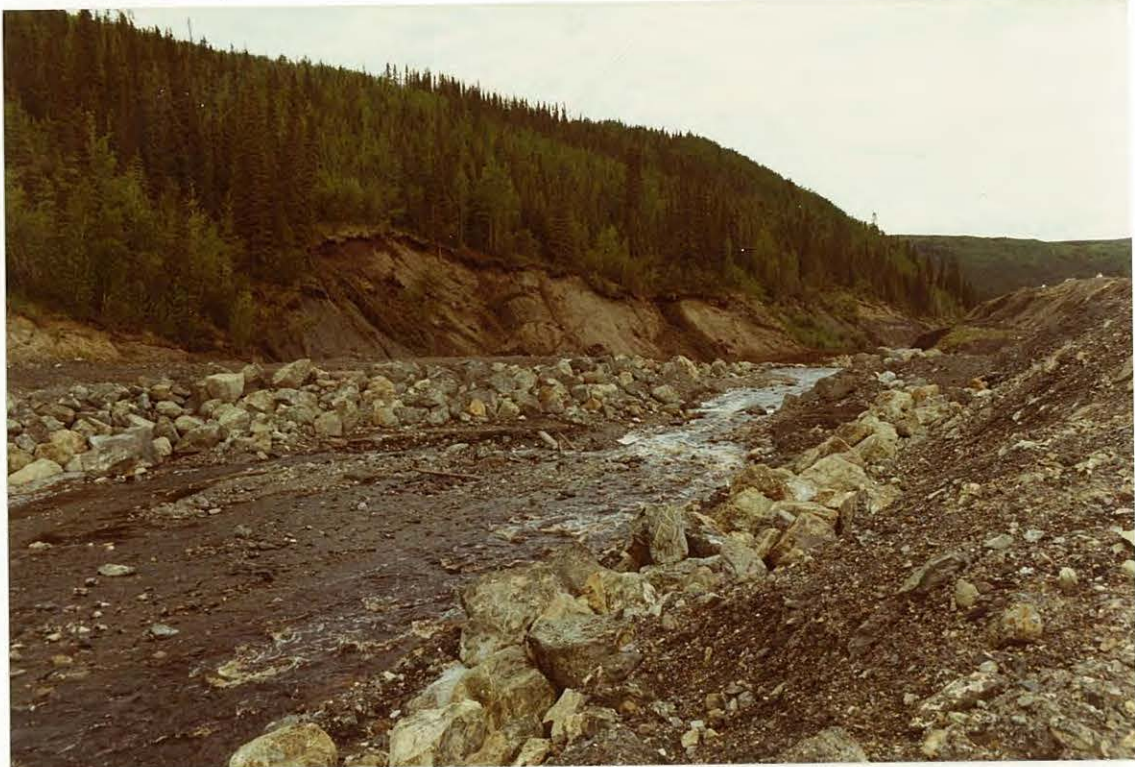
Photo 1: Upstream end of Clinton Creek channel, looking downstream. Note narrow channel opposite bank protection section construction in 1983. June 14, 1984.

Just upstream of this control structure, a portion of the streamflow is deflected toward the erosion channel on the north, at a location where the side channel lining was too low and was overtopped. This small portion of the streamflow has not caused significant new erosion. At the location of the plug constructed upstream of the erosion channel, the stream channel was narrowed during construction. The channel should be widened in this area to avoid concentrated flow and to allow for squeezing by dump movement over the years. Photographs 1 and 2 in Appendix I show the condition of the upstream portion of the channel.

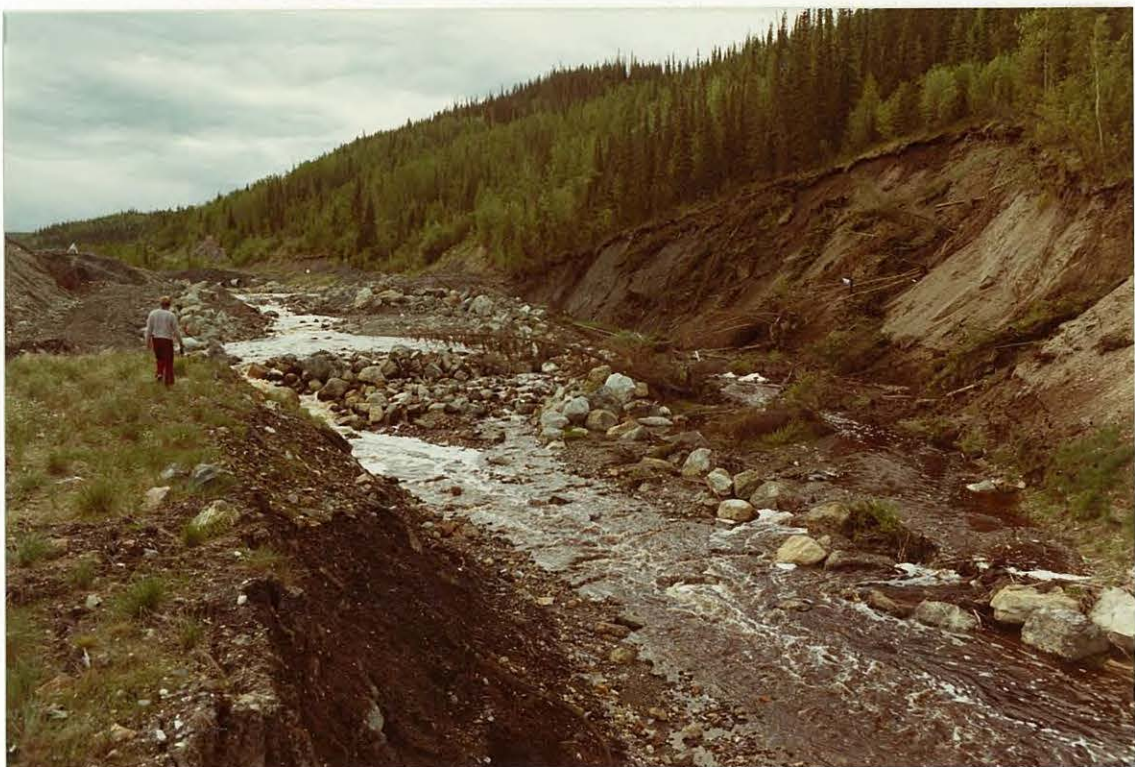
Photo 2: Upstream end of Clinton Creek channel, looking upstream. Note portion of stream flow escaping from channel just upstream of last weir left in channel. June 14, 1984.

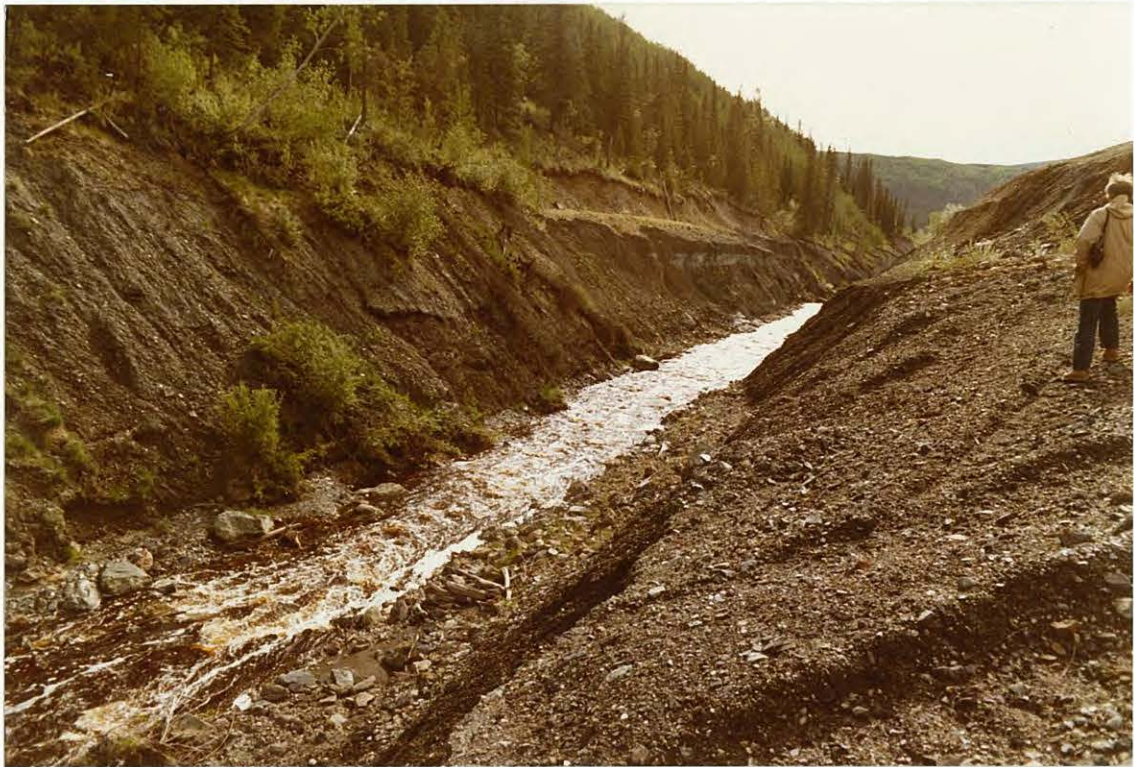
Photo 3: Clinton Creek channel across waste dump, looking downstream. June 15, 1984.

Further downstream, the waste dump channel does not appear to have changed significantly since June 1983. Oversteepened, freshly exposed slopes of waste dump material indicate that some erosion of the creeping waste dump is continuing. Comparison with photographs from 1983 indicates that downcutting of the channel bottom has not advanced significantly in the past year. The channel is becoming increasingly protected by large waste rock fragments which remain following erosion of the waste dump. Photographs 3 and 4 show the armoring in the stream channel and photograph 4 also shows the considerable numbers of large rock fragments available in the waste dump face.

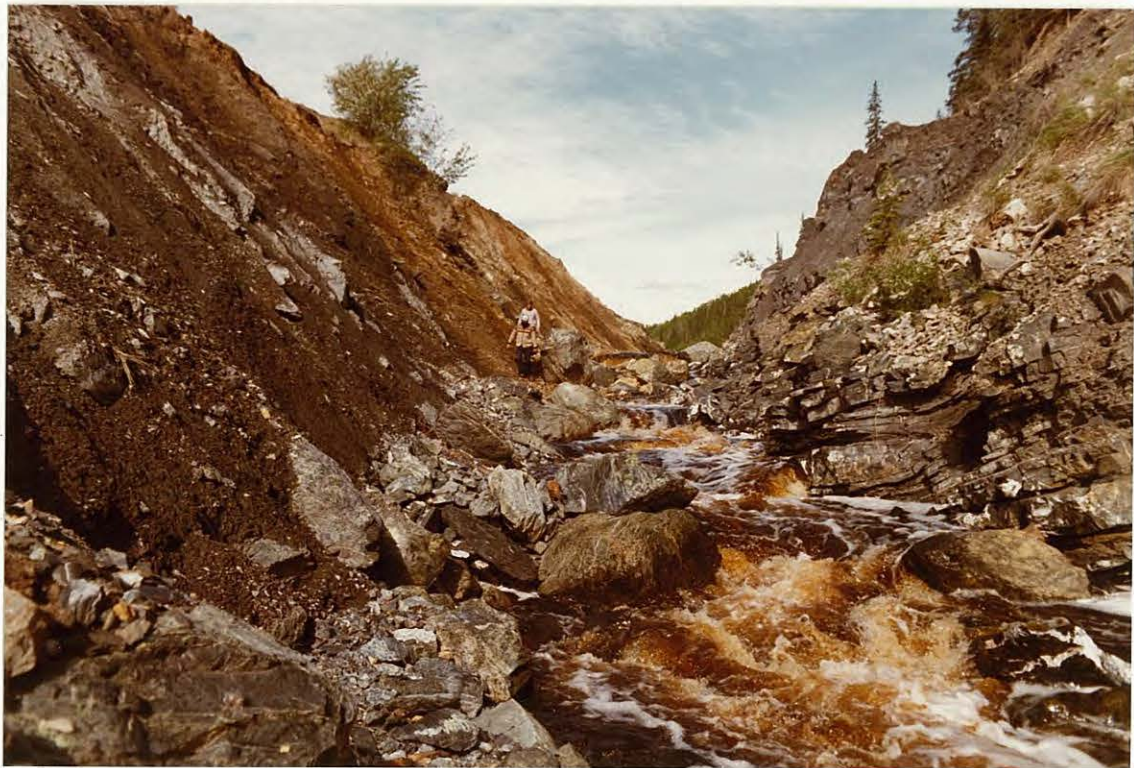
Photo 4: Clinton Creek channel looking upstream. Note accumulation of large rock fragments in stream channel and frequent occurrence of rock in waste material. June 15, 1984.

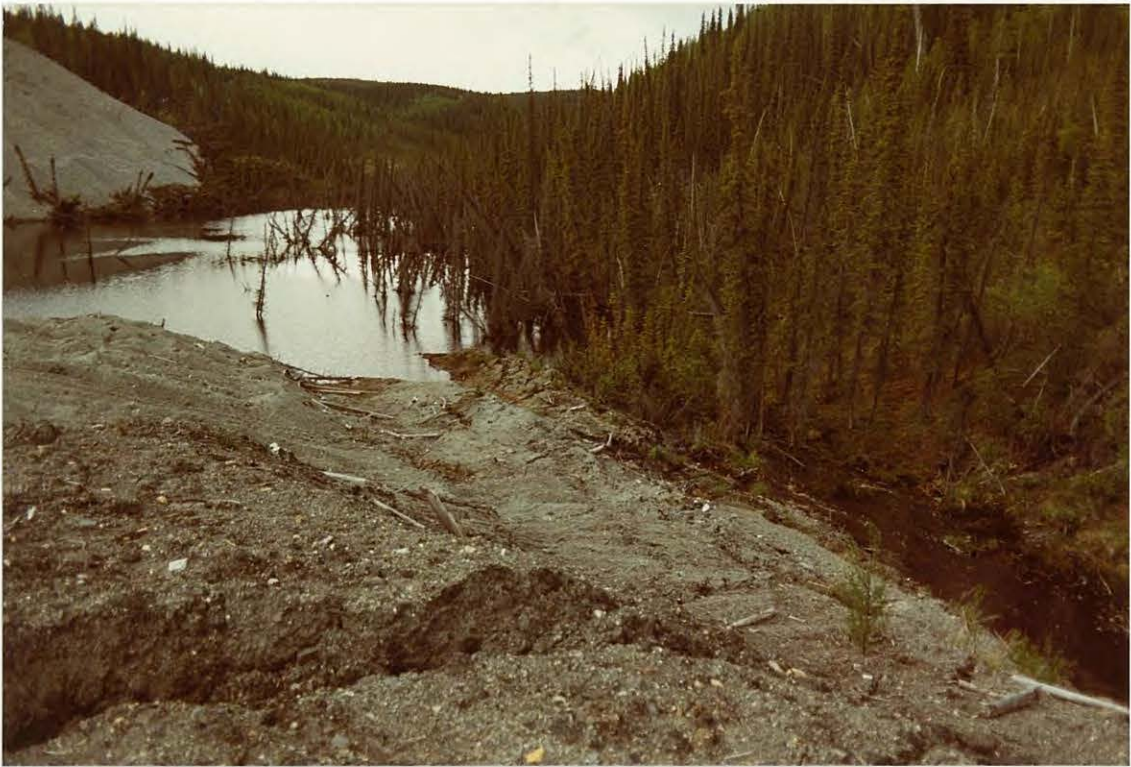
- a) The toe of the south lobe is considerably more cracked and upthrust than in 1983 and the stream channel between the tailings pile toe and the east slope of Wolverine Creek valley is being squeezed by the tailings pile movements. At the outlet of the small lake, the toe of the tailings pile forms a scarp which has undergone minor erosion by Wolverine Creek. Foundation material is undergoing some upward displacement from the tailings pile loading. The channel at the toe of the south lobe is shown on Photographs 5 and 6.
- b) The toe of the north lobe has entered the lake in the valley bottom and extends an estimated 20 ft beyond the 1983 shoreline. The toe of the north lobe is shown on Photograph 7.
- c) Continued development of cracking is evident over the surfaces of both the tailings piles. Photographs 9 and 10 show radial cracking on the south lobe.

Photo 5: Wolverine Creek at outlet of lake formed by south tailings lobe. Note channel squeezing and upthrust foundation material from tailings pile movements. June 14, 1984.

Although the channel of Wolverine Creek was further narrowed by movement of the south tailings lobe over the past year, we consider the channel to have adequate width that no maintenance is recommended for 1984. Some minor erosion of tailings is likely to occur over the next year, but we consider the channel to be safe against major blockages.

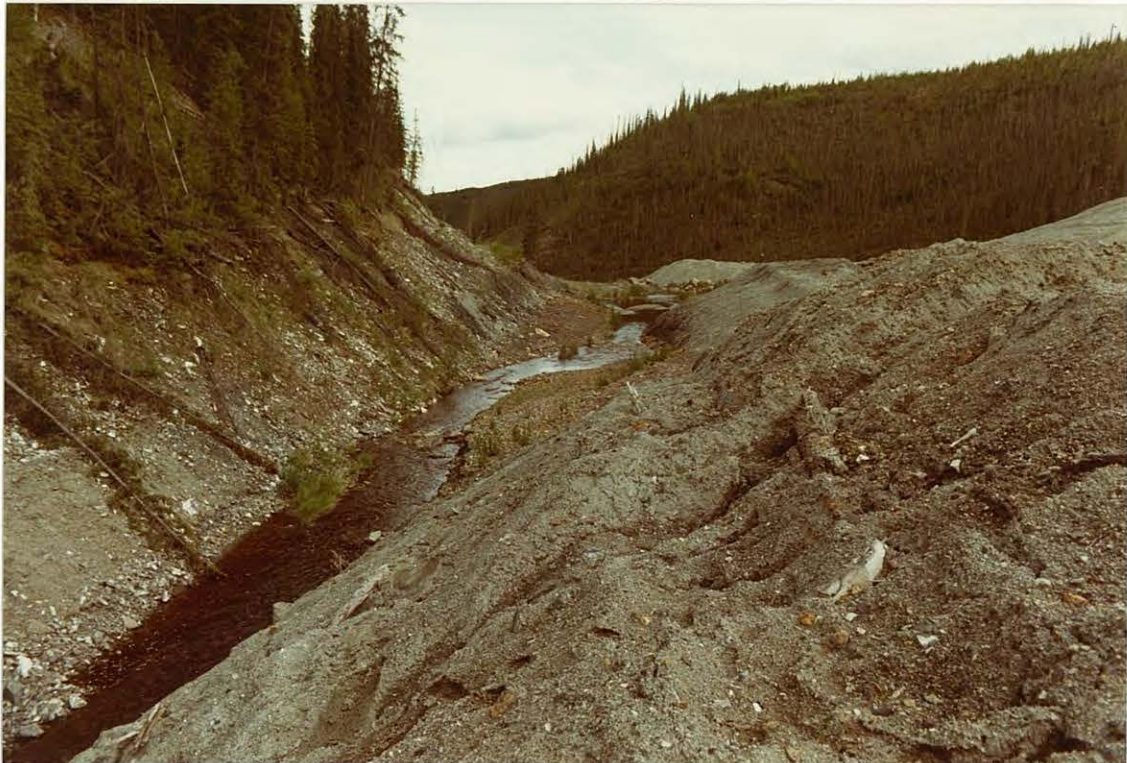
Photo 6: Looking downstream at Wolverine Creek channel at toe of south tailings lobe. June 14, 1984.

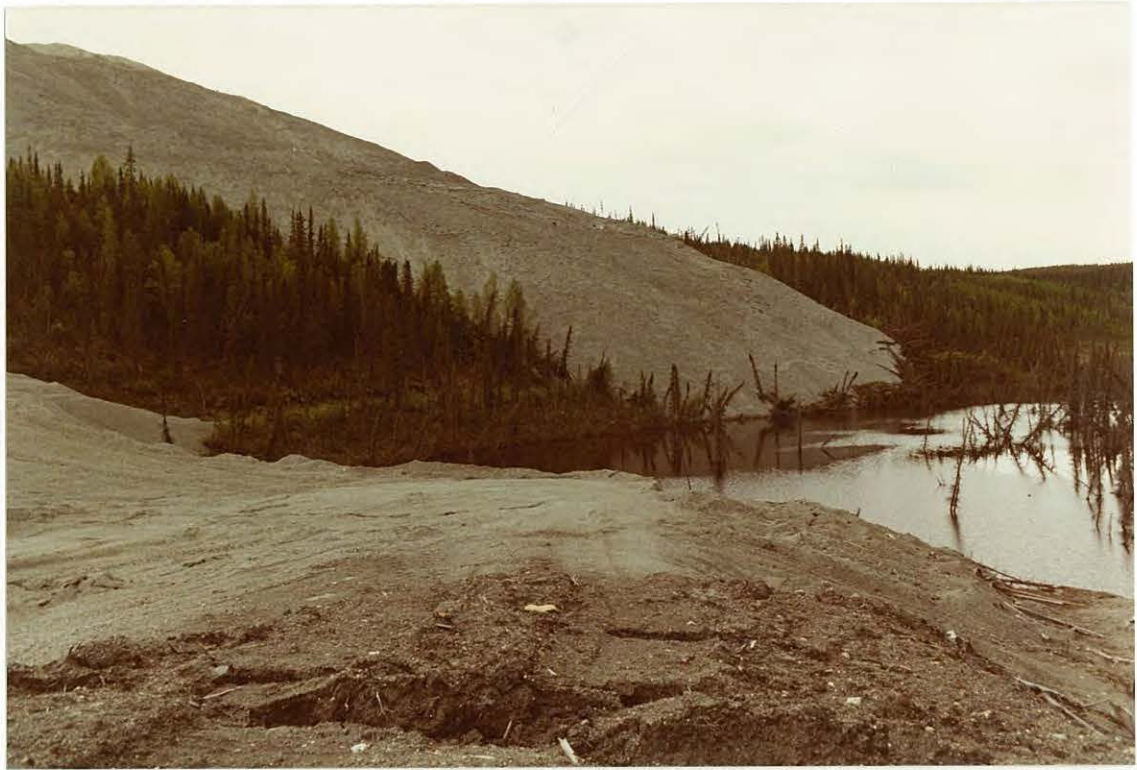
Photo 7: Toe of north tailings lobe extending into lake. June 14, 1984.

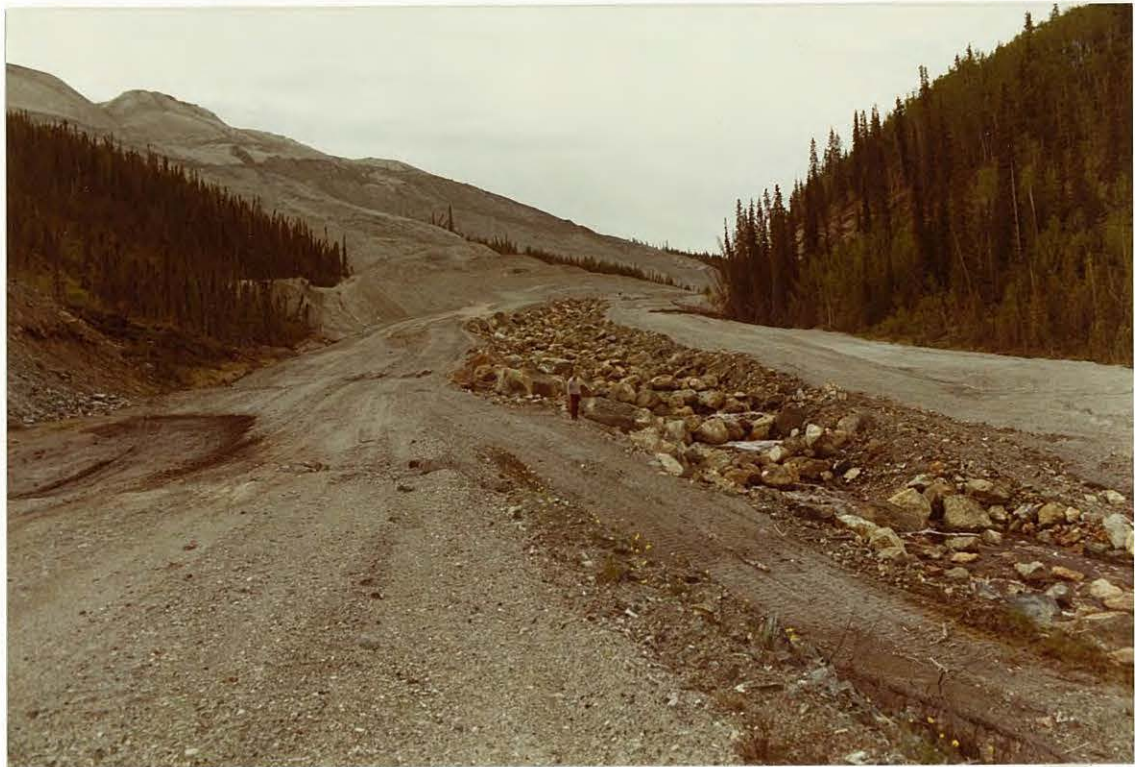
Photo 8: Wolverine Creek channel downstream of tailings piles. For scale, note Peter Jones of Brinco in Centre of photo. June 14, 1984.

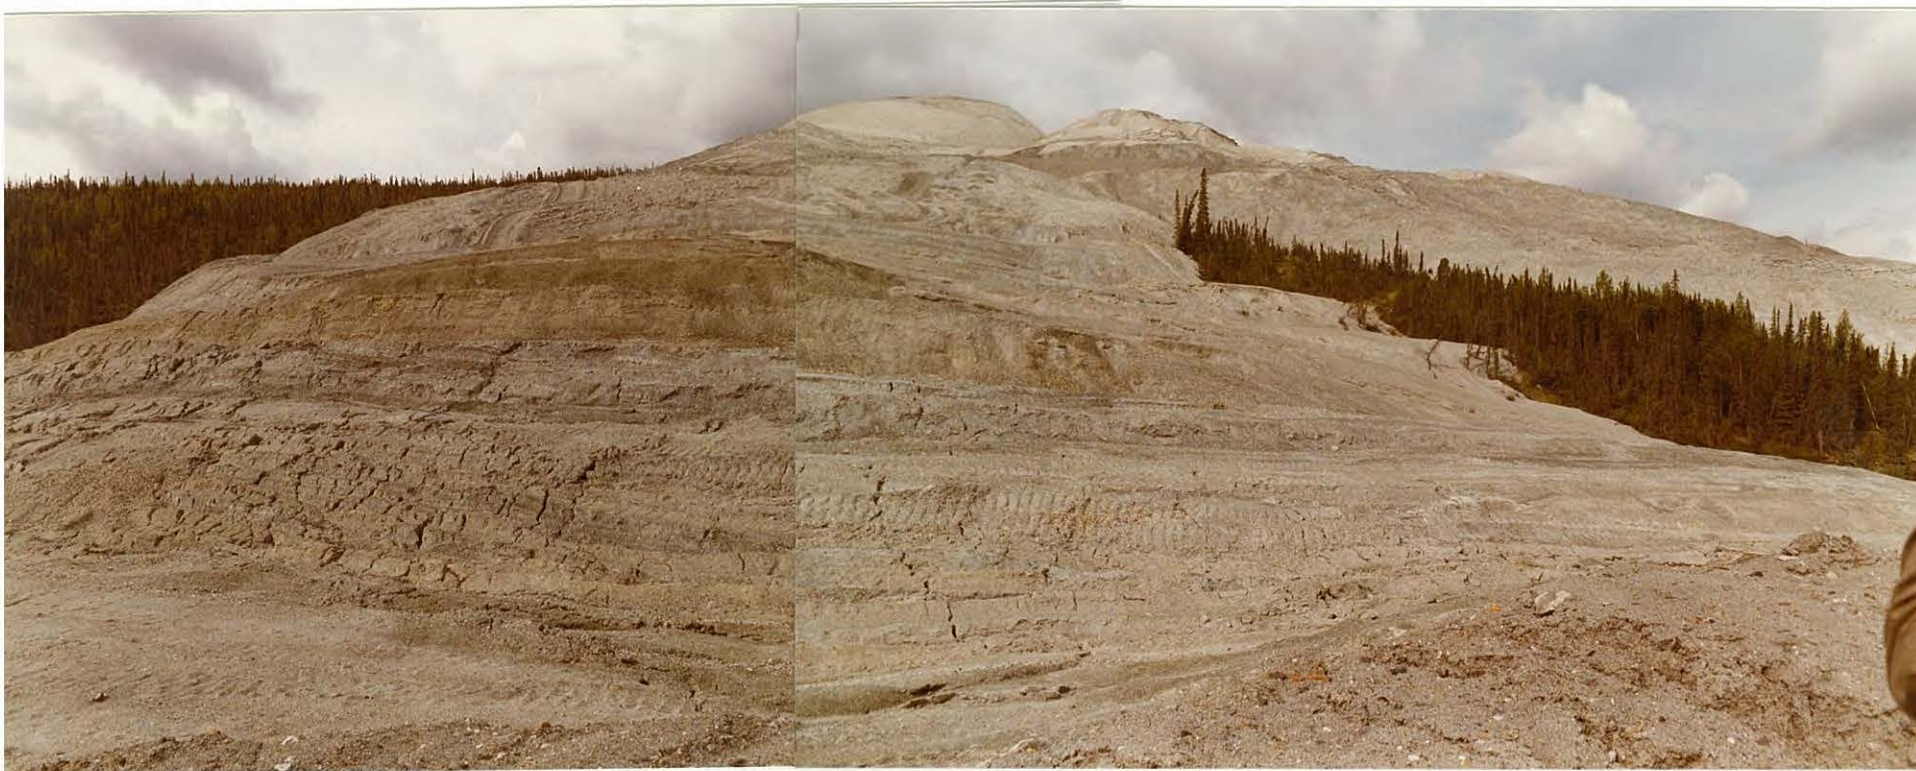
Photo 9 and 10: Panorama looking upslope from toe of south tailings lobe.
Note radial cracking on surface of tailings pile.
June 14, 1984.

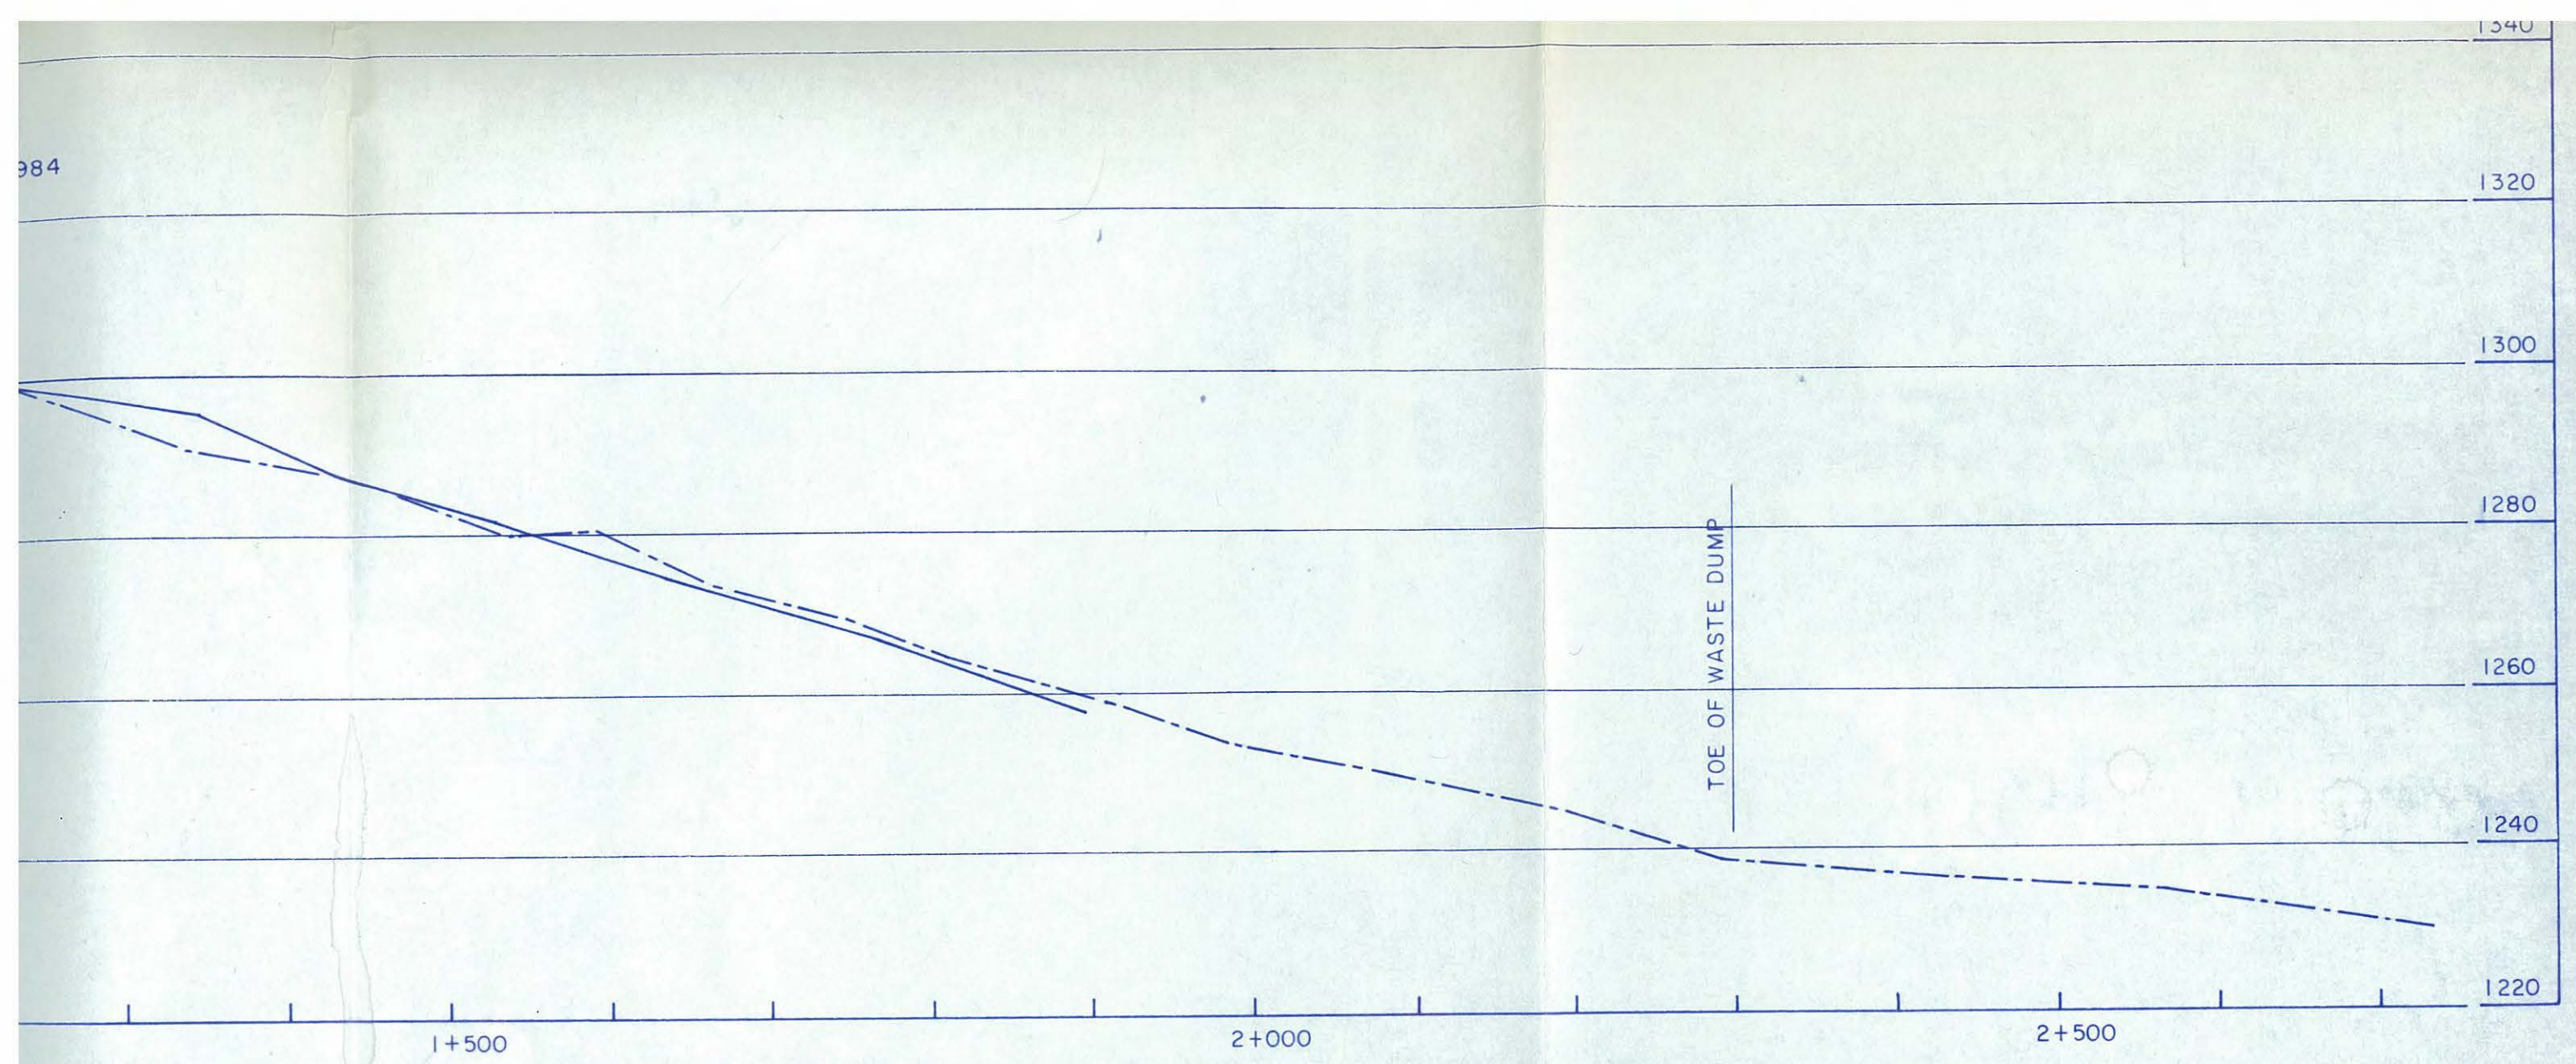
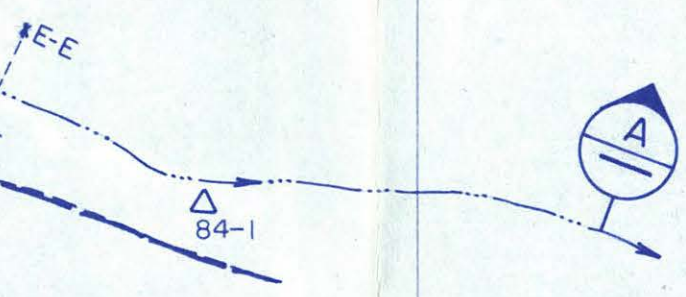
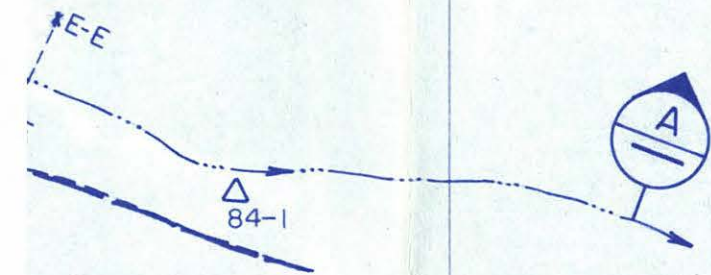
| TITLE | PLAN AND LONGITUDINAL PROFILE OF WASTE DUMP CHANNEL | | | |

because of deterioration of the reflecting prisms. In addition, movements of seven channel closure sections were determined. The locations of monitoring stations are shown on Drawing D-1006A attached.

Survey of the channel bottom of Clinton Creek over the waste dump was also carried out to compare with the profile determined in September 1983. The results of this survey are shown on Drawing D-1006A. The profile was extended approximately 800 ft further downstream. The June 1984 profile shows minor variations from that surveyed in September 1983. These variations are probably because of differences in placement of the stadia rod in the channel, which is made very irregular by the large boulders on the channel bottom. Overall, however, the new profile shows no downcutting trend over the 9 month period. The channel profiling should be continued in future years so that the progress of downcutting can be monitored.

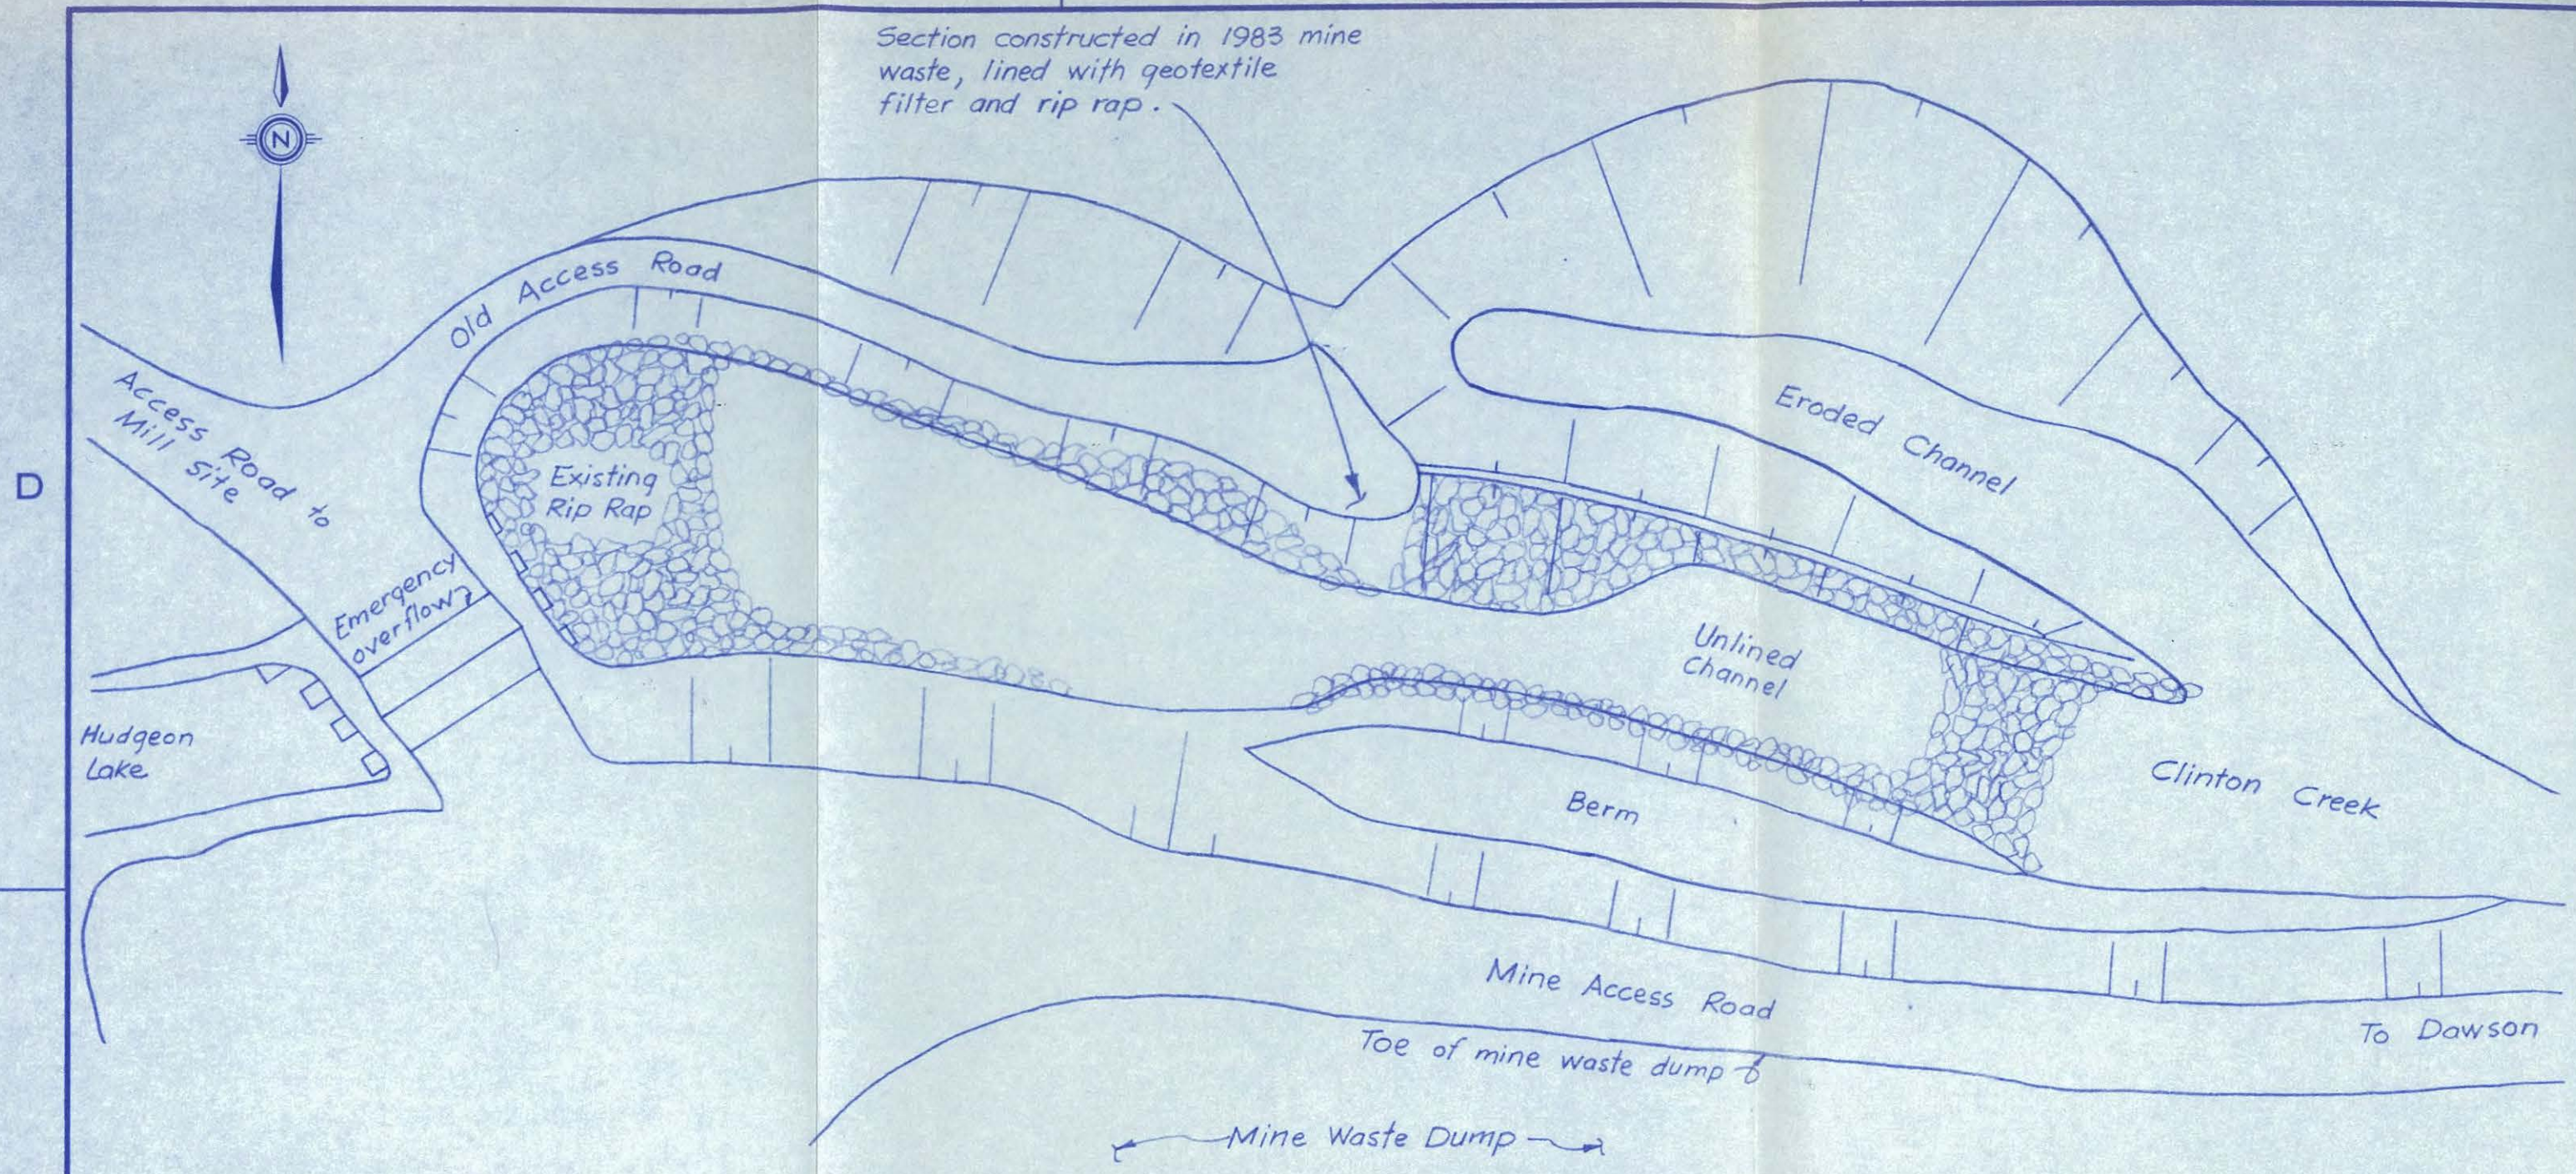
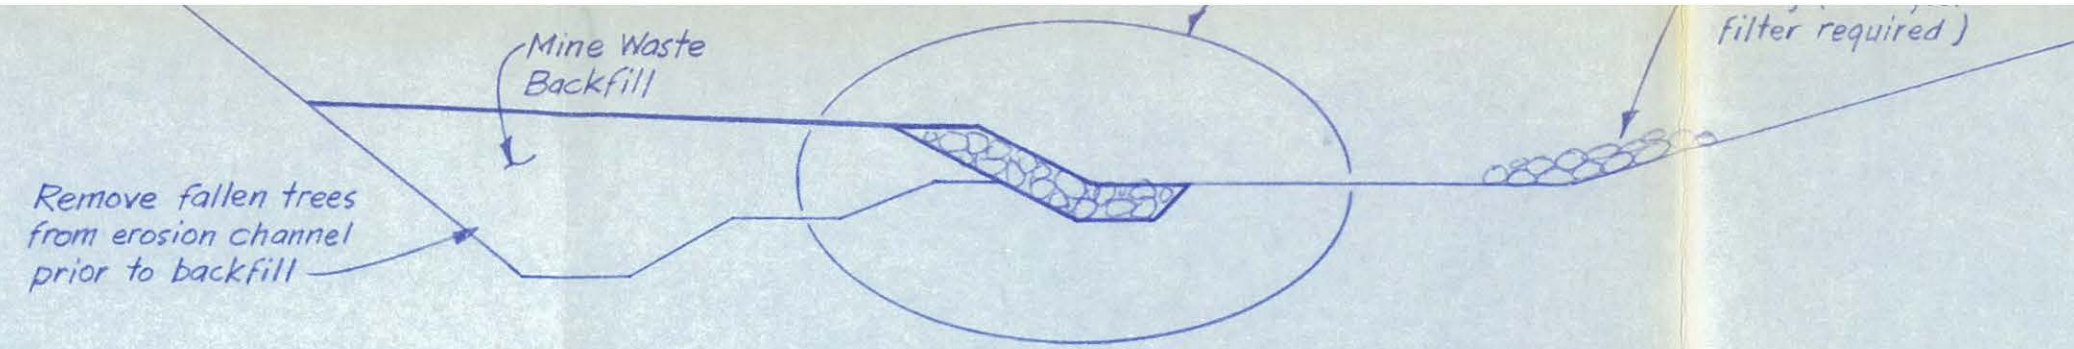
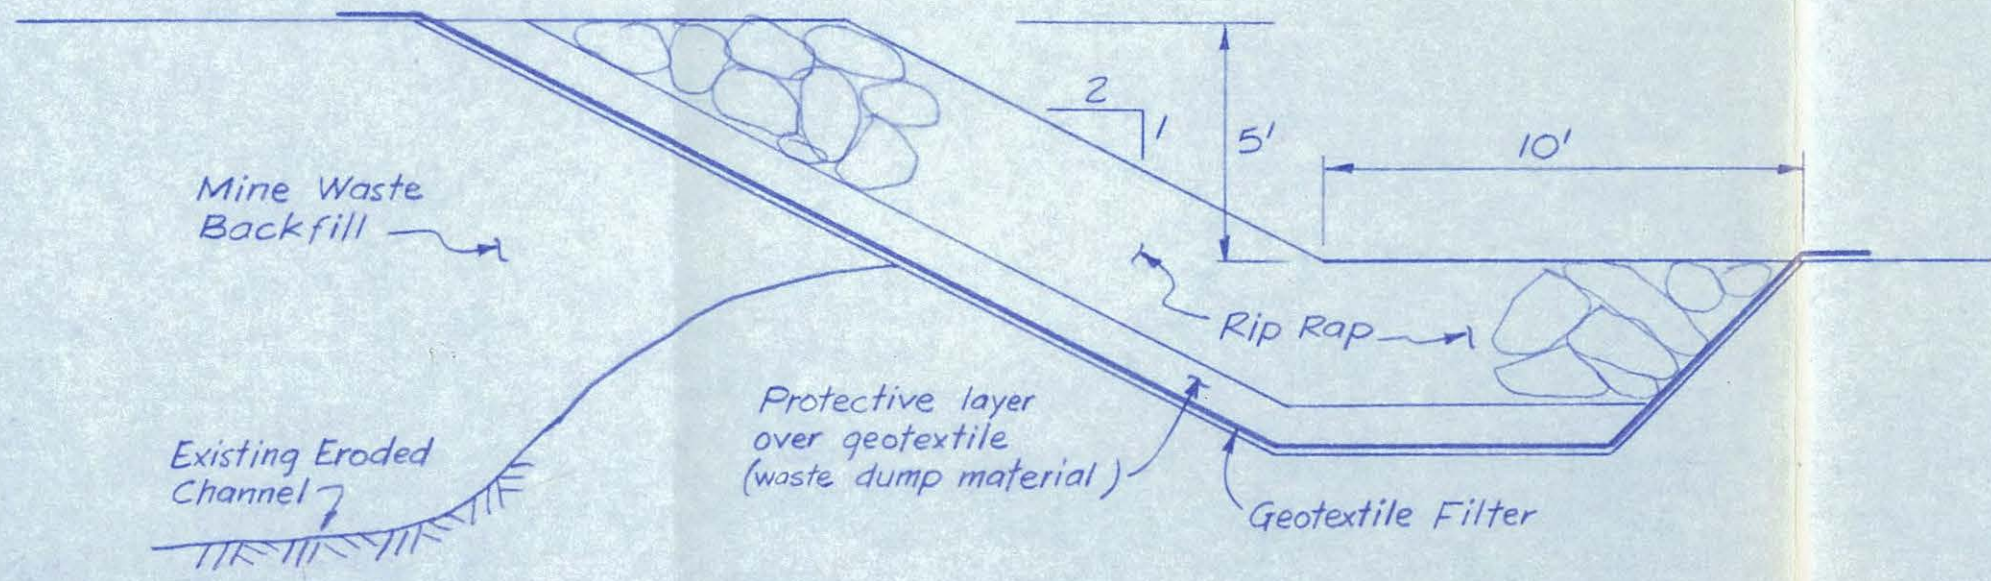
| | | TITLE 1984 CHANNEL MODIFICATIONS PLANS AND SECTIONS | | | |

The work we recommend to be carried out in 1984 to complete the channel modifications is shown on Drawing D-1007. The main items of work are as follows:

- a) Backfilling of the eroded channel should be completed with material borrowed from the waste dump. The backfill should be brought up to about 5 ft above the level of the final stream channel. The configuration of the backfill is shown on Drawing D-1007. The volume of backfill required is estimated as about 5000 yd³.

- b) Geotextile should be laid against the channel side slope formed by the mine waste backfill, covered with a protective layer of mine waste, and riprap placed along the channel side as shown on Drawing D-1007. Placement of riprap and filter are required only on those areas indicated on the drawing. We consider the portion of the existing channel immediately downstream of the plug constructed in 1983 to have adequate side slope protection.
- c) The portion of the channel opposite the 1983 construction should be widened to a minimum bottom width of 50 ft. This can be accomplished by removing the existing side slope riprap, excavating a portion of the existing berm and replacing the riprap on the widened channel sides. The material excavated from the berm may be used as backfill for the eroded channel.
