Clinton Creek Waste Dump and Tailings Piles
1984 Site Visit

REPORT ON 1984 SITE VISIT

PROJECT: CLINTON CREEK MINE WASTE DUMP AND
TAILINGS PILES

LOCATION: CLINTON CREEK, YUKON TERRITORY

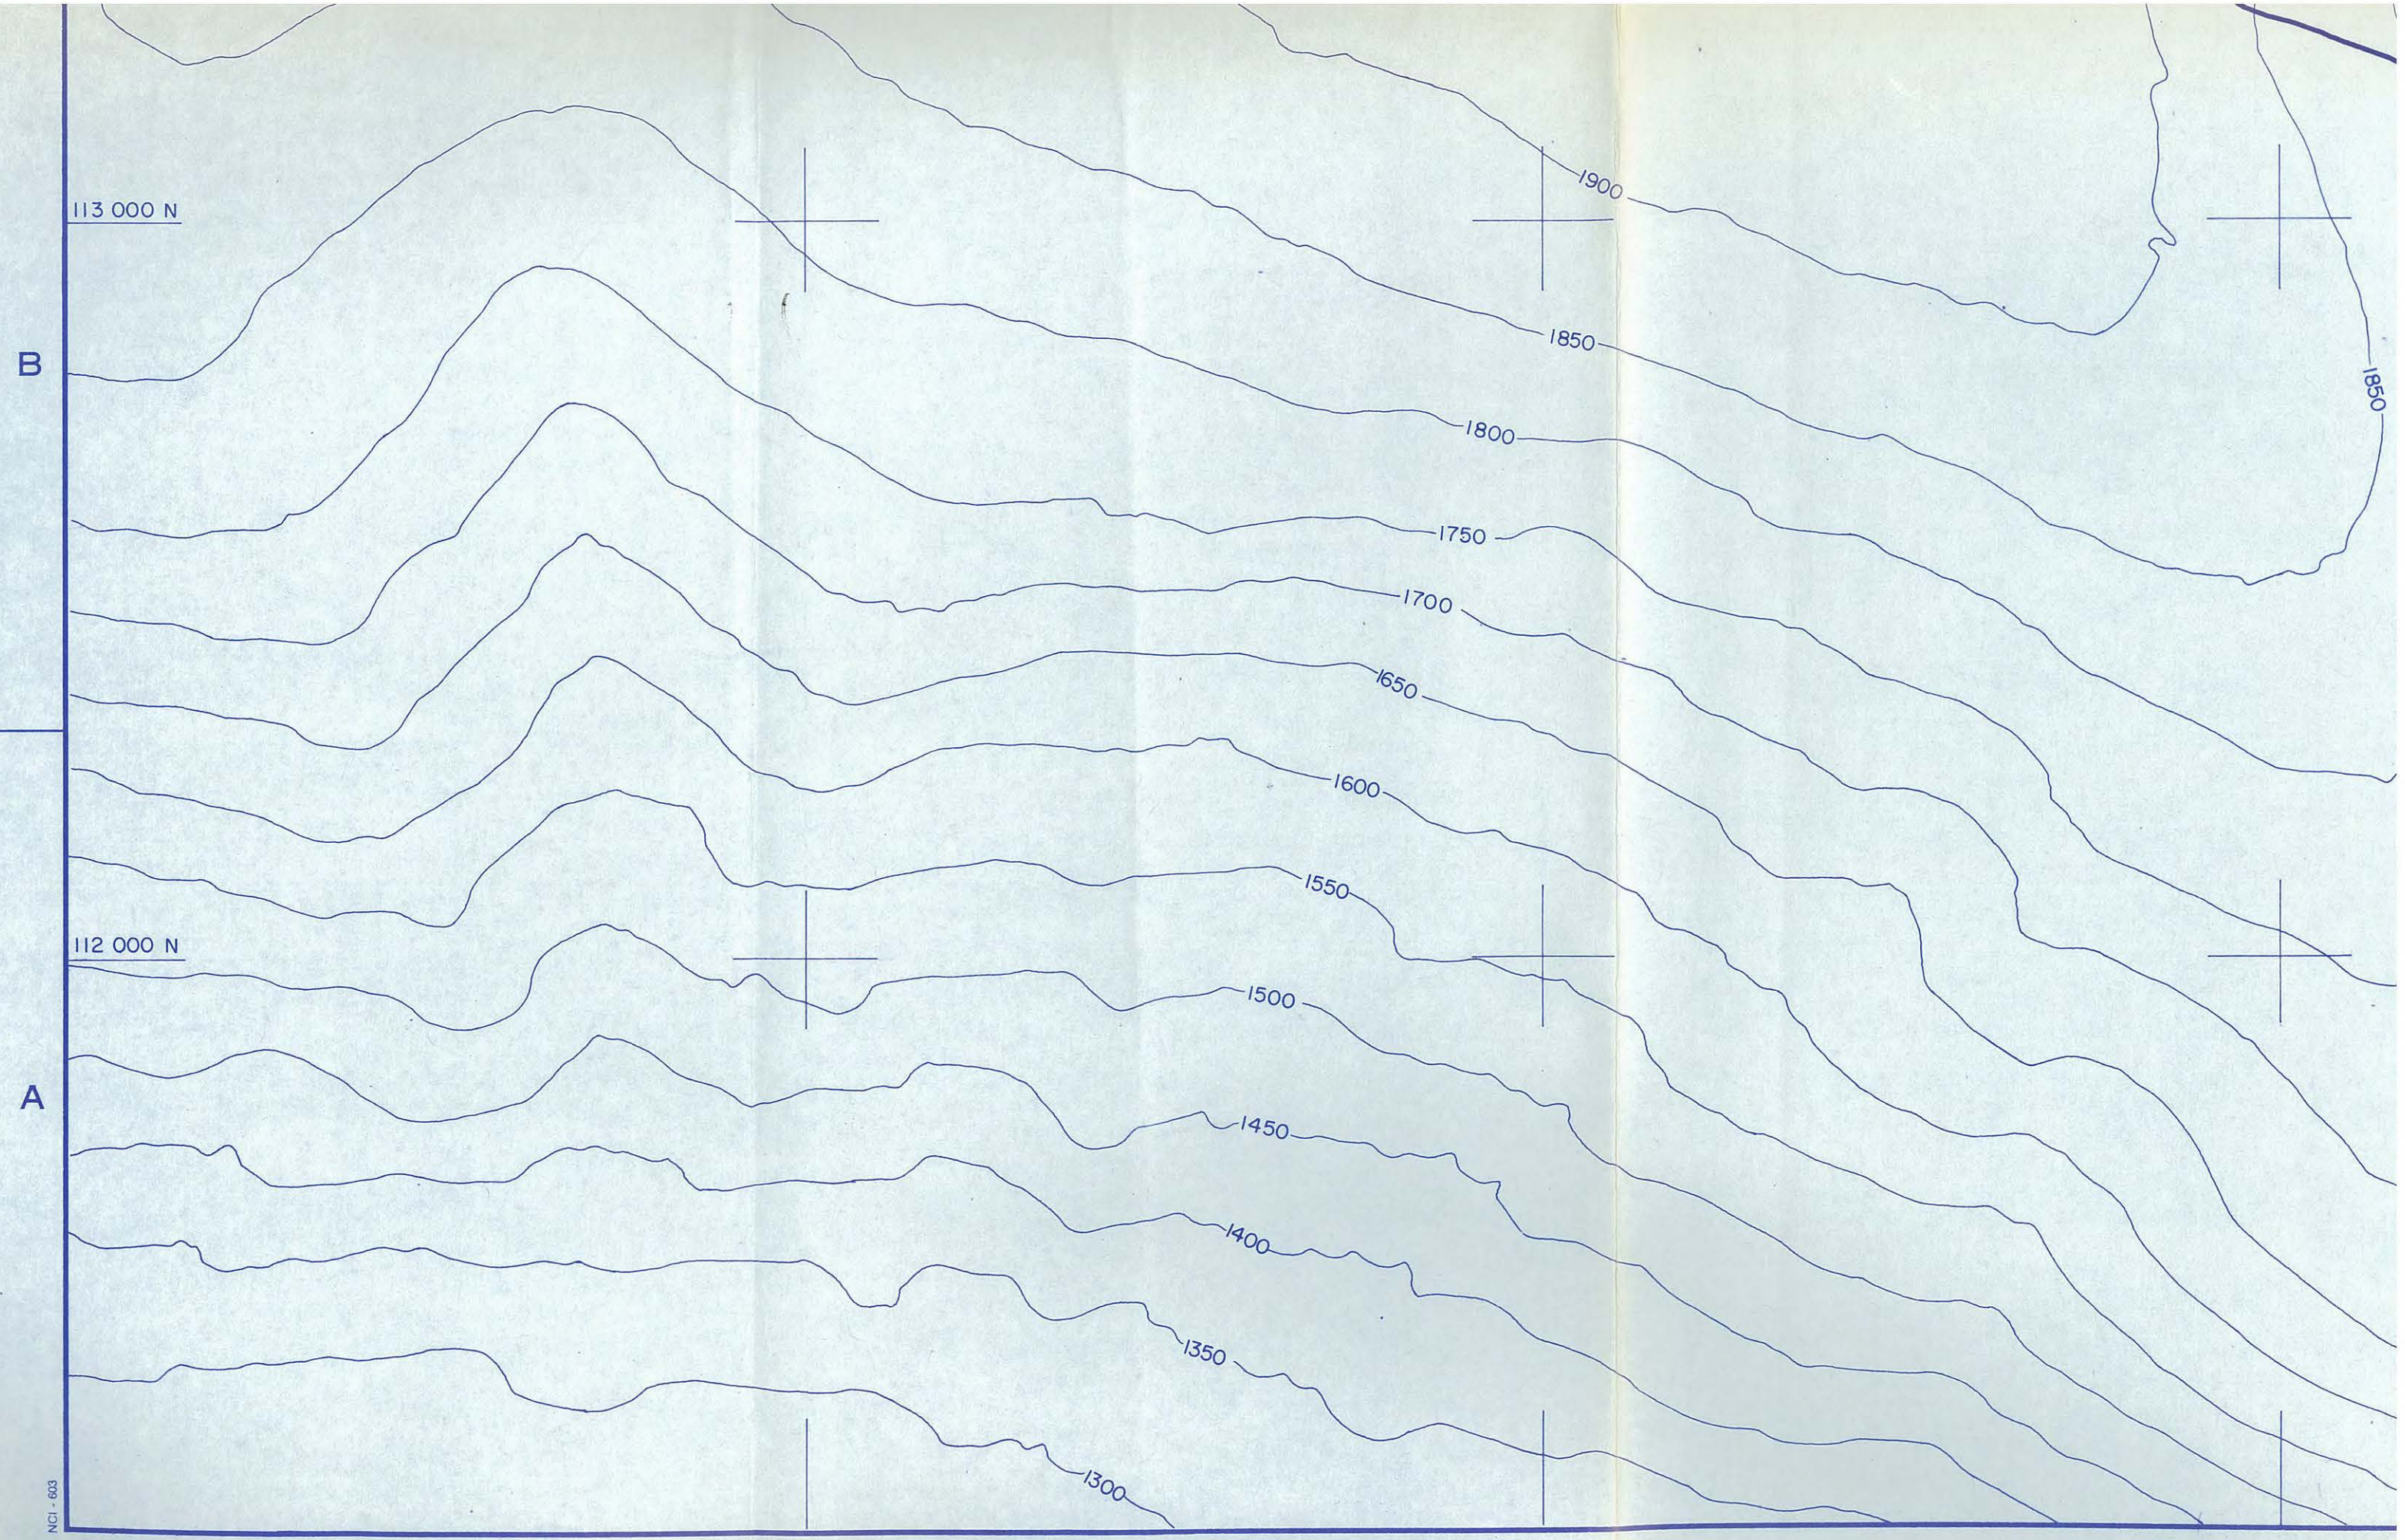
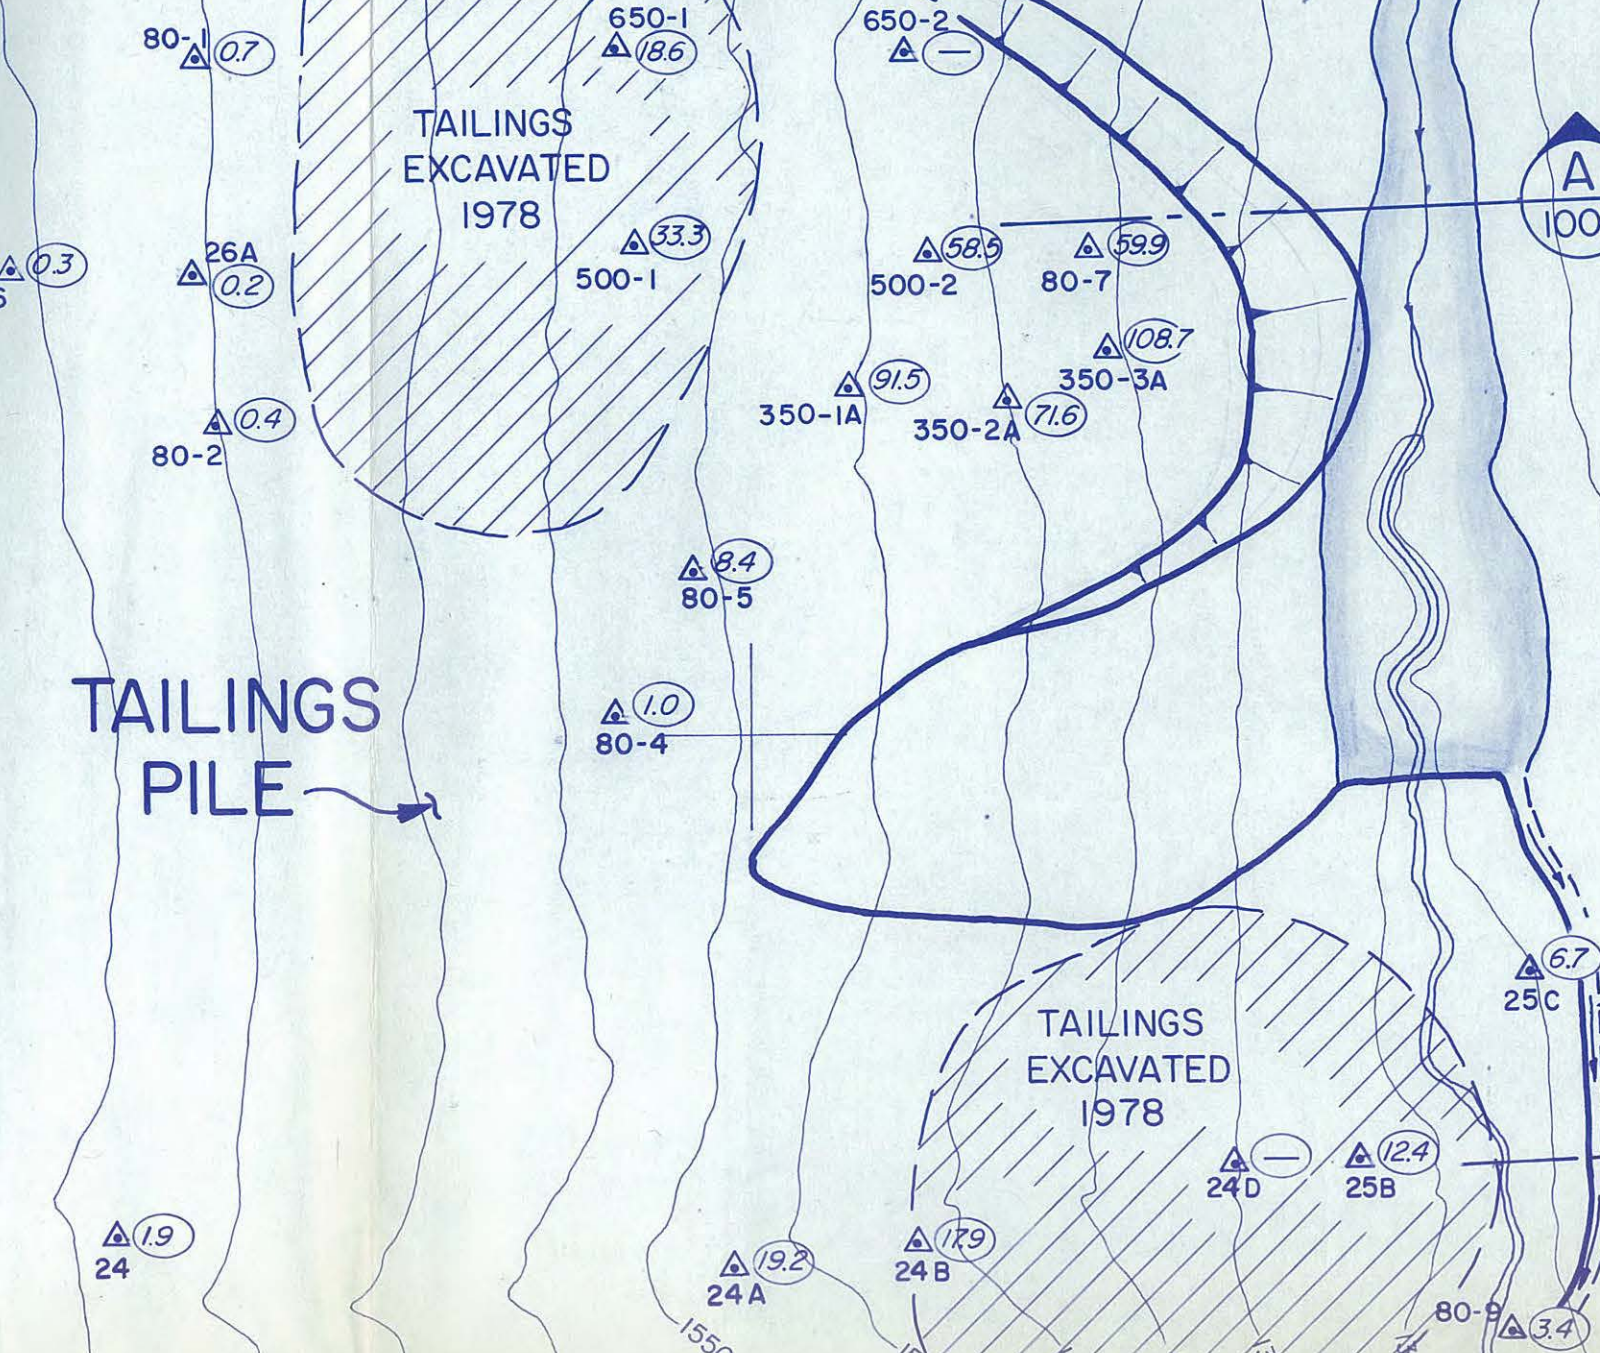
TITLE PLAN OF WOLVERINE CREEK TAILINGS PILES

- a) On the north lobe, the rates of horizontal movement of 11 of 13 points surveyed have decreased from the rates in June 1983. Two points, 350-1A and 350-3A, showed some increase in rate of movement. The maximum rate was at point 350-3A, near the toe of the north lobe, which showed a movement rate of over 100 ft/yr since September 1983. The trend of vertical movements was more or less consistent with the horizontal movements.
- b) Horizontal movements of all six points surveyed on the south lobe showed an increase over the rate for the previous year.

Drawing D-1004A shows monitoring point locations and rates of movement from September 1983 to June 1984.
