REPORT ON 1985 SITE VISIT

PROJECT: CLINTON CREEK ASBESTOS MINE
WASTE DUMP AND TAILINGS PILES

LOCATION: CLINTON CREEK, YUKON TERRITORY

CLIENT: BRINCO MINING LTD.
CASSIAR DIVISION

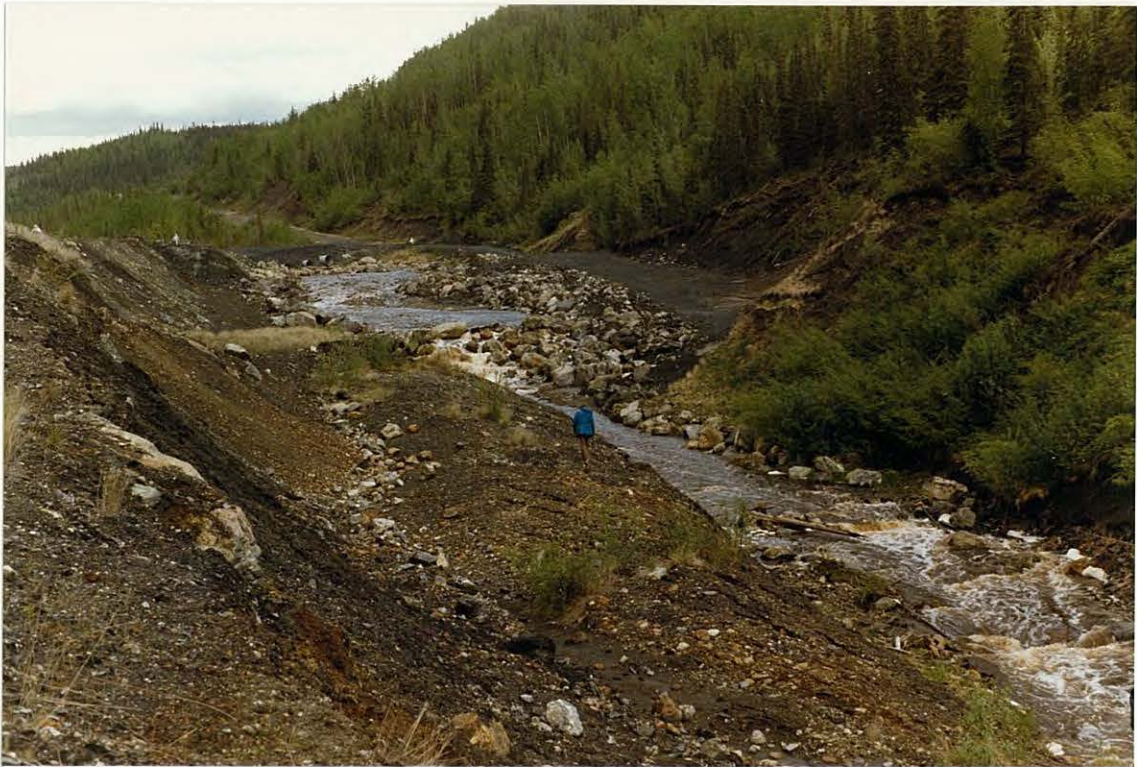
PHOTO 1: Waste Dump channel inlet area looking upstream to channel protection works and inlet culverts.

The channel conveying Clinton Creek over the waste dump performed as expected over the past year. The channel protection works near the upstream end, completed by Brinco in 1984, performed well during spring runoff and appear to be successfully protecting the left bank from further erosion. The remaining rock weir at the lower end of the channel protection works also performed well. Photo 1 shows the channel protection works.

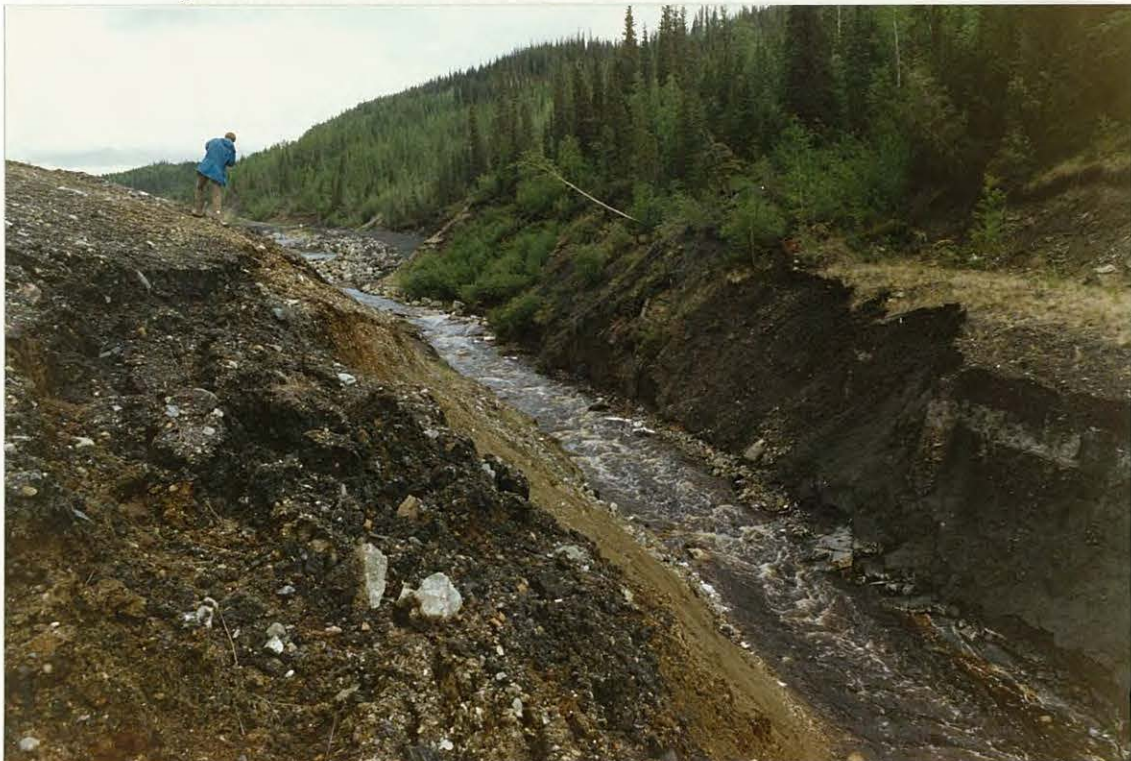
PHOTO 2: Waste Dump channel looking upstream. Erosion protection works in distance.

Some deepening of the Clinton Creek channel, downstream of the 1984 protection works had occurred through downcutting into the bedrock on the left bank. The ongoing process of oversteepening, toe erosion and slumping of the waste material into the stream continued. However, armouring of the stream bed with large rock fragments from the dump also continued. These large fragments serve to dissipate the energy of the stream and also provide erosion protection. Photos 2 and 3 show typical views of the downstream portion of the waste dump channel.

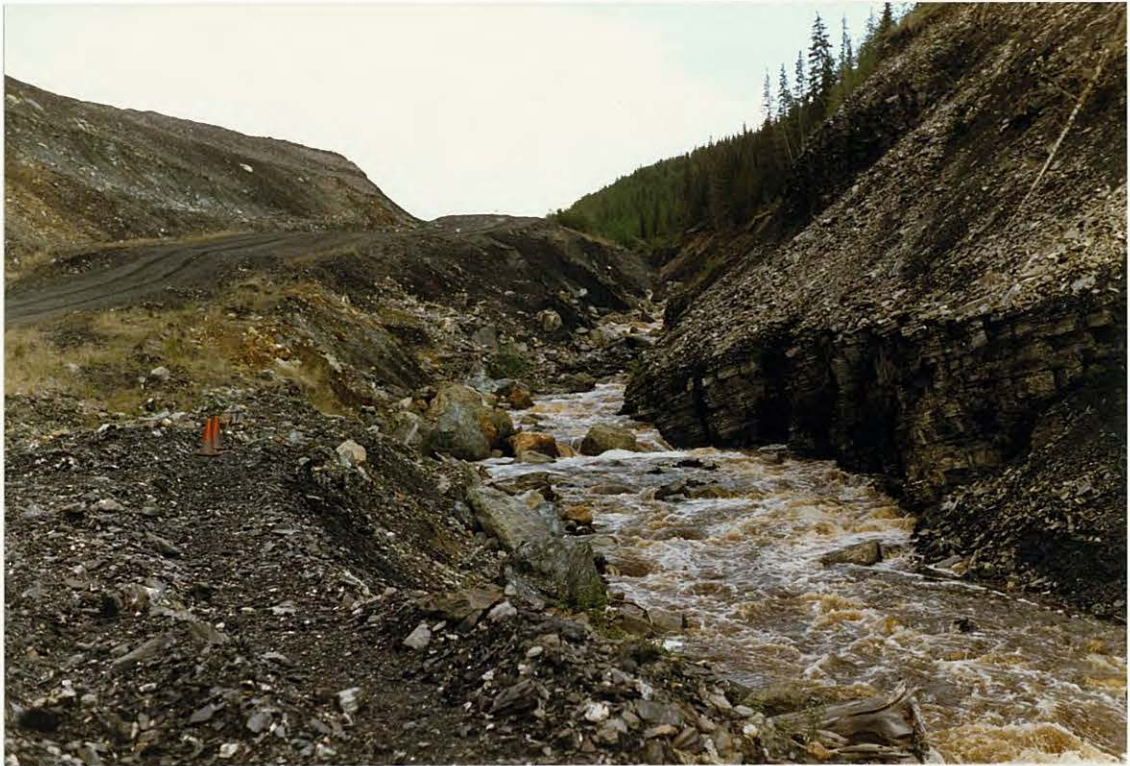
PHOTO 3: Waste Dump channel further downstream.

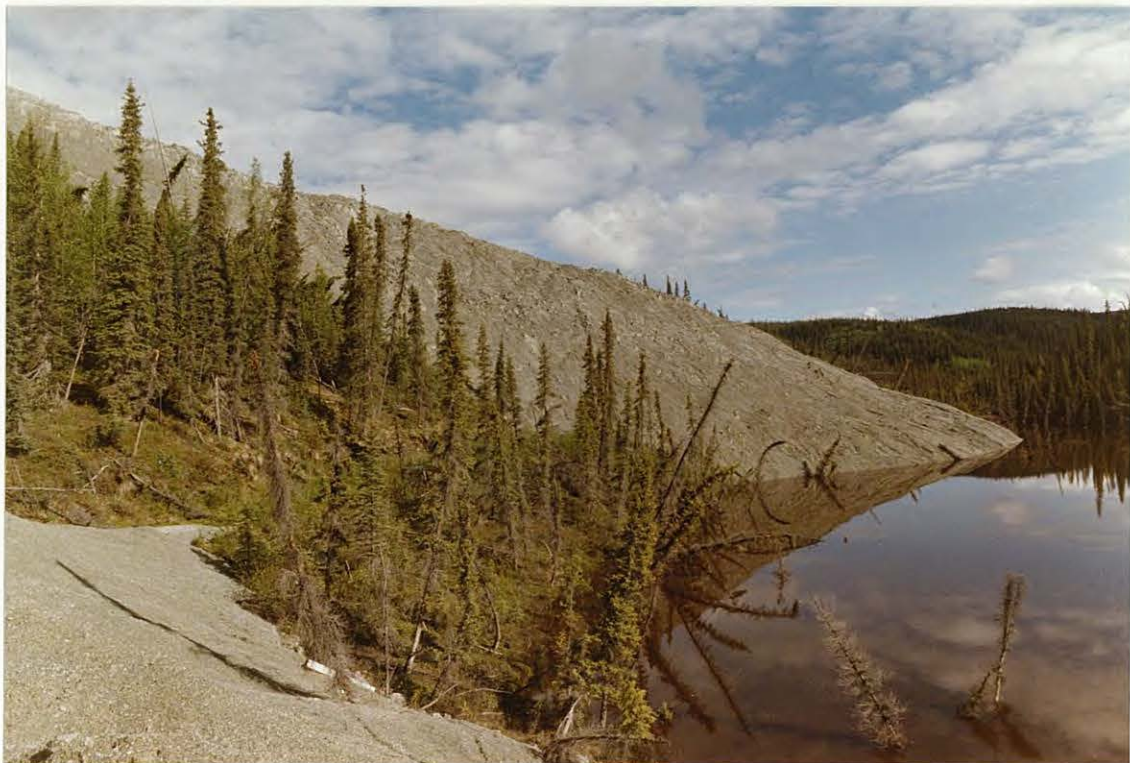
The north lobe of the tailings pile continued large movements on the lower part of the slope. Photo 4 shows the movement of the north lobe into the lake formed by the south lobe. As the photo shows, the previously steep face at the toe flattened considerably as the pile moved into the lake. With this flattened toe, the potential for rapid failure of the north lobe appears to be reduced.

PHOTO 4: North lobe of tailing pile at toe of slope. Toe is now well into lake and slope is flattening.

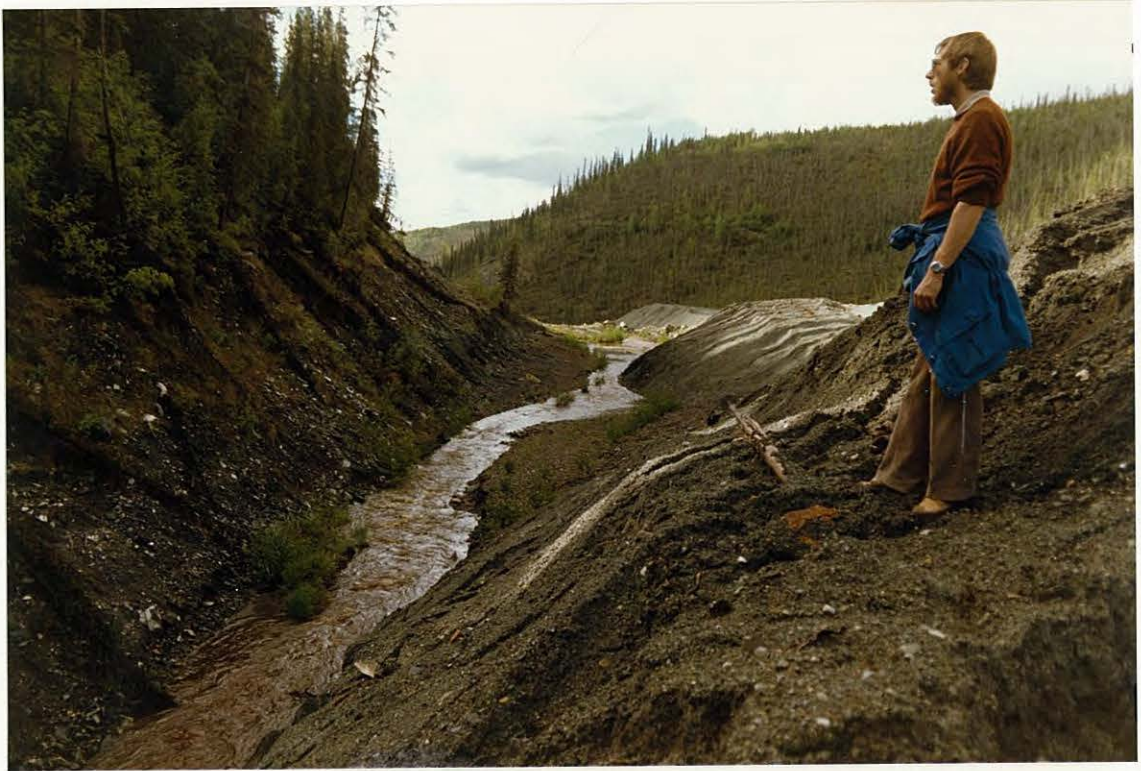
The toe of the south lobe continued to upthrust slightly and to squeeze Wolverine Creek against the left bank. However, an adequate channel remains intact to carry the stream across the south tailings lobe. Some minor erosion of the tailings is occurring at the toe. Photo 5 shows the channel at the toe of the south lobe.

PHOTO 5: Channel at toe of south lobe of tailings pile with inlet to lined channel in distance.

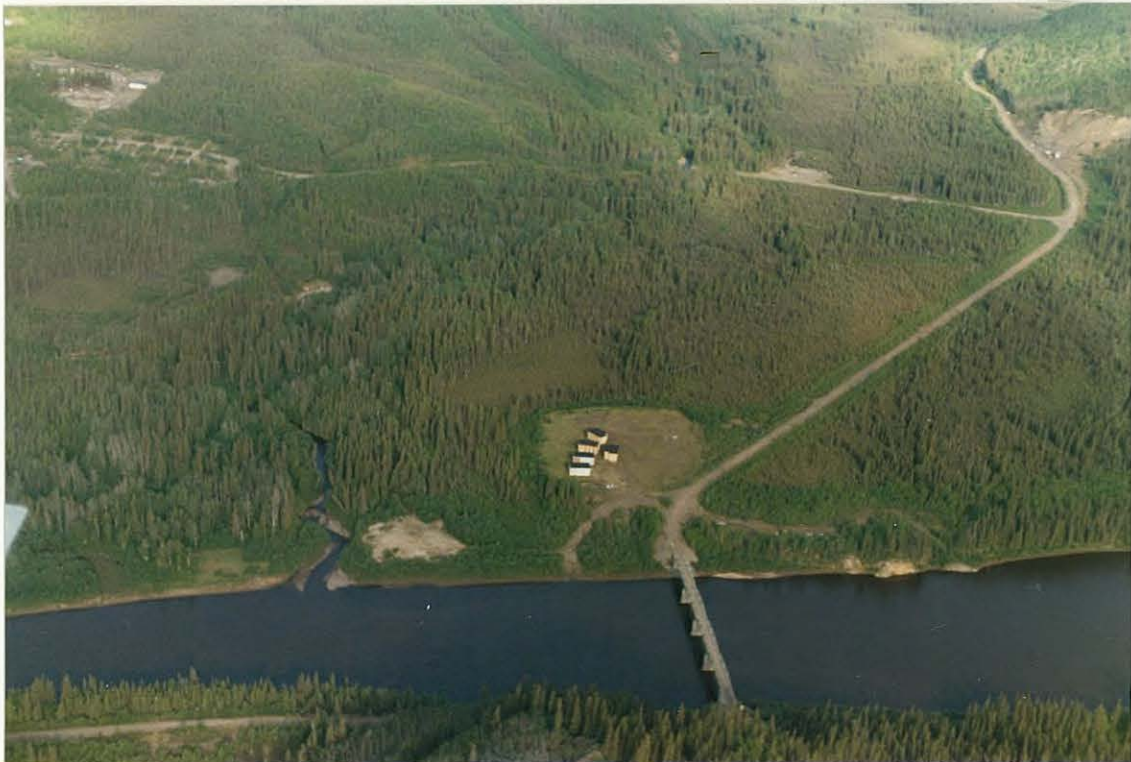
essentially unaffected. Photo 6 shows an aerial view of the mouth of Clinton Creek at the Forty Mile River.

PHOTO 6: Mouth of Clinton Creek at 40 Mile River.
