GEOTECHNICAL ASSESSMENT

**Lot 1 Block 4, Lot 19 and 20 Block 10, and Lot 6 Block 4
Plan 19794 LTO**

Haines Junction, YT

**Yukon Government Community Services
Land Development Branch**

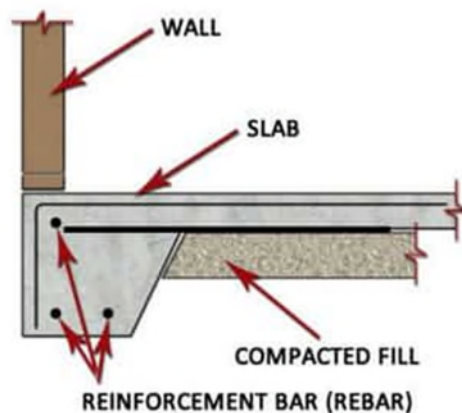
Figure B: Monolithic Foundation

A monolithic slab refers to a type of concrete slab that is cast as a single unit and usually maintains a consistent thickness throughout its entire depth. Nonetheless, variations can occur based on the locality, where the outer portion might be constructed with increased thickness to counter frost heaving and offer improved structural support for external walls. See Figure B.

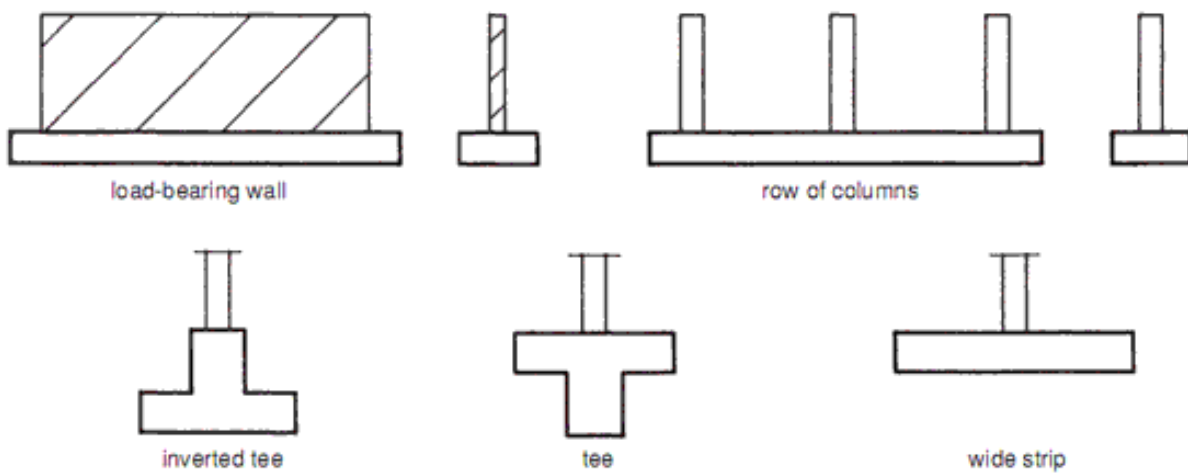
Figure C: Strip Foundation

Strip foundations are versatile and can be used for various subsoils, but they are most effective for soils with decent bearing capacity. They work well for structures with relatively light loads, such as many residential buildings with a few stories. In these cases, mass concrete strip foundations can be used. However, if the situation is different and requires stronger support, reinforced concrete may be required.

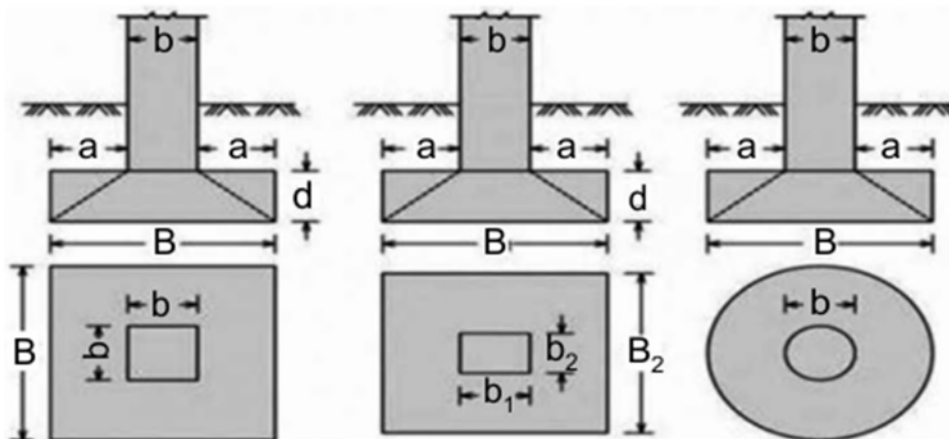
Figure D: Pad/Spread Foundation

Pad foundations are generally shallow, but their depth can be adjusted based on the ground conditions. These foundations are spread-out platforms made of concrete in shapes such as rectangles, squares, or circles. They are designed to carry specific point loads, like the weight of columns or groups of columns in a building's structure. The load is then spread out by the foundation to the soil or rock below. It is also worth noting that pad foundations can also be used to support ground beams in some cases. See Figures C and D.

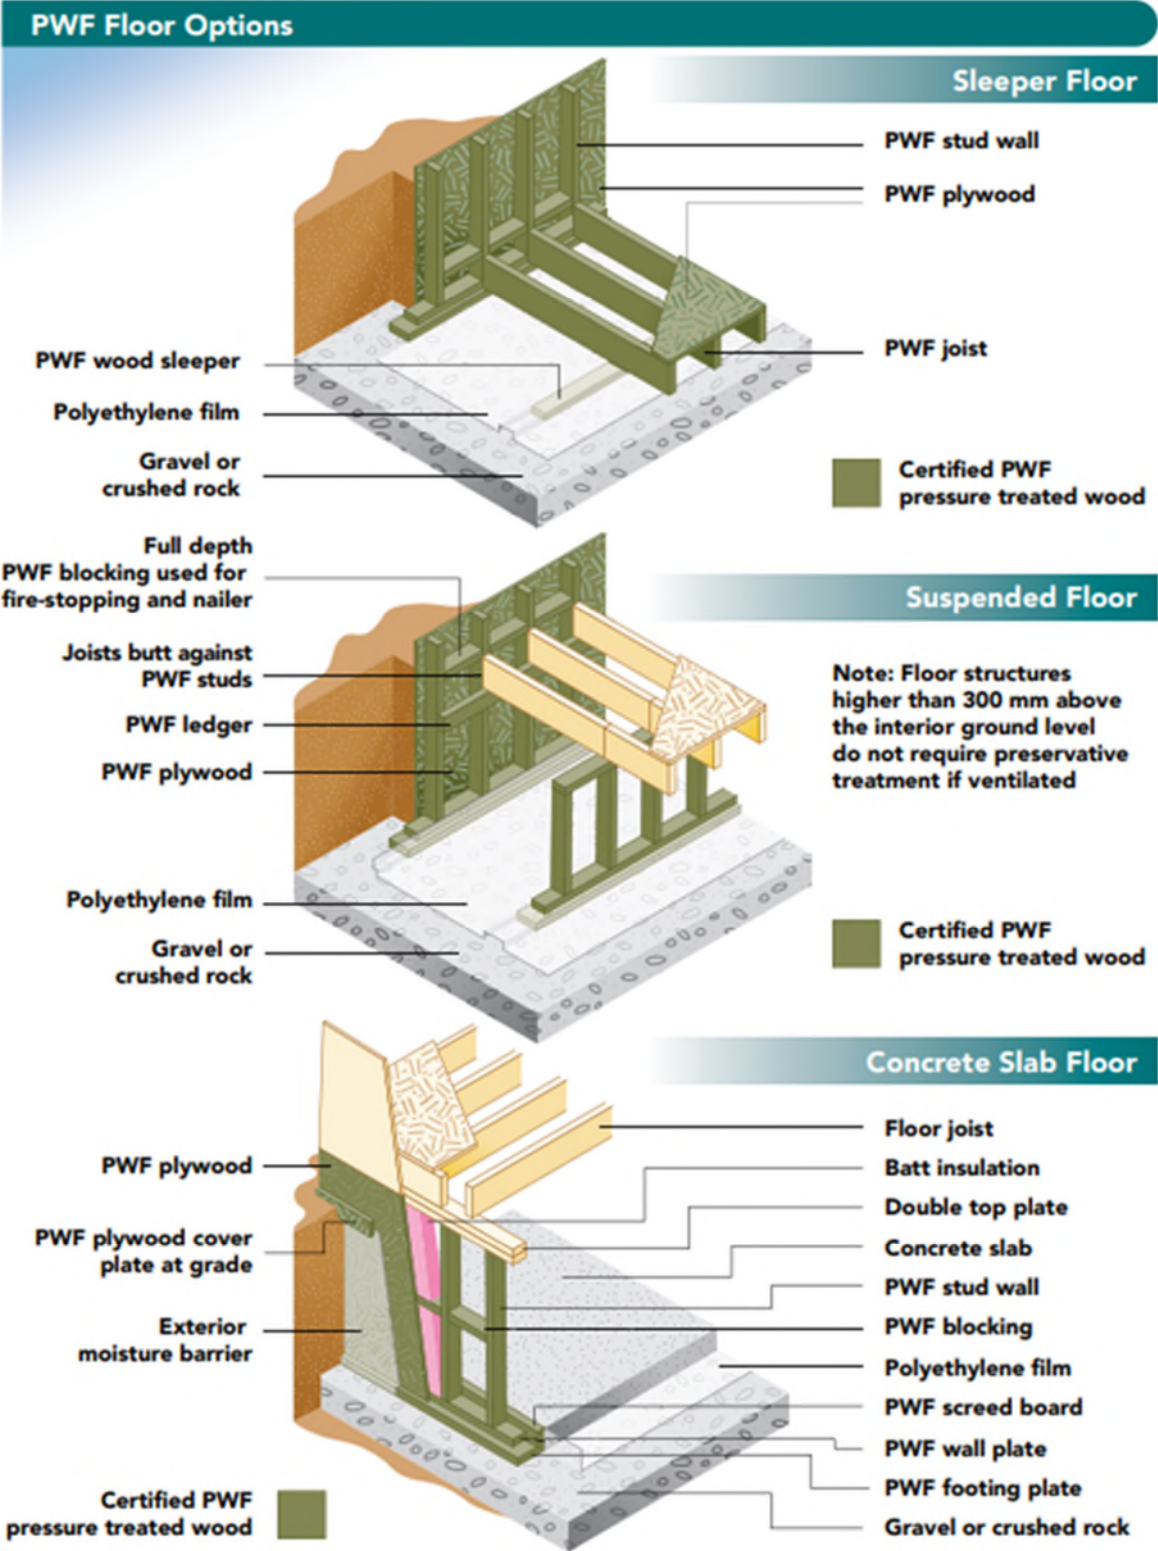
Figure E: Permanent Wood Foundation

A permanent wood foundation (PWF) is an in-ground engineered construction system designed to turn a home's foundation into useable living space. A below-grade stud wall constructed of preservative treated

plywood and lumber supports the structure and encloses the living space. PWFs are suitable for all types of light-frame construction covered under Part 9 (Housing and Small Buildings) of the National Building Code of Canada, under clauses 9.15.2.4.(1) and 9.16.5.1.(1). This includes single-family detached houses, townhouses, low-rise apartments, and institutional and commercial buildings. In addition, the recently revised CSA S406 standard, Specification of permanent wood foundations for housing and small buildings, allows for three-storey construction supported by PWF. See Figure E.

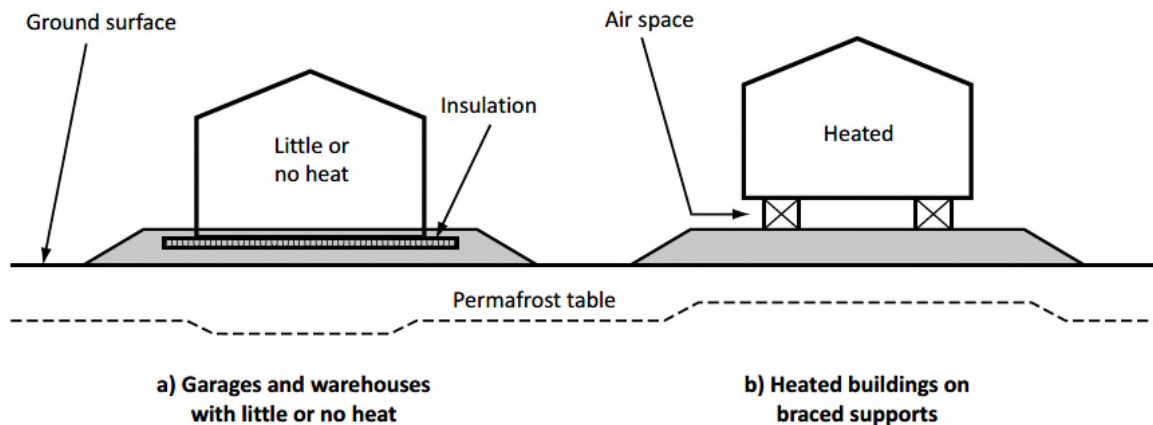
Figure F: Two Basic Pad Foundation Design (CSA 2010)

A granular material pad is commonly used as a base for building on permafrost. It improves access to the site and protects the underlying permafrost. The pad is made of gravel or crushed rock, designed to stay stable during freezing and thawing cycles. It allows permafrost to grow into the base, joining the frozen ground. To prevent heat transfer, buildings are elevated at least 1 m above the pad, allowing air circulation underneath. If buildings are directly on the pad, alternative heat exchangers are used. This method helps to ensure stable construction and protects the permafrost. See Figure F.

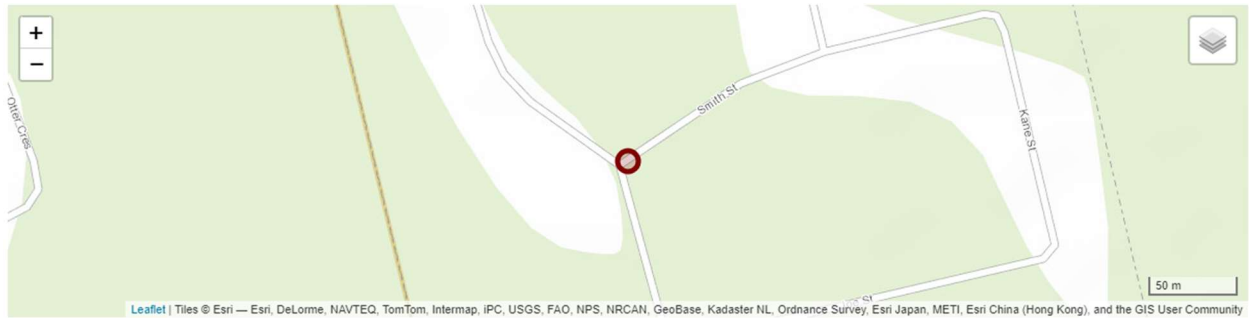
GINT_10016-03

Top depth (m)	Bottom depth (m)	Boundary	Soil description
0.00	0.90	NA	ROAD GRAVEL-classified as SAND(SM)-some gravel, some silt, gravel is fine to medium grained, up to 25 mm in size, subangular, moist when thawed, dark brown
0.90	2.50	0	CLAY(MH)-silty, trace of sand, occasional piece of matrix supported gravel, wet to moist, soft to firm, high plastic, dark olive
2.50	4.50	NA	-seasonally frozen to approximately 2.5 m along roadway
4.50	6.00	NA	-drilling remains easy below seasonal frost line
6.00	6.10	0	NA
6.10	6.10	NA	END OF BOREHOLE 6.0 m

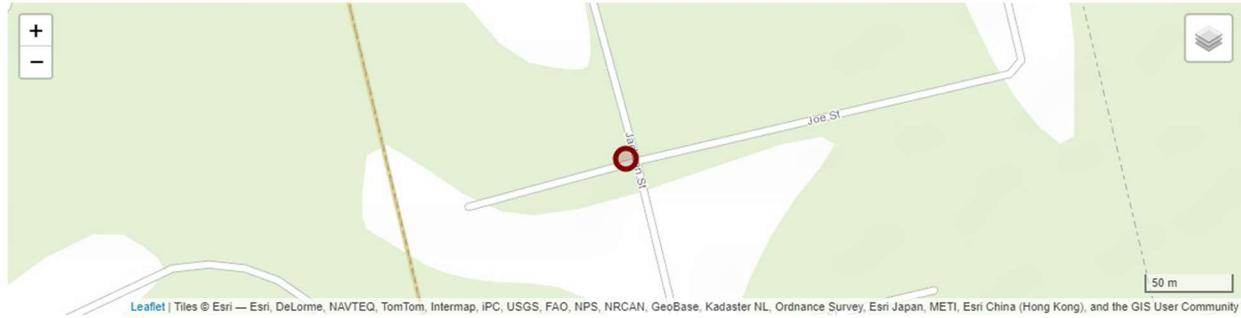
GINT_10016-04

Top depth (m)	Bottom depth (m)	Boundary	Soil description
0.00	0.60	NA	ROAD GRAVEL classified as SAND(SM)-some gravel, some silt, gravel is fine to medium grained, up to 25 mm in size, subangular, moist when thawed, dark brown
0.60	3.00	0	CLAY(MH)-silty, trace of sand, occasional piece of matrix supported gravel, wet, firm, high plastic, dark olive
3.00	5.80	NA	-seasonally frozen to approximately 3.0 m
5.80	6.00	0	SAND, SILT, and GRAVEL (TILL) (SM)- proportions vary throughout unit, moist, compact (est.), light olive
6.00	6.10	0	NA
6.10	6.10	NA	END OF BOREHOLE 6.0 m

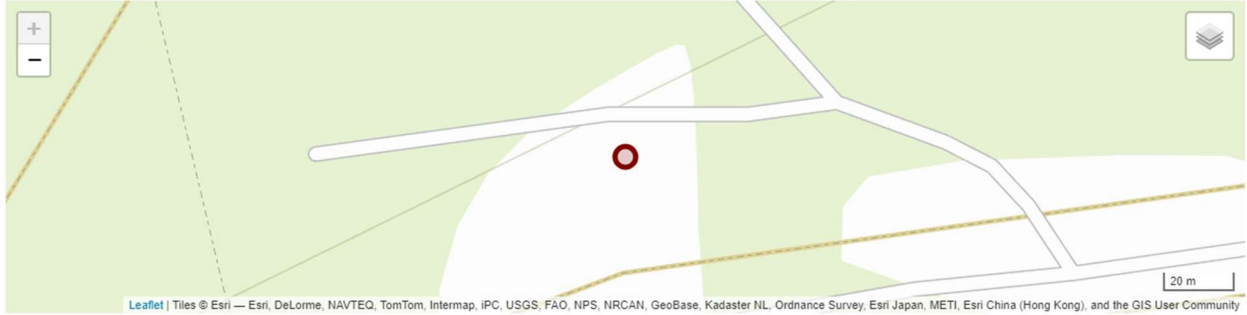
GINT_0722-202

Top depth (m)	Bottom depth (m)	Boundary	Soil description	Comments
0.00	0.15	0	GRAVEL (FILL) - sandy	NA
0.15	3.20	0	CLAY - very silty, moist, firm to stiff, low plastic, medium brown, frozen to 1.4 metres	NA
3.20	3.96	0	SILT - sandy, sand is very fine grained, wet, dense, non plastic, medium brown	NA
3.96	5.33	0	SILT (TILL) - sandy, some fine to medium grained gravel and clay, dry, dense, medium brown	NA
5.33	5.79	NA	NA	- trace of cobbles
5.79	8.54	NA	NA	- reddish iron oxides
8.54	9.45	NA	SAND - sand lenses - fine grained, uniform, (50mm thick)	NA
9.45	9.45	0	END OF BOREHOLE (9.4 metres) slough - 6.7 metres at 0 hrs. water - 6.6 metres at 0 hrs.	NA

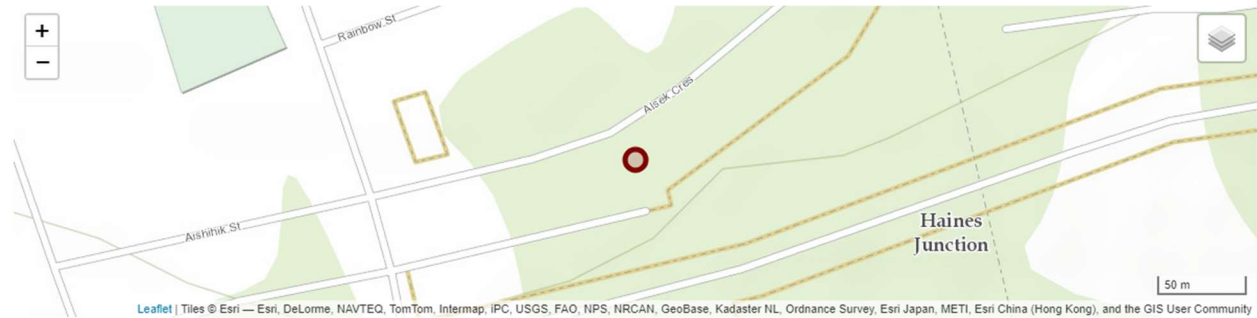
GINT_0923-01

Top depth (m)	Bottom depth (m)	Boundary	Soil description	Comments
0.00	0.30	NA	ORGANIC SILT AND TOPSOIL	NA
0.30	1.80	0	CLAY - sandy, silty, some gravel, hard, moist to dry, grey brown, fine rust-coloured specs	NA
1.80	4.57	NA	NA	- low plastic
4.57	7.77	NA	NA	- as above, moist, silty
7.77	9.30	NA	NA	- more 500 mm gravel
9.30	9.30	0	END OF BOREHOLE AT 9.3 m	NA

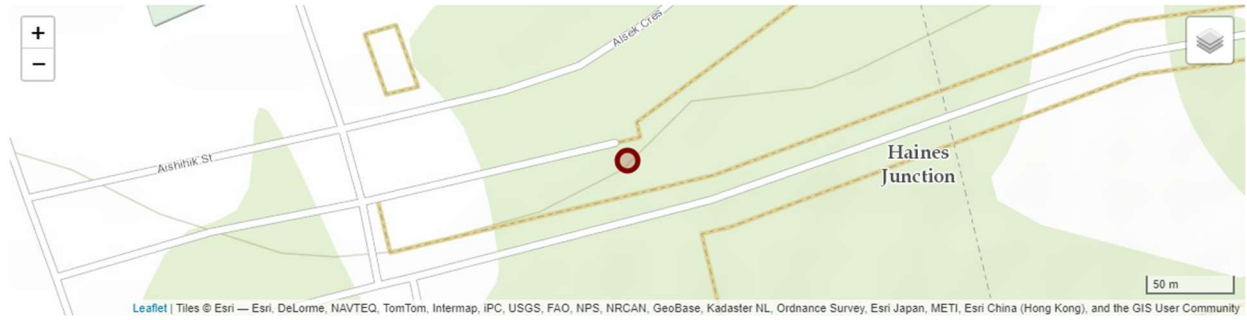
GINT_0923-02

Top depth (m)	Bottom depth (m)	Boundary	Soil description	Comments
0.00	0.15	NA	ORGANIC SILT AND TOPSOIL	NA
0.15	0.90	0	SILT - dry, non-plastic, powdery, grey- brown	NA
0.90	8.84	0	CLAY AND SILT(TILL) - some gravel and sand, low plastic, grey-brown	NA
8.84	9.60	0	NA	- sandy, moist, low plastic, very stiff
9.60	9.60	0	END OF BOREHOLE AT 9.6 m	NA

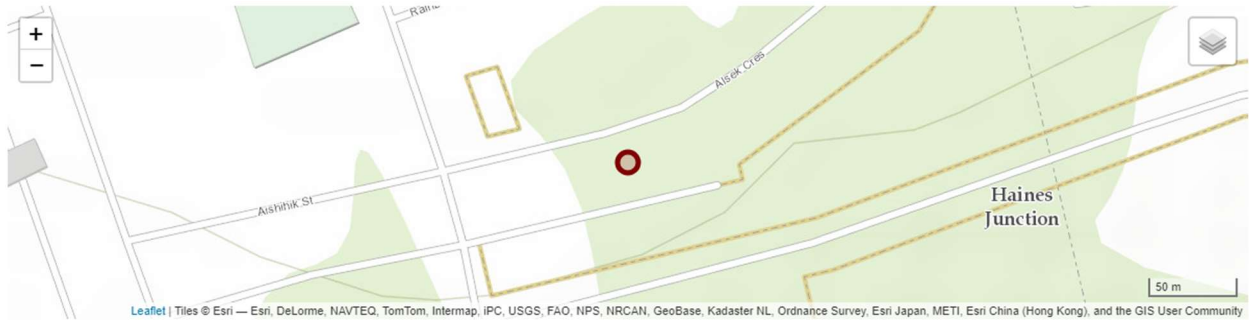
GINT_0923-03

Top depth (m)	Bottom depth (m)	Boundary	Soil description
0.00	0.50	NA	ORGANIC SILT AND TOPSOIL
0.50	7.32	0	CLAY(TILL) - silty, sandy, some fine to medium gravel, low plastic, hard
7.32	7.93	0	GRAVEL - open
7.93	8.54	0	SAND - no recovery
8.54	9.45	0	GRAVEL - medium gravel, sandy(?)
9.45	9.45	0	END OF BOREHOLE AT 9.4 m

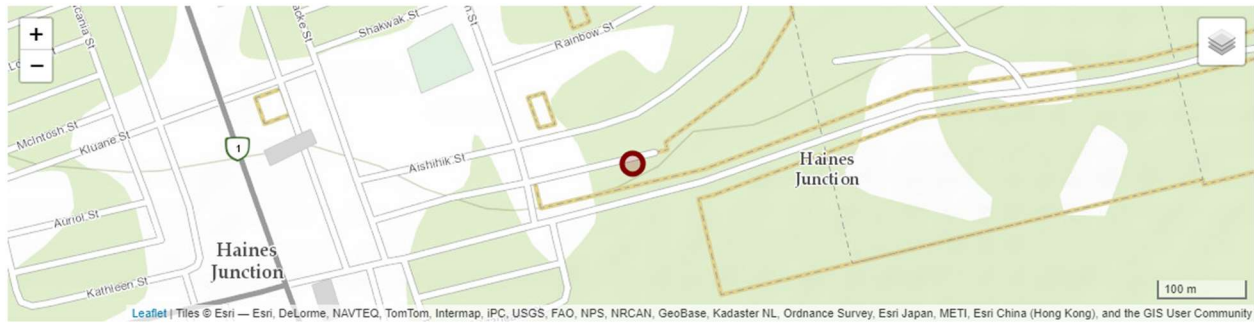
GINT_0923-04

Top depth (m)	Bottom depth (m)	Boundary	Soil description	Comments
0.00	0.50	NA	ORGANIC SILT AND TOPSOIL	NA
0.50	1.52	0	SILT - uniform dry, grey	NA
1.52	6.10	0	CLAY(TILL) - silty, sandy, some gravel, hard, low plastic, rust specs	NA
6.10	6.25	0	NA	- as above
6.25	6.25	0	END OF BOREHOLE AT 6.2 m	NA

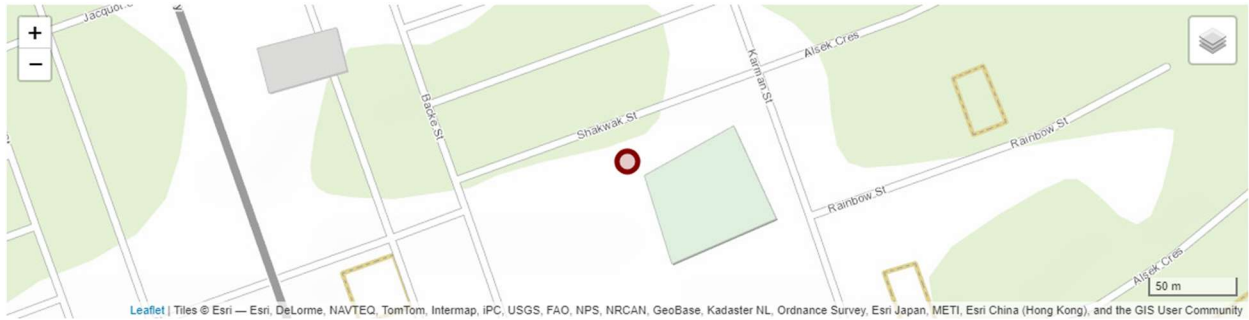
GINT_4167-01

Top depth (m)	Bottom depth (m)	Boundary	Soil description
0.00	1.20	NA	SILT AND CLAY - damp to moist, interbedded olive brown - Seasonal Frost to 0.9 m
1.20	2.30	0	SILT(TILL) - sandy, some gravel, occasional cobbles and boulders, damp, dense, grey-brown
2.30	2.90	NA	- water noted on sampler
2.90	4.50	0	SAND(TILL) - some silt and gravel, occasional cobbles and boulders, dry to damp, very dense, grey-brown
4.50	5.70	NA	- occasional sand lenses
5.70	5.70	0	END OF BOREHOLE AT 5.7 m

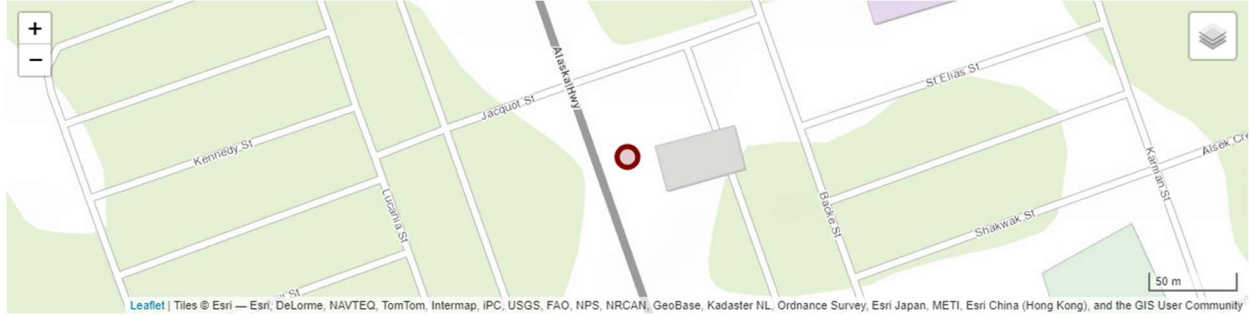
GINT_1240021-TP03

Top depth (m)	Bottom depth (m)	Boundary	Soil description
0.00	0.45	NA	GRAVEL (FILL) - some sand; damp; grey; no hydrocarbon odour- seasonal frost to 0.1 m
0.45	4.50	0	- organic horizon lineSILT (TILL) - some clay, trace of sand, trace of gravel; well graded; dense; moist; grey brown; strong hydrocarbon odour
4.50	4.80	NA	- cobble layer
4.80	4.80	0	END OF TESTPIT @ 4.8 mNo groundwater encountered.

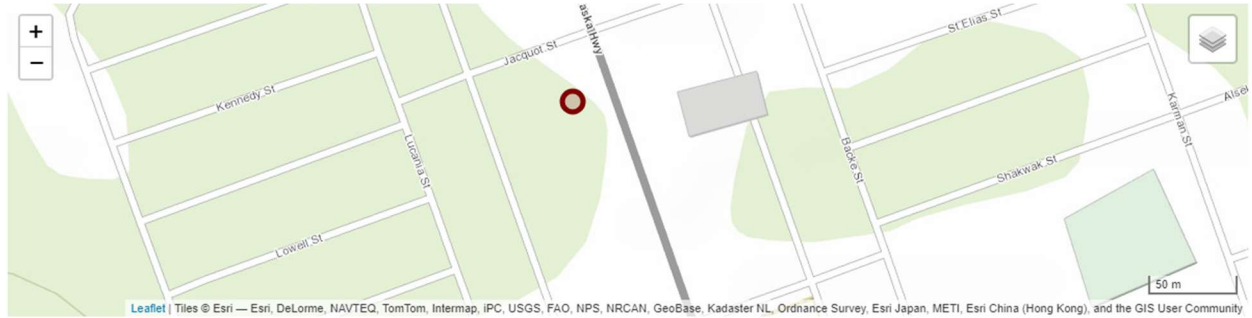
GINT_14019-BH03

Top depth (m)	Bottom depth (m)	Boundary	Soil description
0.00	0.10	0	GRAVEL (FILL) - some sand, damp, grey, hydrocarbon odour
0.10	1.50	0	SILT (TILL) - sandy, some sand, damp, brown, strong hydrocarbon odour
1.50	2.00	NA	- seasonally frost from 1.5 m to 3.0 m
2.00	3.00	0	SILT - clayey, grey, hydrocarbon odour
3.00	5.50	0	CLAYEY SILT (TILL) - trace to some gravel, fine grained, dense, hydrocarbon odour
5.50	6.00	NA	- damp, light brown, slight hydrocarbon odour
6.00	7.00	NA	- trace to some gravel, fine grained, dense, hydrocarbon odour
7.00	7.60	NA	- damp, light brown, slight hydrocarbon odour
7.60	7.60	0	END OF BOREHOLE @ 7.6 m

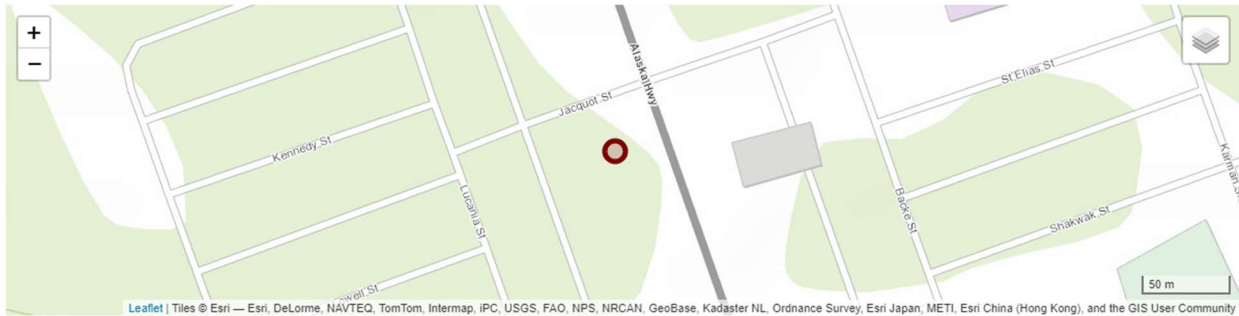
GINT_14019-MW04

Top depth (m)	Bottom depth (m)	Boundary	Soil description
0.00	0.15	0	GRAVEL (FILL) - some sand, damp, grey, strong gasoline smell from surface
0.15	1.50	0	SILT AND SAND (TILL) - trace to some gravel, damp, strong hydrocarbon odour
1.50	3.00	0	SILT - clayey, seasonal frost from 1.5 to 3.0 m, stiff low plasticity grey-brown, strong hydrocarbon odour
3.00	5.00	0	SILT AND SAND (TILL) - gravelly, fine grained sand, fine to medium grained gravel, damp, hydrocarbon odour
5.00	6.00	NA	- uniform, damp, greyish brown, strong hydrocarbon odour
6.00	7.00	NA	- trace to some gravel, fine grained, hydrocarbon odour
7.00	7.60	NA	- uniform, dry, greyish brown, hydrocarbon odour
7.60	7.60	0	END OF BOREHOLE @ 7.6 m

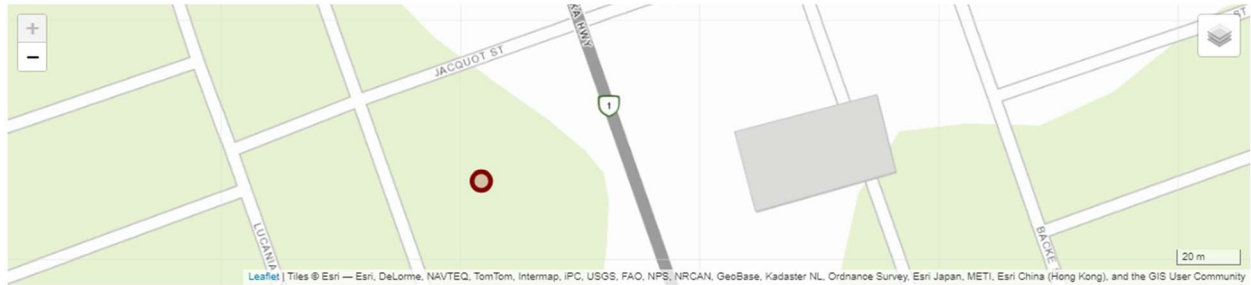
GINT_14019-MW01

Top depth (m)	Bottom depth (m)	Boundary	Soil description
0.00	0.80	0	SAND & GRAVEL (FILL) - trace of silt, fine to medium grained, damp, grey and brown, no odour
0.80	2.00	0	CLAY - silty, stiff, low plasticity, grey-brown, slight hydrocarbon odour
2.00	4.60	NA	- frozen from 2.0 to 4.6 m
4.60	7.60	0	SILT (TILL) - trace to some sand, trace to some gravel, damp, very dense, brown, strong solvent like odour
7.60	10.00	NA	- trace to some sand, dry, dense, grey brown, solvent like odour
10.00	10.70	NA	- some gravel, damp, very dense, brown, hydrocarbon odour
10.70	12.20	NA	- trace to some sand, damp dense, grey brown, slight hydrocarbon odour
12.20	12.20	0	END OF BOREHOLE @ 12.2 m

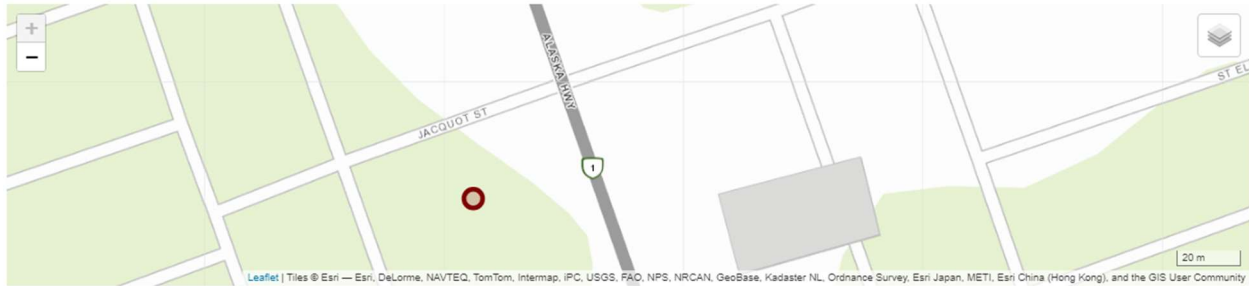
GINT_1240021-TP02

Top depth (m)	Bottom depth (m)	Boundary	Soil description
0.00	2.00	NA	SILT (TILL) - some sand, trace of gravel; well graded; dense; moist; grey brown; mild hydrocarbon odour- seasonal frost to 0.1 m
2.00	4.00	0	SILT - clayey; non-plastic; firm; moist; no hydrocarbon odour
4.00	4.00	0	END OF TESTPIT @ 4.0 m No groundwater encountered.

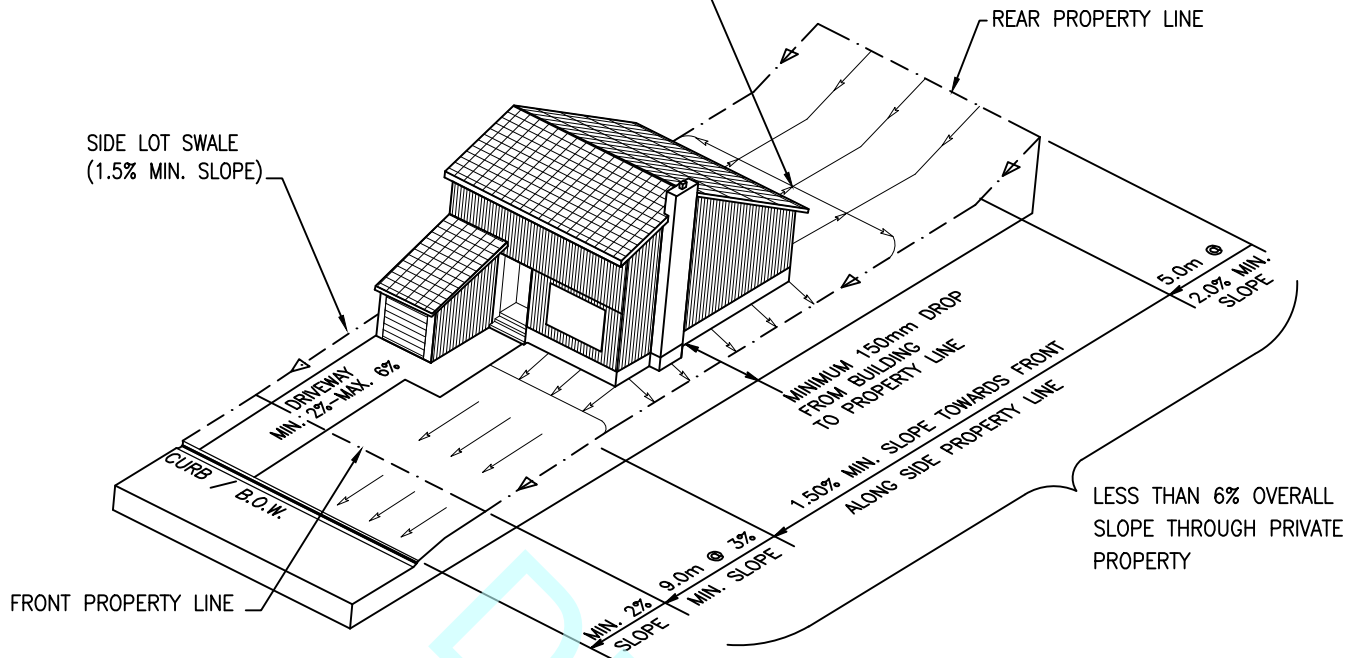
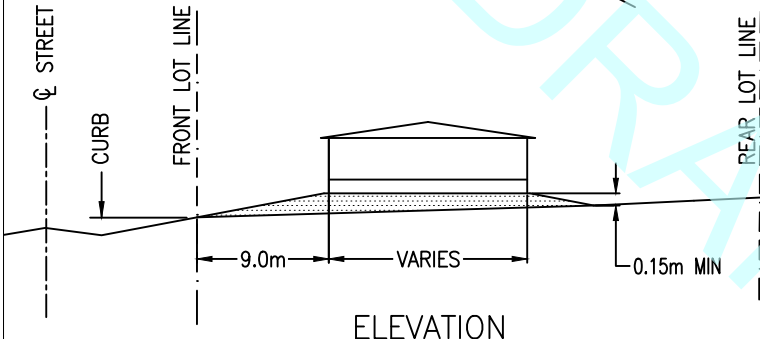
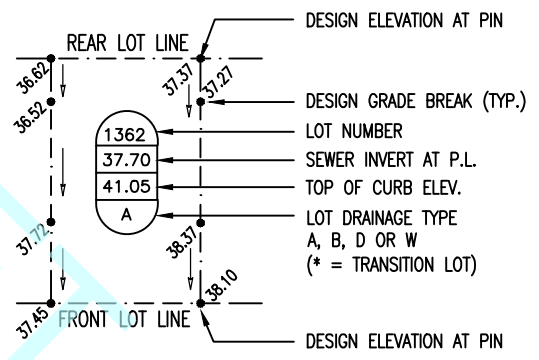
CITY OF WHITEHORSE LOT DRAINAGE DETAIL DRAWINGS

TYPICAL RELATIVE HIGH POINT ACROSS YARD (DRAINAGE MAY BE SPLIT FROM CENTRE OR ALL SLOPED TO LOW SIDE)
TYPICAL 1.5% MIN. CROSS YARD SLOPES.
