## **Geotechnical Evaluation Freegold Road and Lot 193 Residential Development Carmacks, Yukon**

PRESENTED TO  
**Government of Yukon**

SEPTEMBER 29, 2021  
ISSUED FOR USE R1  
FILE: 704-ENG.WARC03938-08

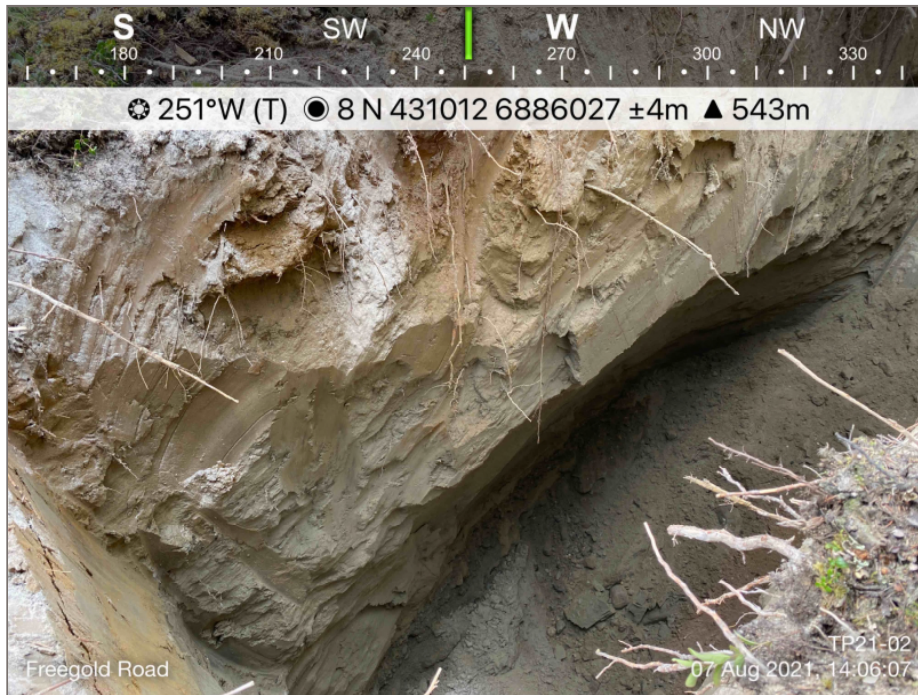
**Photo 1:** Freegold Road Area – Testpit 2 (TP21-02).

- Testpit TP21-02 was excavated in Region 2. At this location, heavy moss cover and organic root mat was noted over a thin veneer of ash layer. At 0.2 m, silty sand was encountered to the depth of 2.4 m. At 2.4 m glaciofluvial sand and gravel with some cobbles and some boulders were encountered and extended to the 4.0 m testpit termination depth.

but poorly bonded frozen soil was observed in Testpit TP21-02 and very cold soil temperatures were noted near the base of TP21-03 which may indicate that permafrost is present beyond the reach of the excavator.

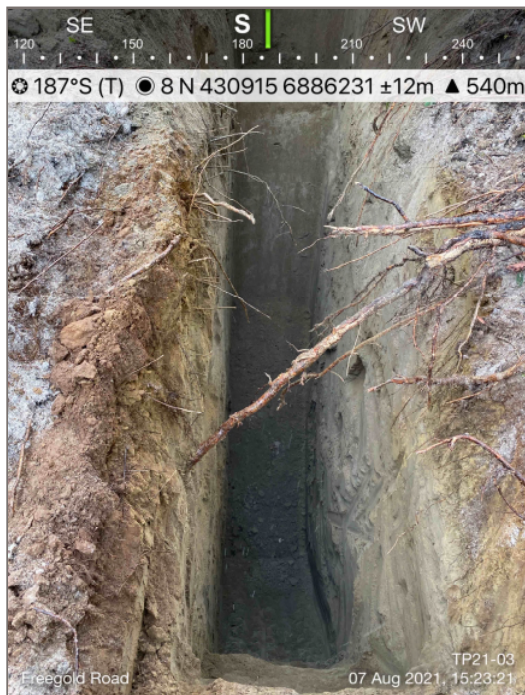
**Photo 2:** Freegold Road Area – Testpit 3 (TP21-03).

- Testpit TP21-03 was also excavated in Region 2, close to the hillside. Below the moss ground cover and organic rootlets mixed with ash, silty sand was encountered to the depth of 2.4 m. From 2.4 m onwards, silt with trace sand was dominant. This fine-grained, frost susceptible, moist soil unit extended to the termination depth of 4.3 m.

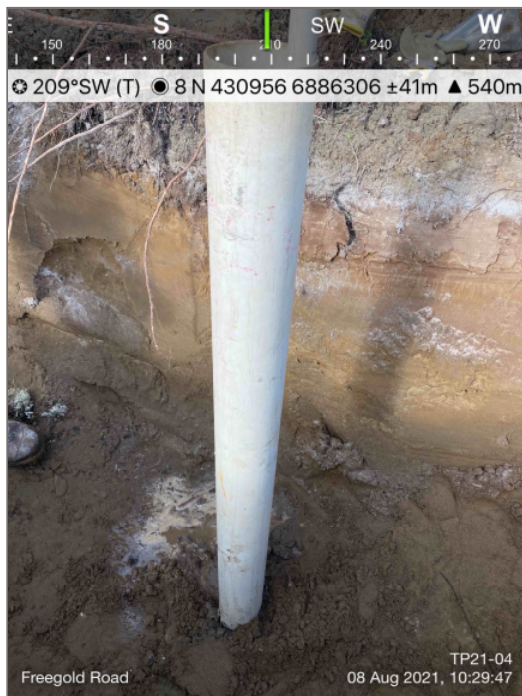
**Photo 3:** Freegold Road Area – Testpit 4 (TP21-04) percolation rates testing.

- Testpit TP21-04 was excavated within the central part of Region 1. Below the organic layer of moss and rootlets a distinctive, 5 mm thick ash layer was noted. Between 0.2 m to 2.9 m, glaciofluvial sand with trace silt was present overlying an interbedded sand and silt unit, which extended to the termination depth of 4.1 m.

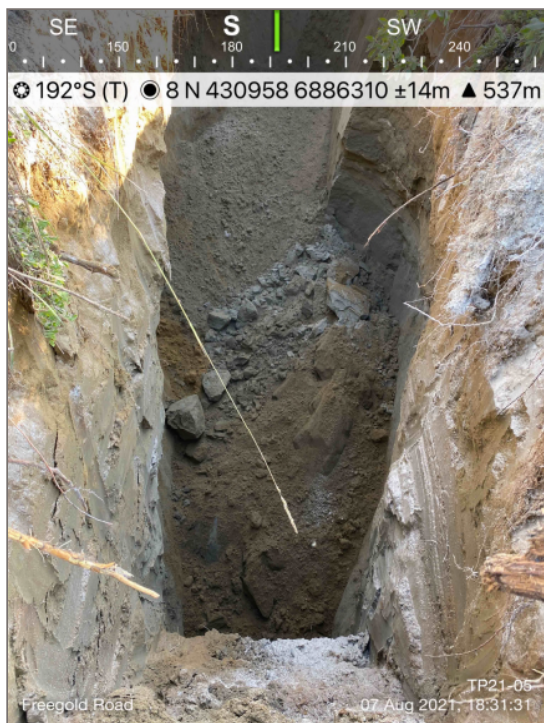
**Photo 4:** Freegold Road Area – Testpit 5 (TP21-05).

- Testpit TP21-05 was excavated in the northwest side of Region 1. At this location moss cover and organic root mat was noted above a 15 mm thick coarse ash layer. Between 0.2 m to 4.1 m silty sand was observed throughout the testpit.
