**ENVIRONMENTAL CLEAN-UP STUDY  
OF  
21 DEW STATION SITES IN CANADA  
FINAL REPORT: DRAFT**

**VOLUME 4  
BAR 2  
Shingle Point, Yukon Territory**

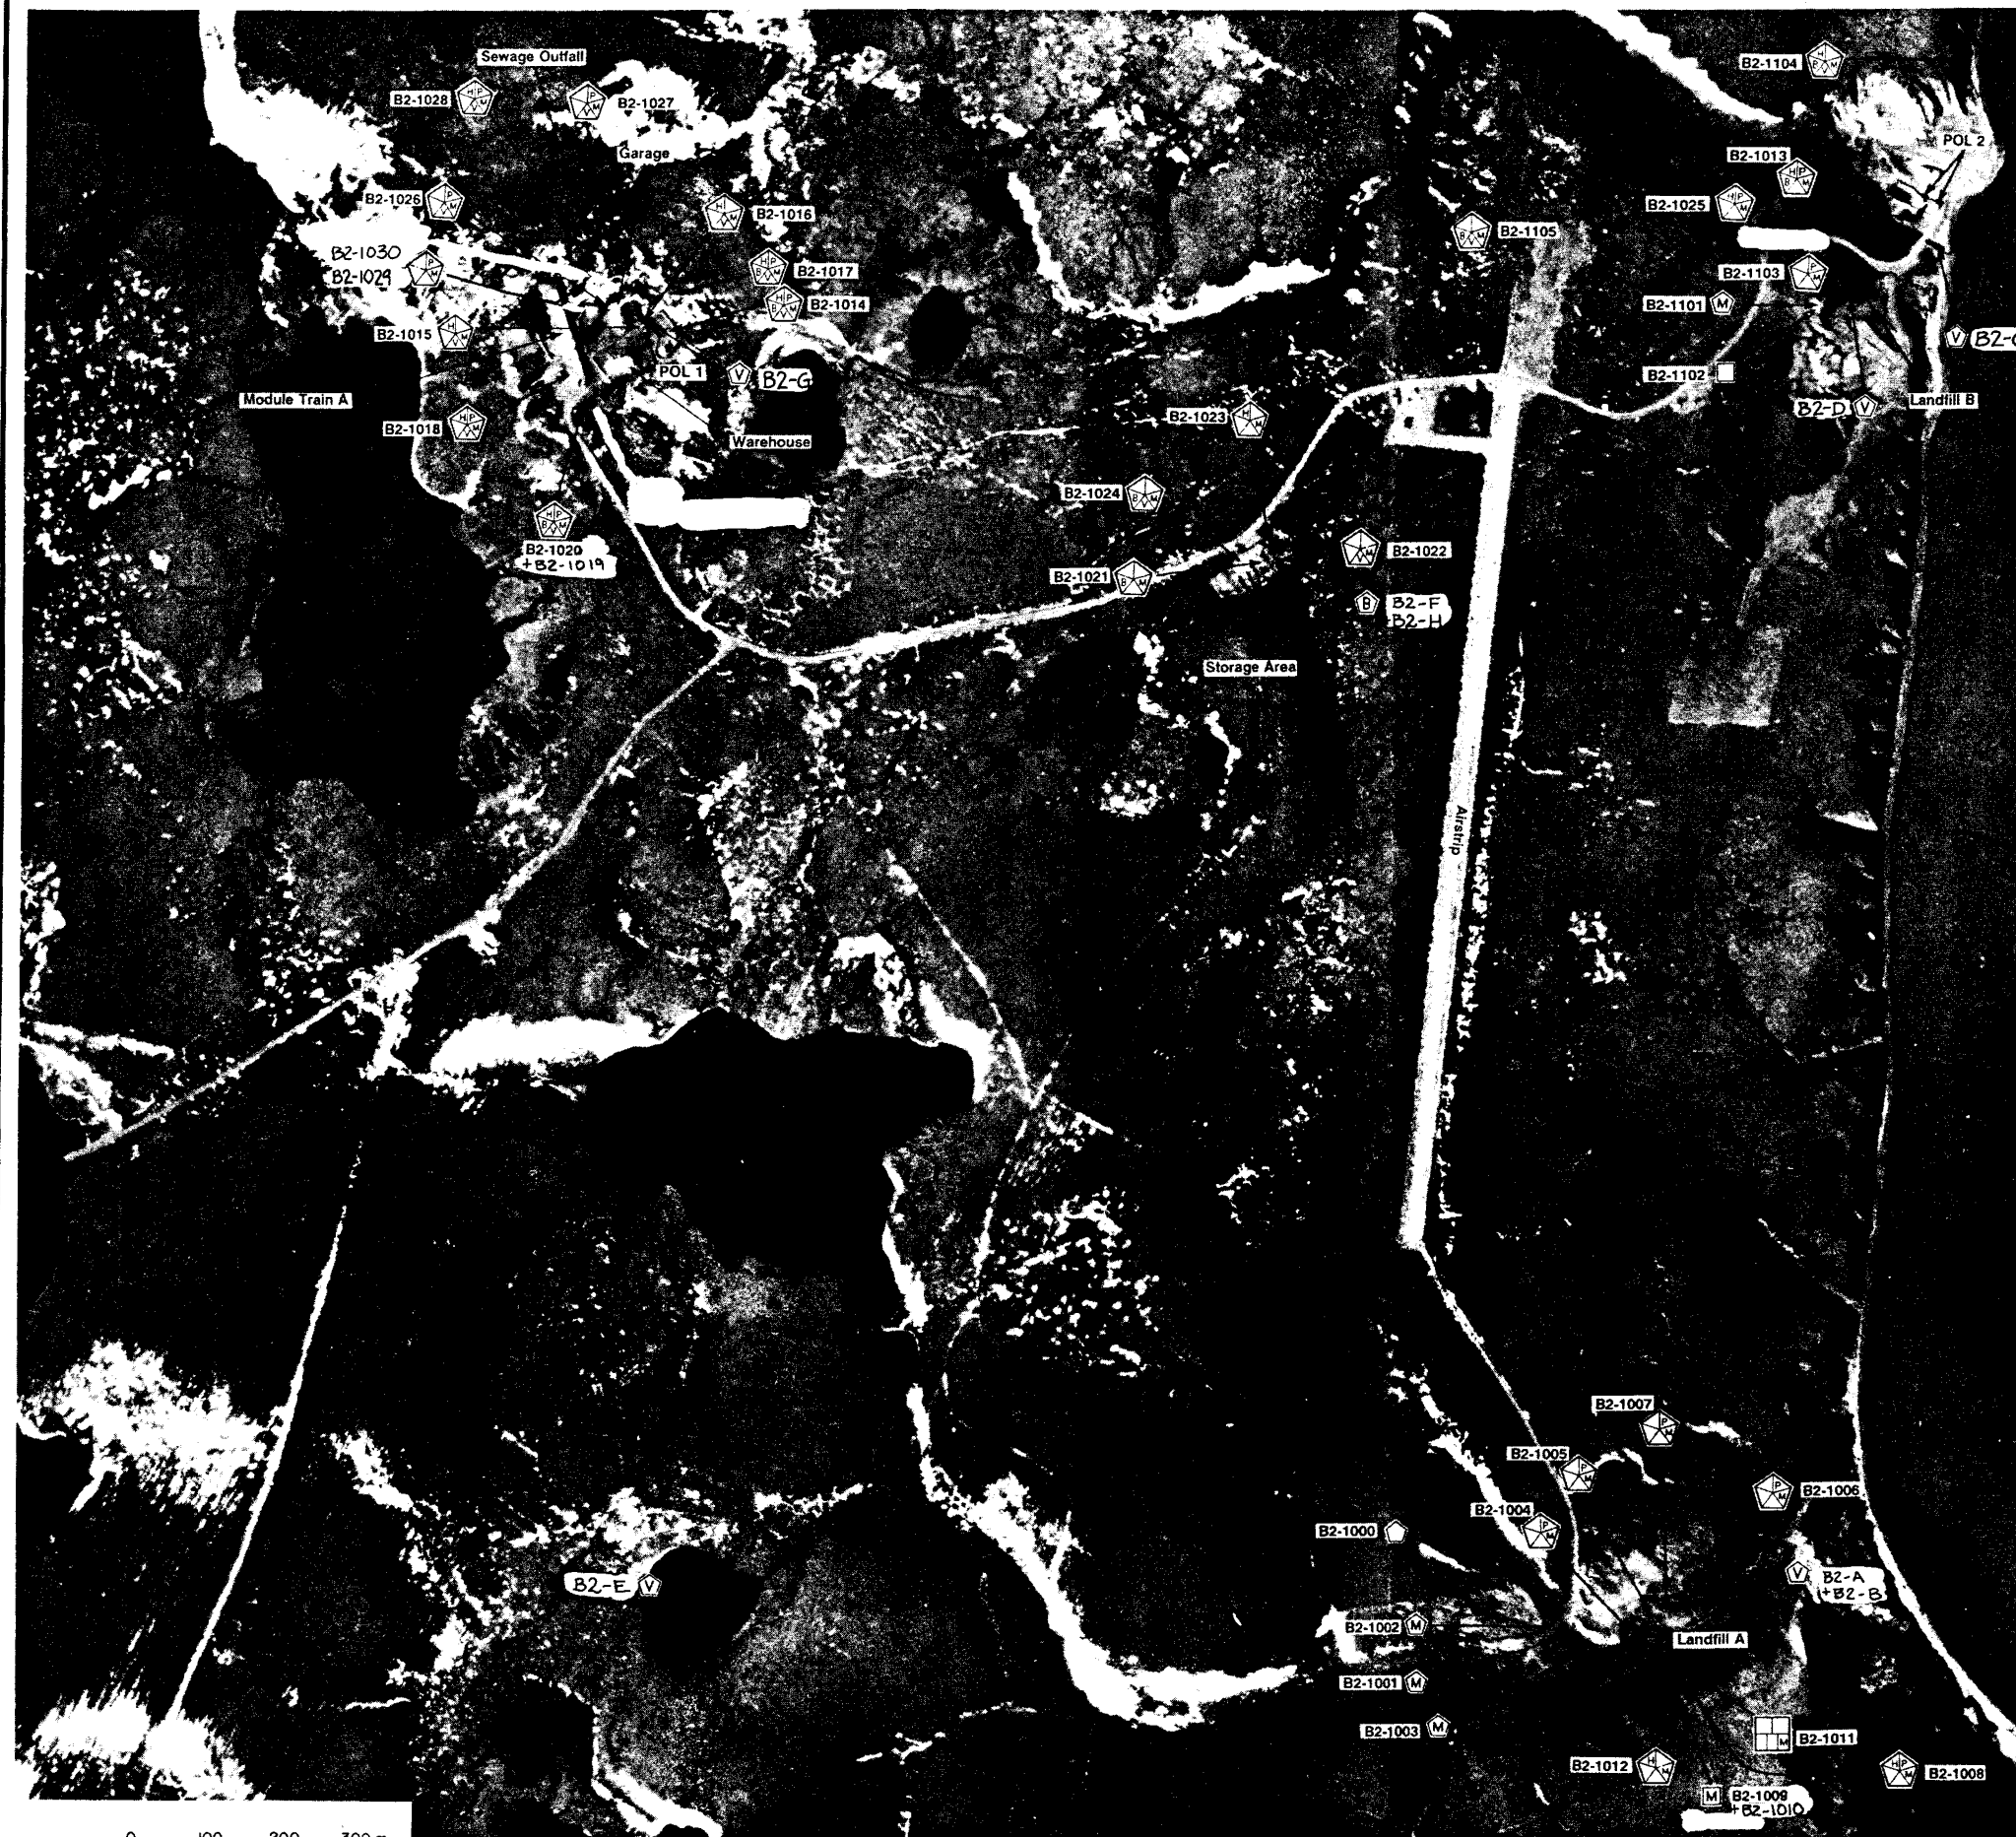
BAR-2 SHINGLE POINT  
 STATION AREA SAMPLE SITES  
 AND PARAMETERS IDENTIFIED  
 FIGURE 6.1

Sample site locations are presented in Figure 6.1. Also indicated is information on elevated parameters at specific sample sites.

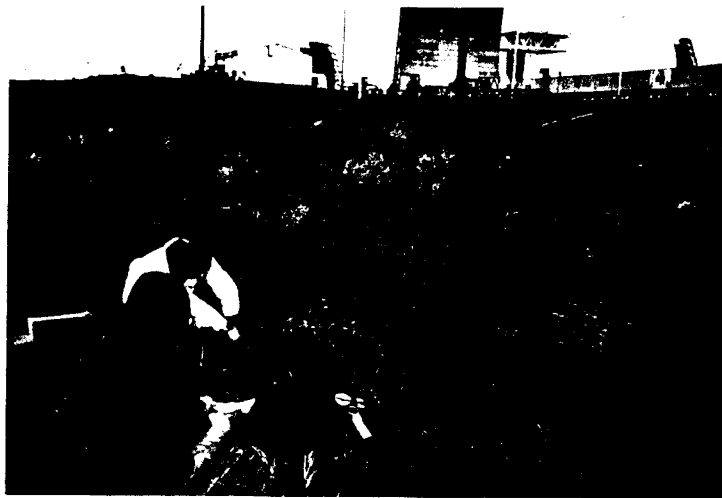
PLATE 1

The sewage outfall area was located 200 m north of main module (Plate 1). Sewage is discharged directly onto organic terrain and disperses along local drainage channels and over the surface. The organic layer was approximately 30 cm thick, with the inclusion of clay at a depth of 15 cm. Permafrost was encountered at 30 cm. The area has experienced eutrophication, as indicated by the lush vegetation and the occurrence of *Senecio* spp. which are characteristic of outfall areas. Some stressed vegetation was noted in the vicinity of the outfall.

SEWAGE OUTFALL AREA

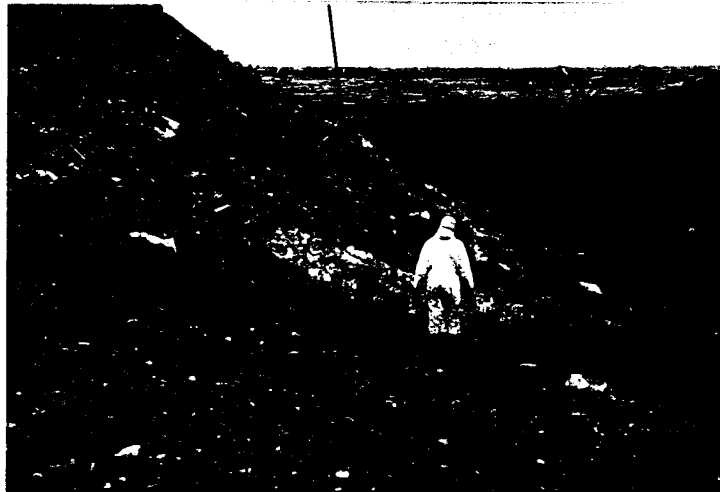
PLATE 2

ACTIVE LANDFILL AREA

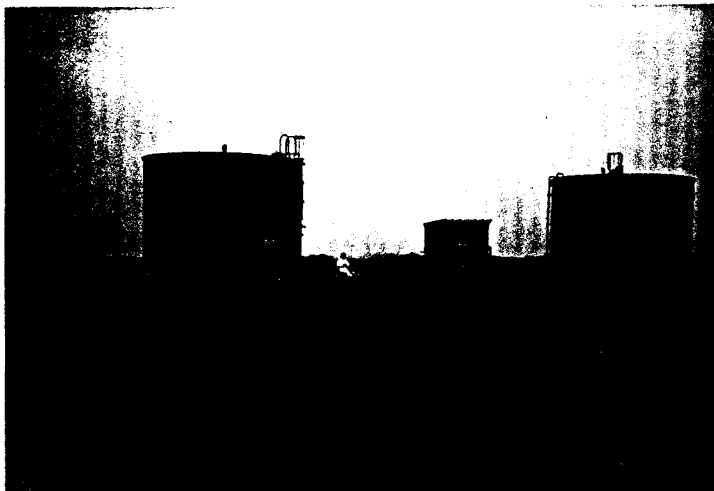
PLATE 4

POL 1 storage facilities are located 100 m north of the module train and consist of two 295 m<sup>3</sup> diesel tanks (Plate 4). General drainage in this area is to the north and northeast (Figure 3.1). Within the catch basin and immediately outside the berm walls, the soils encountered were a silty gravel with some sand. At greater distances, this was overlain by organic soil. The tanks were elevated on a gravel pad above the catch basin, which was partially filled with water; ponded water was also noted outside the berm walls. A slight sheen was noted on the surface of the water inside the basin. The northwest wall of the catch basin berm showed some signs of sloughing.

BUILDING SITE  
POL TANK FACILITIES

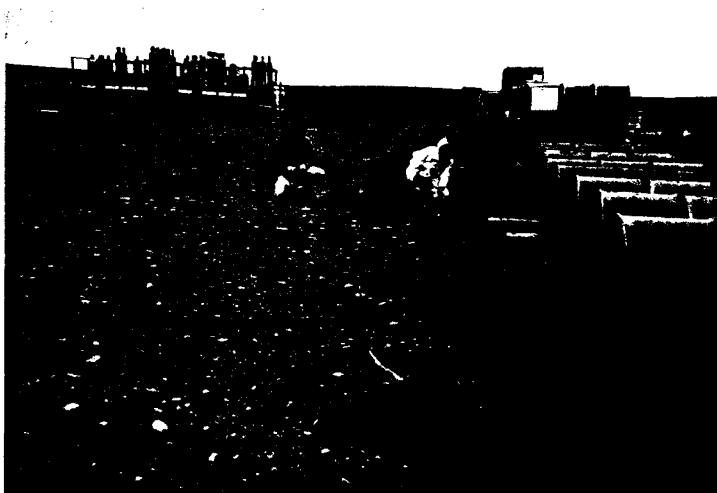
PLATE 5

SOIL SAMPLING WITH RRMG  
AT POL DRUM STORAGE PALLET LINE

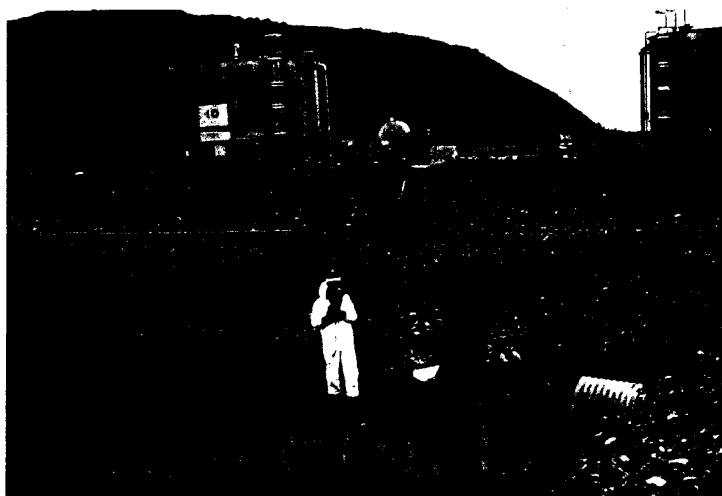
PLATE 6

The POL 2 storage facilities (two 295 m<sup>3</sup> diesel) are located 600 m northeast of the airstrip, within 40 m of the shoreline (Plate 6). The shoreline in this area was characterized by a wide cobble beach, and a steep exposed slope which rose approximately 30 m to the elevation of inland areas. The storage pad and general area was situated on the beach approximately 5 m asl. Staining and odours were noted on a small area of the tank pad. Due to the coarse nature of the fill material on the pad, only two samples were taken. North and west of these facilities, extending to the beach, the material encountered consists of cobble-sized gravel. A small stream which drains the upper slopes of a ravine runs past these POL facilities.

WATER SAMPLING  
NEAR BEACH POL TANK FACILITIES

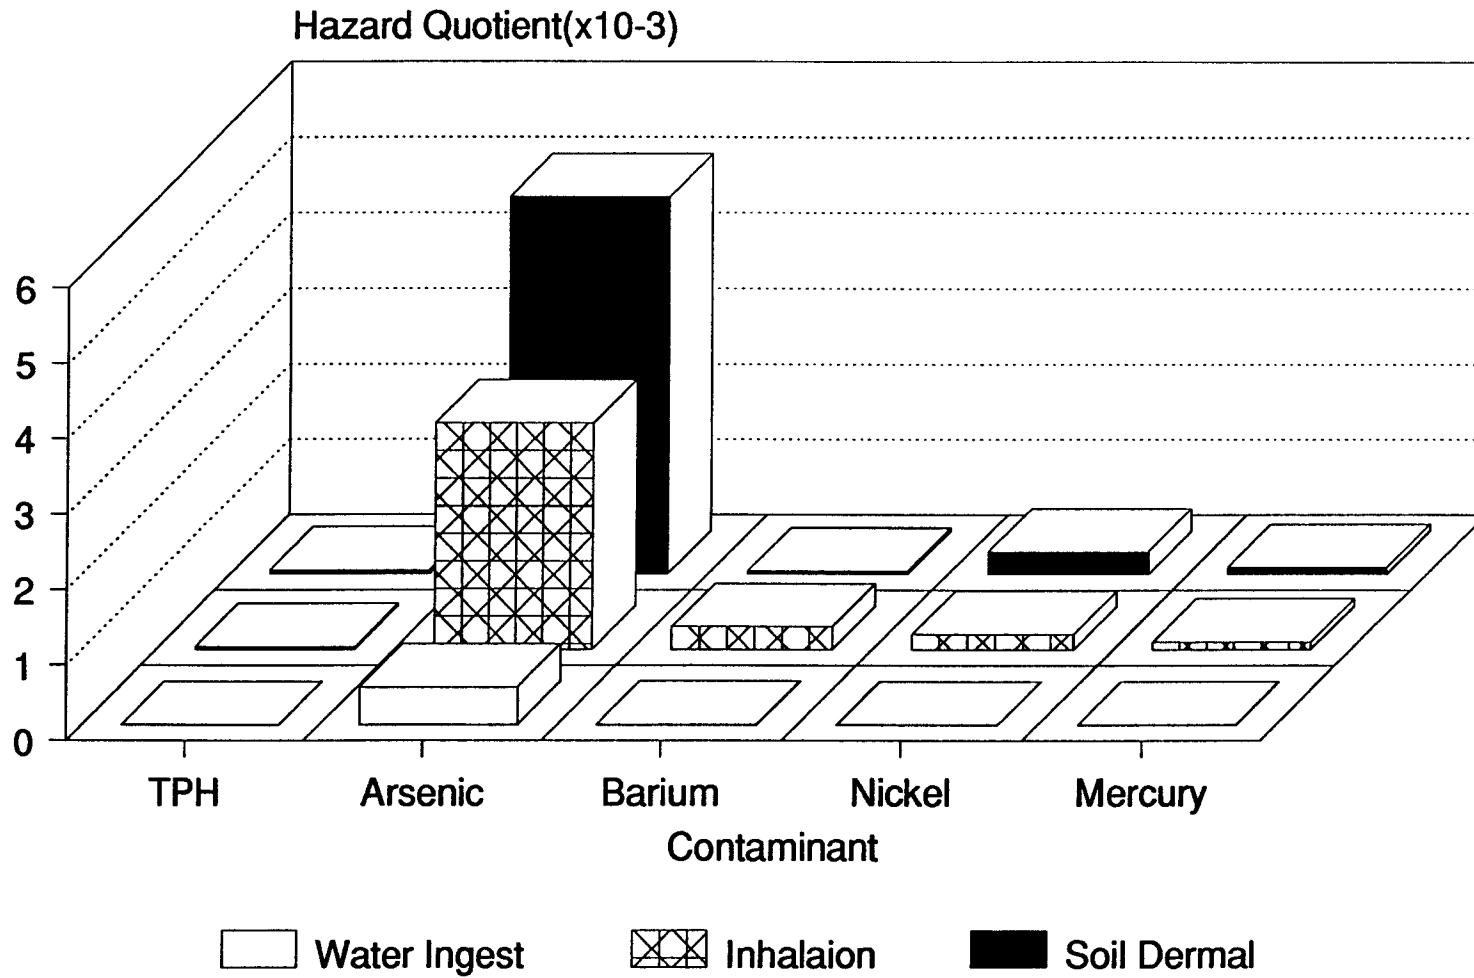
FIGURE E-3

# BAR-2 Site Non-Carcinogenic Hazard Index (Total=1 x10<sup>-2</sup>)

The total site non-carcinogenic hazard index was developed by summing the hazard quotients from each contaminant in each pathway. As previously discussed the uncertainties associated with both the exposure assessment and toxicity assessment vary for each contaminant and the uncertainties associated with summing hazard quotients also depend on the contaminant mixture among other factors. As a first order approximation the hazard quotient was based on conservative assumptions and therefore presents an over estimation of the potential site risk. The BAR-2 hazard index of  $1 \times 10^{-2}$  is much less than the unity criterion and represents a risk for which even sensitive populations are unlikely to experience adverse health effects.
