**DETAILED SUBSURFACE INVESTIGATION  
RANGE ROAD DUMP SITE**

**PUBLIC WORKS CANADA  
WHITEHORSE, YUKON**

May 1992

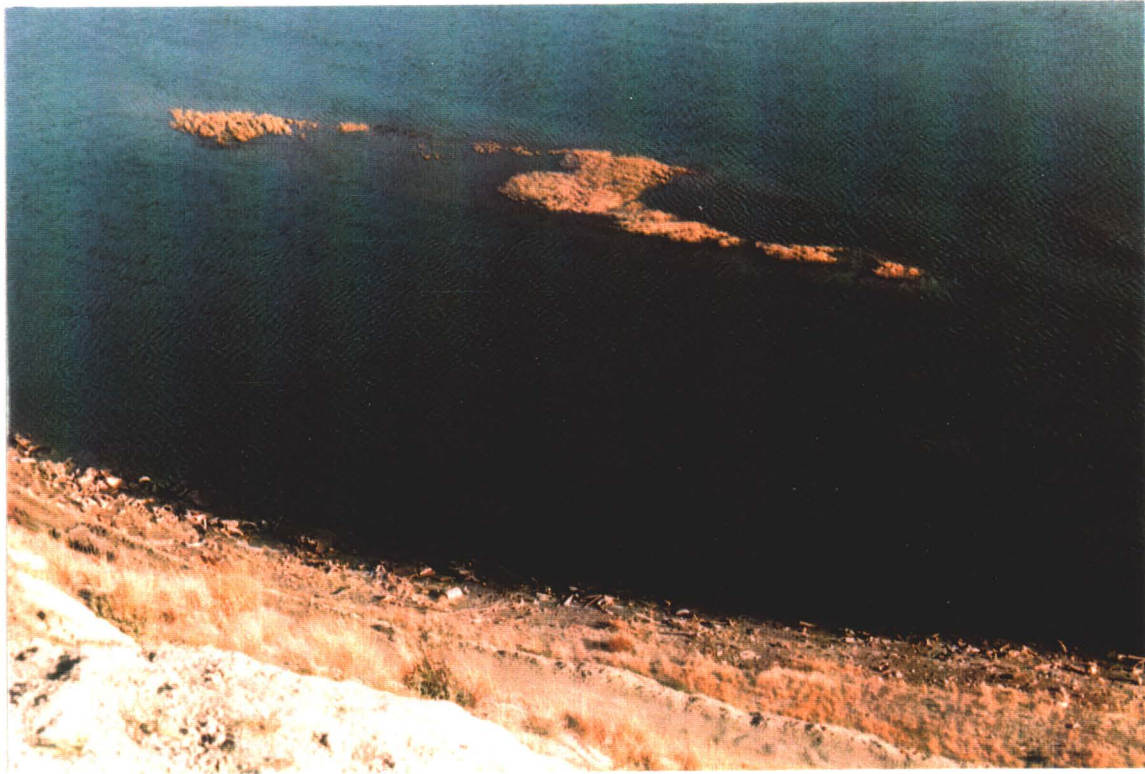
1) Yukon River Bluff

The site was operated as an "open dump". Wastes were deposited on the surface and were frequently burned. Wastes were not covered with earth and were regularly pushed over the edge of the McIntyre Creek and Yukon River banks. A portion of these wastes fell straight into the Creek and the River.

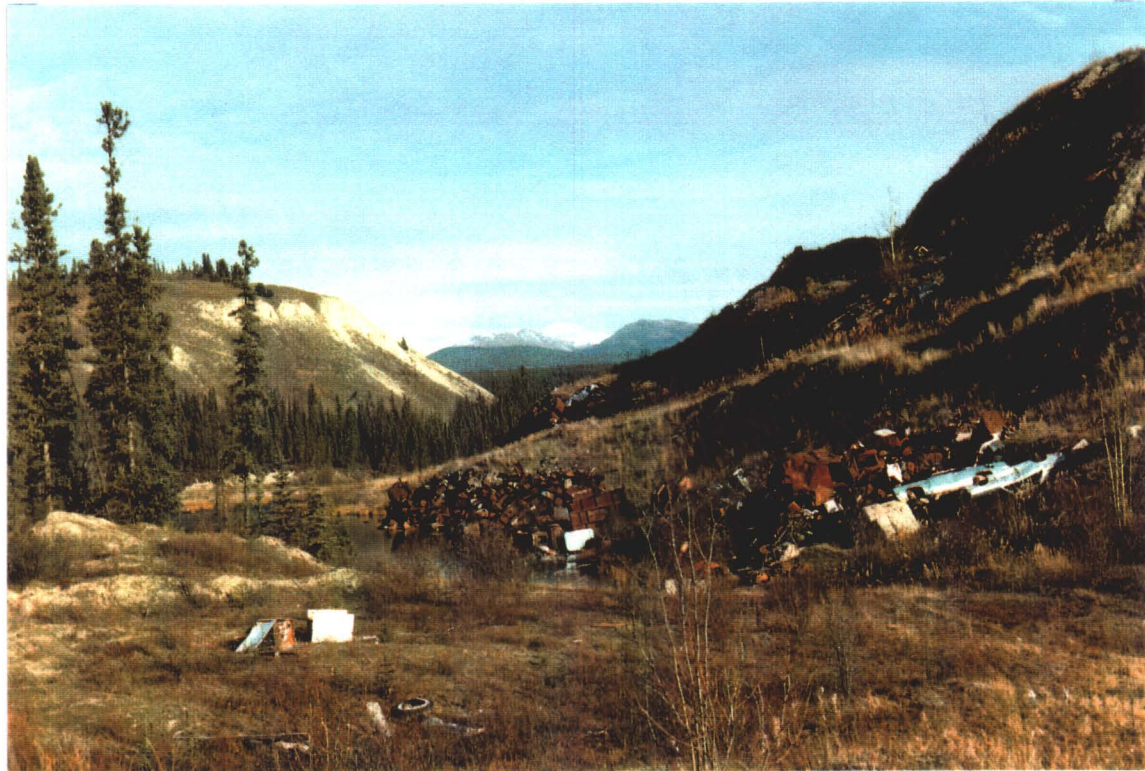
2) McIntyre Creek Bluff

As the volume of wastes at the site increased, a greater proportion of newly deposited refuse would fall into the adjacent Creek and River. A slope failure within the landfill resulted in the movement of a large mass of garbage into McIntyre Creek in 1968 (Environment Canada, 1986). Charges were laid against the City of Whitehorse which resulted in the construction of a levee to divert McIntyre Creek away from the toe of the garbage. The City was subsequently required by the Water Board to relocate waste disposal to a new site (War Eagle) and the Range Road Dump was closed in November, 1975.

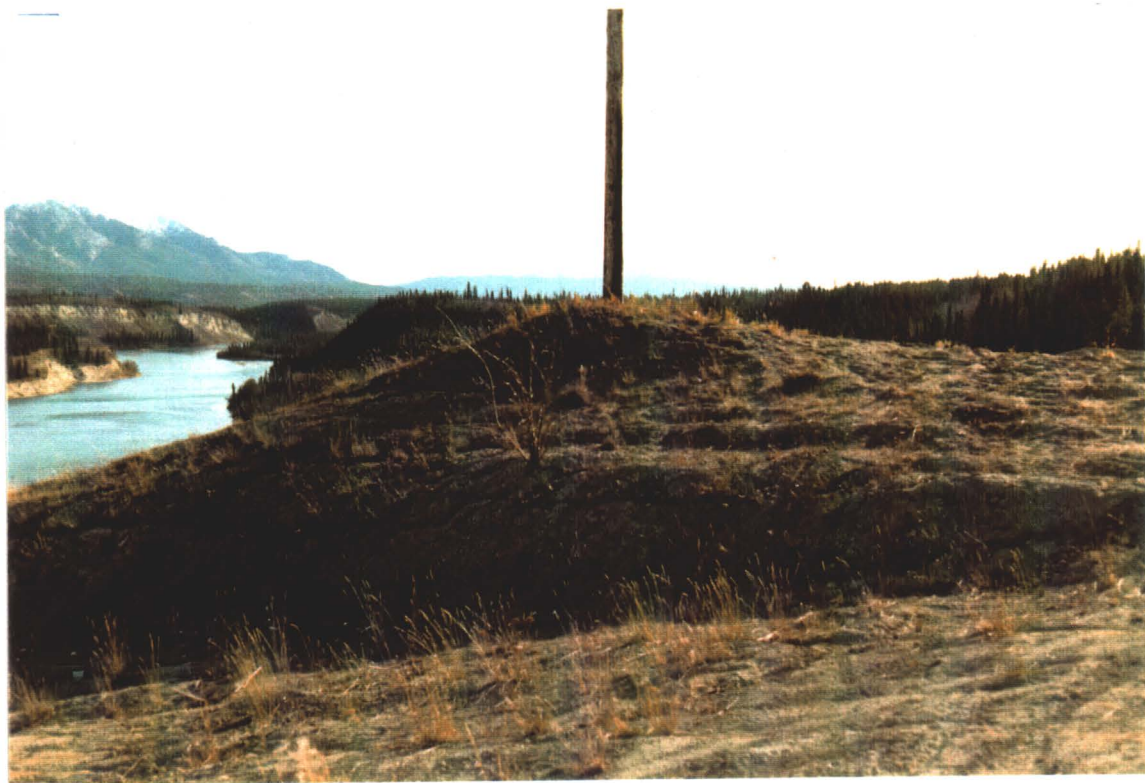
3) Earth Cover and Down Cut

The remaining soils above the bank showed no visible staining nor odours from the solid and liquid waste disposal at the site. The strong horizontal bedding in the upper silts on the bluff means that deep vertical migration of contaminants is unlikely. The soils most likely to be heavily contaminated have been down cut and pushed over the Yukon River and McIntyre Creek banks as cover.

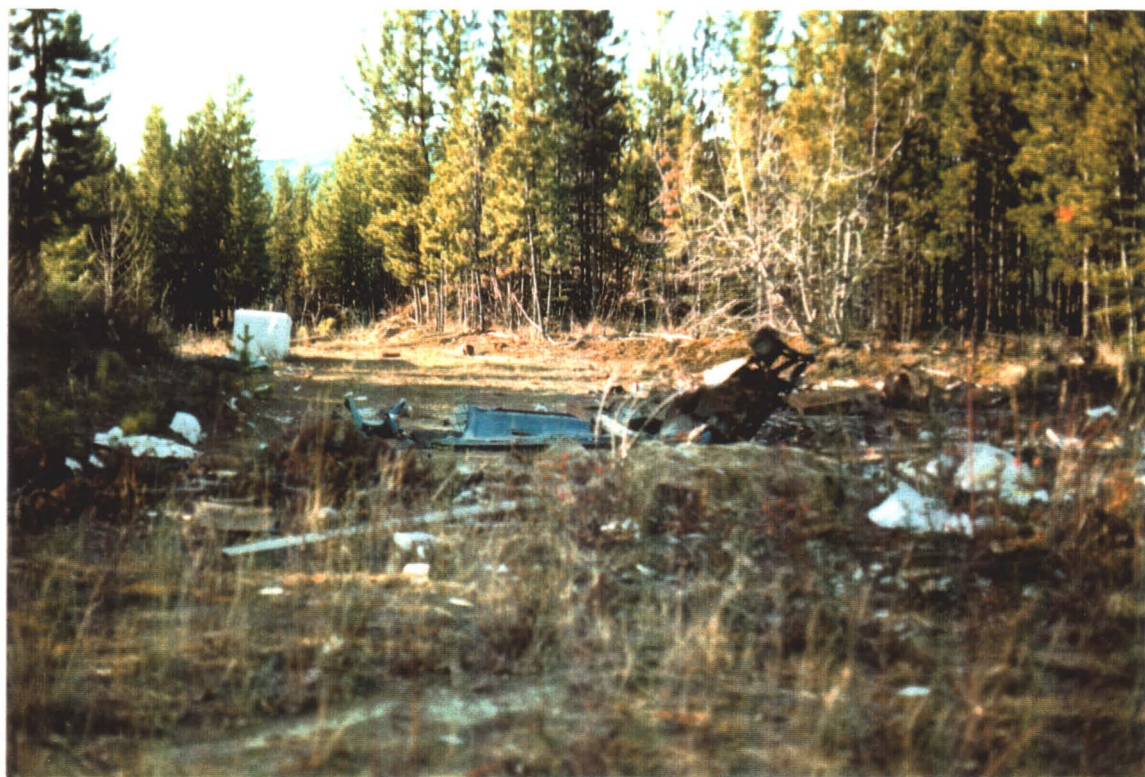
4) Surface Scrap

Although entrance to the site is blocked to vehicles at the Range Road, evidence of some recent dumping is evident. Plate 2 also illustrates an old fridge and assorted scrap metals that lie on the southern forested portion of the site.

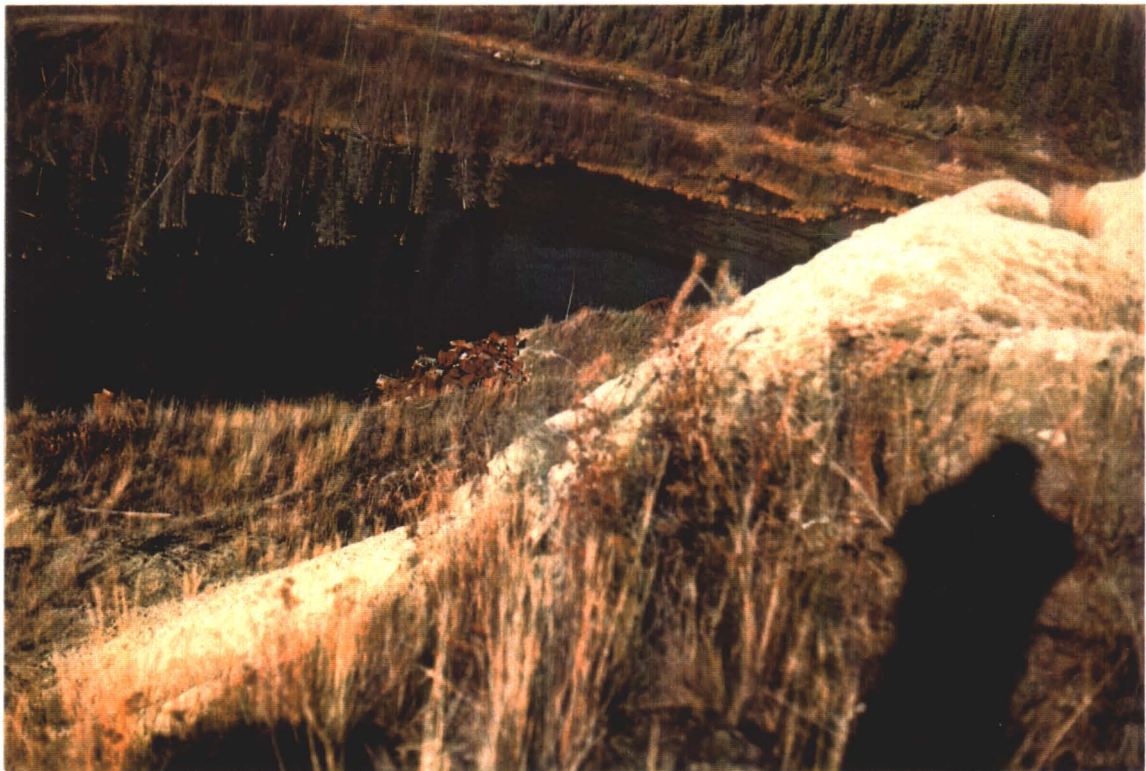
PLATE 3

POND A & B - FALL, 1991

The Yukon River and McIntyre Creek dumps have not been identified as a source of persistent pesticides nor PCB's. Although trace concentrations of PCB's were previously found in the sediments of Pond A & B below the McIntyre Creek dump, they are not mobile at measurable concentrations in the groundwater.

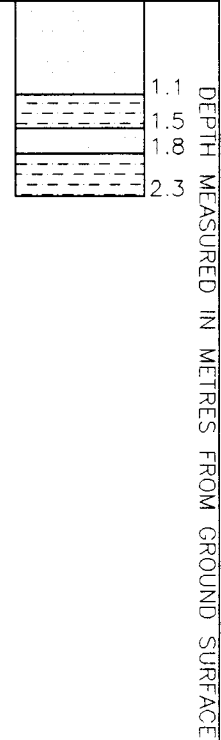
SILT, brown, clayey, very moist

TOTAL DEPTH = 2.3

NOTES: TEST HOLE SEALED AND ABANDONED.

DRILL METHOD: AUGER  
BY: MIDNIGHT SUN
