**ENVIRONMENTAL ASSESSMENT
CHOUTLA SCHOOL SITE
CARCROSS, YUKON**

0201-11151
TAC-154 # 34
August, 1993

EBA ENGINEERING CONSULTANTS LTD.
WHITEHORSE, YUKON

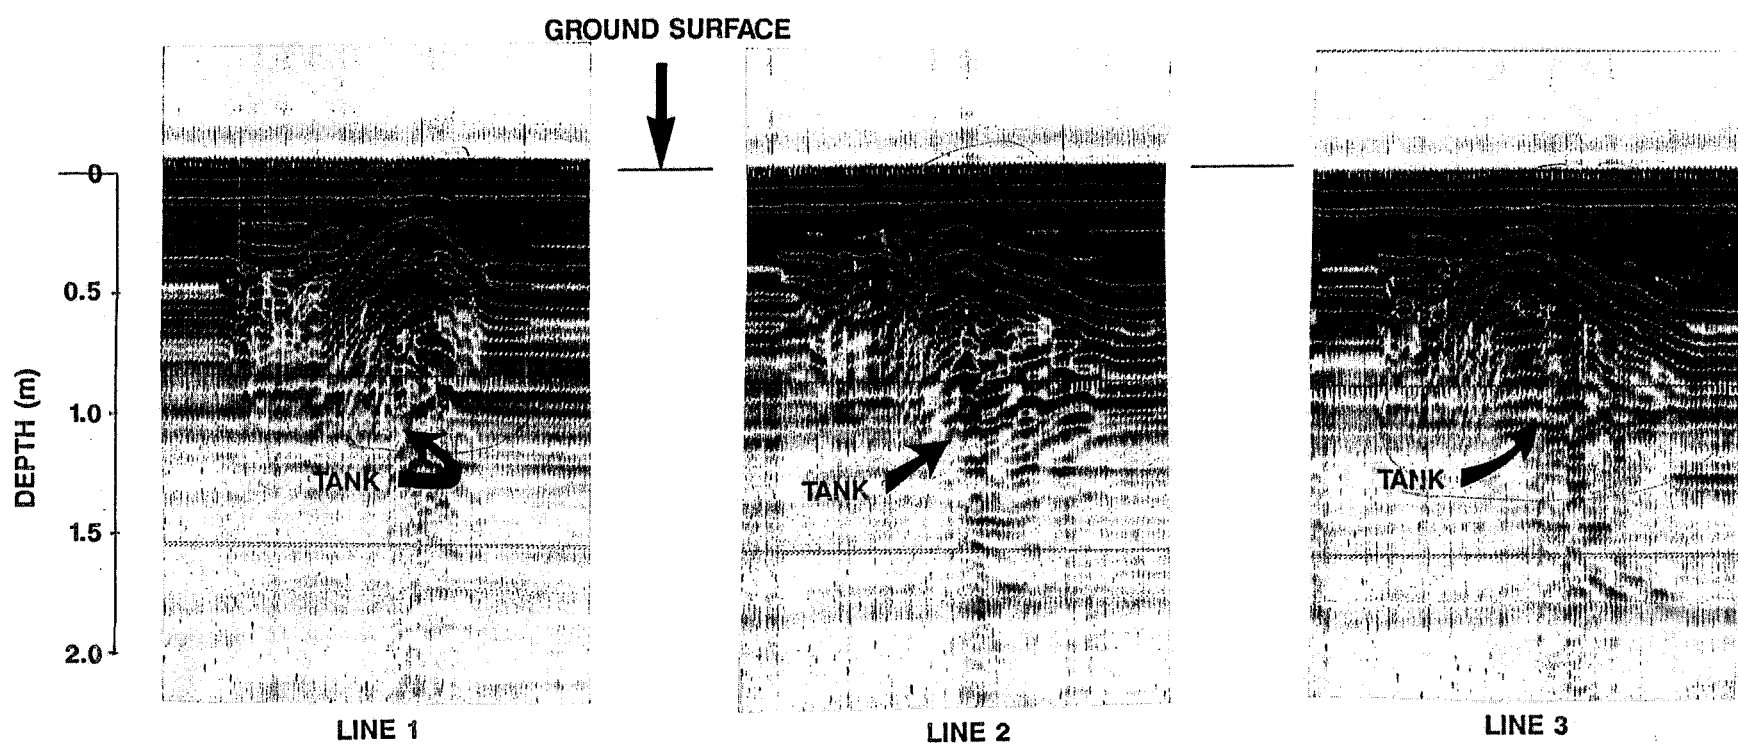
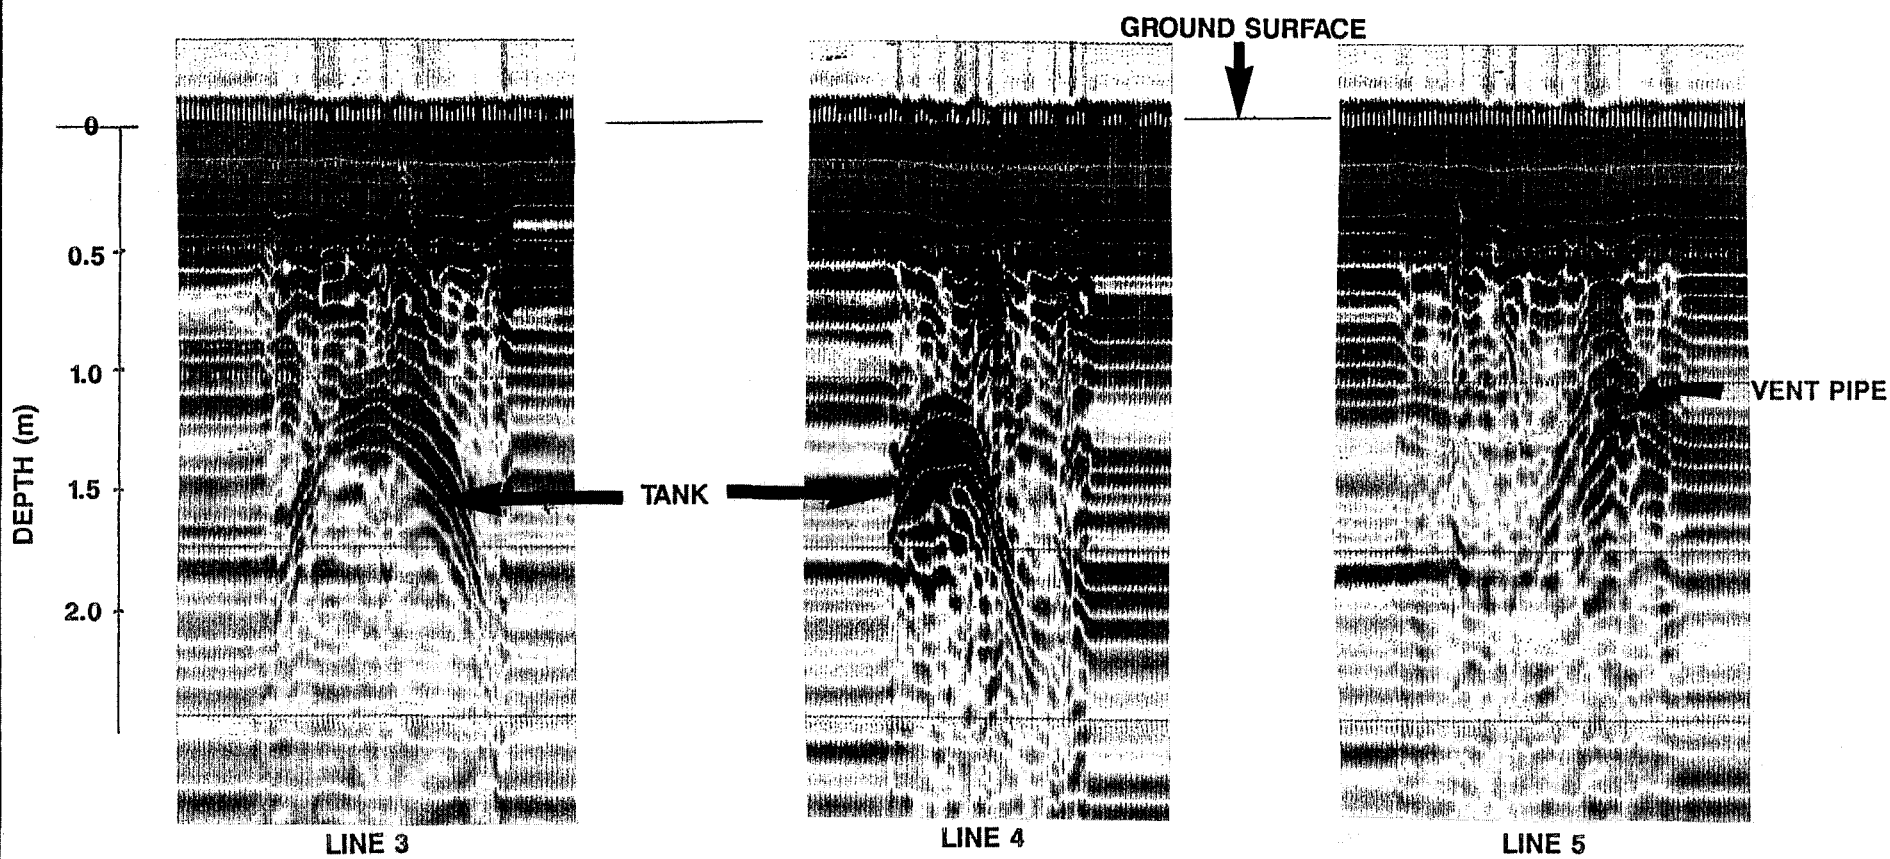
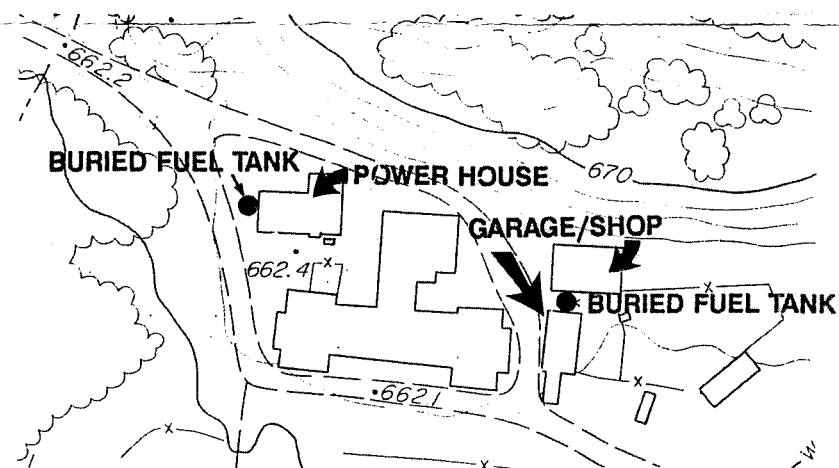
<i>EBA Engineering Consultants Ltd.</i>			PROJECT	ENVIRONMENTAL ASSESSMENT CHOUTLA SCHOOL, CARCROSS
CLIENT PUBLIC WORKS CANADA			TITLE	GROUND PENETRATING RADAR TRACES
DATE	93-03-26	DWN.	MCP	CHKD.
			FILE NO.	0201-11151
				FIGURE 2

- Two underground fuel storage tanks were detected. One was located adjacent to the northwest corner of the power house while the second tank was found between the garage and warehouse structure just east of the school. Both tanks were found to have less than 1.0 m of soil cover.

POWER HOUSE BURIED FUEL STORAGE TANK

UNDERGROUND FUEL STORAGE TANKS BETWEEN GARAGE AND WAREHOUSE

EBA recommends that the PCB contamination on site be removed as soon as possible. There is a possibility that residents in the area have come into direct contact with the PCB wastes. EBA also recommends that the two existing underground fuel storage tanks and all contaminated soil noted in the three areas where tanks were located be removed to minimize the risk of further contamination by eliminating the possible sources of contamination.

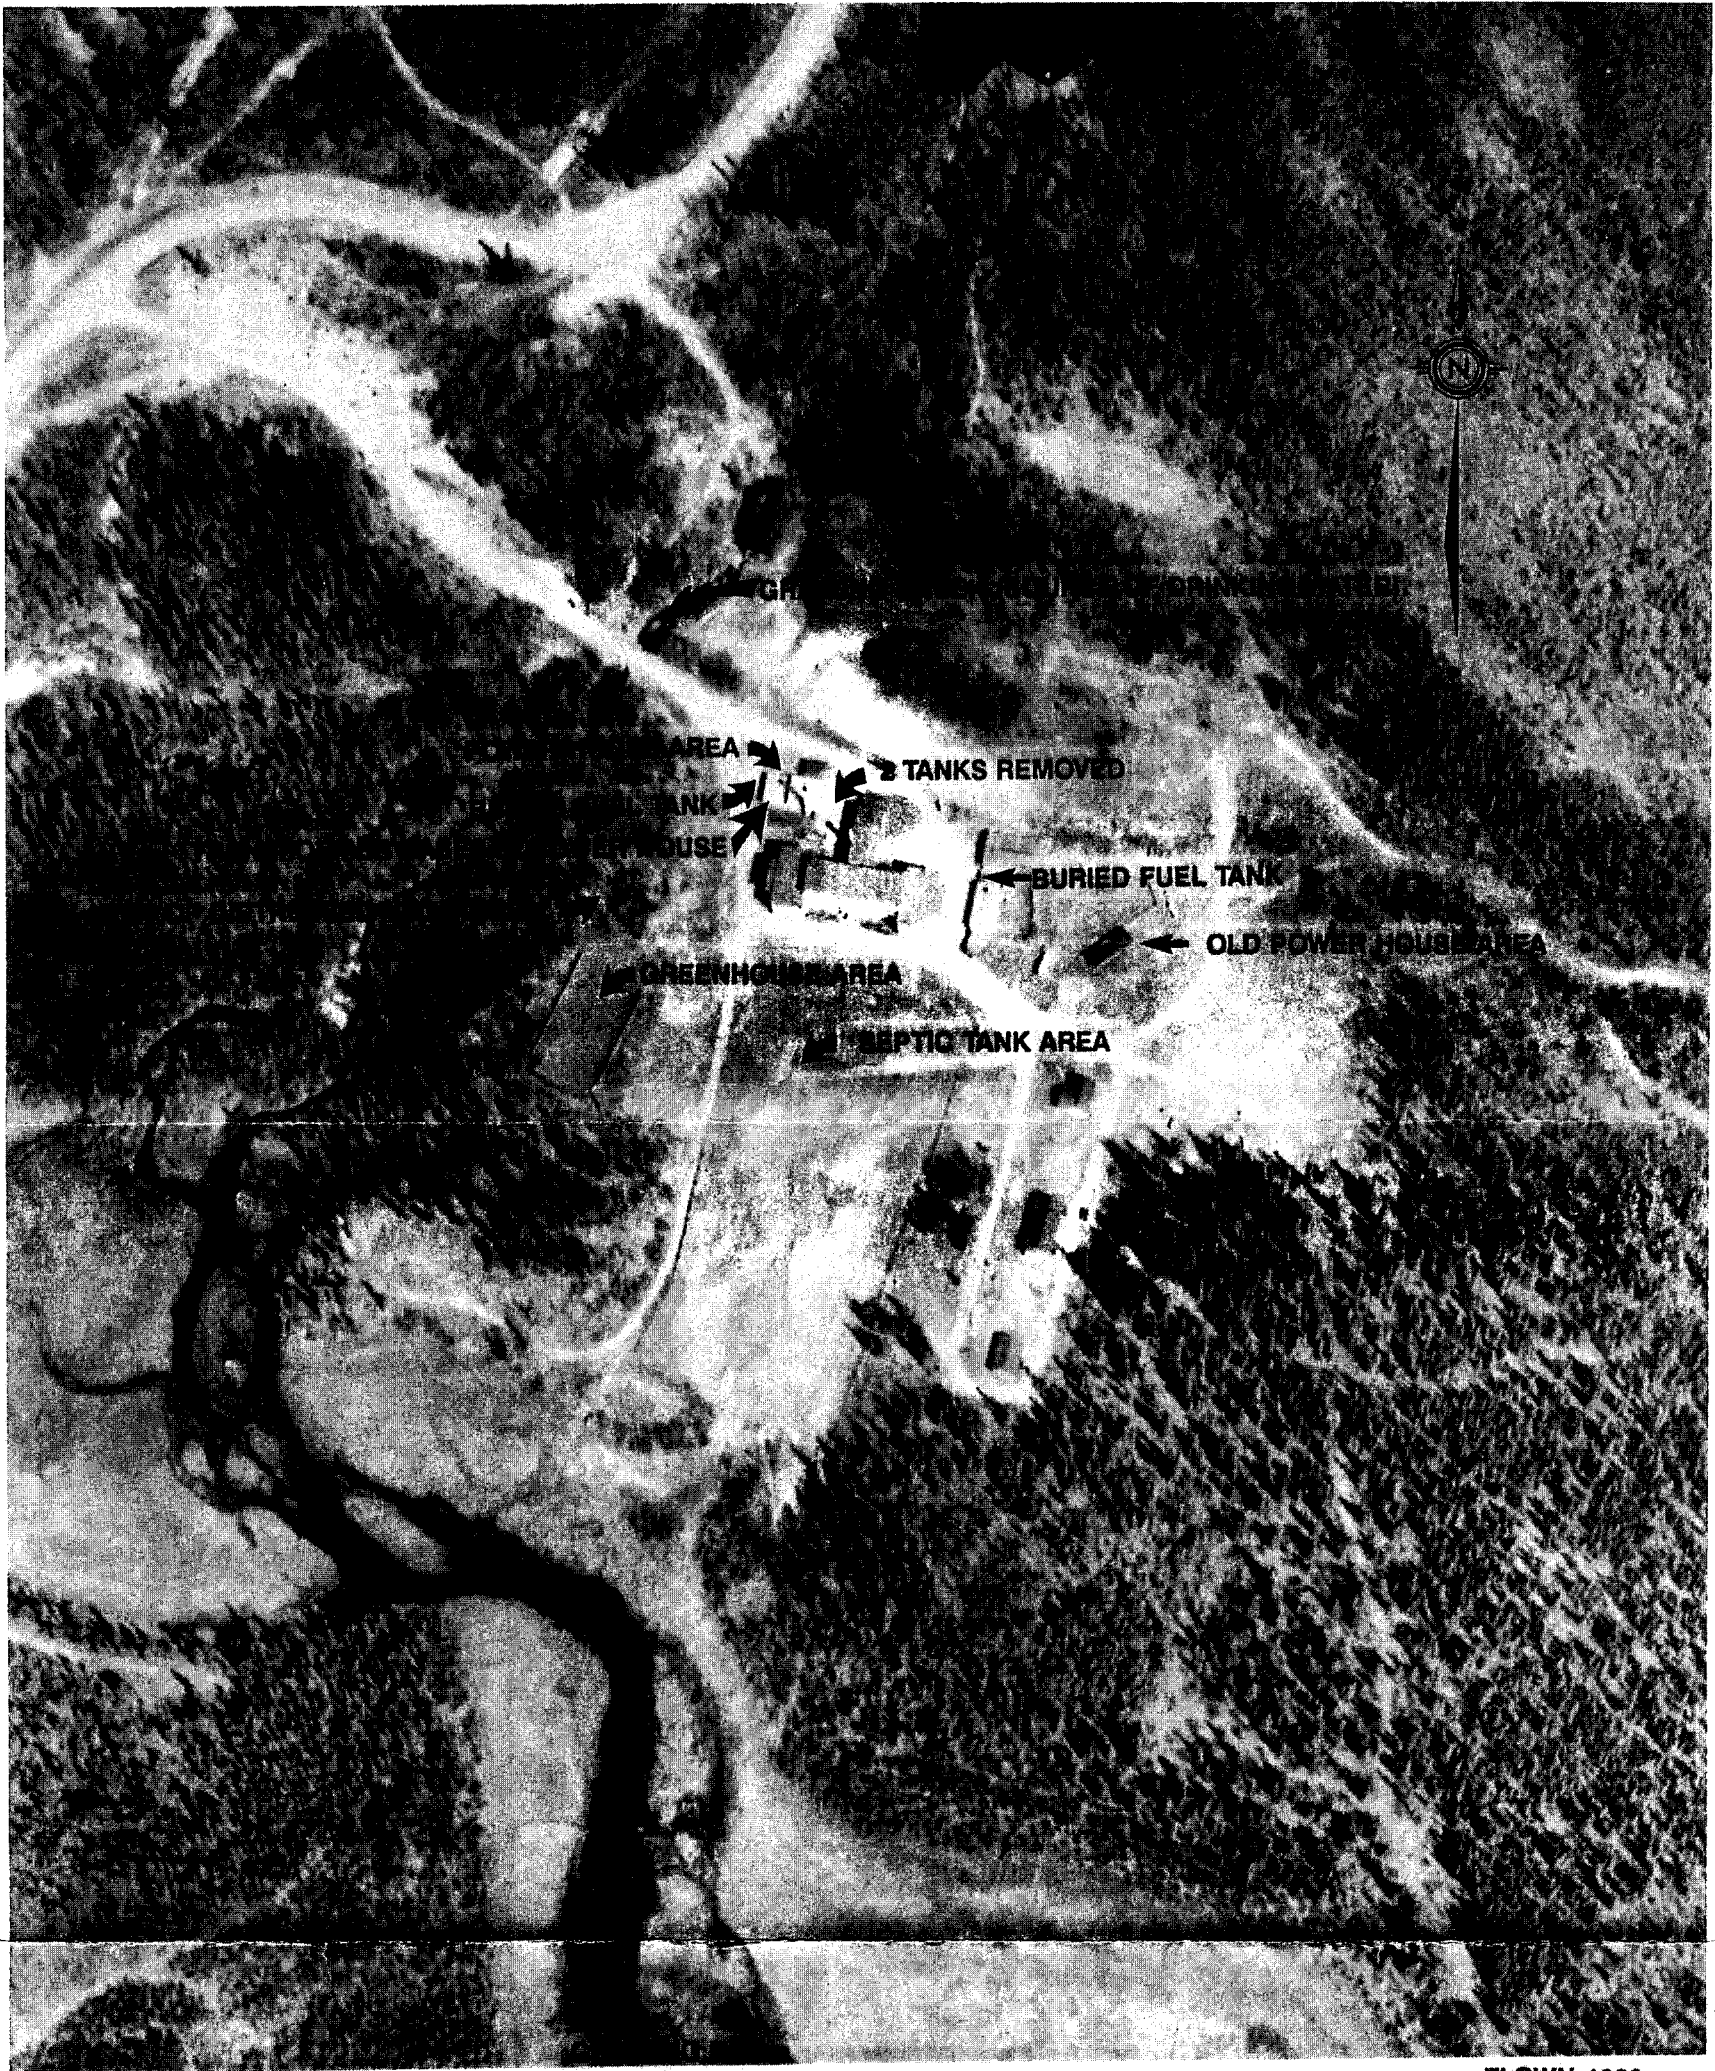
<i>EBA Engineering Consultants Ltd.</i>			PROJECT	ENVIRONMENTAL ASSESSMENT CHOUTLA SCHOOL, CARCROSS
CLIENT			TITLE	SITE PLAN IDENTIFYING AREAS OF CONCERN
DATE	93-03-26	DWN.	MCP	CHKD.
			FILE NO.	0201-11151
				11151-A-03

Based on information gathered during the GPR survey and the initial stages of this project, potential areas of concern were identified. These areas included:

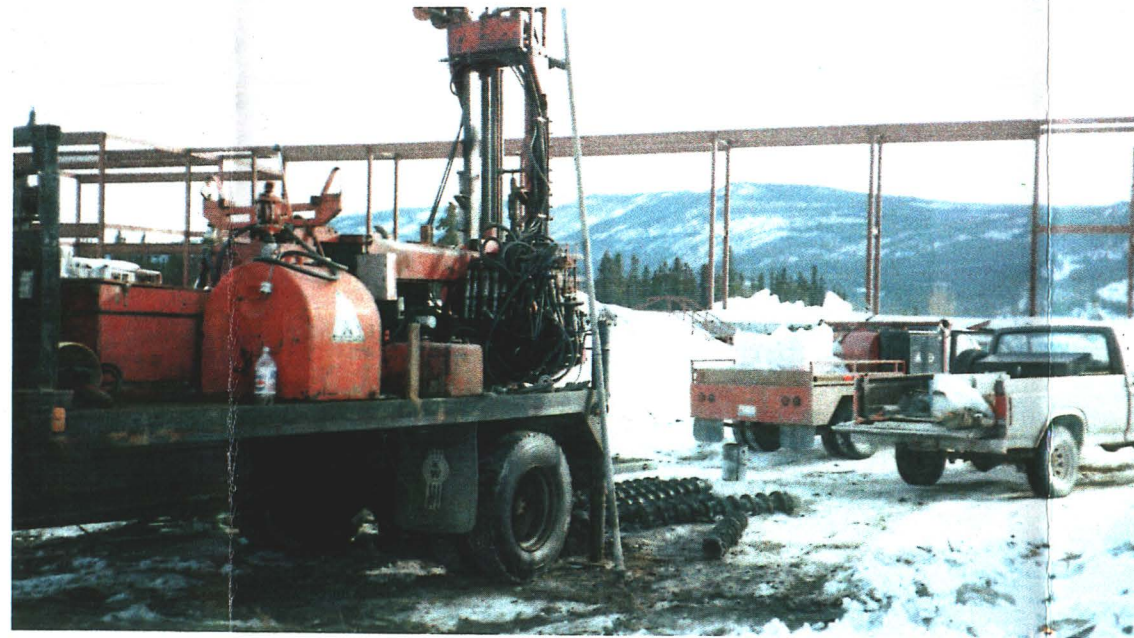
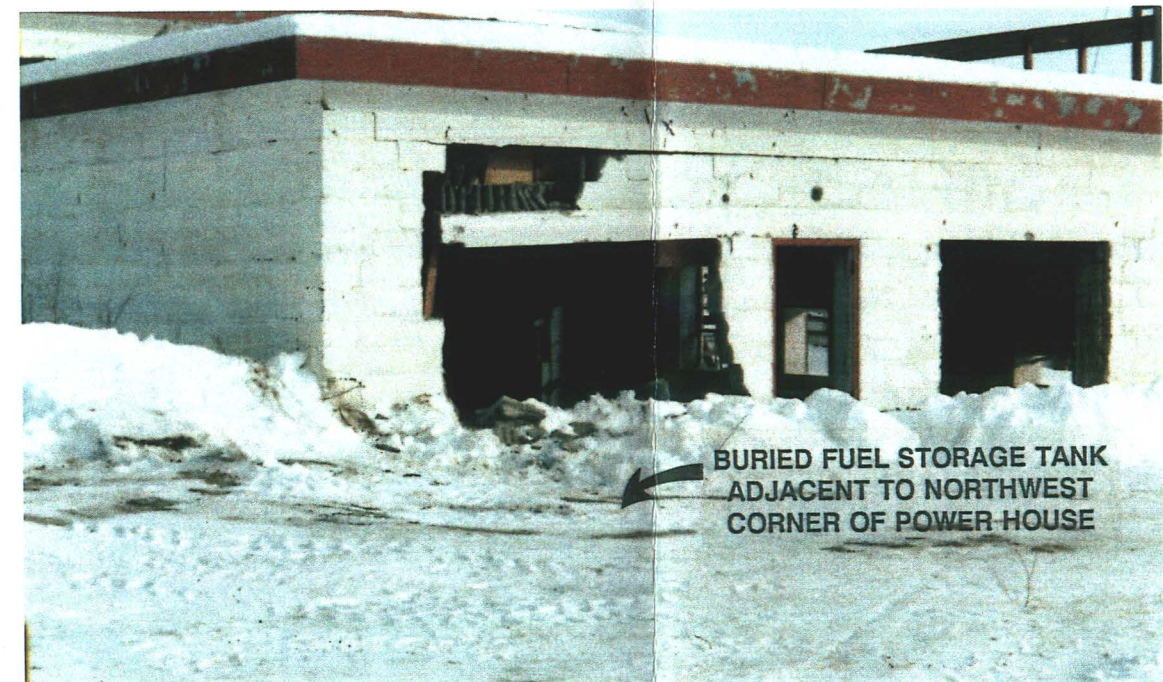
**UNDERGROUND TANK
LOCATIONS**

Total extractable hydrocarbon levels in the soil and water samples collected from BH 11151-04 were significant, indicating the possibility of the tanks leaking prior to removal or the remaining contents of the tanks may have spilled out during removal.

**DRILL RIG AT BH 11151-04
LOCATION WHERE TWO FUEL
STORAGE TANKS HAD
BEEN LOCATED**

**(BETWEEN NORTH WING OF
SCHOOL AND NORTHEAST
CORNER OF POWER HOUSE)**

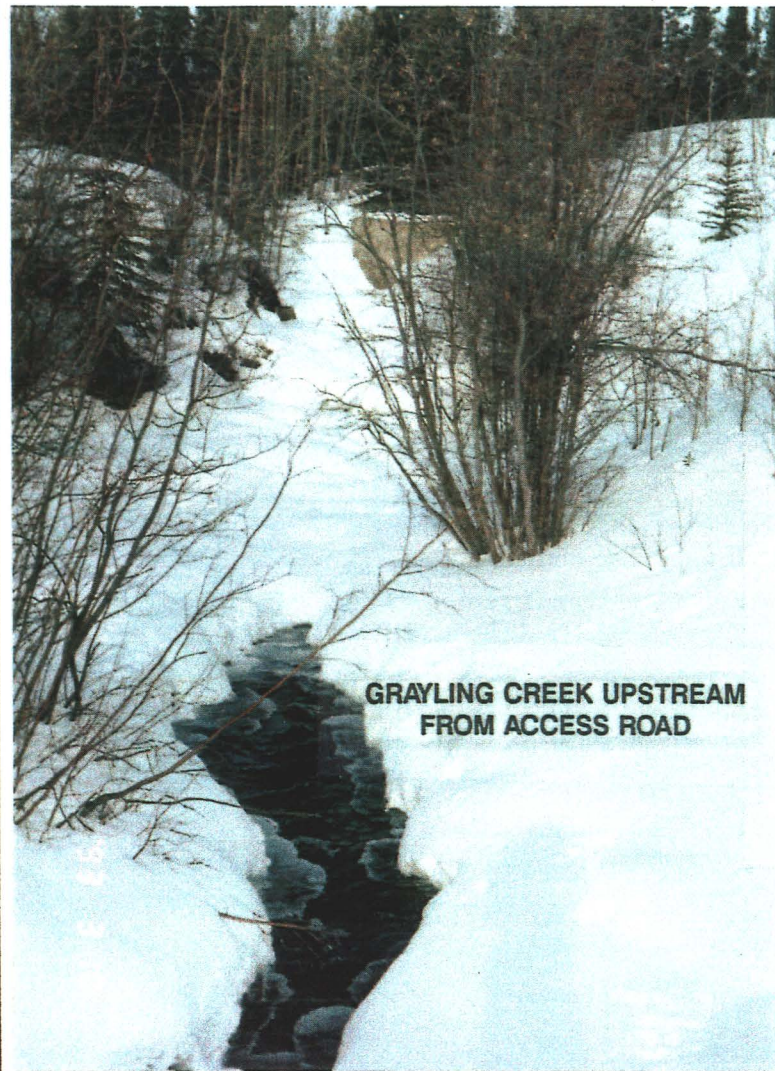
A water sample from the mouth of Grayling Creek, and ground water from Borehole 11151-03 (near the septic tank) were analyzed for total and faecal coliforms. No faecal coliforms were detected in the water samples, however, the total coliforms in the water sample at Grayling Creek as 13 CFU100ml. The Canadian Drinking Water Guidelines recommend that drinking water should not contain more than 10 CFU100ml.

GRAYLING CREEK UPSTREAM
FROM ACCESS ROAD

NOTE CONCRETE INTAKE STRUCTURE
IN PHOTO WHERE THE WATER FOR
THE SCHOOL SITE WAS DRAWN

EBA also recommends that residents of the area be advised of the high total coliform count in the Grayling Creek water and to either boil or chemically treat all water from the creek prior to its use as drinking water or to haul in potable water.

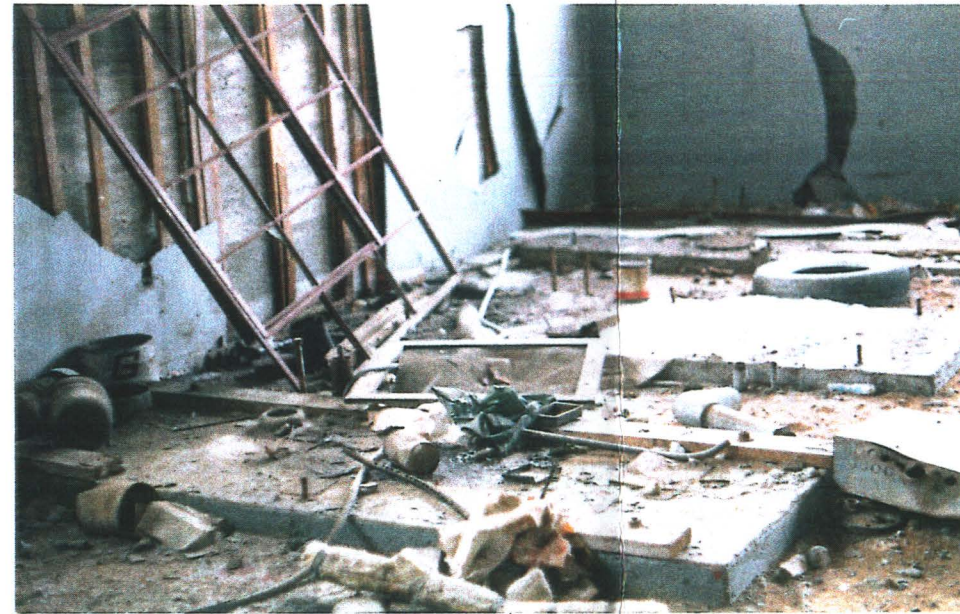
- The school and power house structures are presently in ruins. Access in and around both buildings is hazardous.
- The garage and warehouse buildings are being utilized as workshops by area residents. As well, vehicles are scattered throughout the site.
- The greenhouses and garden appear to be utilized during the growing season. No evidence of any fertilizers exists on site.
- Water for the site was directed from Grayling Creek just upstream of the school access road. The concrete structure built to facilitate water supply is structurally unsound.

WEST SIDE OF
POWER HOUSE

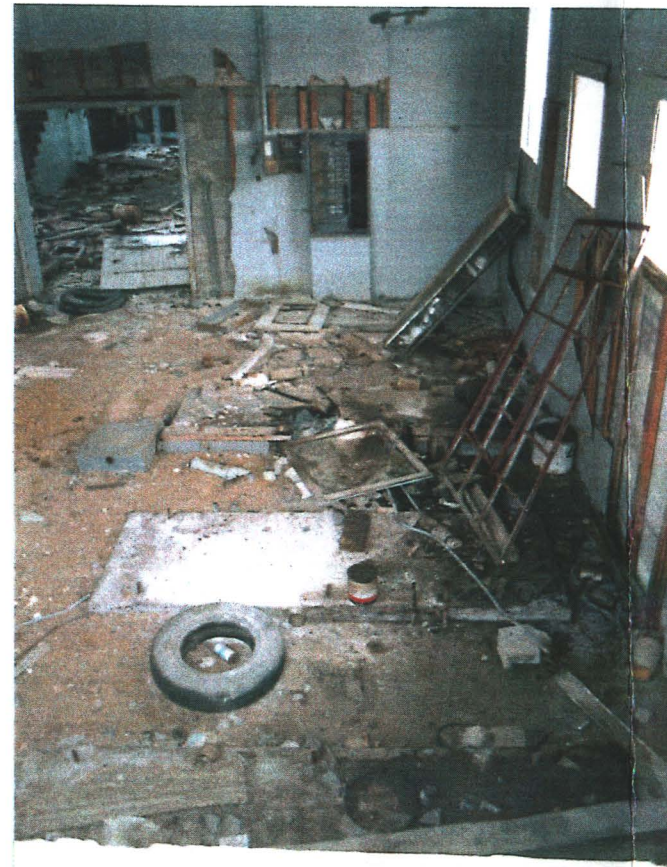
The sludge sample collected from the concrete surfaces of the transformer bases, located in the power house, was analyzed and found to contain 130 ppm PCB's (aroclor 1260). The Canadian Environmental Protection Act prohibits the release of liquids with a PCB concentration of 50 ppm or greater into the environment.

TWO PHOTOS SHOWING
THE TRANSFORMER BASES.
