**PRELIMINARY ASSESSMENT
OF THE
OLD MAYO LANDFILL SITE**

Arctic Environment Strategy - Action on Waste
Department of Indian Affairs and Northern Development
Whitehorse, Yukon

J. Gibson & Associates
Whitehorse, Yukon

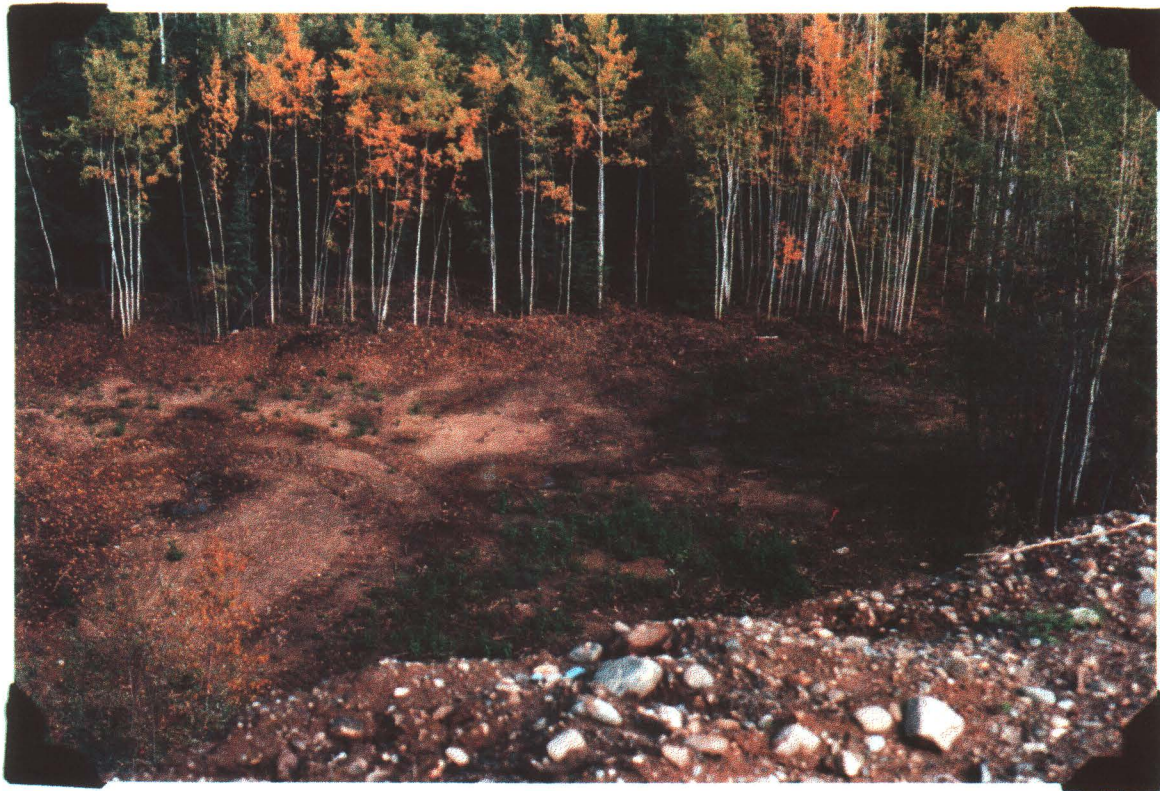
Figure 4. Mayo Landfill - Base of landfill area viewed from dump crest.

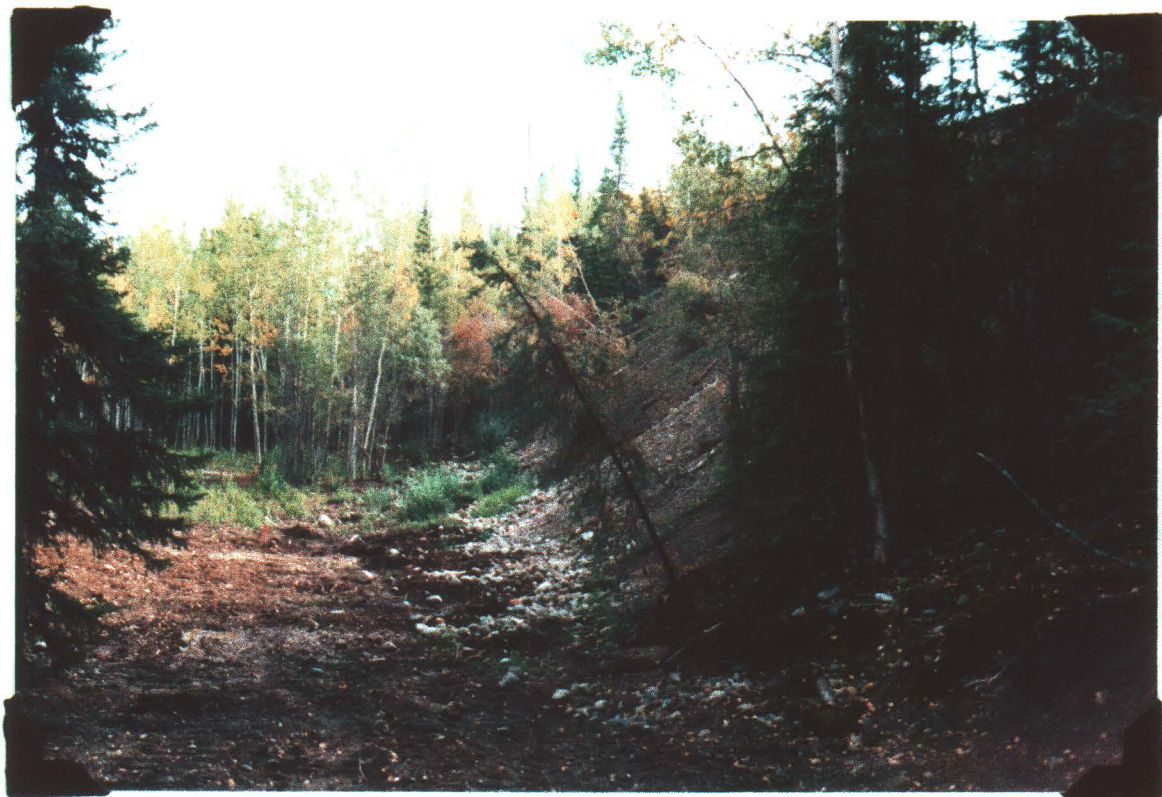
Figure 5. Mayo landfill - area at toe of dump slope.

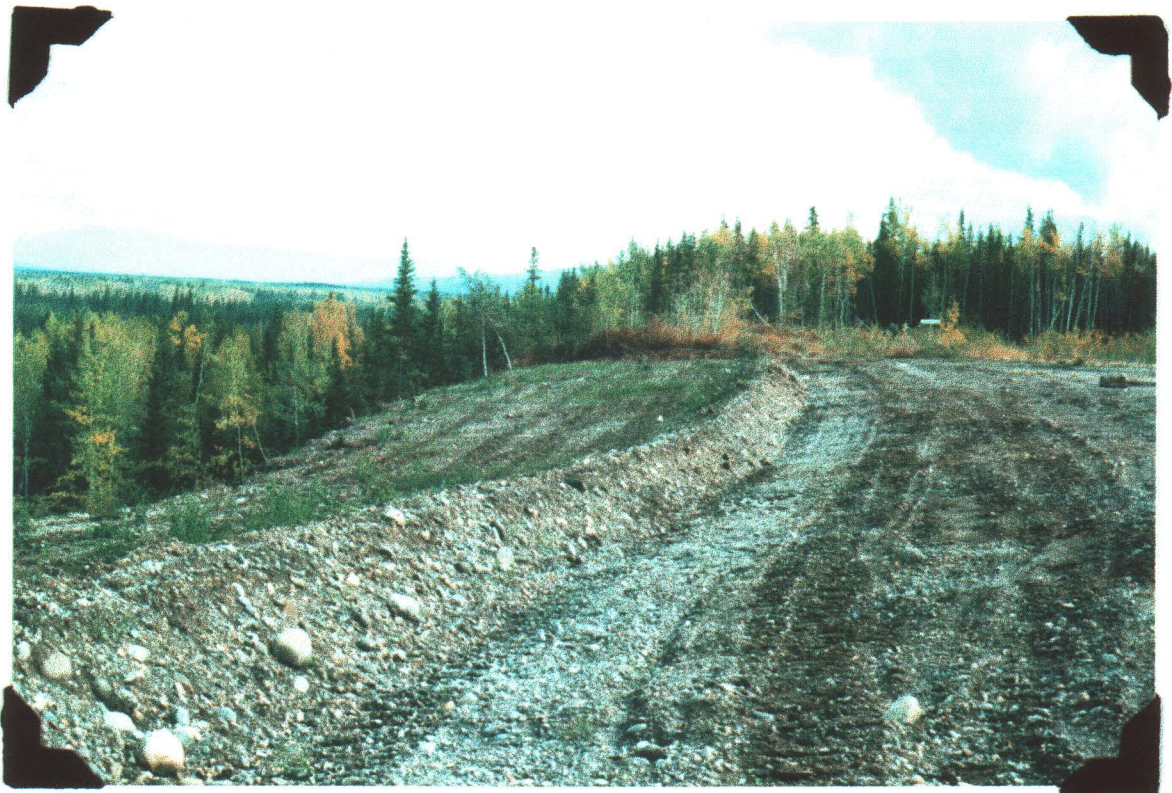
Figure 6. Mayo Landfill - Dump crest with recent fill cover.

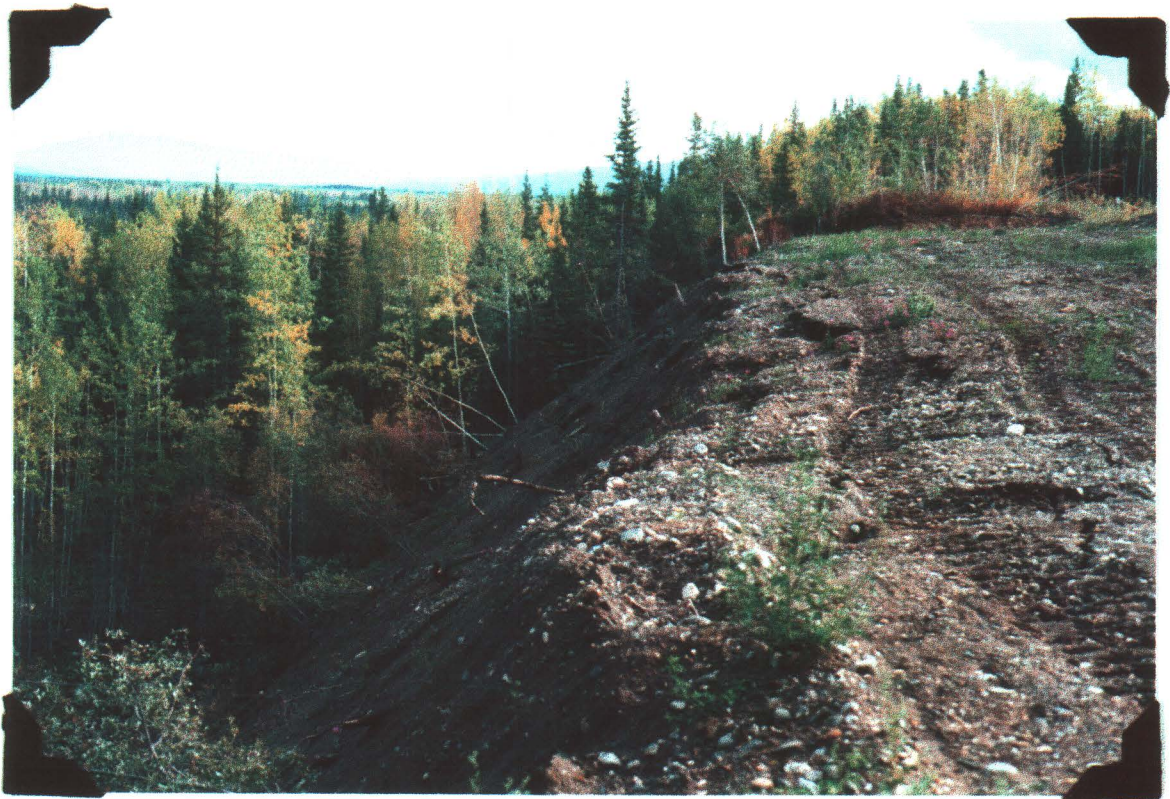
Figure 7. Mayo landfill - Dump slope.

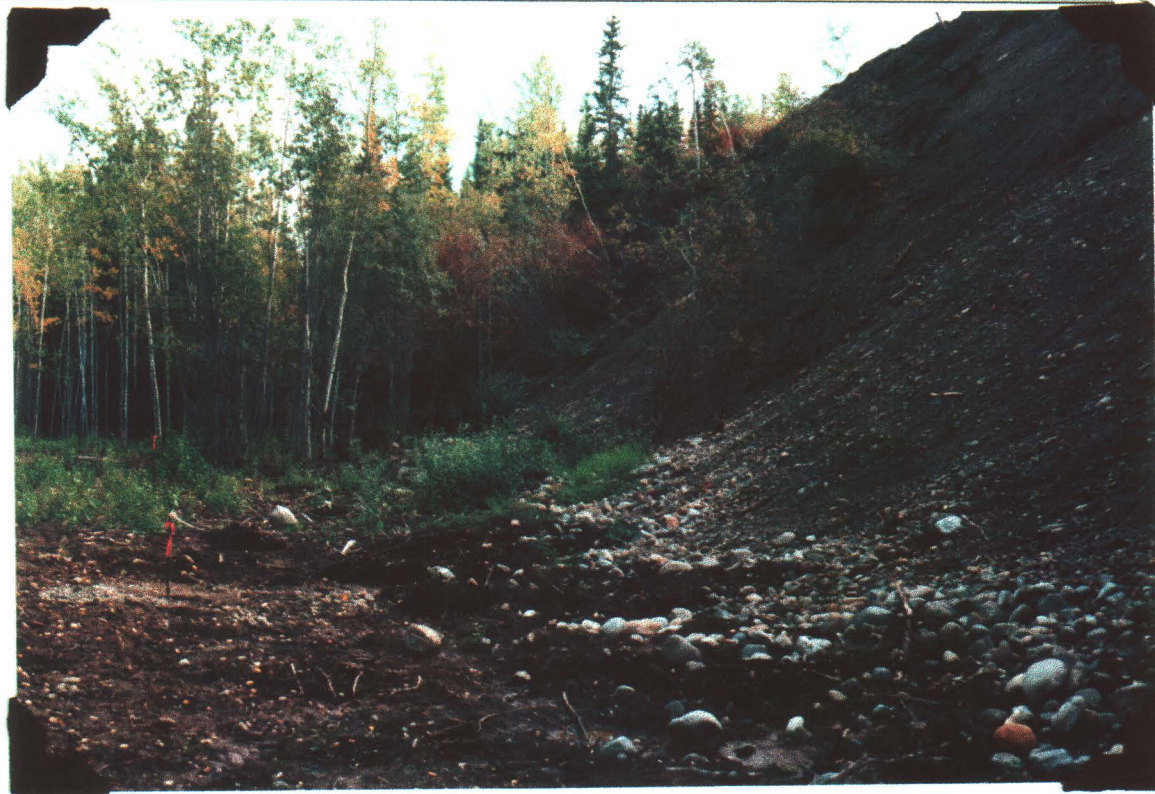
Figure 8. Mayo Landfill - Toe of dump slope with test hole sites flagged.

As there were no surface water flows or evidence of groundwater seeps at or within 200 meters of the dumpsite, three test holes were excavated by hand within 10 meters of the slope toe in an attempt to intercept groundwater flows. The first test hole (M-1) was excavated to 1.5 meters depth on September 4 and allowed to stand overnight. As there was no intercepted flows on September 5, and the glacial till soil horizon was consistent throughout, the remaining two test holes were then excavated to depth of 1.0 meter. It is assumed the glacial till is consistent to a 20 meter depth (estimated height of bench above the Mayo River floodplain).

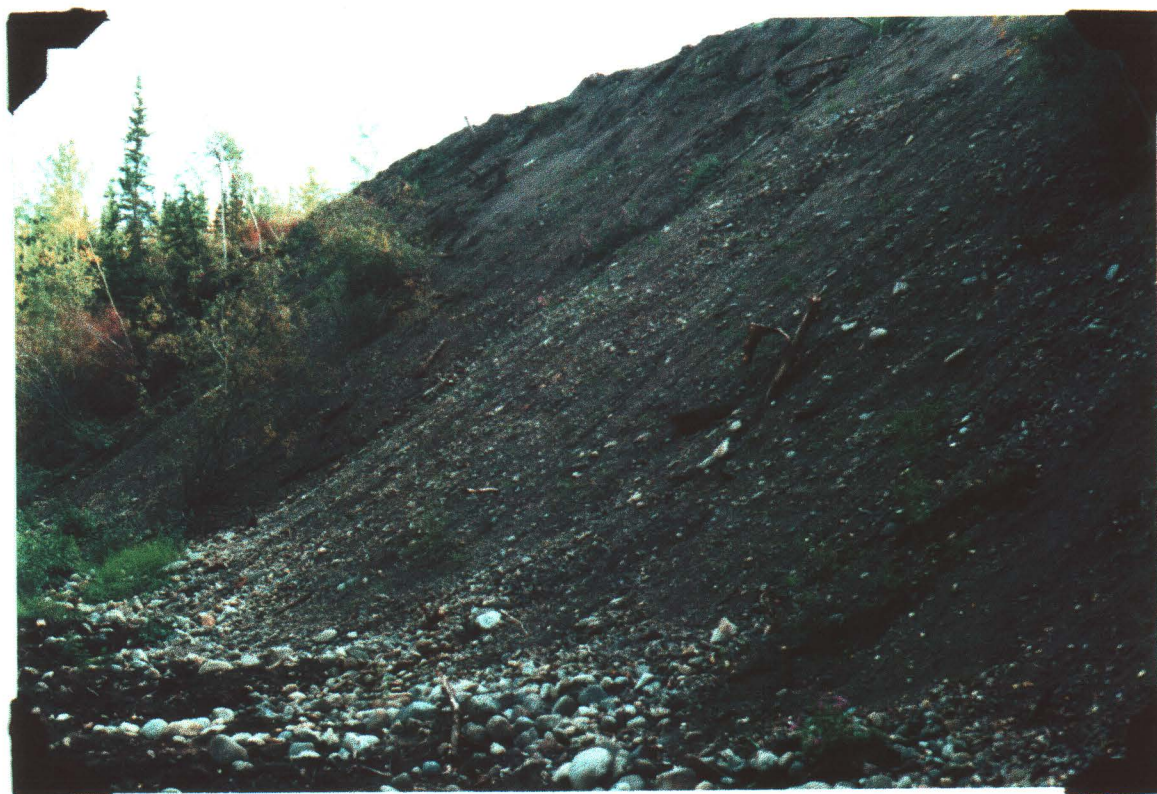
Figure 9. Mayo landfill - Dump face.

The soil sample taken at station M-5, a composite of pre-abandonment soils from along the lower dump face had detectable concentrations of the following organochlorine insecticides:

- 4'4 DDT at Trace concentrations
- 2'4 DDT at 0.07 mg/kg concentrations
- 4'4 DDD at 0.28 mg/kg concentrations

1. Verify the September 1994 sample results.
2. Determine the extent of contamination. Initially this could involve:
 - isolating the section of the dump face identified "hot" from the composite soil sample.
 - establishing a deeper test hole at station M-1 (by backhoe) with sampling at 1 meter intervals to determine vertical migration.
 - establish a second test hole 50 m. north of the slope face to determine horizontal migration.
3. Monitor the Mayo River water on an annual basis at the highway bridge, combined with determining the extent of the contamination, river water sampling would allay fears of a public health concern.
