# PRELIMINARY ENVIRONMENTAL ASSESSMENT HAINES-FAIRBANKS PIPELINE

**PRELIMINARY ENVIRONMENTAL ASSESSMENT  
HAINES-FAIRBANKS PIPELINE**

Mile 207.6 Spill Site  
Haines Junction Pump Station  
Million Dollar Falls  
Blanchard River Pump Station  
Border Pump Station

**RE: PRELIMINARY ENVIRONMENTAL ASSESSMENT**  
**HAINES-FAIRBANKS PIPELINE**  
**FINAL REPORT**

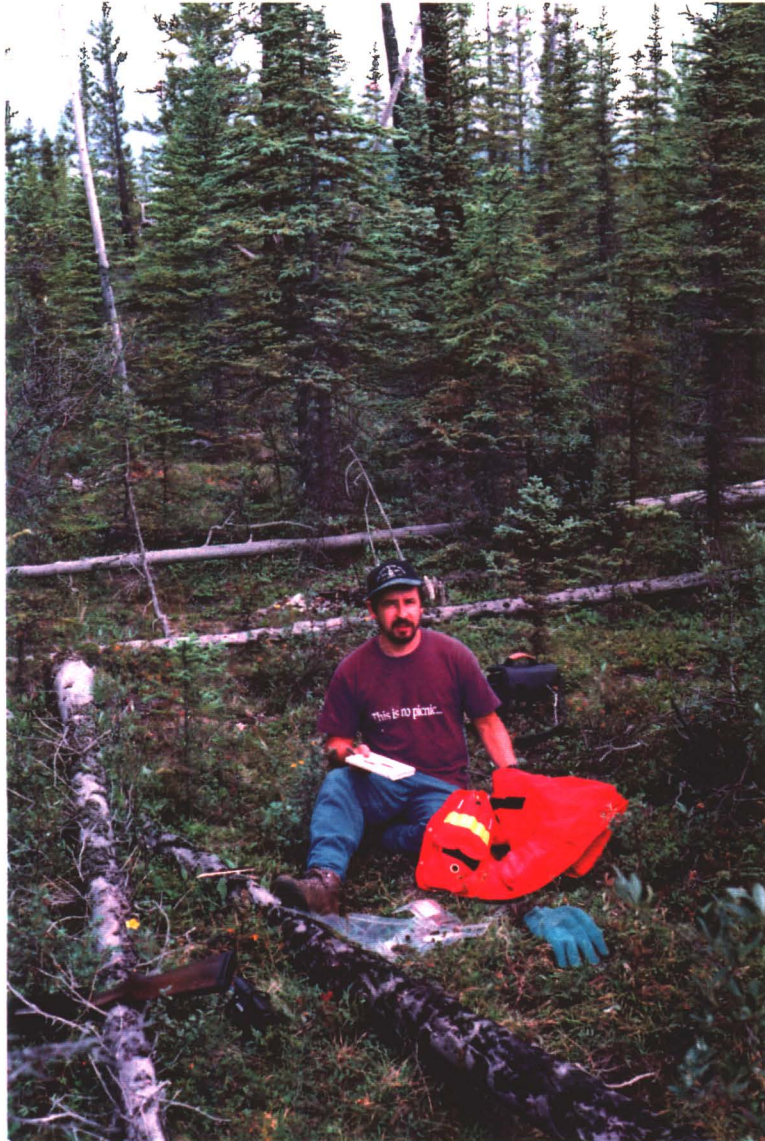
Photo 3.1.2: Ground cover re-establishment and recolonization  
in the Mile 207.6 spill over the past 20 years.

A notable recovery in vegetation has occurred at this site since the above study was conducted over the past 20 years. Although the original area of damage is still demarcated by the presence of dead, sometimes burnt spruce (standing and fallen), the abundance and diversity of ground cover has increased significantly and includes many successional species which were previously absent or severely reduced (Photo 3.1.2): willow (*Salix* sp.) cingefoil (*Potentilla* sp.), soap berry (*Shepherdia* sp.), bear berrys, twin flower, crow berry, willow-herb (*Epilobium* sp.), lupine (*Lupinus* sp.), fernweed (*Pedicularis* sp.), sweet coltsfoot (*Petasites* sp.), mountain cranberry (*Vaccinium* sp.), bluegrass (*Poa* sp.) and other grasses, sedges (*Carex* spp.), and moss (*Spaghnum* sp.). A number of young white spruce (up to 1.5 m in height) are also colonizing the spill area suggesting this site is beginning to revert back to its "natural" or original state.

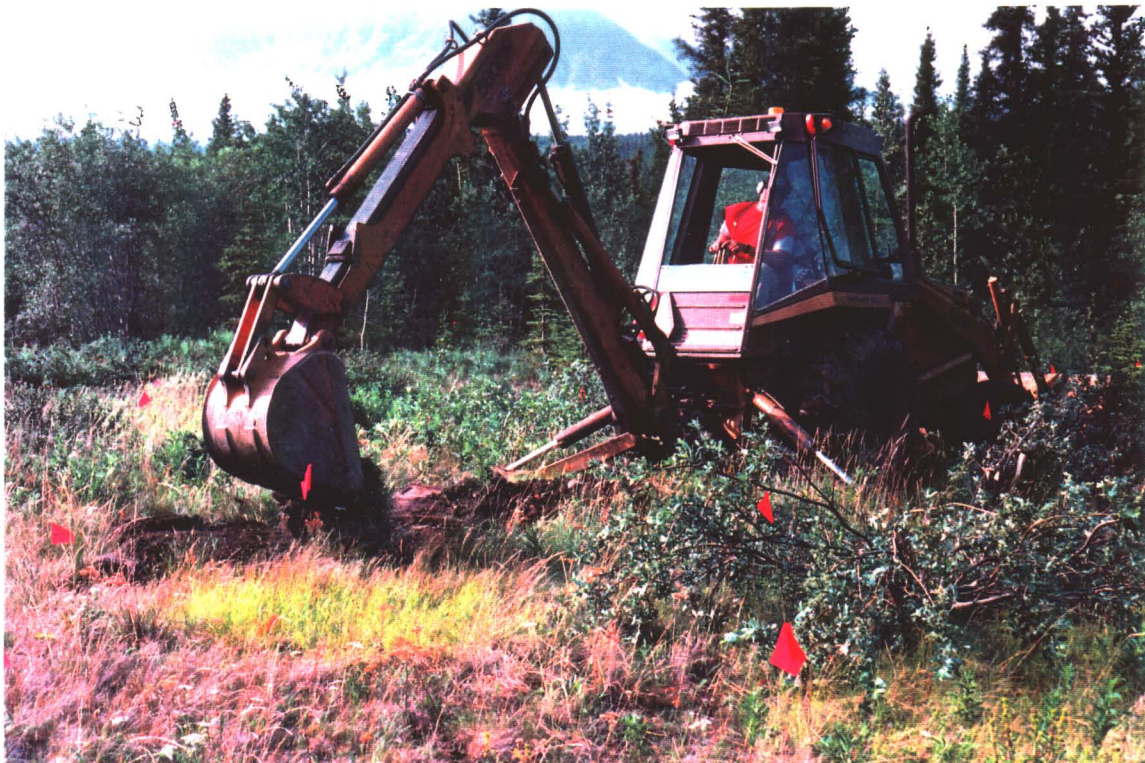
Photo 3.2.2: Re-establishment of vegetation including trees, shrubs (willow) and grasses in larger, suspected dumpsite area west of Junction Station site. Excavation of test pit.

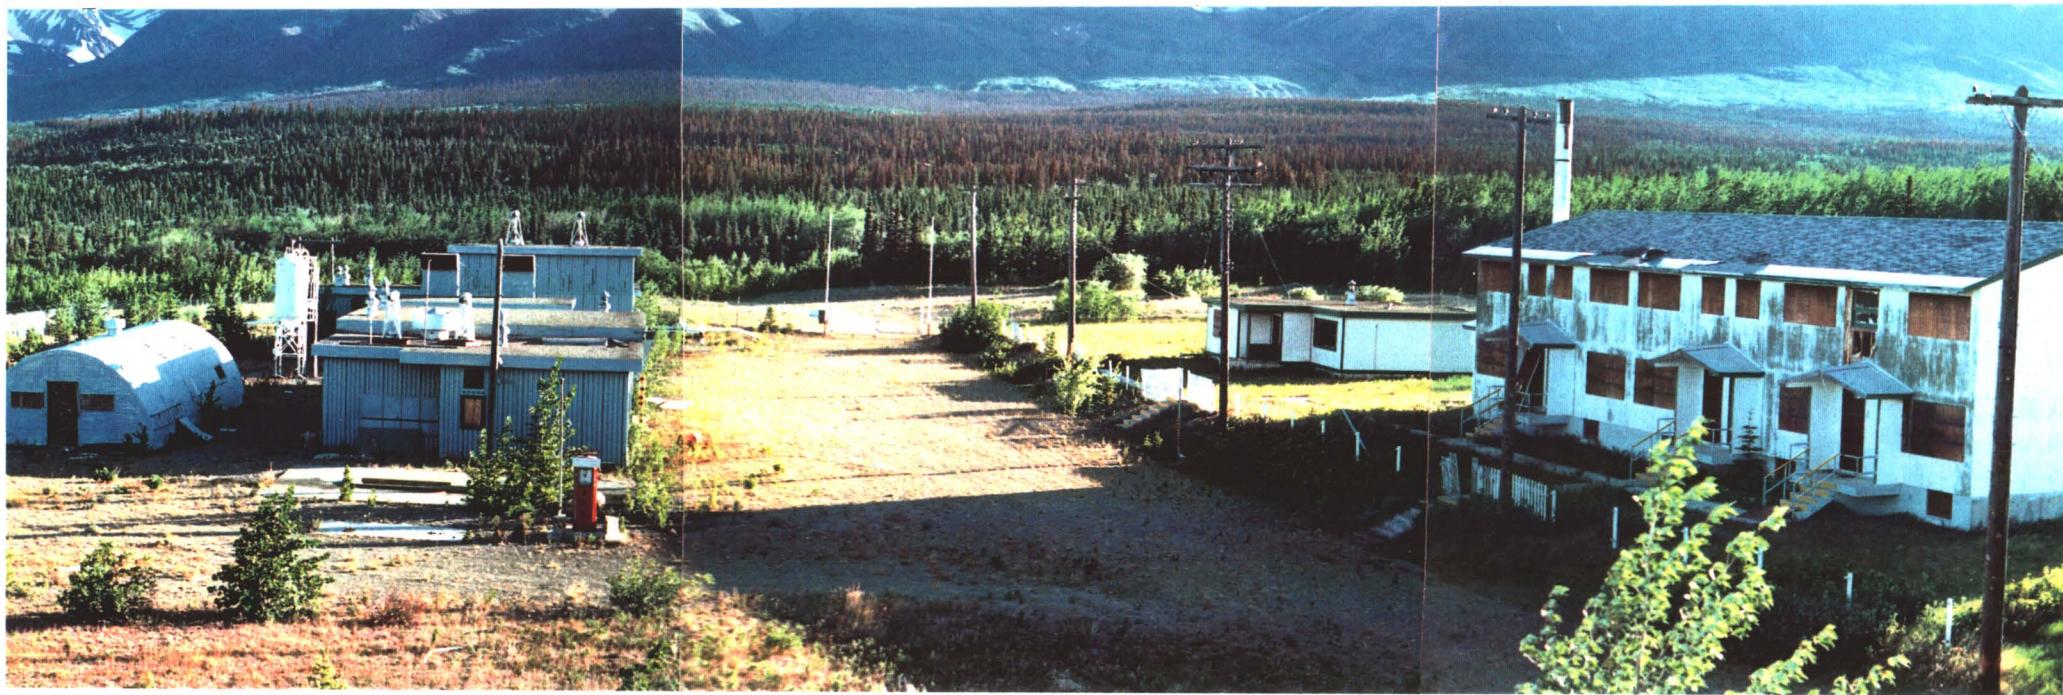
Photo 3.2.3: Haines Junction Pump Station - looking west from the POL tank

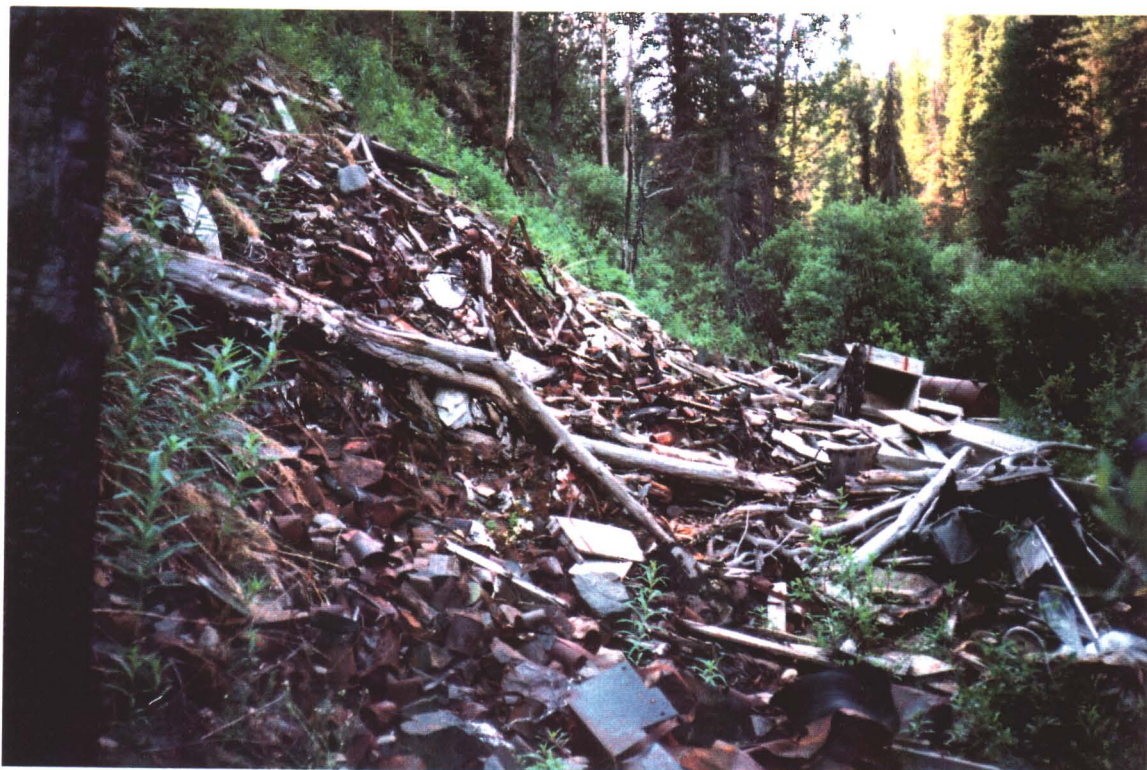
Photo 3.3.2: Dump along ravine at west side of Million Dollar Falls site.

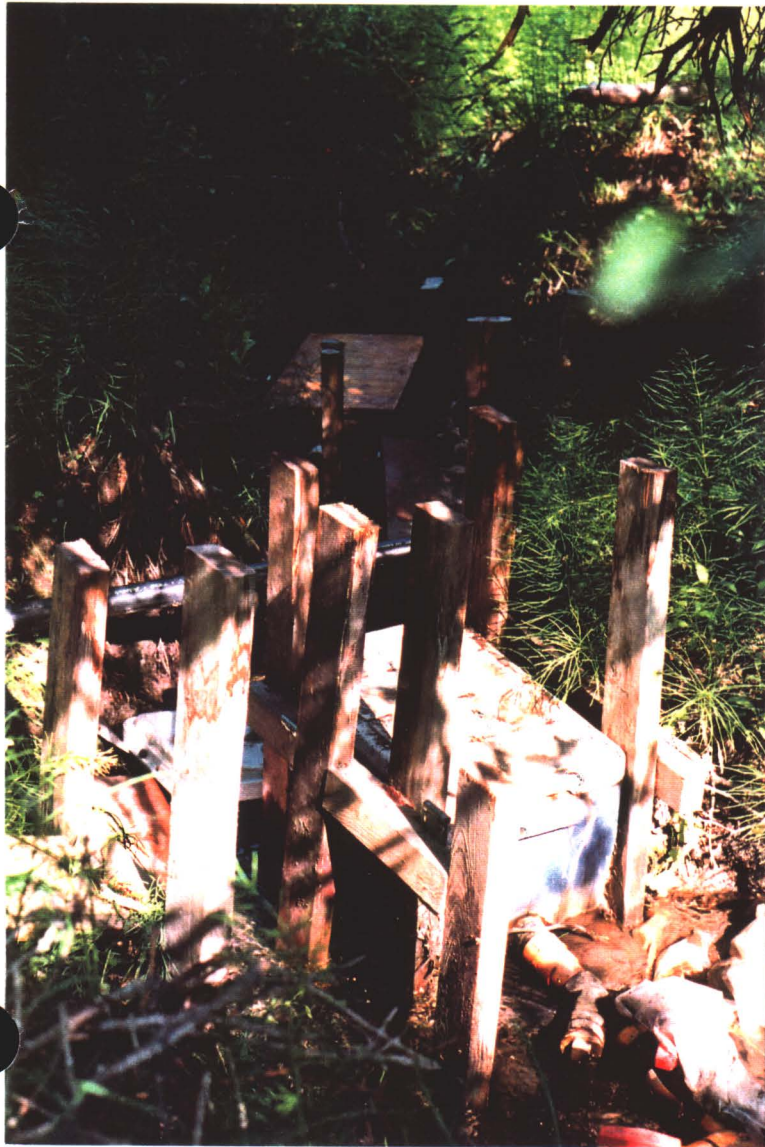
Photo 3.3.3: Small salmon hatchery in creek along ravine west of site.

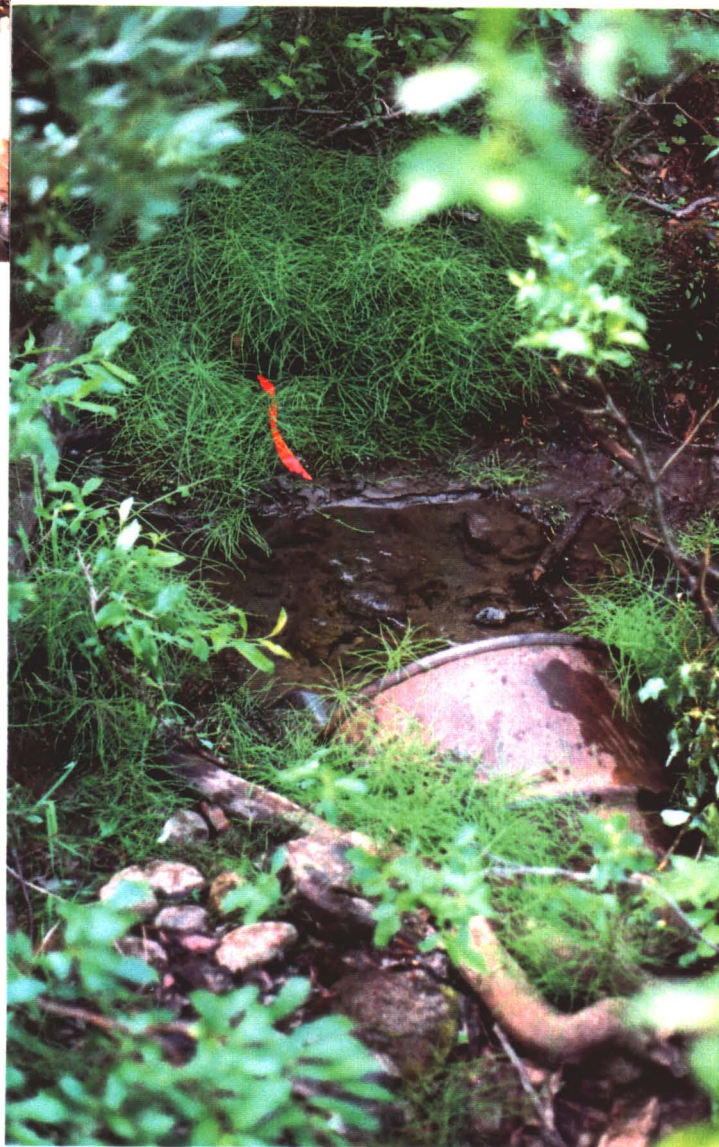
Photo 3.3.4: Partially buried barrel in creek bed upstream from the Takhanne River.

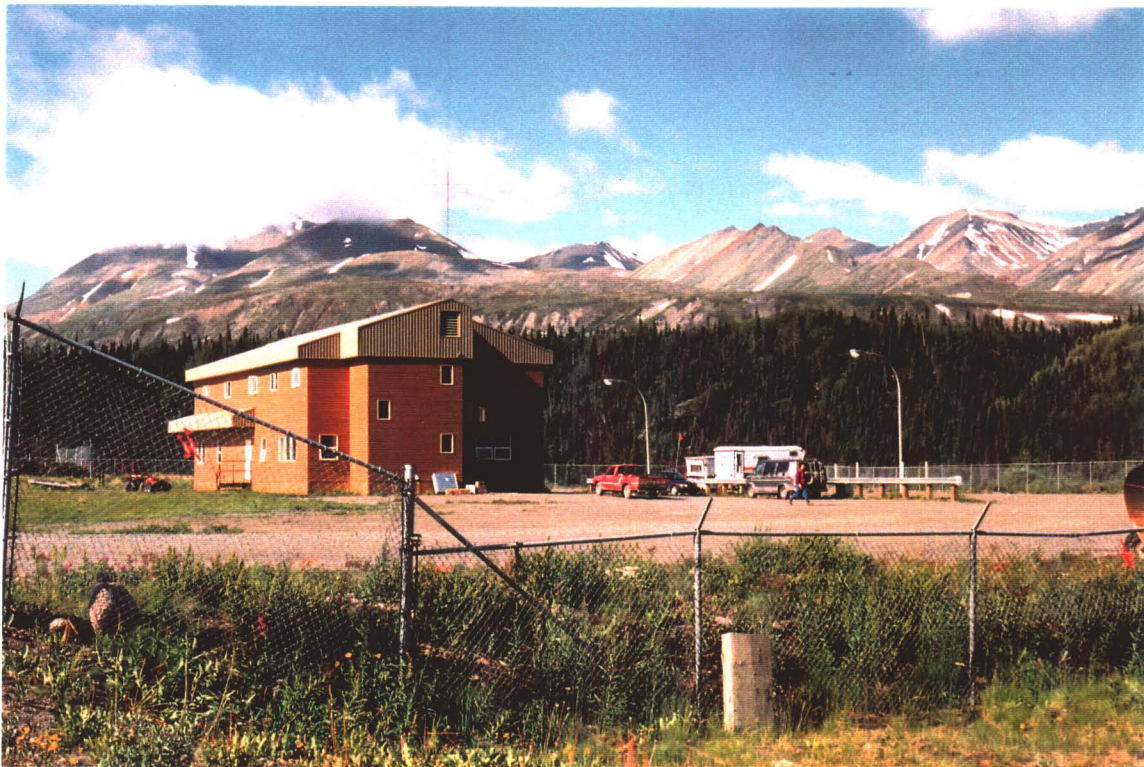
**FIGURE 5**

Blanchard River Station originally consisted of one main multi-purpose building which housed the engine room, pumps, generators, maintenance shop and water supply; and six accommodation trailers used as family housing. Two POL storage tanks were also located at the south end of the site (Figure 5).

Electromagnetic geophysical surveys, back-hoe test pitting and drilling were employed to evaluate sub-surface conditions at Blanchard. Five geophysical grids were surveyed. Their locations are shown on Figure 5. Grid 1 was north of the residence and inside the fence line. Grid 2 was outside the fenced area on the north side of the station and encompassed the former waste site. Grid 3 was west of the residence and outside the fence line in a suspected waste disposal area. Grid 4 was south of the station in a suspected dump site. Grid 5 represents an informal survey near a hydrocarbon contaminated area on the west side of the station. EM 31 surveys were completed in all grid areas. EM 61 surveys were completed only in areas 1 and 2.

Selected soil and water samples from test pits (TP 95-1 and 95-3), test holes (TH-1, TH-2, TH-4 and TH-5), and stained locations at the west and north edges of the station were analyzed for various contaminants. These included total extractable hydrocarbons (TEHs), volatile organic compounds (VOCs), organochlorine pesticides (OCs), phenoxyacid herbicides, polycyclic aromatic hydrocarbons (PAHs) and polychlorinated biphenyls (PCBs). These results are tabulated in Appendix G. The relative positions of these sample locations are indicated in Figure 5.

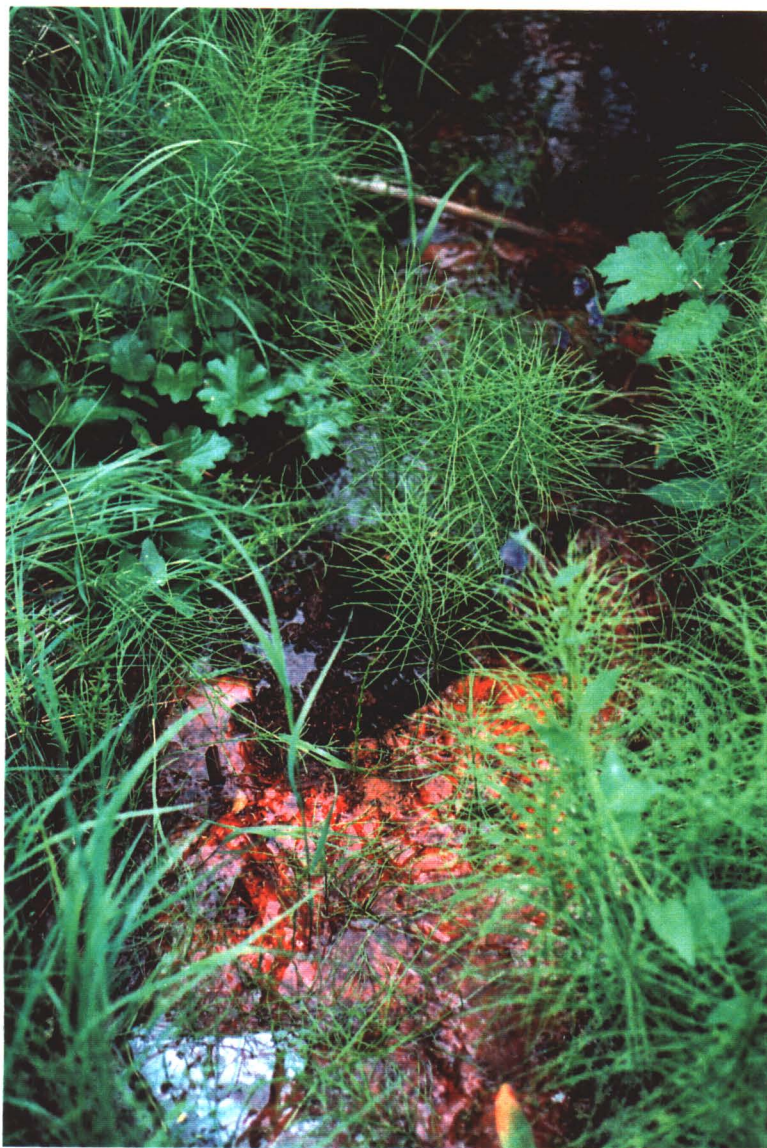
Photo 3.4.2: Rusty leachate from a spring near the top of a slope at the north end of the site.

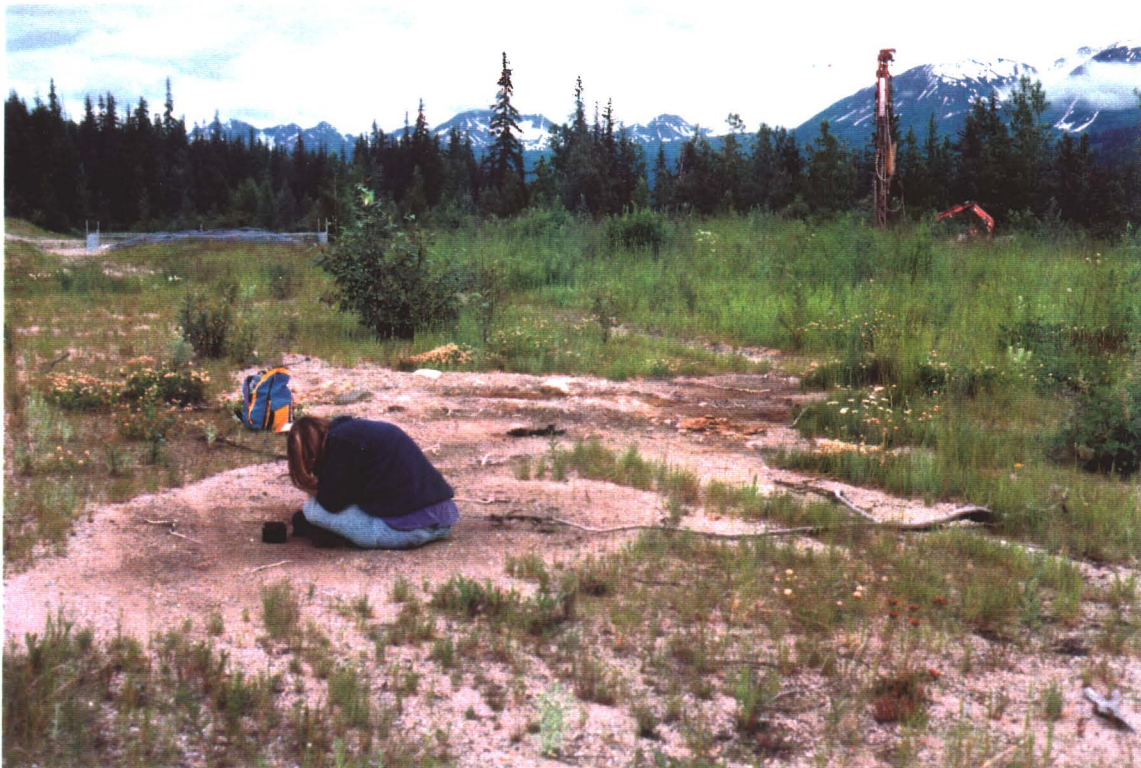
Photo 3.5.1: Large hydrocarbon stain/spill (B01S-001/002) at the west end of the site. The DDT soil storage facility and drill rig can be seen in the background to the left and right, respectively.

| Site | Problems Detected | Risk | Recommended Action |
|---|---|---|---|
| Border Pump Station | <ul style="list-style-type: none"> <li>- Soil and groundwater contaminated with hydrocarbons.</li> </ul> | <ul style="list-style-type: none"> <li>- Potential for downgradient migration to Klehini River via Rainy Hollow site.</li> </ul> | <ul style="list-style-type: none"> <li>- Collate all available contaminant and geotechnical information, and provide recommendations.</li> <li>- Resample monitoring wells MW-8a and 8b in TH-8.</li> </ul> |

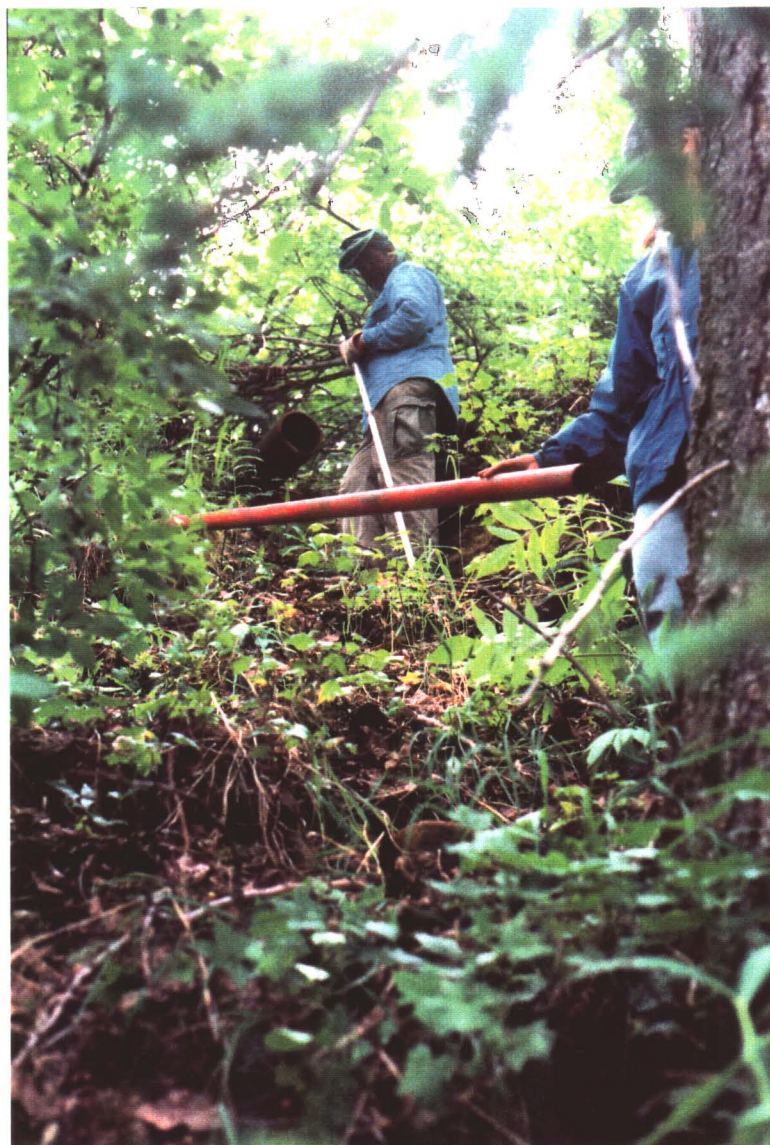
Photo 3.5.2: Two drainage pipes extending from the south side of the old Haines Road above Rainy Hollow.
